FINAL TOWN WIDE FACILITIES PLAN

TOWN OF EXETER

SPACE NEEDS AND BUILDING ASSESSMENTS

DECEMBER 16, 2015

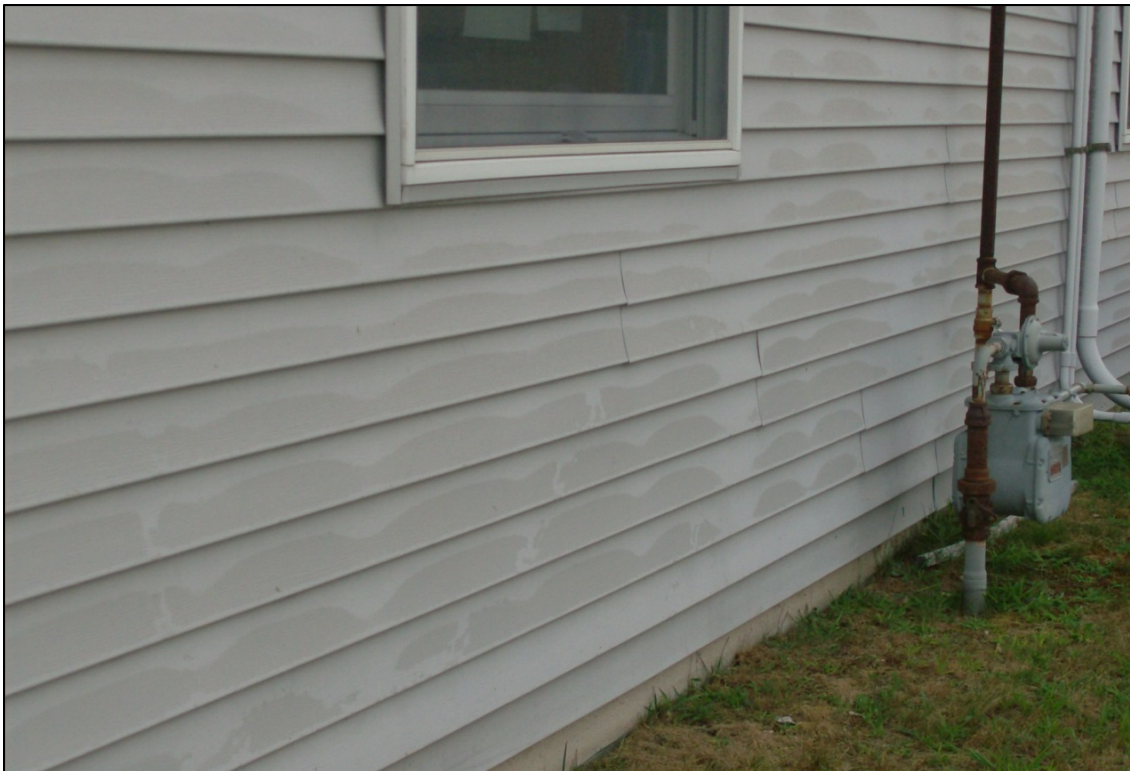
Condensation formed early morning on south side of building.

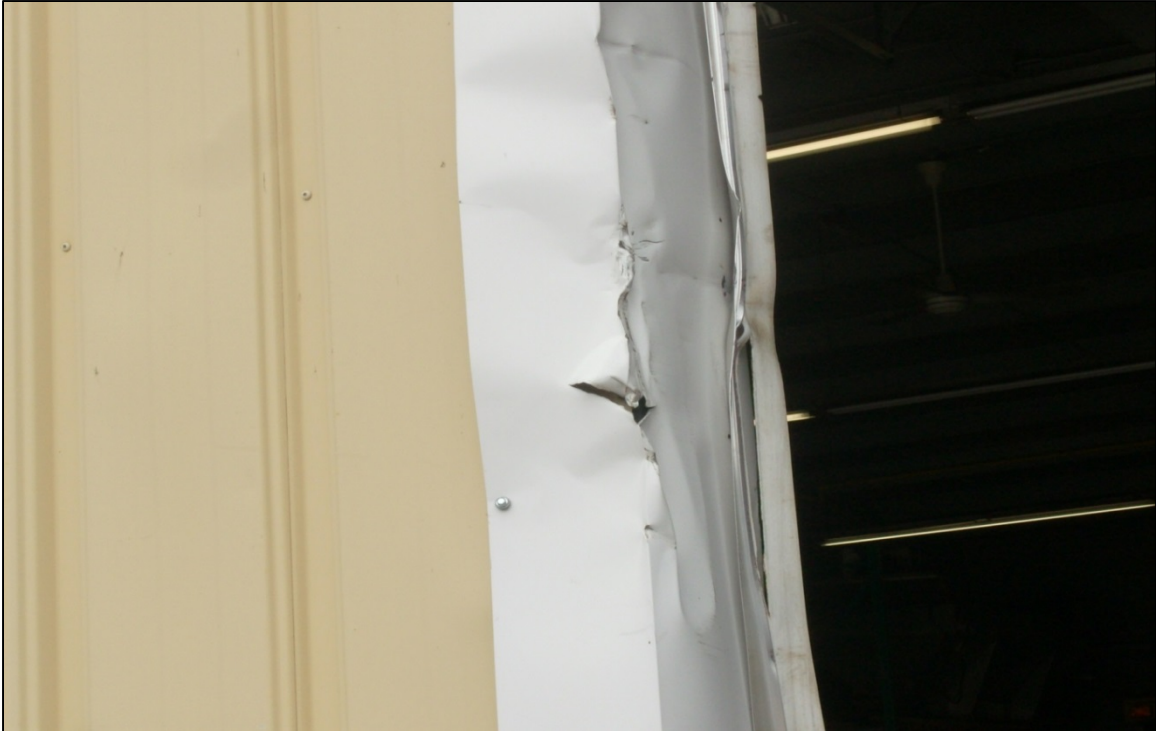
Damage to door jamb at one of the truck bays.

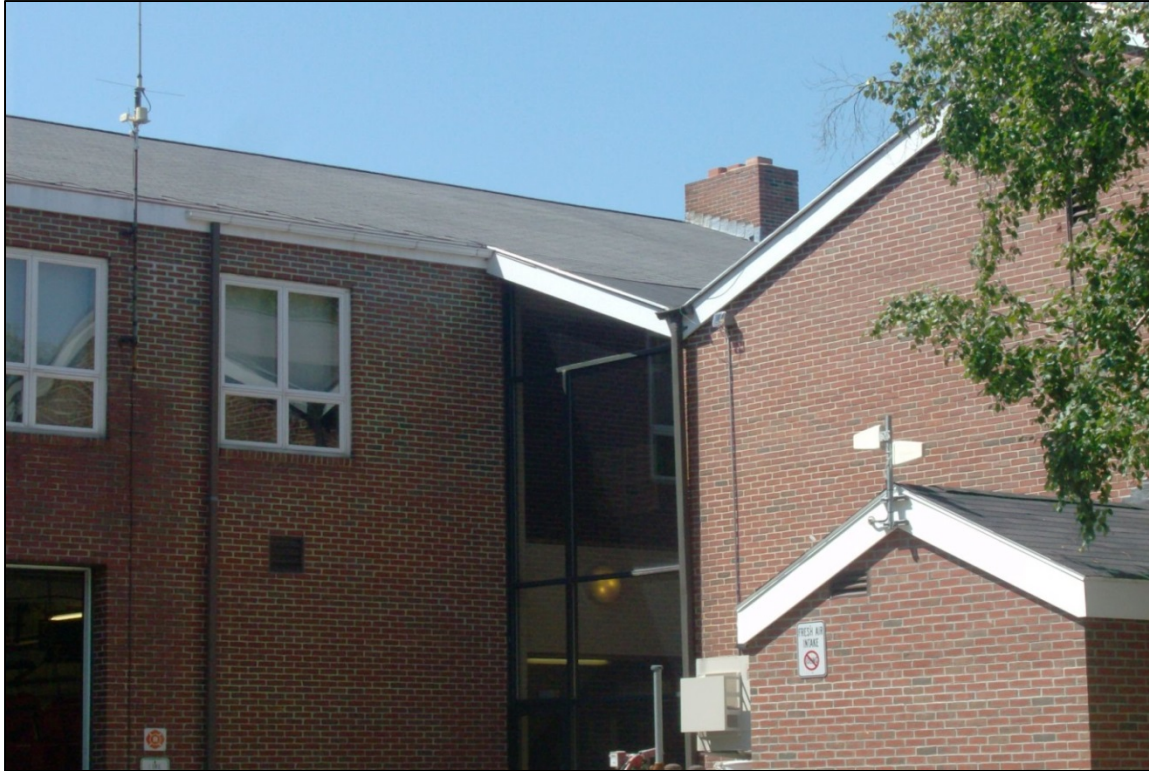
South edge of roof valley over central portion of building.

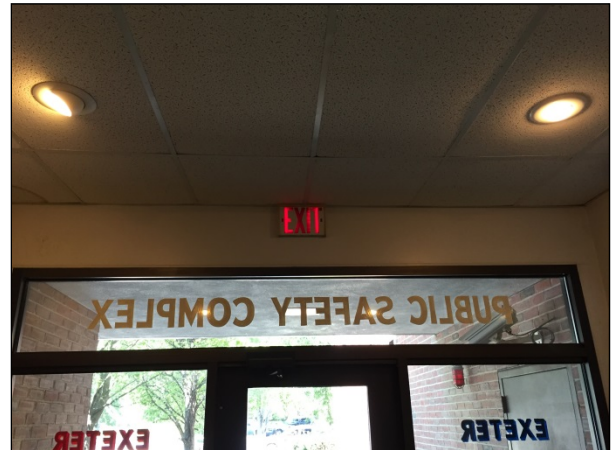
Plastic Incandescent Exit Sign

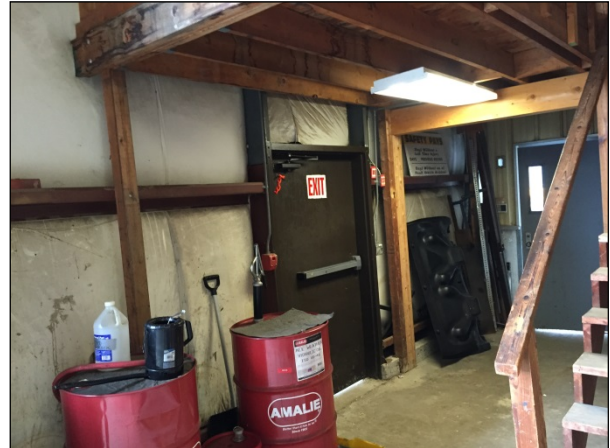
Plastic Non-Illuminated Exit Sign

- Provide additional fire alarm notification devices and replace older devices with new devices.
- Provide 120V battery backed-up emergency exit signs and emergency battery units throughout to meet all life safety requirements.

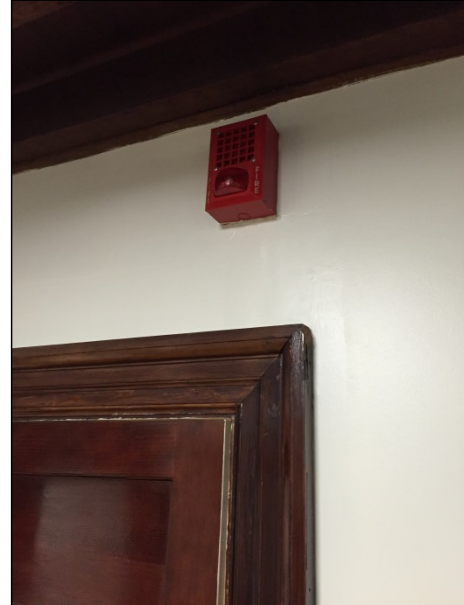
Existing Fire Alarm Audio Visual Device

It is recommended notification devices shall be replaced with new ADA style devices and additional devices added to meet NFPA coverage requirements. Additional smoke detectors shall be provided on 30'-0" centers in corridors and open office areas. Existing pull stations shall be relocated to 48" to meet ADA requirements.

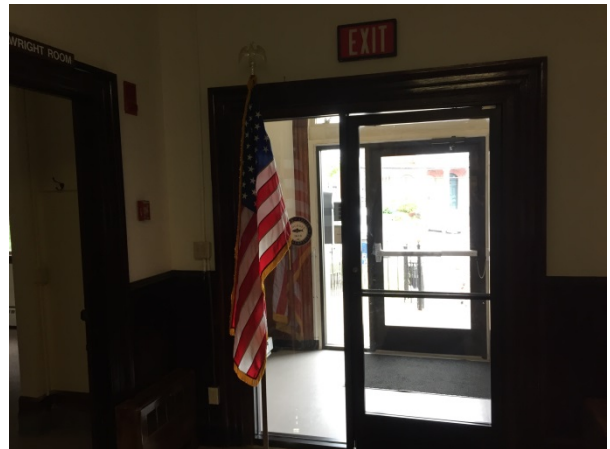
Plastic Iridescent Non-Illuminated Exit Sign

- Provide additional fire alarm notification devices and replace older devices with new devices.
- Provide 120V battery backed-up emergency exit signs and emergency battery units throughout to meet all life safety requirements.
- Exhaust stack for the generator exhaust shall be reviewed and run to the top of the roof line as required.

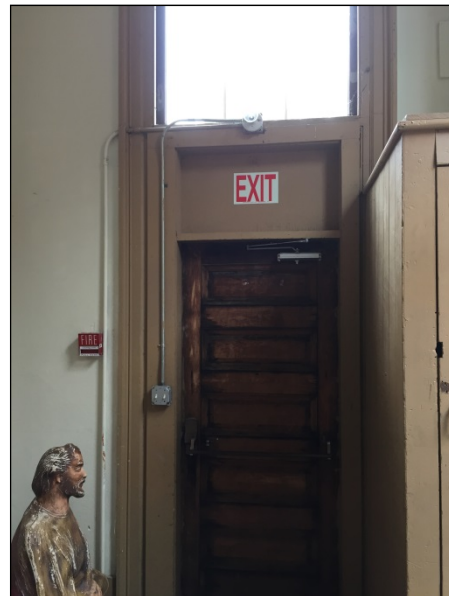
Plastic Non-illuminated Exit Sign

- Provide additional fire alarm notification devices and replace older devices with new devices.
- Provide 120V battery backed-up emergency exit signs and emergency battery units throughout to meet all life safety requirements.

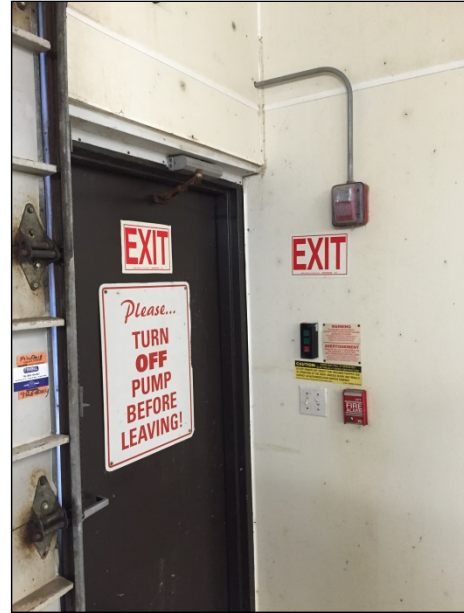
Plastic Non-Illuminated Exit Sign

- Provide additional fire alarm notification devices and replace older devices with new devices.
- Provide 120V battery backed-up emergency exit signs and emergency battery units throughout to meet all life safety requirements.
