Chase Wiggin Barn Exeter, New Hampshire

Historic Structures Report

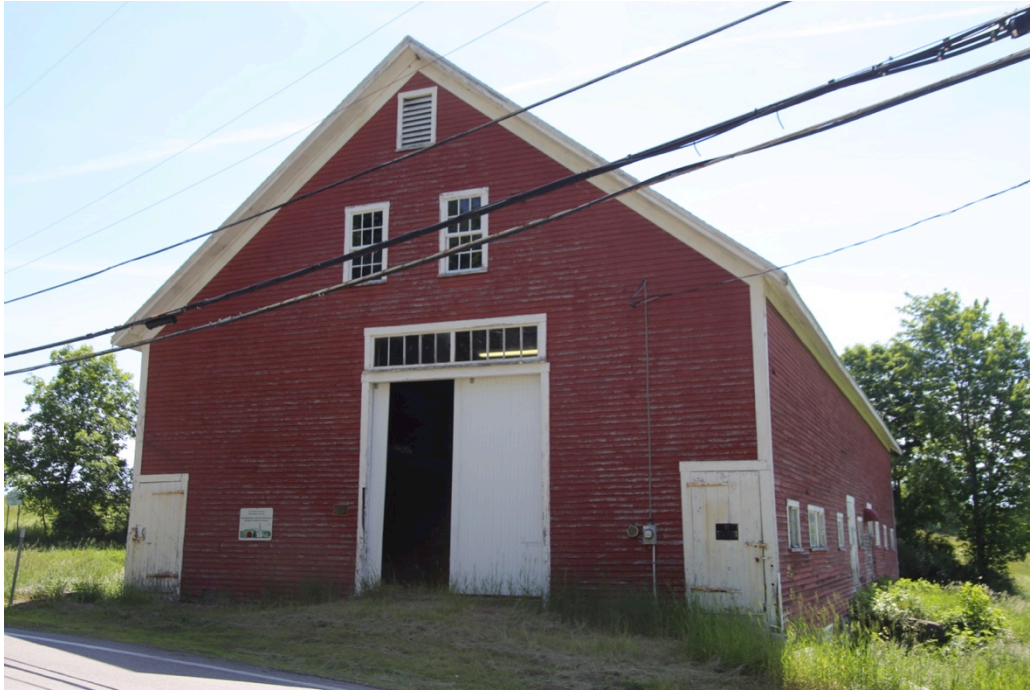
West gable end from Newfields Road, 2018

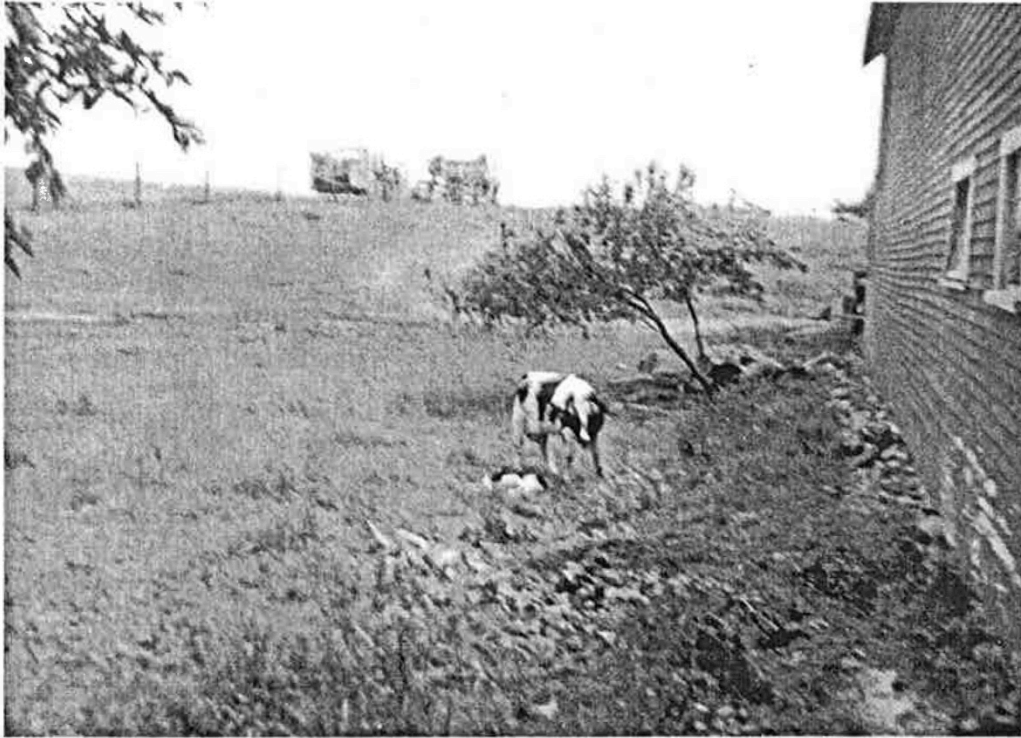
North elevation, facing east, before overhead door area was dug out. Historic photo ca. 1950.

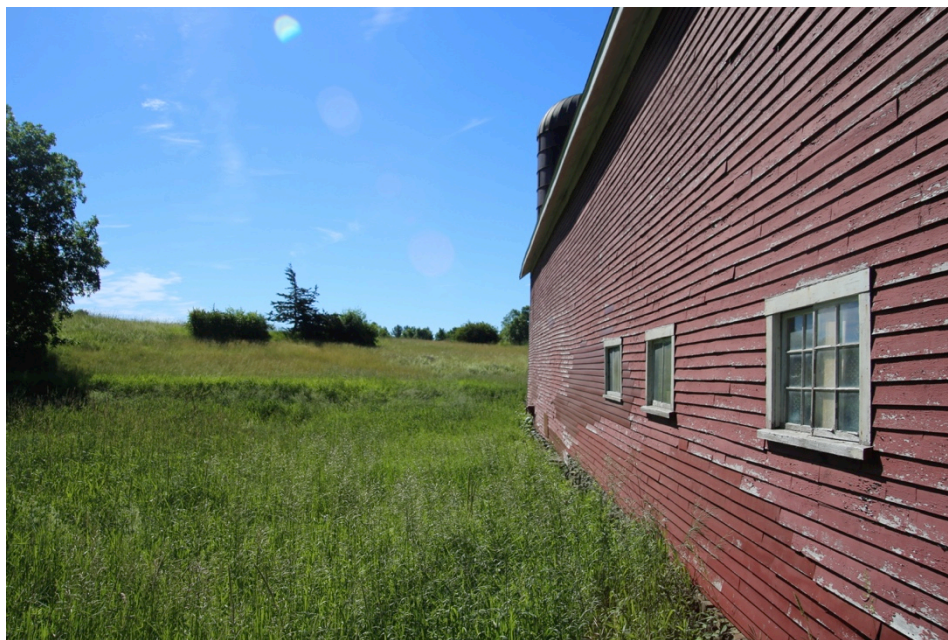
North elevation after repairs to foundation, 2018

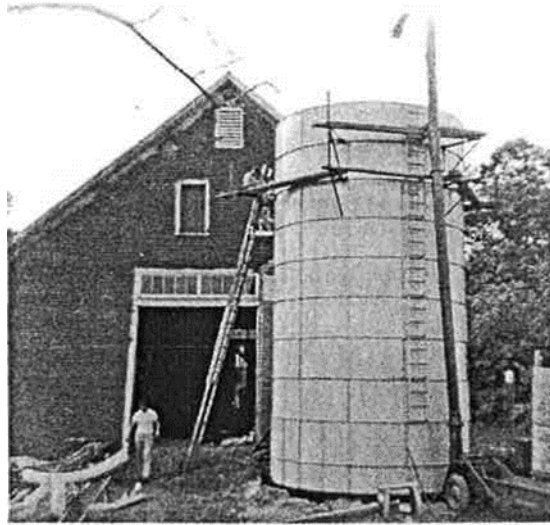
Historic photo of barn and silo under construction, ca. 1958. Note that the domestic door on the southeast corner did not exist.

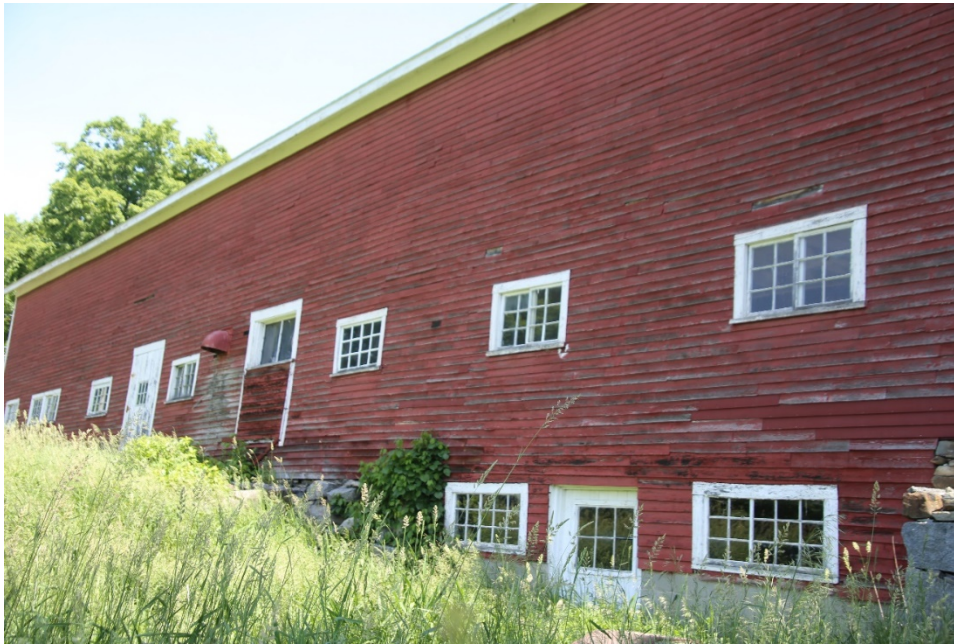
Photo 13) South elevation, showing variety of windows and condition of clapboards
Direction: WNW

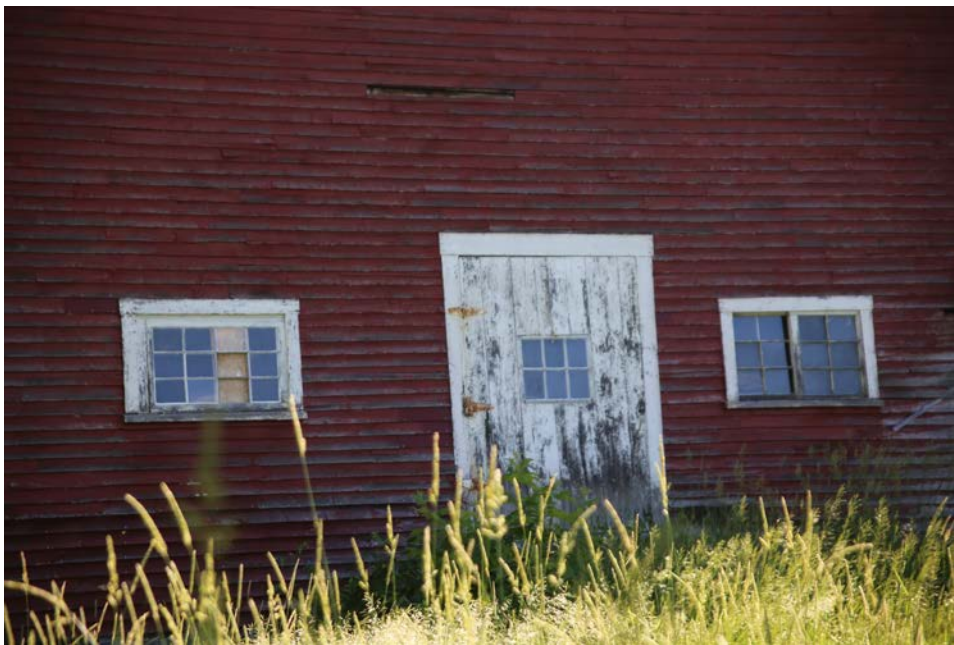
Photo 14) South elevation, cow door at top of ramp, showing window conditions
Direction: NNE

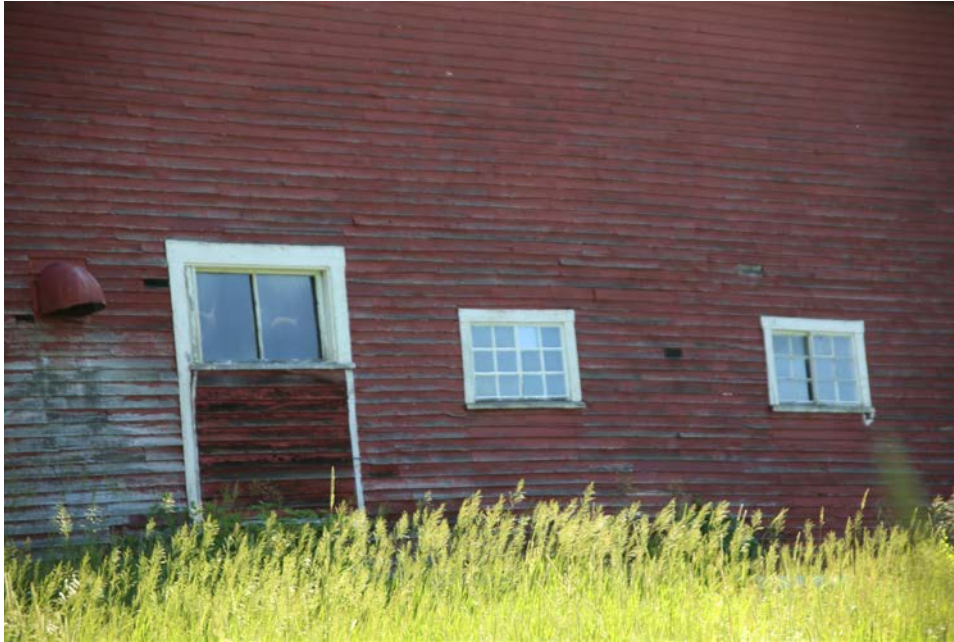
Photo 15) South elevation, infilled door with clapboards and window sash, showing window conditions and ventilator hood at left

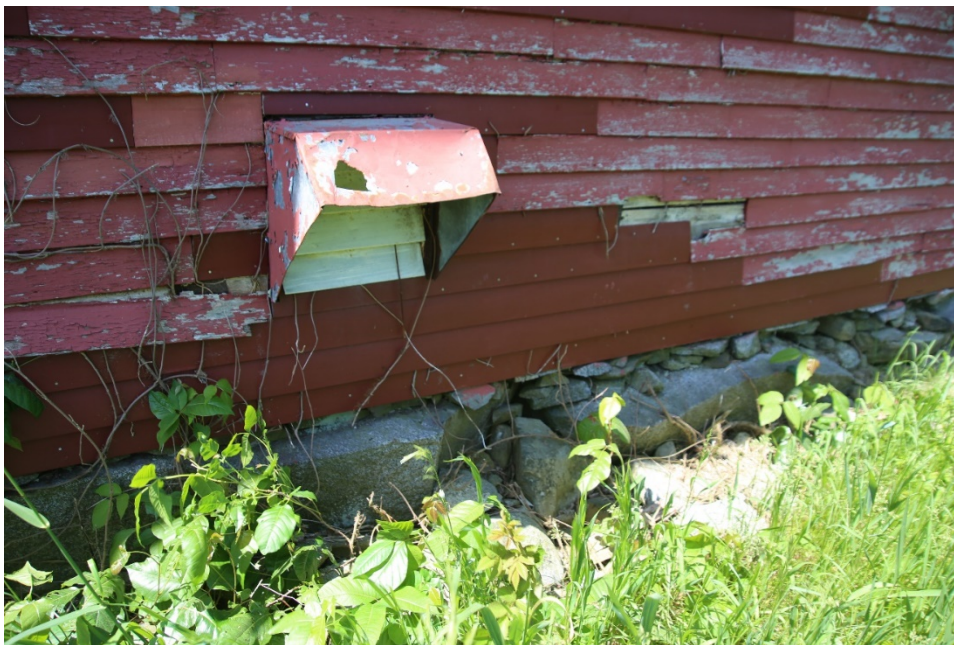
Photo 16) North elevation, ventilator hood

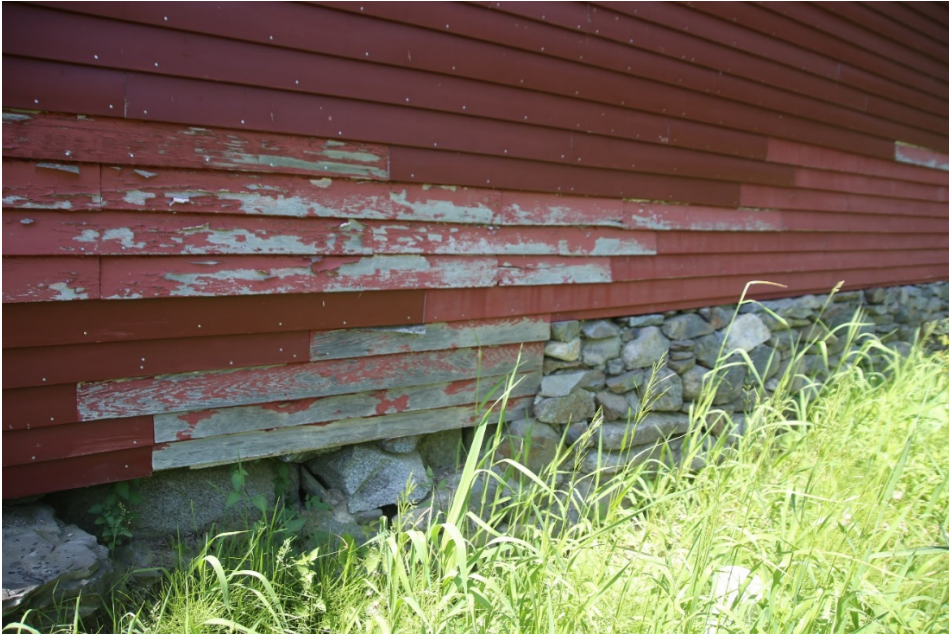
Photo 17) North elevation, showing clapboard condition and foundation walls. Foundation wall repair from 2004 seen at right, failing foundation wall in need of repair at left.
Direction: SE

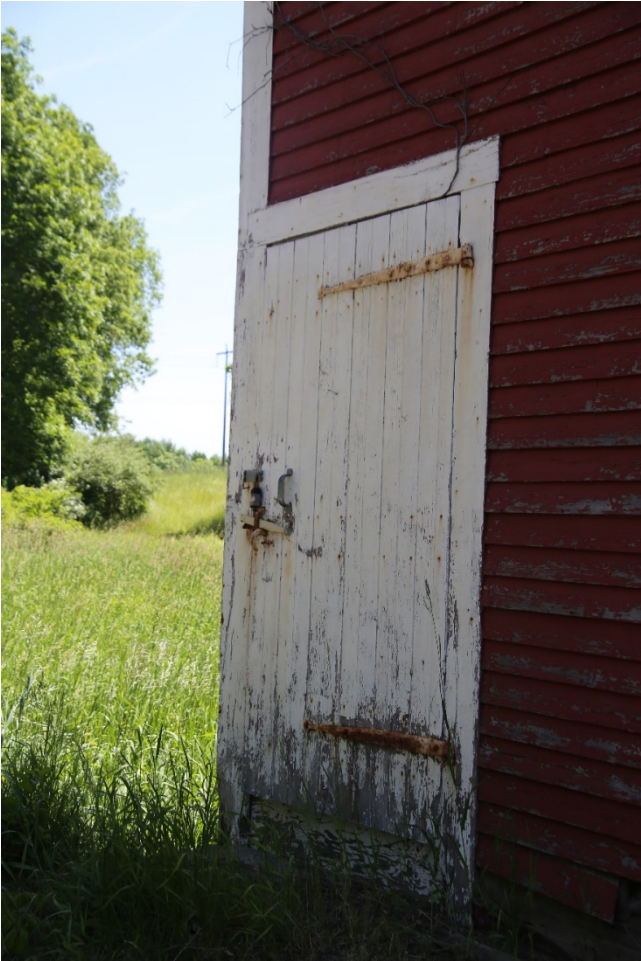
Photo 19) West elevation, door at south end
Direction: NE

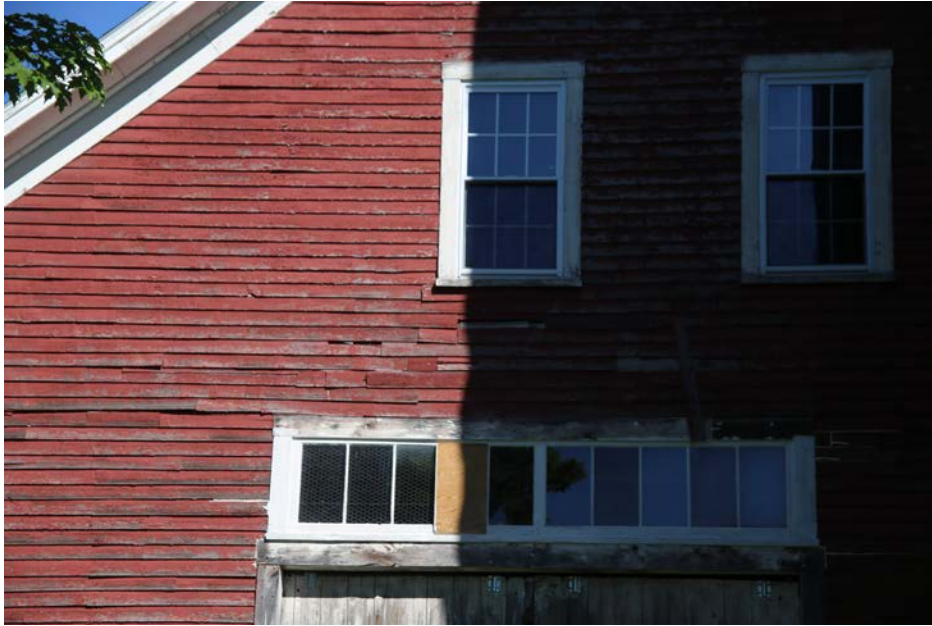
Photo 21) East elevation, showing clapboard condition and broken transom lights, vinyl replacement windows in gable
Direction: W

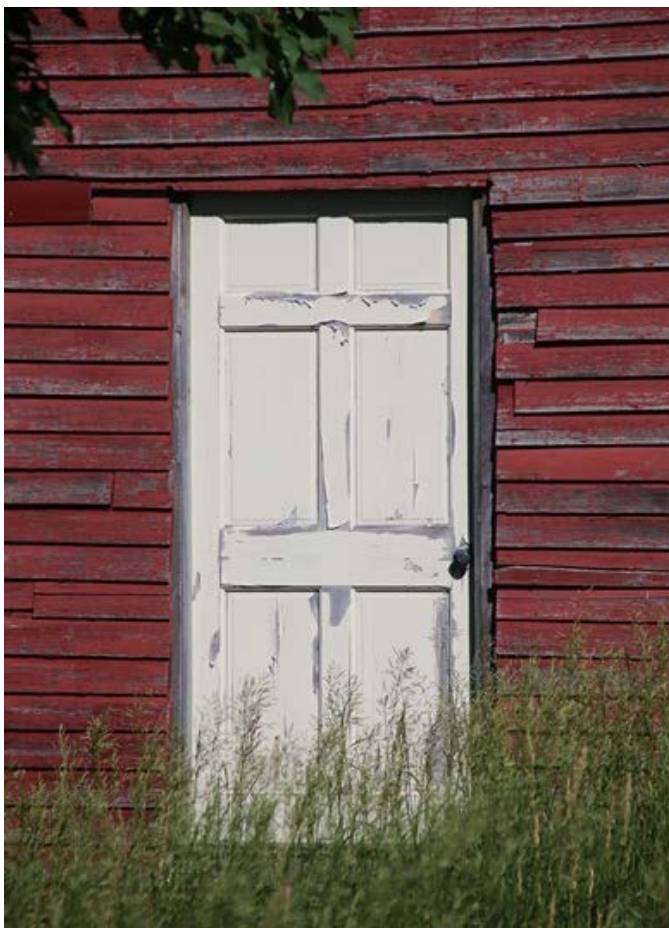
Photo 22) East elevation, south doorway, showing 1960s residential door in former sliding door opening
Direction: W

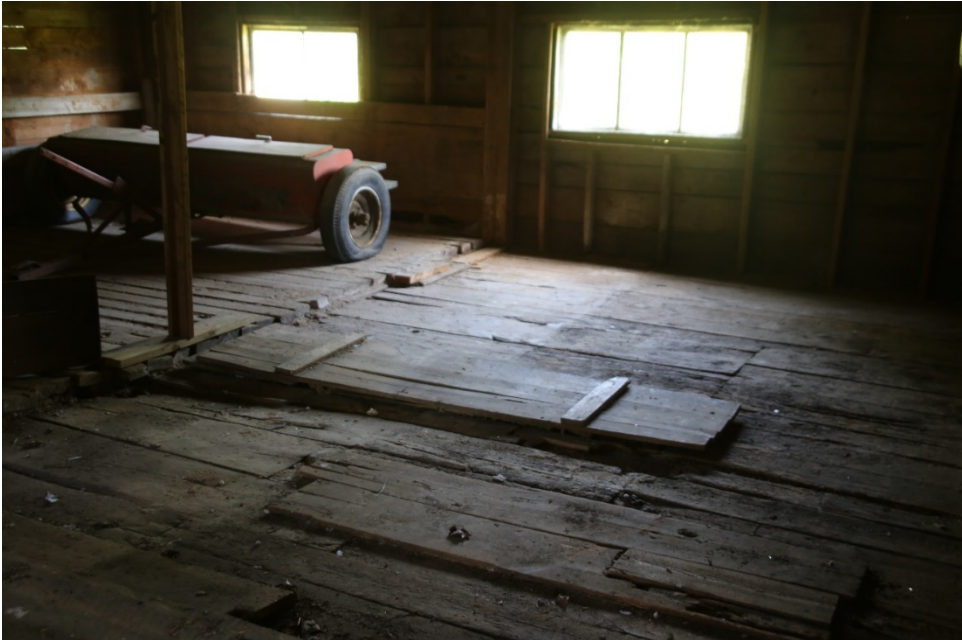
Photo 31) Floor condition, carriage storage area, north aisle
Direction: NW

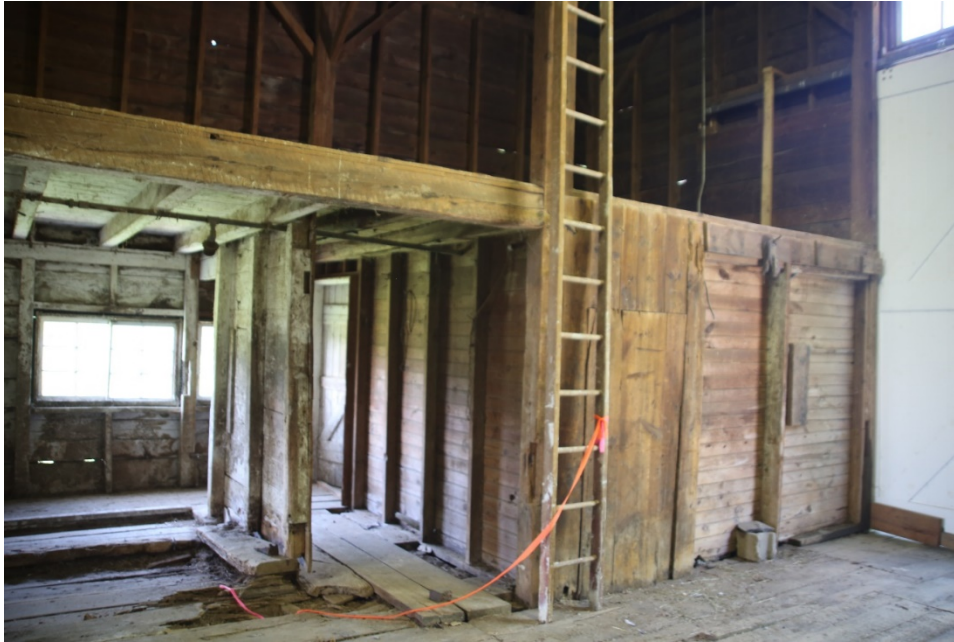
Photo 37) Southwest corner milk room, ladder to hayloft, animal tie up area at left with deteriorated flooring at stanchion
Direction: SW

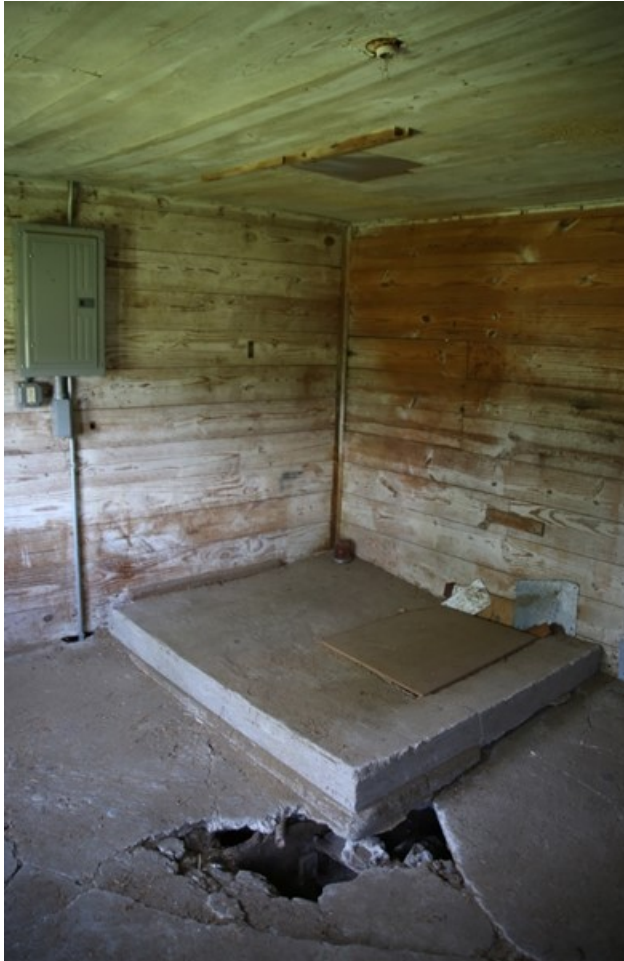
Photo 38) Main floor milk room later grain room, southwest corner, showing yellow pine walls and ceiling boards, deteriorated concrete floor, and upgraded electrical system
Direction: NW

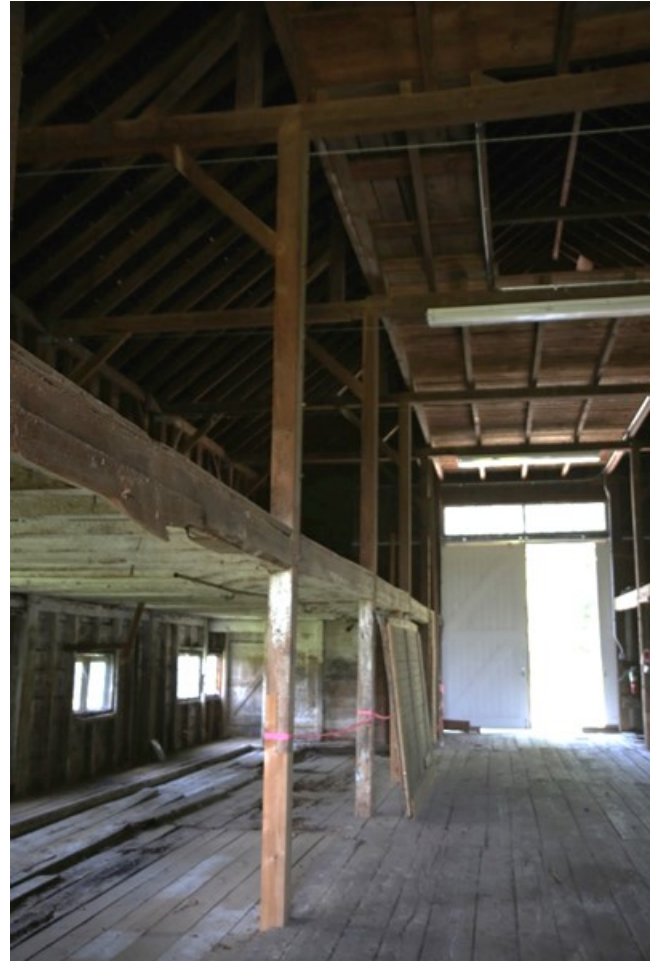
Photo 39) Central drive bay and south aisle with hayloft above, looking west
Direction: W

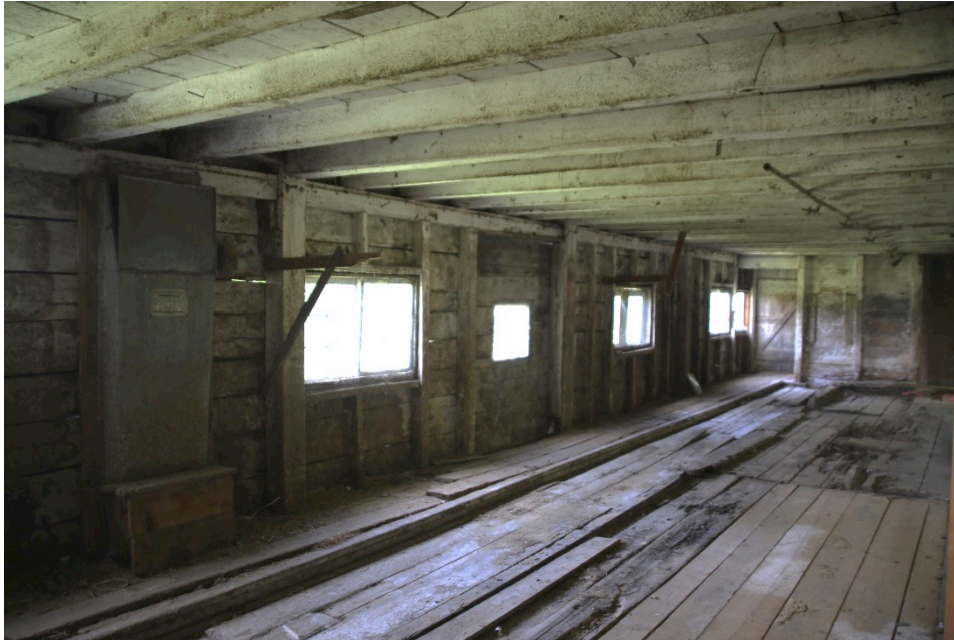
Photo 40) South aisle and whitewashed animal tie up area, outline of original gutter, showing deteriorated floor condition

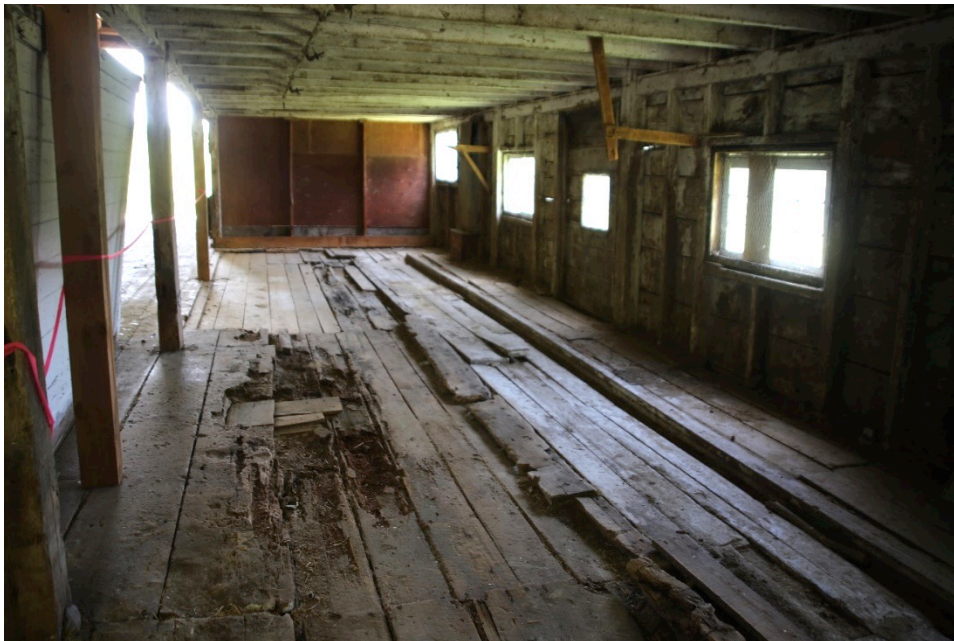
Photo 41) South aisle and whitewashed animal tie up area, showing deteriorated floor condition

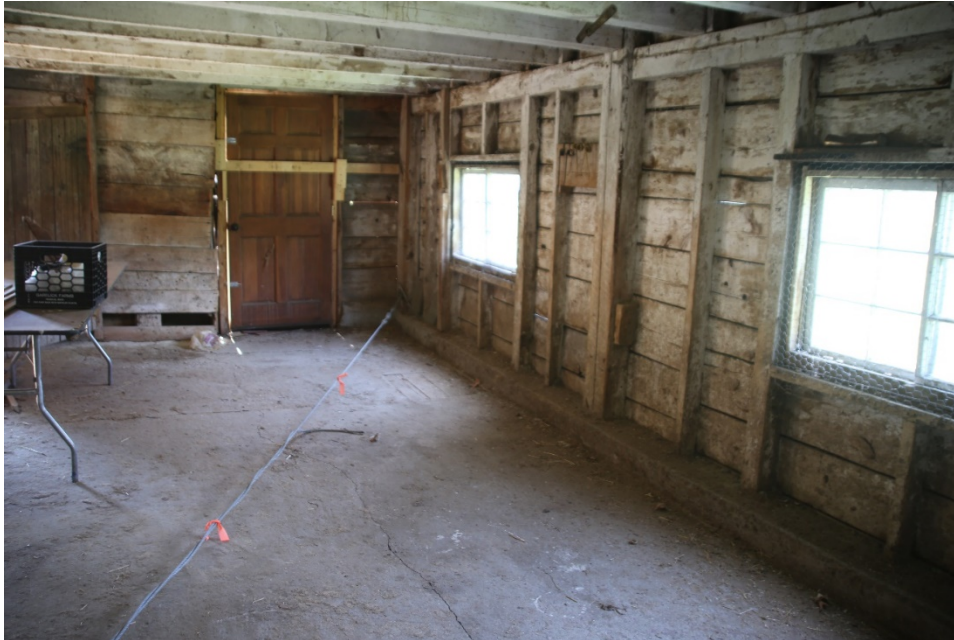
Photo 42) Southeast room, privy area with whitewashed walls and 1960s residential door in former sliding doorway. Assume cable introduced to maintain integrity of corner posts while foundation was being repaired.

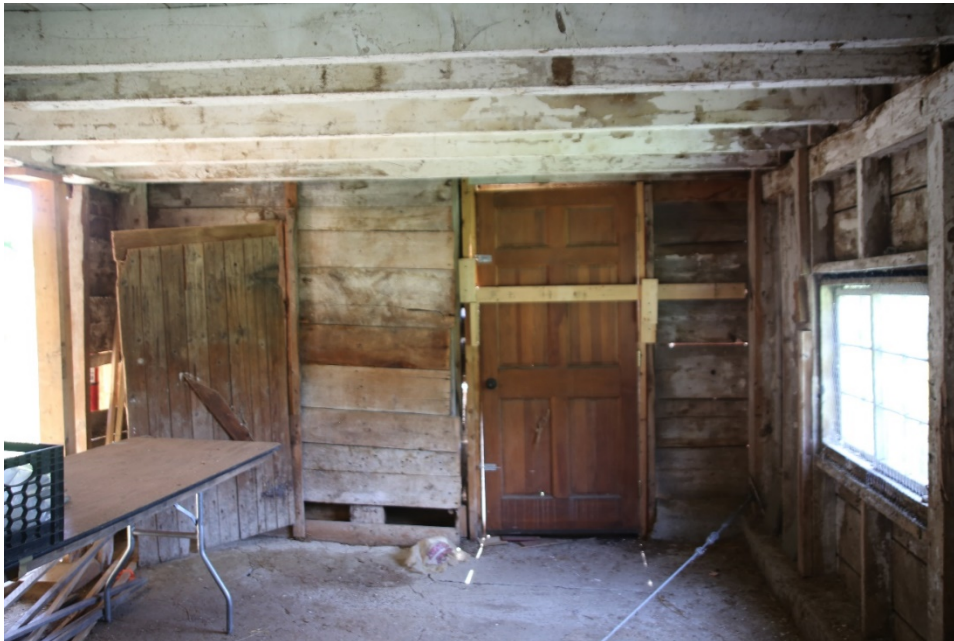
Photo 43) Southeast corner and wall, whitewashed privy area, showing 1960s residential door
Direction: E

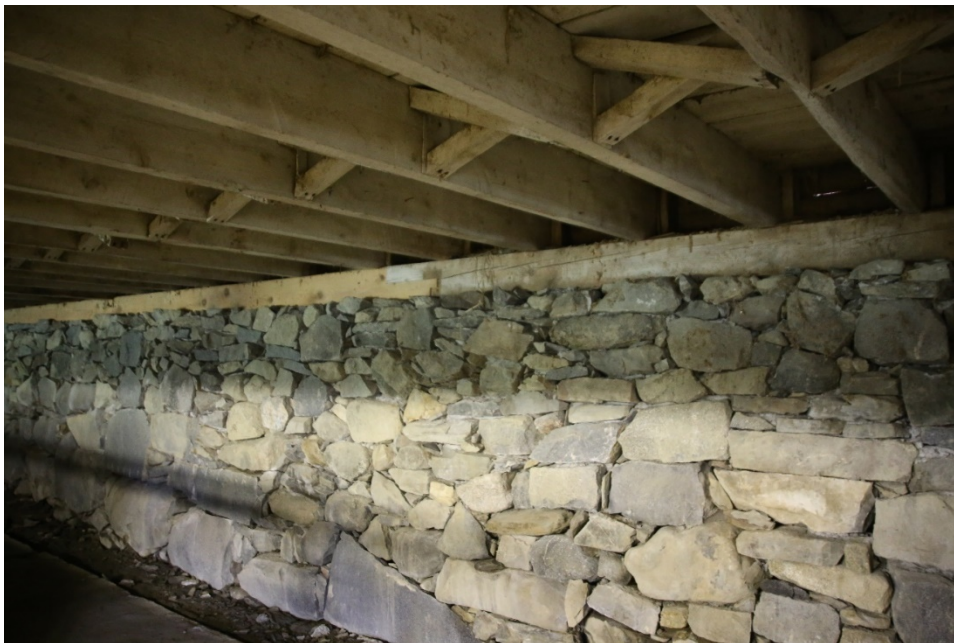
Photo 55) Interior of north foundation wall, reconstructed in 2004
Direction: NNW

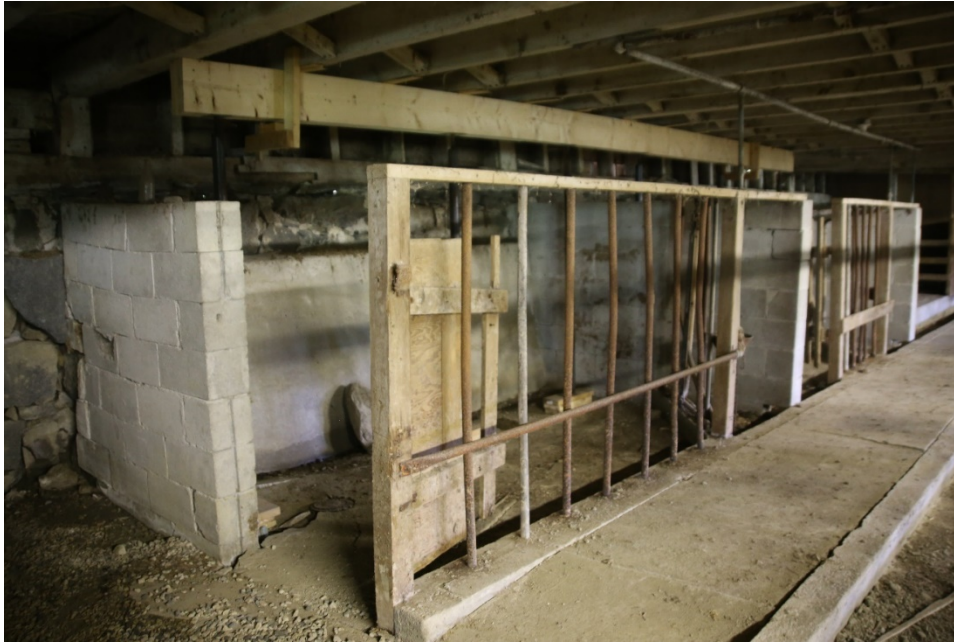
Photo 56) Milking area, calf pens North wall, showing temporary support to northeast floor joists
Direction: NNE

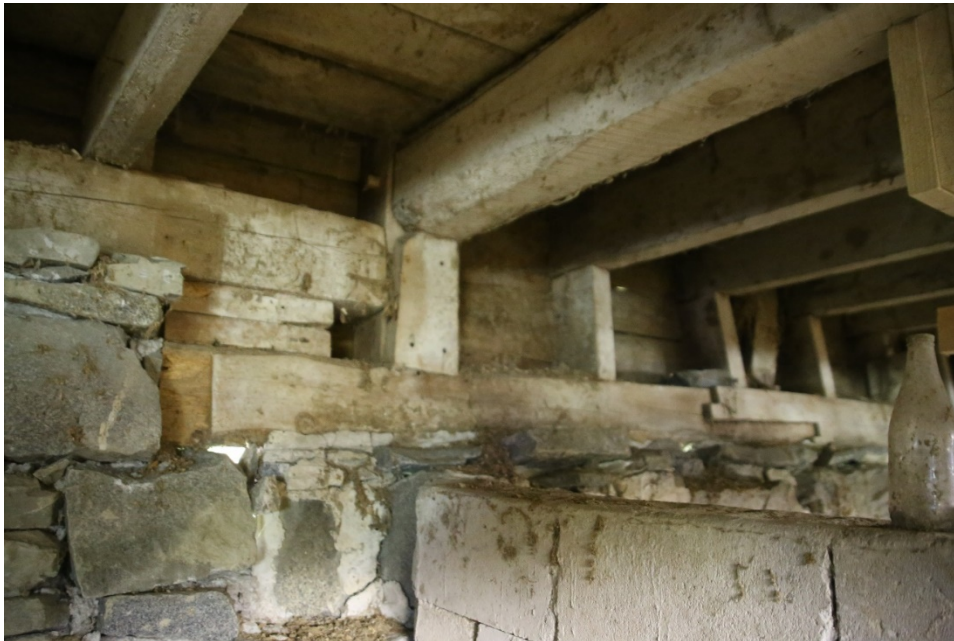
Photo 57) North foundation wall and sill, reconstructed area to left
Direction: NNE

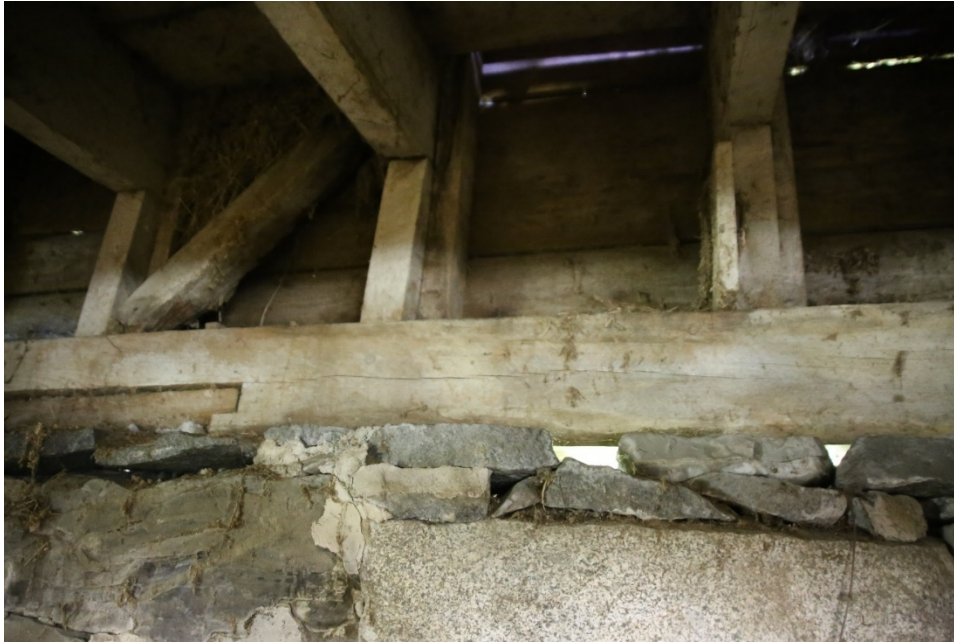
Photo 58) North foundation wall and sill, replaced sill
Direction: N

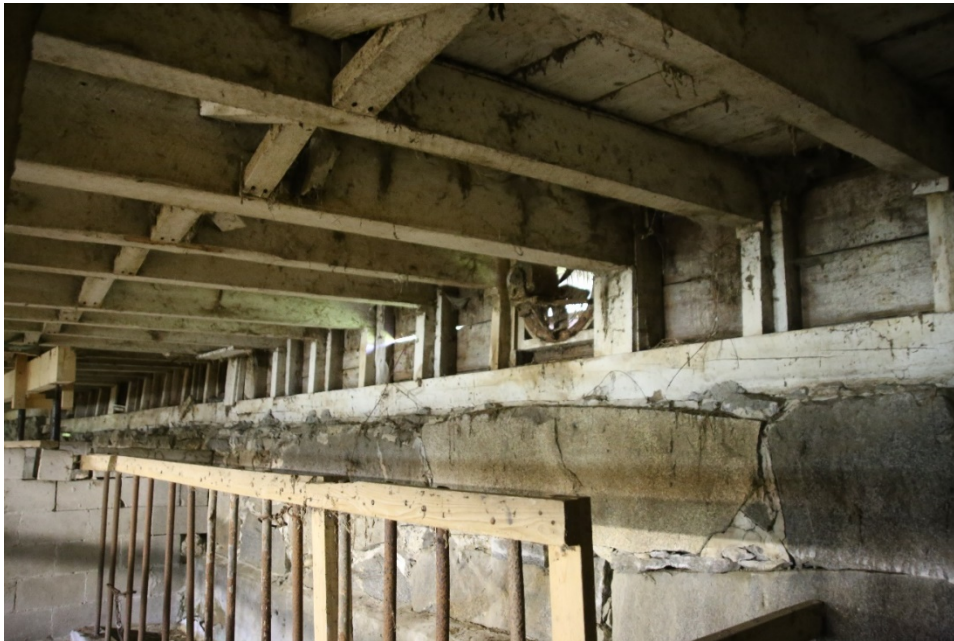
Photo 59) East end of North foundation wall and sill, exhaust fan
Direction: NW

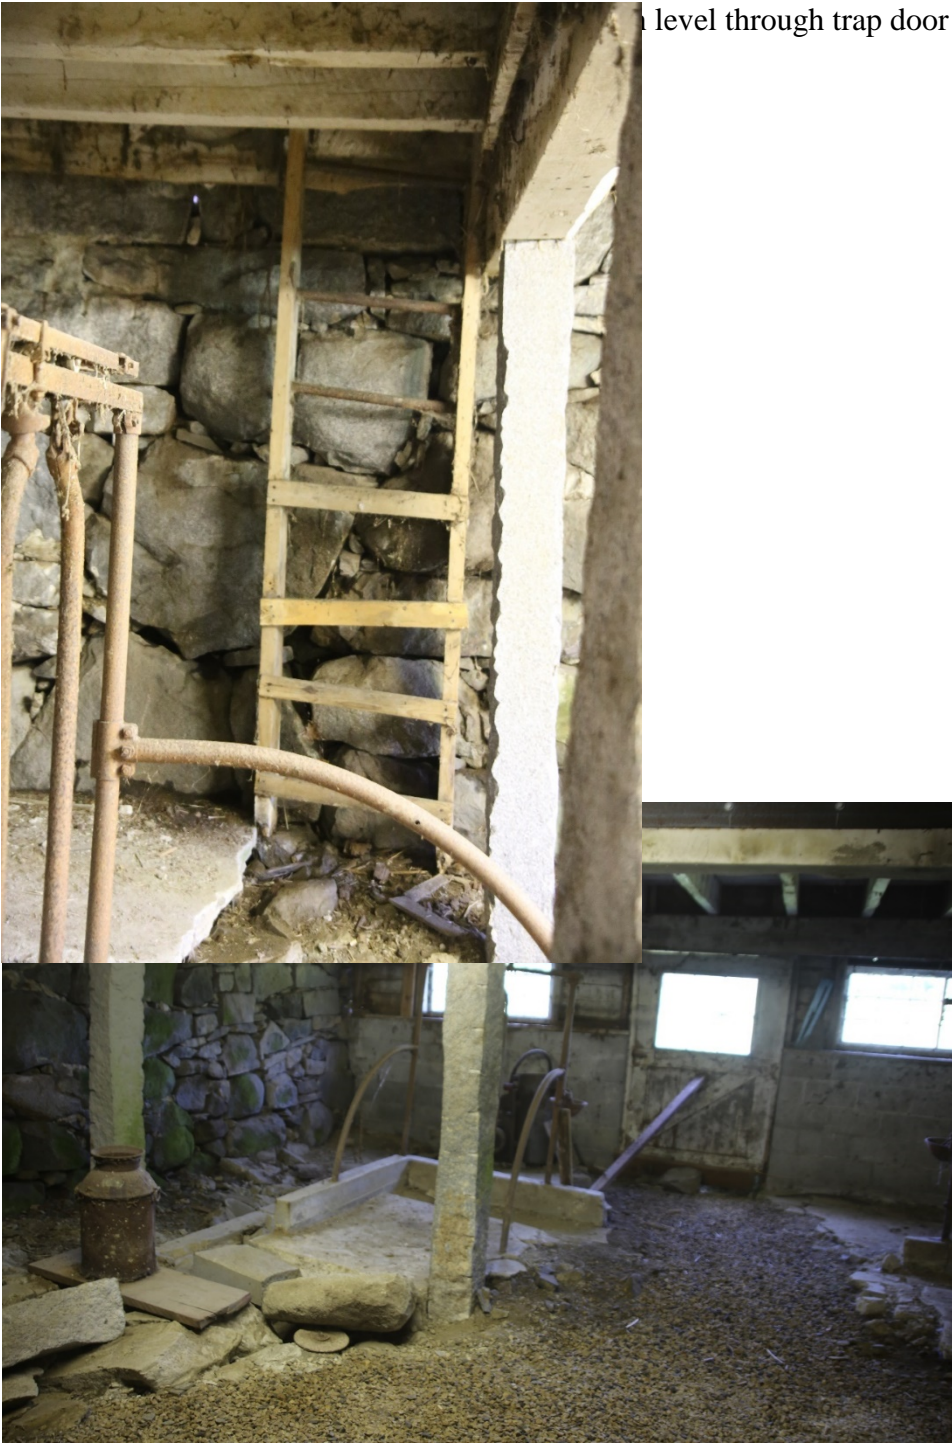
1 level through trap door

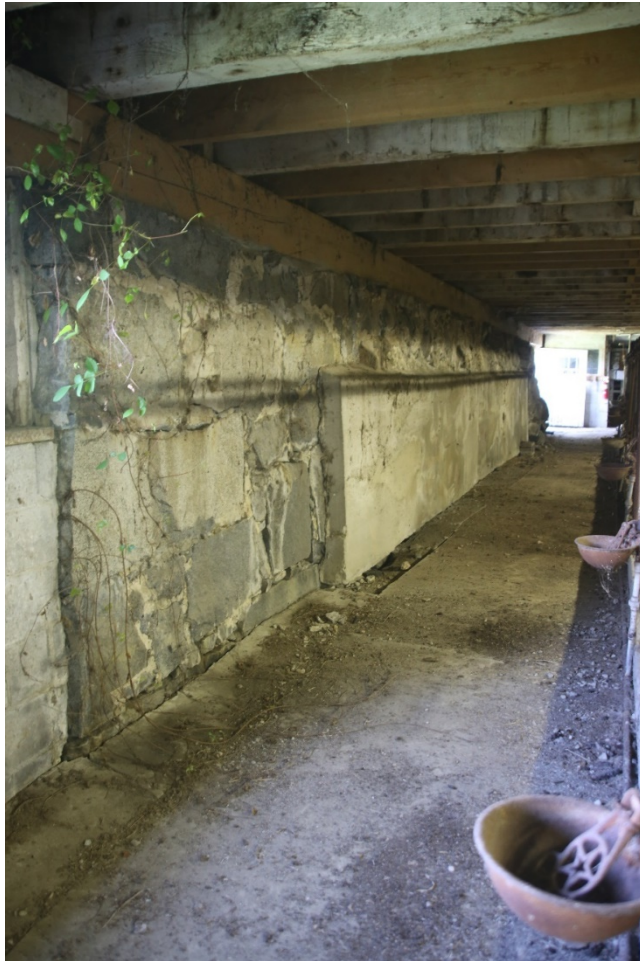
l, sections replaced in 2006

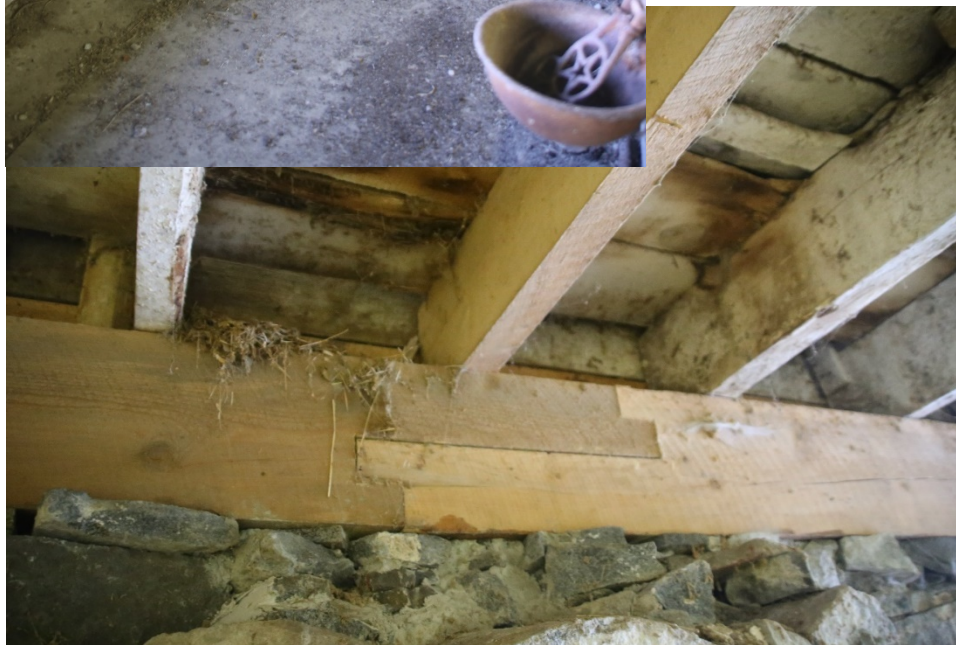
Photo 63) South foundation wall, new sill, and floor joists, sections replaced in 2006
Direction: S

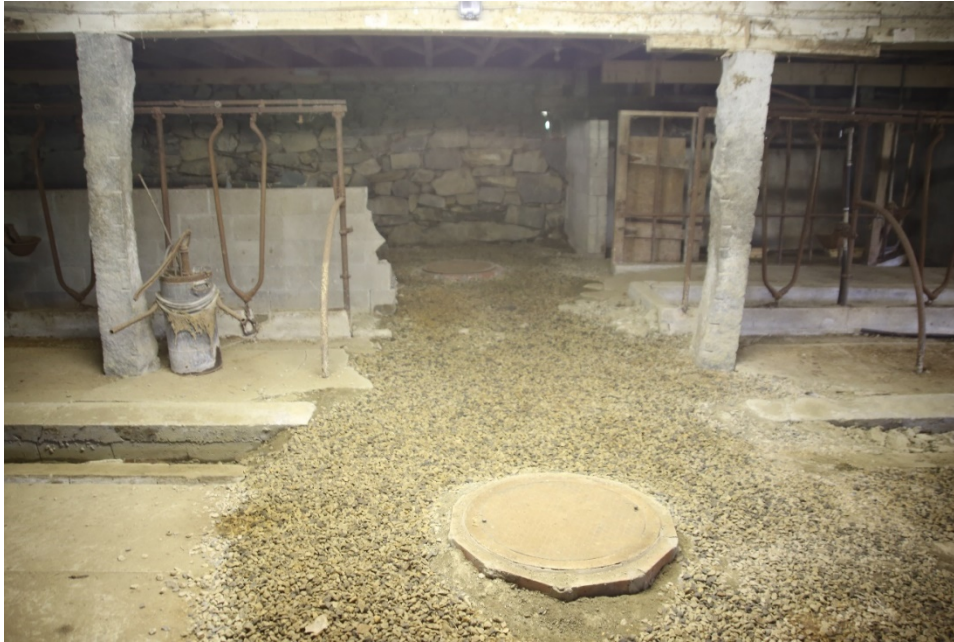
Photo 64) Basement milking area floor, showing stormwater drainage system in floor installed in 2004
