New Hampshire Preservation Alliance - Barn Assessment Worksheet

Owner(s): Exeter Conservation Comm Date: 6/2/17
 Farm Name: Raugus Barn
 Address of Barn: 61 Newfields Rd. Town: Exeter.
 Mailing Address (if different): 10 Front St. Town: Exeter

Barn Style: Yankee Approximate Date of Construction: 1890

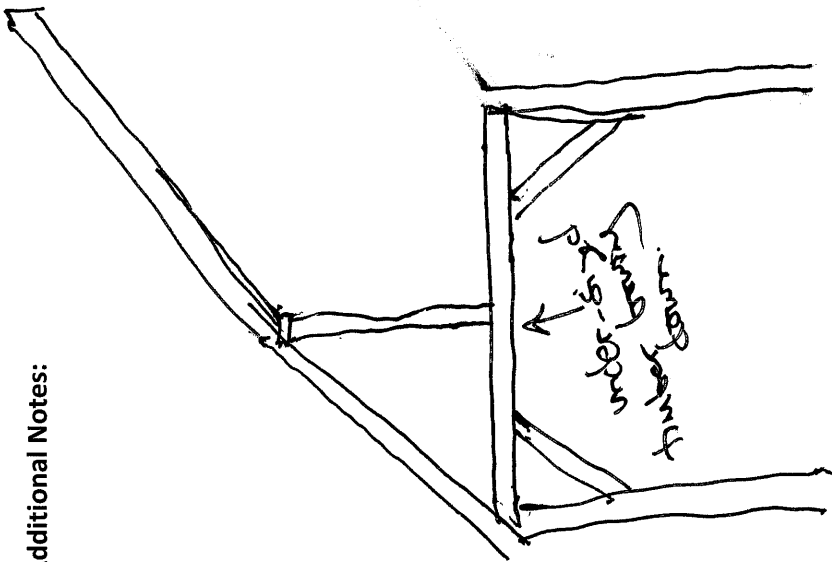
Building Material	Condition: poor/fair/good/excellent	Specific Problems	Suggested Repairs	Rough Estimate for Repairs
Framing	timbers and stick rafters are 2x6's	Good	large left hand bay has undersized top dirt with post to intermediate plate at roller joint. The dirt is hanging over the roof board.	Bracing to first floor timber or add knee brace to post from joint between joint and post to roller plate.	\$10,000
Foundation	Stone	Good	Concrete has been poured on the inside of the foundation to facilitate stall cleaning	Remove Concrete on inside of foundation.	Sweat equity
Grading/Slope/Vegetation		Good	drainage has been installed on the up-slope side of the barn and extends to dry wells in the basement.	Keep vegetation mowed around the barn and monitor the dry wells and pipe exit to daylight to make sure it is moving water away from bldg.	Sweat equity
Exterior sheathing/Siding	Clayboards	Poor	Gable-end frame (roof) has deteriorated the most some to be re-sided with 1/2" x 6" boards. Both sides of the barn should also be dealt with and also in poor condition at this time (stein side frame)	Re-side back gable (making re-siding 25,000-50,000 per side and gable.

Framing of large bay along side of barn

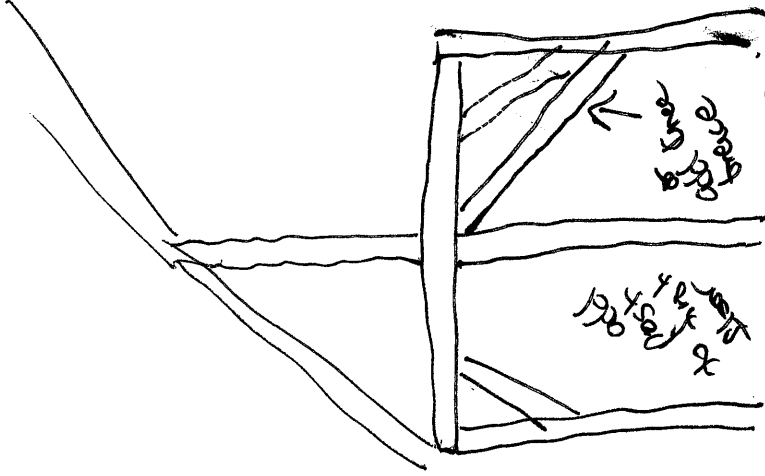
Solution to Framing in large bay

It should be remembered that the barn has survived this long and probably would be alright w/o added framing (metal roof with help)
