# Raynes Barn

61 Newfields Rd, Exeter, NH 03833

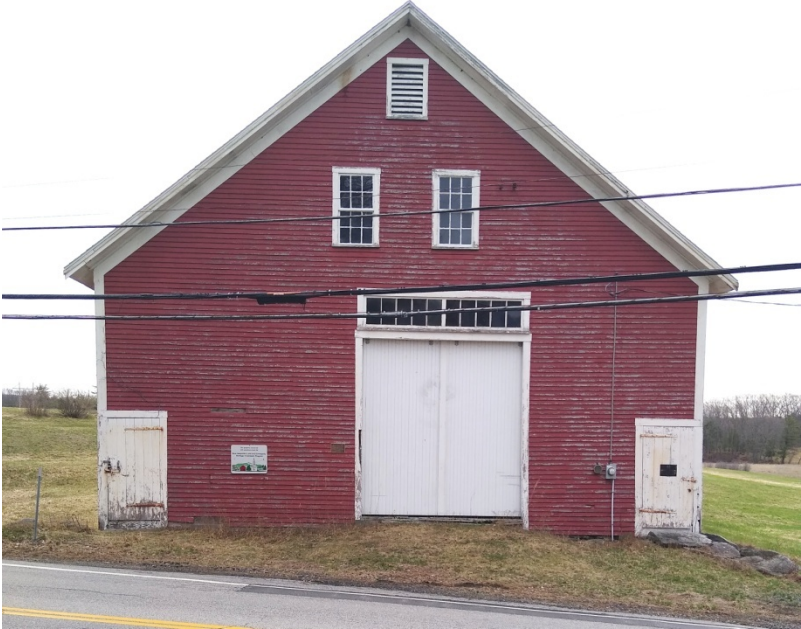
West Façade (road side)

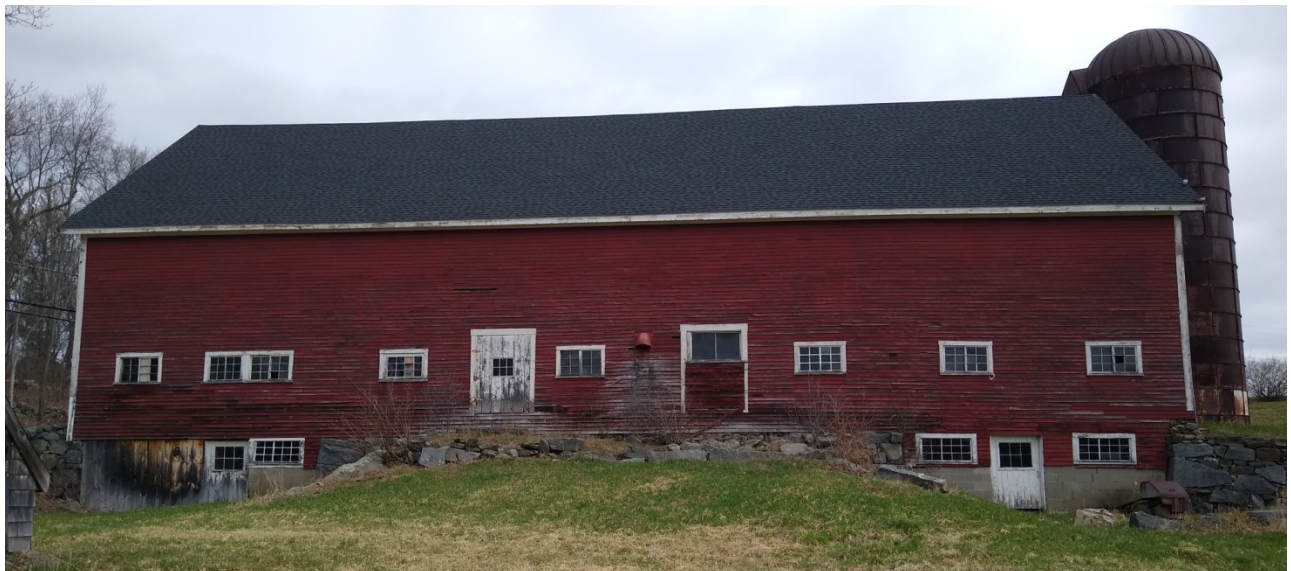
South side with dual lower level entrances

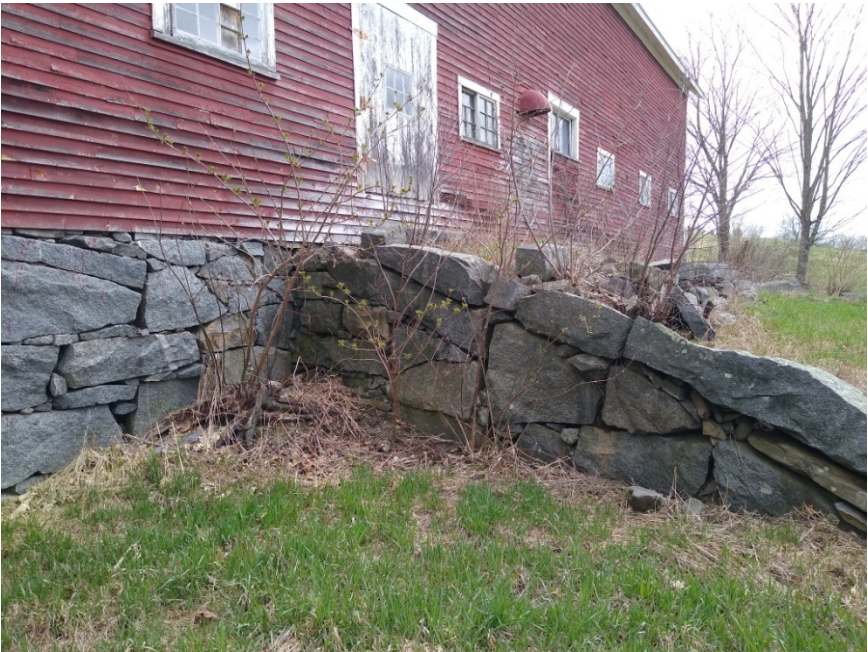
Western side of south side ramp with brush

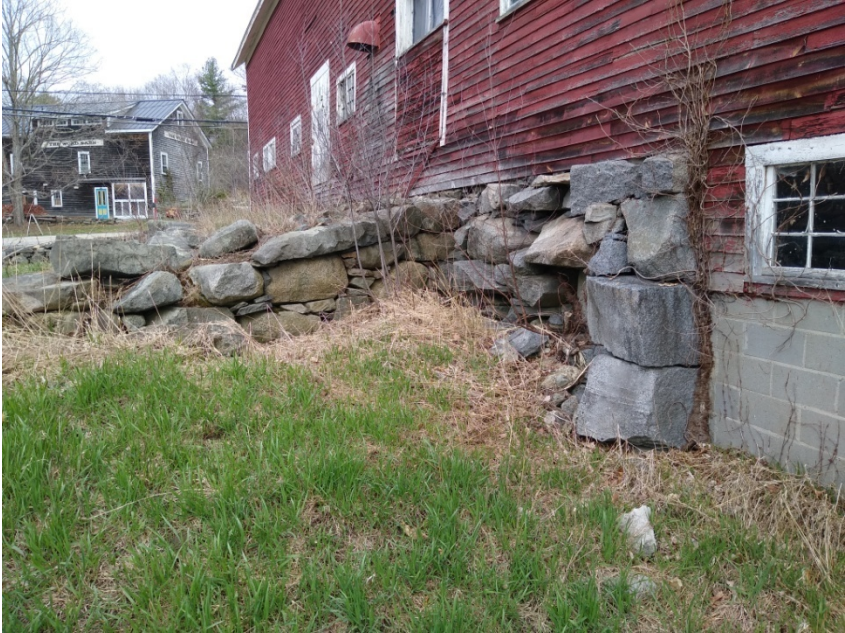
Eastern side of south ramp with brush growing along the foundation

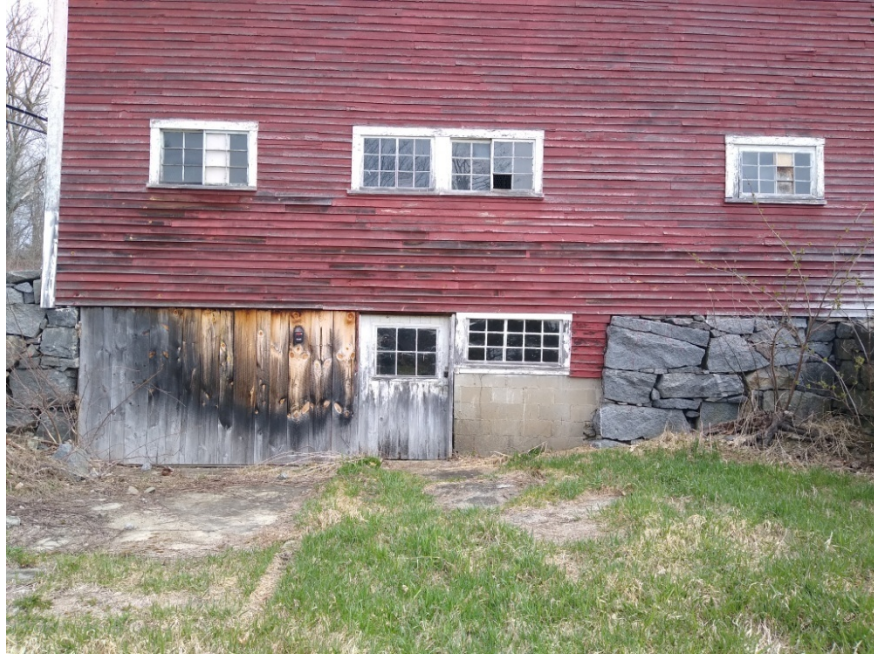
Westerly entrance into the lower level area on the south side

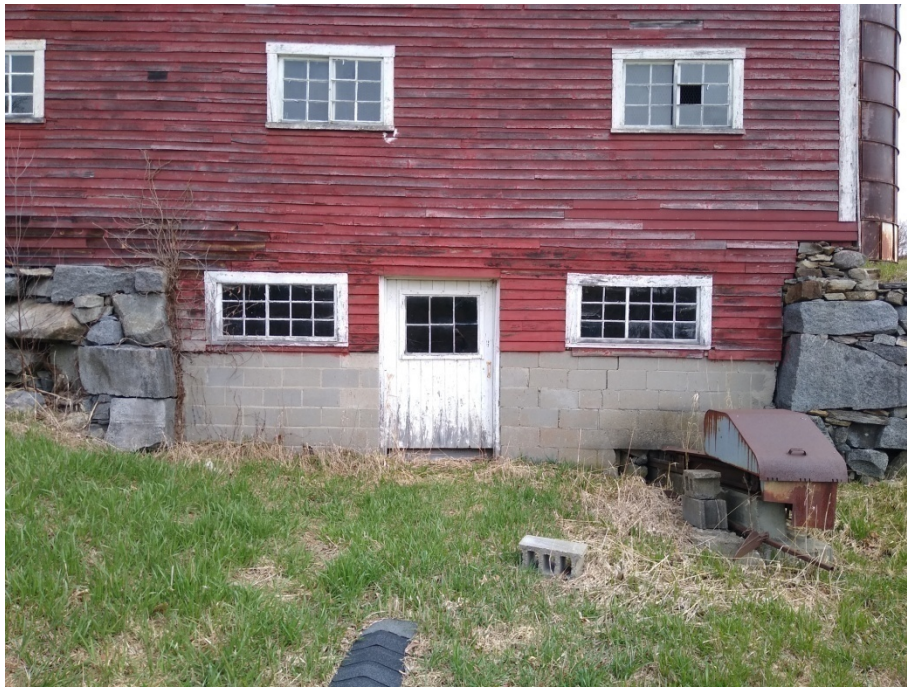
Easterly entrance into the lower level area on the south side

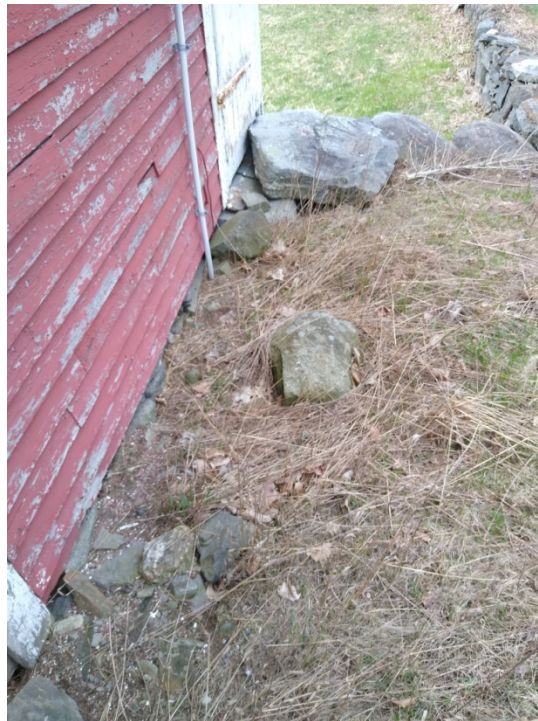
West façade looking southeast

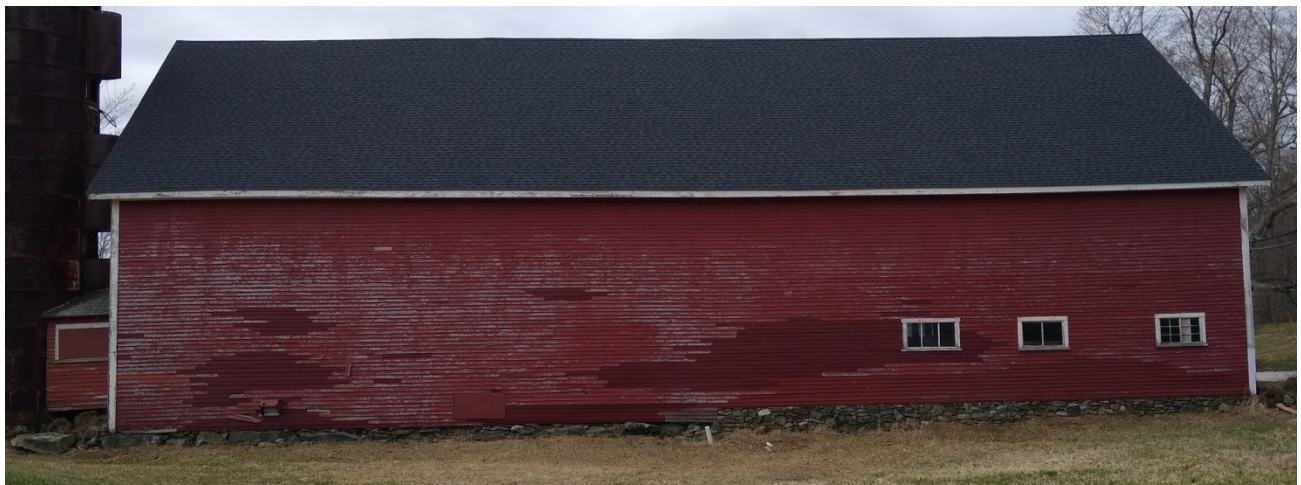
Foundation on north side

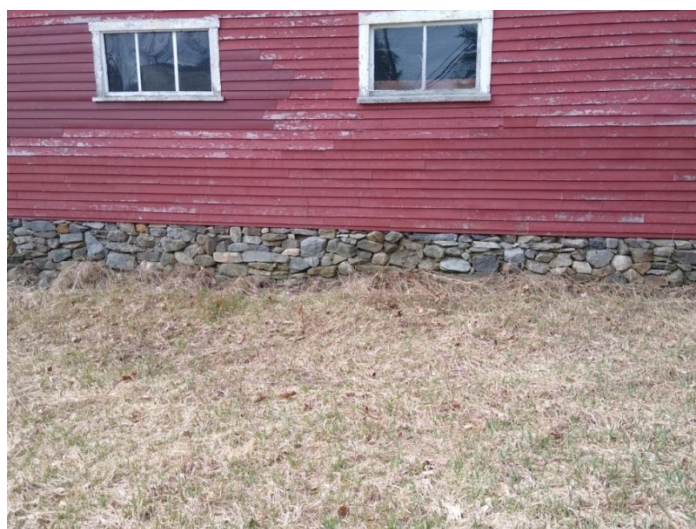
Westerly section of north foundation

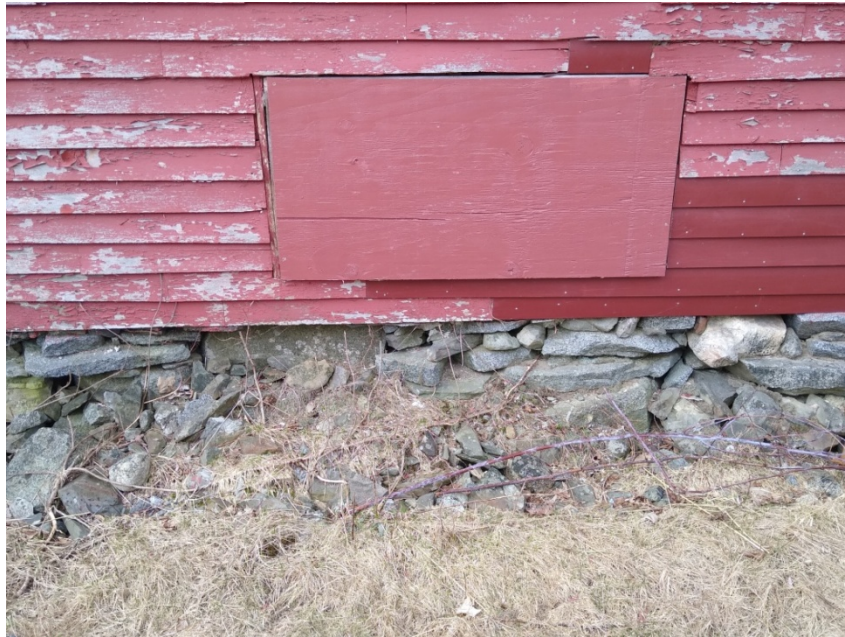
Easterly section of north foundation

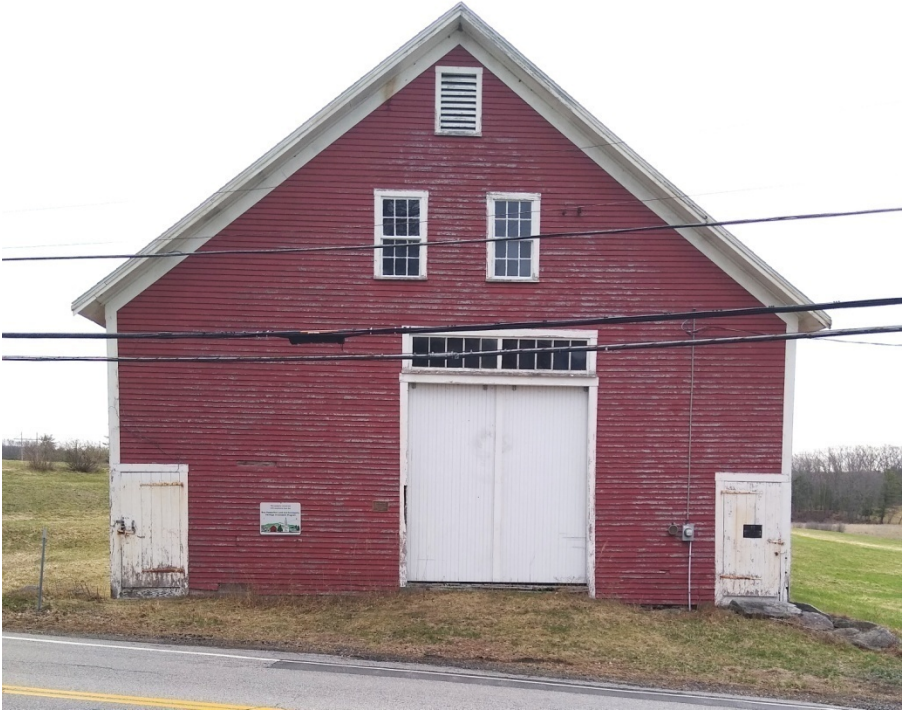
West façade with minor clapboard damage/loss

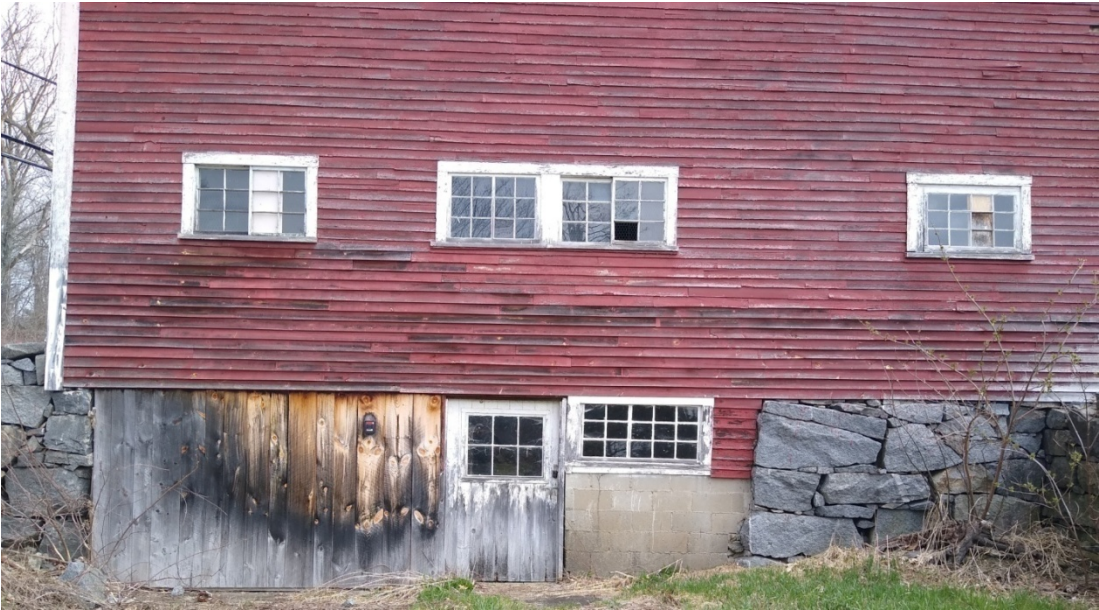
South side, westerly section with damaged clapboards, mainly above and below windows

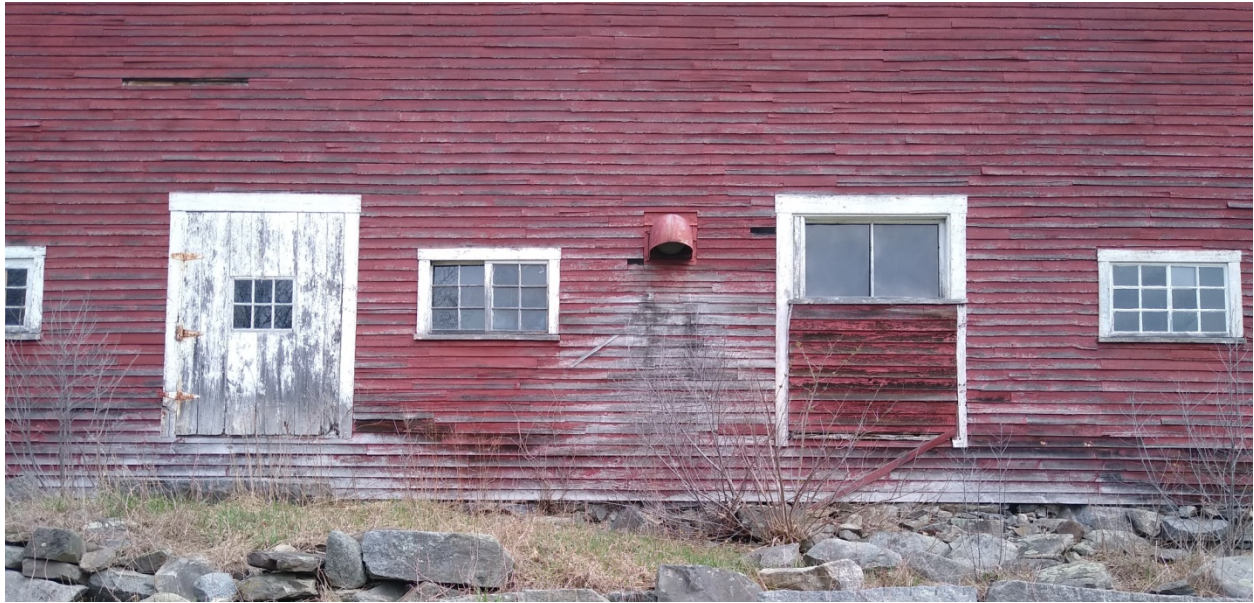
South side, middle section showing damaged and missing clapboards

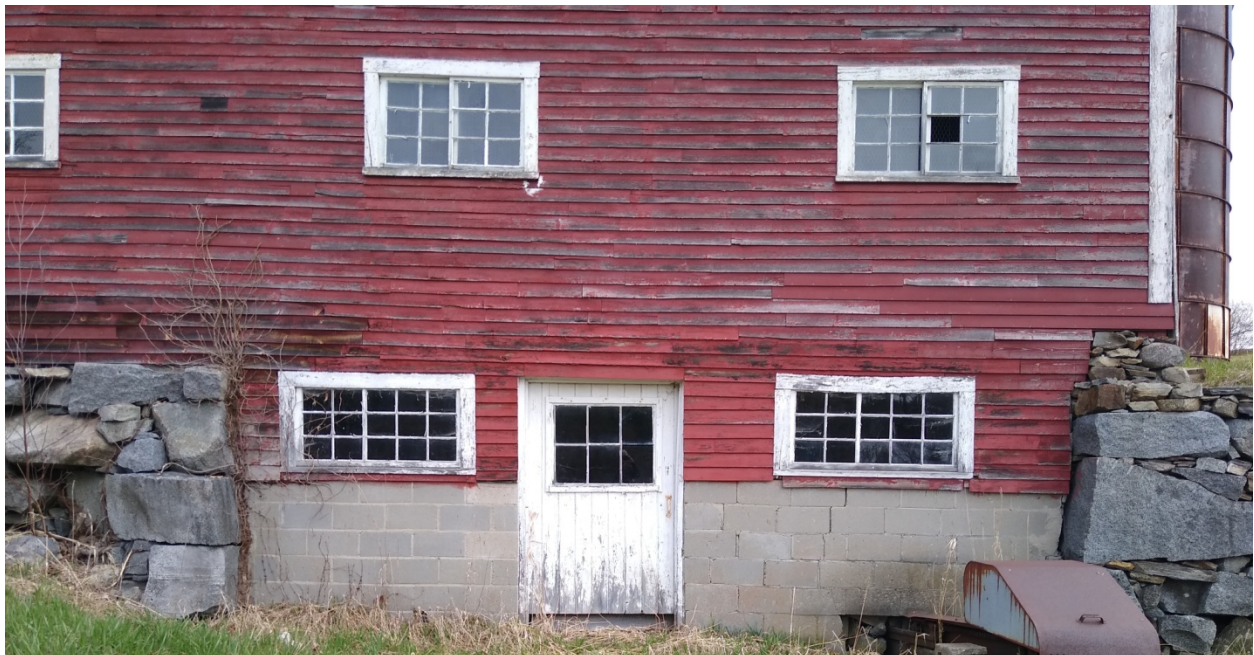
South side, easterly section showing damaged and missing clapboards with “toothed-in” clapboards in newer red paint

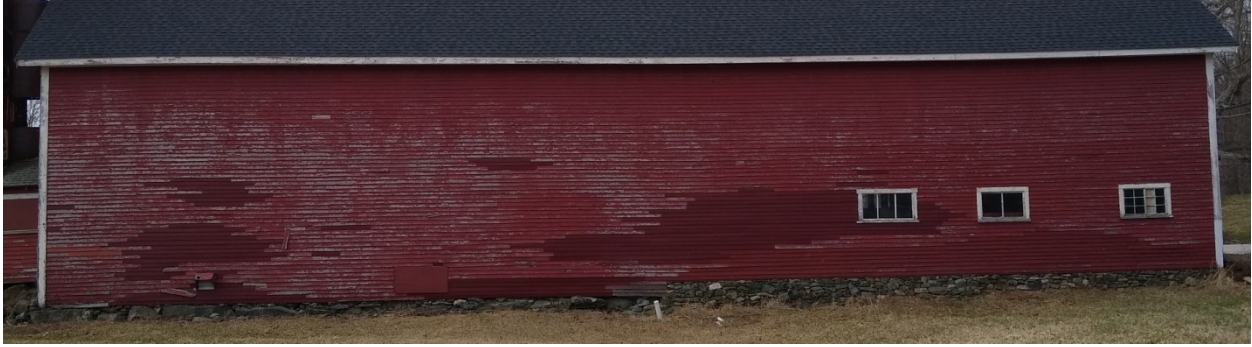
North side of barn showing a minimum of two areas of clapboard replacement as evidenced by the two newer barn red colors, "toothed-in" to the worn and lighter colored original clapboards

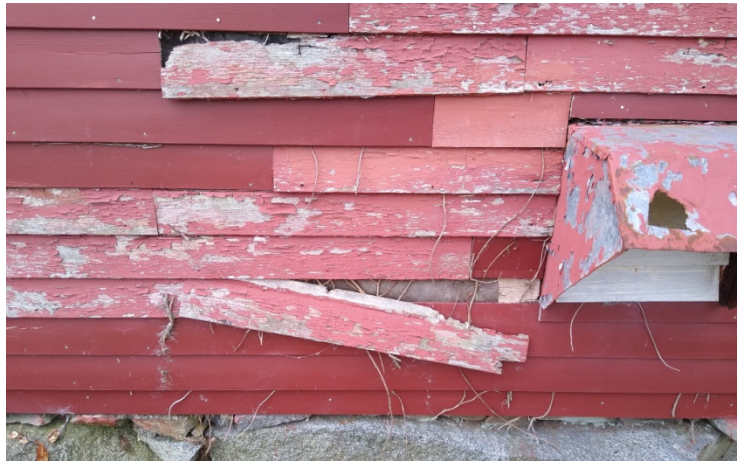
North side easterly section with clapboard repairs and damage

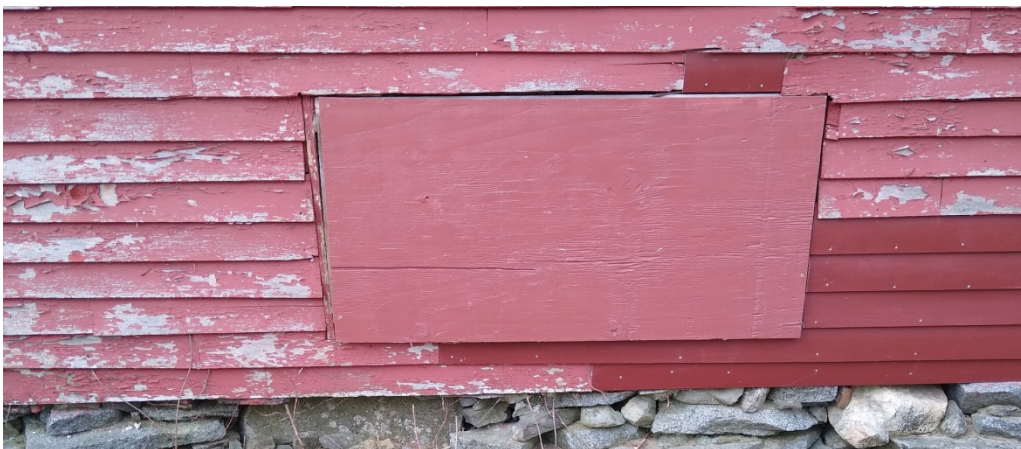
North side, middle section of clapboards showing replaced clapboards and plywood covering opening

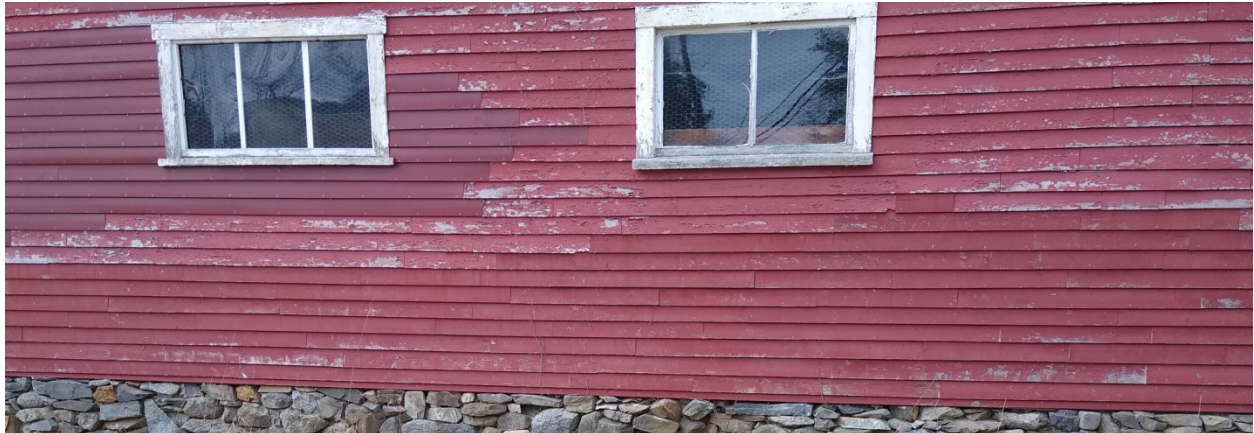
North side, easterly section showing clapboard replacement

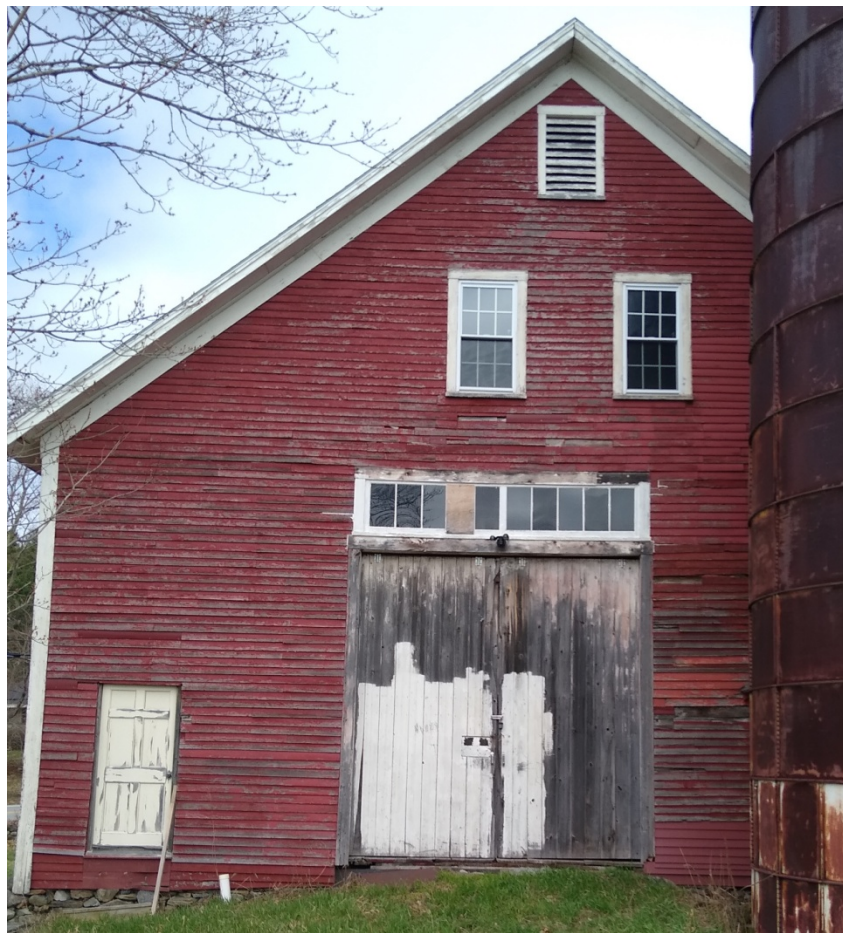
East side with damaged and missing clapboards

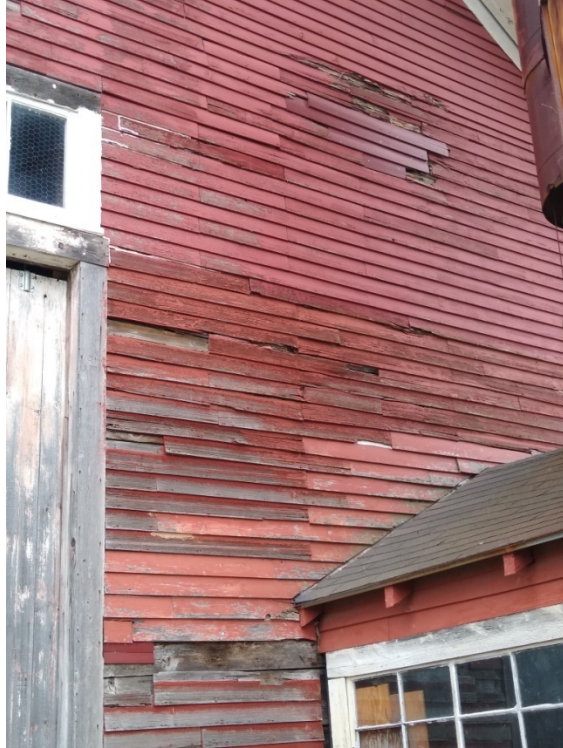
East side, northerly section with damaged, missing and replaced clapboards above connector with silo

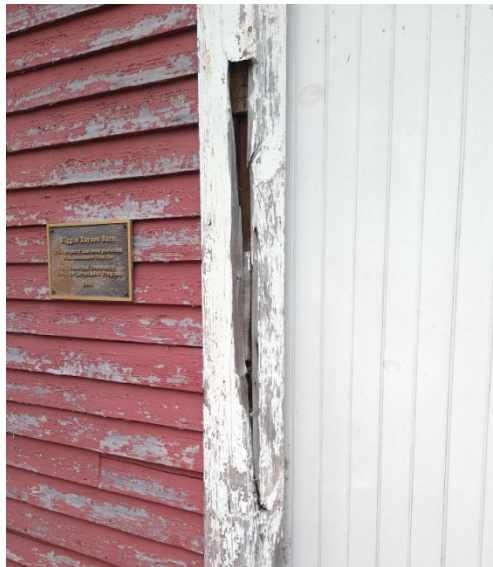
West Façade, trim on left side of barn door opening

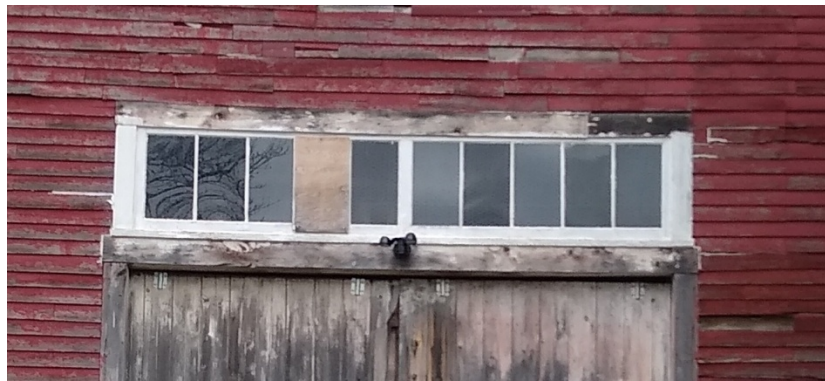
East side with damaged window and door trim

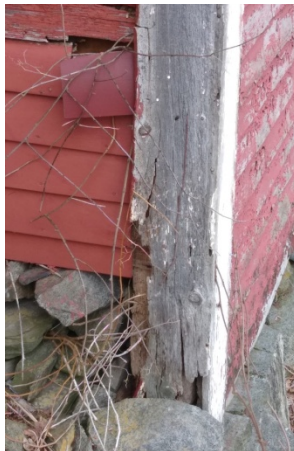
East/north corner board with deteriorated corner boards

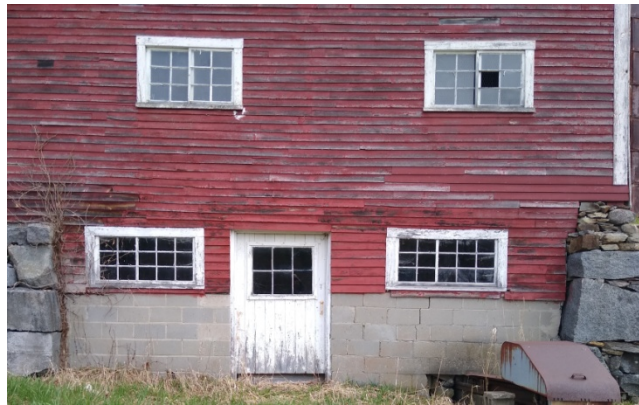
The barn window sash is in poor condition due to the lack of paint, missing glazing, deteriorated frames and broken or missing panes. These window sash, with a few exceptions, appear to have been reused from an earlier barn or house. There are also sash that were actually 9 over 6 storm windows for an old 9 over 6 house sash. These storm windows were installed horizontally in the two filled-in walkout basement walls as well as the windows above which are 6 over 6 windows.

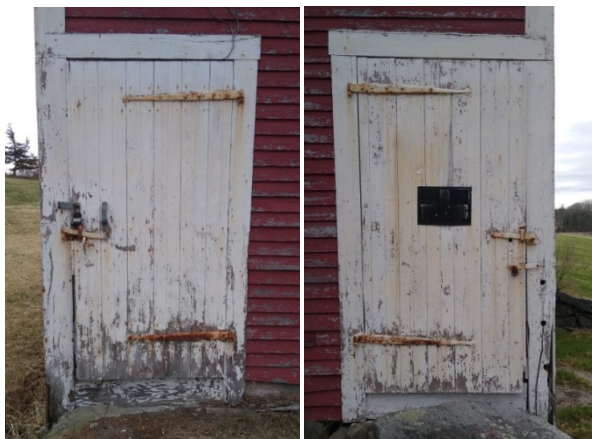
West façade passage doors on both sides of the large barn doors

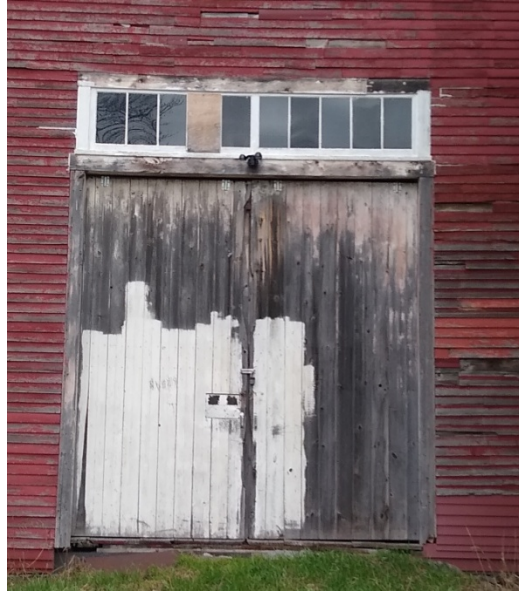
East side, large sliding doors

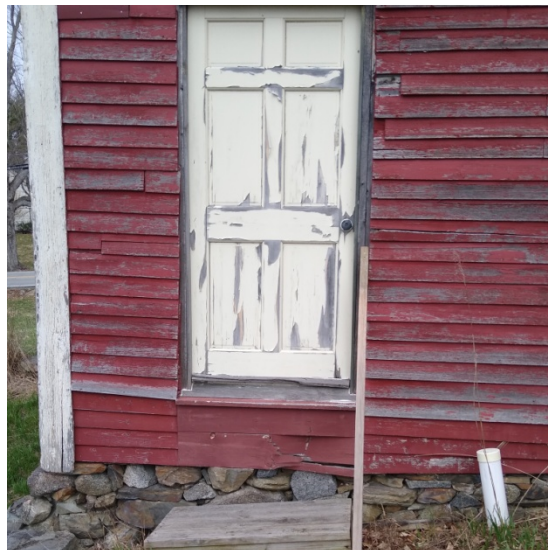
East side, modern passage door on southerly corner

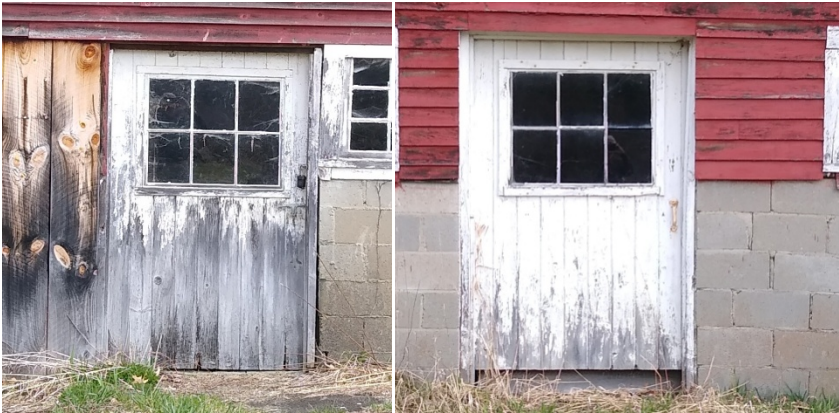
South side, westerly door

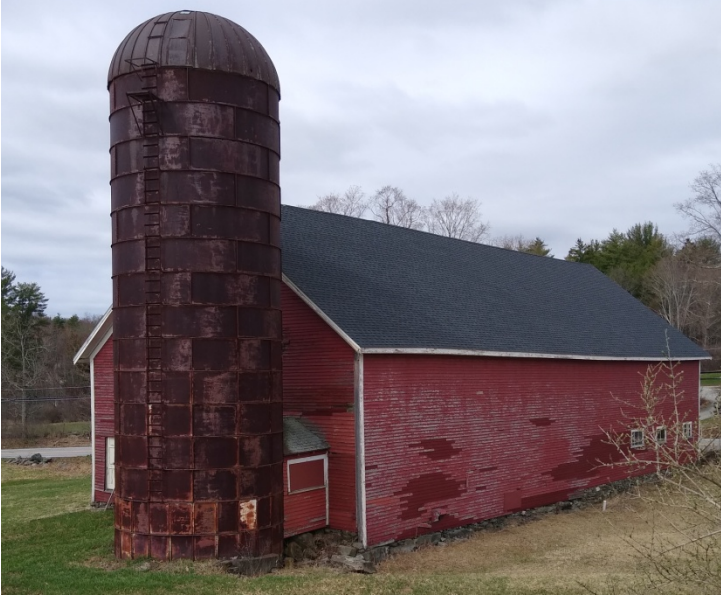
East side, connector and silo

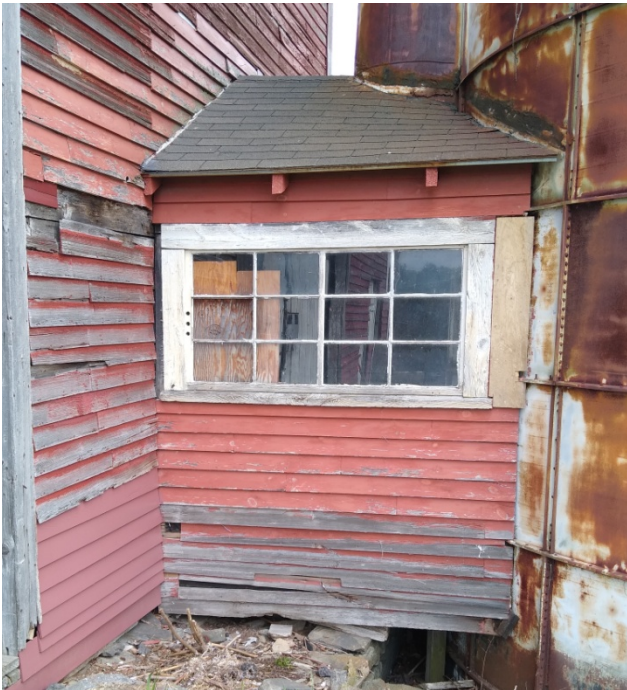
East side, southerly connector side

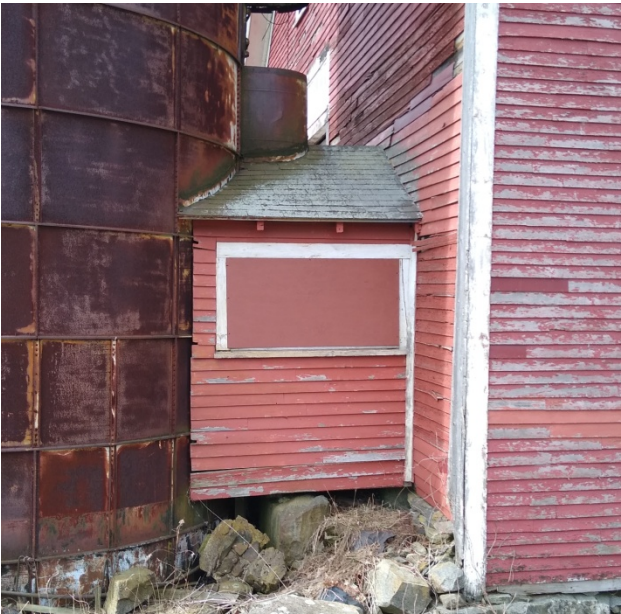
East side, northerly connector side

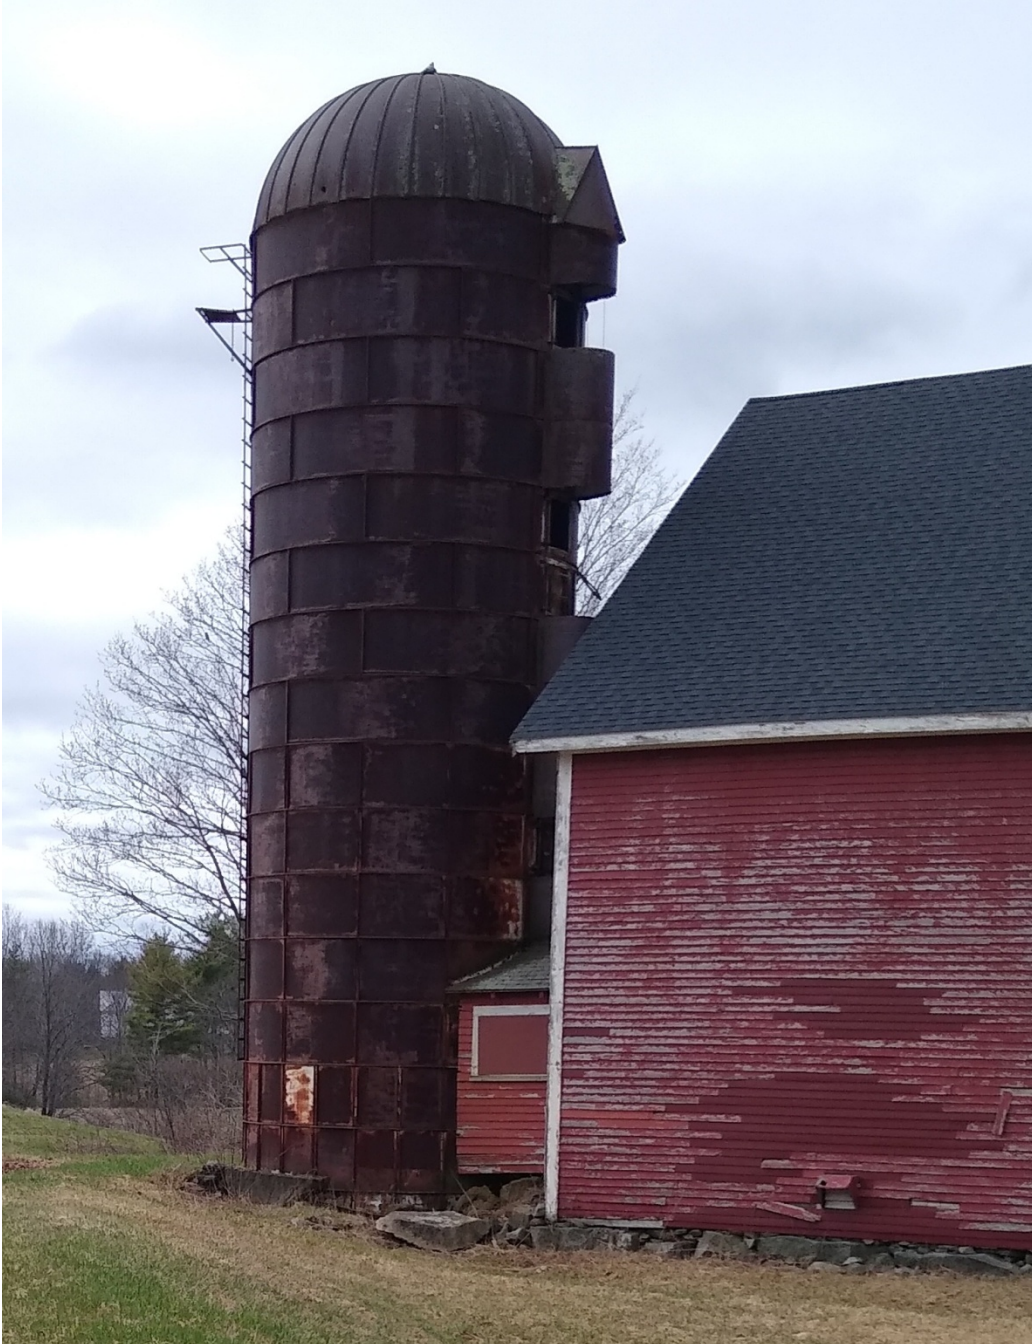
Left to right, south easterly view of silo, connector and barn

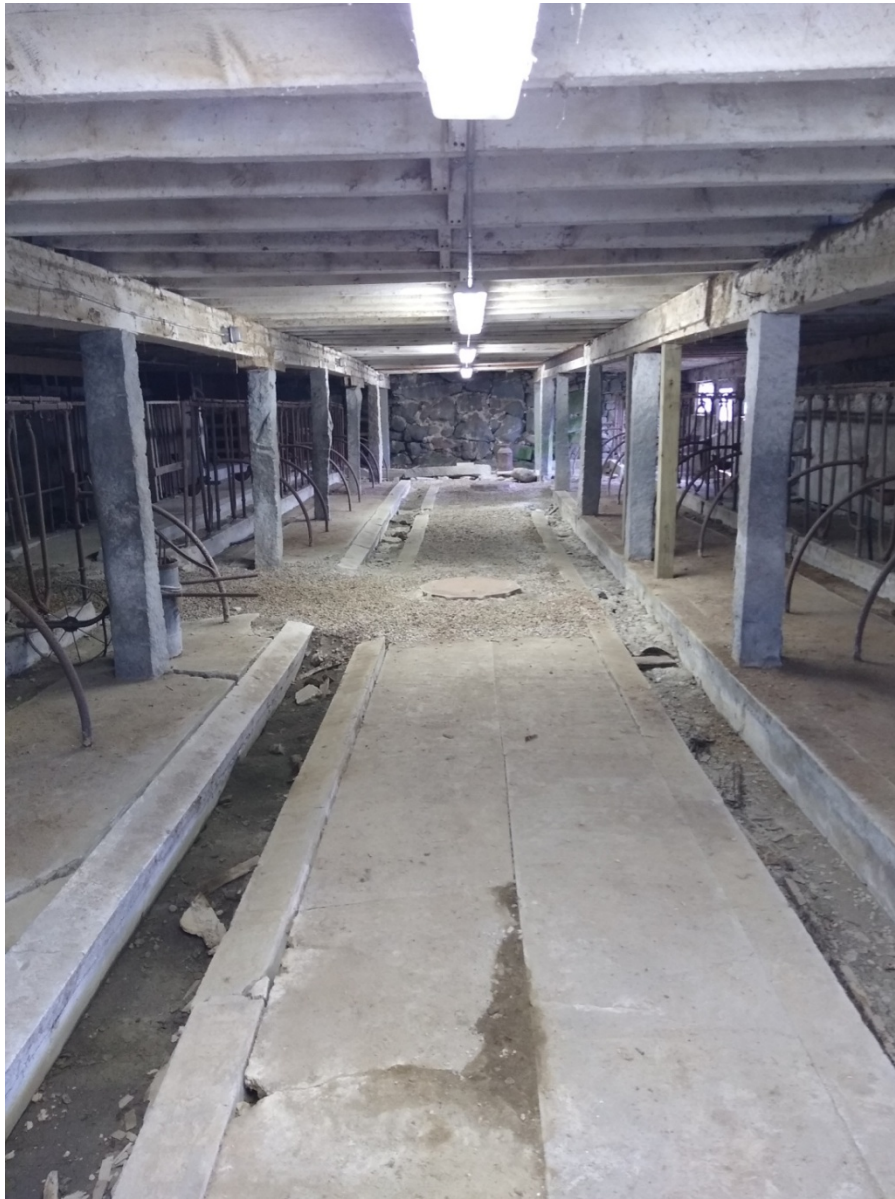
Looking east, lower level milking parlor remnants  
Please note the original granite posts that support the first floor main carriers

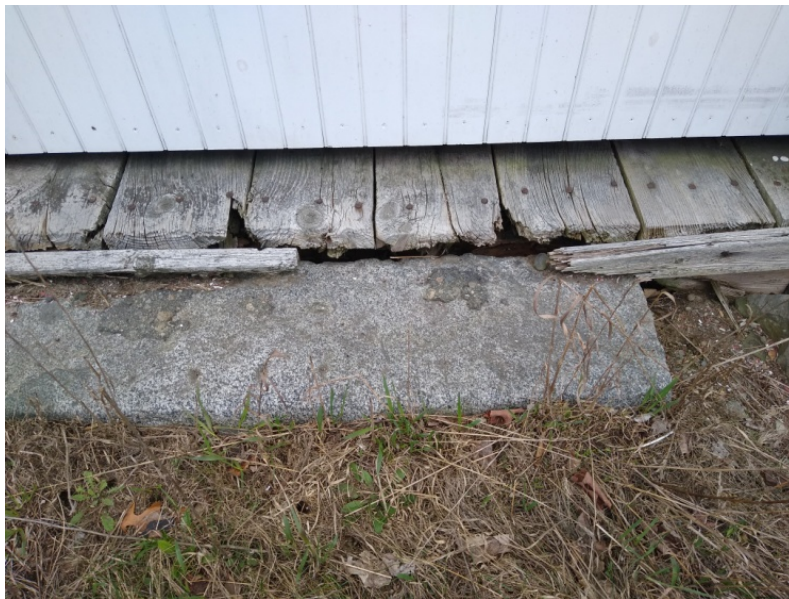
West façade, under floor at large barn doors threshold

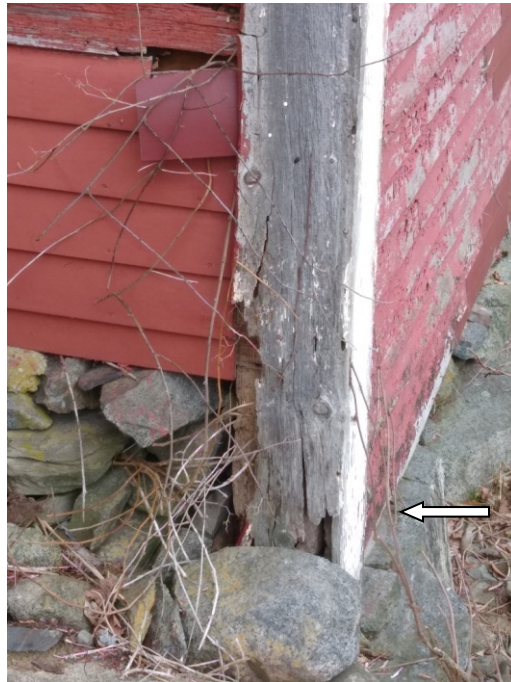
East and north corner, with the north wall (white arrow)  
Extending down past the height of the top of the stone foundation  
of the east wall (east, south and west walls are all at the same elevation)

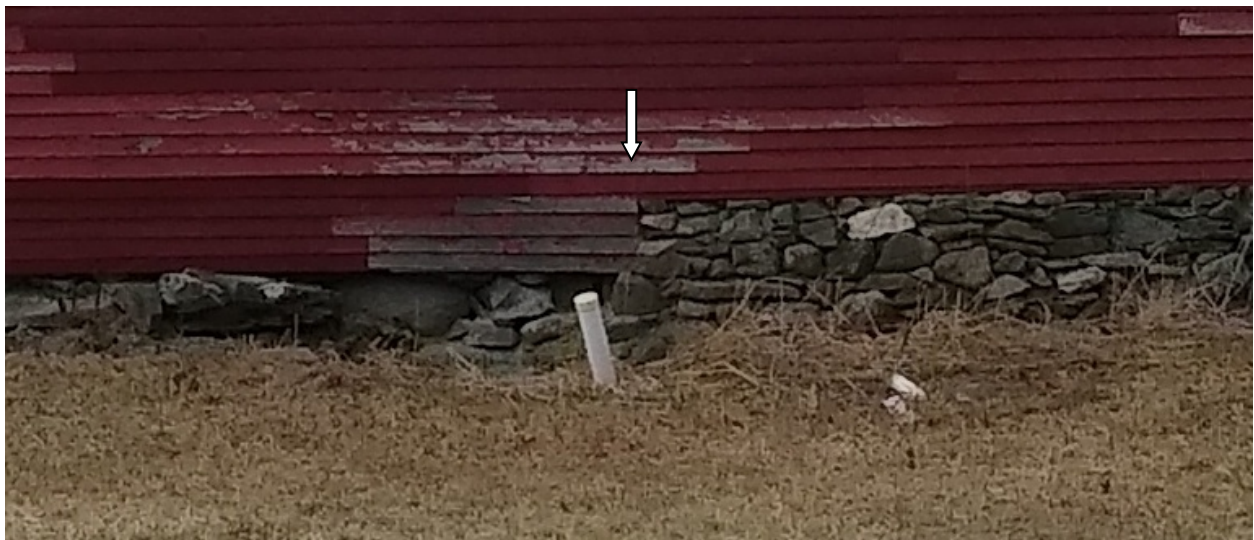
North foundation, sub-sill area about half way along north wall

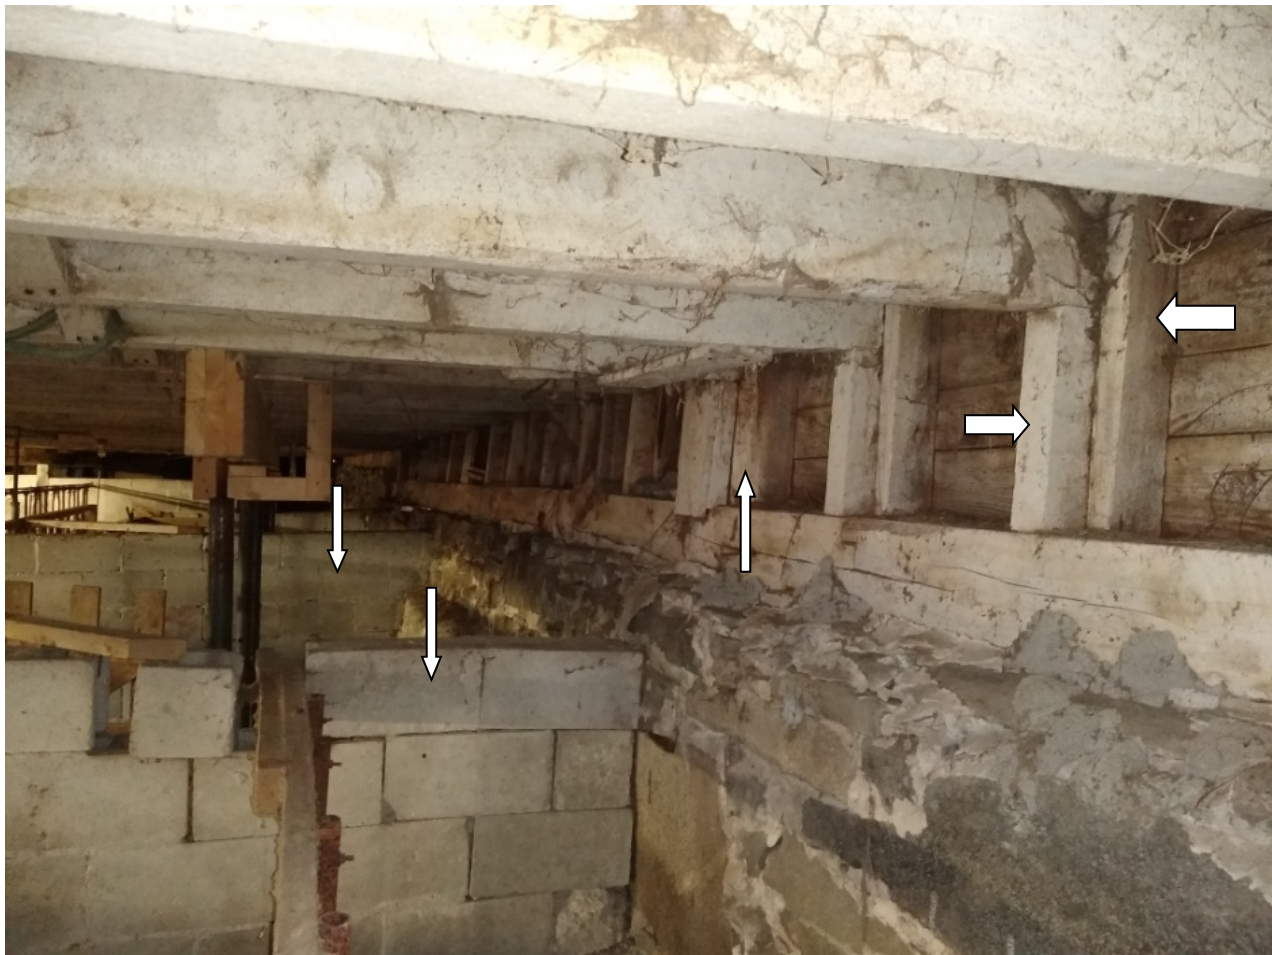
North sill and foundation wall  
(with “arrow” explanation below)

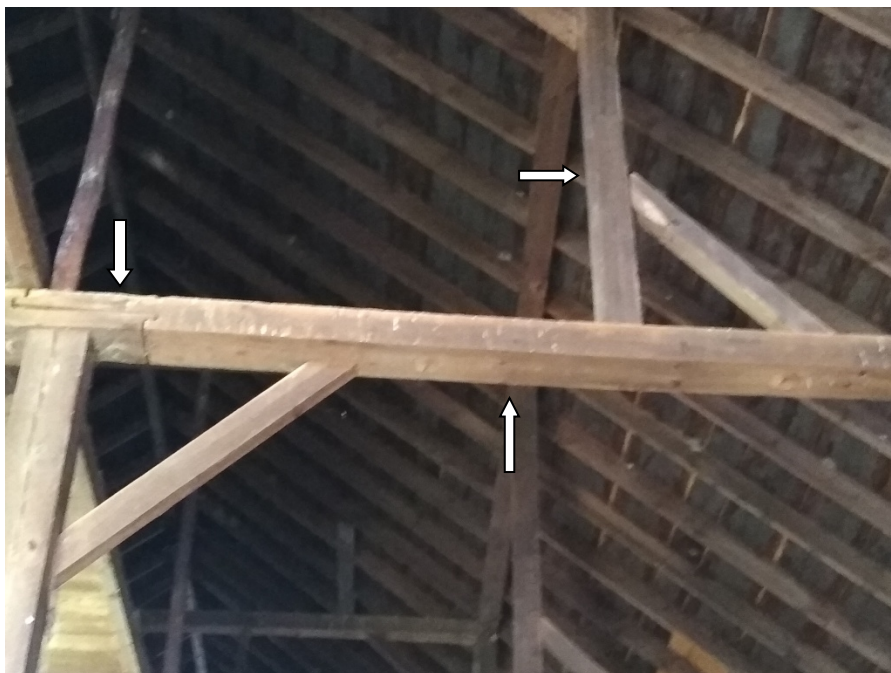
Northerly section of tie beam  
(downward arrow at scarf joint)  
(right pointing arrow at major support post for major roof purlin)  
(upward arrow at sagging tie beam)

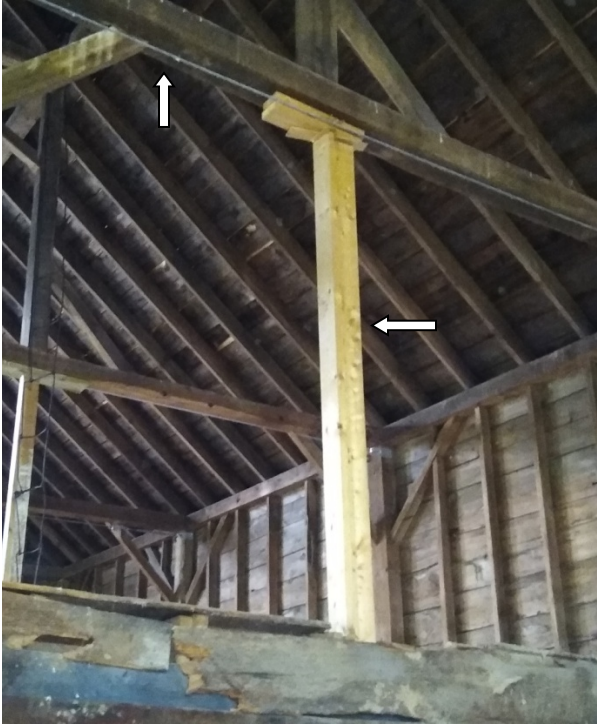
Looking northwesterly, steel cable (upward arrow) added support beam (left hand arrow)

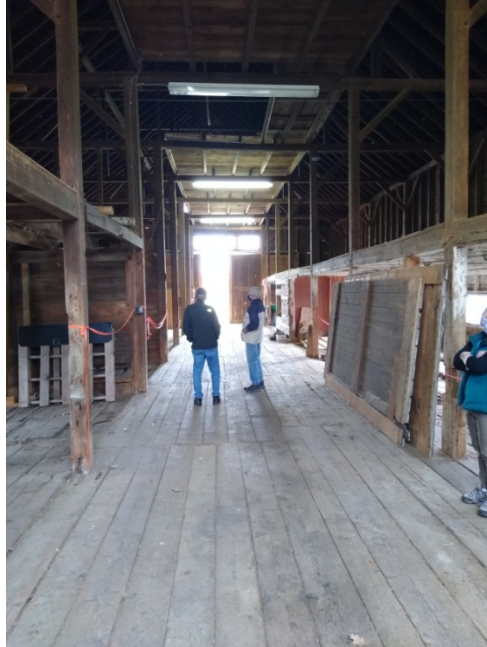
Barn center aisle looking east

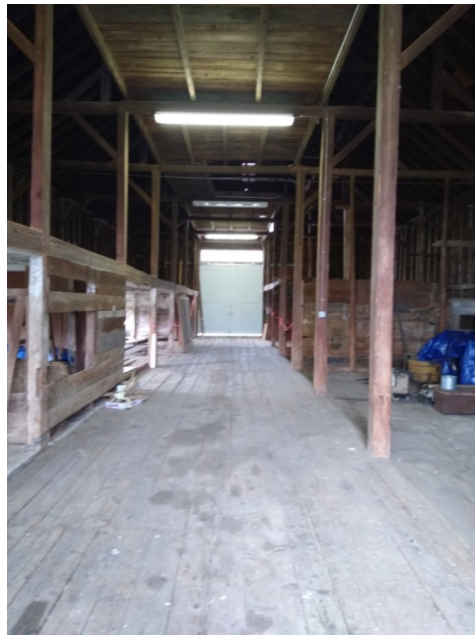
Barn center aisle looking west
