**WINTER STREET CEMETERY  
CONSERVATION TREATMENT REPORT  
EXETER, NEW HAMPSHIRE**

**Submitted By:**            Conserve ART LLC  
                                  Francis Miller, Conservator  
                                  19 Lansdowne Avenue  
                                  Hamden, CT 06517  
                                  Cell:     203-506-6846  
                                  Email:   conserveartllc@gmail.com

**Date:**                        January 18, 2017

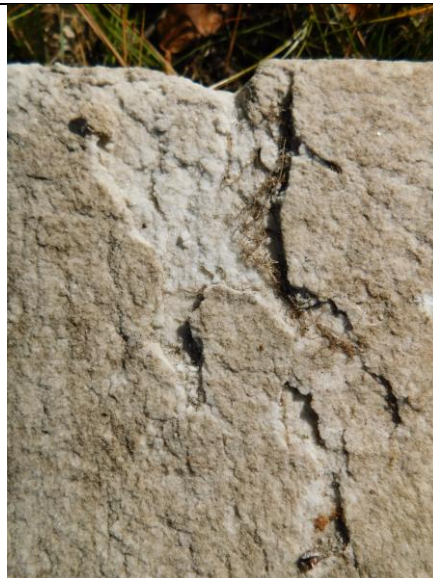
EWSC A39 5. During Reset. Warped stone crack.

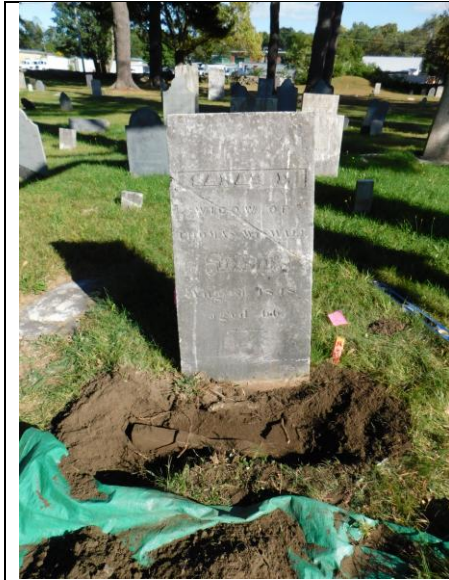
EWSC D53 2. During Reset. Broken below grade and base set in concrete.

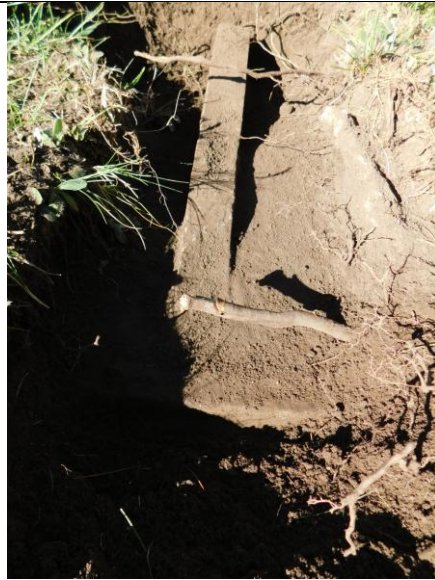
EWSC D53 3. During Reset. Detail of base set in concrete.

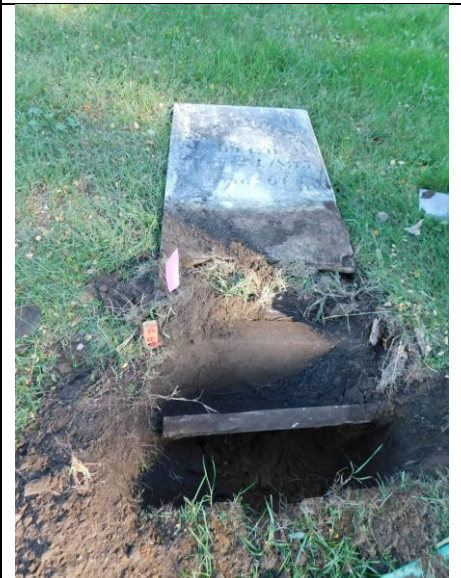
EWSC F29 2. During Reset. Stone broken below grade.

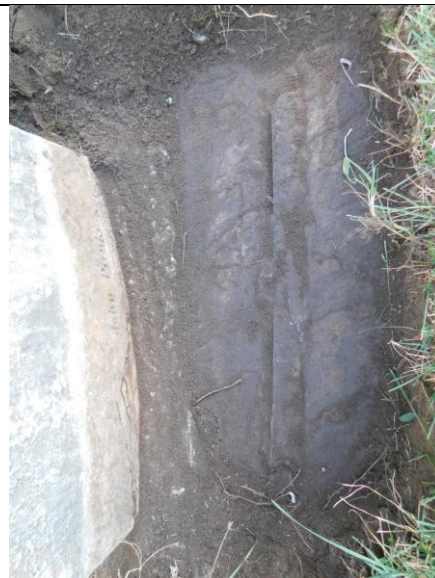
EWSC F73 2. During Reset. Marker has base, broken at base.

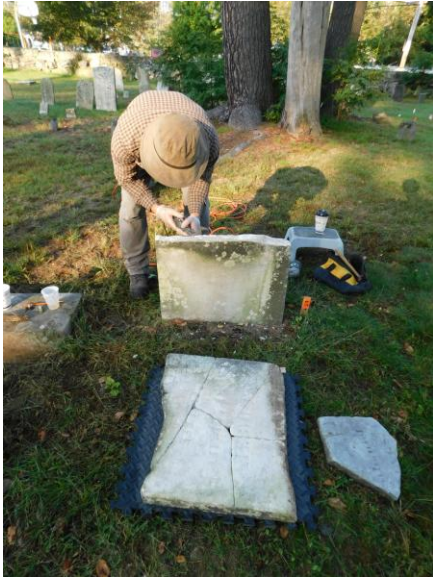
4. EWSC. A29. DT. Removing failed adhesive mortar at break-line.

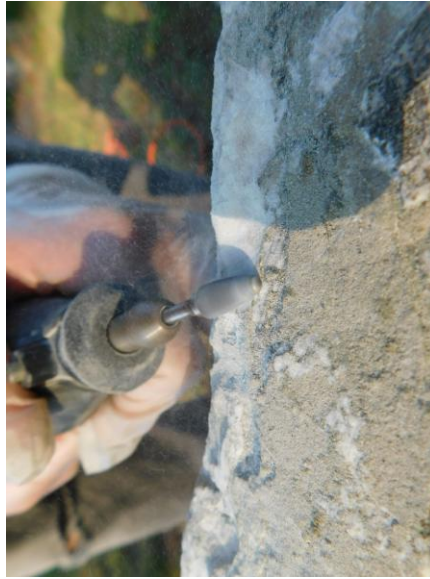
5. EWSC. A29. DT. Removing failed adhesive mortar at break-line.

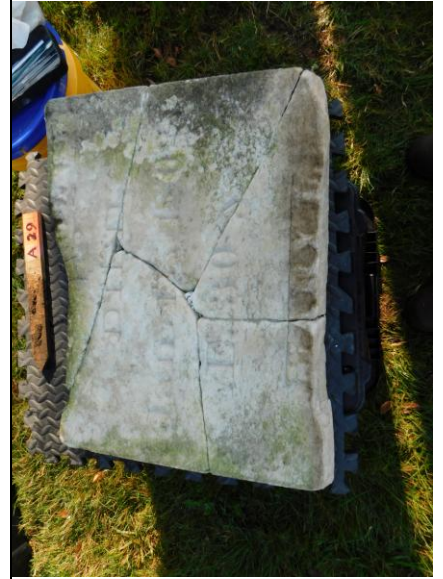
6. EWSC. A29. DT. Misaligned previous repairs with adhesive mortars.

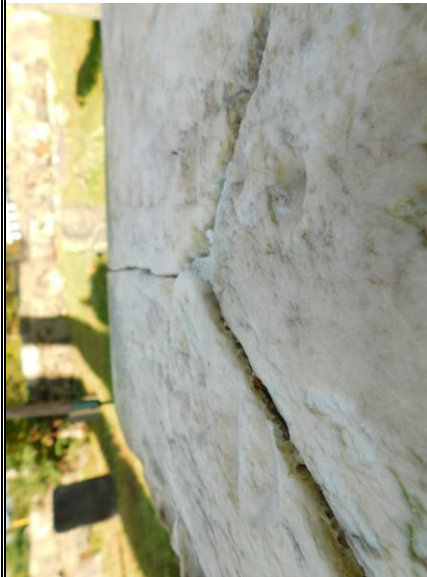
7. EWSC. A29. DT. Detail of misaligned previous repairs with adhesive mortars.

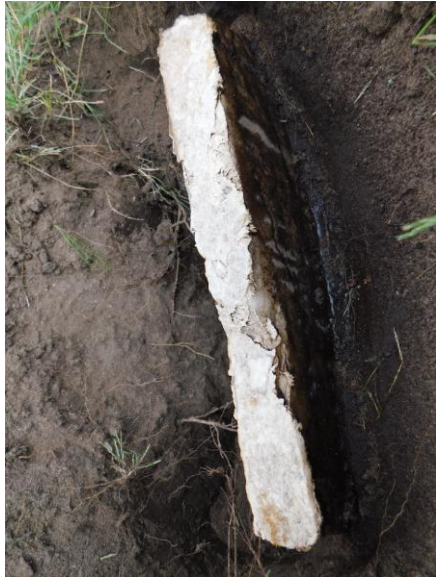
3. EWSC. A76. DT. View of lower portion with failed adhesive.

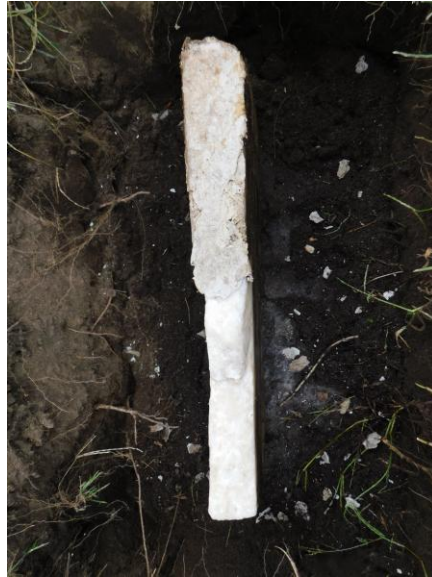
4. EWSC. A76. DT. Removal of failed adhesive.

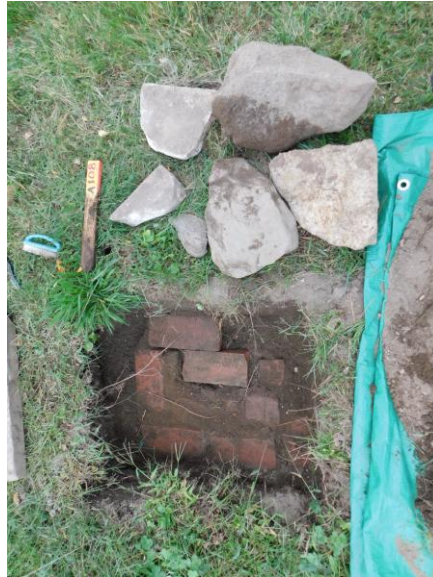
4. EWSC. A108. DT. View of below grade foundation materials. No base found.

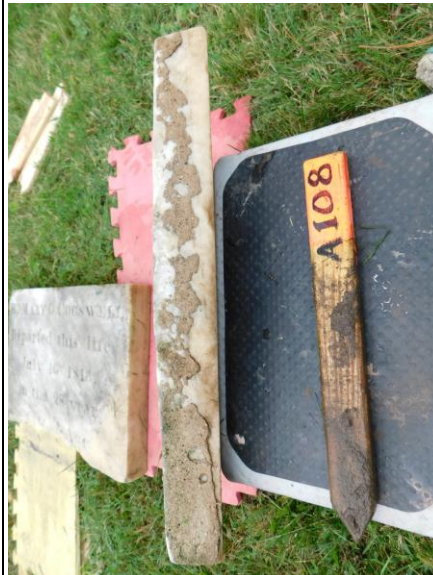
7. EWSC. A108. DT. View of failed bonding cement on break-line.

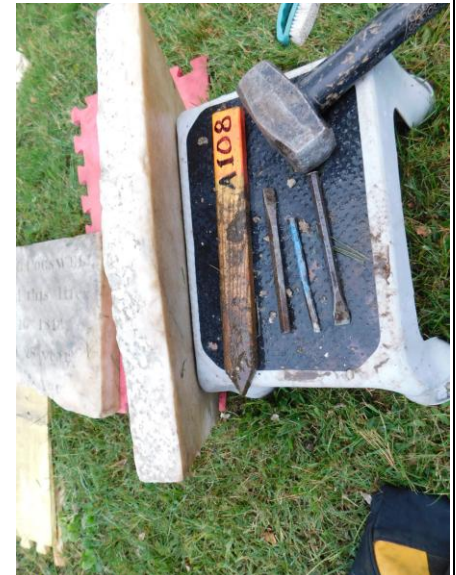
8. EWSC. A108. DT. Removal of failed bonding cement with hammer and chisle and Dremel.

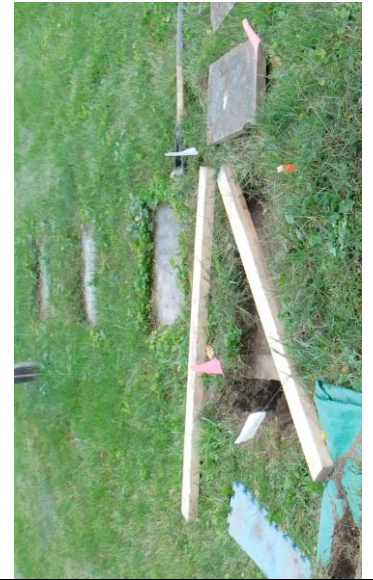
2. EWSC. A109. DT. Granite base found below grade.

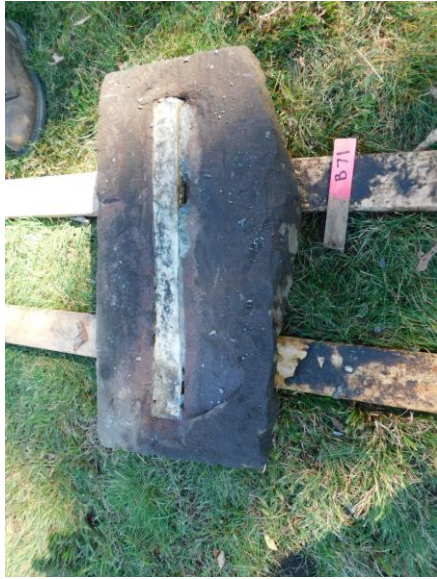
3. EWSC. B71. DT. Sandstone base with broken marble in mortise.

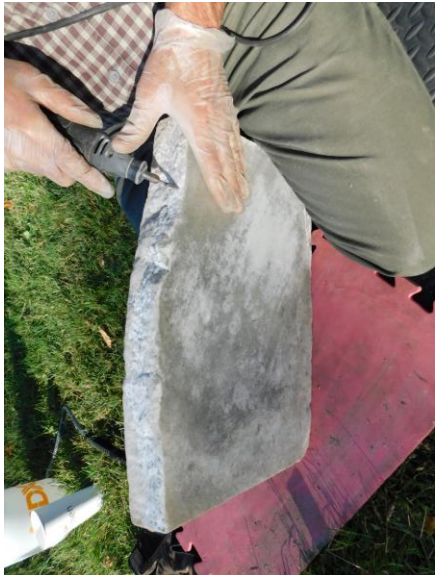
12. EWSC. B71. DT. Removal of failed adhesive on break-line with Dremel.

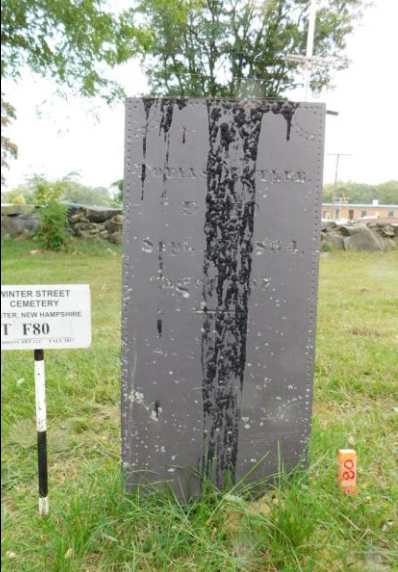
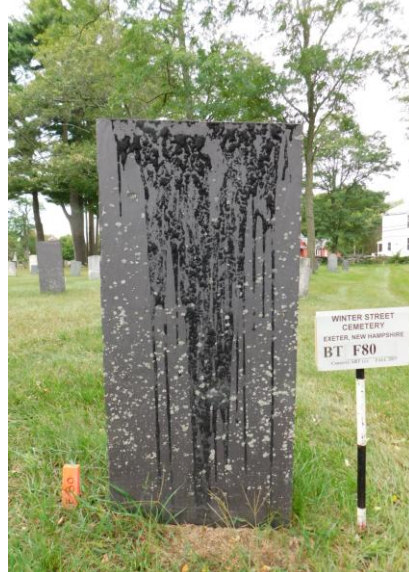
Marker F80, Tobias Cutler, is one of the few African American markers in the cemetery. The slate headstone honoring this Revolutionary War veteran is defaced with this tar on the front and back of the stone. No other vandalism was noted.

</div> </div>		
<p>1. EWSC. F80. BT. Front overview before treatment.</p>		<p>2. EWSC. F80. BT. Back overview before treatment.</p>
