# Leathers & Associates

## Playground Name & Location

Inspected Date: 03/31/2016

Planet Playgroud - Exeter, NH

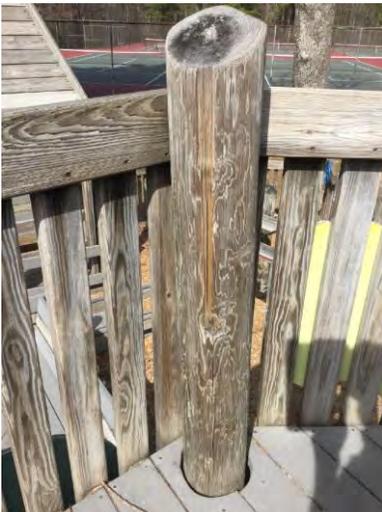
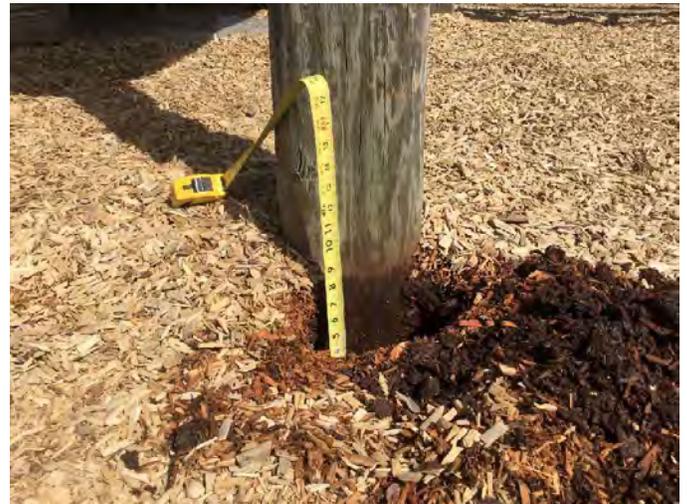
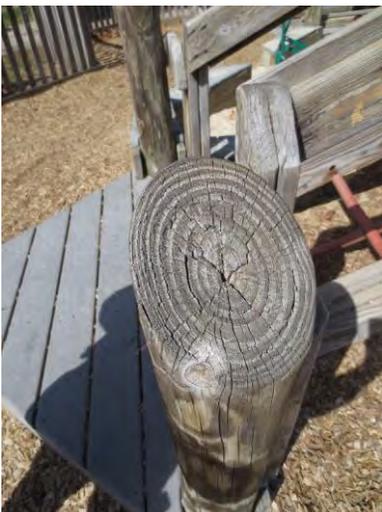
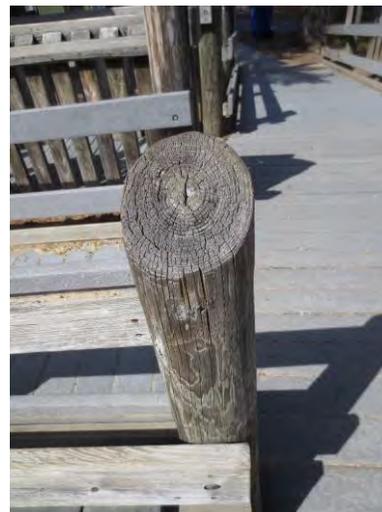
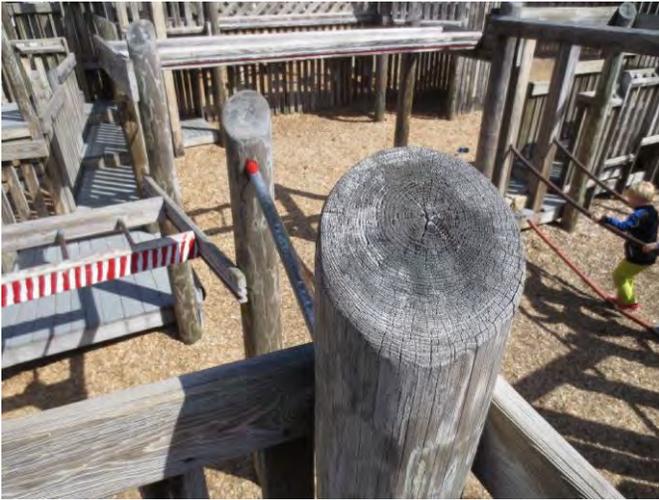
The framing is in medium condition. Has some splintering but not structural

To achieve long-term viability and low maintenance for the playground, we would recommend that the framing be replaced with structural plastic. As with the main support posts, staining and sealing exposed surfaces with solid body stain would only be a short-term fix with significantly limited longevity.

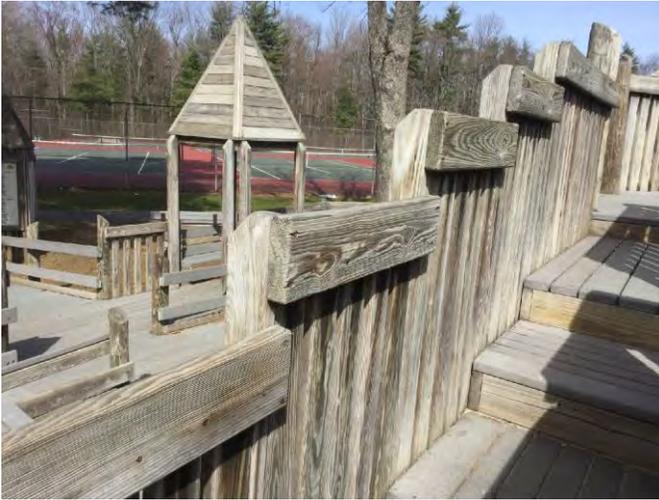
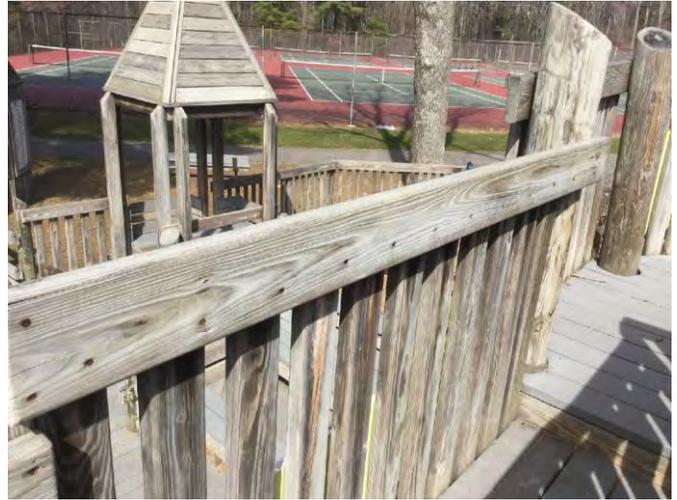
The handrail posts are in poor condition. Has major splintering and some structural issues.

Replace with recycled structural plastic.

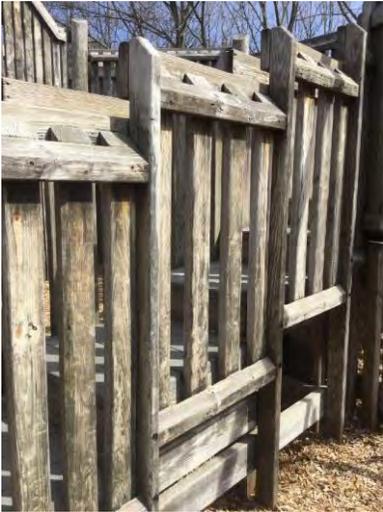
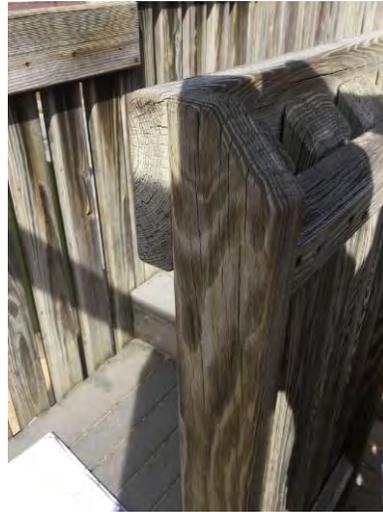
The balusters are in poor condition (severe splintering & wear).

Replace with powder coated pipe balusters.

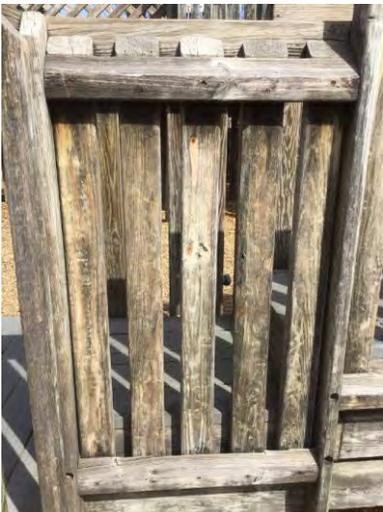
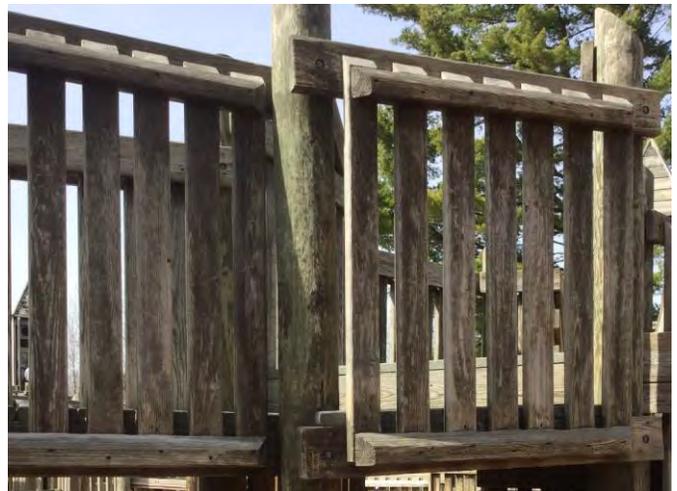
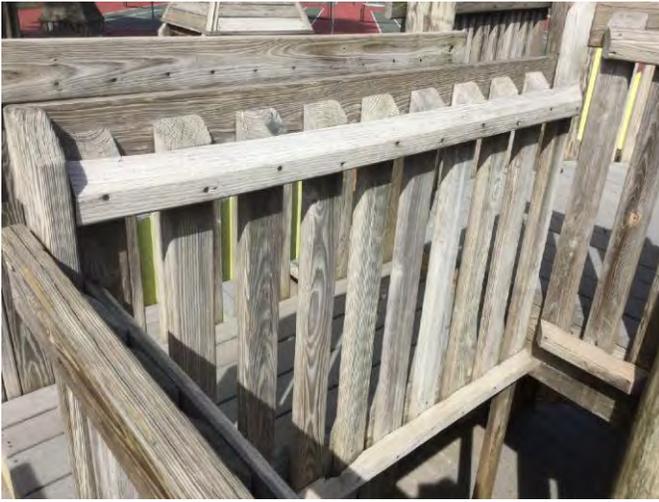
The maze cubes are in medium condition (minor splintering & wear).

Rebuild with current style larger maze cubes using structural plastic framing and recycled plastic decking.

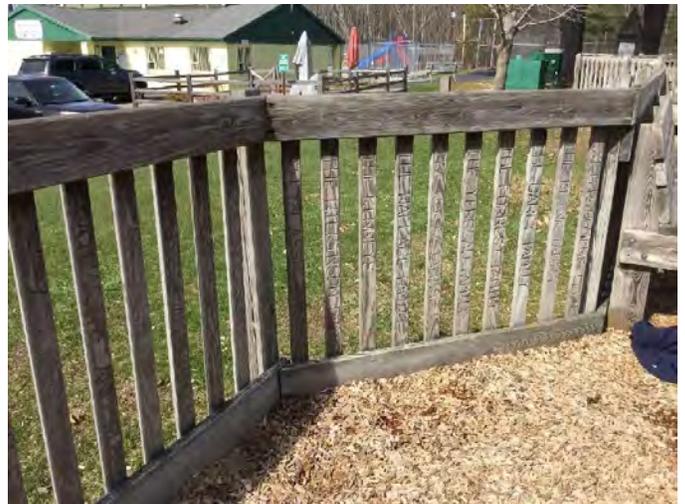
The fence is in poor condition (major splintering, missing pickets and wear).

Replace with new all plastic fence.

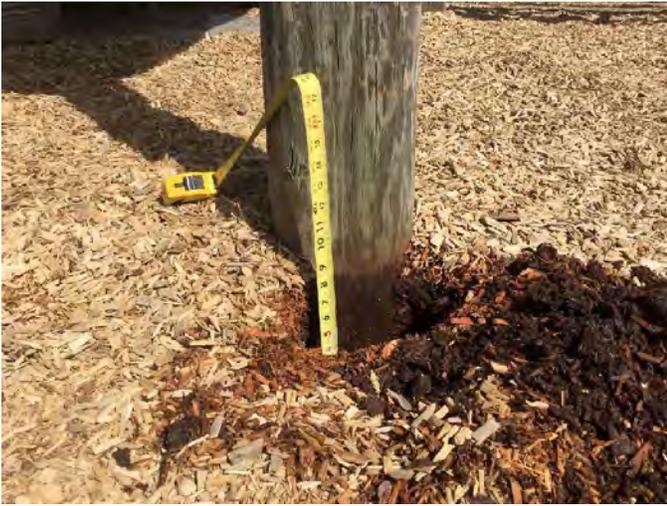
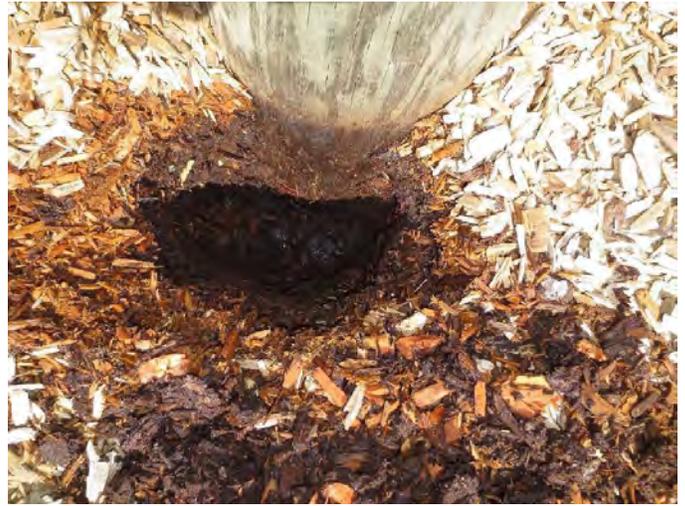
Safety surfacing is in medium condition. Some areas are not at a sufficient depth.

Make sure the finished safety surfacing continues to meet all safety requirements. The park maintenance crews have done a great job in maintaining a uniform and compliant safety surface on the playground. Additional EWF has been added each year to maintain proper depth.

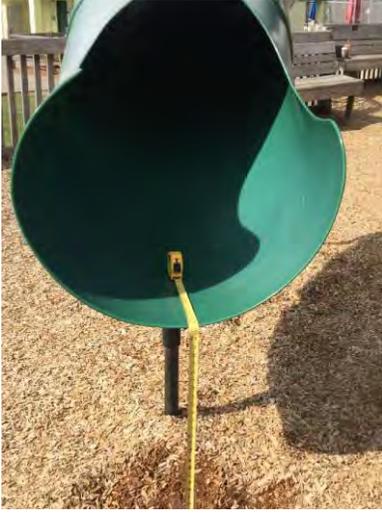
### **Slide #1 (Type & Condition)**

Exit height is greater than 15" from safety surface.

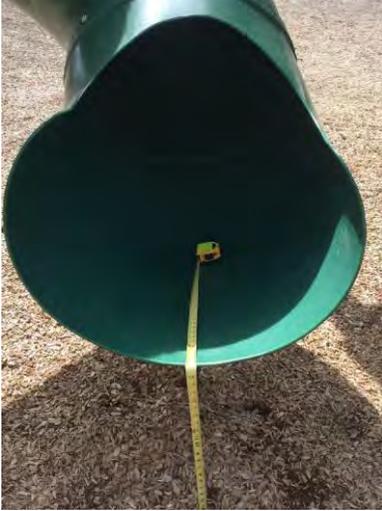
**Slide #2 (Type & Condition)**

Exit height is greater than 15" from safety surface.

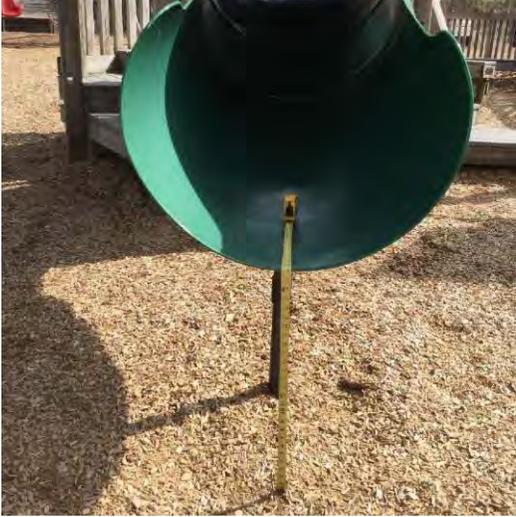
**Slide #3 (Type & Condition)**

Exit height is greater than 15" from safety surface.

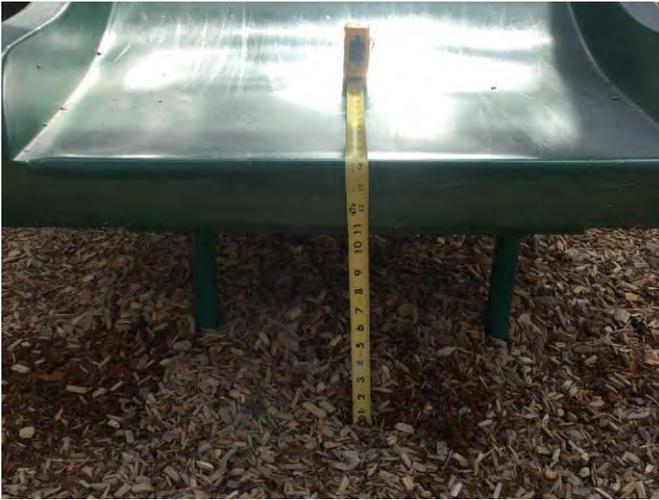
**Slide #5 (Type & Condition)**

The transition platform for this slide is less than 48" from the safety surface which necessitates an exit height between 0 - 11". The exit height on this slide is 14".

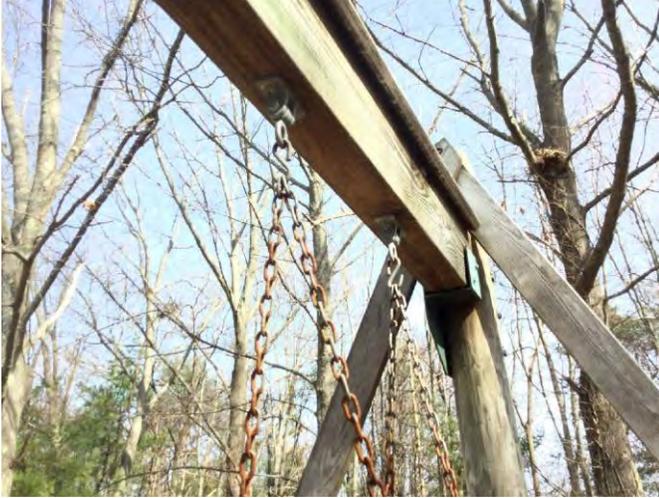
S hooks in many locations are open beyond compliance.

This piece of equipment needs maintenance. Replace S hooks with clevis hangers.

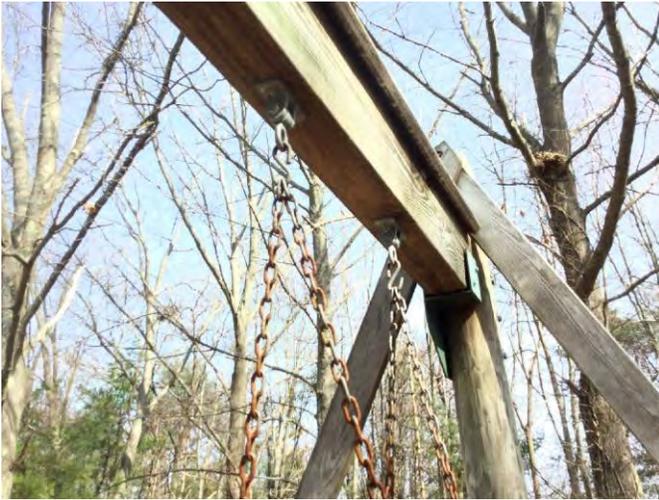
S hooks open in many areas. (see above).

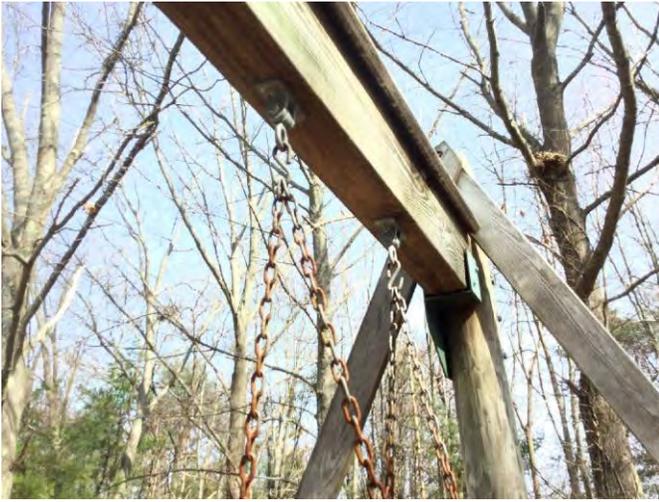
S Hooks open in many places.

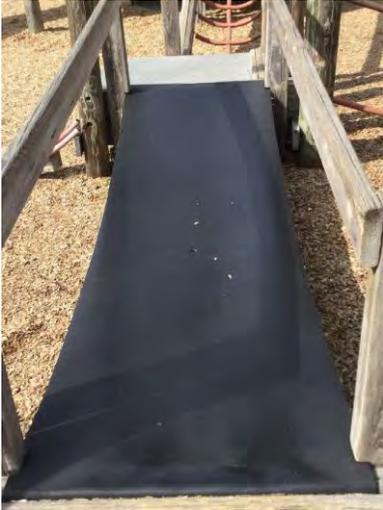
Bridge is sagged and needs to be replaced.
