Leathers & Associates

Planet Playgroud - Exeter, NH

General Playground

This assessment is based on a site visit meeting with Michael Favreau. The playground is 17.5 years old. The playground should be expected to last around 20 years with proper maintenance. It's apparent from its condition that this playground is a well-used attraction in the area. There is a strong emotional connection with the community and the playground.

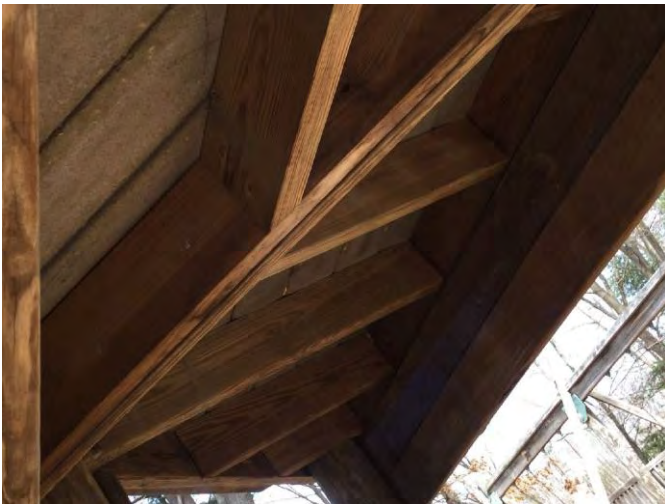
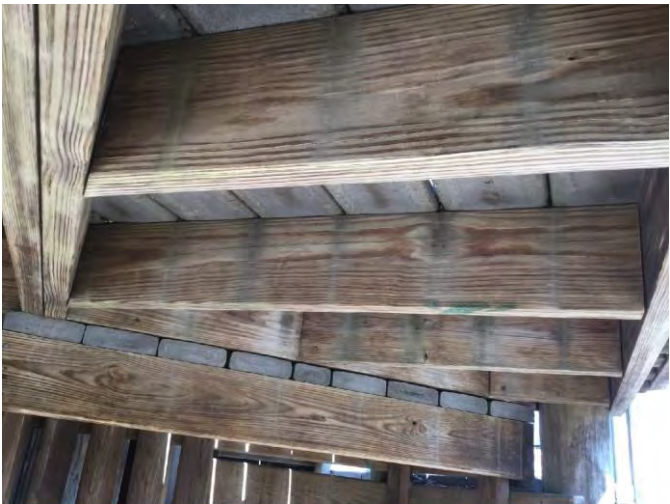
Decking	Composite
Decking Size	2x6

Decking treatment	N/A
Decking Condition	The decking is in medium condition. Some splintering but not structural.
Decking Recommendations	Notes
Replace with recycled plastic

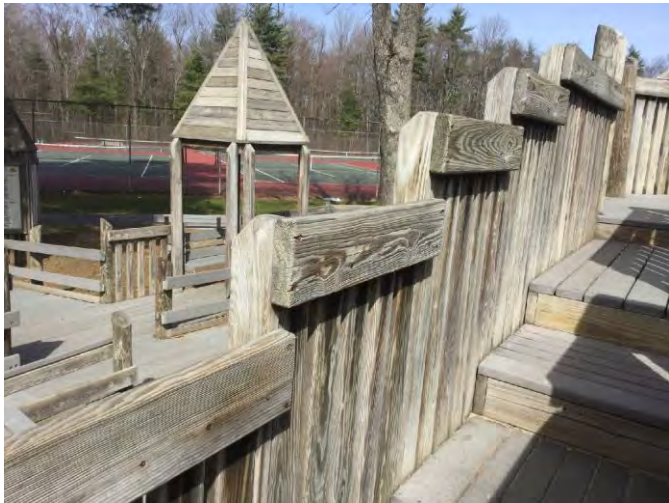
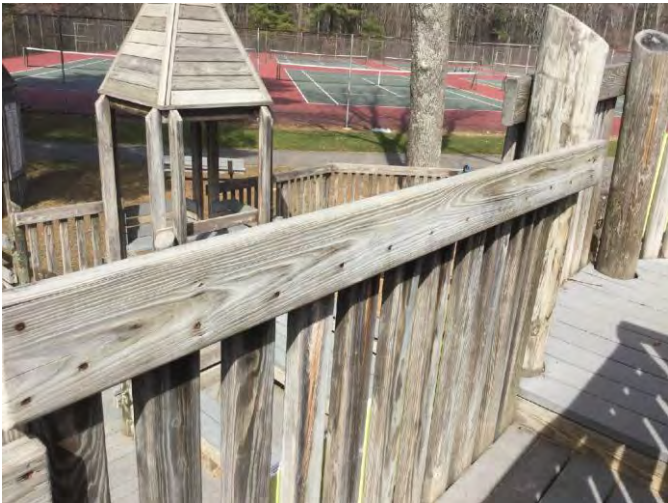
The handrails are in poor condition and have severe splintering

The handrail posts are in poor condition. Has major splintering and some structural issues.

Replace with recycled plastic

Replace with recycled structural plastic.

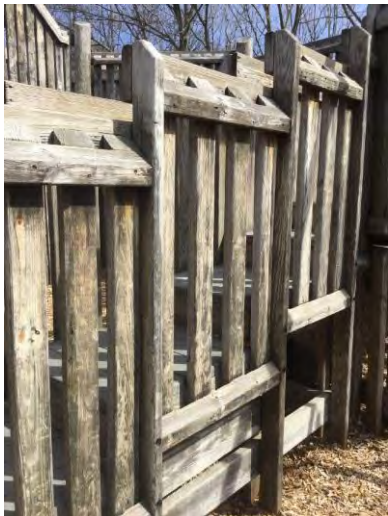
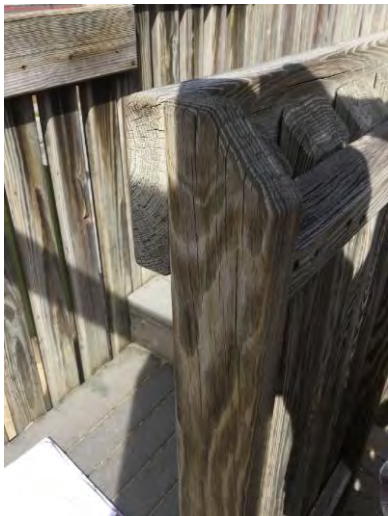
The balusters are in poor condition (severe splintering & wear).

Replace with powder coated pipe balusters.

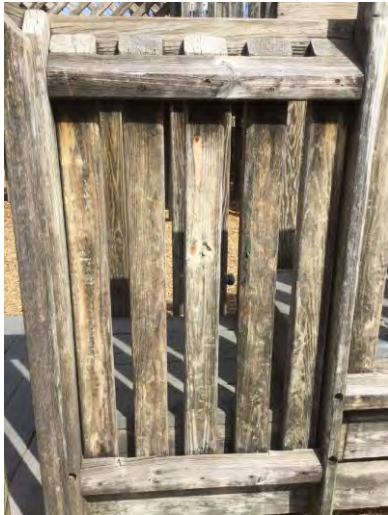
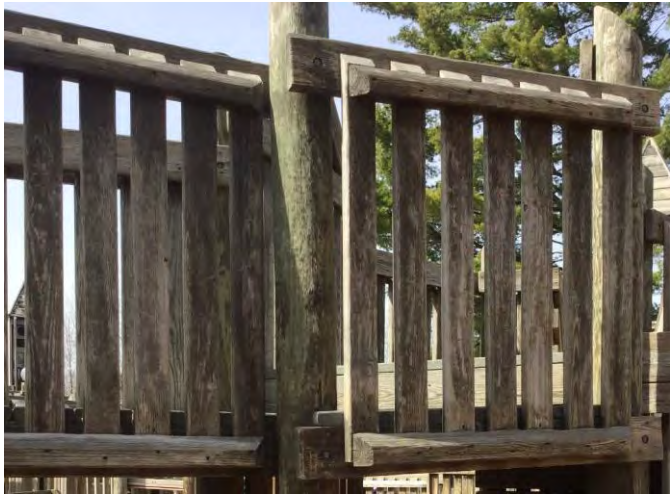
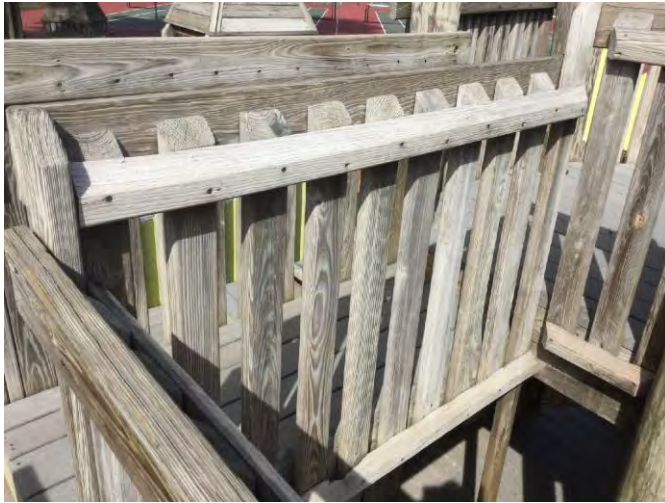
Maze Cubes	Wood framing and composite decking.
Maze Cube Size	24"
Maze Cube Condition	The maze cubes are in medium condition (minor splintering & wear).
Maze Cube Recommendations	Notes
Rebuild with current style larger maze cubes using structural plastic framing and recycled plastic decking.

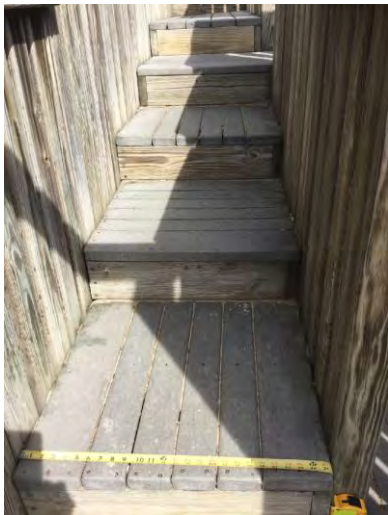
Accessible Ramps	Notes
Expand existing ramps and create an updated design that would incorporate additional ramps to create greater accessibility.

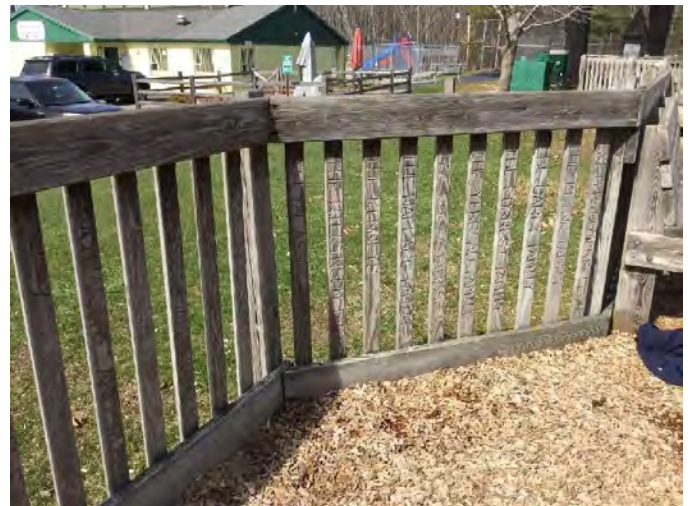
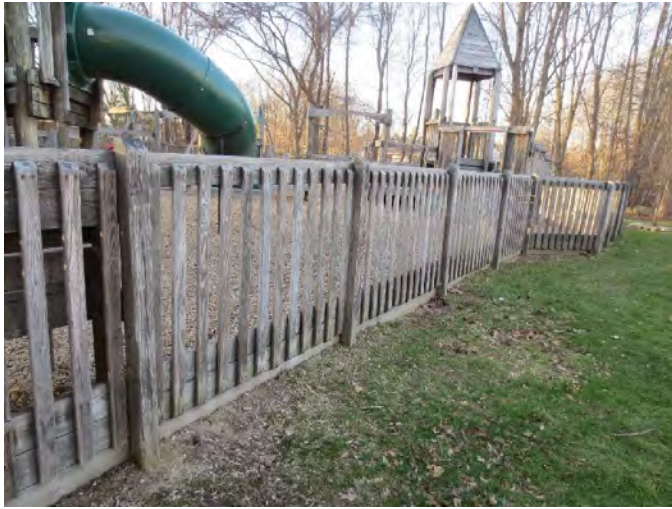
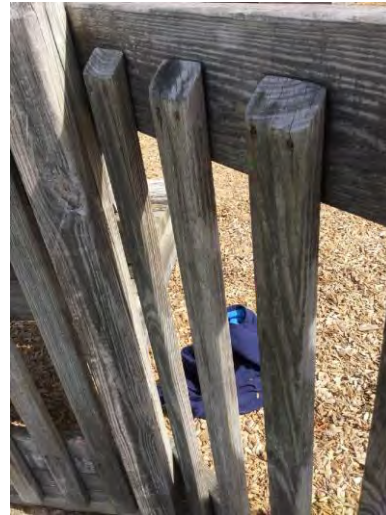
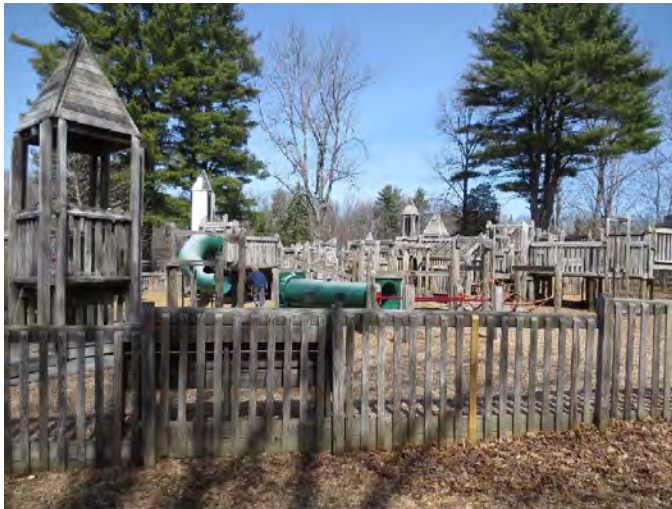
The fence is in poor condition (major splintering, missing pickets and wear).

Replace with new all plastic fence.

- **Accessible ramps:**
 - Leave “as-is”
 - **Fence:**
 - Replace with new all plastic fence. The entire playground has a chain link fence around it, including the pavilion and "world map" area. Gates provide accessibility. Some of the fence with pickets is inside (immediately adjacent) to the chain link fence. Overall the fence and perimeter are unattractive. A new fence with some color, named pickets and possibly some areas with hand tiles would greatly increase the overall "curb appeal" of the play area.

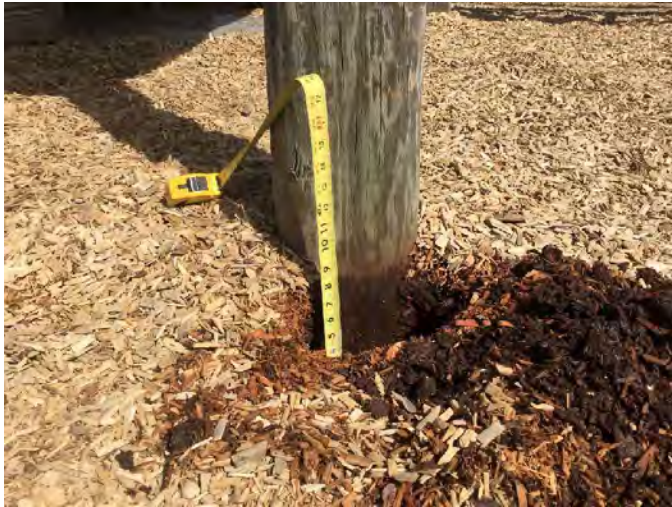
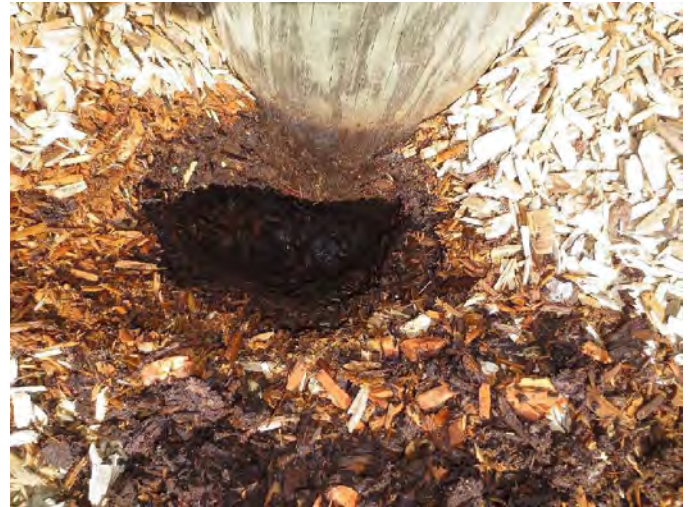
Safety surfacing is in medium condition. Some areas are not at a sufficient depth.

Make sure the finished safety surfacing continues to meet all safety requirements. The park maintenance crews have done a great job in maintaining a uniform and compliant safety surface on the playground. Additional EWF has been added each year to maintain proper depth.

- **Low perimeter:**
 - Replace loose or missing pieces and cap with plastic.
 - **Safety Surfacing:**
 - Add additional engineered wood fiber to a total depth of 12" throughout.

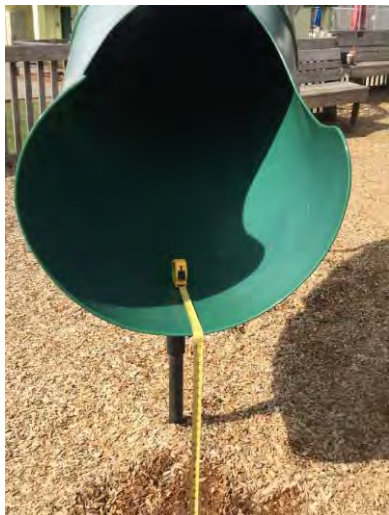
Left Turn Tube Slide

Exit height is greater than 15" from safety surface.

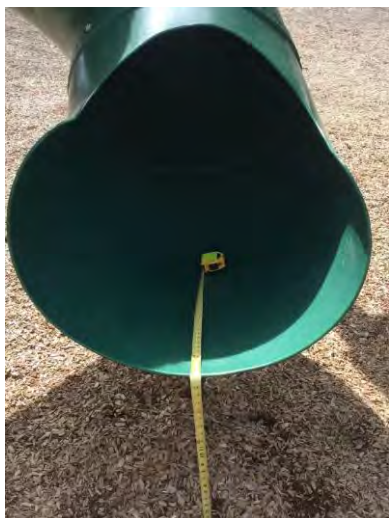
Spiral Tube Slide

Exit height is greater than 15" from safety surface.

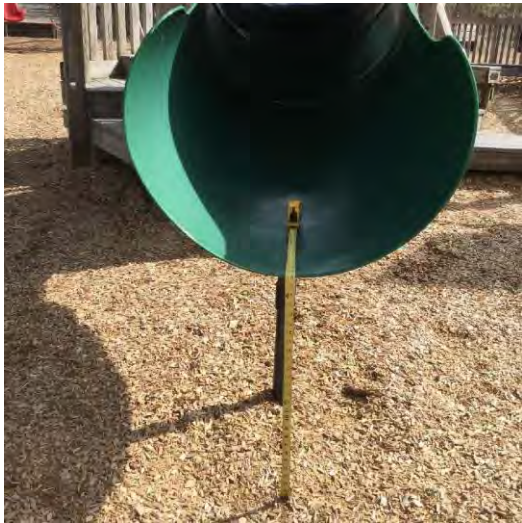
Tot Tube Slide

Exit height is greater than 15" from safety surface.

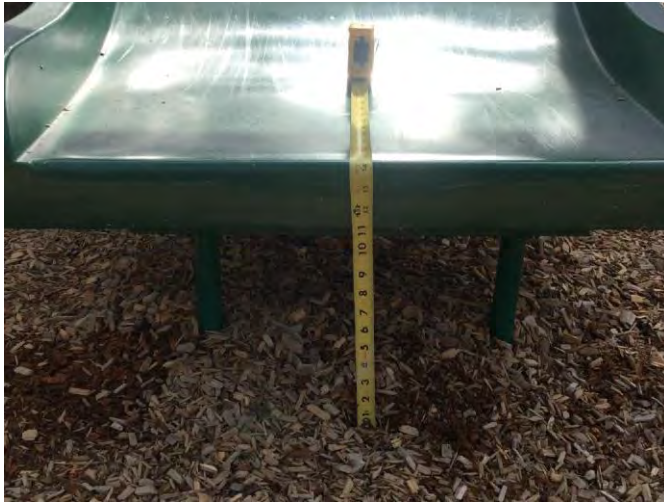
Tot Slide

The transition platform for this slide is less than 48" from the safety surface which necessitates an exit height between 0 - 11". The exit height on this slide is 14".

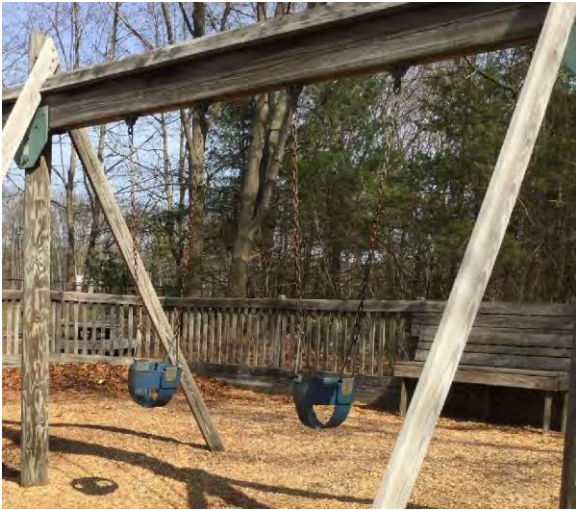
This piece of equipment needs maintenance. Replace S hooks with clevis hangers.

Swing support brackets and swing beams show the wear of 18 years of use. We recommend replacing all swing supports and swings with new powder coated steel manufactured apparatus.

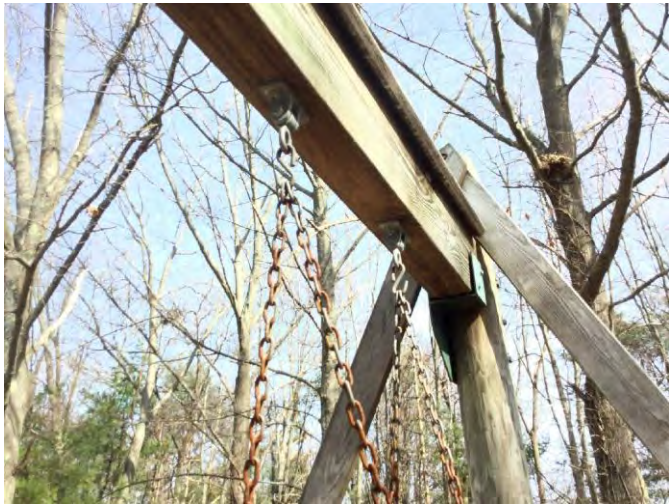
S hooks in many locations are open beyond compliance.

Hangers show the wear of 18 years of use.

Swing chins are rusted.

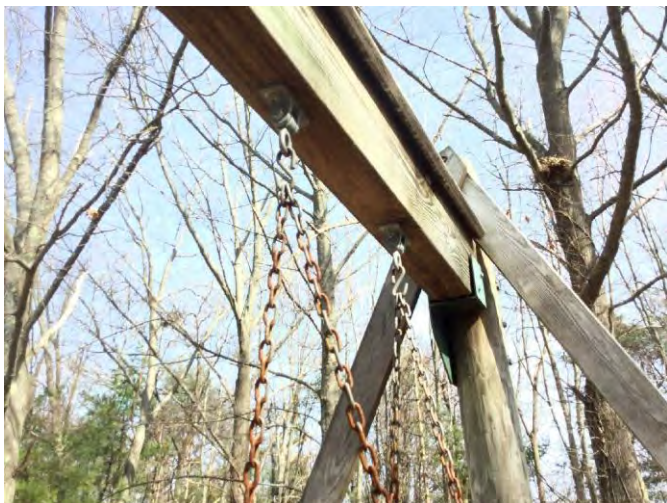
Swing support brackets and swing connected swing beams show sagging and wear due to 18 year of use. We recommend a full replacement.

S hooks open in many areas. (see above).

Hangers show signs of 18 years of use.

Swing chains are rusted.

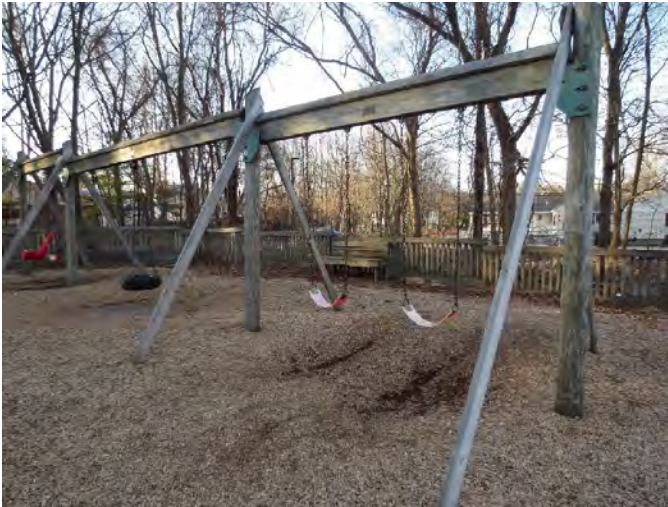
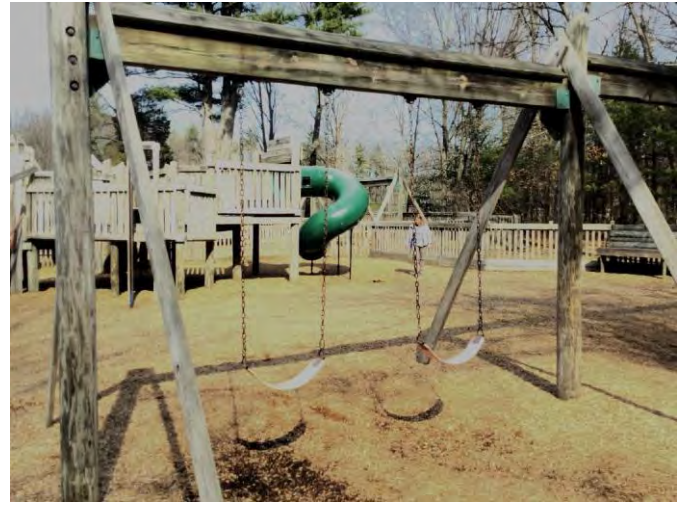
Swing beam brackets and beams show wear after 18 years of use.

Replace with new manufactured equipment

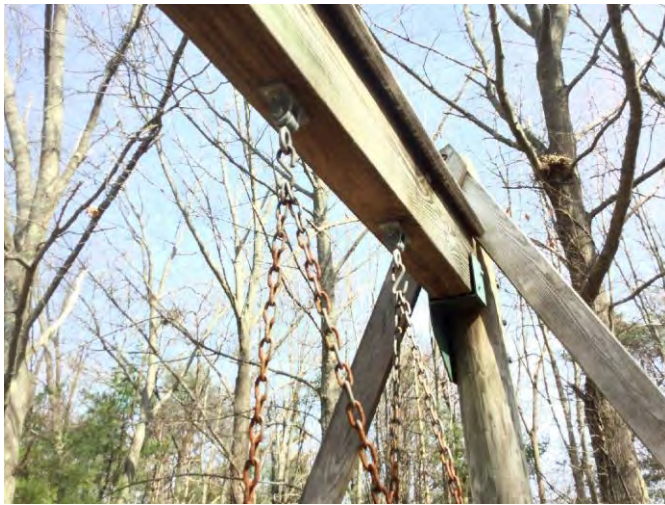
S Hooks open in many places.

Swing hangers show signs of wear after 18 years of use.

Swing chains are rusted.

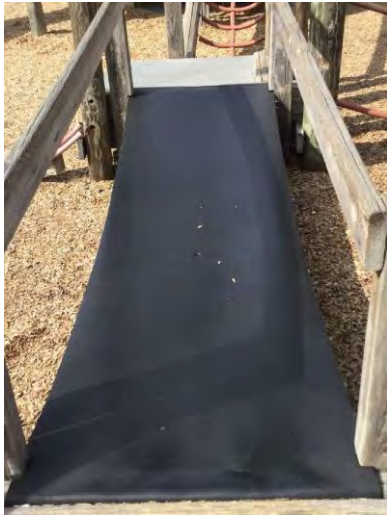
Bridge is sagged and needs to be replaced.

Replace with new.

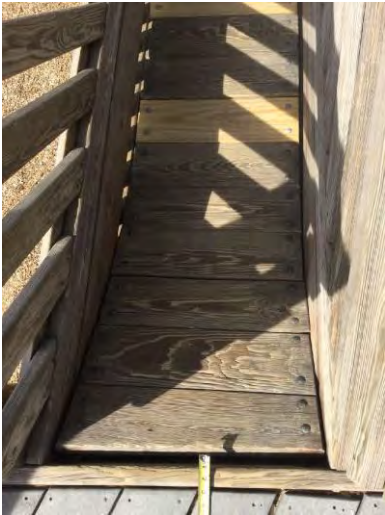
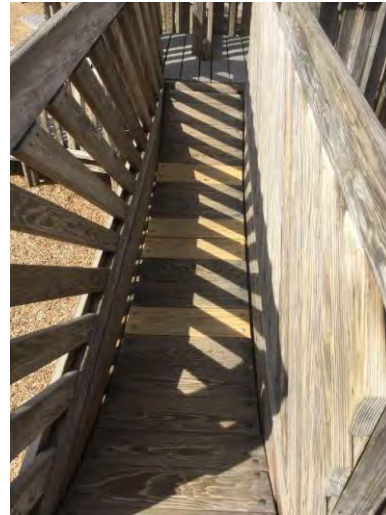
This piece of equipment is non-compliant. This piece of equipment needs maintenance and should no longer used.
We recommend replacing with newer play element.
