EXETER FIRE DEPARTMENT SPATIAL NEEDS ASSESSMENT

Exeter Public Safety Complex

Facility Overview – Central Fire Station located at 20 Court Street

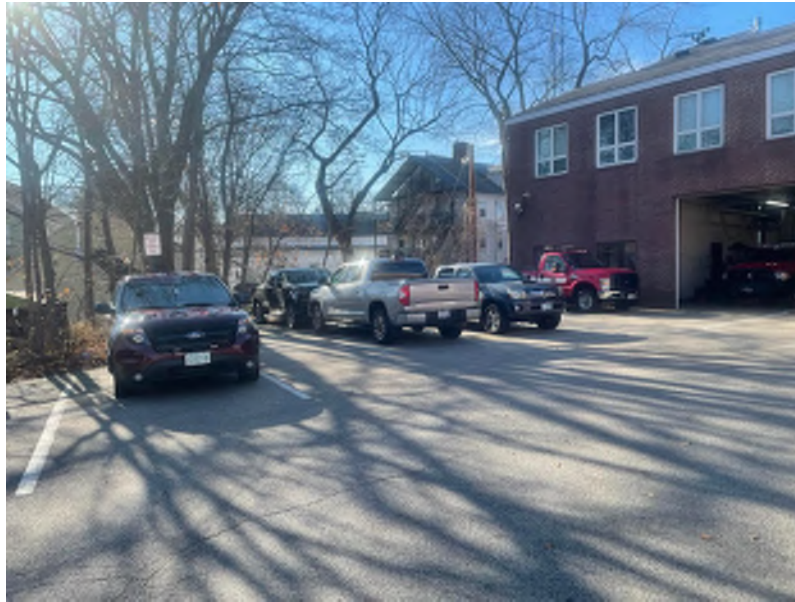
Figure 6 – Rear Parking Lot (double parked vehicles to keep the parking lot response route clear).

Considering the use of the structure and the amount of exterior public safety operational use, these spaces is not adequate to accommodate existing needs. The congestion of this space is demonstrated by the need to double park employee vehicles in an effort to maximize the use of this area. In addition, it is also difficult to maneuver apparatus around vehicles in the rear parking lot. There is a concern of apparatus entering onto Bow Street, during heavy traffic hours as this practice can elongate response times.

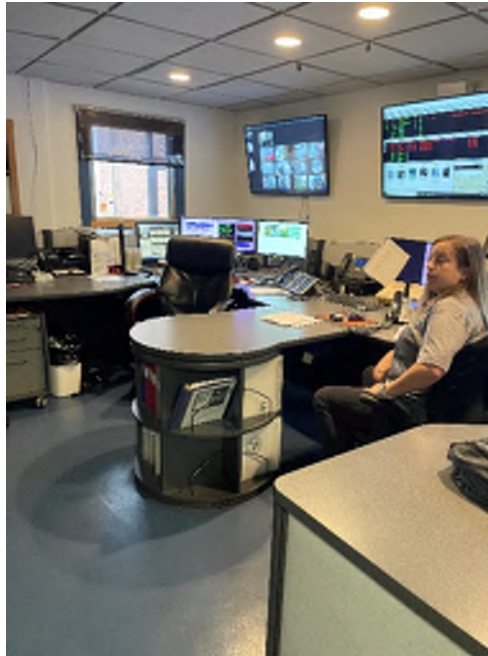
Figure 7 - Two of Three Dispatch Workstations.

Dispatching operations are performed within a well-lit, clean, and comfortable appearing space. Though a thorough assessment was not performed, casual observation of electronics suggests that the radio and computer-based systems are modern and capable. Dispatchers do not have easily accessible secure space for the storage of personally owned property while on duty. Limitations of job tasks prohibits the dispatchers from taking restorative breaks away from their workspace. Gender-neutral rest facilities only feet away from the workspace substantially limits privacy. The addition of separate/private rest areas, personally owned property storage area, and equipped meal break room near the communications center is recommended.

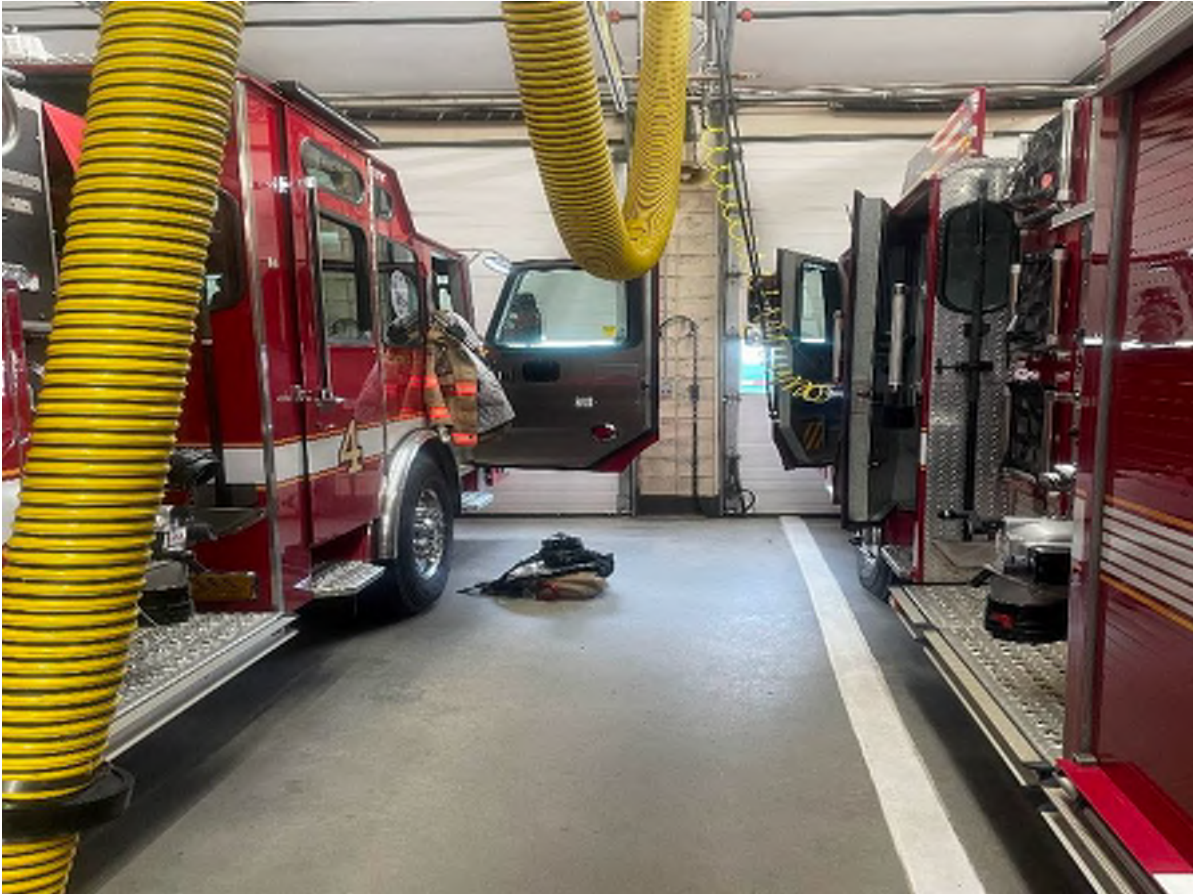
Figure 8- Limited space Between Parked Apparatus – This space limitation can delay response, plymovents strike adjacent apparatus when they disengage from responding units. A lack of traction-based flooring provides the potential for injury.

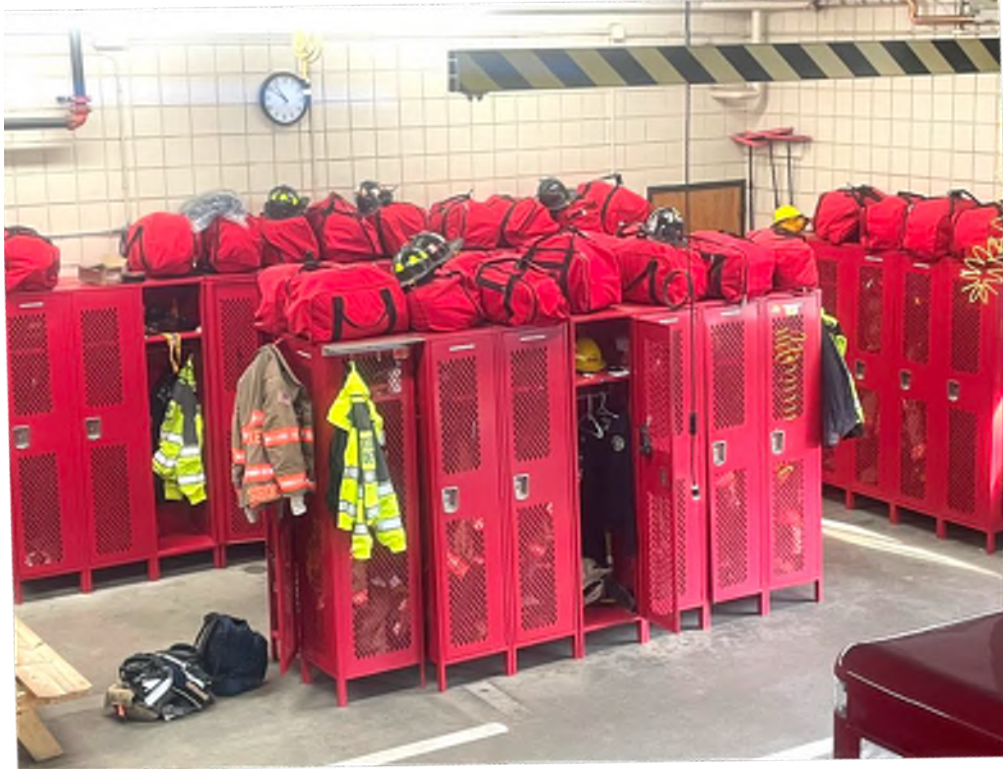
- Turnout gear storage on the apparatus floor without separation from dirt, soot, and other potentially carcinogenic particulates.
- A lack of separated decontamination space exists as the current decontamination area is also a restroom.

Figure 9 – Personal protective Equipment Improper Storage - Turnout Gear storage in the apparatus bays decreases the useable space for apparatus, lacks particulate separation, proper ventilation, climate control or protection from UV light which deteriorates the components of turnout gear.

- E-8: The personal protective clothing storage area should be partitioned off from the apparatus floor and properly climate controlled, ventilated and protected from UV light.*

- E-11: Turnout gear should be restricted to the apparatus bays and extractor area. Signs should be added indicating this policy.*
- E-12: The physical fitness area should be partitioned from the apparatus floor separated from potential contaminates.*

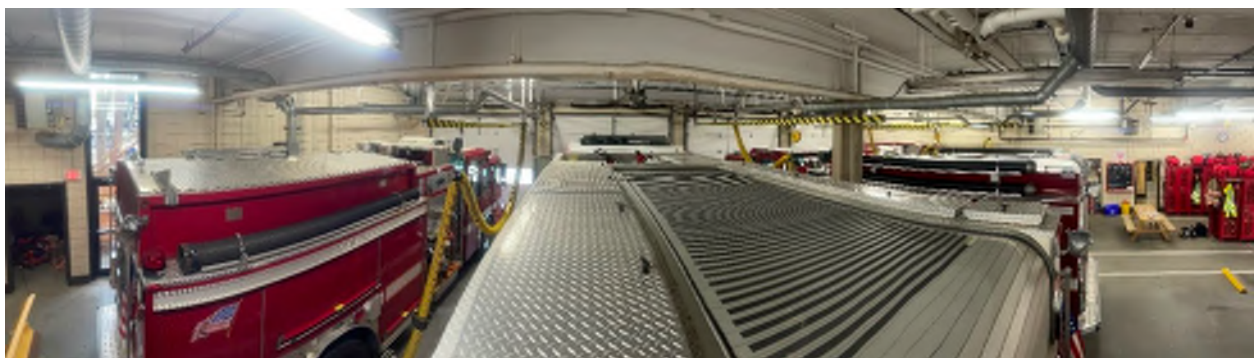
Figure 910– Lack of Clearance – Operational Inefficiency - Low ceiling height prevents easy hose loading or filling engines with water.

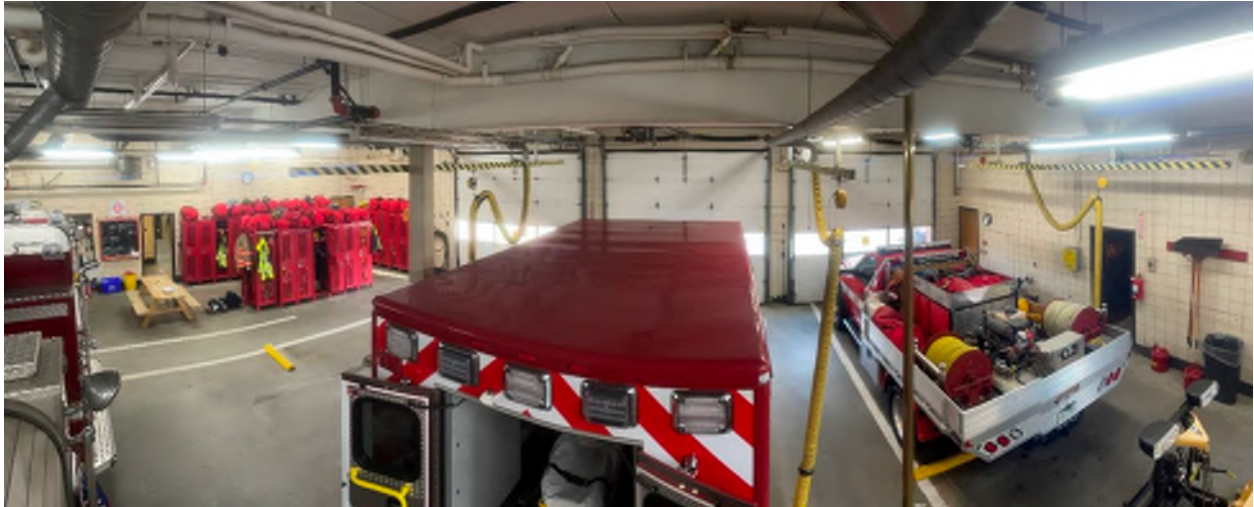
- The rear response paths through tight spaces and onto congested street which can complicate response.
- The kitchen lacks sufficient infrastructure to accommodate 24/7 utilization by the on-duty crew.

Figure 11 – Rear Response Risks - Rear facing response of EMS and forestry units requires vehicles to navigate the police/fire parking lot and enter onto Bow Street which can be congested with stopped traffic.

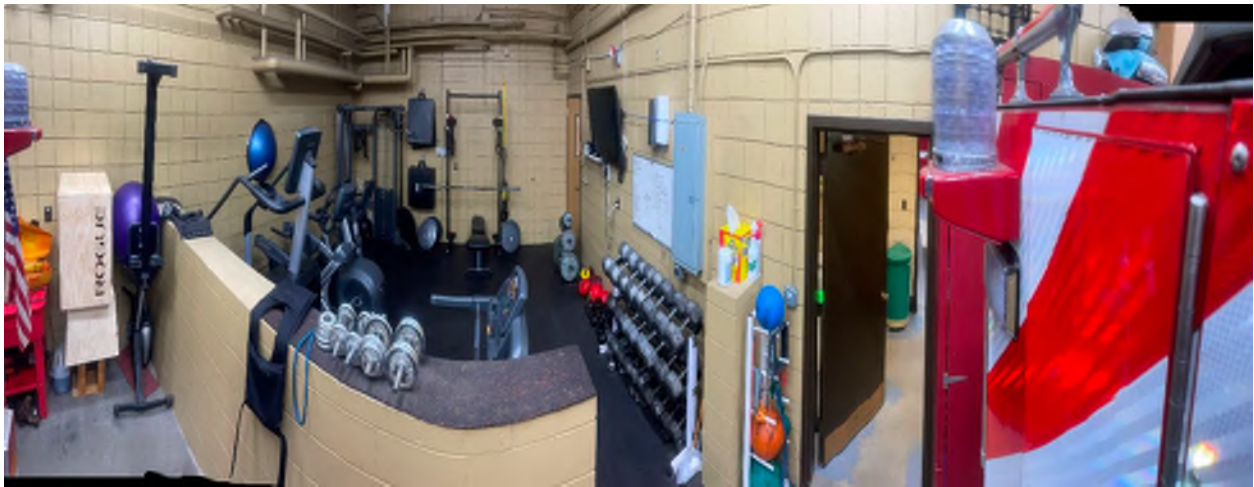
Figure 12 – Inappropriate and Undersized Space – The physical fitness area lacks sufficient space and is on the apparatus floor and exposed to dirt, soot and other particulates.

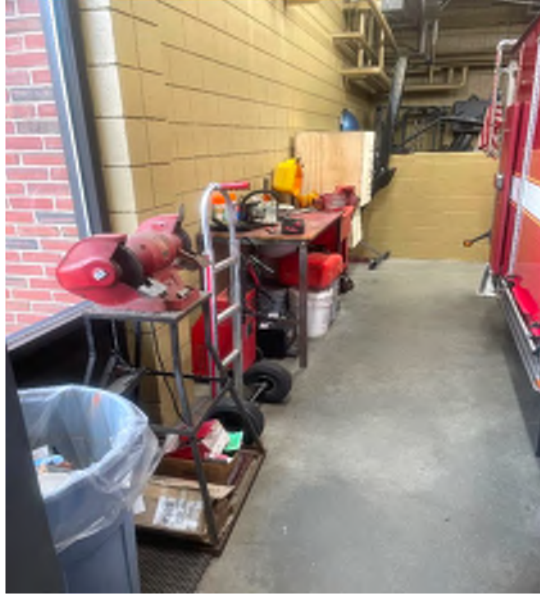
Figure 13 – Adapted Space - Adapted tool and maintenance are on the sides of the station. This presents an operational issue as well as the inability to properly store and secure vital tools.

- E-13: Given space constraints and to repurpose existing space, secured storage should be shifted to exterior storage containers. This should be recognized as a temporary measure which will further reduce available parking but will maximize the use of the current structure while the public safety complex is being considered.*

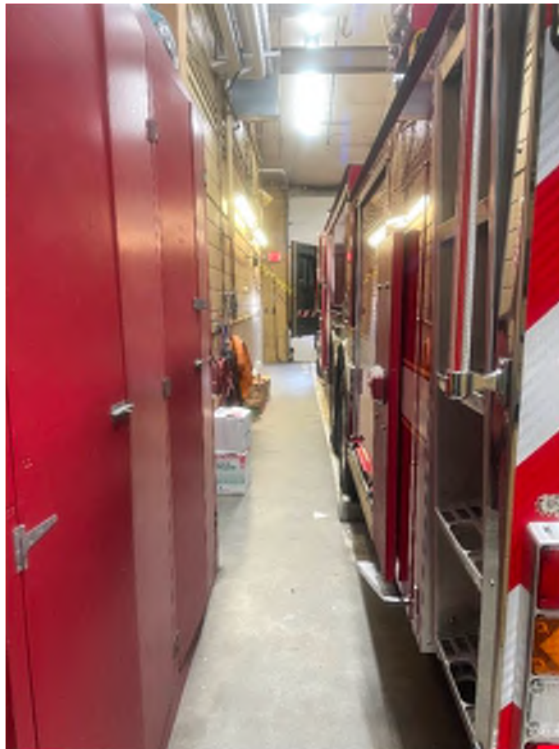
Figure 14 – Limited Space and Clearance – this image clearly shows the space limitations that have emerged as the size of apparatus has increased.

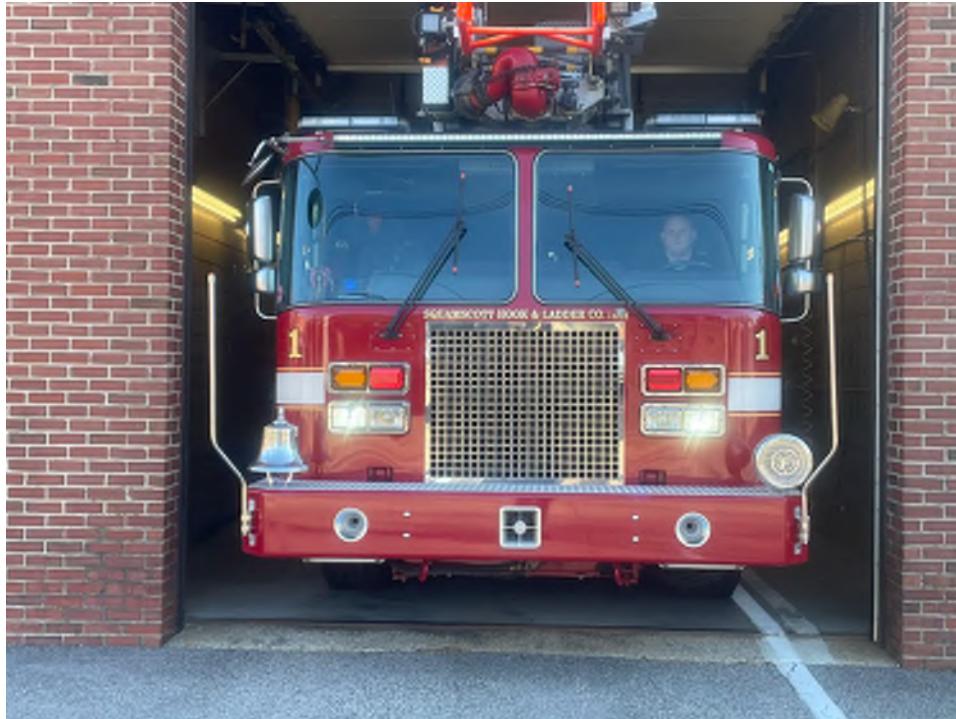
Figure 54 – Limited Clearance – this image demonstrates a lack of appropriate apparatus clearance which can complicate response and create difficult conditions to operate vehicles. This has already resulted in multiple incidents including one accident that caused \$27,000 in damage and placed the aerial ladder out of service for an extended period.

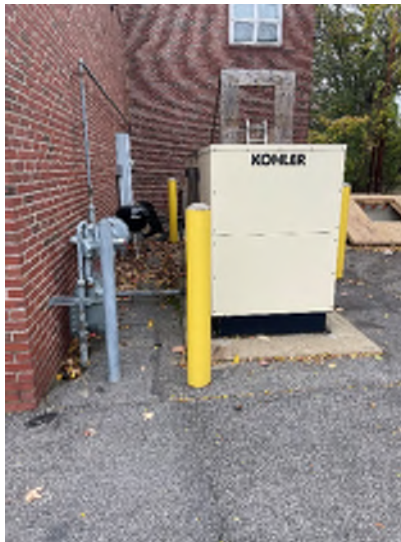
- The generator and utilities are not access protected.

Figure 16 – Unsecured utilities and backup generator

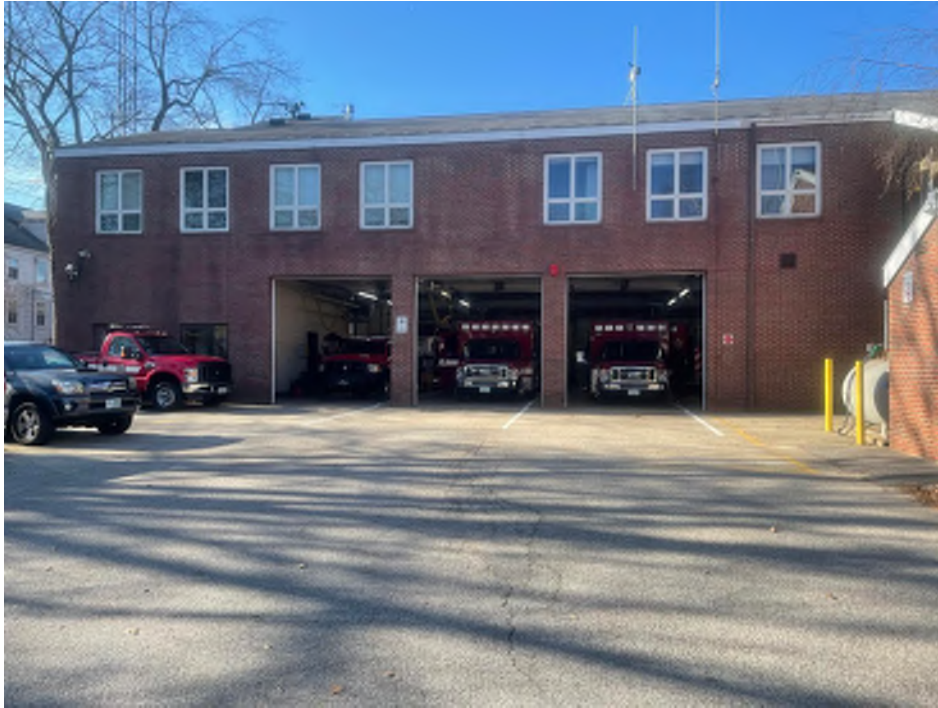
Figure 17 – Rear response path through parking lot

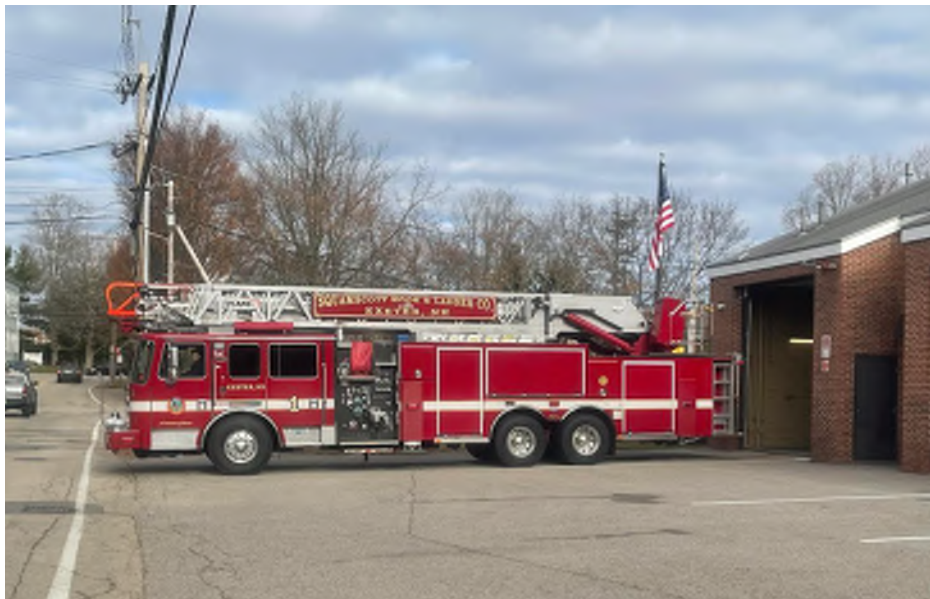
- The front apron can barely fit larger apparatus. As an example, the aerial ladder barely fits on the front apron. This requires that drivers cautiously negotiate turning onto Court Street. This has already contributed to a significant accident where the building was stuck as apparatus moved out of the station and turned onto Court Street.

Figure 18 – Aerial ladder barely fits on the front apron

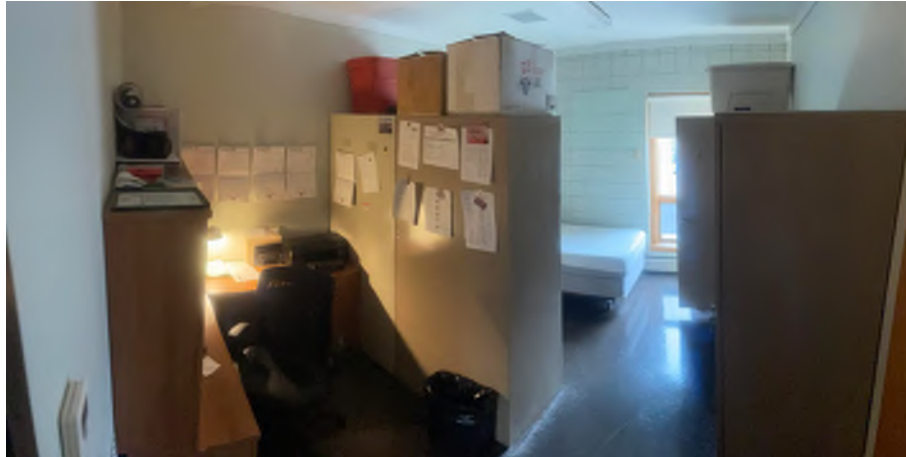
Figure 19 – Dorm room combined into the shift commander's office and dorm

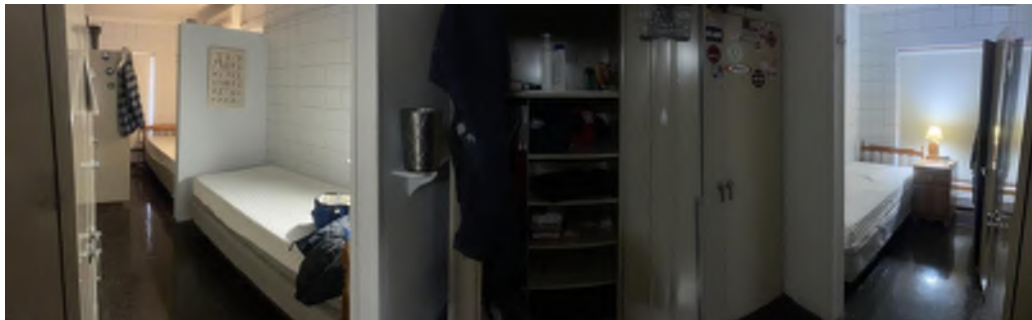
- There is a lack of sufficient walking space in the triple occupancy dorm room.
- **The shift commander's office is combined with his dorm room which is remote from most operations. This is an inefficient practice that was developed out of necessity based on a lack of office space.**

Figure 20 – Cramped triple occupancy dorm room

- E-9: The use of double occupancy rooms should be limited and only occur when staffing exceeds the number of available bunk rooms.*
- E-10: Personnel and equipment decontamination areas should be marked.*

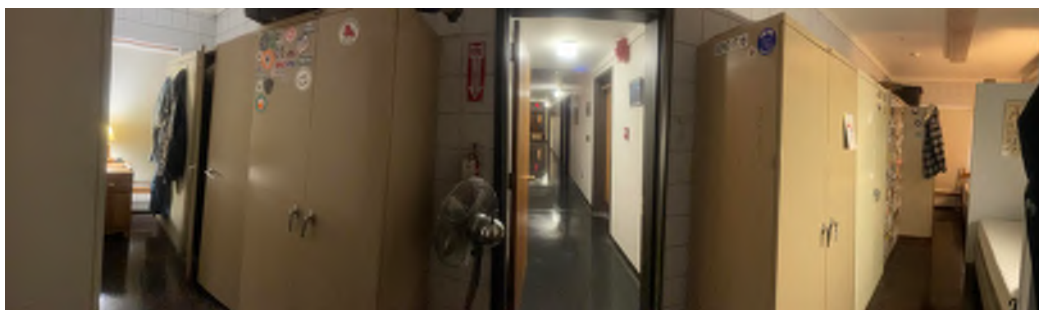
Figure 21 – Limited clearance and walking space

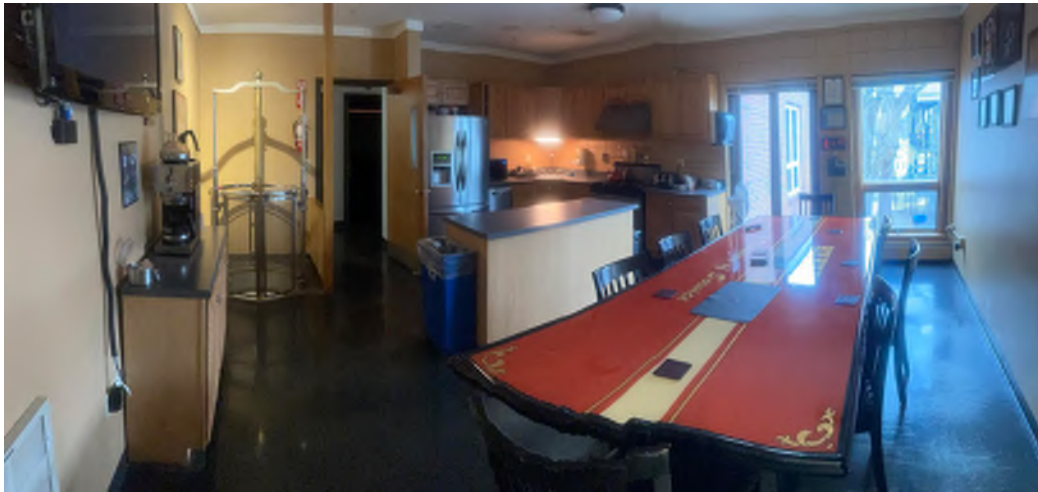
Figure 22 – Kitchen/Dining area cramped based on current Staffing

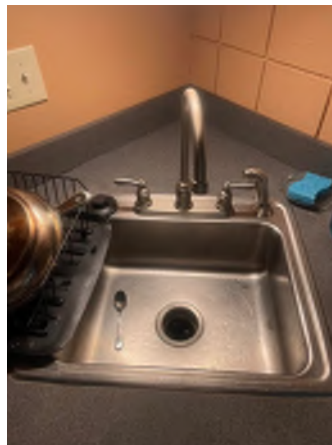
Figure 23 – Small RV sink in the kitchen

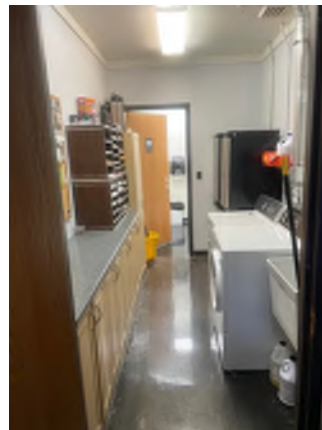
- The ready room/day room is at capacity and cannot accommodate additional staff.
- As spaces have been adapted living space has been condensed into several cramped multiple use areas. An example is the pantry/laundry/mailroom restroom access space.

Figure 24 – Adapted Multi use Space- Pantry, laundry, mailroom, restroom access space.

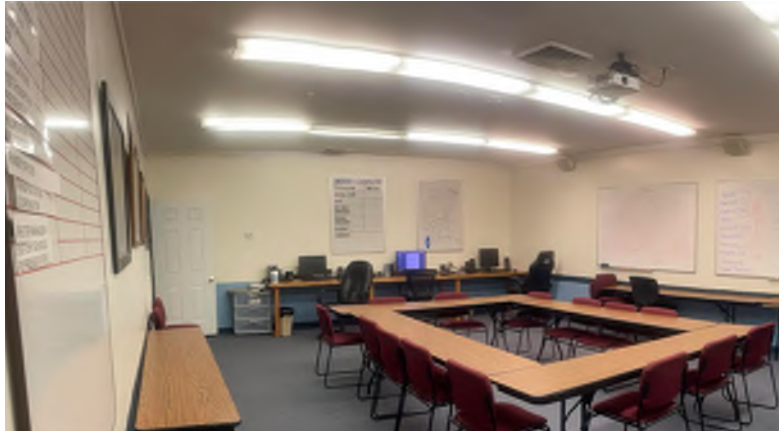
- The EFD Training Room also serves as the space where incident reports are generated. This space is only available when the space is not being utilized for meetings, public safety training or as the EOC.

Figure 245– Incident Report data Entry Space

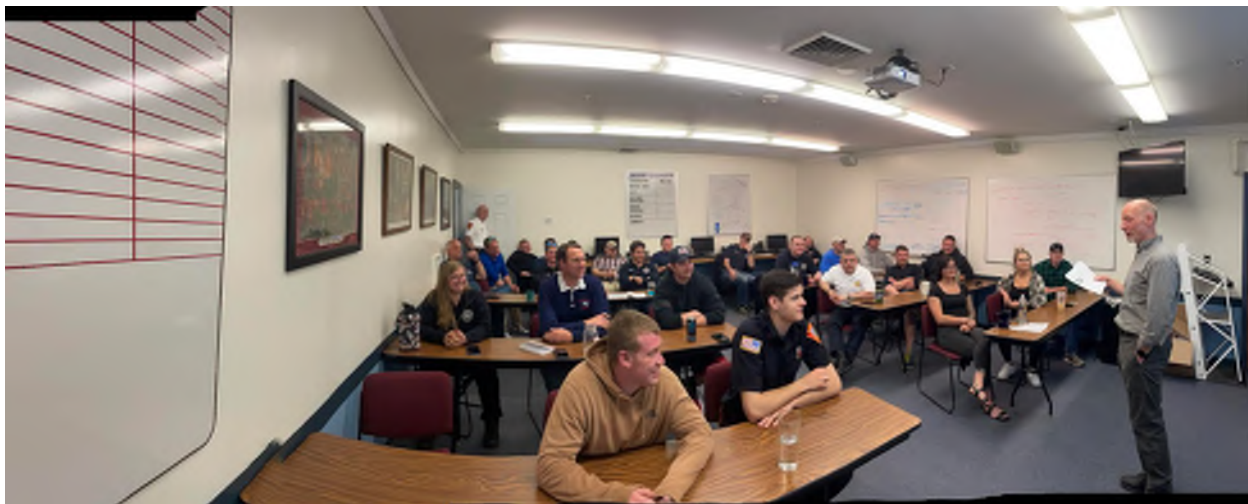
- The Public Safety Training Room doubles as the Emergency Operations Center (EOC). This space cannot accommodate a full Department meeting nor would it be suitable as a EOC during a significant community event.

Figure 26- Training room at capacity

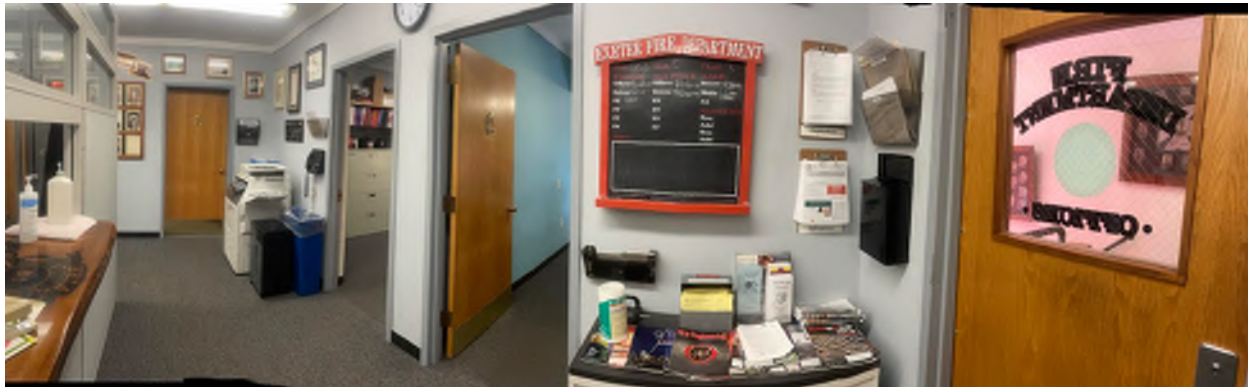
Figure 27 – Adapted Administrative Space

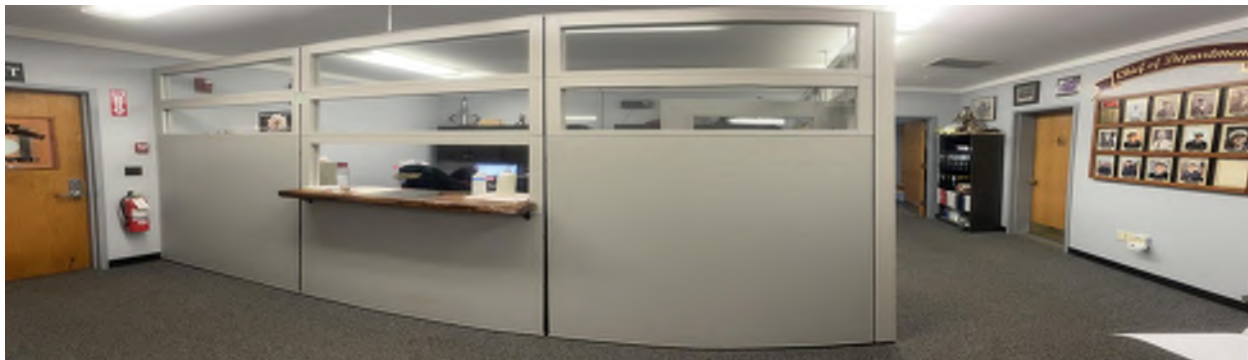
- **A lack of adequate office and administrative space, some offices have been created by moving walls or erecting temporary partitions in open areas.**

Figure 28 – Temporary office partitions
