STRUCTURAL ANALYSIS OF ROOF SUPPORT STRUCTURE
TO DETERMINE SAFE LOAD CARRYING CAPACITY

Structural Analysis of Roof Support Structure to Determine Safe Load Carrying Capacity

Main Department of Public Works Garage and the Water Department Garage

January 2016

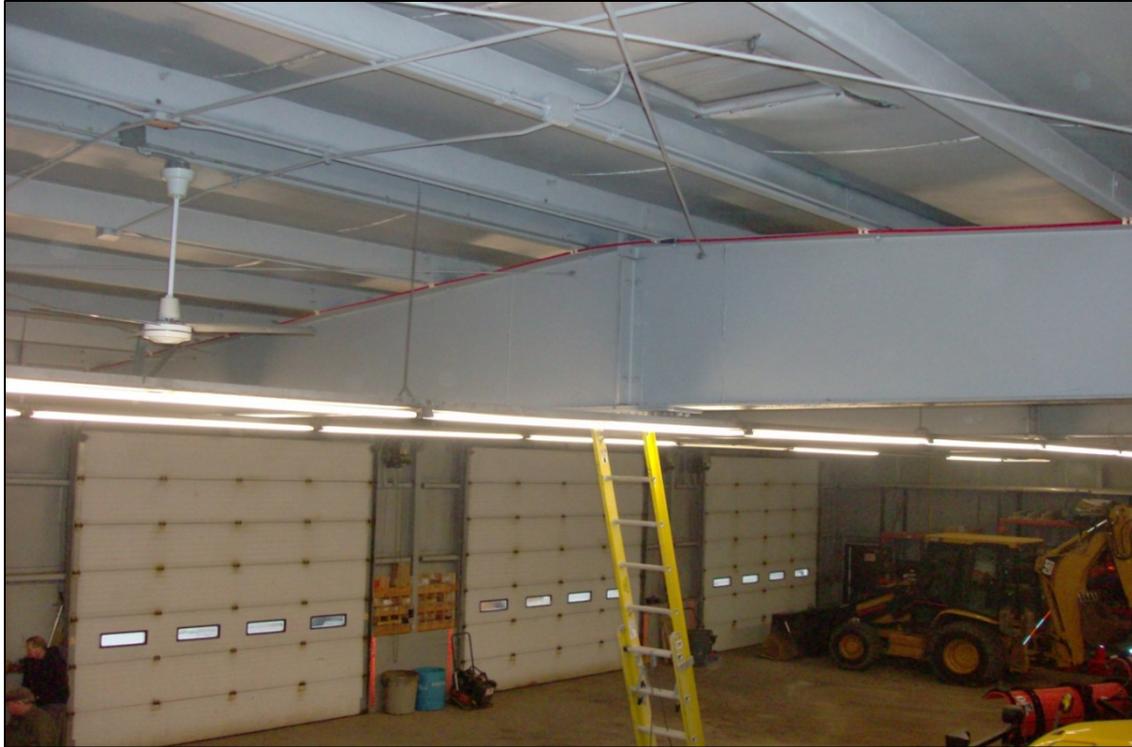
The structural analysis of the 8-inch deep girts, which span from bent-to-bent, indicates that the girts are capable of safely supporting a live load of approximately 20 pounds per square foot or about 57% of the current code mandated snow load of 35 psf.

The horizontal bents which span across the full 60-foot width of the building are 42 inches deep at centerline and taper down to 11-3/8" at the exterior walls. The top and bottom flange widths are constant at 10 inches wide. The structural analysis of this portion of the bent indicates that the member is capable of safely supporting the current code mandated snow load of 35 pounds per square foot.

The columns are 4" x 8" members and the structural analysis of the columns supporting the bents indicate that they are capable of safely supporting a live load of only 18 pounds per square foot or about 50% of the current code mandated snow load.

Framing in 1969 section of DPW Garage.

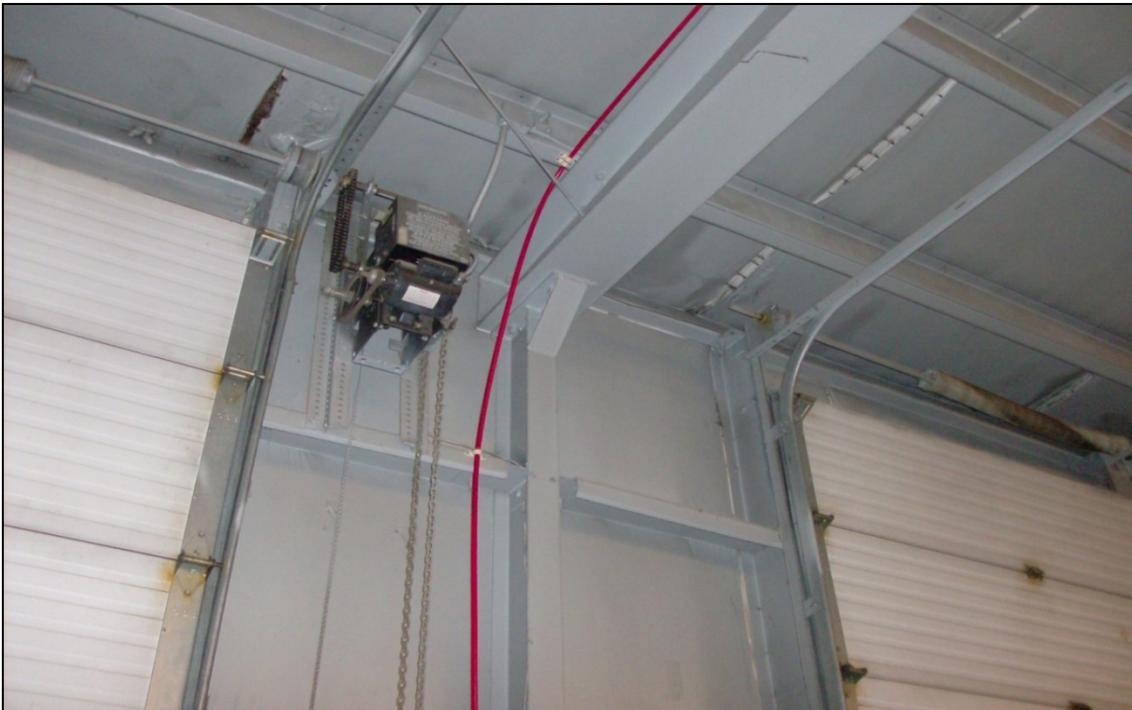
Column-to-beam connection at exterior wall of DPW Garage. Note size of column.

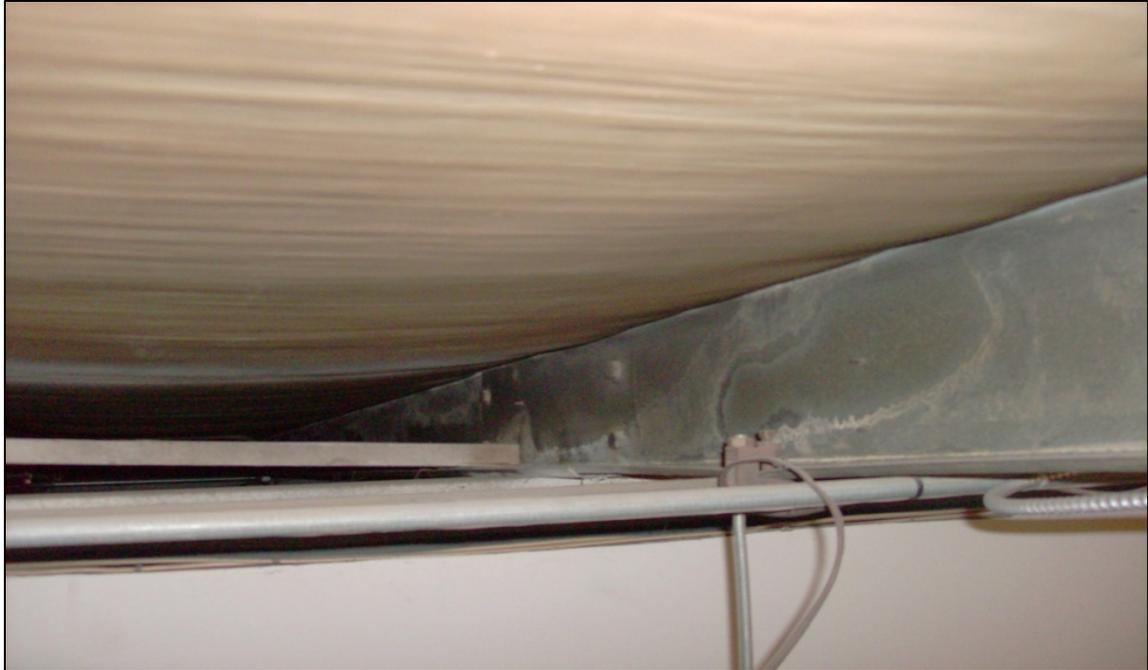
1969 Section of DPW Garage: Roof panel support girt running over bent (note insulation).

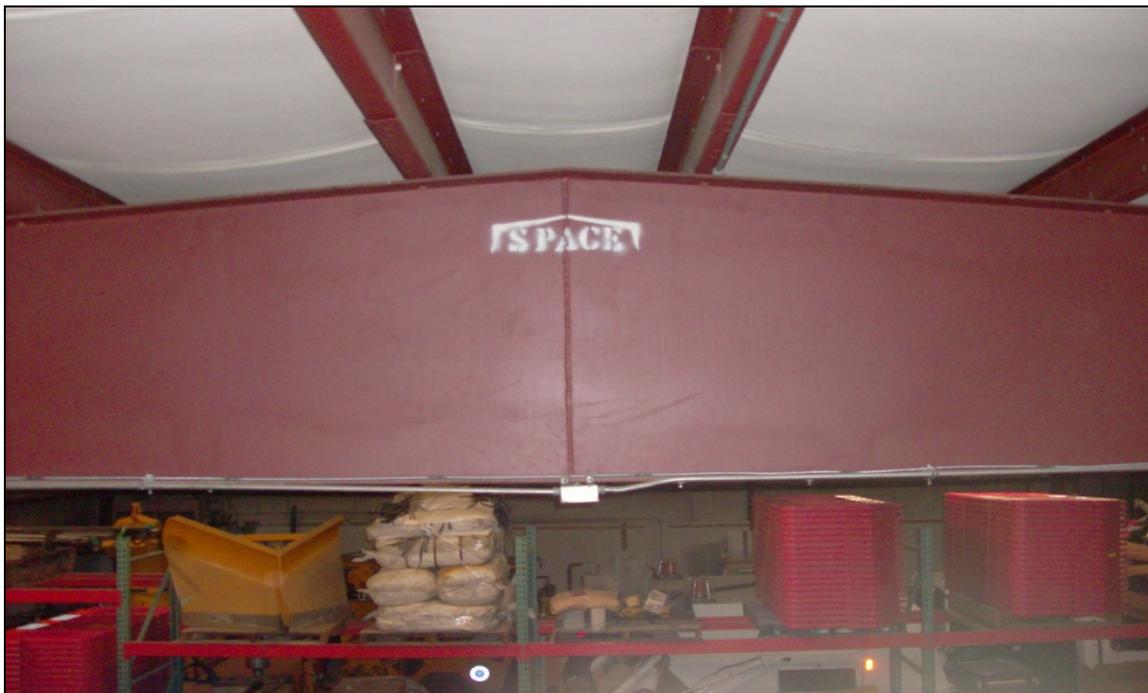
The horizontal bents which span across the full 60-foot width of the building are 44 inches deep at centerline and taper down to 15-1/8" at the exterior walls. The top and bottom flange widths are constant at 8 inches wide. The structural analysis of this portion of the bent indicates that the member is capable of safely supporting the current code mandated snow load of 35 pounds per square foot.

The columns are 6" x 10" members and the structural analysis of the columns supporting the bents indicate that they are capable of safely supporting a live load of 25 pounds per square foot or about 70% of the current code mandated snow load.

Mid-1970's Section of DPW Garage: Typical bent at centerline with girts and roof insulation.

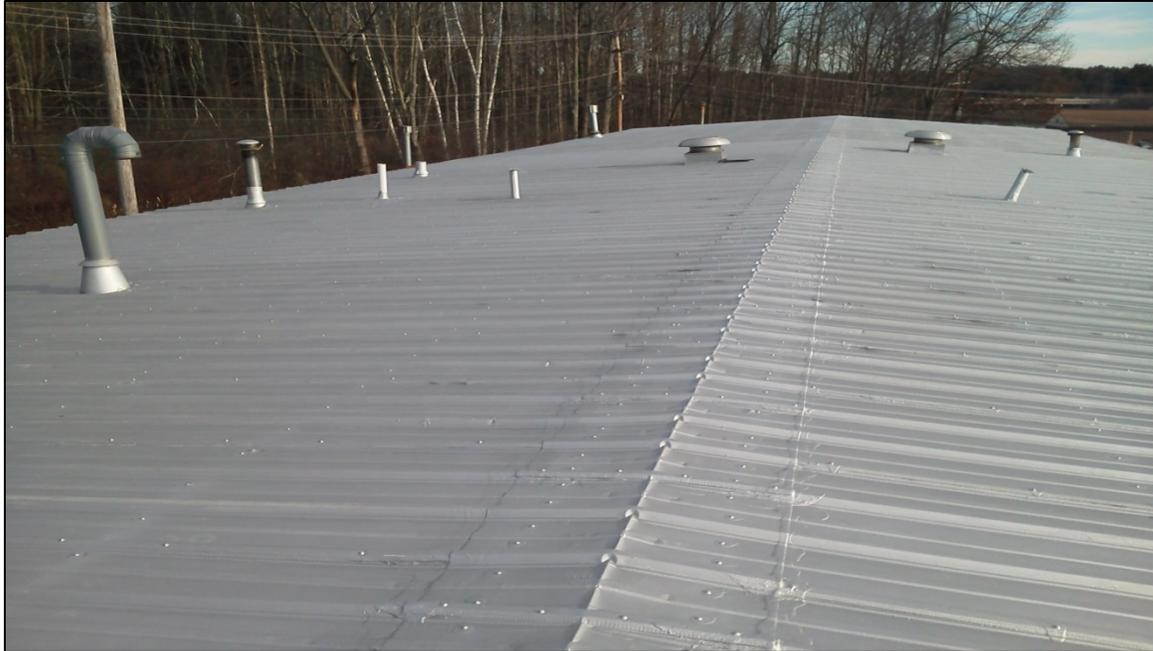
The metal roof panels are attached with exposed fasteners and it appears that the roof panels were coated with an elastomeric, membrane type coating designed to lengthen the life expectancy of an existing roof. During our evaluation and measurements we observed signs of leakage, which explains the installation of the coating system. The roof edge detail on the Main DPW Garage appears to be incomplete. The closure piece is set about 12 inches in from the edge of the roof panel such that it is slightly inboard of the plane of the wall. It appears that water can penetrate the area between the top of the wall and the bottom of the roofing and easily find its way down the inside face of the wall. The closure piece appears to have a significant number of openings. The roof edge detail combined with the lack of insulation and venting makes this roof very susceptible to the formation of ice dams.

Overview of roof on DPW Garage. Note exposed fasteners and metallic roof coating.

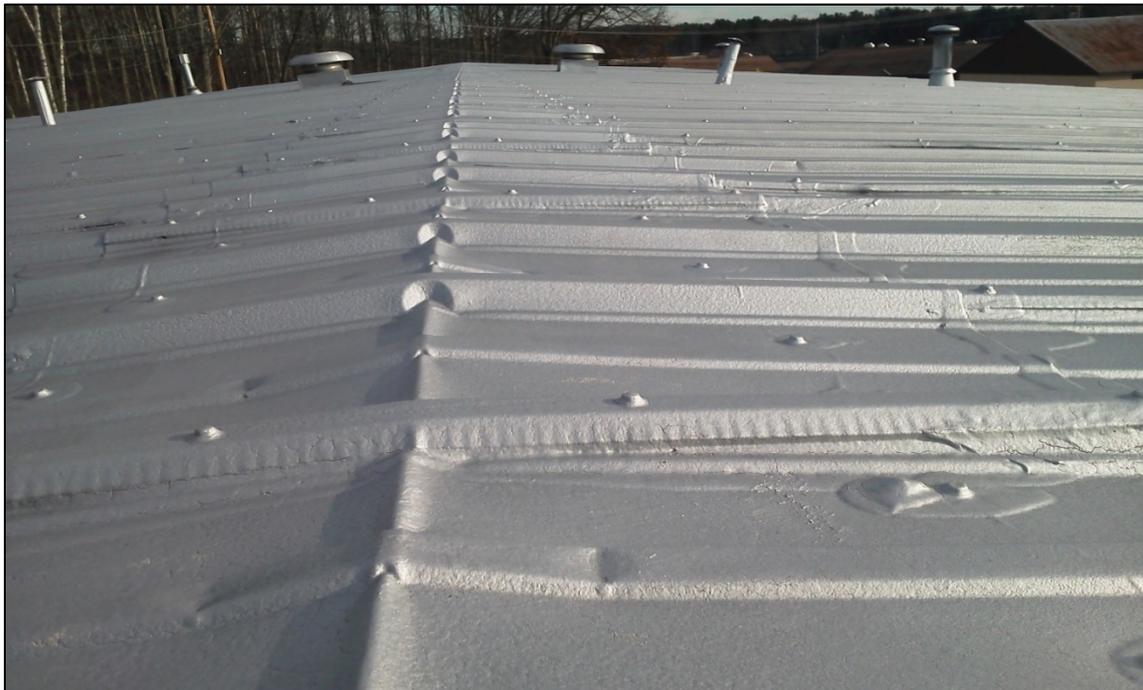
Close-up of ridge of DPW Garage.

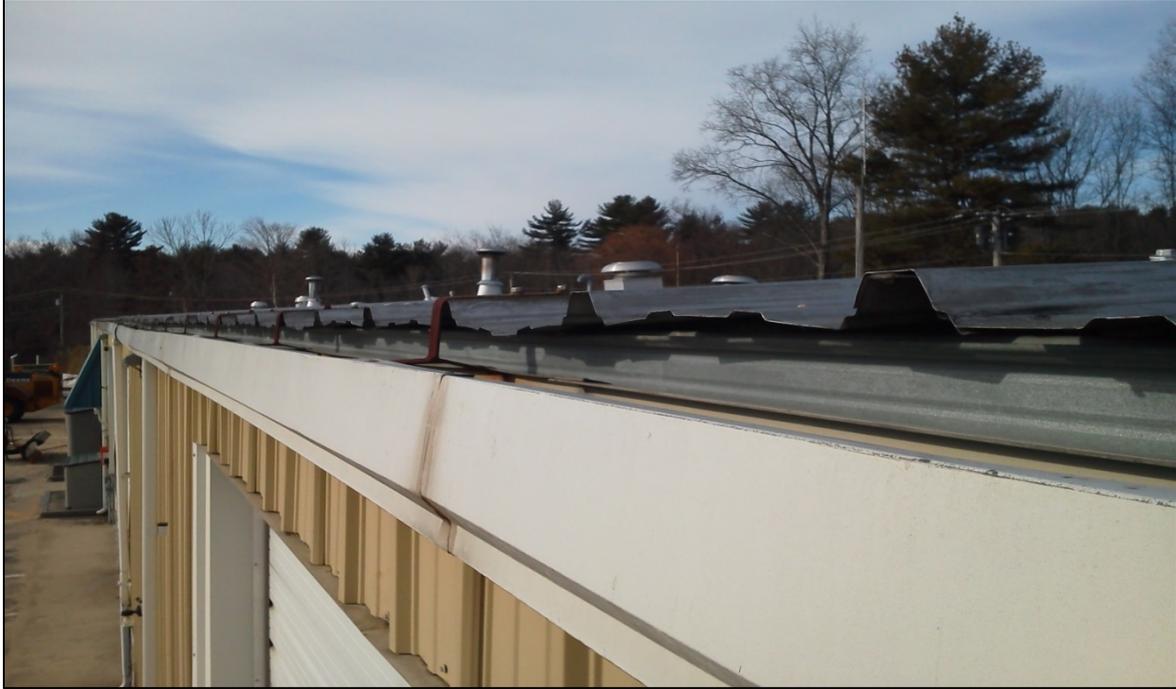
DPW Garage roof edge detail.

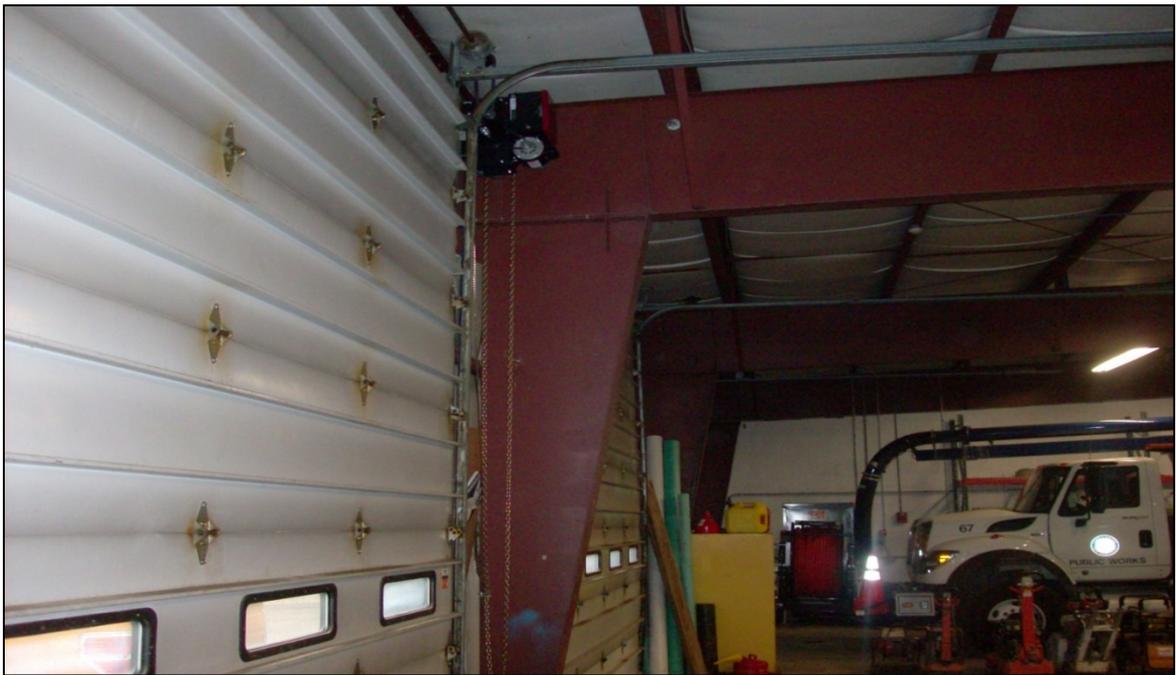
The horizontal bents which span across the full 60-foot width of the building are 32 inches deep at centerline and remain constant at this depth at the exterior walls. The top and bottom flange widths are constant at 8 inches wide. The structural analysis of this portion of the bent indicates that the member is capable of safely supporting the current code mandated snow load of 35 pounds per square foot, with no excess capacity.

Steel bent in Water Department Garage.

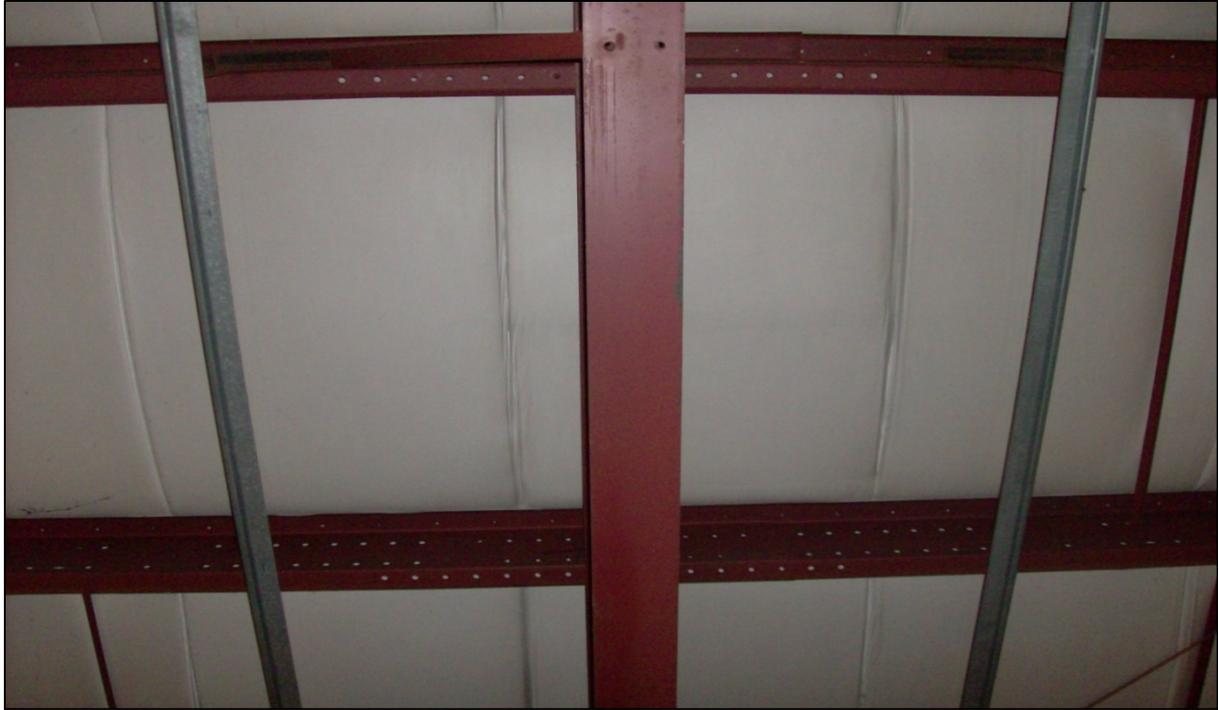
The structural analysis of the 9-inch deep girts, which span from bent-to-bent, indicates that the girts are capable of safely supporting a live load of approximately 30 pounds per square foot or about 85% of the current code mandated snow load of 35 psf.

Water Department Garage: Steel bent with roof panel support girts and insulation.

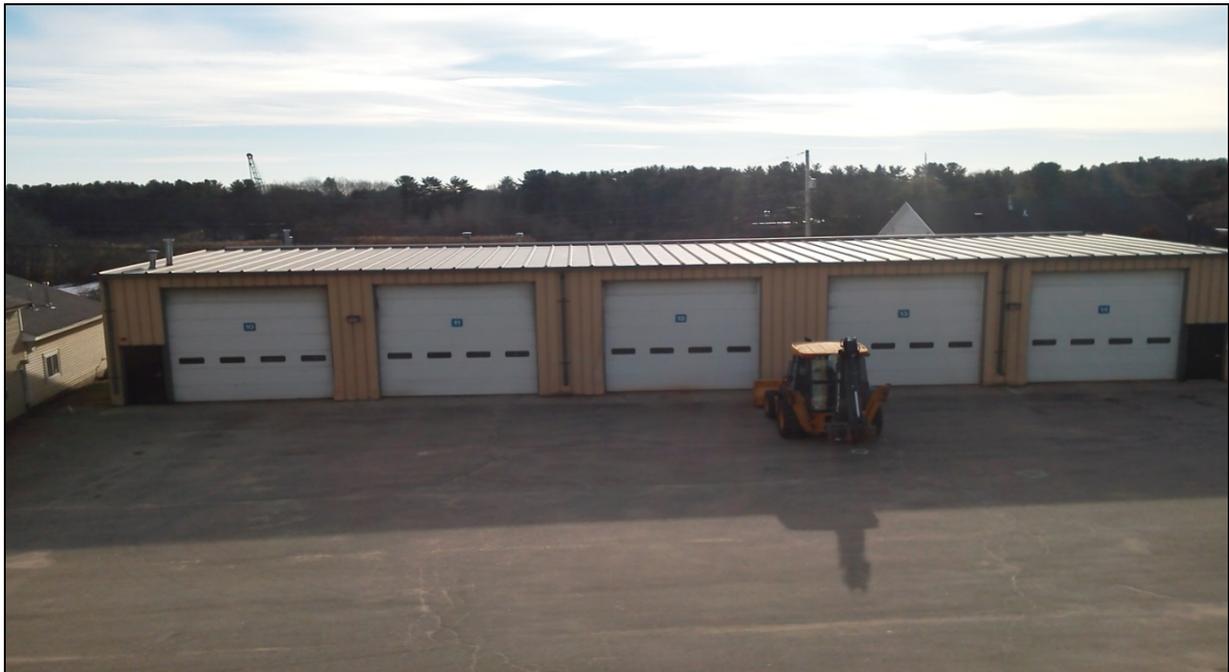
The Water Department Garage was constructed during the late 1980's and is a typical, pre-engineered, metal building built on a perimeter frost wall with a concrete slab-on-grade in the interior of the building. The building is approximately 6,000 square feet, measuring 100 feet long by 60 feet wide. There are five bays, each with an overhead door. The bay on the east side of the building serves as a drive-thru wash bay and therefore, has an overhead door at each side of the building. The building is comprised of steel bents spaced at 20 feet on center with 9-inch roof purlins spaced approximately 4 feet on center spanning between the bents. The building is clad with metal roofing panels and metal siding. The low slope roof is typical of a pre-engineered metal building. The lack of insulation and venting in these types of buildings makes them very susceptible to the formation of ice dams.

Overview of Water Department Garage.

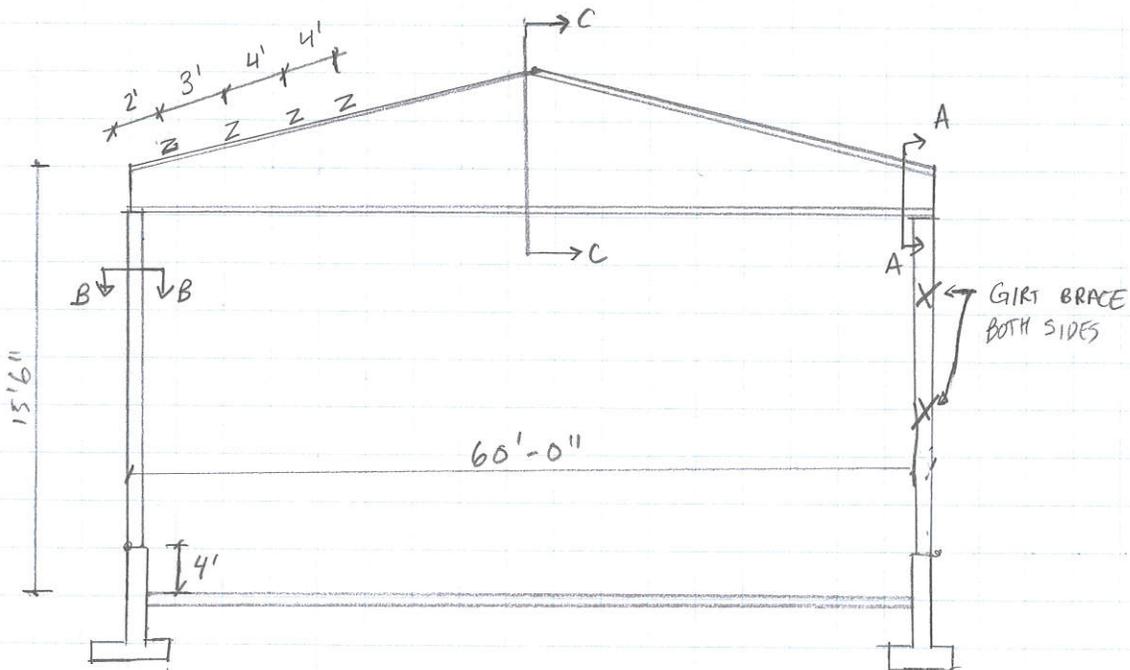
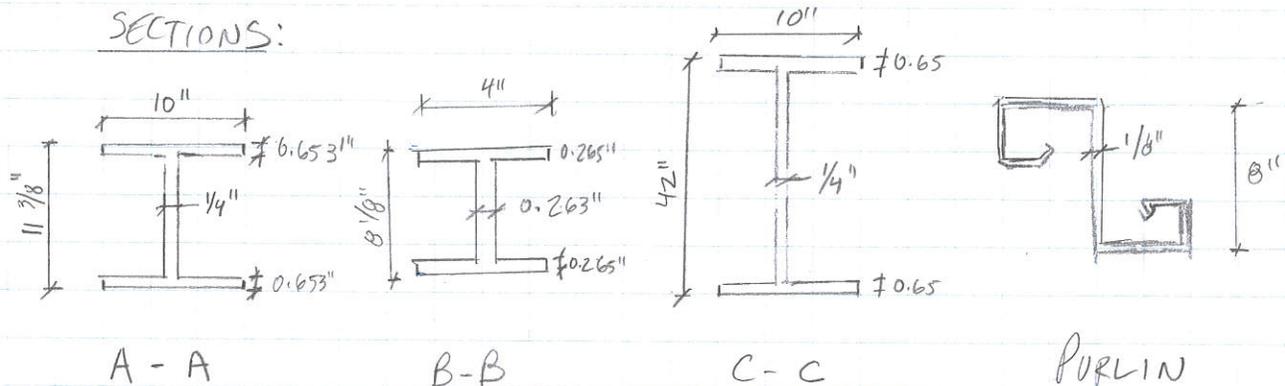
DEPARTMENT OF PUBLIC WORKS GARAGE BAY 1; ORIGINAL BLDG (CONSTRUCTED ≈ LATE 60'S - EARLY 1970'S)

* COLUMNS DO NOT MEET CURRENT CODE.
STRUCTURE RATED FOR 10 PSF OF SNOW

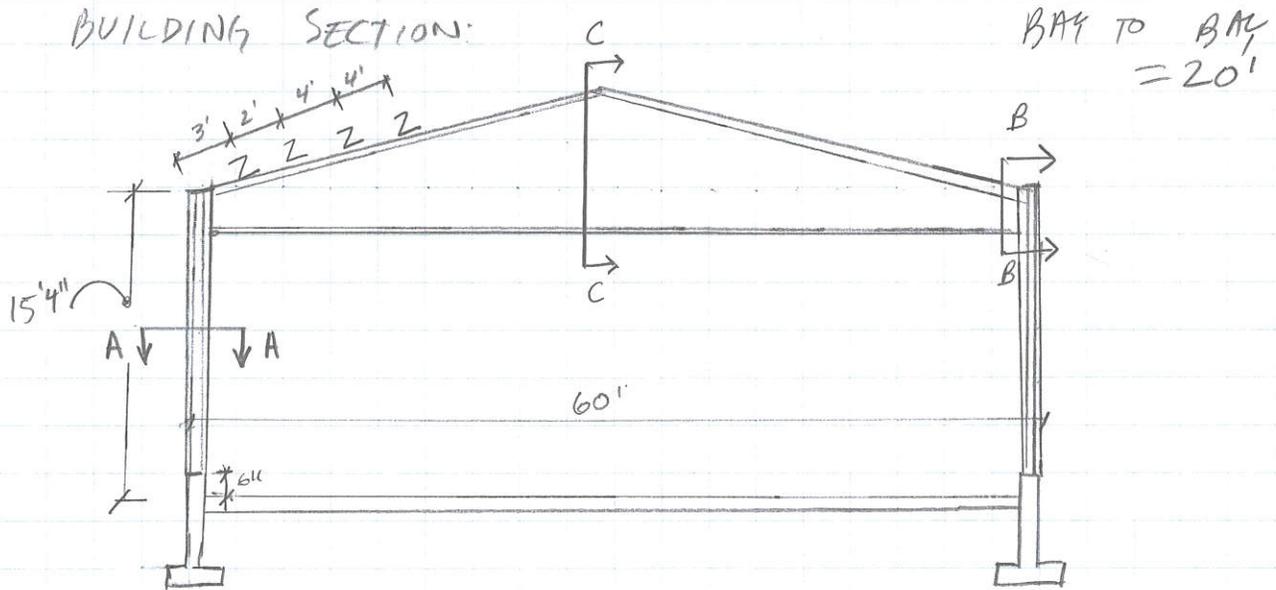
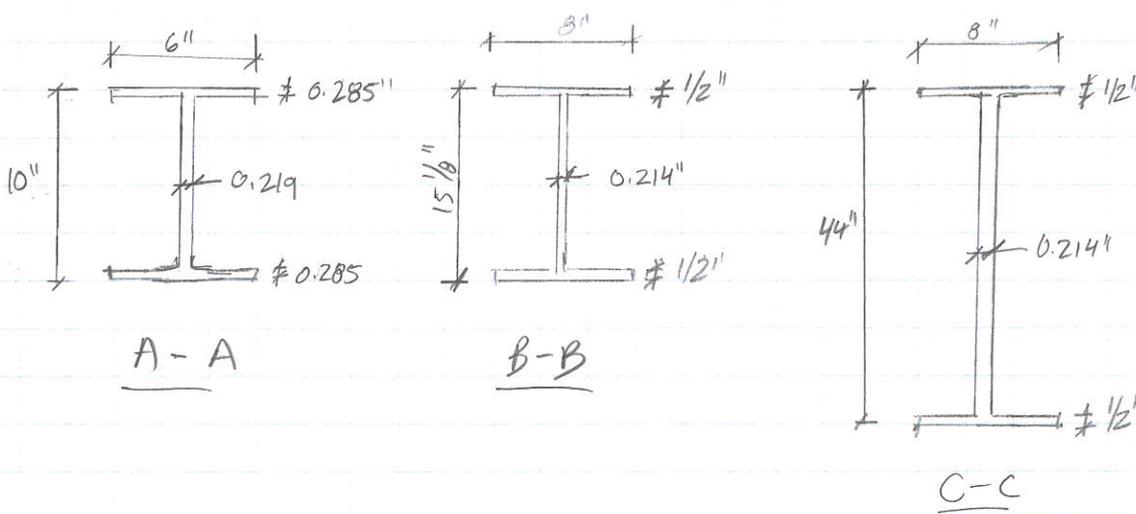
BAY 2: ADDITION TO ORIGINAL BLDG
CONSTRUCTED \approx 1977 +/-

PURLIN SYSTEM IS SAME CONDITION AS BAY 1

* COLUMNS DO NOT MEET CURRENT CODE
STRUCTURE RATED FOR 2.5 PSF OF SNOW

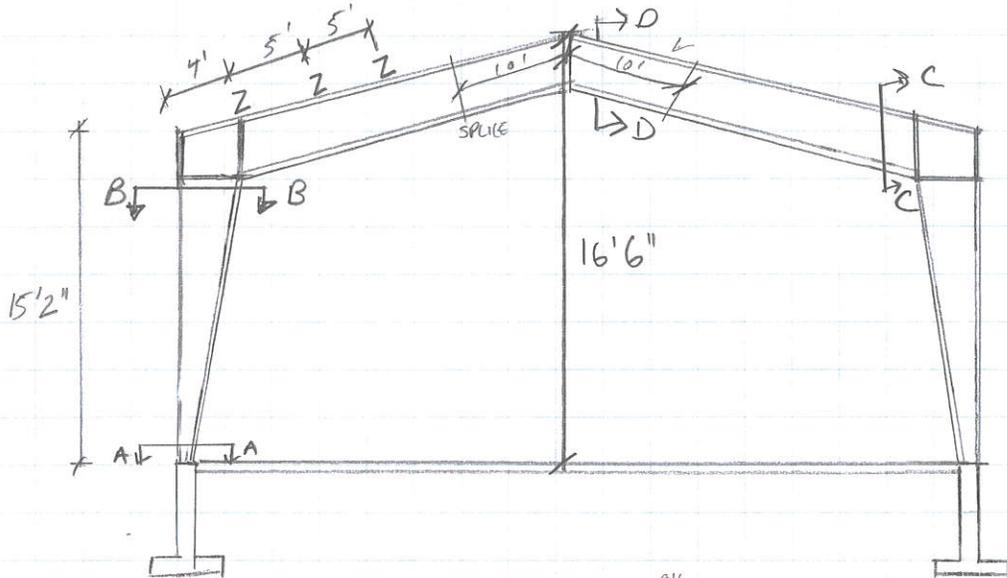
BAY 3: NEWEST METAL BLDG ON SITE
CONSTRUCTED \approx LATE 1980'S

* STEEL BENT MEETS CORRENT CODE.
