**WESTSIDE DRIVE SEWER PLANNING
NHDES Project No. D2020-0607**

EXETER, NEW HAMPSHIRE

FINAL - MAY 23, 2022

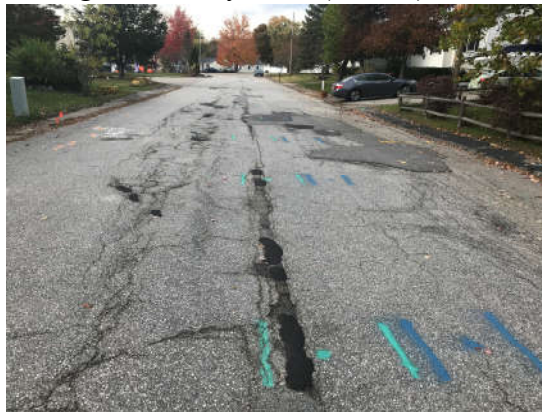
The existing roads (~5,500 feet) are constructed of bituminous asphalt paving approximately 40’-50’ wide with non-functioning, deteriorated sidewalks and bituminous curb. UE evaluated the roadway surface conditions of the neighborhood roads in accordance with Road Surface Management System (RSMS) standards in March 2021. Condition assessment forms are

provided (Appendix H). RSMS condition ratings ranged from 40 to 60 meaning the roads have deteriorated to a condition beyond maintenance overlays and reconstruction is recommended (Figure 2C). The road profile and crown has regressed so that they do not effectively convey/drain stormwater in many areas. The areas with the poorest RSMS condition ratings were in the northeast portion of the site and corresponded with areas of high groundwater and peaty materials and areas with most severe drainage issues identified during public input.

3. **Road reconstruction** - The road surface condition assessment (Section 2.4.2) indicated that the roads have deteriorated to the point where they need reconstruction so trench repairs should not be considered for infrastructure improvements. Road reconstruction would provide opportunity to re-establish the road profile/crown necessary to improve drainage and allow for mitigating the impact of peat underlying the road in the northeast corner of the neighborhood. The road base materials do not meet NHDOT specifications, but the geotechnical report (Appendix F) recommended that it may be possible to amend reclaim with added stone to improve road performance/durability. Reduction of the impervious road width would have additional environmental benefits of non-point source mitigation.

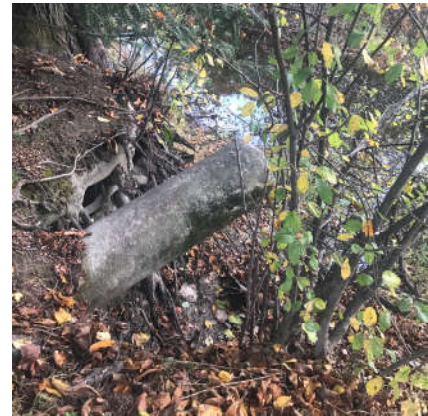
Outfall #1: The drainage system that conveys stormwater to this outfall includes one (1) precast concrete catch basin and drain manhole that collects stormwater from the northwest portion of the neighborhood and outfalls to the Little River. The structures appeared to be serviceable condition, but the outfall pipe was observed hanging over the stream embankment. The outfall pipe also appeared to have a reverse slope and did not appear to be functioning properly (photo right). During public participation, residents identified drainage issues in this catchment indicating that improvements are needed to effectively collect and convey stormwater in this area.

- Replace two (2) drainage outfalls on the west side of the neighborhood (Outfalls #1 & #2) and improve outlet protection. Consider incorporating end-of-pipe stormwater treatment at Outfall #2 since site conditions at this location may allow the addition of treatment (such as rain gardens). Conceptual drainage profiles have been provided to evaluate the feasibility of avoiding utility conflicts and showing the 100-year flood elevation at these sites (Figures PRO#1 and PRO#2).

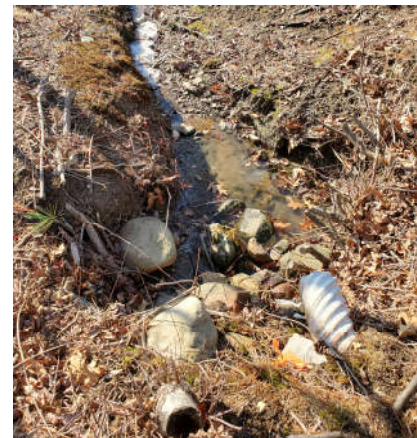
Outfall #2: The drainage system that conveys stormwater to this outfall includes one (1) block drop inlet that collects stormwater from the southwest portion of the neighborhood and outfalls overland to the Little River. The catch basin structure was in poor condition with limited cover over the CMP outlet pipe and erosion was observed downstream of the outfall due to insufficient scour protection (photo right). During public participation, residents identified drainage issues in this catchment indicating that improvements are needed to effectively collect and convey stormwater in this area.

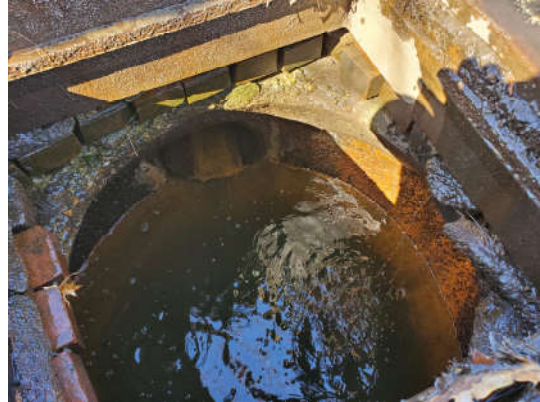
Outfall #4: The drainage system that conveys stormwater to this outfall includes one (1) block drop inlet (photo right) that collects stormwater from the east-central portion of the neighborhood and outfalls to a wet area along the east side of the site. The catch basin structure was in poor condition with limited cover over the outlet pipe and surcharged outlet conditions (Appendix I). During public participation, residents identified drainage issues in this catchment indicating that improvements are needed to effectively collect and convey stormwater in this area.

- Replace one (1) drainage outfall on the east side of the neighborhood (Outfall #3), eliminate the poorly functioning Outfall #4, and direct drainage to the reconstructed Outfall #3. Conceptual drainage profiles have been provided to evaluate the feasibility of avoiding utility conflicts at these sites (Figures PRO#3 and PRO#4).

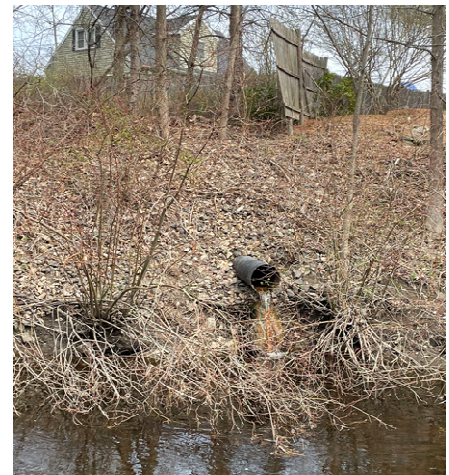
Outfall #5: The drainage system that conveys stormwater to this outfall was the largest in extent, appeared to be in the best condition, and appeared to be the only potentially salvageable site drainage infrastructure. It generally consists of 4' precast concrete diameter and brick catch basins with 12" PVC, HDPE, RCP, and CMP pipes in serviceable condition, but pipe conditions should be confirmed with CCTV and may be undersized. Outfall #5 is 15" HDPE that is hanging over the Little River embankment with limited outlet protection (photo right).

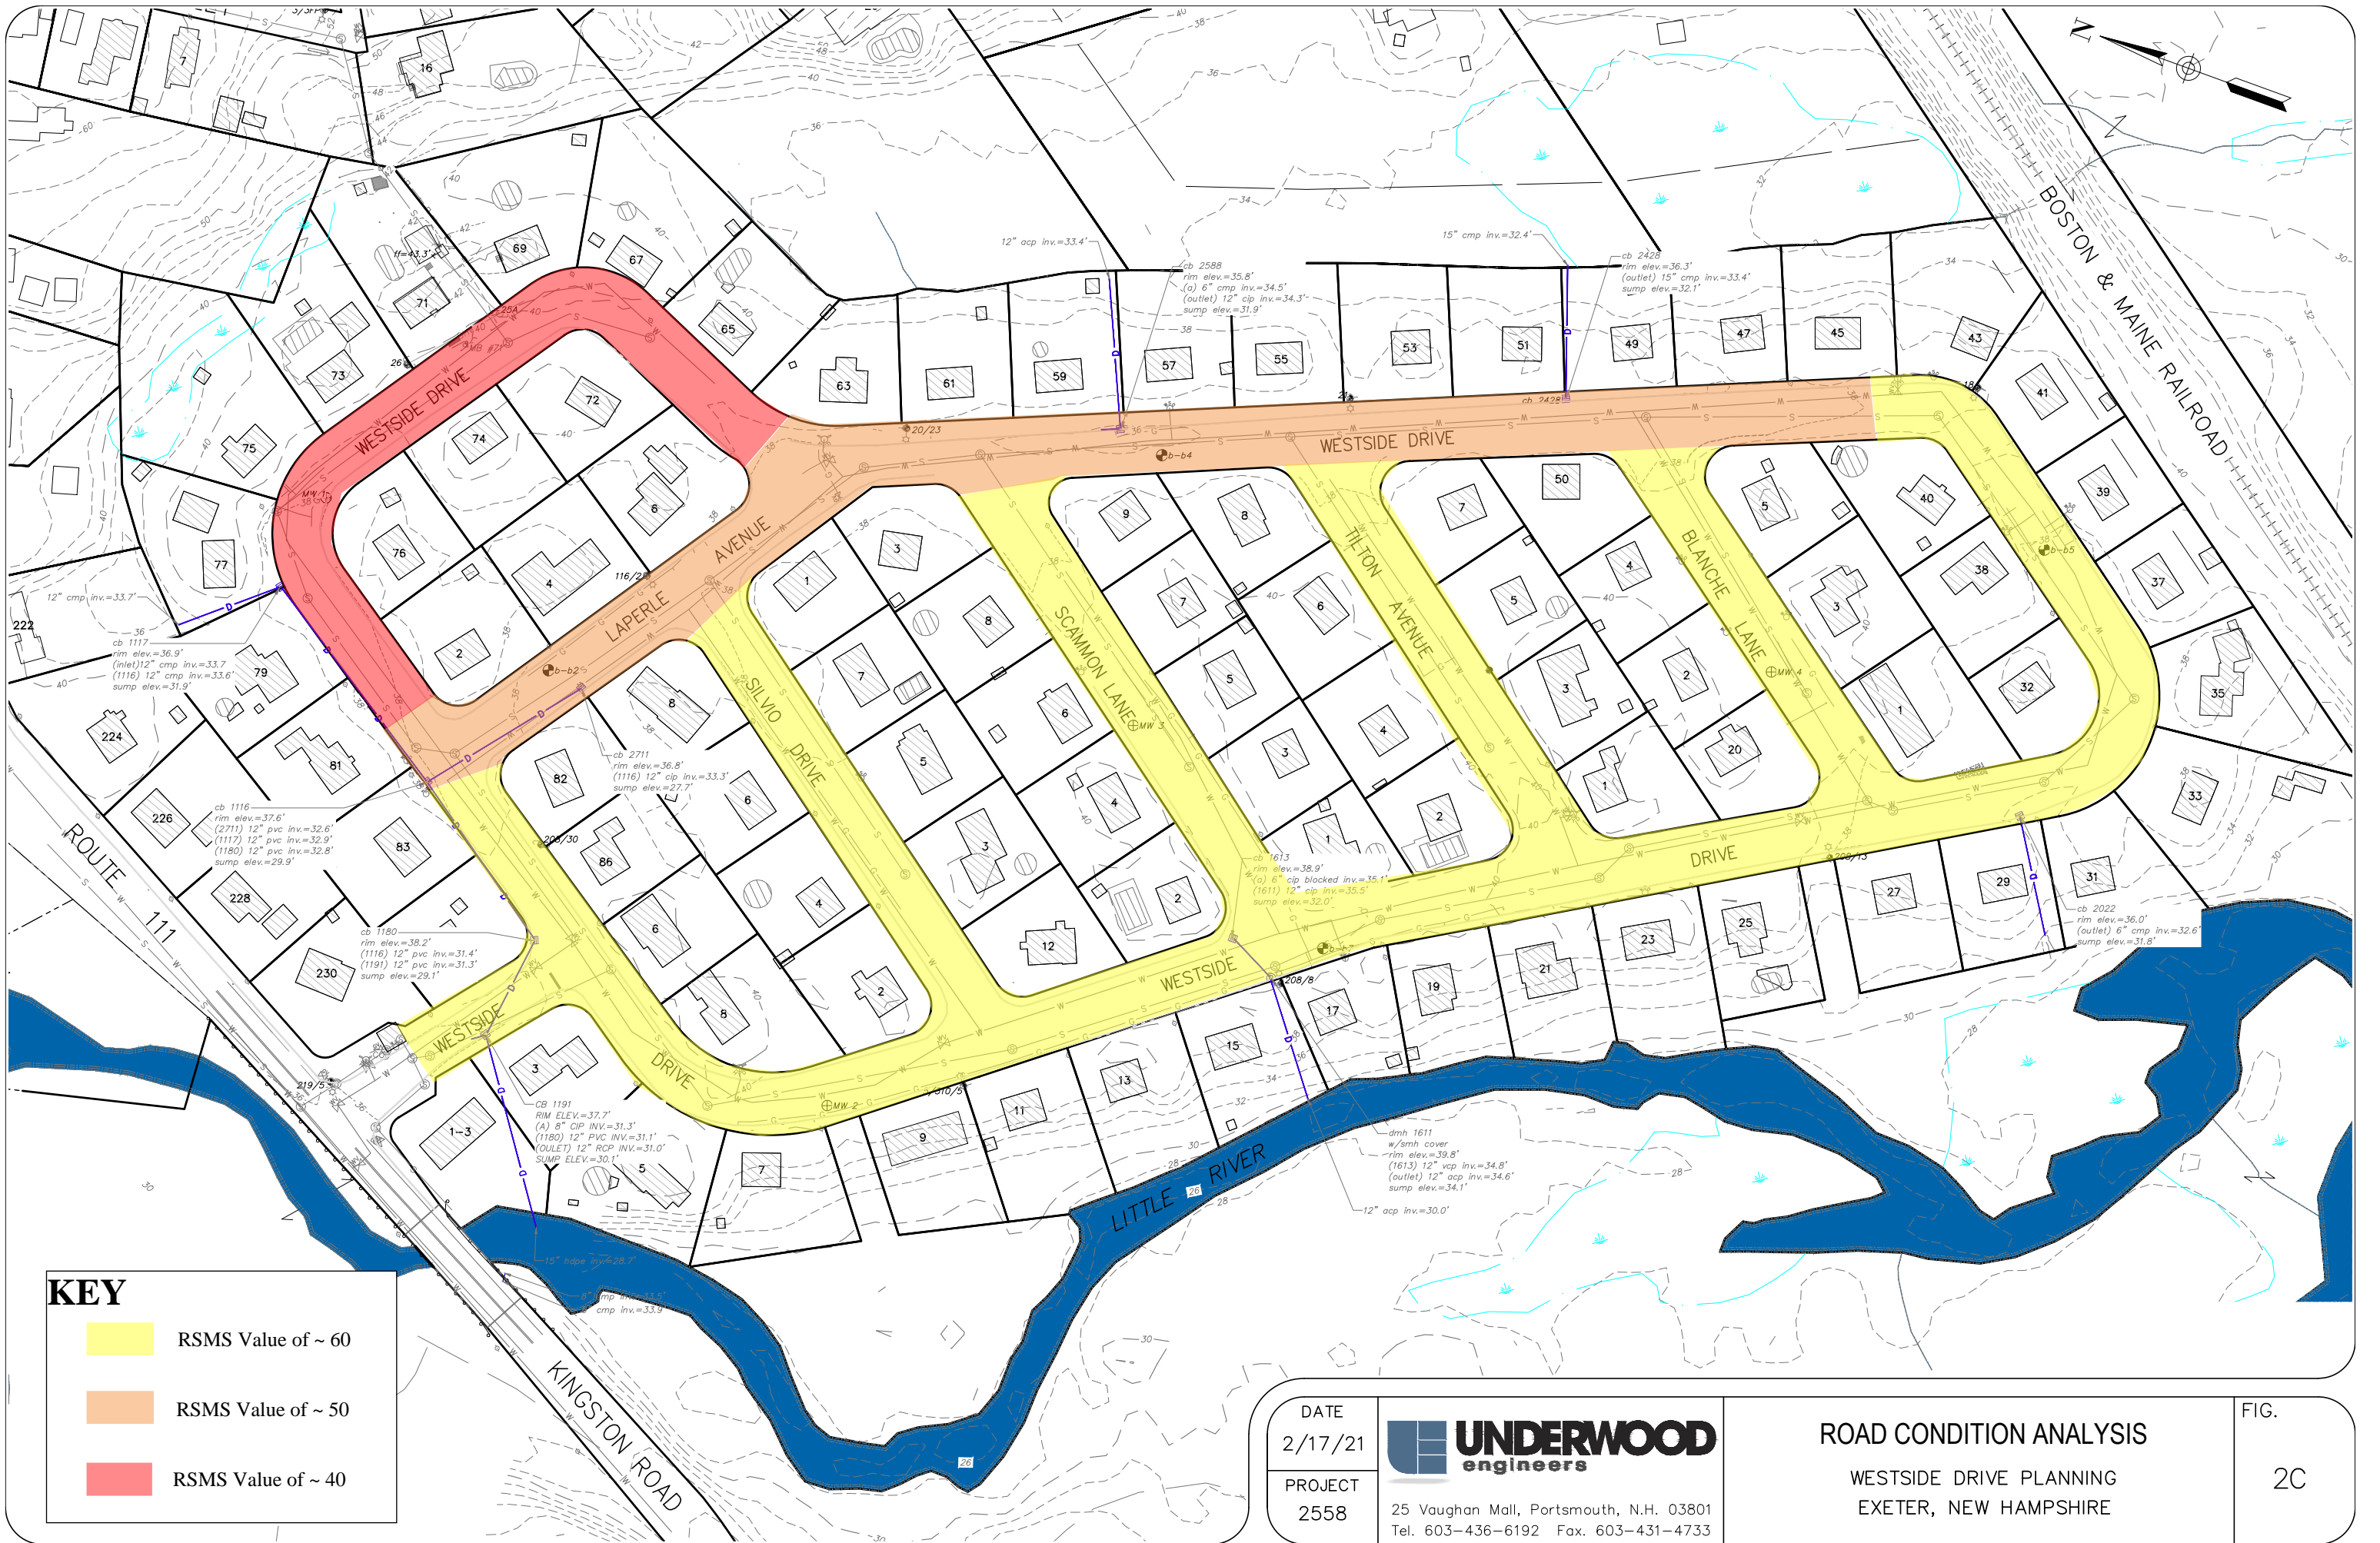
KEY	
	RSMS Value of ~ 60
	RSMS Value of ~ 50
	RSMS Value of ~ 40

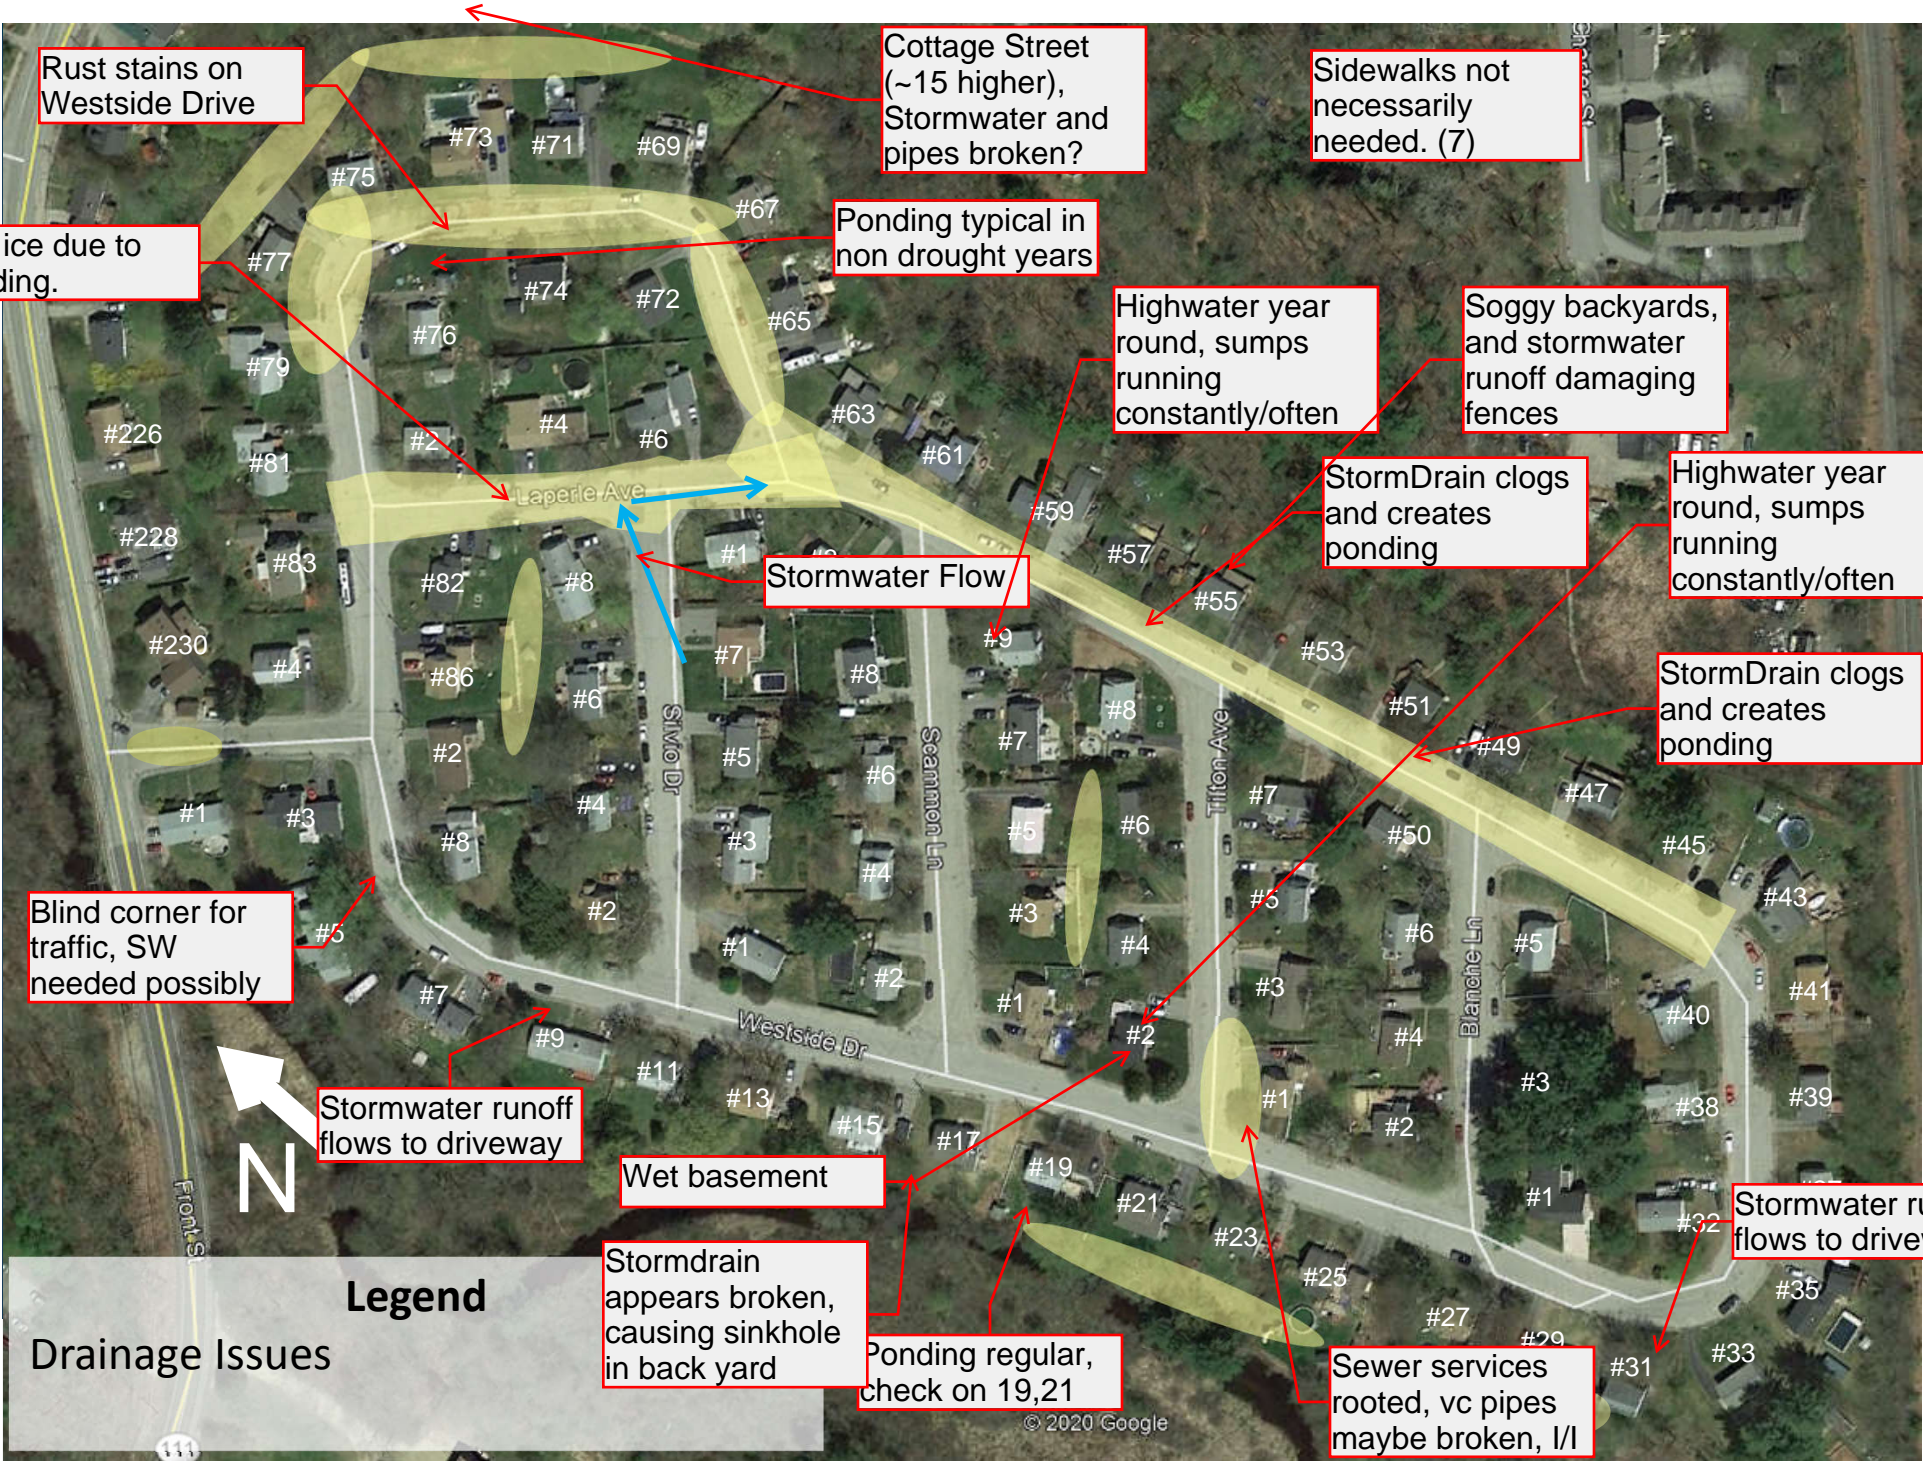
Rust stains on Westside Drive

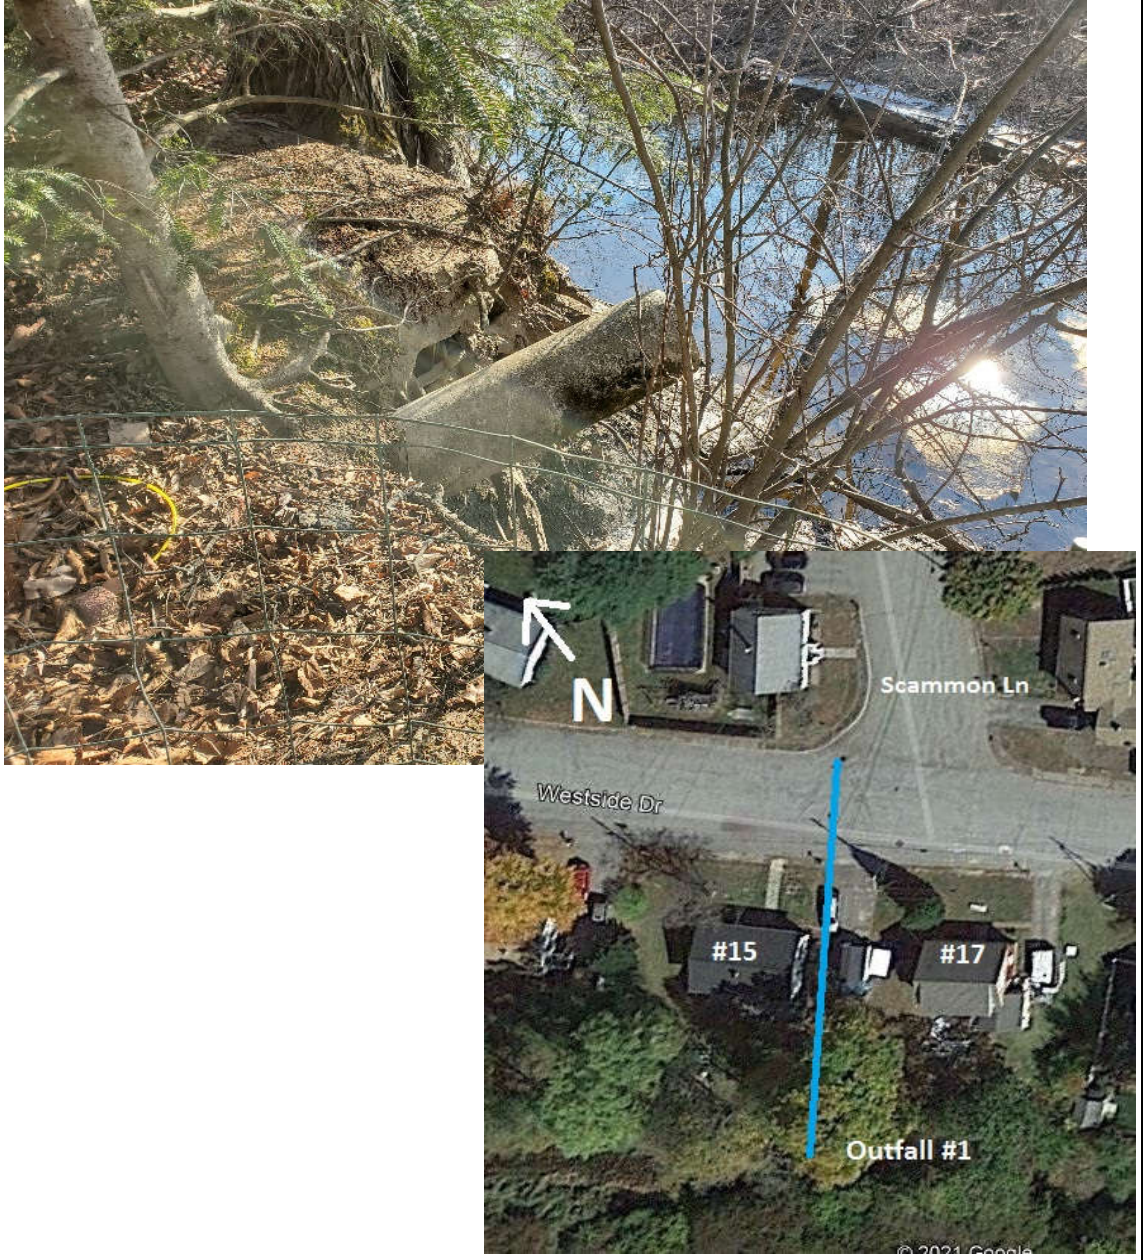
Date Inspected	1/22/2021
2588 Westside Drive Conceptual Improvements, Exeter NH	
Outfall ID	#1
Location	Discharges to the Little River between 15 and 17 Westside Drive
Size	12"
Material	ACP
Condition	No Visible Damage to pipe, no visible blockage, water was flowing out.
Notes	Approximately 40" of the pipe is exposed and hangs over the river bank unsupported. Outfall appears that it would be damaged easily.

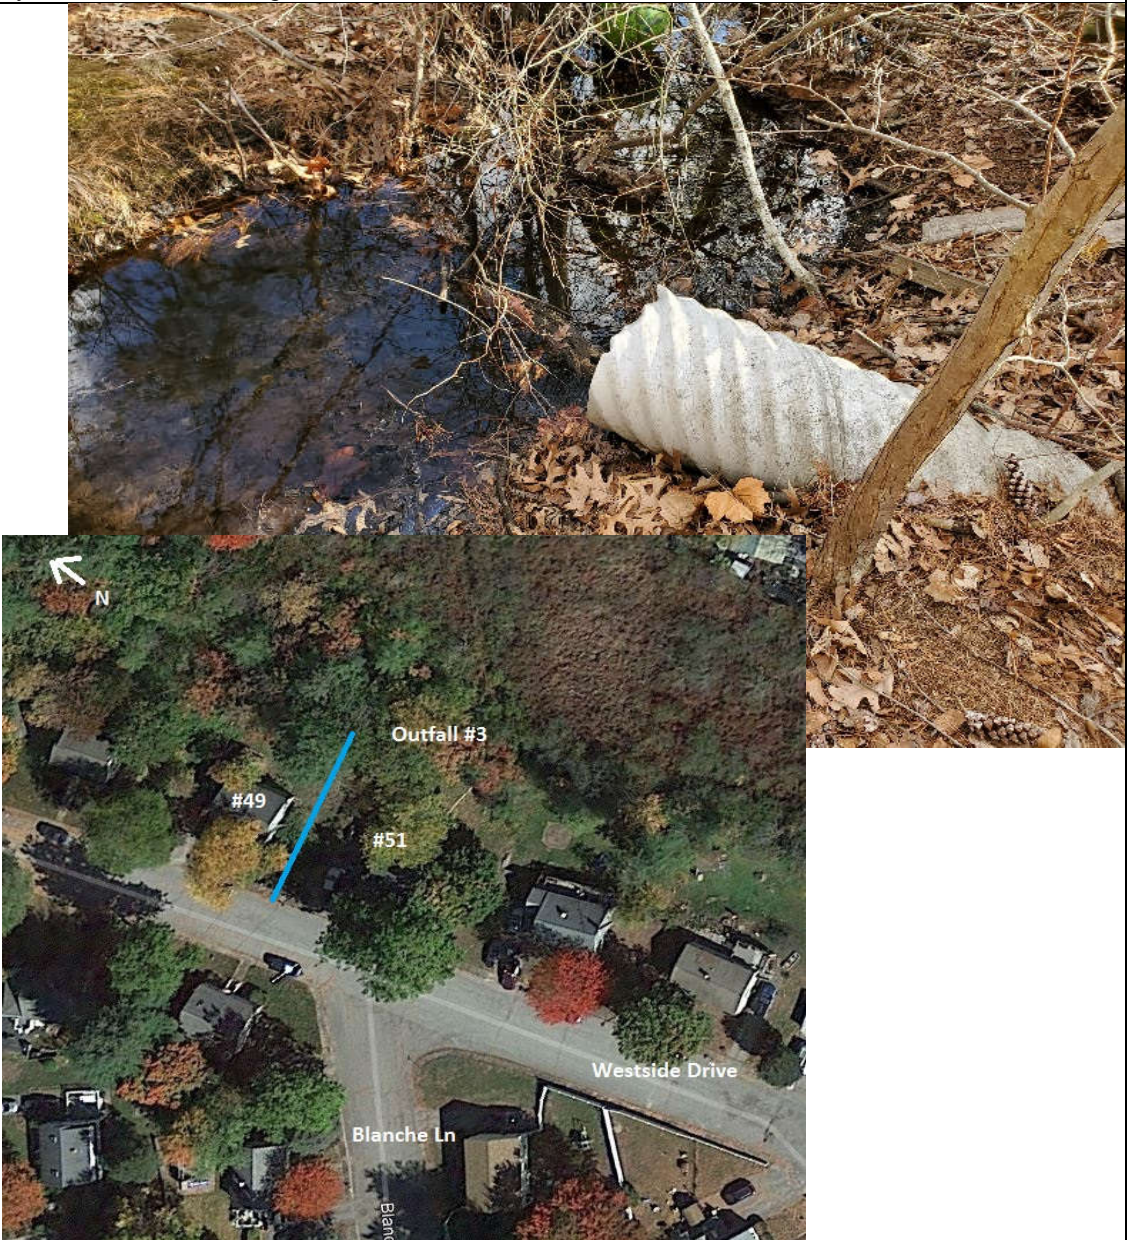
Date Inspected	1/22/2021
2588 Westside Drive Conceptual Improvements, Exeter NH	
Outfall ID	#3
Location	Discharges behind 49 and 51 Westside Drive
Size	15"
Material	CMP
Condition	No blockage visible, Top of outfall has been flattened
Notes	Discharges to small stream behind properties. Water is trickling out of pipe. CB on Westside Drive was mostly covered in leaves and pine needles.

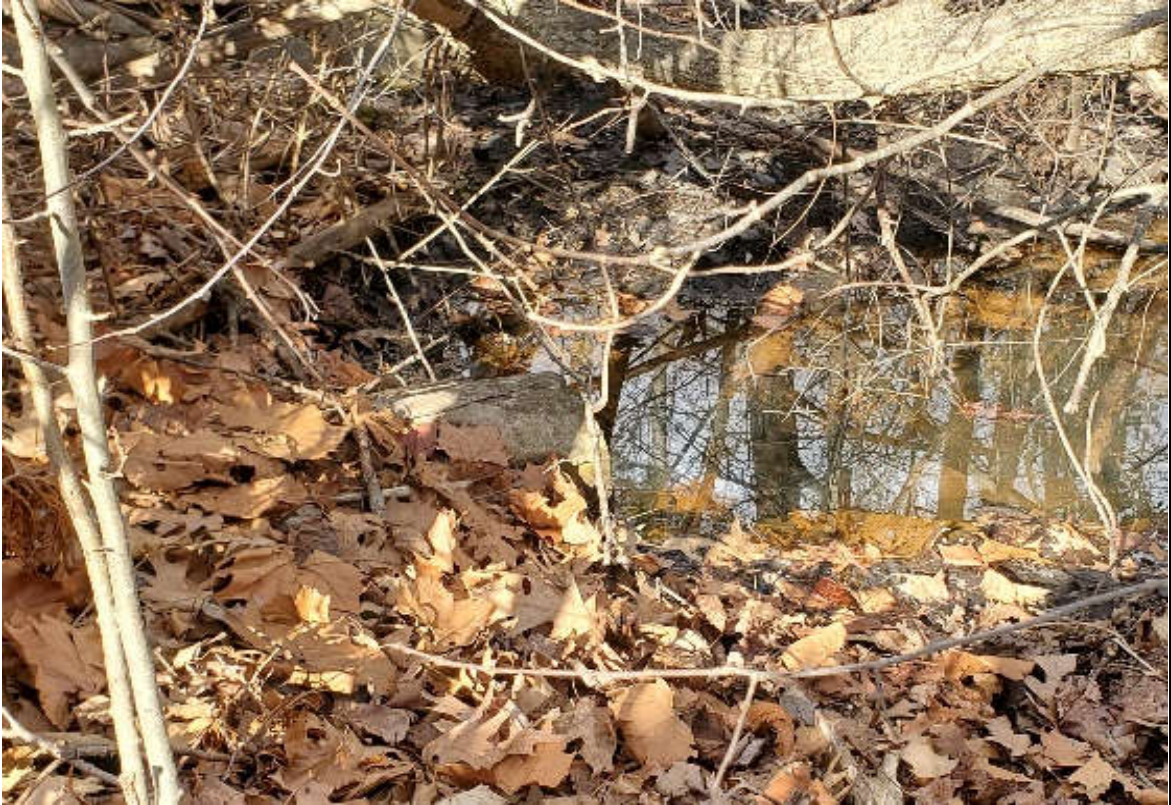
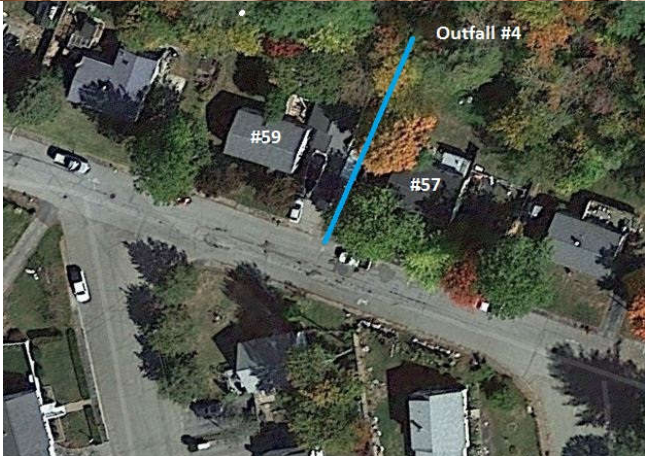
Date Inspected	1/22/2021
2588 Westside Drive Conceptual Improvements, Exeter NH	
Outfall ID	#4
Location	Discharges behind 59 and 57 Westside Drive
Size	12"
Material	ACP
Condition	No blockage visible, Outfall partially submerged
Notes	Discharges to small stream behind properties. Outfall is approximately 50% submerged within the wetland.

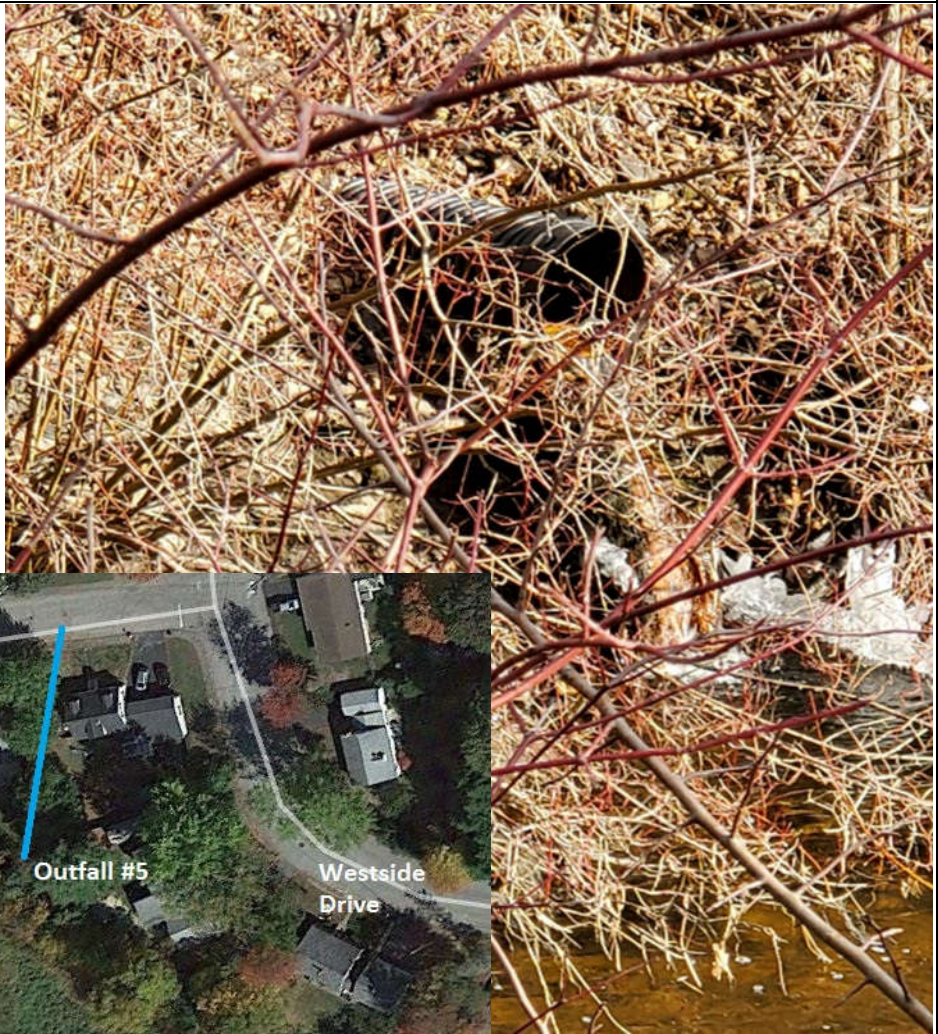
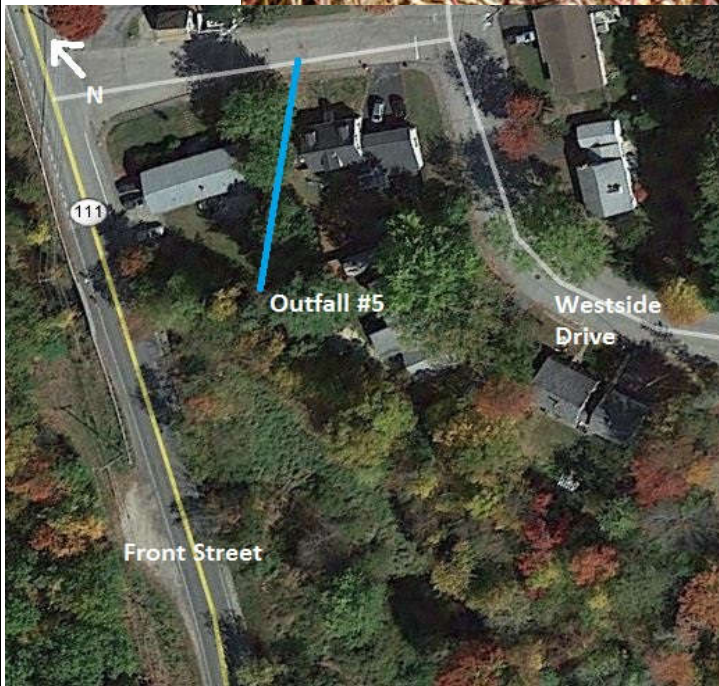
Date Inspected	1/22/2021
2588 Westside Drive Conceptual Improvements, Exeter NH	
Outfall ID	#5
Location	Discharges behind 1 Westside Drive and into the Little River
Size	15"
Material	HDPE
Condition	No blockage or damage visible
Notes	Discharges to the Little River, constant flow coming out of outfall during investigation.
