FACILITY CONDITION ASSESSMENT

Town of Exeter New Hampshire
10 Front Street
Exeter, New Hampshire 03833-2737
Russell Dean

Town Hall
9 Front Street
Exeter, New Hampshire 03833

April 25, 2023

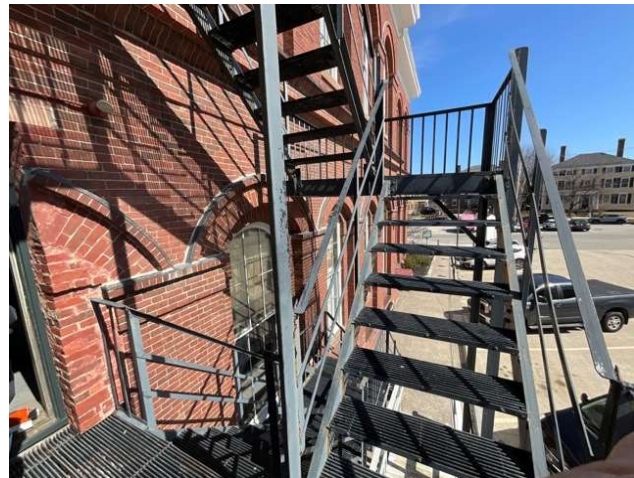
22 - FIRE ESCAPE

The town hall shares the upper parking lot with Citizens bank. The asphalt is at midlife with a few transverse cracks starting. The fire escape has corrosion at several connections and should be checked for safety. The balcony guardrails over the portico have isolated areas of deteriorated paint finishes.
