# FACILITY CONDITION ASSESSMENT

**Town of Exeter New Hampshire**  
10 Front Street  
Exeter, New Hampshire 03833-2737  
Russell Dean

Town Offices  
10 Front Street  
Exeter, New Hampshire 03833

*April 20, 2023*

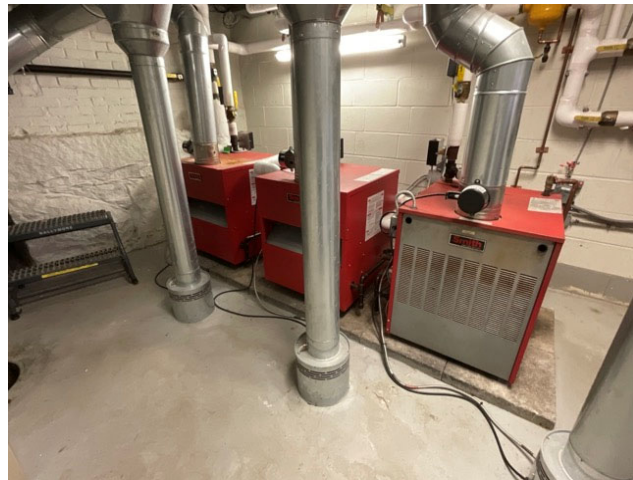
16 - BOILER ROOM

The building has various heating systems. There are three gas boilers that were installed in 2015 providing heated water to hydronic baseboard throughout the building. The boilers lack controls to modulate between boilers when exterior temperatures are moderate. At time of manufacture the efficiency is 82%. Increased efficiency when boilers reach end of life is recommended. An energy recovery ventilation system was added around 2008 to bring in fresh outside air. There are several Mitsubishi and Daiken ductless Minisplit systems throughout the offices to provide cooling and dehumidification. The main electric distribution panel was replaced in 1995. The plumbing system is dated but new repairs are completed throughout the building as needed. There is no fire suppression system in the building.

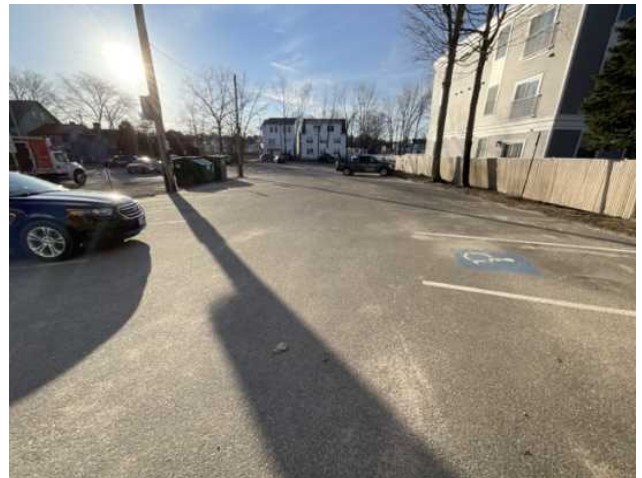
22 - PARKING LOT

The parking lot appears free of cracks and heavy wear. The concrete walk and handicap ramp look very good and are well maintained.

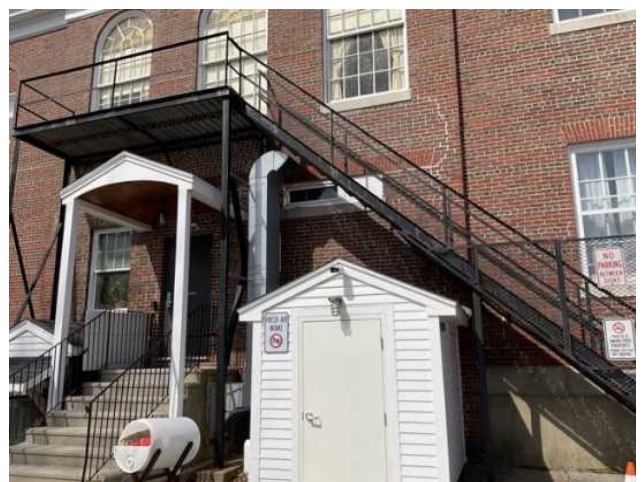
24 - FIRE ESCAPE

UF L3 Code	Location	Condition	Asset/Component/Repair	Quantity	RUL	ID
<b>Structure</b>						
B1080	Fire escape	Fair	Stairs, Metal, Exterior, Refinish	200 SF	2	5960039
<b>Pedestrian Plazas &amp; Walkways</b>						
G2020	Site	Fair	Parking Lots, Pavement, Asphalt, Mill & Overlay	5,624 SF	12	5960068
<b>Sitework</b>						
G2060	Site	Good	Signage, Property, Building or Pole-Mounted, Replace/Install	1	7	5960030
