FACILITY CONDITION ASSESSMENT

Town of Exeter New Hampshire
10 Front Street
Exeter, New Hampshire 03833-2737
Russell Dean

Public Works Campus
13 Newfields Road
Exeter, New Hampshire 03833

July 28, 2023

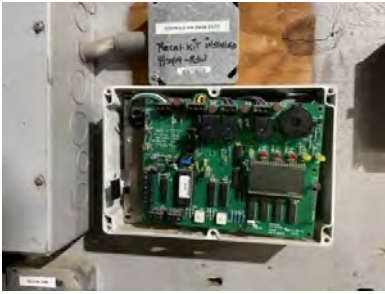
CO Switch in Failed condition.

Smoke/Carbon Monoxide Detector/Switch, by contractor
Highway Garage Building Public Works
Campus Highway vehicle storage

Carbon monoxide sensor in garage operates fan exhaust. This sensor not working. - AssetCALC ID: 5922998

Uniformat Code: D7050
Recommendation: **Replace/Install in 2023**

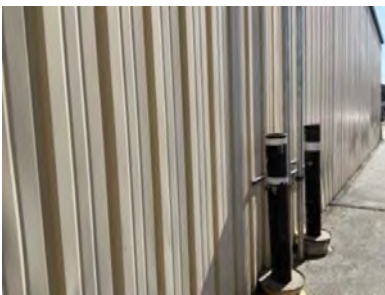
Exterior Walls in Poor condition.

Metal Siding
W/S Garage and Wash Bay Public Works
Campus Building Exterior

Siding is dented and ripped in areas. - AssetCALC ID: 5921020

Uniformat Code: B2010
Recommendation: **Replace in 2024**

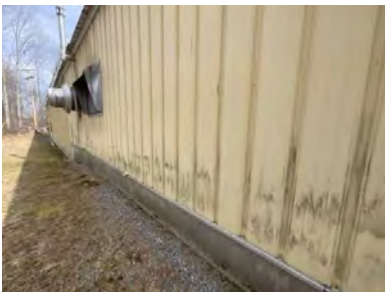
Exterior Walls in Poor condition.

any painted surface
Highway Garage Building Public Works
Campus Building Exterior

Siding is weathered - AssetCALC ID: 5922946

Uniformat Code: B2010
Recommendation: **Prep and Paint in 2024**

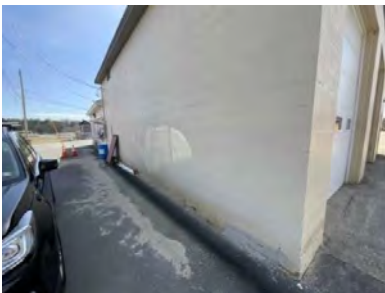
Exterior Walls in Poor condition.

Concrete Block (CMU)
Maintenance Tech Building Public Works
Campus Building Exterior

Repointing needed around bottom three courses block - AssetCALC ID: 5923044

ID	Location	Location Description	UF Code	Description	Condition	Plan Type	Cost
5923044	Public Works Campus / Maintenance Tech Building	Building Exterior	B2010	Exterior Walls, Concrete Block (CMU), Repair/Repoint	Poor	Performance/Integrity	\$12,900
Total (1 items)							\$12,900

Uniformat Code: B2010
Recommendation: **Repair/Repoint in 2023**

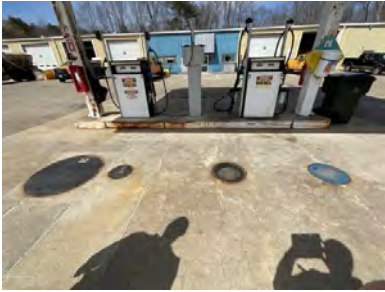
Fueling Station in Poor condition.

Fueling station is aged, replacement budget for canopy, pumps and accessories based on previous quote of \$305,000 plus 18% for inflation. Final cost of approx. \$360k appears when project markup is applied. - AssetCALC ID: 5924305

Uniformat Code: G3060
Recommendation: **Replace in 2024**

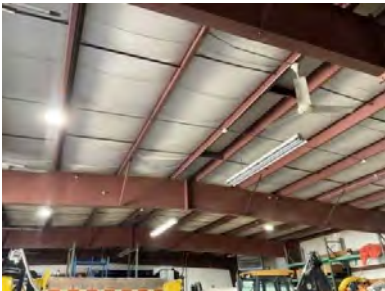
Structural Framing in Poor condition.

Per structural engineer's report, "girts carry 85% of required snow load. Budget cost assumes new girts to be installed at 25% of framed roof area. - AssetCALC ID: 5921026

Uniformat Code: B1010
Recommendation: **Reinforce in 2024**

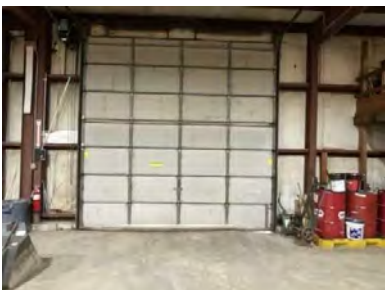
Structural Framing in Poor condition.

Uniformat Code: B1010
Recommendation: **Reinforce in 2024**
