# FACILITY CONDITION ASSESSMENT

**Town of Exeter New Hampshire**  
10 Front Street  
Exeter, New Hampshire 03833-2737  
Russell Dean

Parks/Recreation Building (Hampton Road)  
10 Hampton Road  
Exeter, New Hampshire 03833

*April 24, 2023*

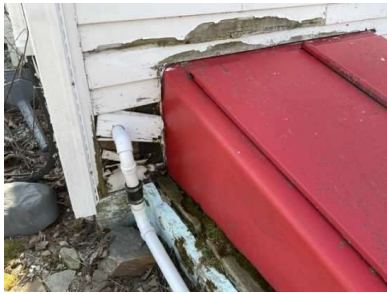
#### Exterior Walls in Poor condition.

Wood Siding  
Parks/Recreation Building (Hampton Road)

Clapboard around bulkhead in rear of house and needs to be rebuilt - AssetCALC ID: 5959356

Uniformat Code: B2011  
Recommendation: **Replace in 2023**

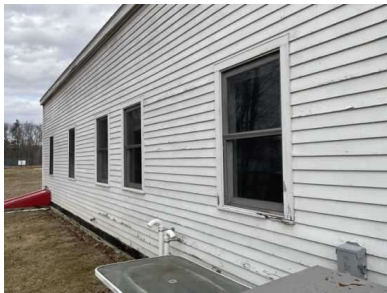
#### Exterior Walls in Poor condition.

any painted surface  
Parks/Recreation Building (Hampton Road)  
Building Exterior

Clapboard and aluminum siding, deteriorated - AssetCALC ID: 5959342

Uniformat Code: B2011  
Recommendation: **Prep & Paint in 2023**

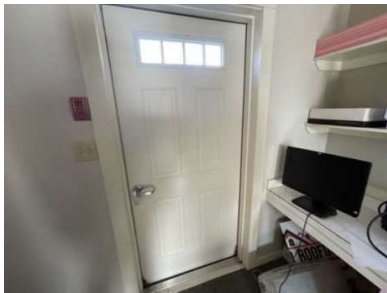
#### Exterior Door in Poor condition.

Steel, Standard  
Parks/Recreation Building (Hampton Road)  
Building Exterior

Jam on hinge side, rotted at threshold - AssetCALC ID: 5959371

Uniformat Code: B2051  
Recommendation: **Replace in 2023**

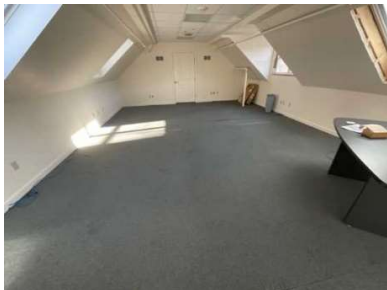
#### Flooring in Poor condition.

Carpet, Commercial Standard  
Parks/Recreation Building (Hampton Road)  
Throughout building

Flooring being replaced at time of assessment - AssetCALC ID: 5959349

Uniformat Code: C2037  
Recommendation: **Replace in 2023**

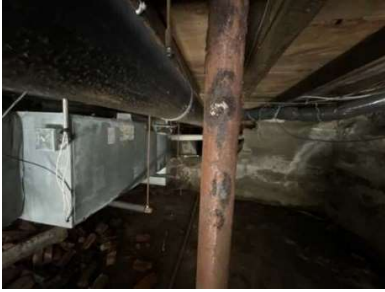
**Foundation System in Poor condition.**

Parks/Recreation Building (Hampton Road)  
Basement

Columns, steel jacket rusting thru - AssetCALC ID: 5959338

Uniformat Code: A1028  
Recommendation: **Replace in 2023**

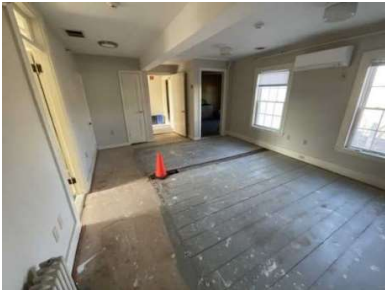
**Flooring in Poor condition.**

Vinyl Tile (VCT)  
Parks/Recreation Building (Hampton Road)  
second floor

Uniformat Code: C2035  
Recommendation: **Replace in 2023**
