FACILITY CONDITION ASSESSMENT

Parks/Recreation Building (Court Street)
32 Court Street
Exeter, New Hampshire 03833

157332.22R000-009.354

April 26, 2023

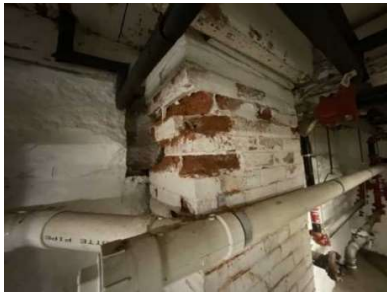
Masonry (CMU) Bearing Walls
Parks/Recreation Building (Court Street)
Basement

Structural Framing in Poor condition.

Deteriorating brick in basement next to fire suppression system. Brick column. - AssetCALC ID: 5990821

Uniformat Code: B1011
Recommendation: **Replace in 2023**

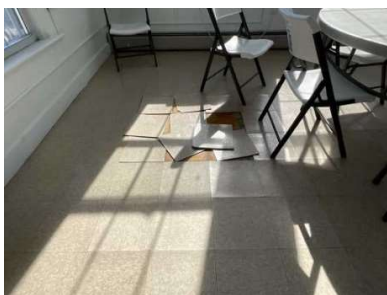
Vinyl Tile (VCT)
Parks/Recreation Building (Court Street)
Throughout building

Flooring in Poor condition.

There are areas on the second floor where the VCT has come loose from the subfloor - AssetCALC ID: 5990828

Uniformat Code: C2035
Recommendation: **Replace in 2023**
