# FACILITY CONDITION ASSESSMENT

**Town of Exeter New Hampshire**  
10 Front Street  
Exeter, New Hampshire 03833-2737  
Russell Dean

Parks/Recreation Garage  
32 Court Street  
Exeter, New Hampshire 03833

August 2, 2023

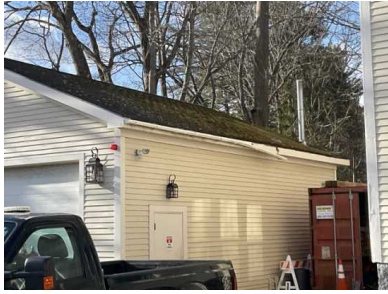
#### Roofing in Poor condition.

Asphalt Shingle, 30-Year Premium  
Parks/Recreation Garage Roof

The roof has moss growing on it. It is past recommended useful life. - AssetCALC ID: 5994517

Uniformat Code: B3010  
Recommendation: **Replace in 2024**

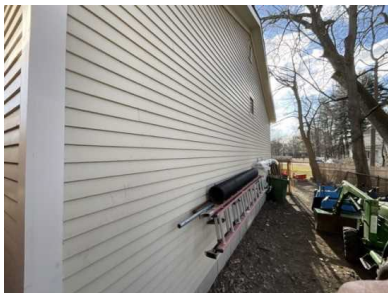
#### Exterior Walls in Poor condition.

any painted surface  
Parks/Recreation Garage Building Exterior

Paint bubbling and chipping throughout - AssetCALC ID: 5994510

Uniformat Code: B2010  
Recommendation: **Prep and Paint in 2024**

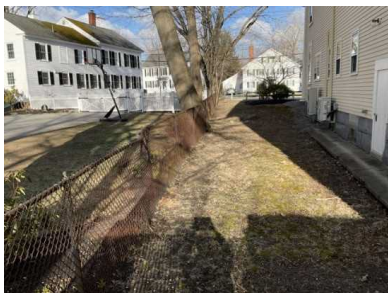
#### Fences and Gates in Poor condition.

Fence, Chain Link 4'  
Site Parks/Recreation Garage Site

Corroded, bent - AssetCALC ID: 5994515

Uniformat Code: G2060  
Recommendation: **Replace in 2024**

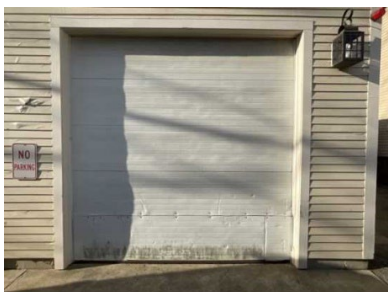
#### Overhead/Dock Door in Poor condition.

Aluminum, 12'x12' (144 SF)  
Parks/Recreation Garage Building Exterior

Dented, damaged - AssetCALC ID: 5994512

Uniformat Code: B2050  
Recommendation: **Replace in 2024**

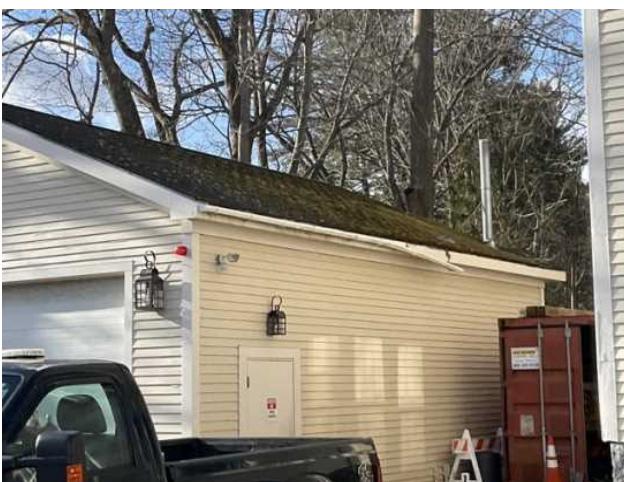
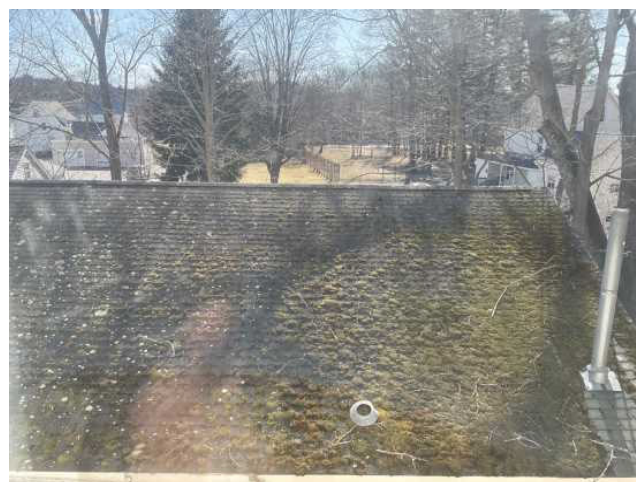
The building is wood framed with clapboard siding and an aluminum overhead door. There is a steel side entrance. Interior is unfinished slab on grade with painted sheetrock walls and ceilings. The roofing is moss covered and is in poor condition. Replacement in the short term is recommended.

5 - ROOFING

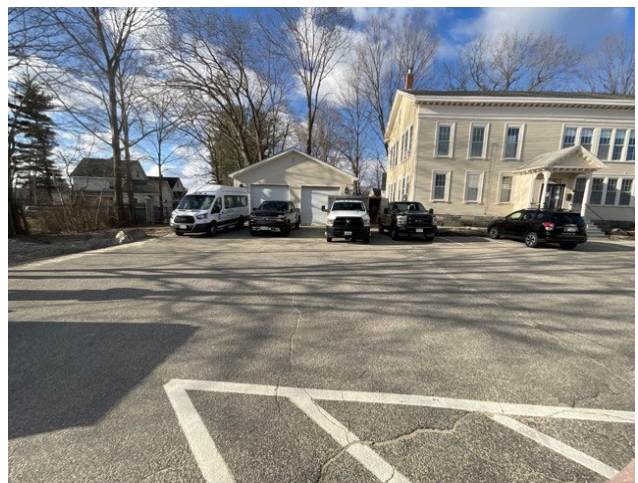
The garage shares its parking lot with the Parks and Recreation Building and the Senior Center. The parking lot is worn and cracking. There are several different size chain link fences along the rear of the parks and recreation office to behind the garage and turning North toward South Street. There is a small grass area behind the building used for storage.

18 - SHARED PARKING LOT

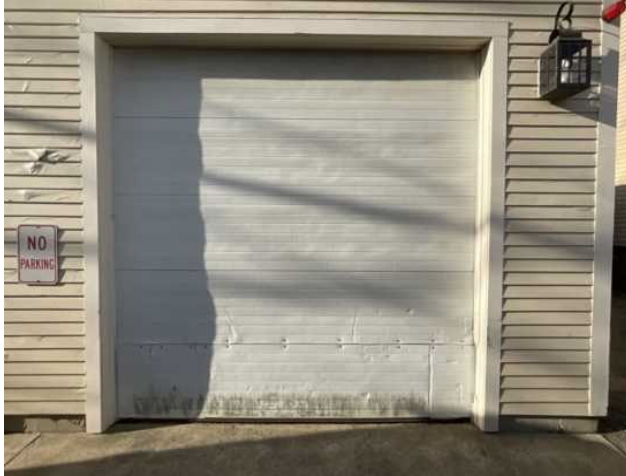
19 - OVERHEAD DOOR

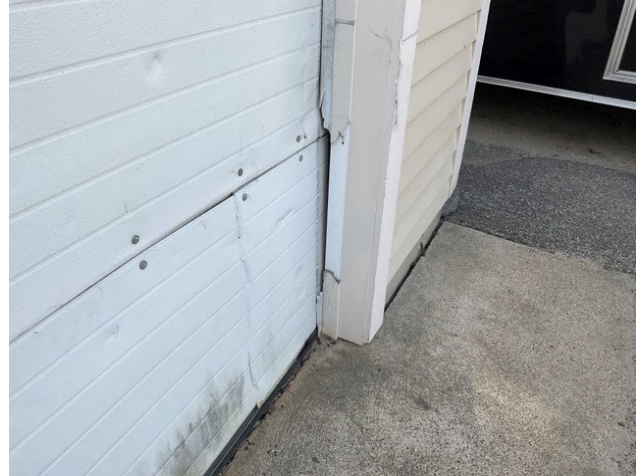
20 - DAMAGED WEATHSTRIPPING

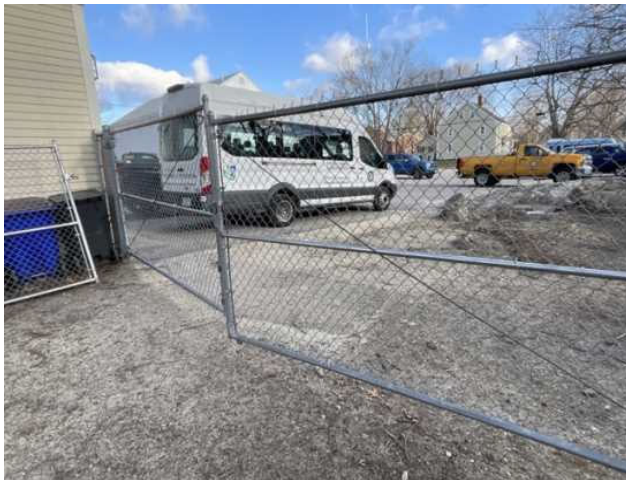
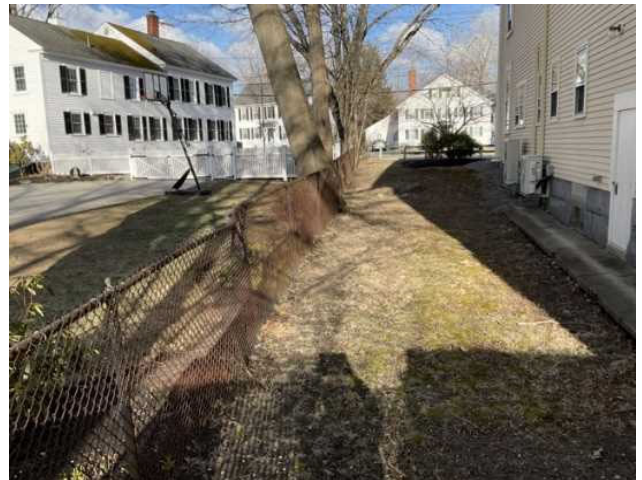
21 - FENCES AND GATES

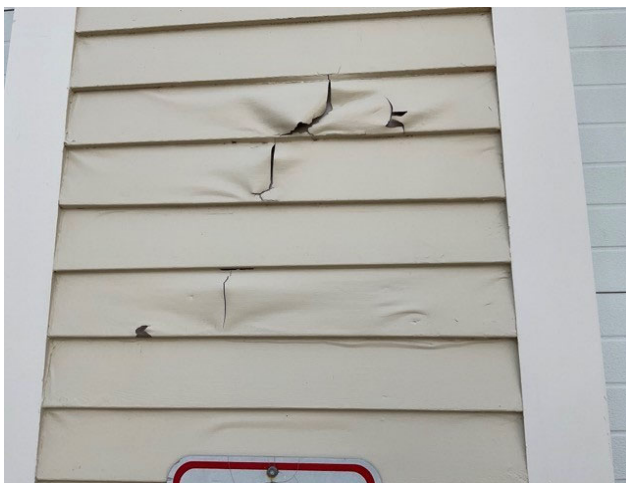
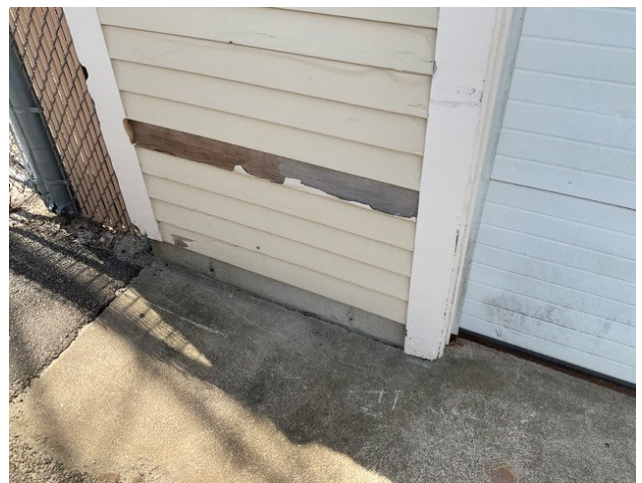
23 - SIDING
