# FACILITY CONDITION ASSESSMENT

Senior Center  
32 Court Street  
Exeter, New Hampshire 03833

*April 25, 2024*

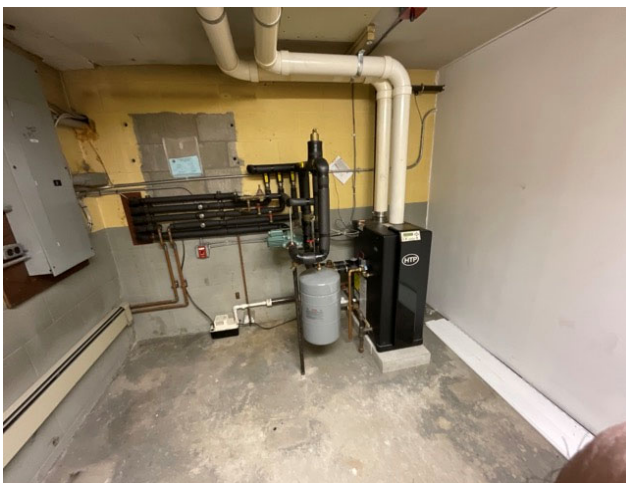
11 - HVAC BOILER

It is unknown when any renovations have taken place; however, several mechanical items were replaced between 2006 and 2011. These HVAC, boiler and hot water units are now beyond their life expectancy and are in poor condition. The roofing, last replaced in 2010, appears to be sound; however, it too needs replaced based on conditions observed in the field.

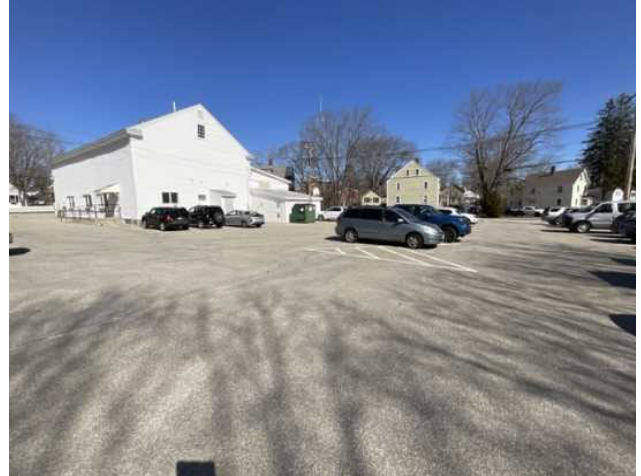
20 - PRIMARY PARKING

This site consists of a small asphalt parking lot with nominal issues that can be remedied with crack filling, sealing and restriping. The concrete walks and ramps provide adequate access to entry with no visible signs of needing repairs. There are two brick planters at the main entrance that are in fair condition.
