FACILITY CONDITION ASSESSMENT

Rec Bath House/Concession
4 Hampton Road
Exeter, New Hampshire 03833

157332.22R000-012.354

April 21, 2023

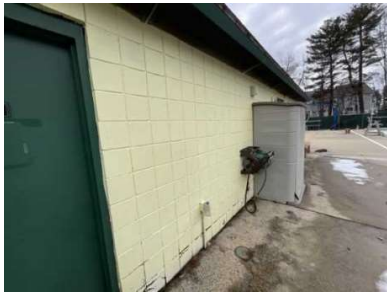
Exterior Walls in Poor condition.

Concrete Block (CMU)
Rec Bath House/Concession Building Exterior

Bottom courses of block should be re-pointed. - AssetCALC ID: 5971765

Uniformat Code: B2012
Recommendation: **Repair/Repoint in 2023**

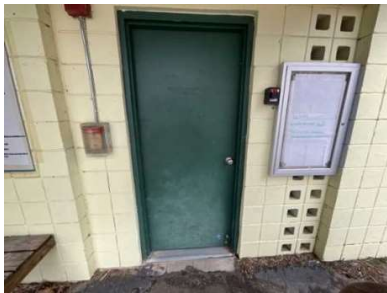
Interior Door in Poor condition.

Steel, Standard
Rec Bath House/Concession Building Exterior

GM's of the interior steel doors are rotting away from the moisture in the showers in Locker room area - AssetCALC ID: 5971741

Uniformat Code: C1031
Recommendation: **Replace in 2023**

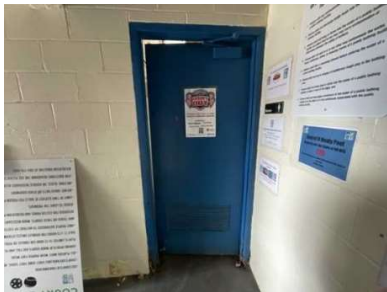
Exterior Door in Poor condition.

Steel, Standard
Rec Bath House/Concession Building Exterior

The exterior doors are not fitting properly. Jams are rusting at the floor line. - AssetCALC ID: 5971774

Uniformat Code: B2051
Recommendation: **Replace in 2024**

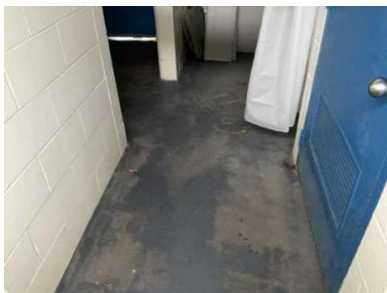
Flooring in Poor condition.

any surface, w/ Paint or Sealant
Rec Bath House/Concession Throughout building

Worn finish - AssetCALC ID: 5971742

Uniformat Code: C2031
Recommendation: **Prep & Paint in 2024**
