**WESTSIDE DRIVE SEWER PLANNING  
NHDES Project No. D2020-0607**

**EXETER, NEW HAMPSHIRE**

**FINAL - MAY 23, 2022**

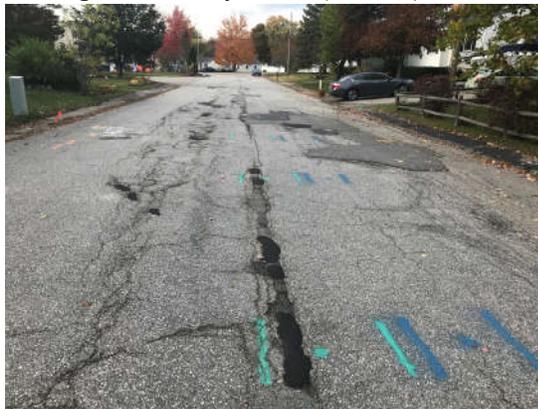
The existing roads (~5,500 feet) are constructed of bituminous asphalt paving approximately 40’-50’ wide with non-functioning, deteriorated sidewalks and bituminous curb. UE evaluated the roadway surface conditions of the neighborhood roads in accordance with Road Surface Management System (RSMS) standards in March 2021. Condition assessment forms are

provided (Appendix H). RSMS condition ratings ranged from 40 to 60 meaning the roads have deteriorated to a condition beyond maintenance overlays and reconstruction is recommended (Figure 2C). The road profile and crown has regressed so that they do not effectively convey/drain stormwater in many areas. The areas with the poorest RSMS condition ratings were in the northeast portion of the site and corresponded with areas of high groundwater and peaty materials and areas with most severe drainage issues identified during public input.

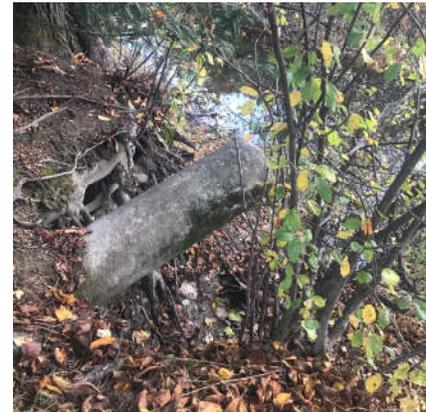
Outfall #1: The drainage system that conveys stormwater to this outfall includes one (1) precast concrete catch basin and drain manhole that collects stormwater from the northwest portion of the neighborhood and outfalls to the Little River. The structures appeared to be serviceable condition, but the outfall pipe was observed hanging over the stream embankment. The outfall pipe also appeared to have a reverse slope and did not appear to be functioning properly (photo right). During public participation, residents identified drainage issues in this catchment indicating that improvements are needed to effectively collect and convey stormwater in this area.

- Replace two (2) drainage outfalls on the west side of the neighborhood (Outfalls #1 & #2) and improve outlet protection. Consider incorporating end-of-pipe stormwater treatment at Outfall #2 since site conditions at this location may allow the addition of treatment (such as rain gardens). Conceptual drainage profiles have been provided to evaluate the feasibility of avoiding utility conflicts and showing the 100-year flood elevation at these sites (Figures PRO#1 and PRO#2).

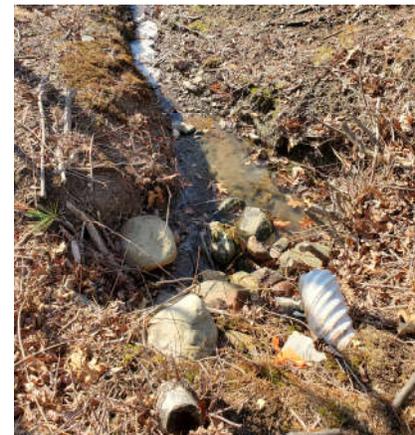
Outfall #2: The drainage system that conveys stormwater to this outfall includes one (1) block drop inlet that collects stormwater from the southwest portion of the neighborhood and outfalls overland to the Little River. The catch basin structure was in poor condition with limited cover over the CMP outlet pipe and erosion was observed downstream of the outfall due to insufficient scour protection (photo right). During public participation, residents identified drainage issues in this catchment indicating that improvements are needed to effectively collect and convey stormwater in this area.

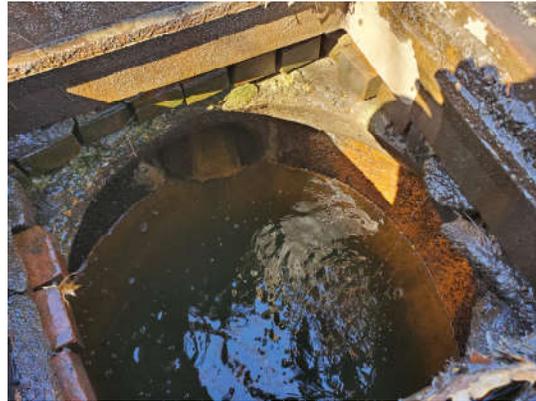
Outfall #4: The drainage system that conveys stormwater to this outfall includes one (1) block drop inlet (photo right) that collects stormwater from the east-central portion of the neighborhood and outfalls to a wet area along the east side of the site. The catch basin structure was in poor condition with limited cover over the outlet pipe and surcharged outlet conditions (Appendix I). During public participation, residents identified drainage issues in this catchment indicating that improvements are needed to effectively collect and convey stormwater in this area.

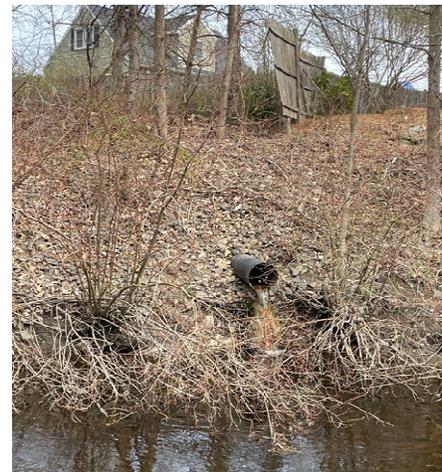
Outfall #5: The drainage system that conveys stormwater to this outfall was the largest in extent, appeared to be in the best condition, and appeared to be the only potentially salvageable site drainage infrastructure. It generally consists of 4' precast concrete diameter and brick catch basins with 12" PVC, HDPE, RCP, and CMP pipes in serviceable condition, but pipe conditions should be confirmed with CCTV and may be undersized. Outfall #5 is 15" HDPE that is hanging over the Little River embankment with limited outlet protection (photo right).

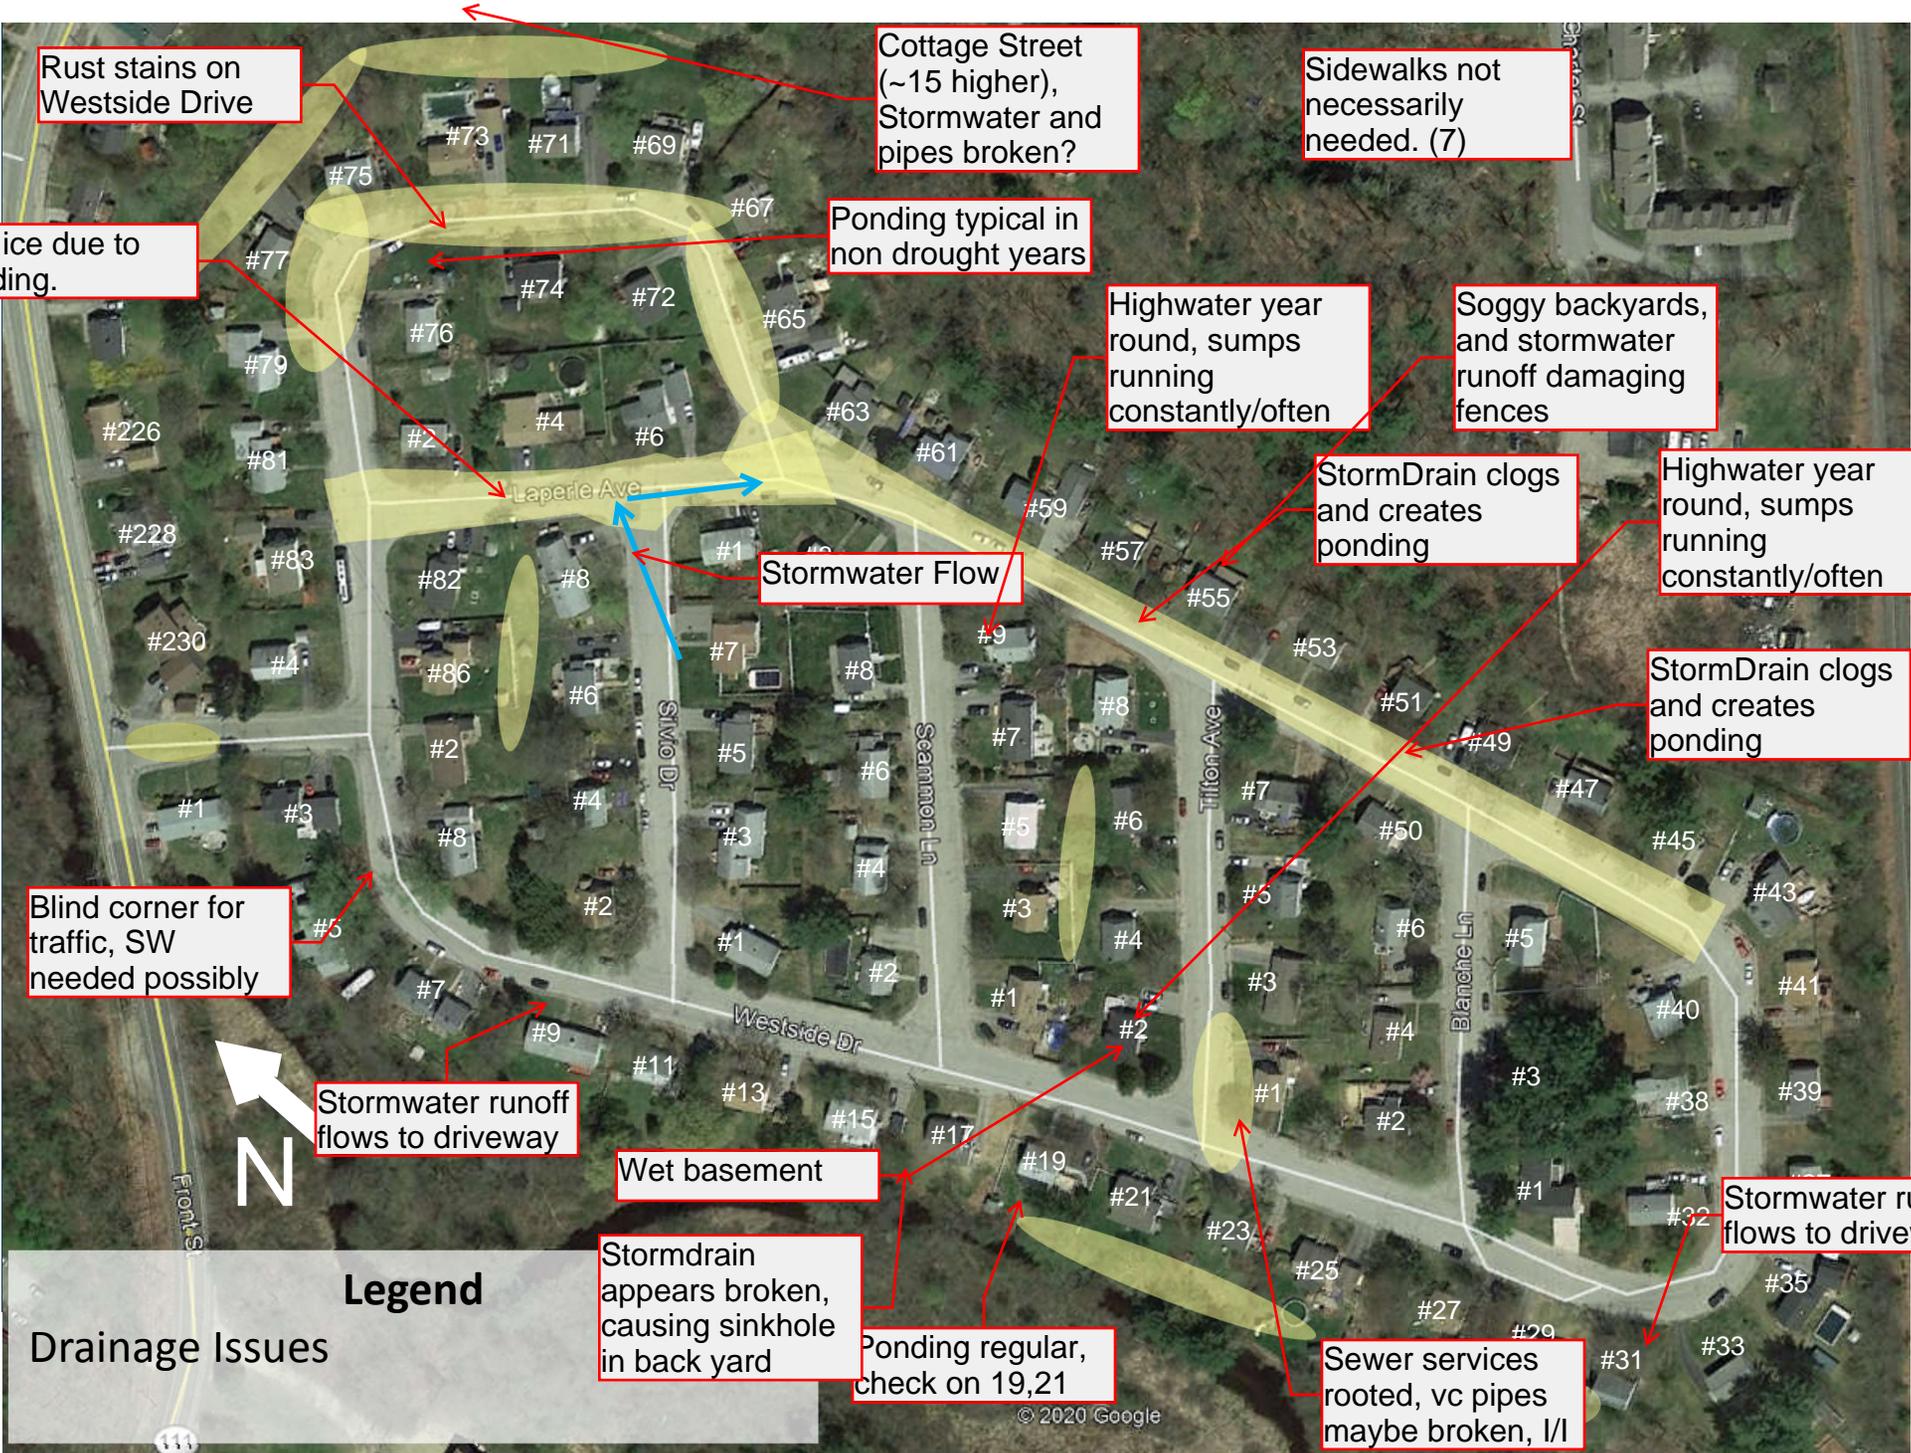
Rust stains on Westside Drive

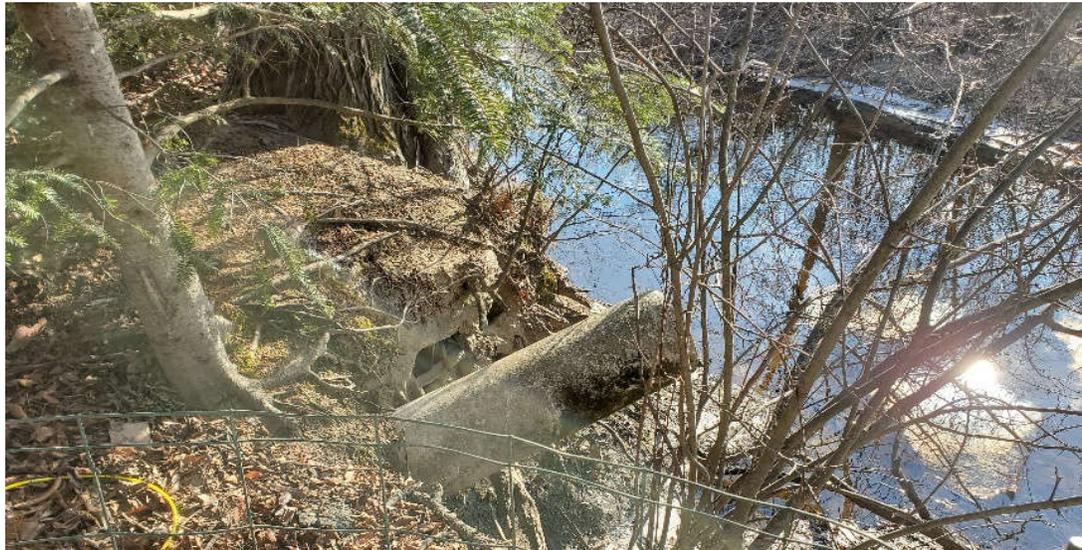
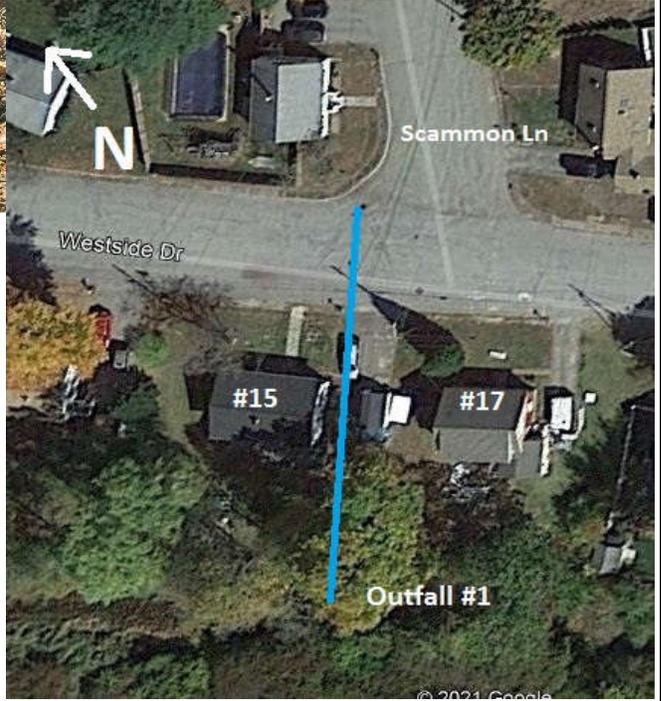
Notes  
Approximately 40" of the pipe is exposed and hangs over the river bank unsupported. Outfall appears that it would be damaged easily.

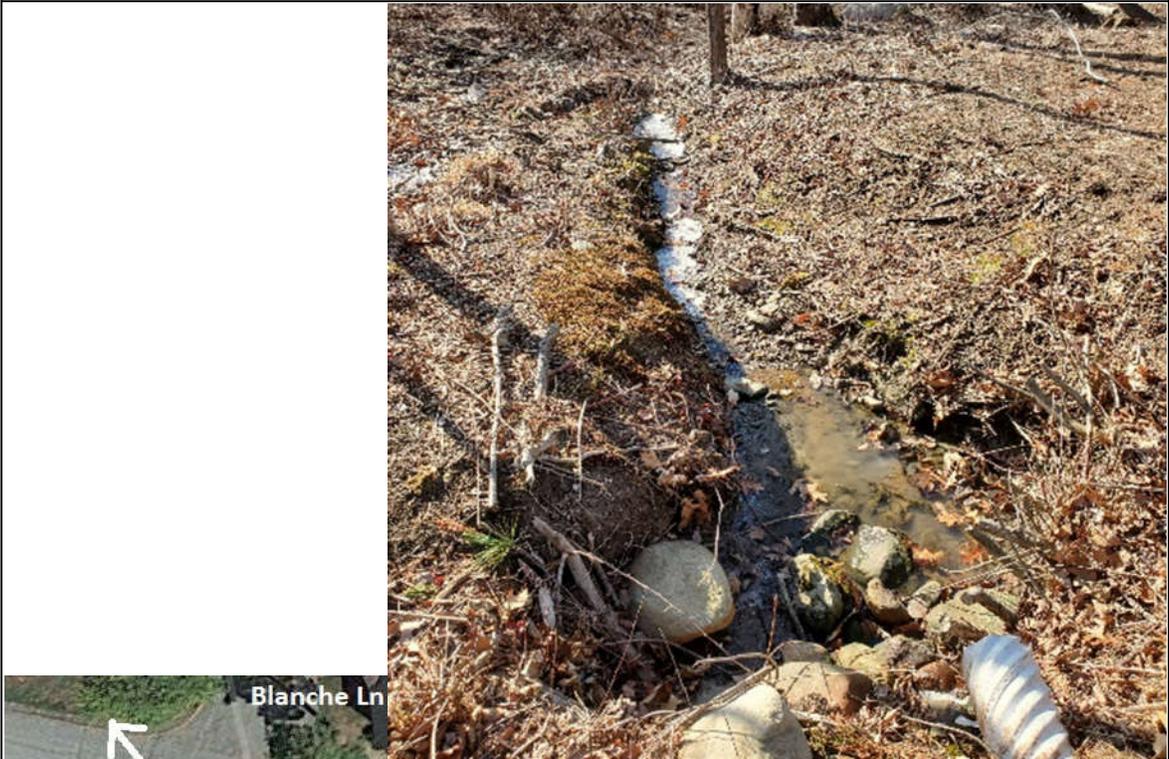
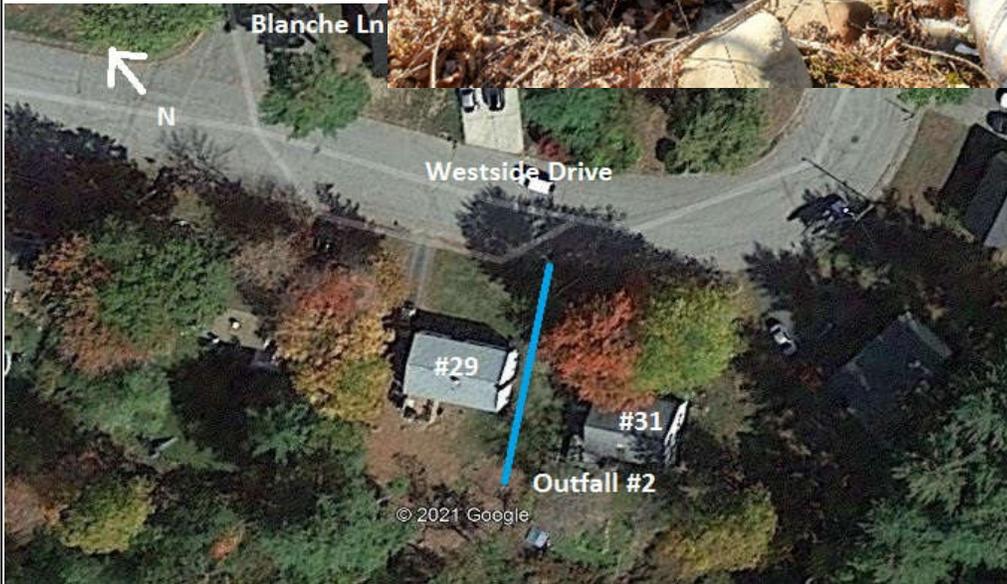
Approximately 13" of the pipe is exposed and discharges to a swale in the backyard and eventually into the Little River

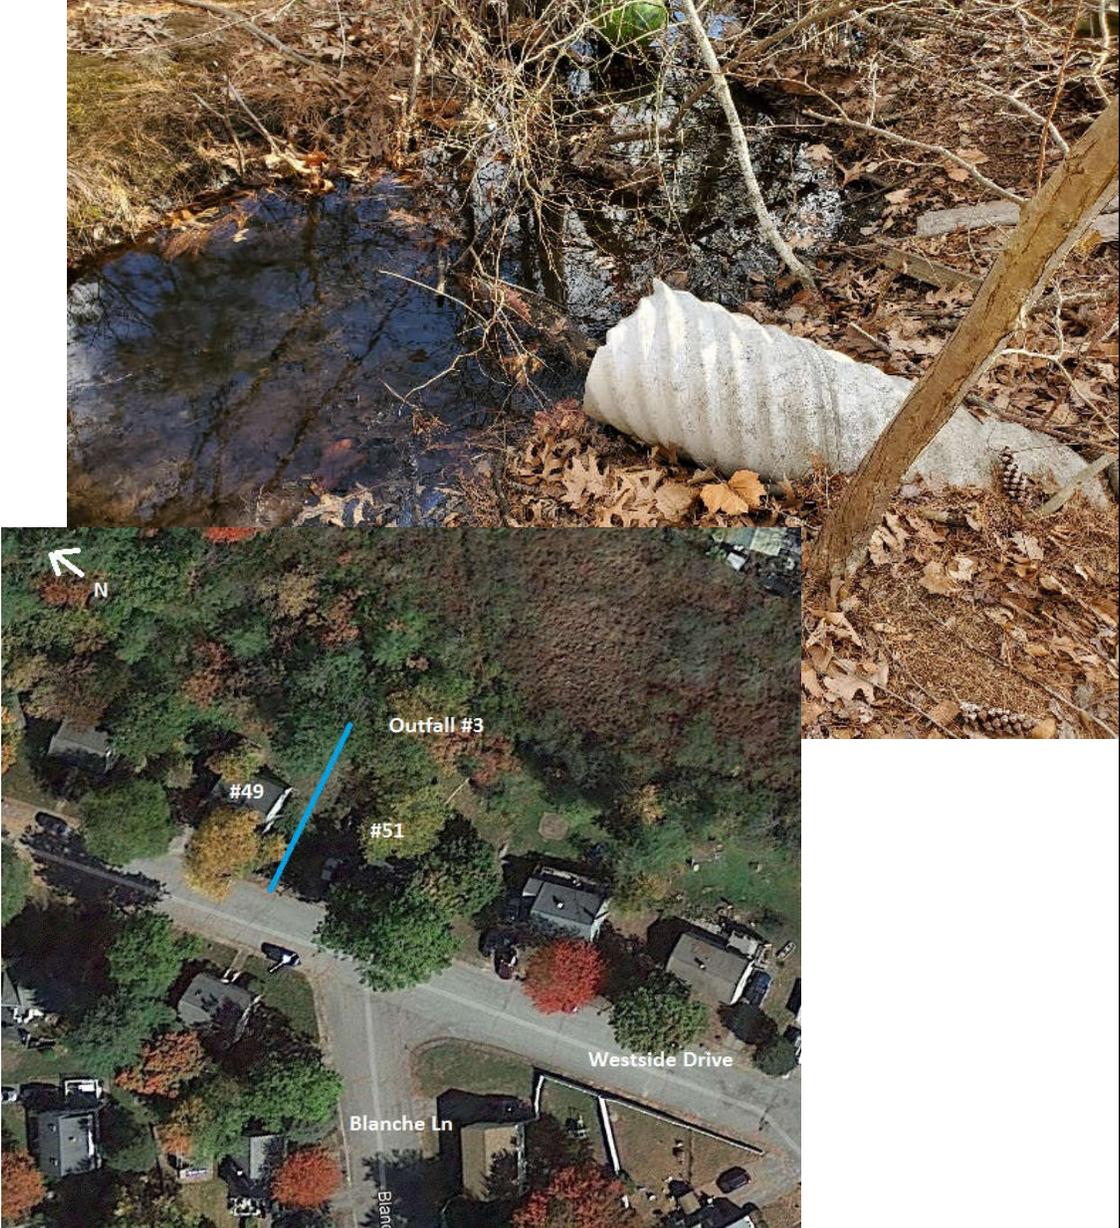
Date Inspected	1/22/2021
2588 Westside Drive Conceptual Improvements, Exeter NH	
Outfall ID	#3
Location	Discharges behind 49 and 51 Westside Drive
Size	15"
Material	CMP
Condition	No blockage visible, Top of outfall has been flattened
Notes	Discharges to small stream behind properties. Water is trickling out of pipe. CB on Westside Drive was mostly covered in leaves and pine needles.

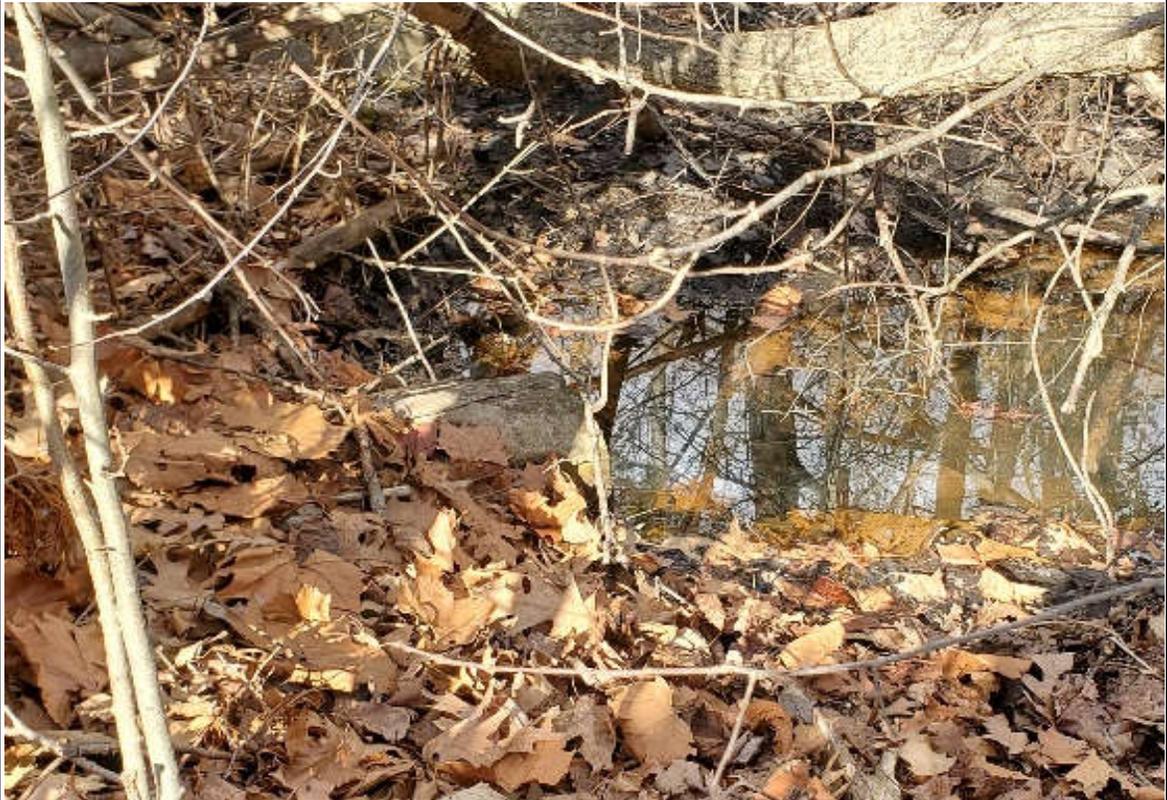
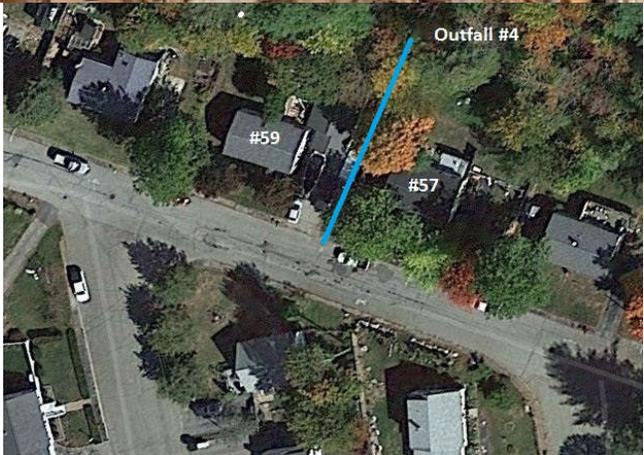
Discharges to small stream behind properties. Outfall is approximately 50% submerged within the wetland.

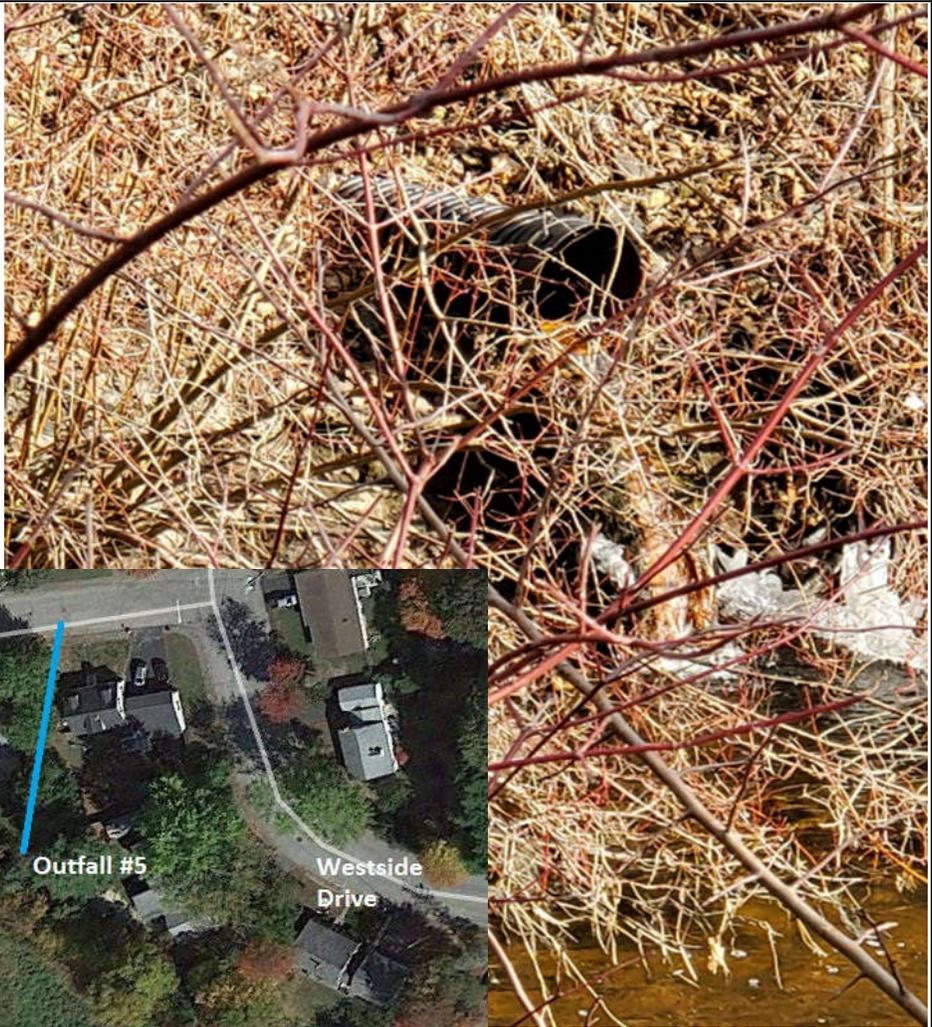
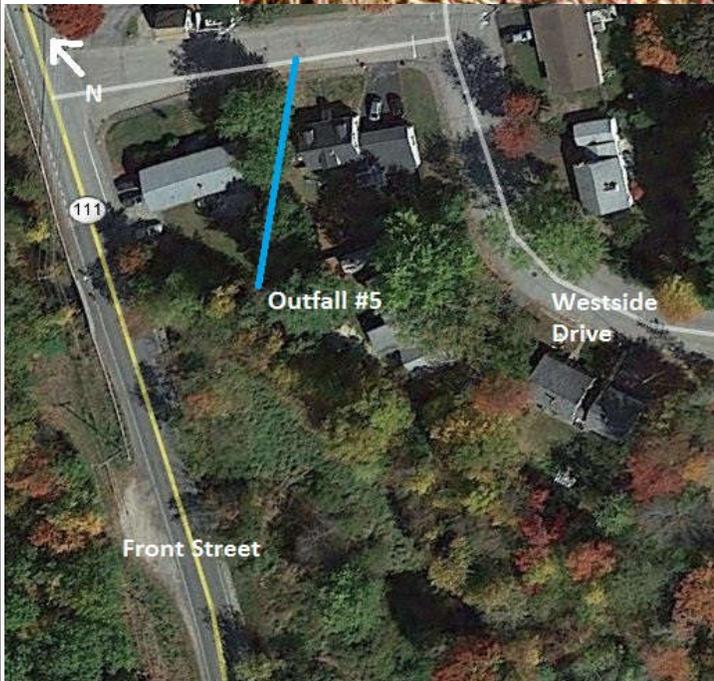
Date Inspected	1/22/2021
2588 Westside Drive Conceptual Improvements, Exeter NH	
Outfall ID	#5
Location	Discharges behind 1 Westside Drive and into the Little River
Size	15"
Material	HDPE
Condition	No blockage or damage visible
Notes	Discharges to the Little River, constant flow coming out of outfall during investigation.

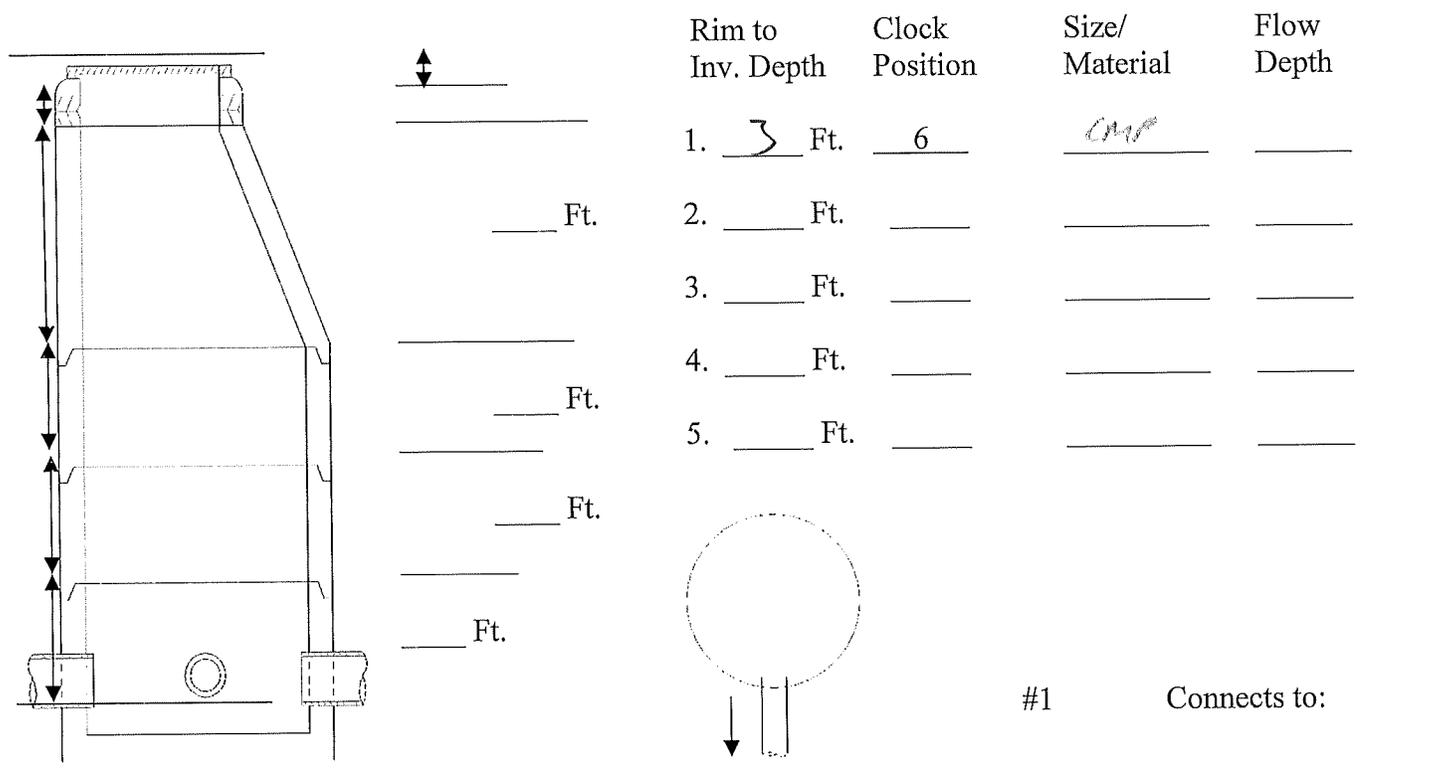
Location: Blake + Westsk Ave ID No. 2022  
 Dia. 2 Ft. Material: \_\_\_\_\_ By: ECN Date: \_\_\_\_\_  
 Clear Opening: \_\_\_\_\_ In. Corbel: 6 In. Frame .3' In. Potential: \_\_\_\_\_ S.F.  
 Notes: 2' Prop'd Brk cor, Bottom @ 4' ; slant. Poor  
Condition
