The State of New Hampshire
DEPARTMENT OF ENVIRONMENTAL SERVICES

July 25, 2019
Letter of Deficiency
DSP #19-016

RE: Pickpocket Dam #D029007, Brentwood

Dam# D029007, Pickpocket Dam, Brentwood, Inspected: 03/07/18

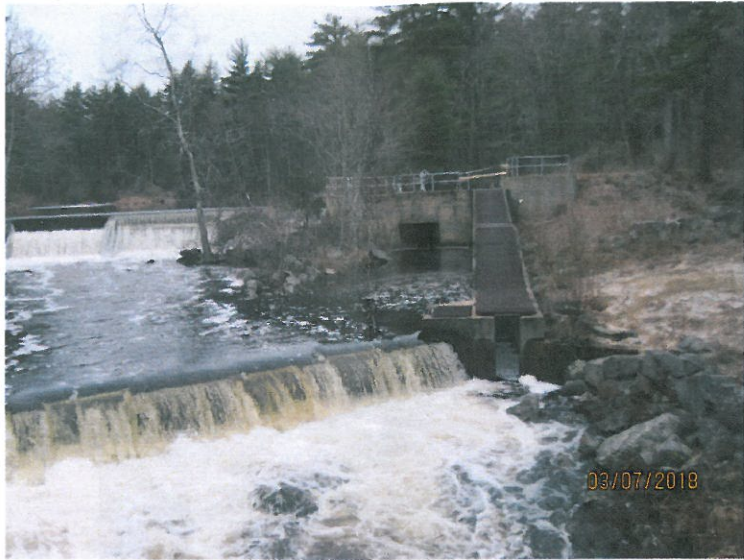
4. Remove the trees and brush from the crest, upstream and downstream portions of the embankment, within 15 feet of the spillway abutment walls and within 15 feet of the toe of the embankments. (Photos: B - E, G - N).

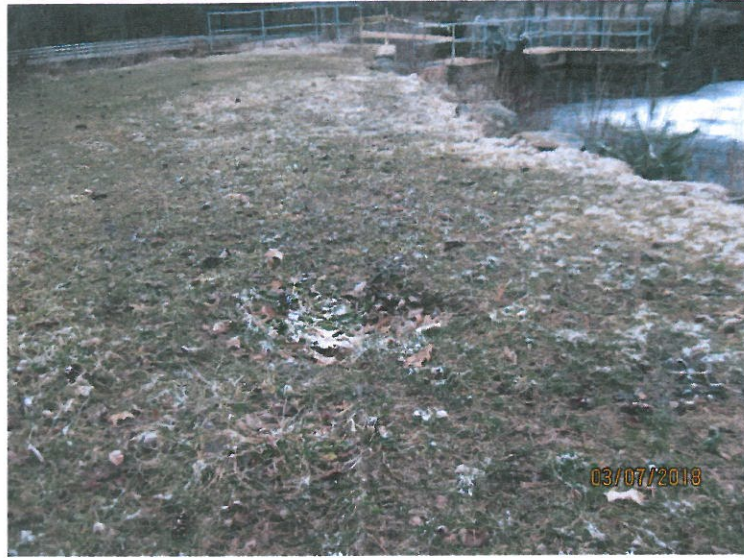
F

1. Remove the log from the spillway. (Photos: L, O & P).
2. Repair the sinkhole on the left embankment crest. (Photo: F).
3. Update the Operations, Maintenance and Response form (OMR) form included the following items, at a minimum;

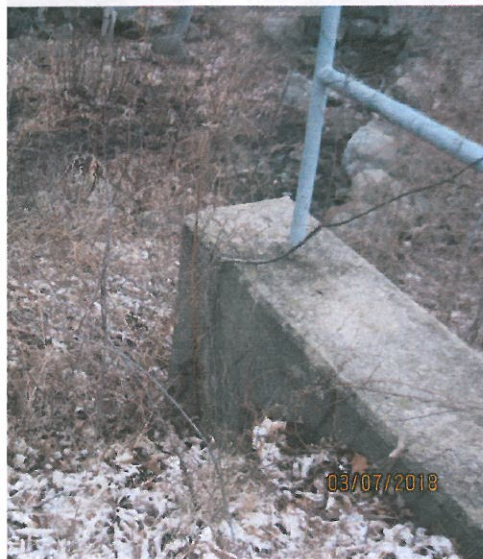
G

5. Repair the erosion and loss of material adjacent to left downstream spillway abutment wall on the left embankment section. (Photo: G).
6. Repair the erosion and loss of material, likely due to foot traffic, left of upstream wing wall on the left embankment section. (Photo: H).

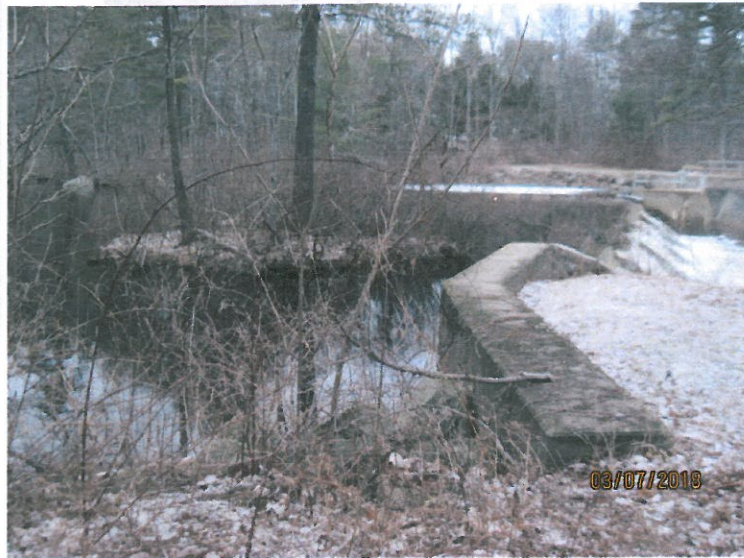
7. Repair the erosion and loss of material adjacent to end of the right spillway abutment wall on the right embankment section. (Photos: N & O).
