# Rose Farm Planning Department Materials

**RE: Peer Review Report of Wetland Functional Evaluation and Roadway Crossing Alternatives, Exeter Rose Farm, LLC Exeter, NH**

**TAX MAP 54 LOTS 5, 6 & 7 AND MAP 63 LOT 205 EXISTING SITE CONDITIONS PLAN**

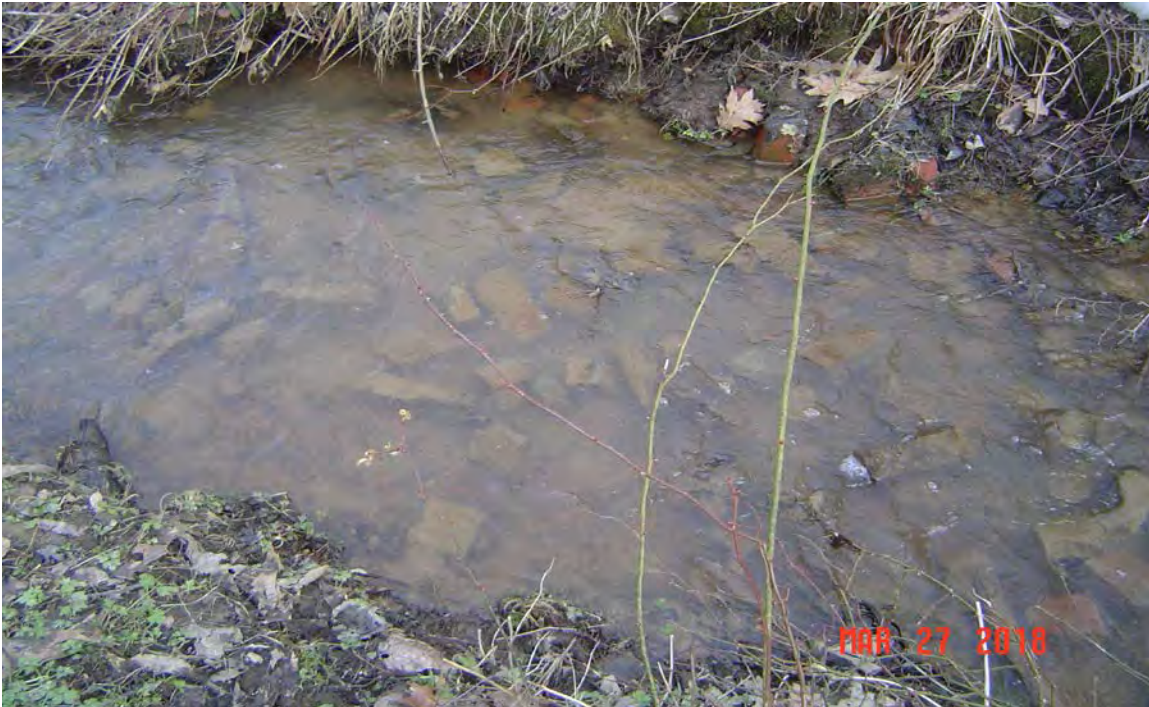
Image 1 – Unnamed perennial stream. Note bricks and turbidity. (*@Jacobs2018*)

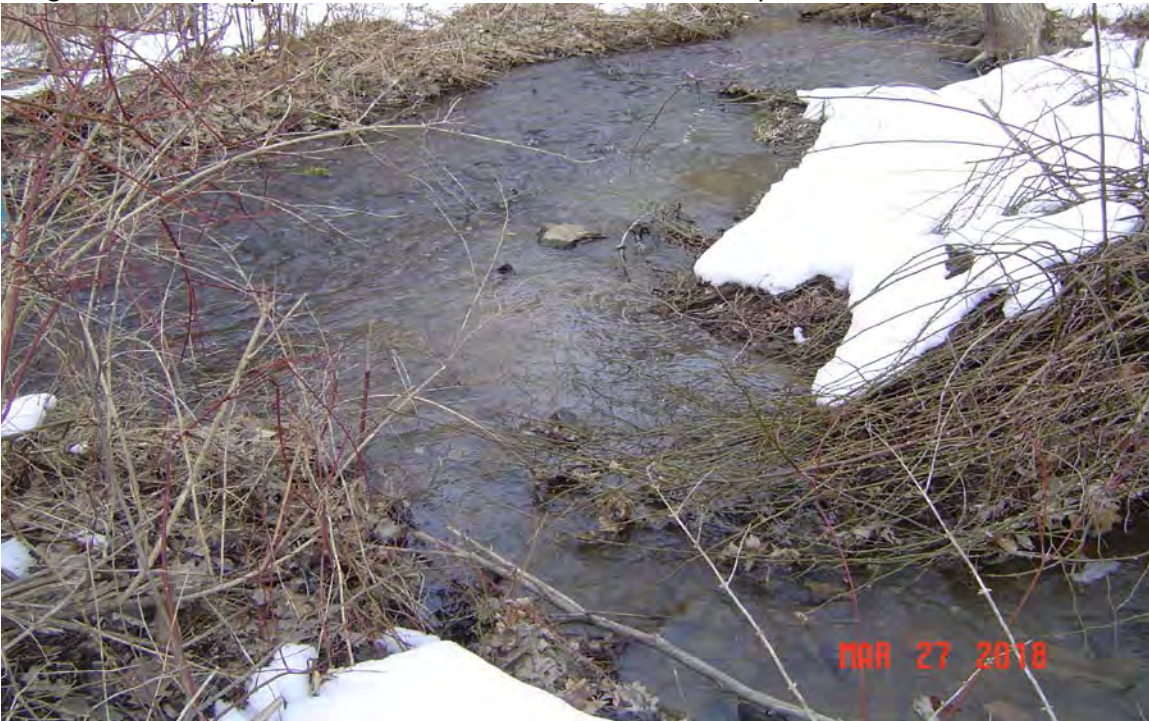
Image 2 – Juncture of unnamed perennial stream and Norris Brook (background). Note plume of slightly turbid water in foreground and on right side of Norris Brook. (*@Jacobs2018*)

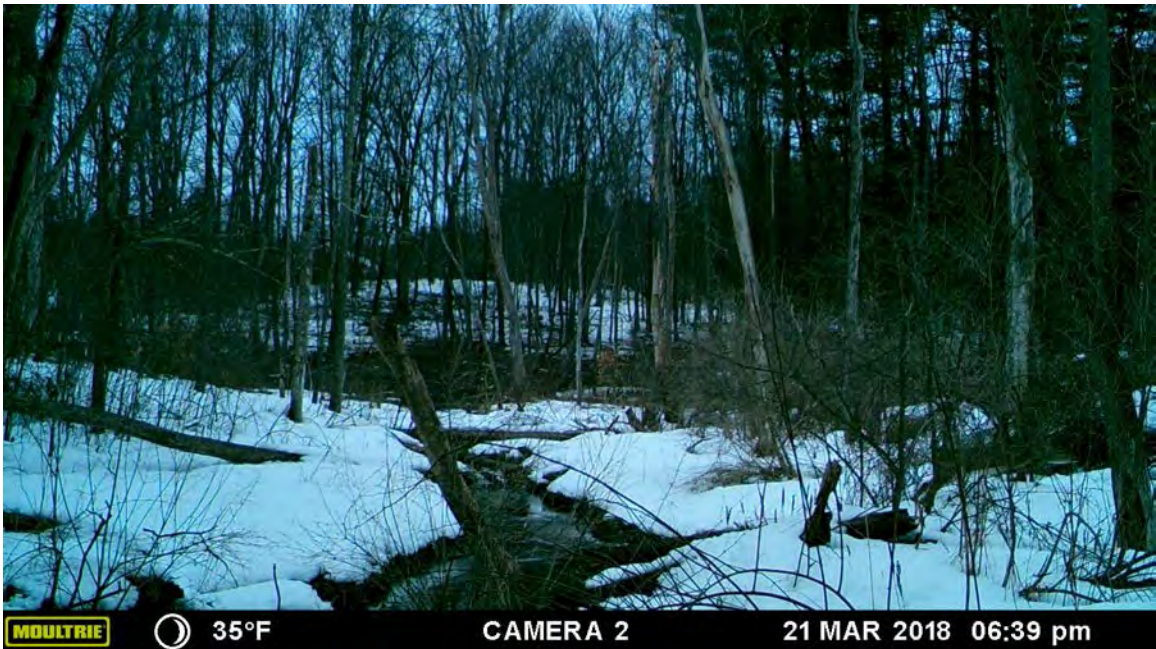
Image 3 – Wildlife camera image in the Green Wetland Study Area looking upstream (west) along Norris Brook. Note existing home in on left in center background and deer on right in foreground (*@Jacobs2018*)

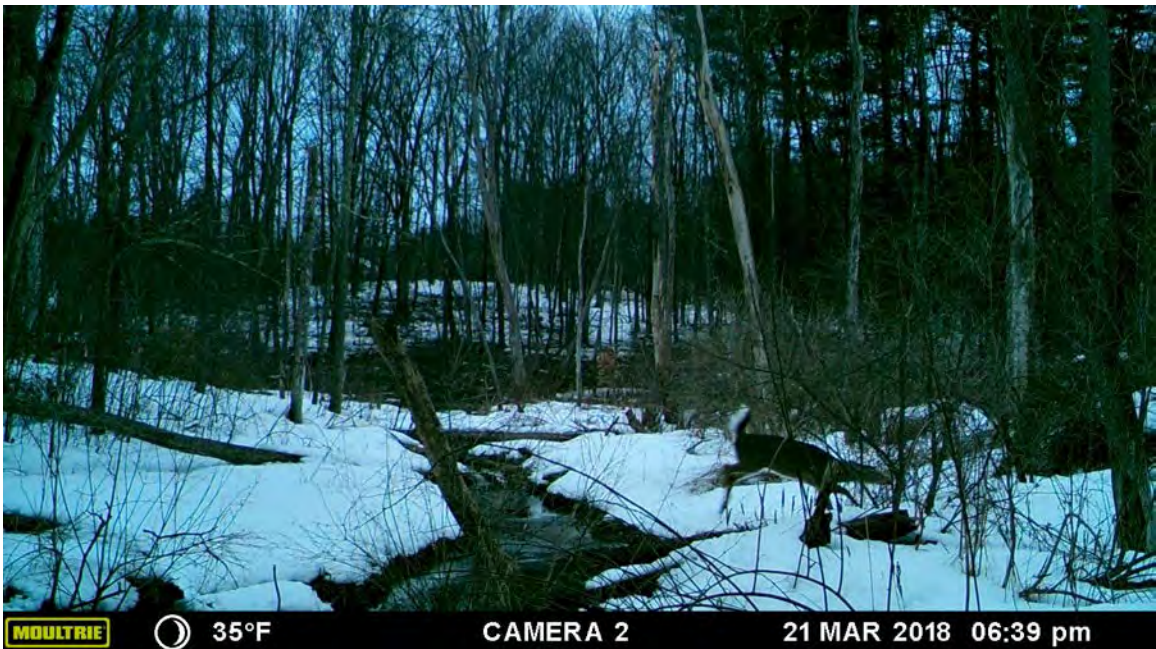
Image 4 – Wildlife camera image in the Green Wetland Study Area looking upstream (west) along Norris Brook. Note existing home on left in center background and deer on right in foreground (*@Jacobs2018*)

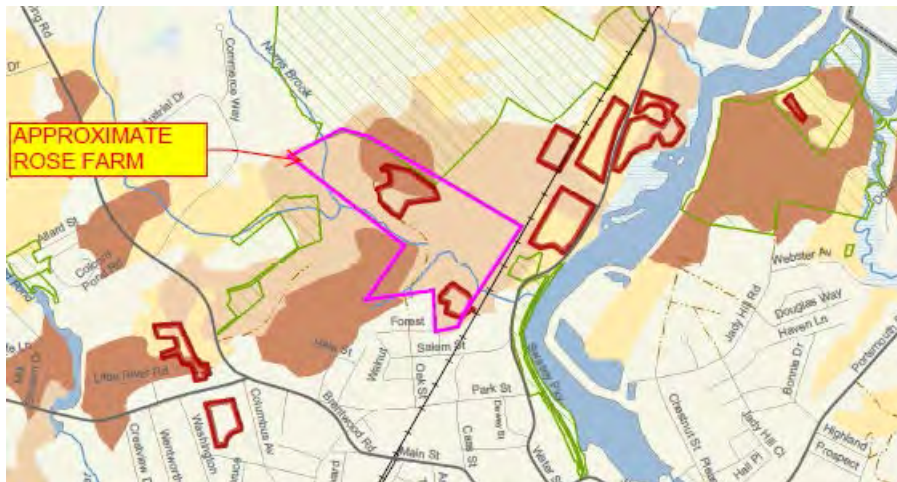
**Figure 1**

According to the Natural Resource Inventory prepared on behalf of the town, the subject property contains prime agricultural farmland, farmland of statewide importance and active agricultural areas. See Figure 1 below as well as the associated legend on page 5.

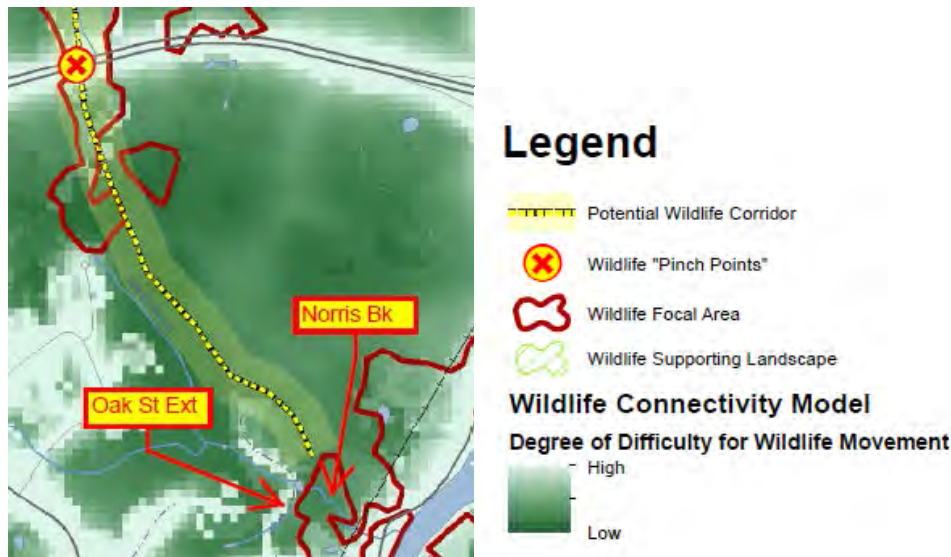
**Figure 10 Wildlife Connectivity**

The road crossing is being designed to provide an open bottom culvert with stream simulation and a migration corridor along the stream banks to encourage and permit migration by wildlife along the Norris Brook corridor. The Wildlife Connectivity map (Number 9) from the NRI identifies a separate potential wildlife corridor that runs through the Henderson-Swasey town forest along the northern boundary with the project site. The 100 foot vegetative buffer along the common property line with the Henderson-Swasey town forest will ensure that the project does not interfere with this potential wildlife corridor and the western forest that will remain as dedicated open space after the project is constructed will allow these migration corridors to merge. Refer to Figure 10 below.

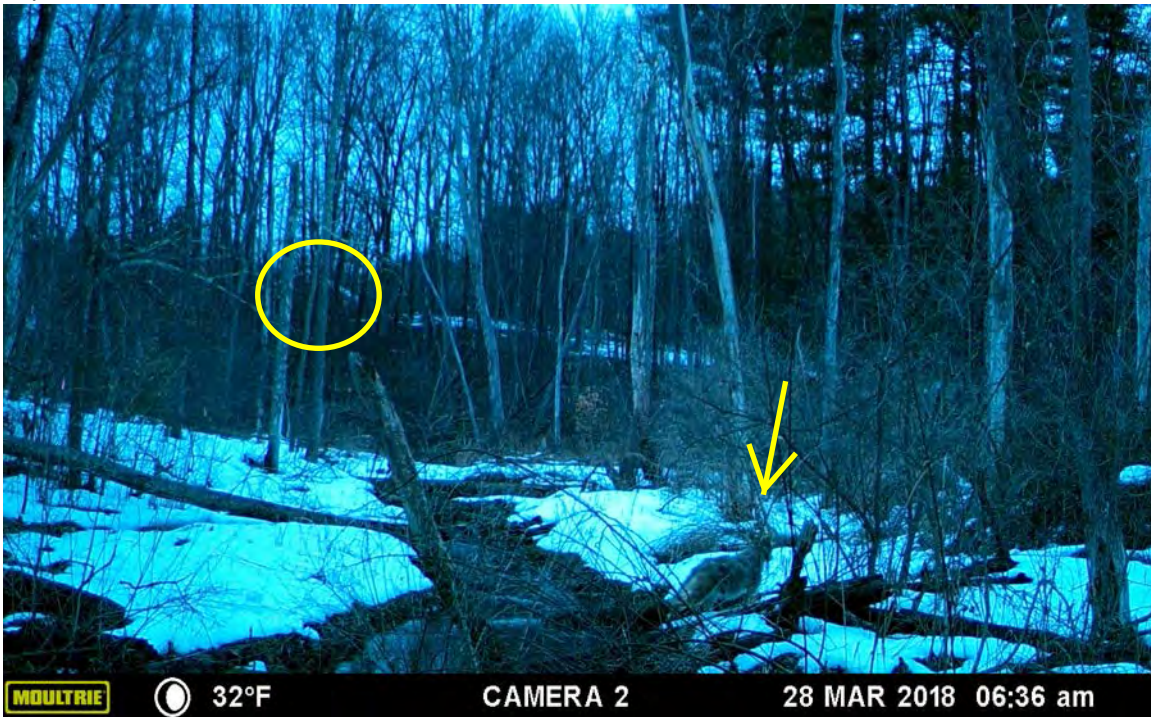
Note the coyote on the right in the foreground adjacent to Norris Brook and the existing home along Oak Street Extension in the background.

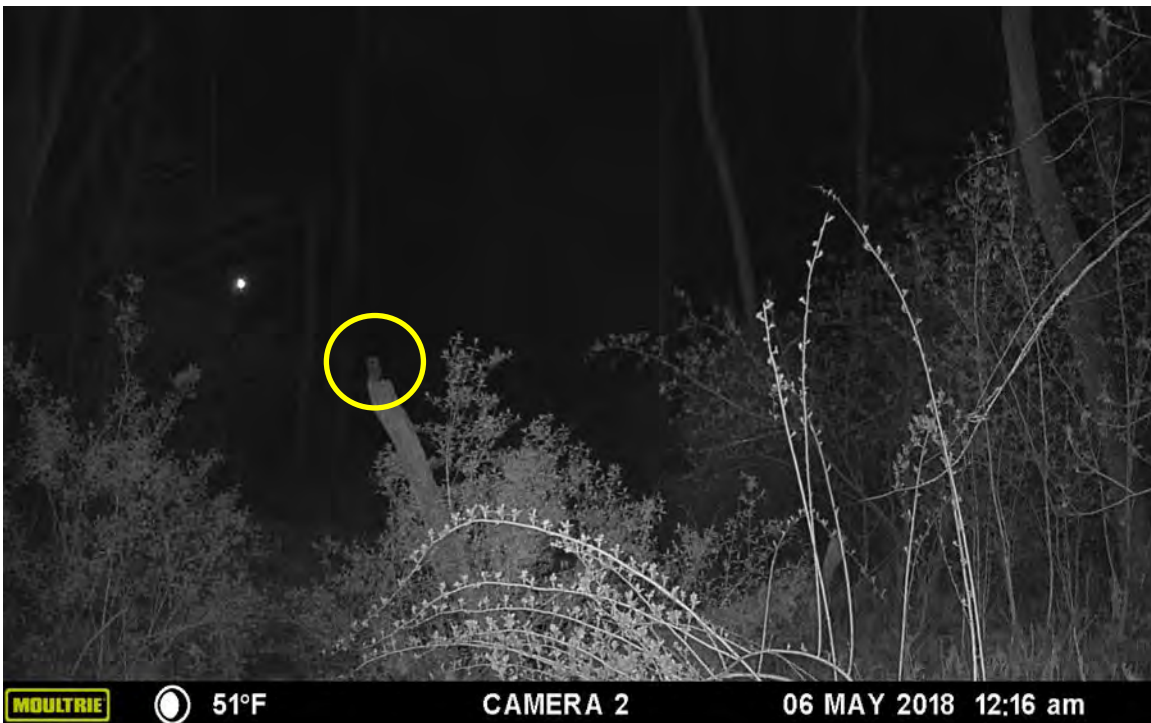
Note the owl on the stump left of center and the exterior light from the existing home on Oak Street Extension.

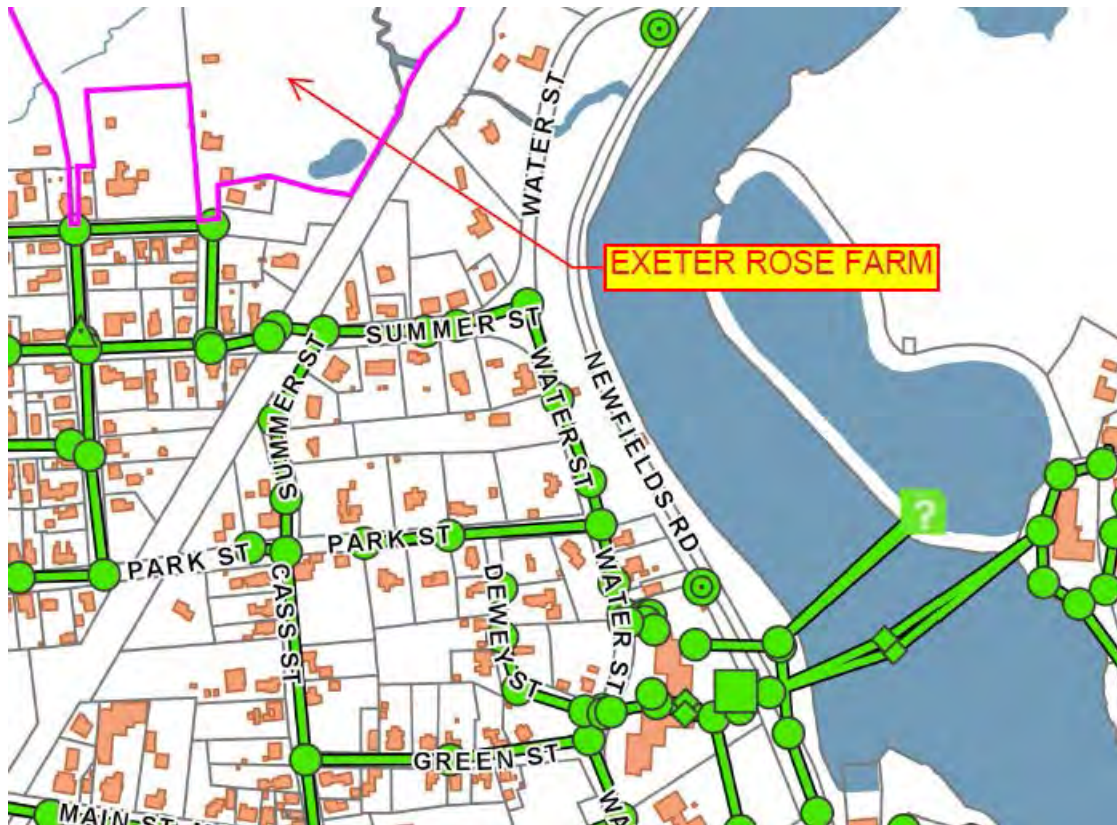
FIGURE 2

Additionally, we have identified and included at least two areas of the existing sewer infrastructure layer from the town Geographic Information System, which identifies considerable existing sewer infrastructure within existing 100-year flood plain and extending through or beneath existing waterways and wetlands, including the Squamscott River. Indeed, flood plains are often targeted for construction of sewer infrastructure by municipalities due to the soil types which are frequently easier to excavate due to the general lack of boulders and bedrock as well as the advantageous topography. Refer to Figures 2 and 3 below.

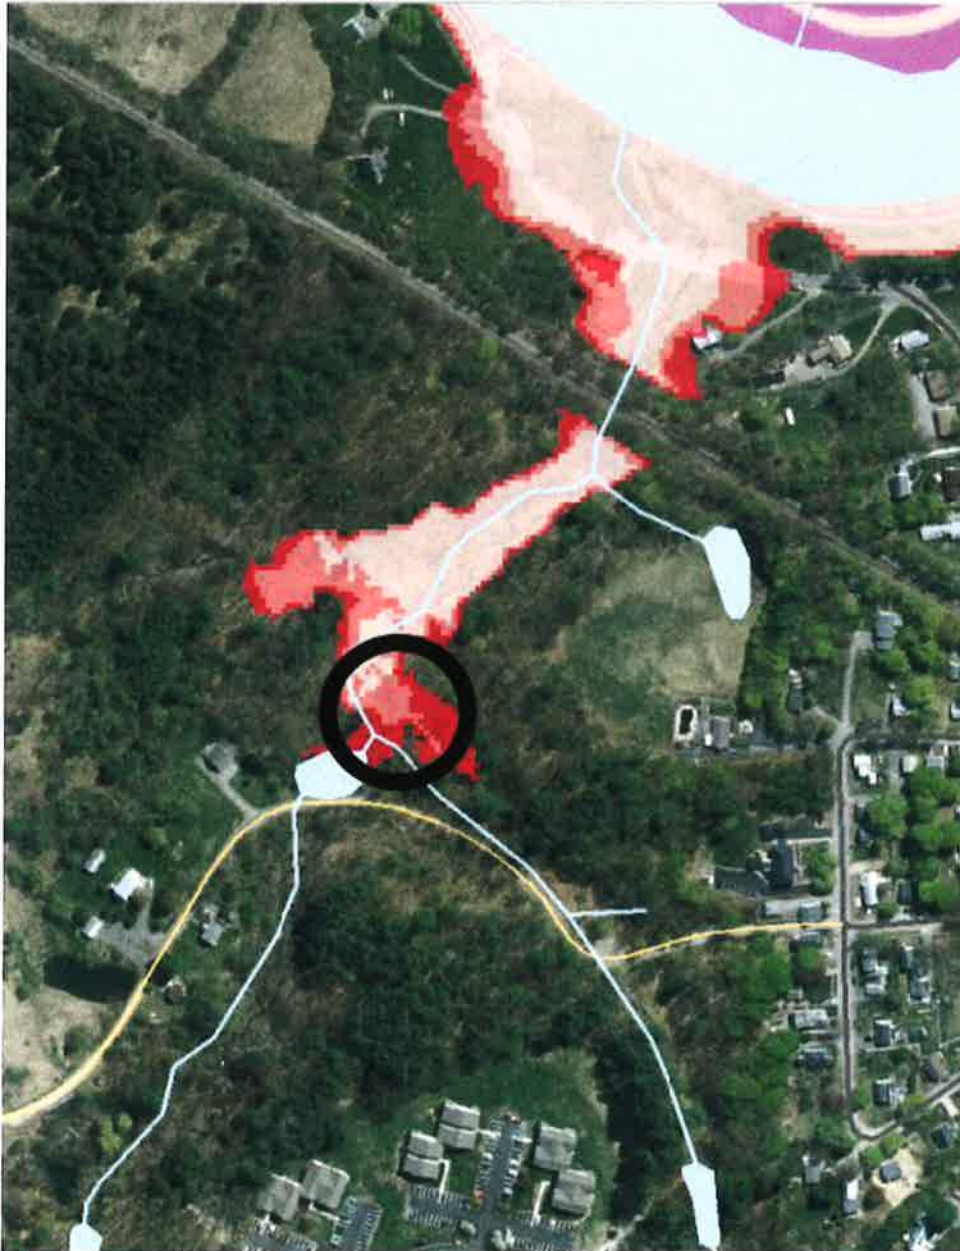
**Figure 2: Sea-Level Rise + Storm Surge Map for Norris Brook Showing Location of Proposed Rose Farm Pump Station**
