Re: 53 Water Street/Ioka Marquee

Re: *Ioka Theatre Building, Exeter, NH*
Existing Marquee

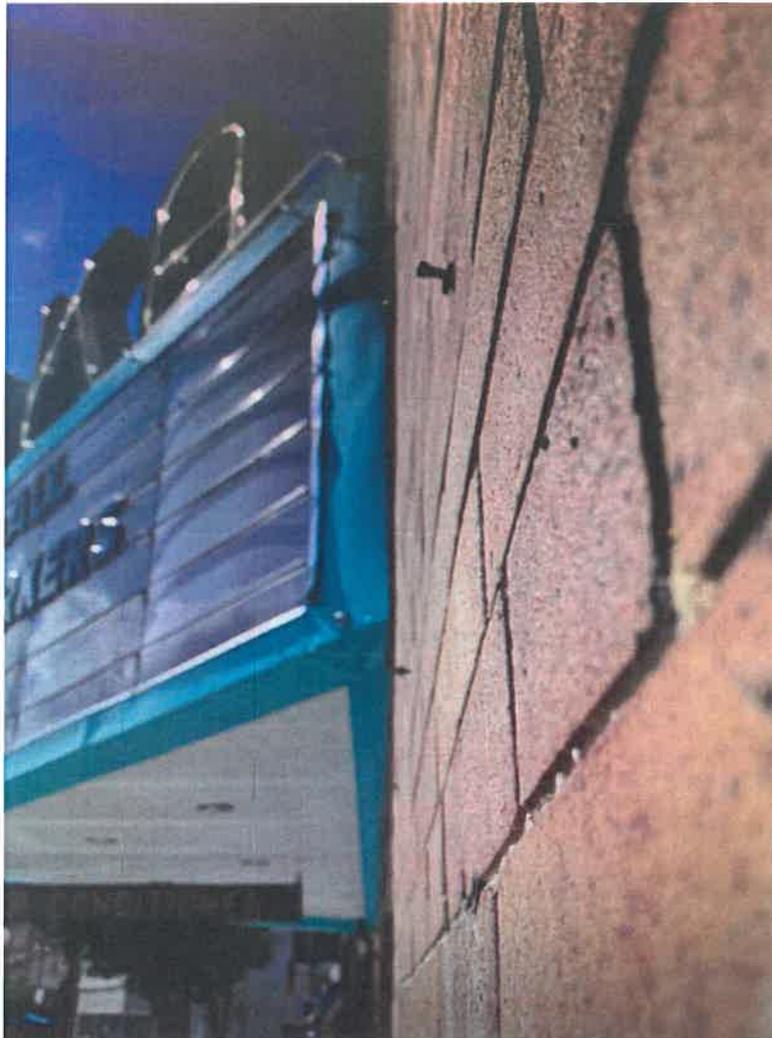
At your request I have done some review on the existing Marquee sign mounted to the front wall of the former Ioka Theatre. The existing sign is a large steel framed structure, protruding over 8 feet off the face of the building, and supported at the top by a single chain tied back into the masonry. Photo #1 shows a side view, and shows that the upper portion of the sign has pulled and tilted outward some from the wall. Photo #2 shows the chain connection to the sign, as well as the huge volume within this sign to collect snow, increasing its weight significantly. This snow "well" is almost 4 feet deep. Photo #3 shows the connection to the building, which occurs at a window head very close to the window. This is not a location of strength within this wall. Distress cracks can be seen in this photo. Photo #4 shows the mounting plate inside the masonry, where more distress cracks can be seen.

Photo #1 – Marquee tilting out from face of building at top

It is safe to say the engineers do not like heavy objects pulling on the face of un-reinforced masonry buildings. It is my opinion that this is currently not a safe condition and would take a significant

amount of structural reinforcing to correct it.

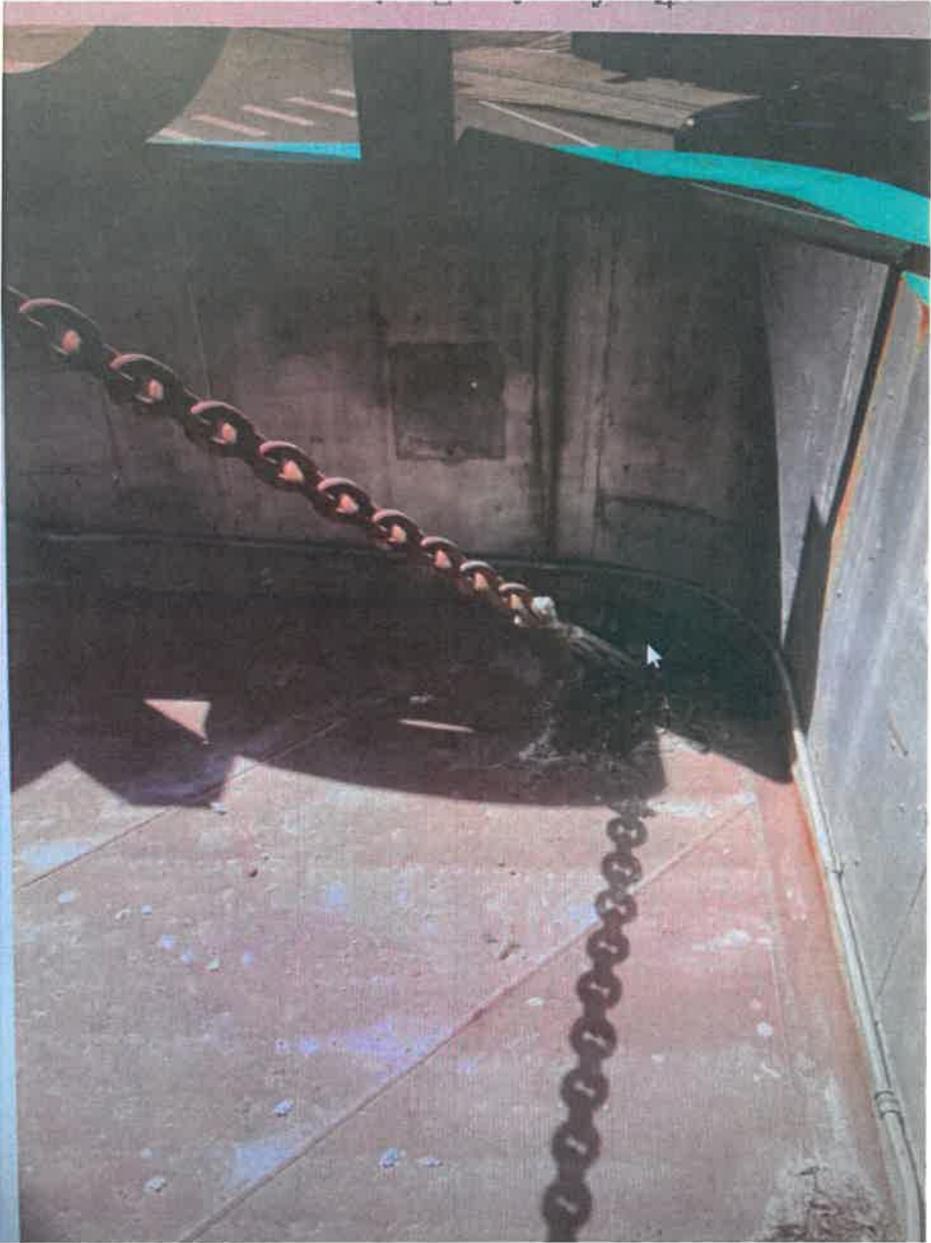
The marquee is 19' 6" long and protrudes 8' 4" off the face of the building. The plan area of this sign is approximately 81 square feet. Considering self-weight of the structure plus snow, an estimation of weight is about 6,000 lbs. or more. Based on this weight, and the angle of the chain, the approximate tension in the chain under full snow load is approximately 4,500 lbs. This is a significant enough load that modern engineers and modern codes would not even consider this attachment without major additional reinforcing. It is a significant enough load to a highly perforated unreinforced brick wall to consider it dangerous, even understanding the length of time that it has not yet failed.

Photo #2 – Chain attachment to Marquee

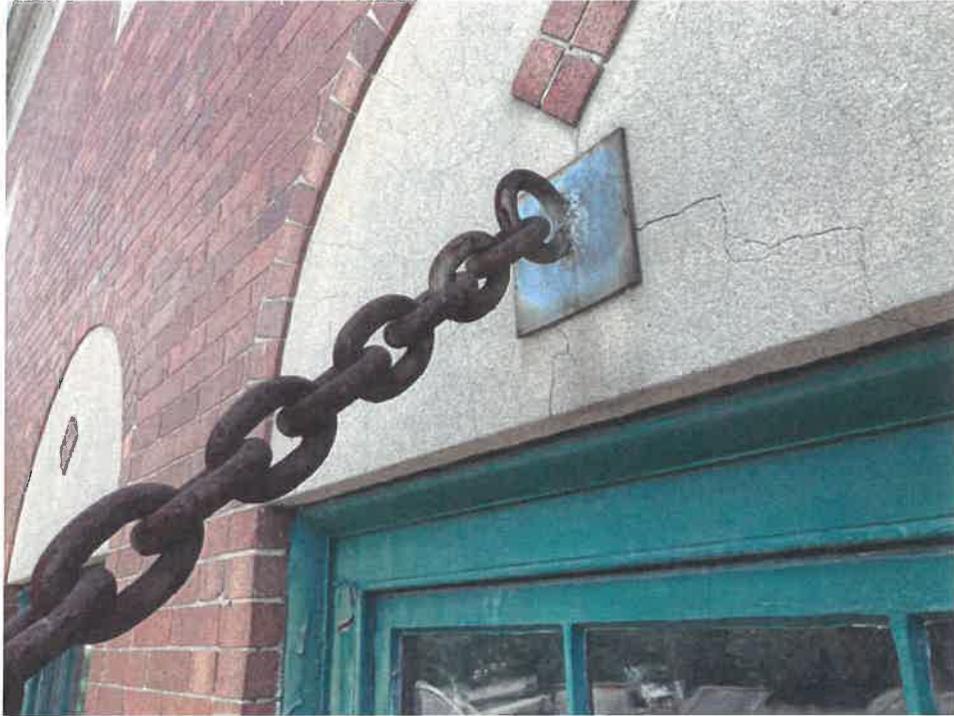
Photo #3 – Stress cracks at sign attachment to building

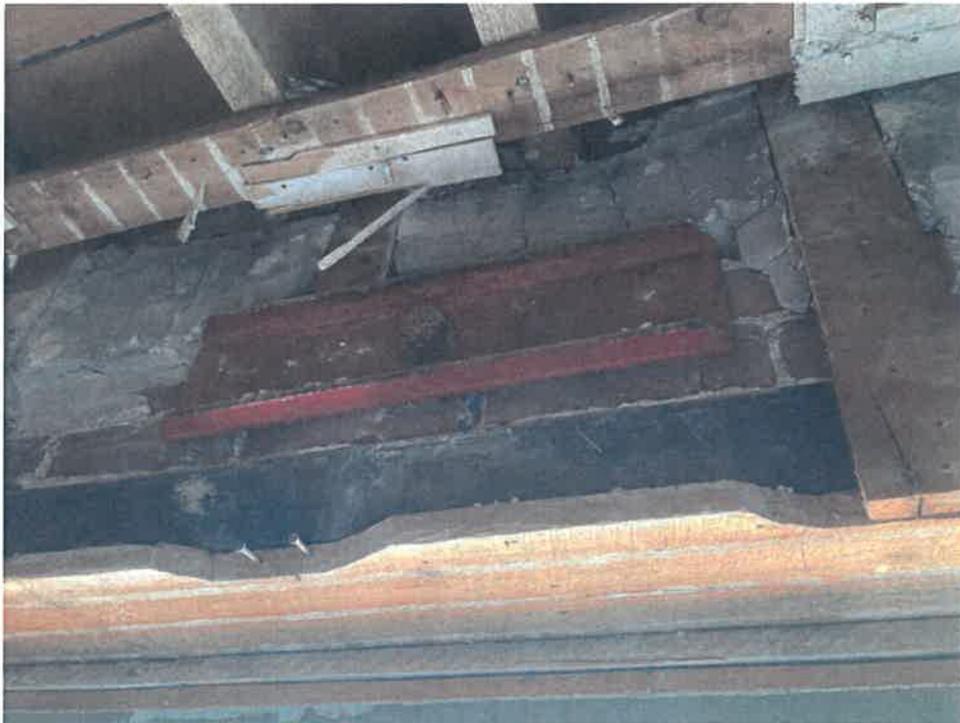
Photo #4 – Stress cracks on interior of sign attachment
