Historic Name(s), source(s): S.A. Seavey, 1892 map (replaced earlier structure)

Address: 125 High St.

Style: Second Empire

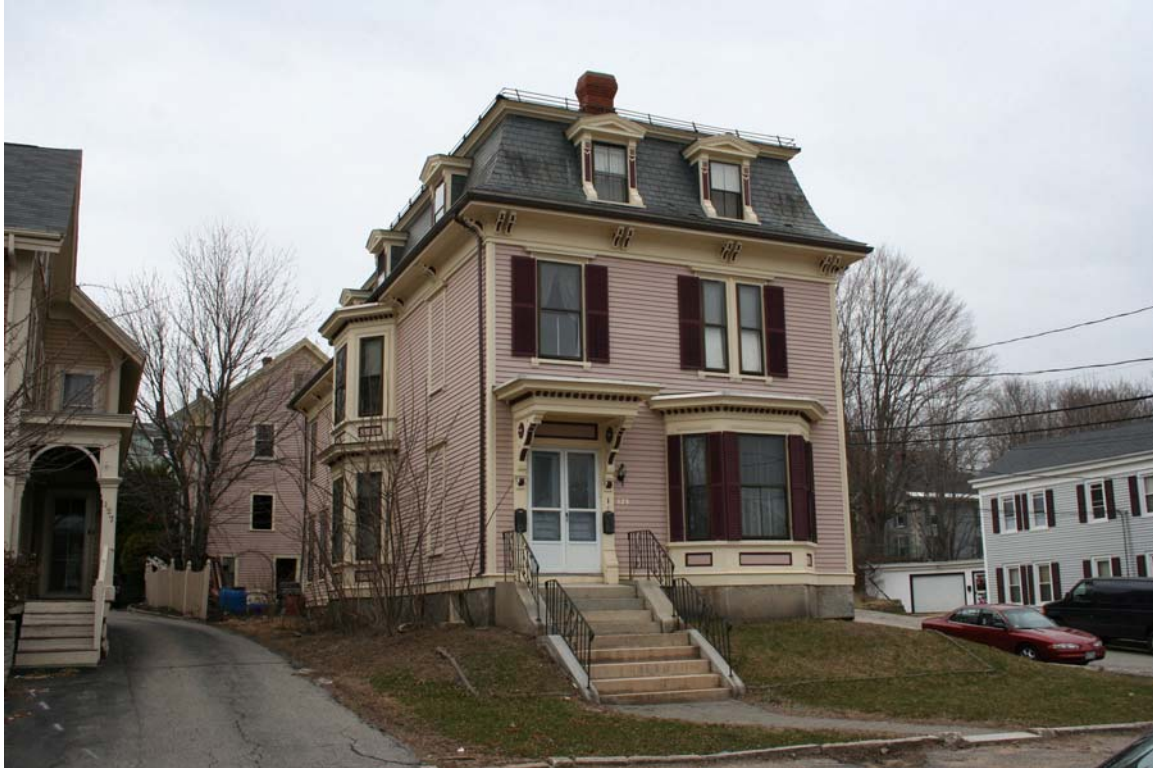
Photo No. 1 Front (E) and side (S) elevations

Note: Located on corner of High & Mt. Vernon streets

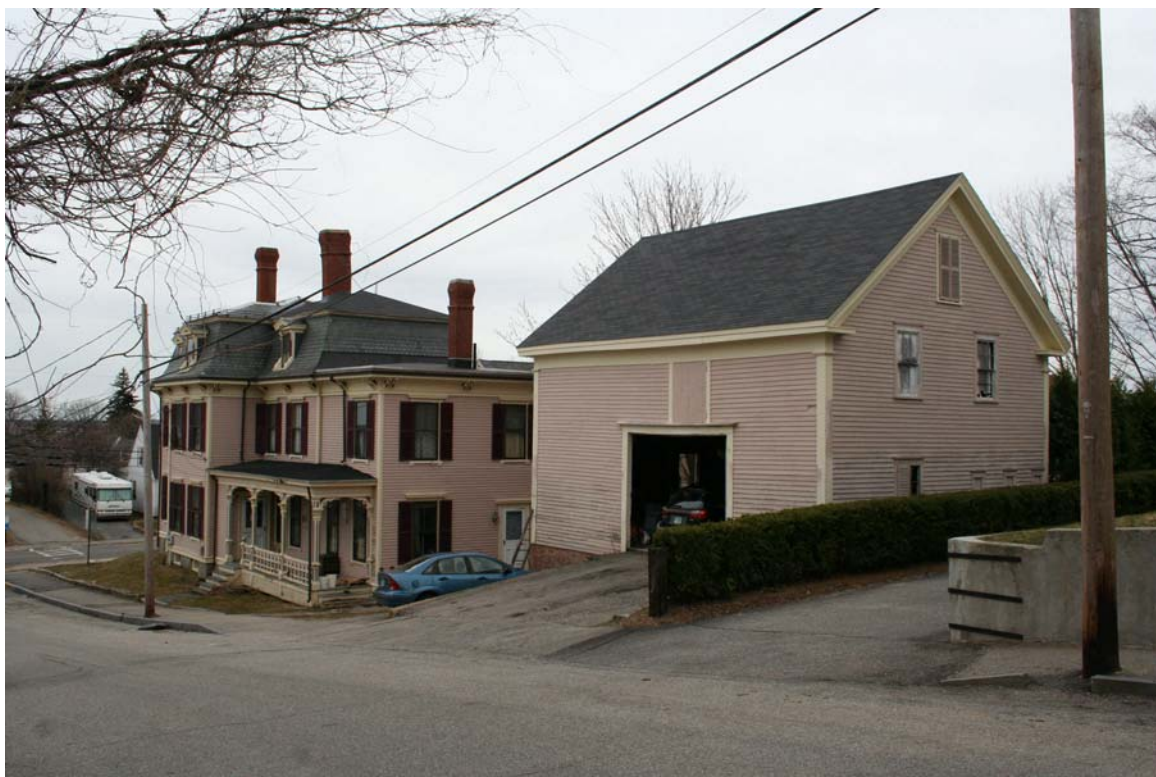
Photo No. 2	Mt. Vernon St. (N side) elevation	Looking: SE	Photo File # 5-23
--------------------	-----------------------------------	--------------------	--------------------------

Note: Greek Revival carriage barn dates to earlier house replaced by present structure

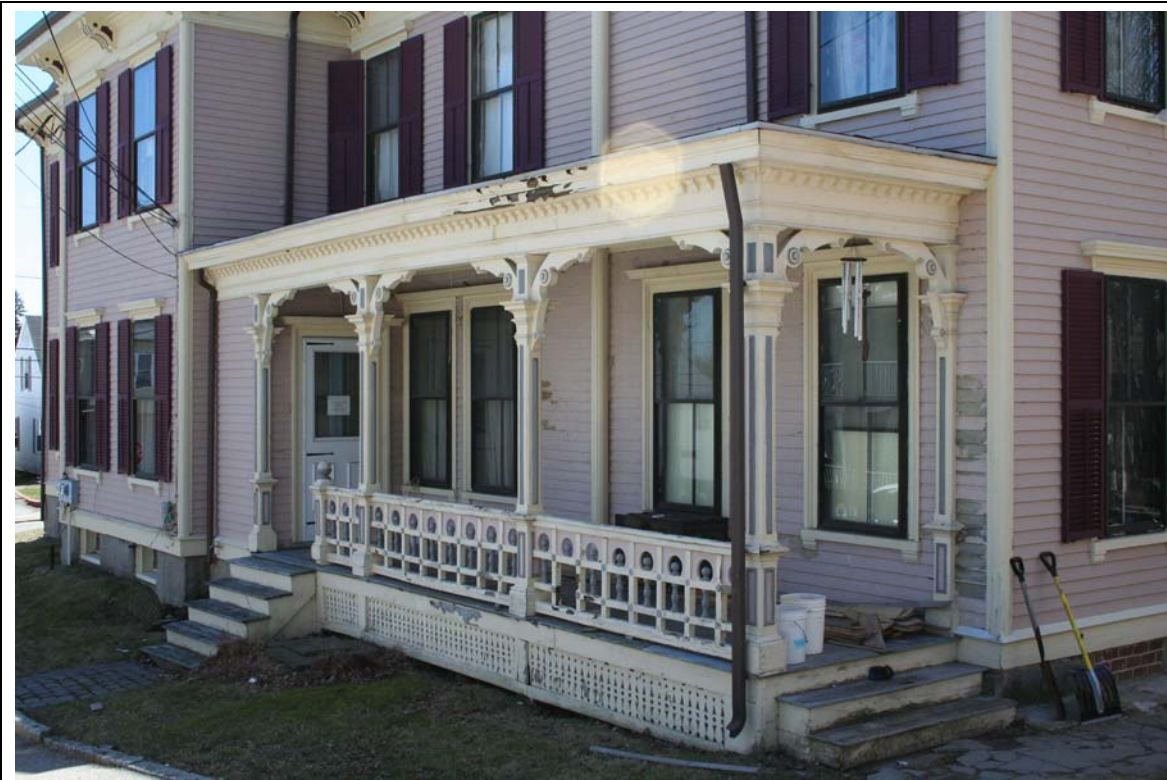
Doors	front paired doors with molded panels and etched glass; side door off porch is 2-light with molded panels	Y
Porches	side porch is unusually styled with square paneled posts, scrolled-cut post brackets, dentil moldings, spindlework balustrade, and pierced floor screen all which appears to be original	Y
Other		
Outbuildings	2-story side-gable carriage barn on raised walk-out brick basement with clapboard siding, wood 4/4 & 6/6 windows, sliding main door, hay door, cornice returns	Y
Landscape	granite entrance steps up from sidewalk with modern "wrought-iron" railings; granite curbing on inside edge of sidewalk	Y
Setting	located at bottom edge of Hilltop District, fronting High St., prominently situated on corner of Mt. Vernon St.	
Integrity	nearly 100%, retains all essential character defining features	
Significance	One of the most elaborate of the handful of Second Empire houses in the District; prominent location, high style and high integrity make this a primary contributing resource to the Hilltop District

Photo No. 4	Side porch detail	Looking: SE	Photo File # 7-056
Note: unusual balustrade

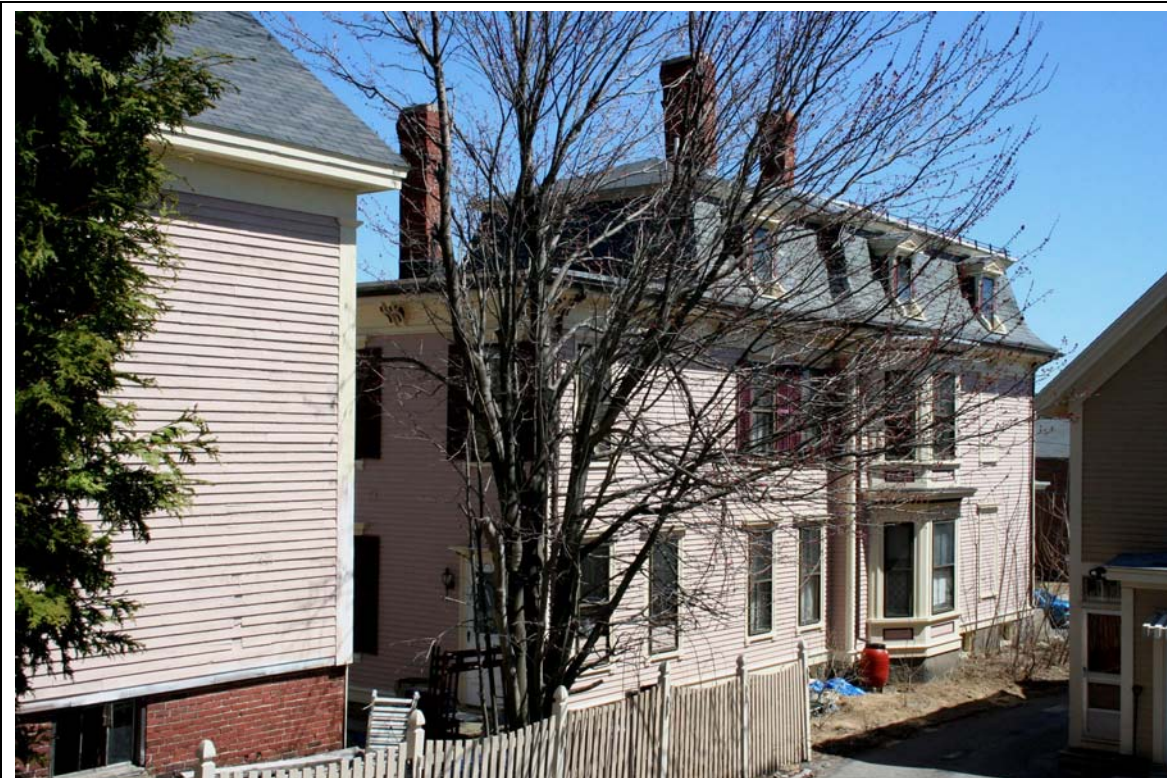
Photo No. 5	Side (S) elevation	Looking: NE	Photo File # 7-059
Note: Carriage barn on left

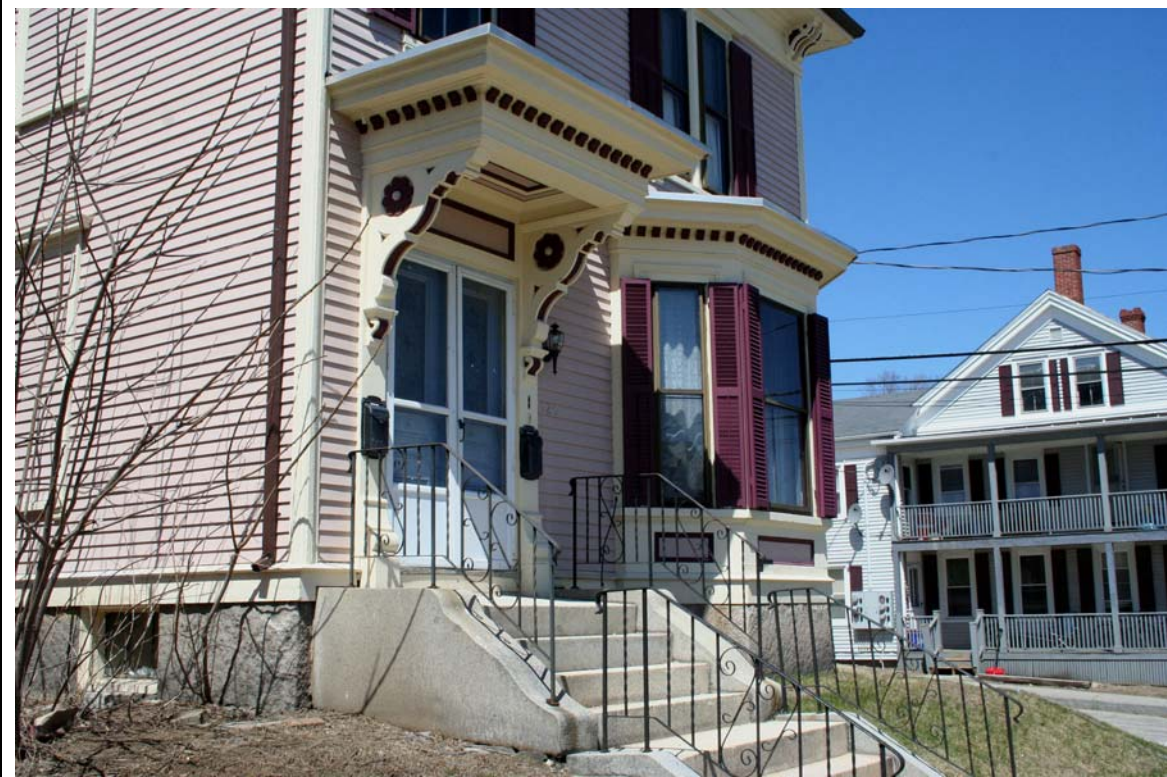
Photo No. 6	Front entrance detail	Looking: NW	Photo File # 7-062
--------------------	-----------------------	--------------------	---------------------------

Note: double doors under hood carried on scroll brackets; angle bay with 1/1, 2/2 windows

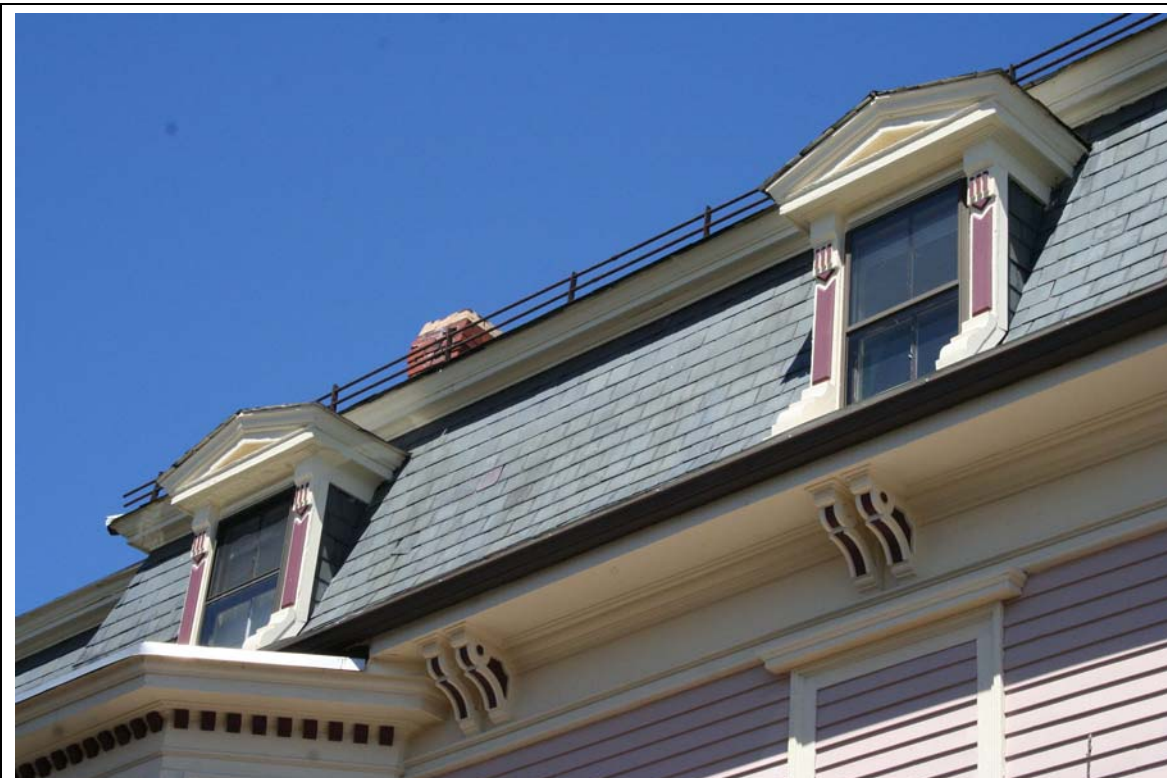
Photo No. 7	Detail, Mansard roof features	Looking: NW	Photo File # 7-063
--------------------	-------------------------------	--------------------	---------------------------

Note: slate roof shingles; eaves with brackets, dentils and crown moldings; dormers with pediments

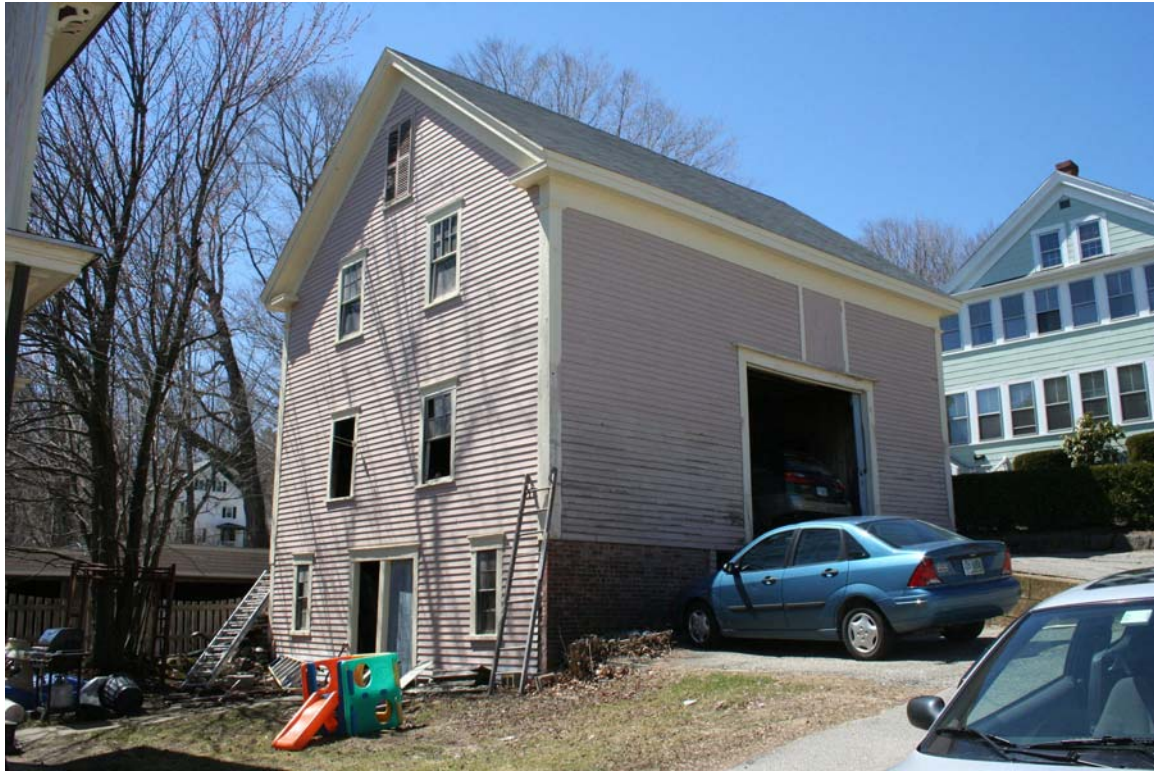
Photo No. 8	Carriage barn	Looking: SW	Photo File # 7-060
--------------------	---------------	--------------------	---------------------------

Note: brick foundation; some original 6/6 windows; basement entrance
