**TOWN OF EXETER,  
NEW HAMPSHIRE**

**PHASE III  
INFILTRATION AND INFLOW  
EVALUATION**

**January 14, 2013**

Prepared by:  
**Underwood Engineers, Inc.**  
**Portsmouth, New Hampshire**  
FILE NO. 1542

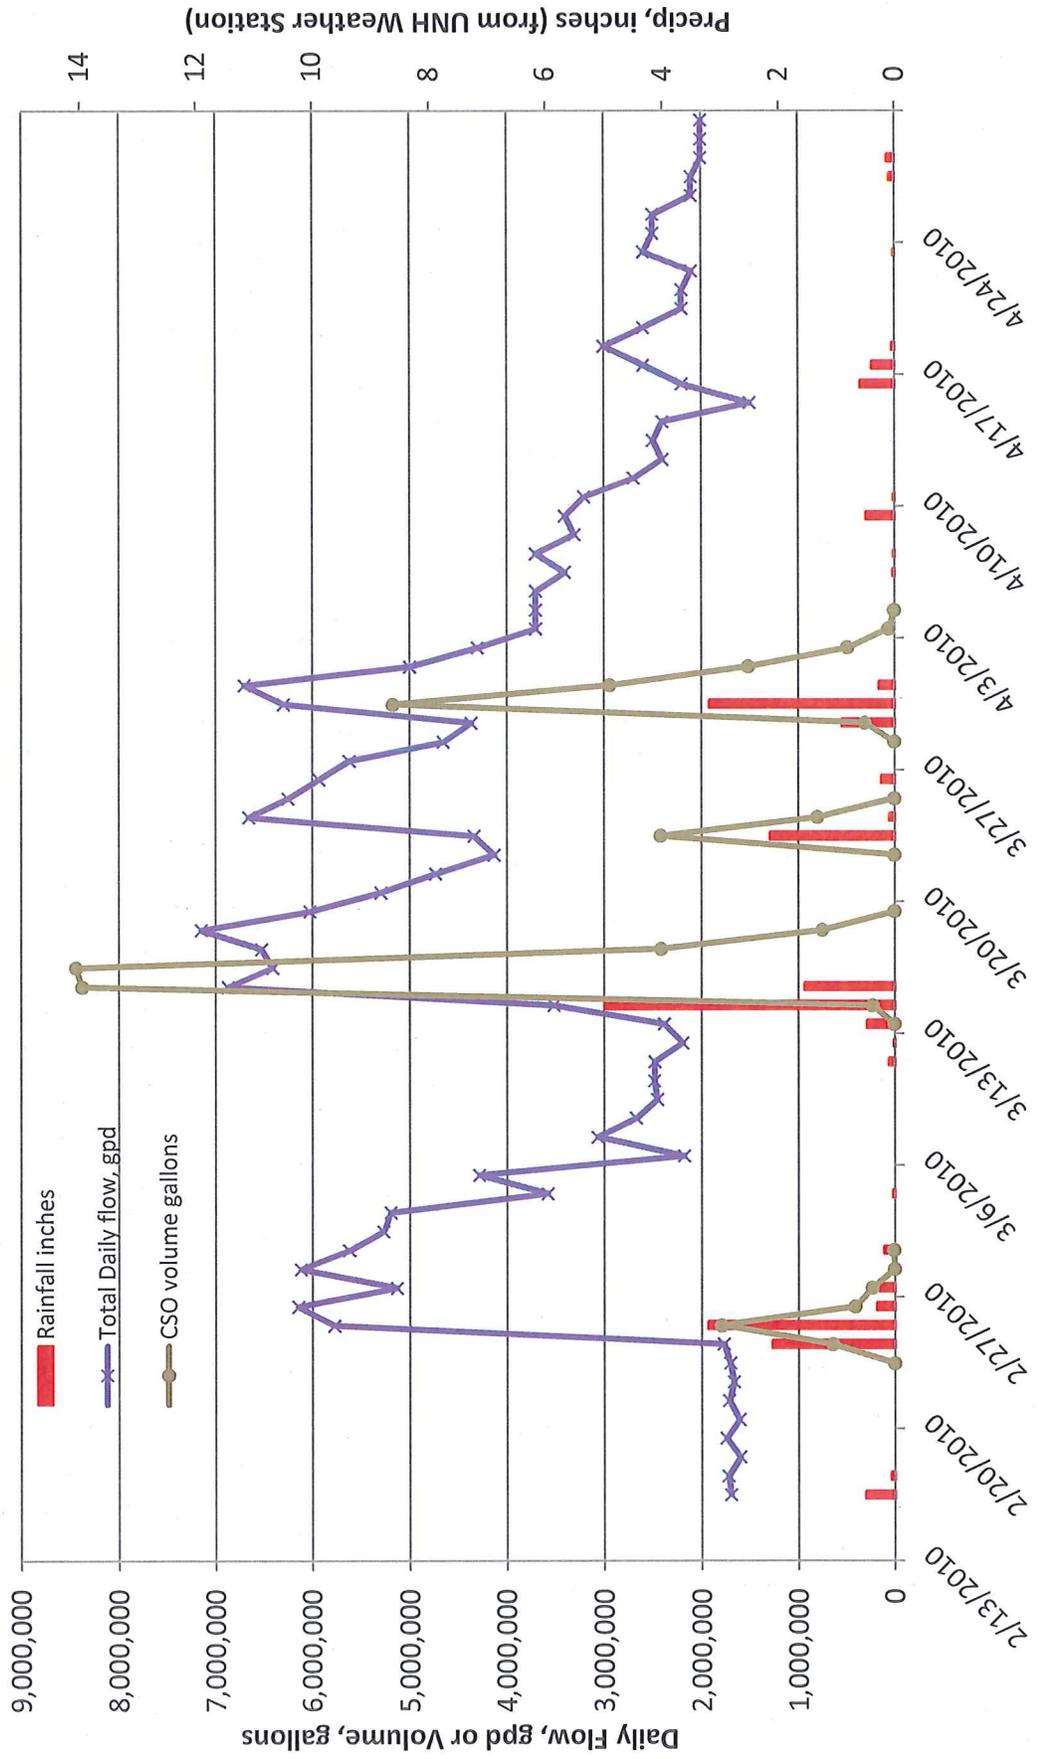
**Figure 3-1**  
**Main Pump Station Flow**  
**2010**  
**Exeter, NH**

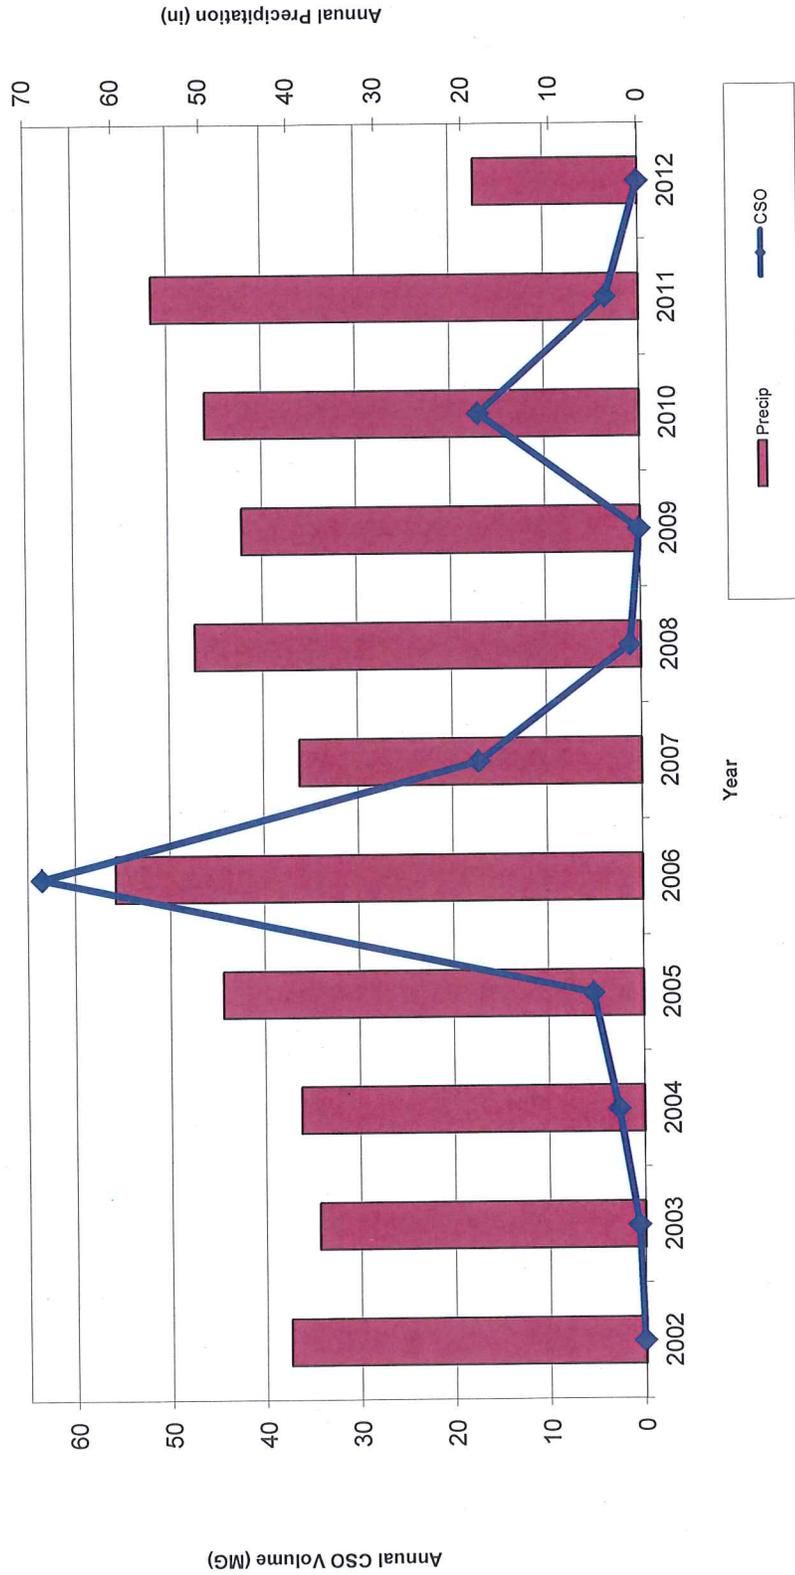
**Figure 3-2**  
**Total Annual CSO Volume 2002-2012**

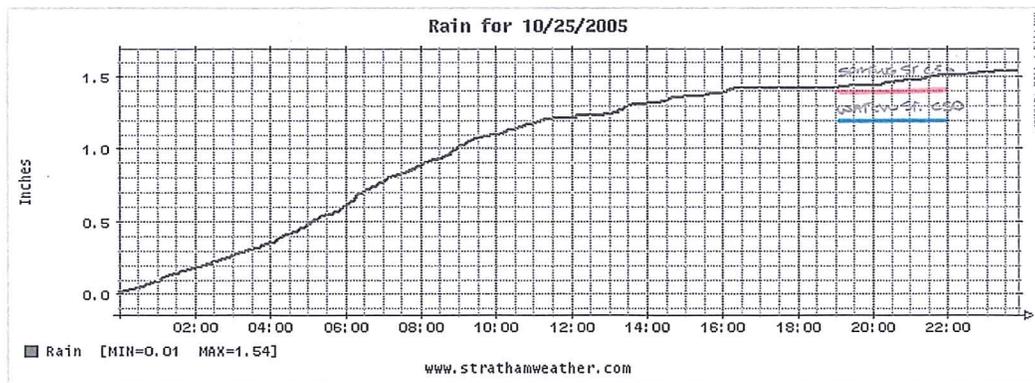
**Figure 3-3**  
**Example - October 25, 2005 Rainfall Hydrograph with CSO**

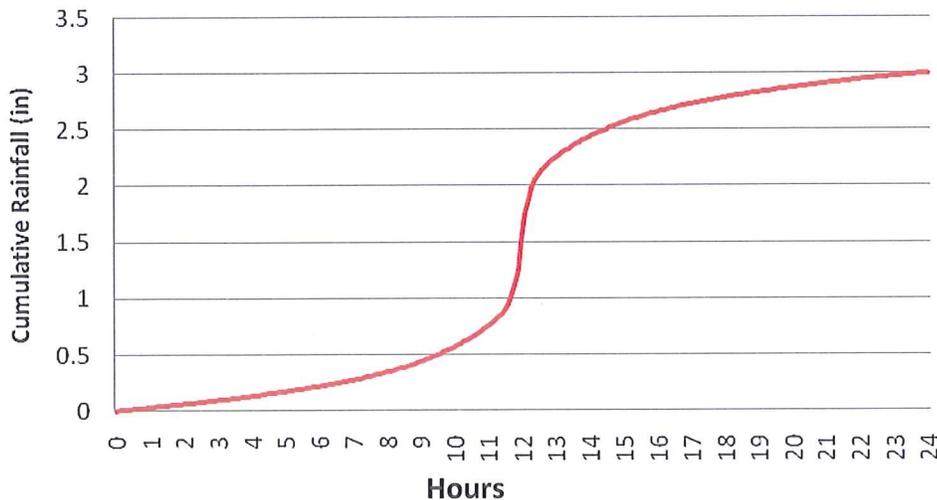
**Figure 3-4**  
**Typical SCS, Type-III, 24-Hour Unit Hydrograph (2-year recurrence interval)**

The total storm rainfall as measured by the weather station during CSO events were compared to the Soil Conservation Service (SCS) Type III, 24-hour rainfall unit hydrograph as described in TR-55. It should be noted that actual rainfall hydrographs rarely occur over 24-hours or reflect the SCS Unit Hydrograph rainfall distribution shown (Figure 3-4). However, based on the guidance information provided in TR-55 the following recurrence intervals for 24-hour rainfall totals for the Town were used in the analysis:

- *2-Year Recurrence Interval = 3"*
- *5-Year Recurrence Interval = 3.8" (CDM Modeling = 3.71", 20-hour)*
- *10-Year Recurrence Interval = 4.5"*
- *25-Year Recurrence Interval = 5.2"*
- *50-Year Recurrence Interval = 5.7"*
- *100-Year Recurrence Interval = 6.5"*

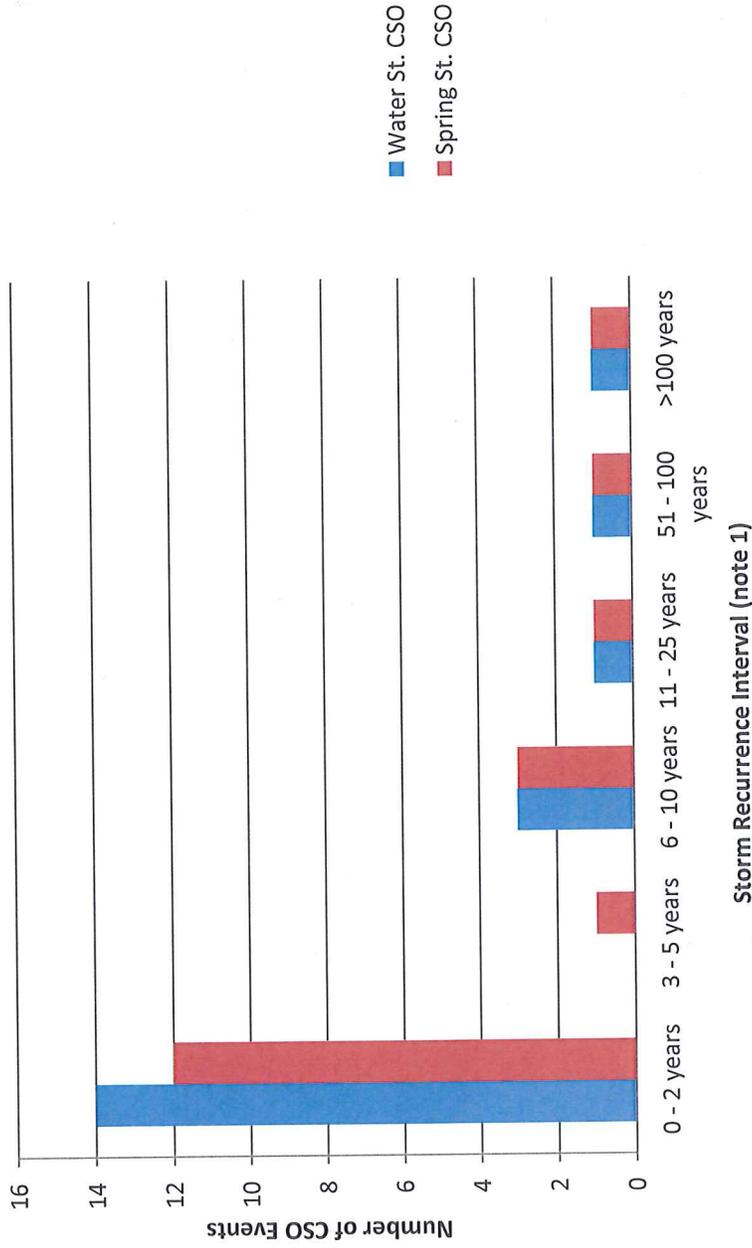
**Figure 3-5**  
**Number of CSO events and Storm Recurrence Interval of Storm Contributing to CSO**  
**2004-2009**

1. Storm total rainfall was compared to 24-hour SCS recurrence interval rainfall totals. Since storms were rarely 24 hours in duration or followed the SCS rainfall intensity curves, it is only a rough approximation of recurrence frequency.

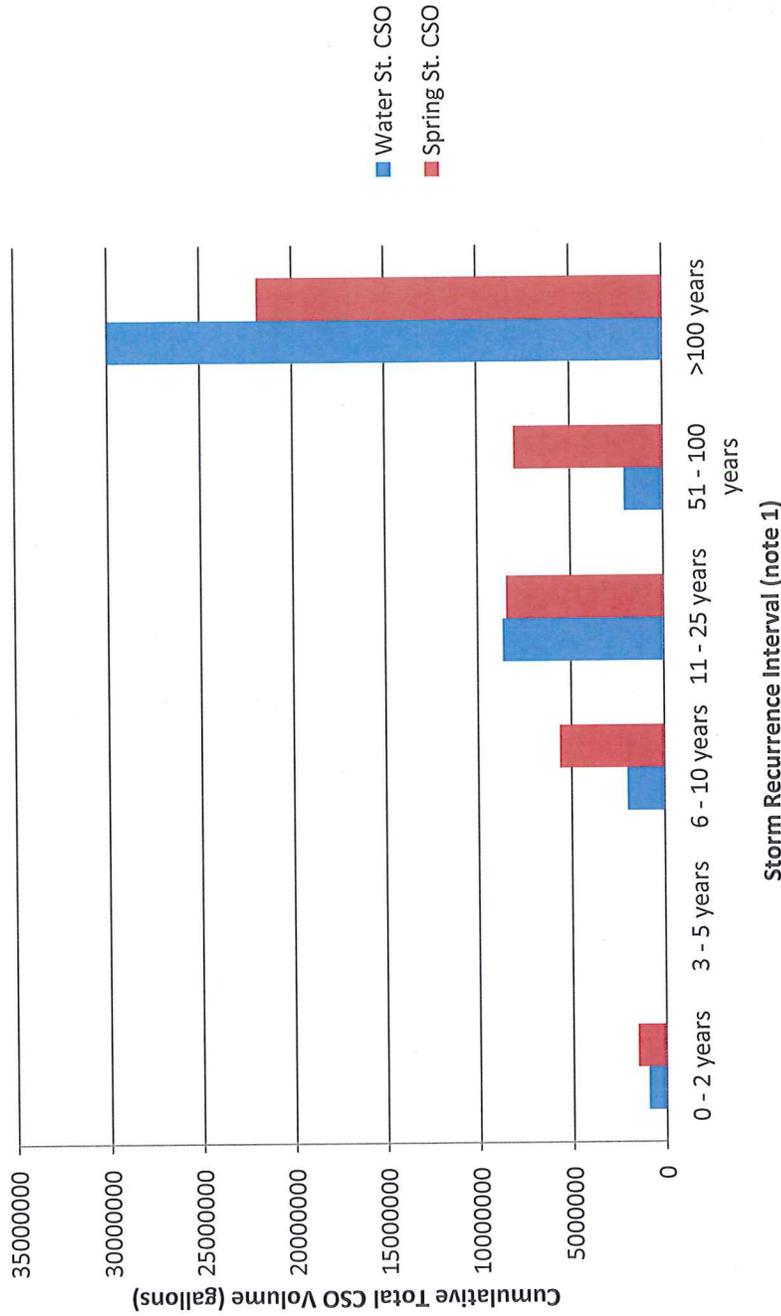
**Figure 3-6**  
**Total CSO Volume and Storm Recurrence Interval Contributing to CSO Event**  
**2004-2009**

1. Storm total rainfall was compared to 24-hour SCS recurrence interval rainfall totals. Since storms were rarely 24 hours in duration or followed the SCS rainfall intensity curves, it is only a rough approximation of recurrence frequency.

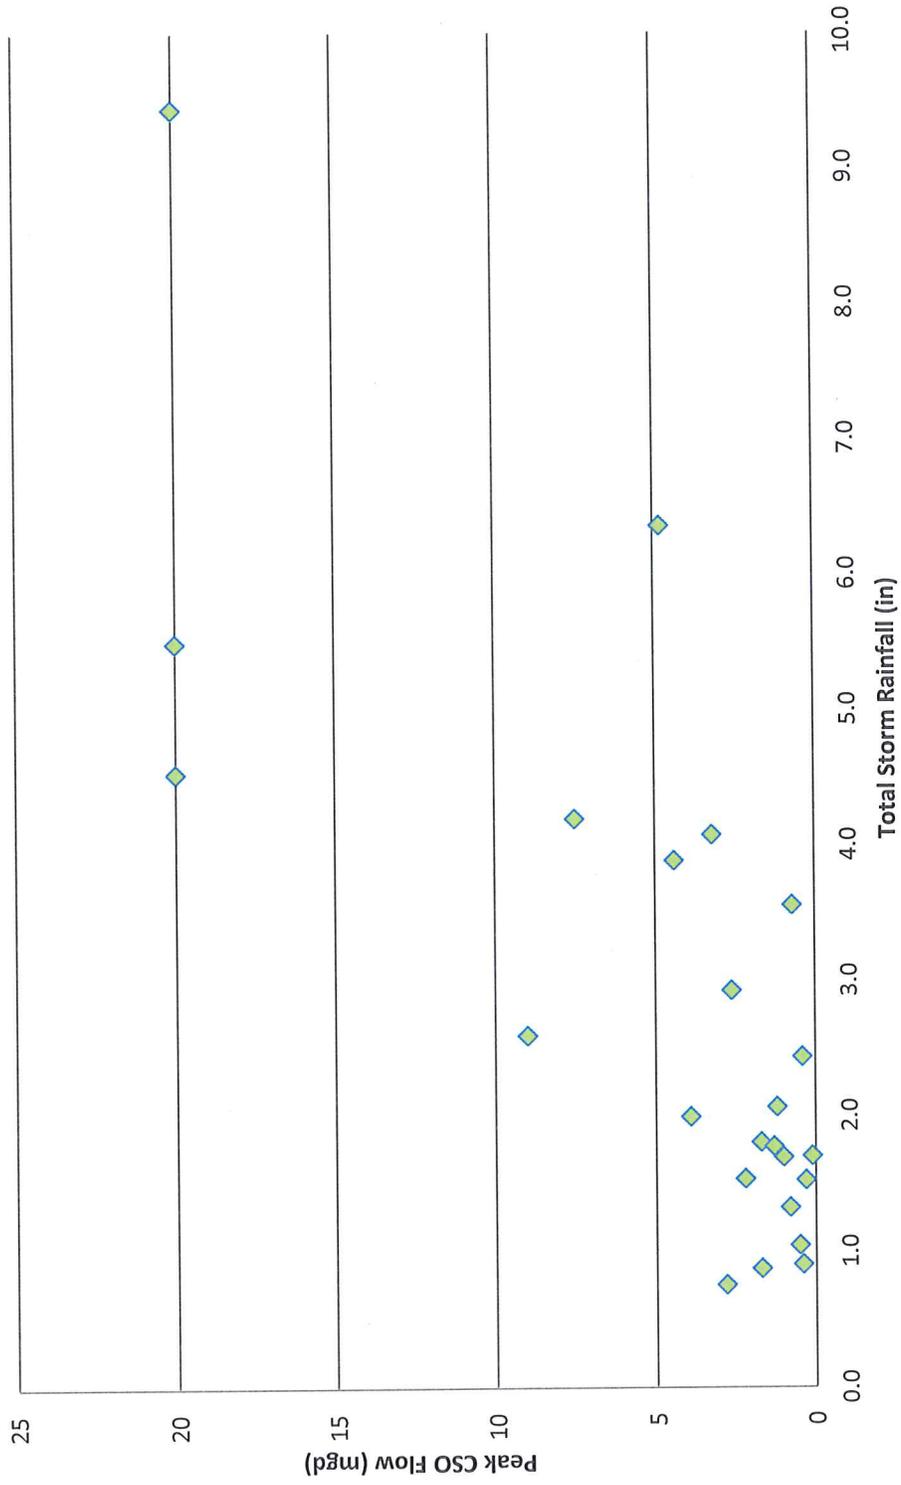
Figure 3-7  
Combined Peak CSO Flow (Water & Spring St.) and Total Storm Rainfall  
2004-2009

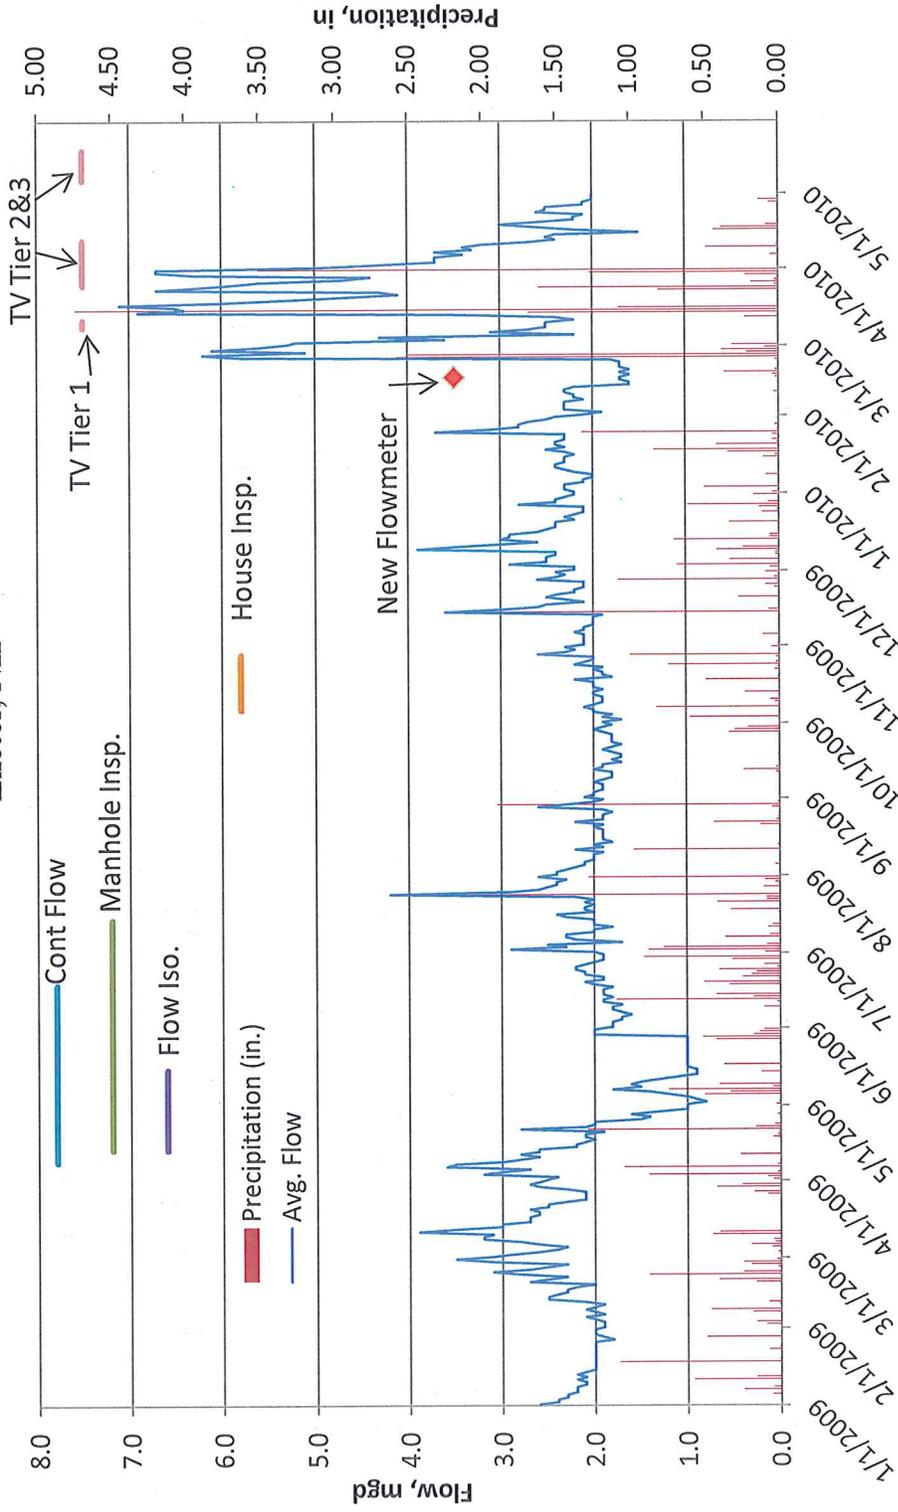
**Figure 5-1**  
**2009-2010 Average WWTF Influent flow, Daily Precipitation & Field Investigations**  
**Exeter, NH**

It should be noted that Town personnel indicated that WWTF influent flow data may not be accurate or reliable due to the configuration of the WWTF influent meter. Influent flow at the WWTF is measured using an area-velocity meter in the bottom of the pipe, but the water surface at this location is subject to wave action, as the pipe does not always experience free-flow characteristics. However, due to the long residence time of the WWTF (estimated by the Town to be 30-40 days), and the configuration of the WWTF effluent discharge (a manually operated valve that permits operators to control the discharge), the WWTF influent flow is the best indicator of relative system-wide flows available to show general relative seasonal fluctuations in I/I. There is currently no flow meter at the main pump station.

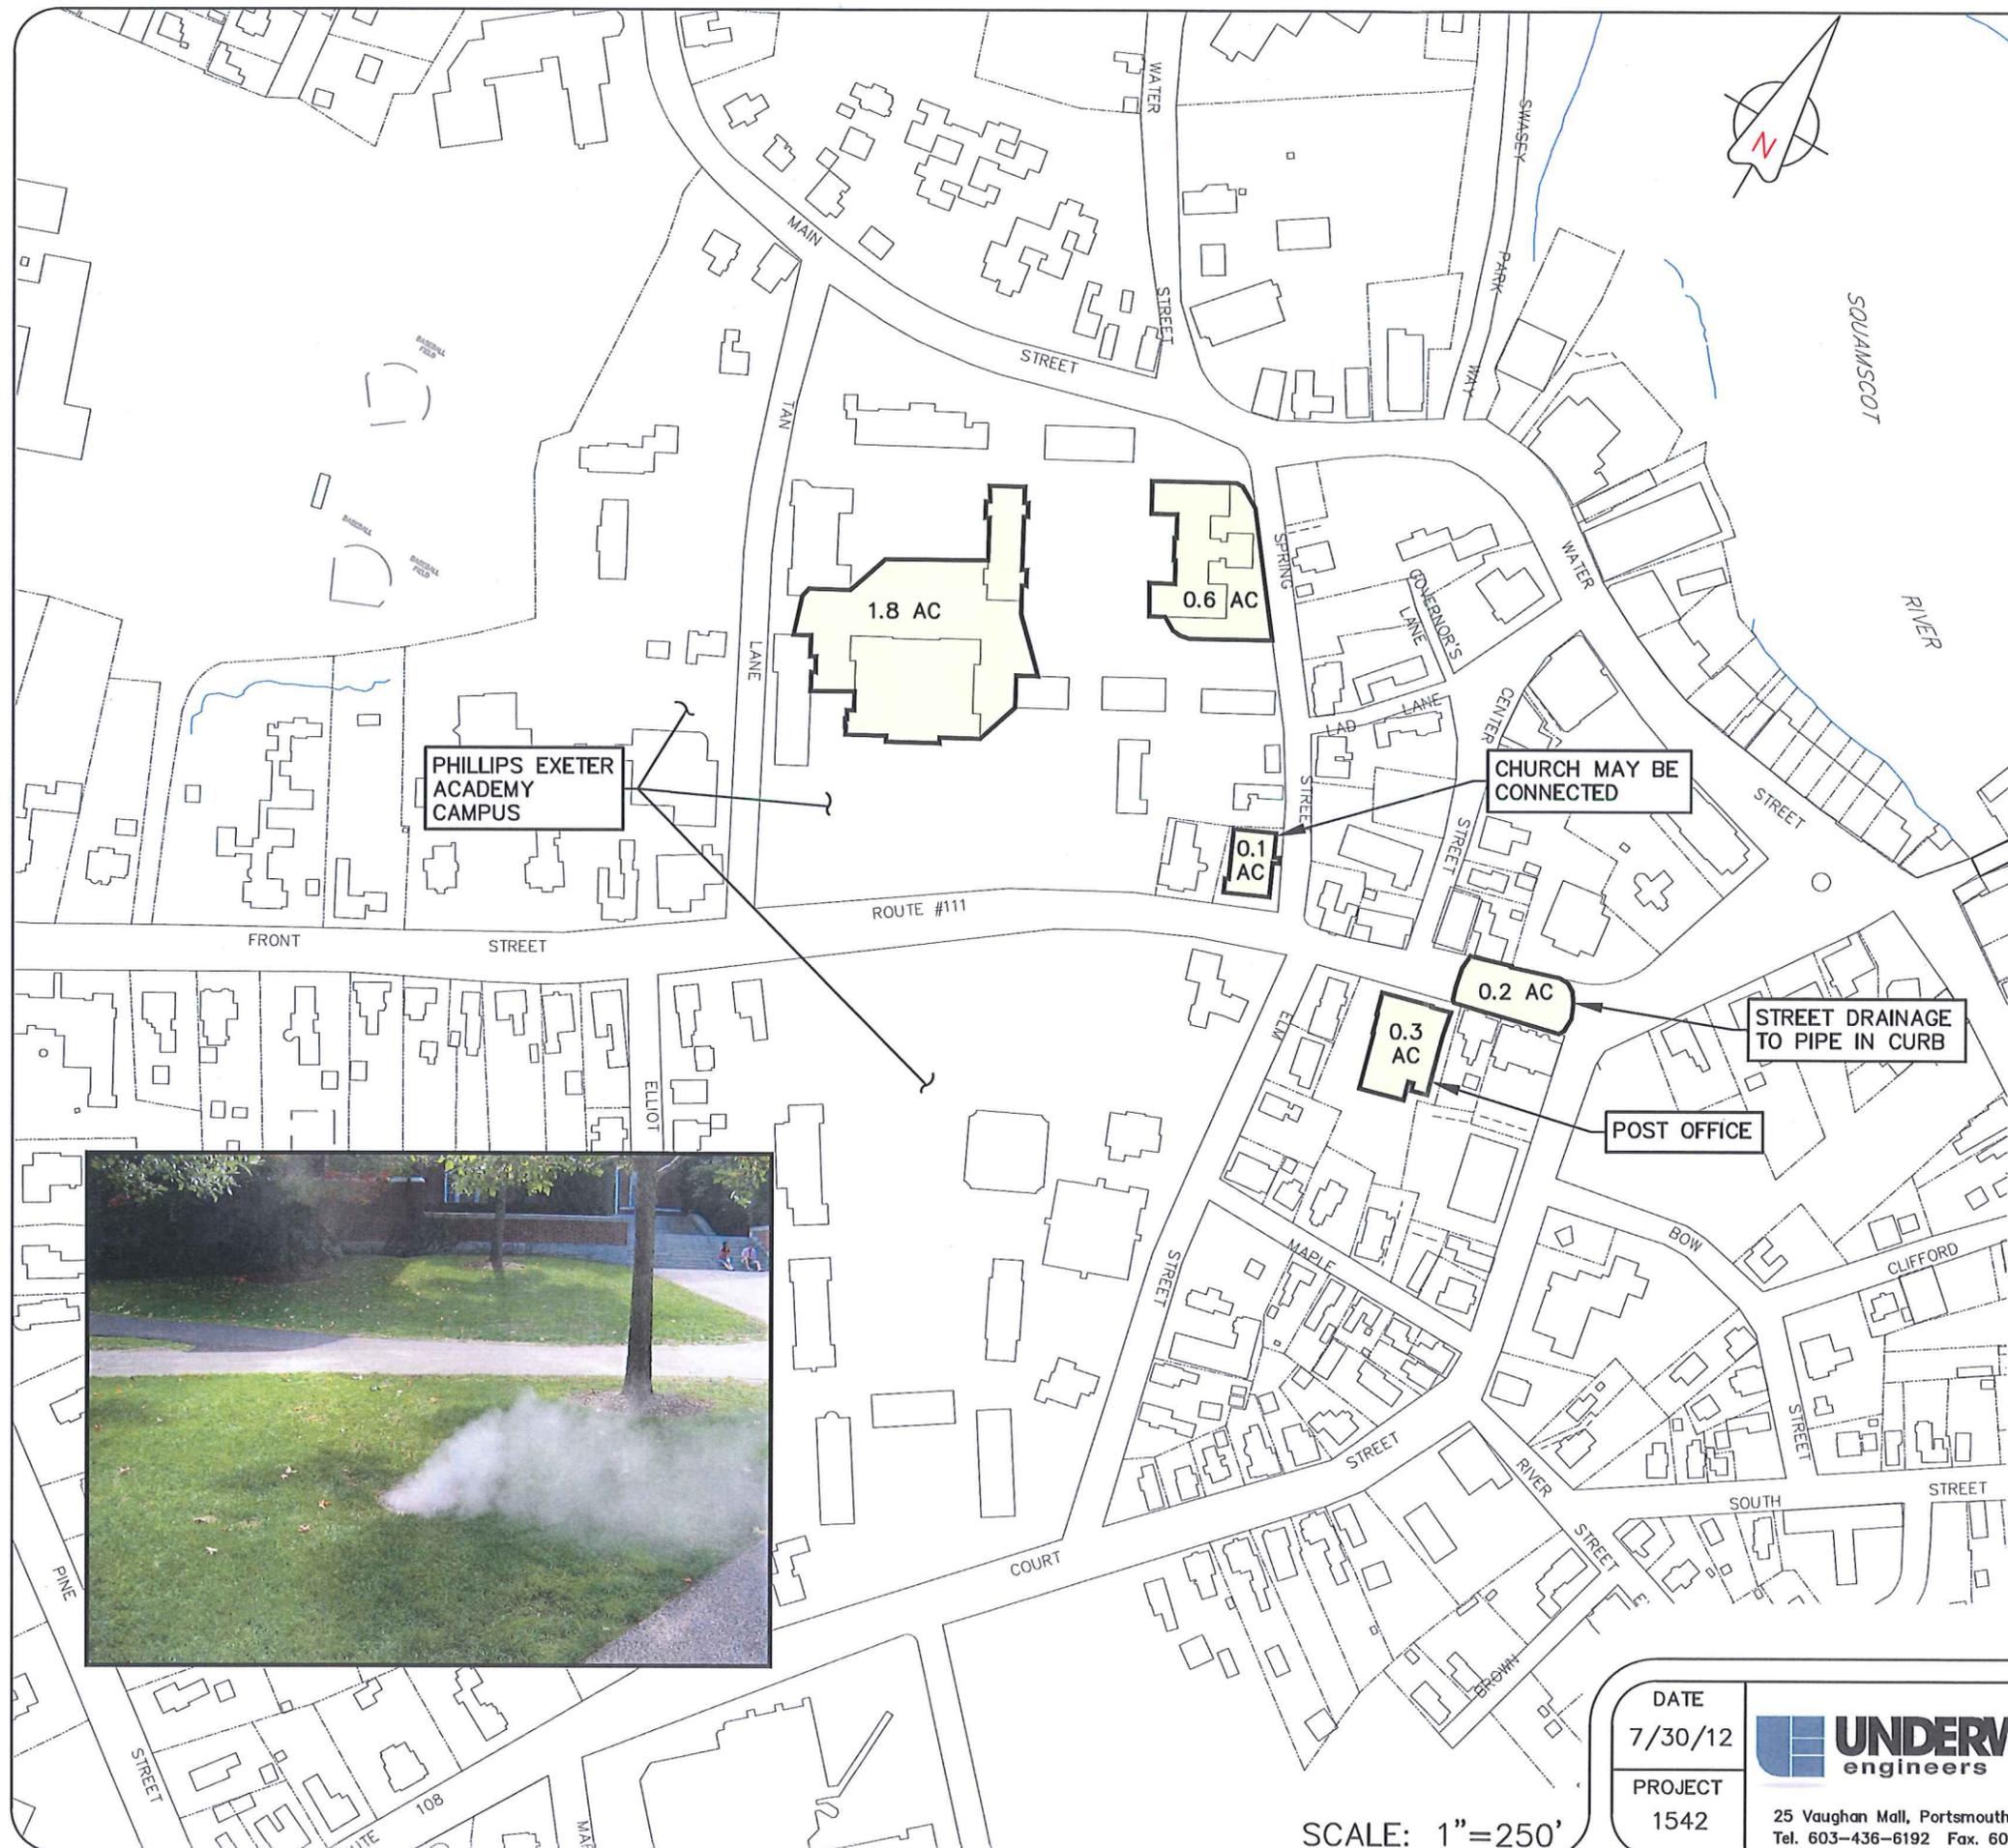
H:\SDS\PROJ\1542\1542LDD\dwg\1542\_FIG\_INVESTIGATION.dwg, smoke fig 5-8, 11/12/2012 2:55:23 PM, r1a

APPROXIMATE DRAINAGE AREA CONNECTED TO SEWER

- *Town Performed Smoke Testing* was performed by the Town and the findings were relayed to UE for inclusion in this report. Drainage from portions of Phillips Exeter Academy (PEA) campus, the US Post Office and limited street drainage on Front St. were found to be connected to the sanitary sewer.

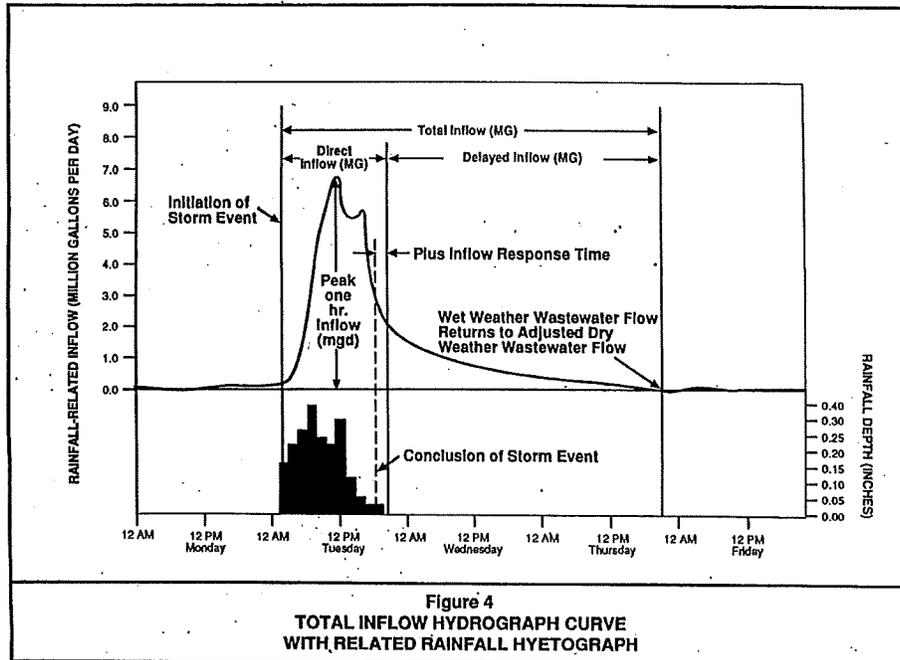
Total Inflow Schematic

In order to quantify inflow, the metered flow rate (shown as “Wet Weather Wastewater Flow” on the figure) during a storm period, rainfall, and pre-storm flow rate (shown as “Adjusted Dry Weather Wastewater Flow” on the figure) were reviewed from continuous flow monitoring graphs. The area between the pre-storm and actual flow rates is calculated to be the total inflow. A period of time immediately preceding the storm event is used to represent the pre-storm flow rate. This period was repeated continuously for the period of delayed inflow. Rainfall is plotted to determine the inflow response time, or the time for an increase in flow rate to be observed following the beginning of the storm event. Direct and indirect inflow were quantified, where direct inflow was calculated as the volume of wastewater between the actual flow rate and pre-storm flow rate curves from the beginning of the storm event to the end of the storm event plus inflow response time and delayed inflow was calculated as the volume of wastewater between the flow rate and pre-storm flow rate curves from the end of direct inflow to the point at which the pre-storm and actual flow rate were approximately equivalent.

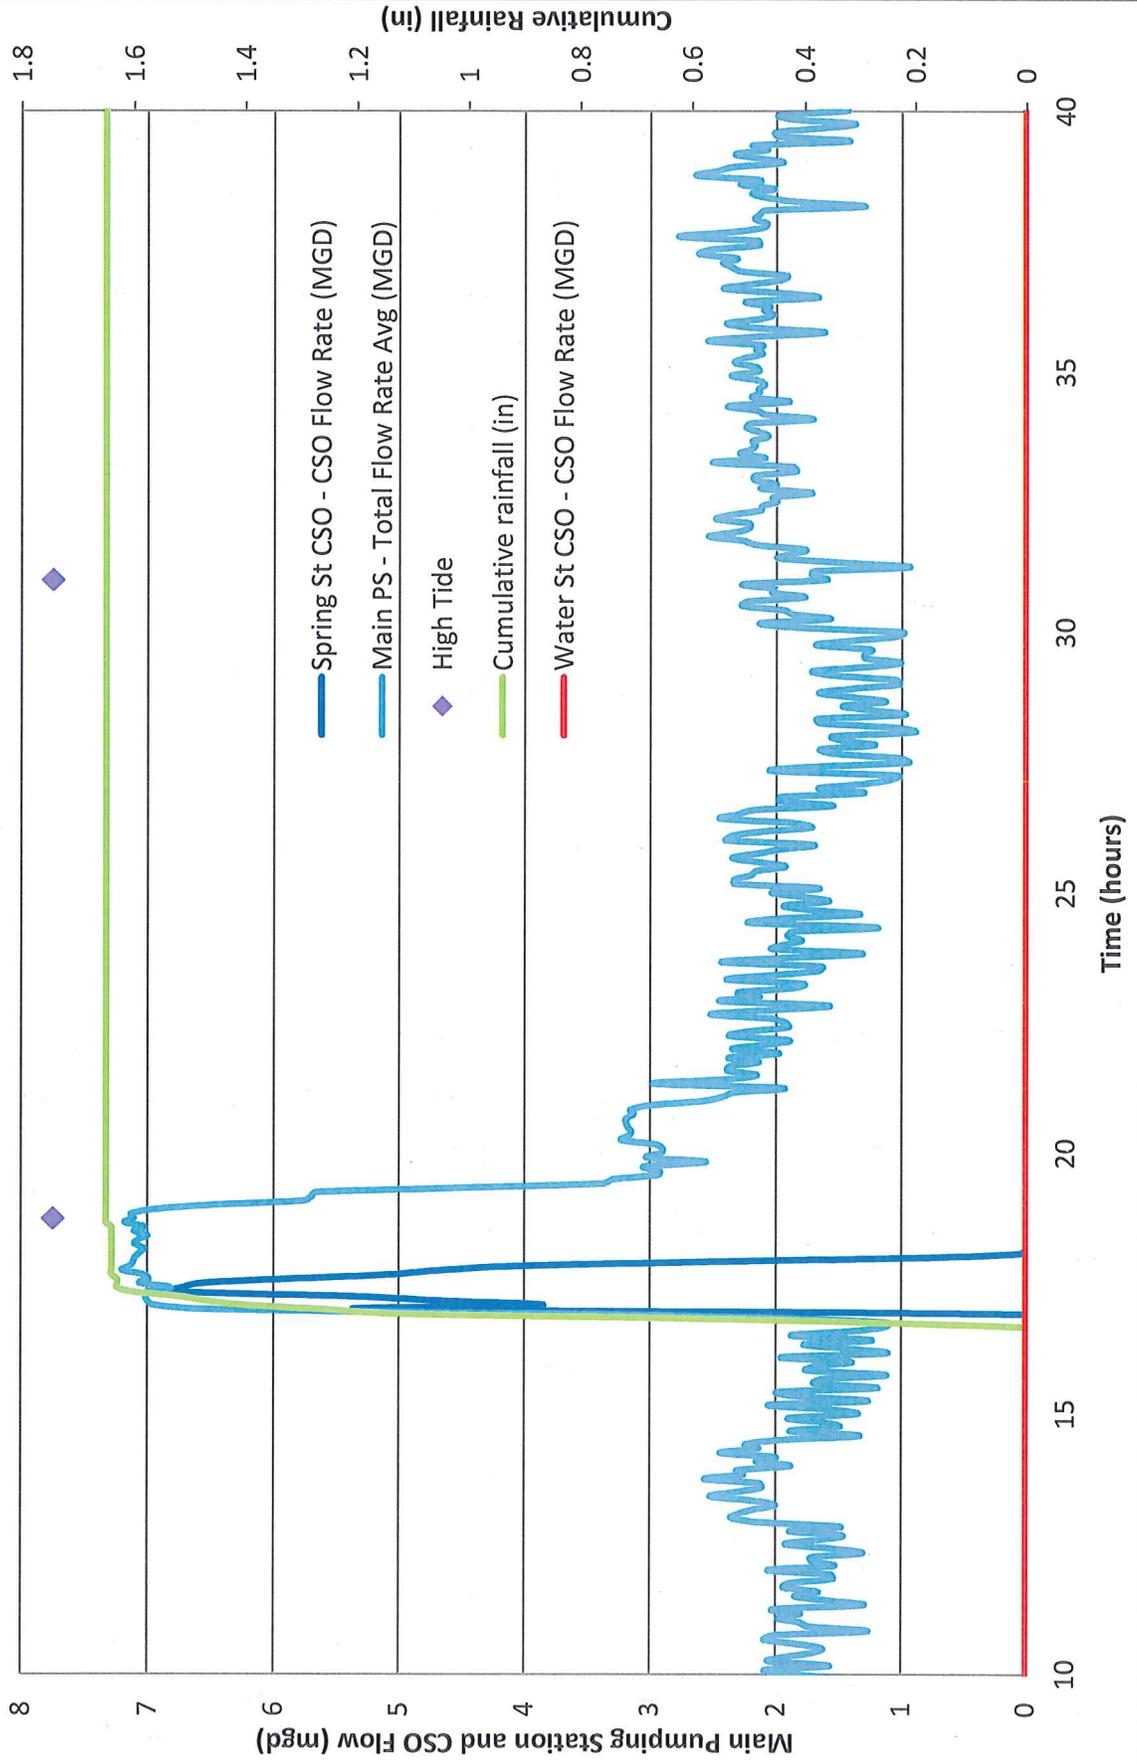
**Figure 6-2**  
**August 19, 2011 Storm Event**

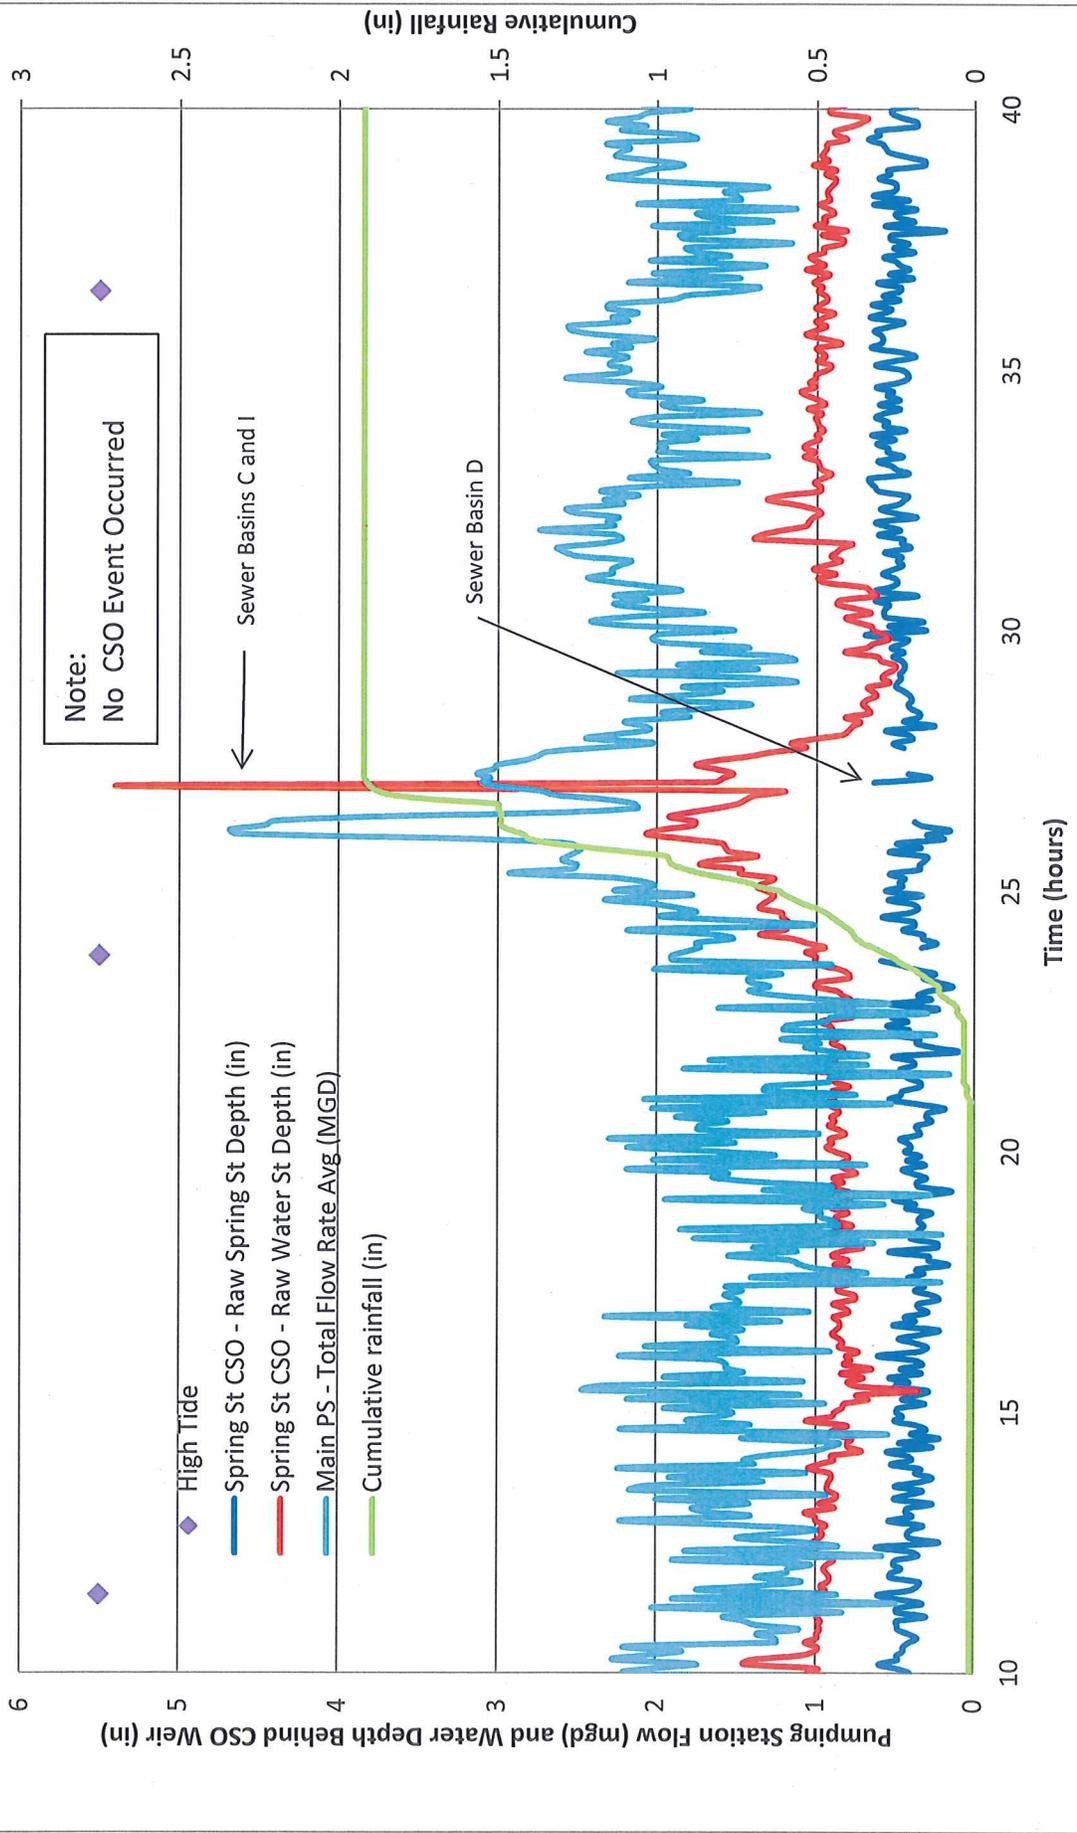
**Figure 6-3  
August 10, 2011 Storm Event**

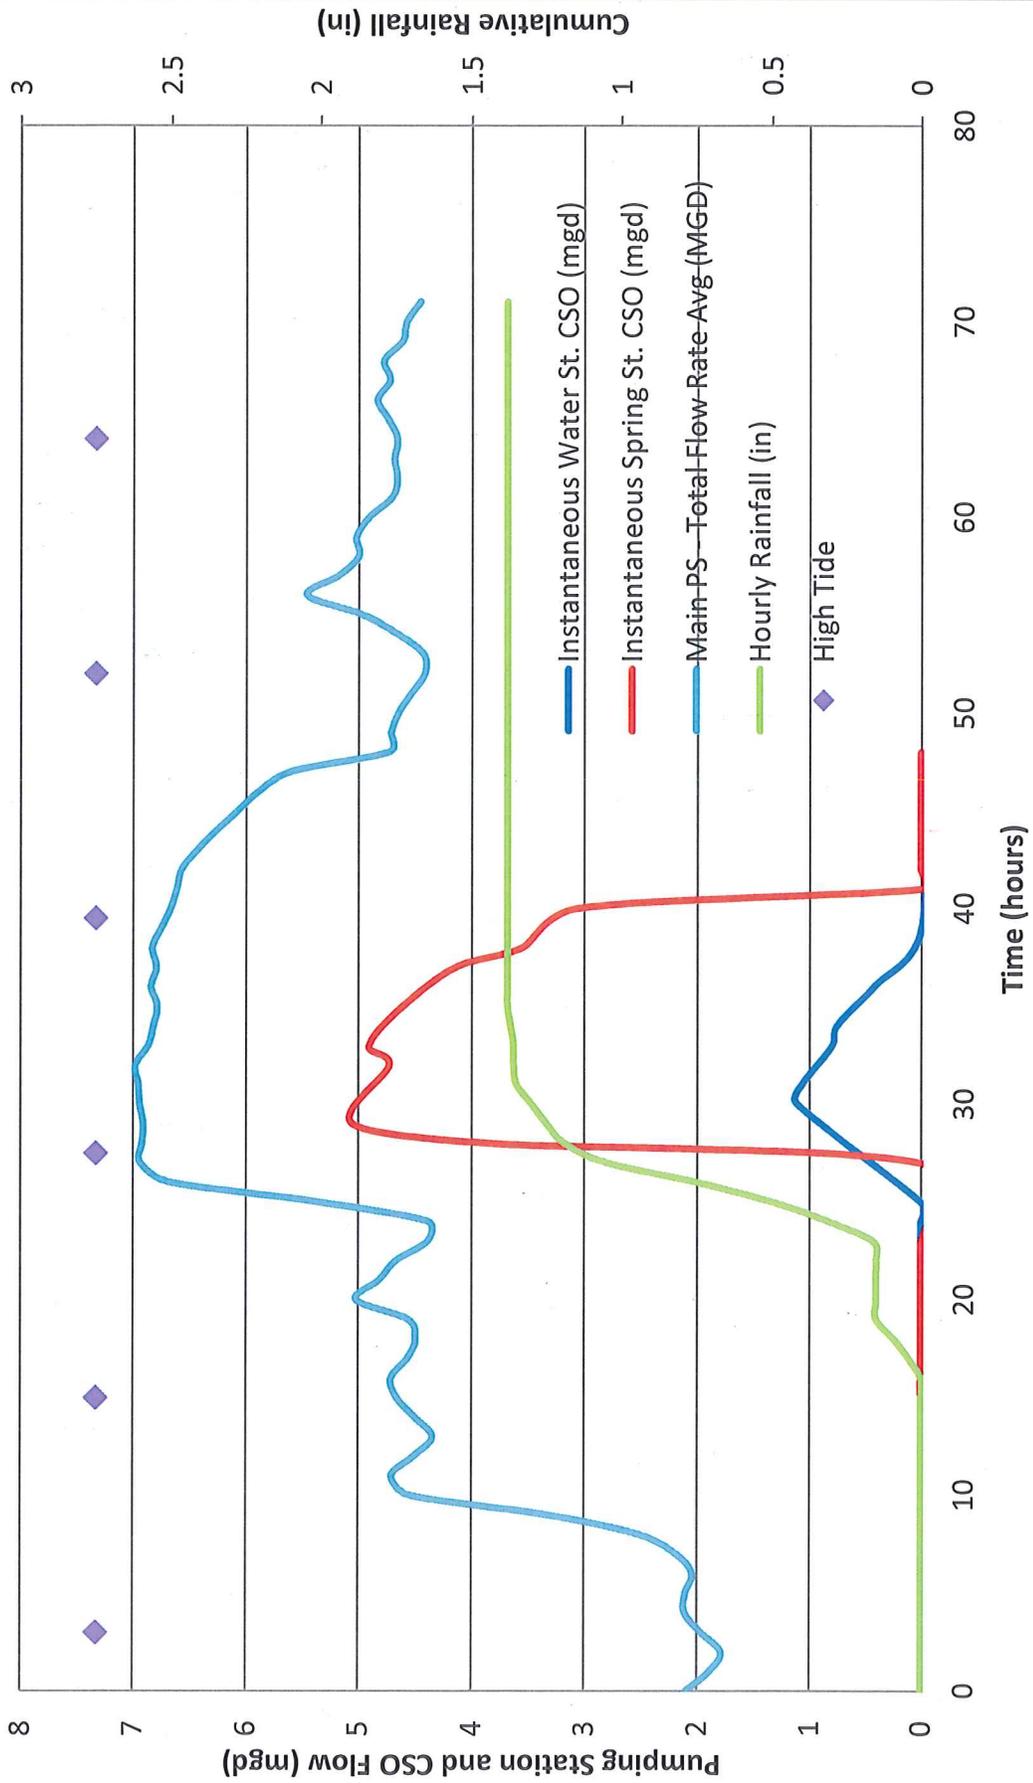
**Figure 6-4**  
**March 7, 2011 Storm Event**

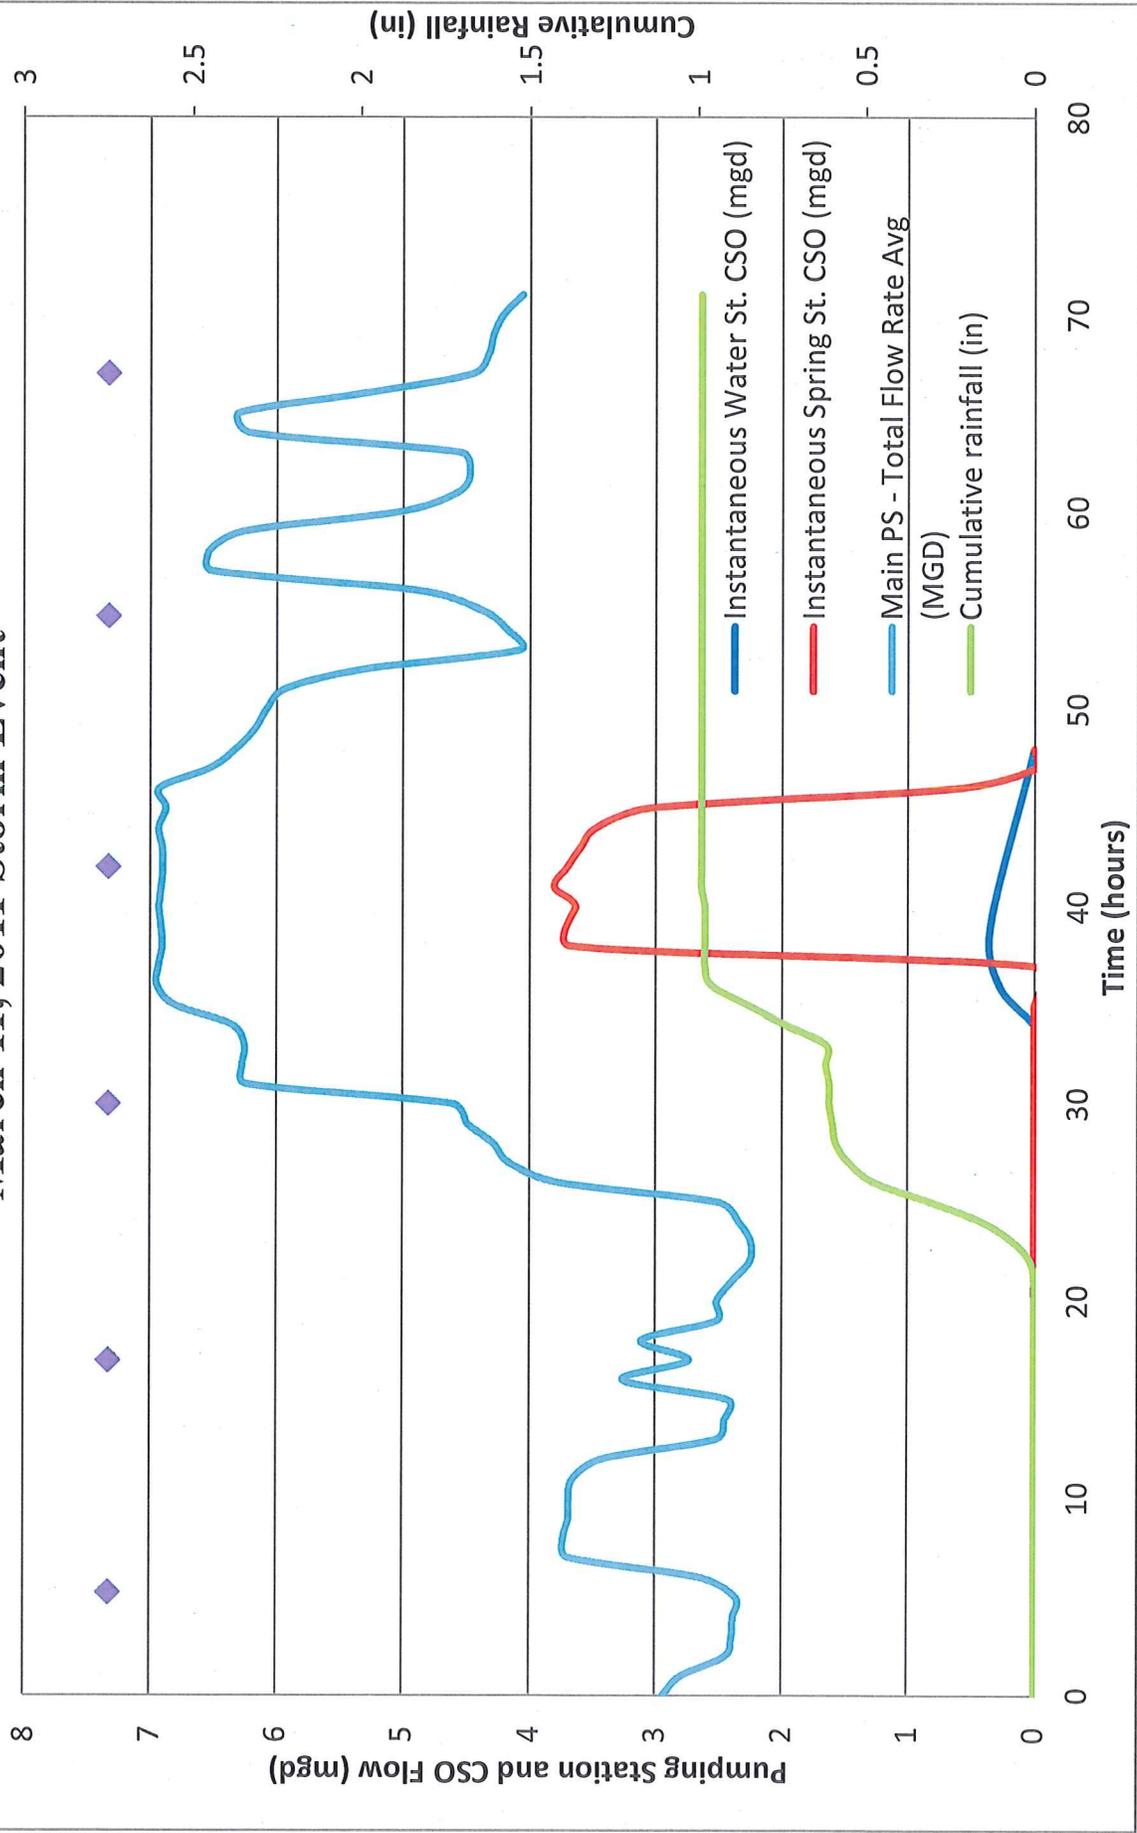
**Figure 6-5**  
**March 11, 2011 Storm Event**
