**TOWN OF EXETER,  
NEW HAMPSHIRE**

**PHASE III  
INFILTRATION AND INFLOW  
EVALUATION**

**January 14, 2013**

Prepared by:  
**Underwood Engineers, Inc.**  
**Portsmouth, New Hampshire**  
FILE NO. 1542

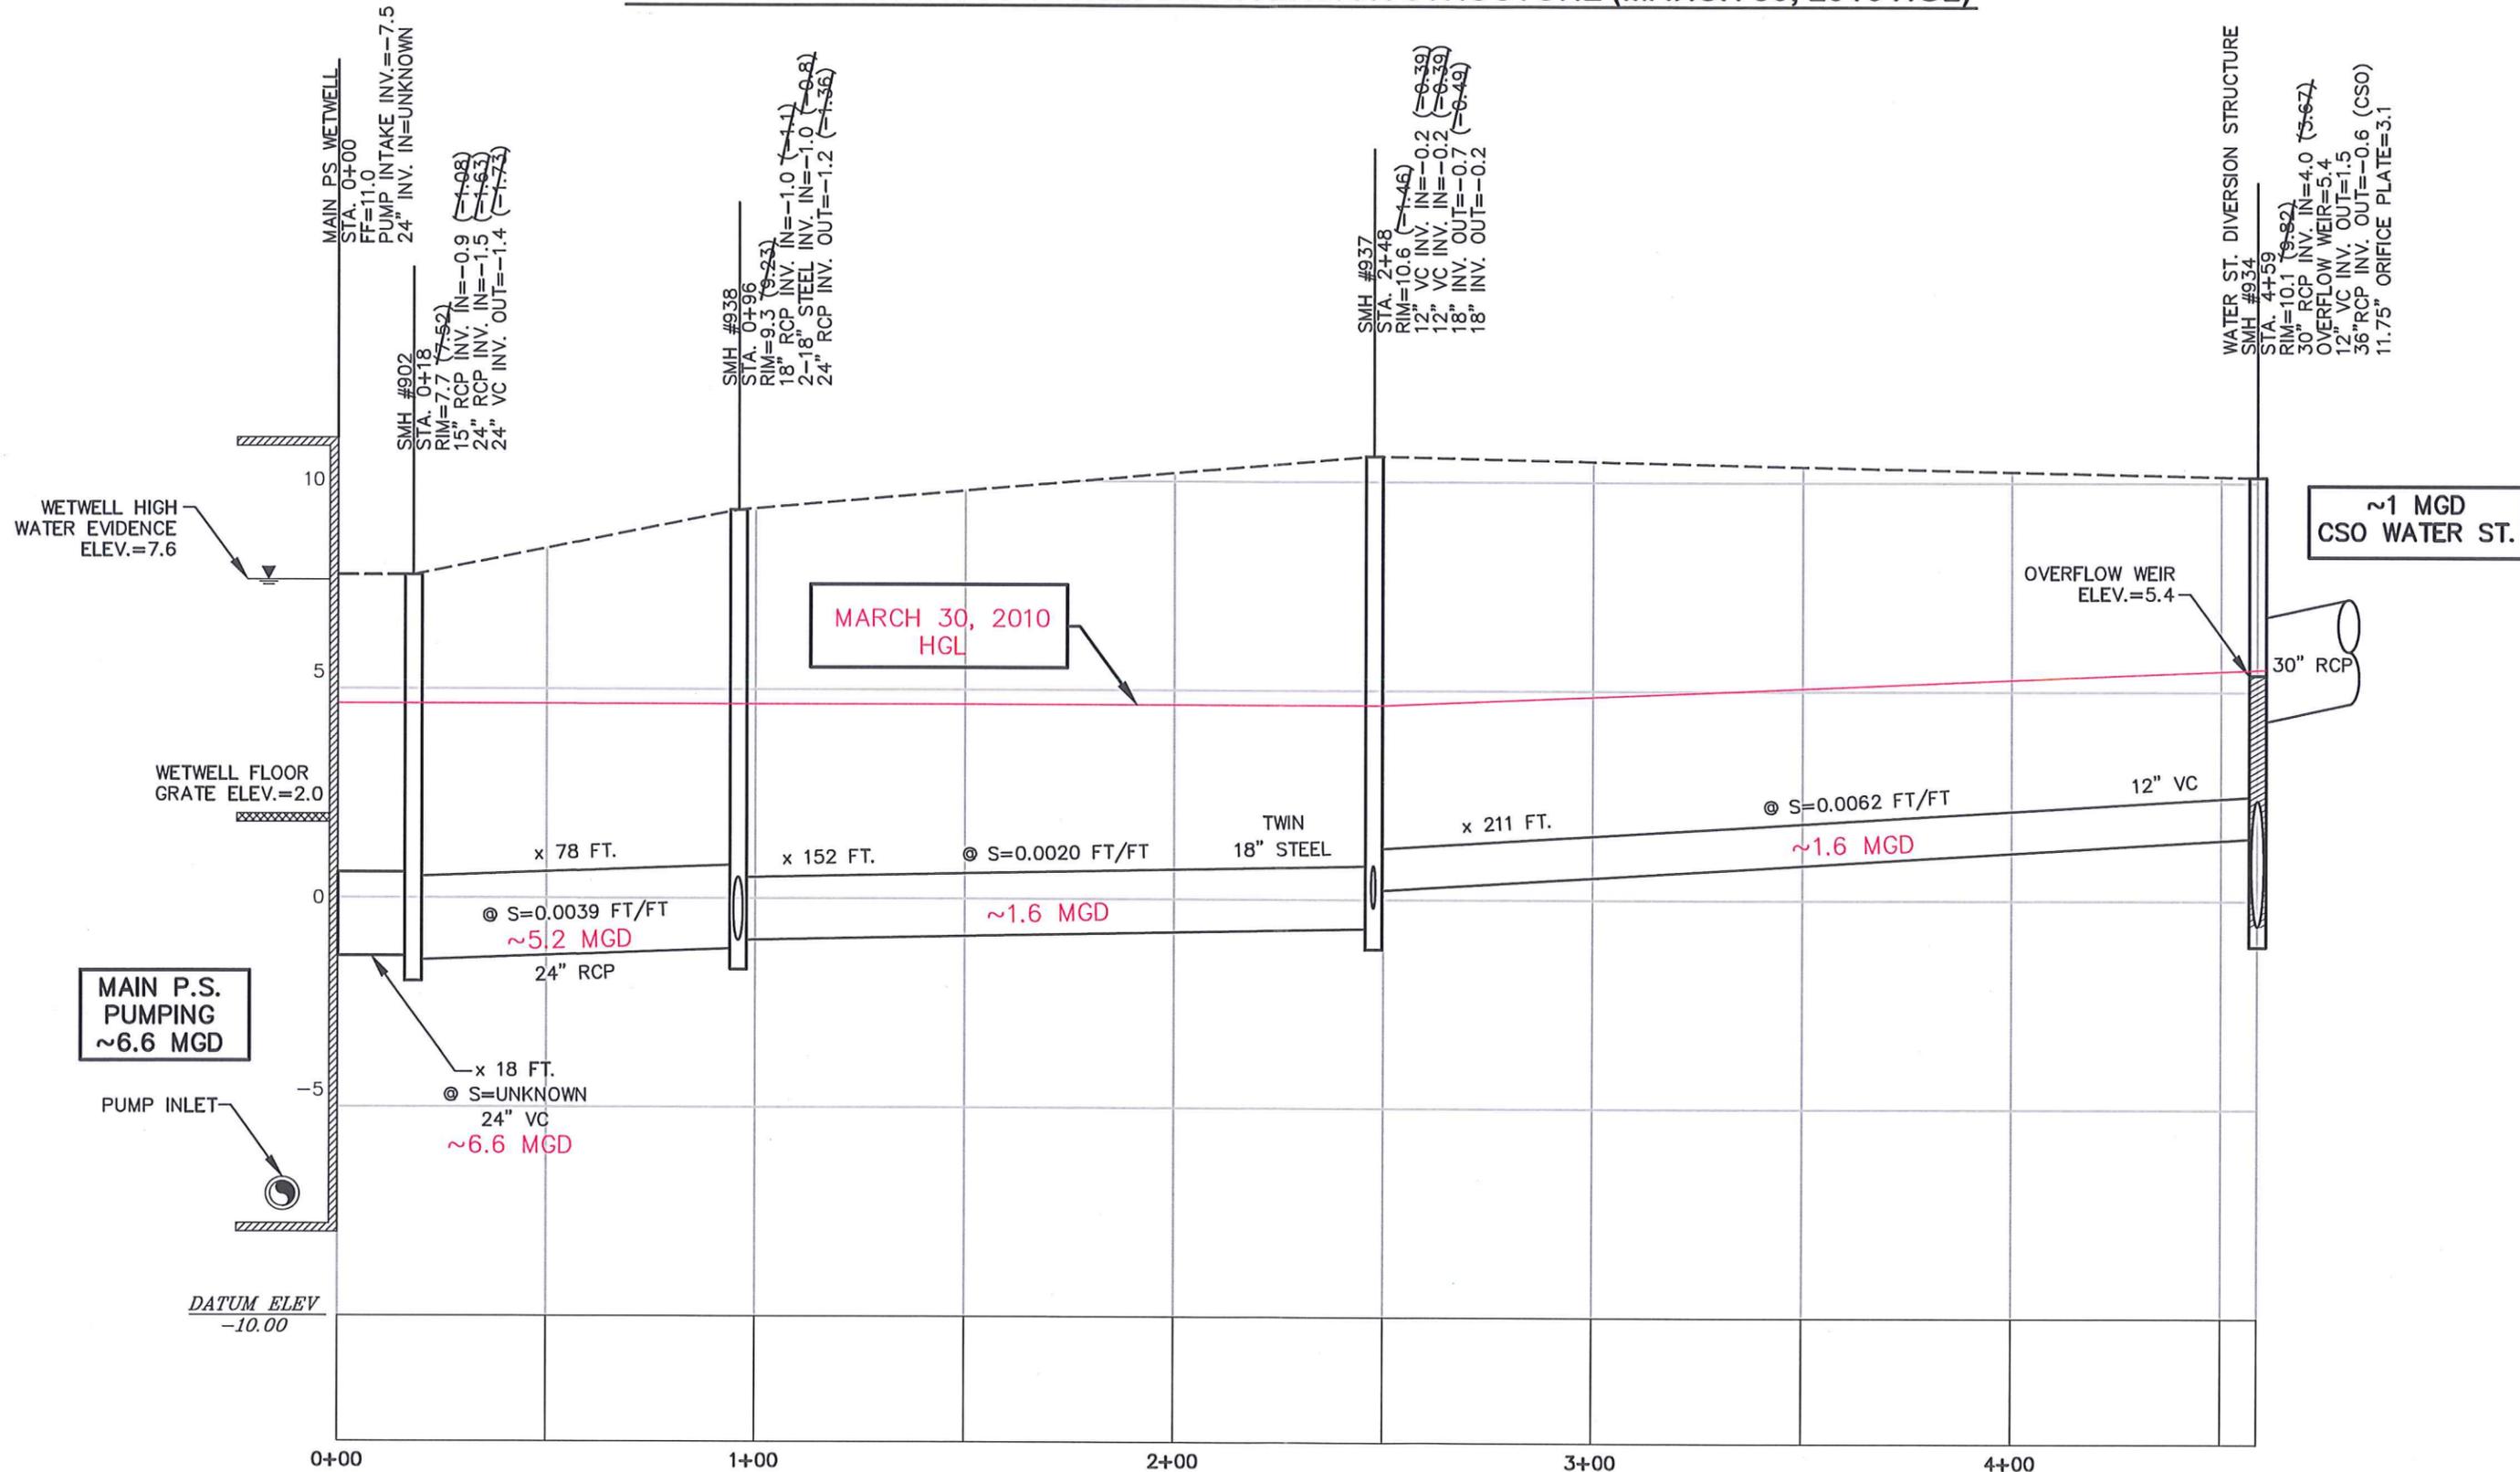
MAIN PUMP STATION TO WATER ST. DIVERSION STRUCTURE (MARCH 30, 2010 HGL)

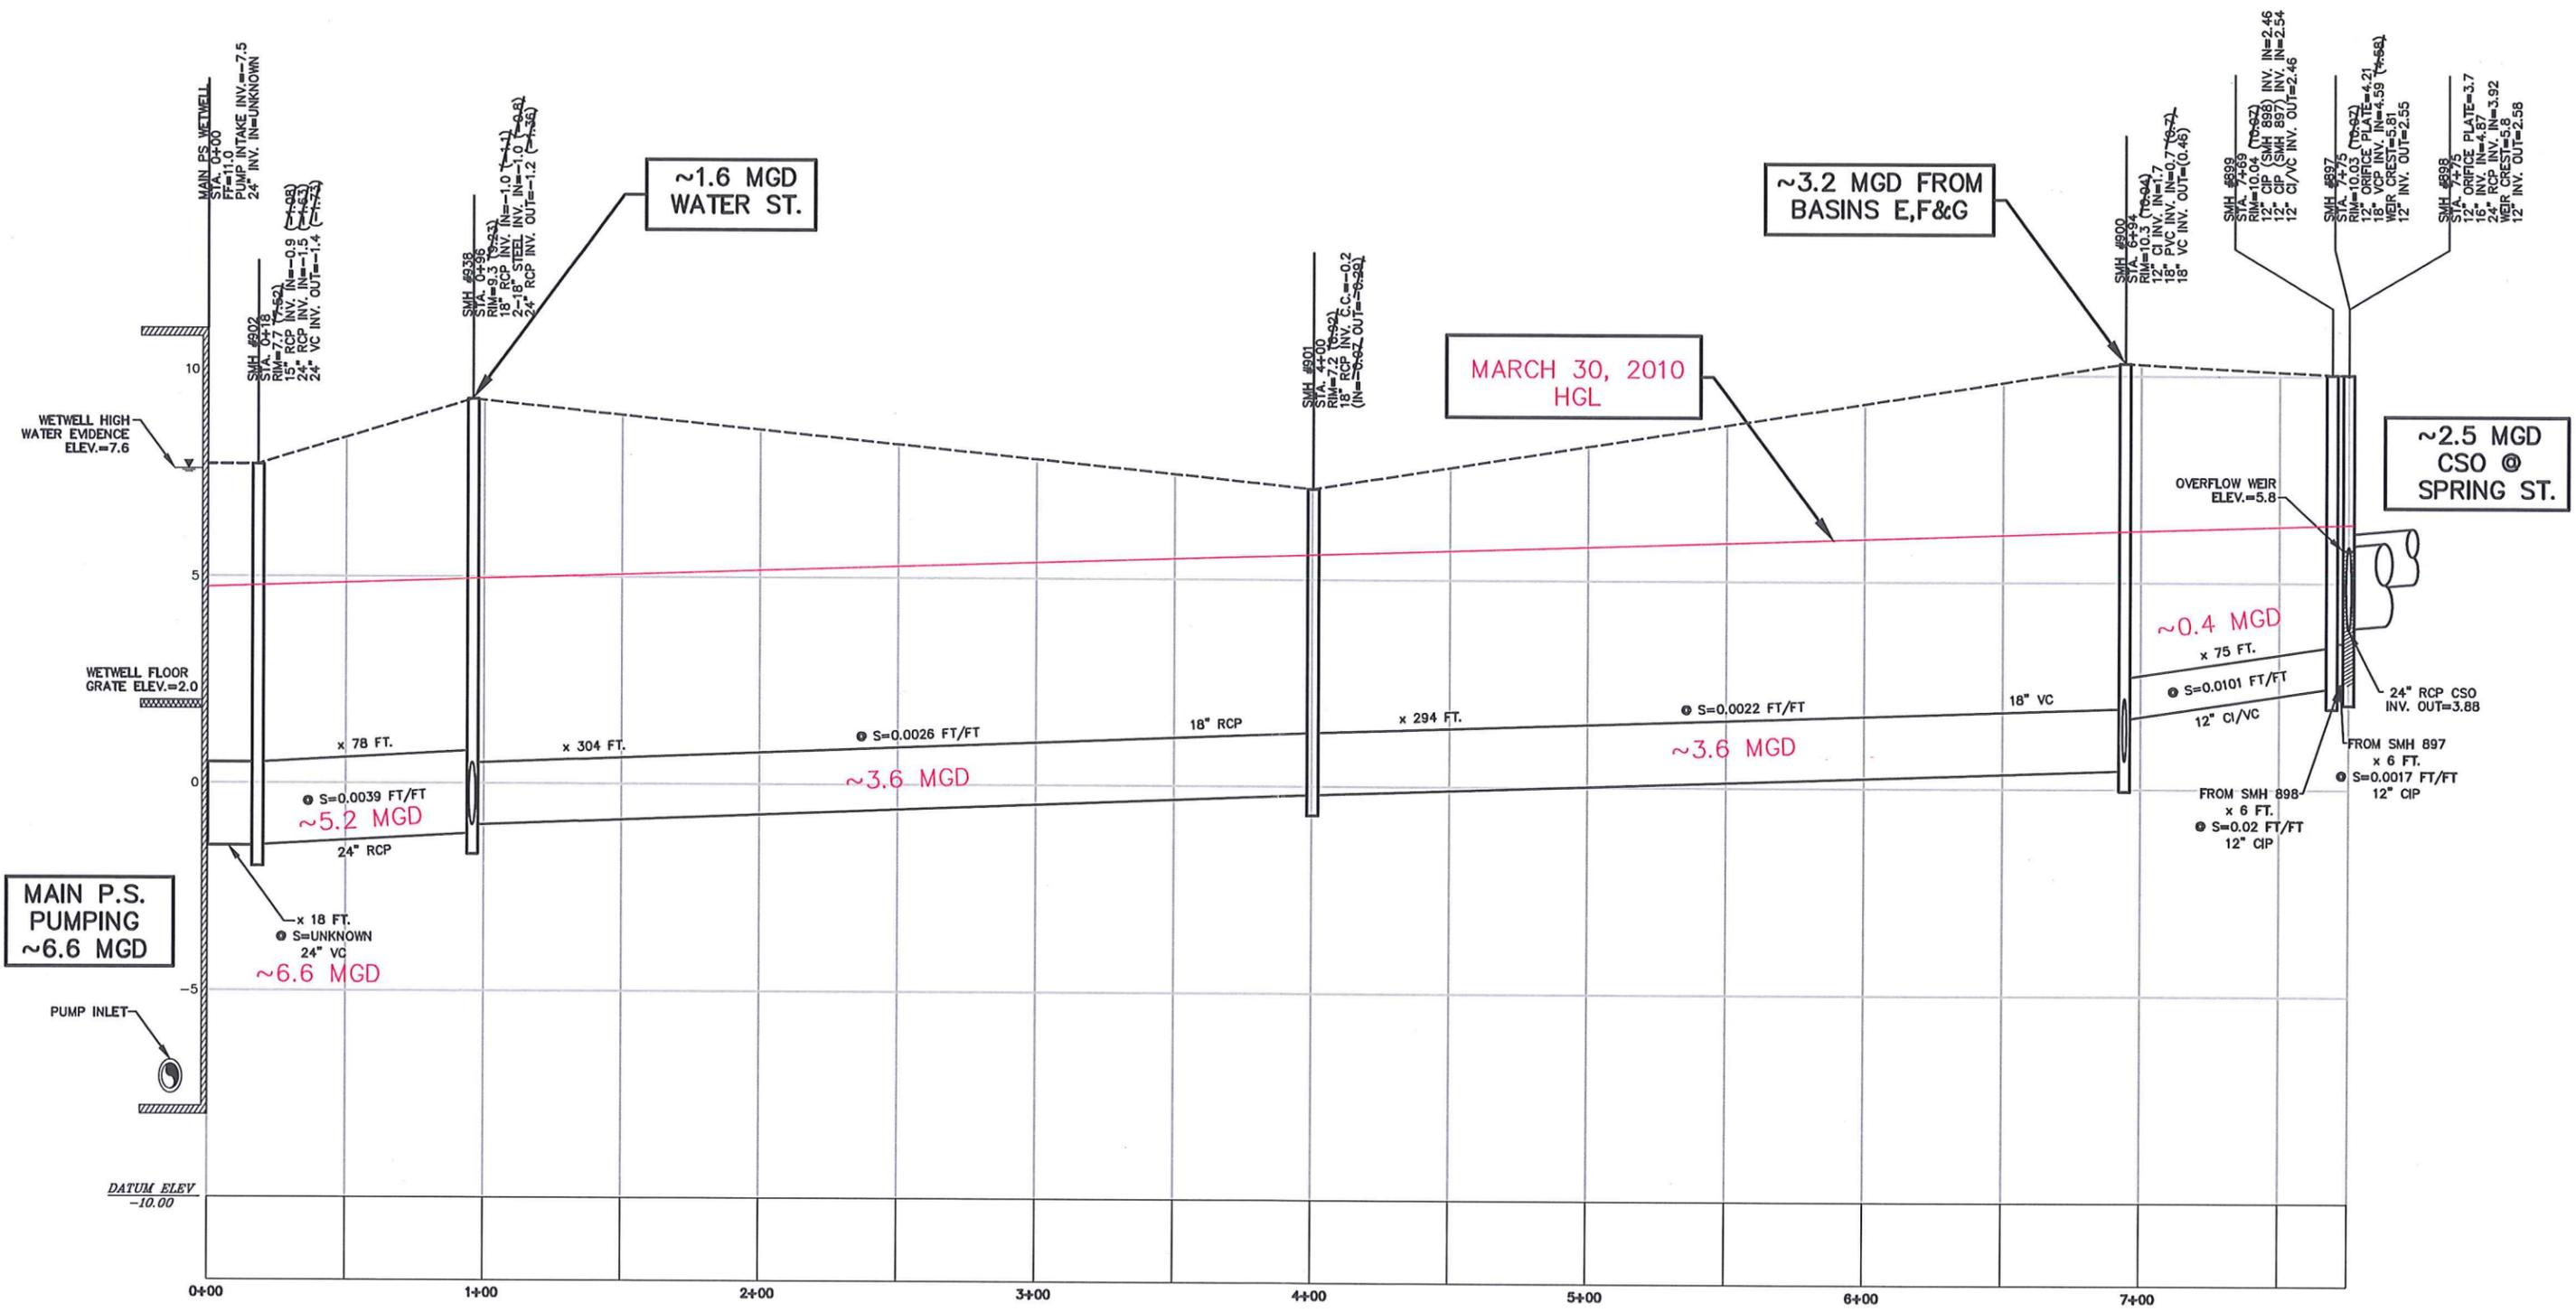
# MAIN PUMP STATION TO SPRING ST. DIVERSION STRUCTURE (MARCH 30, 2010)

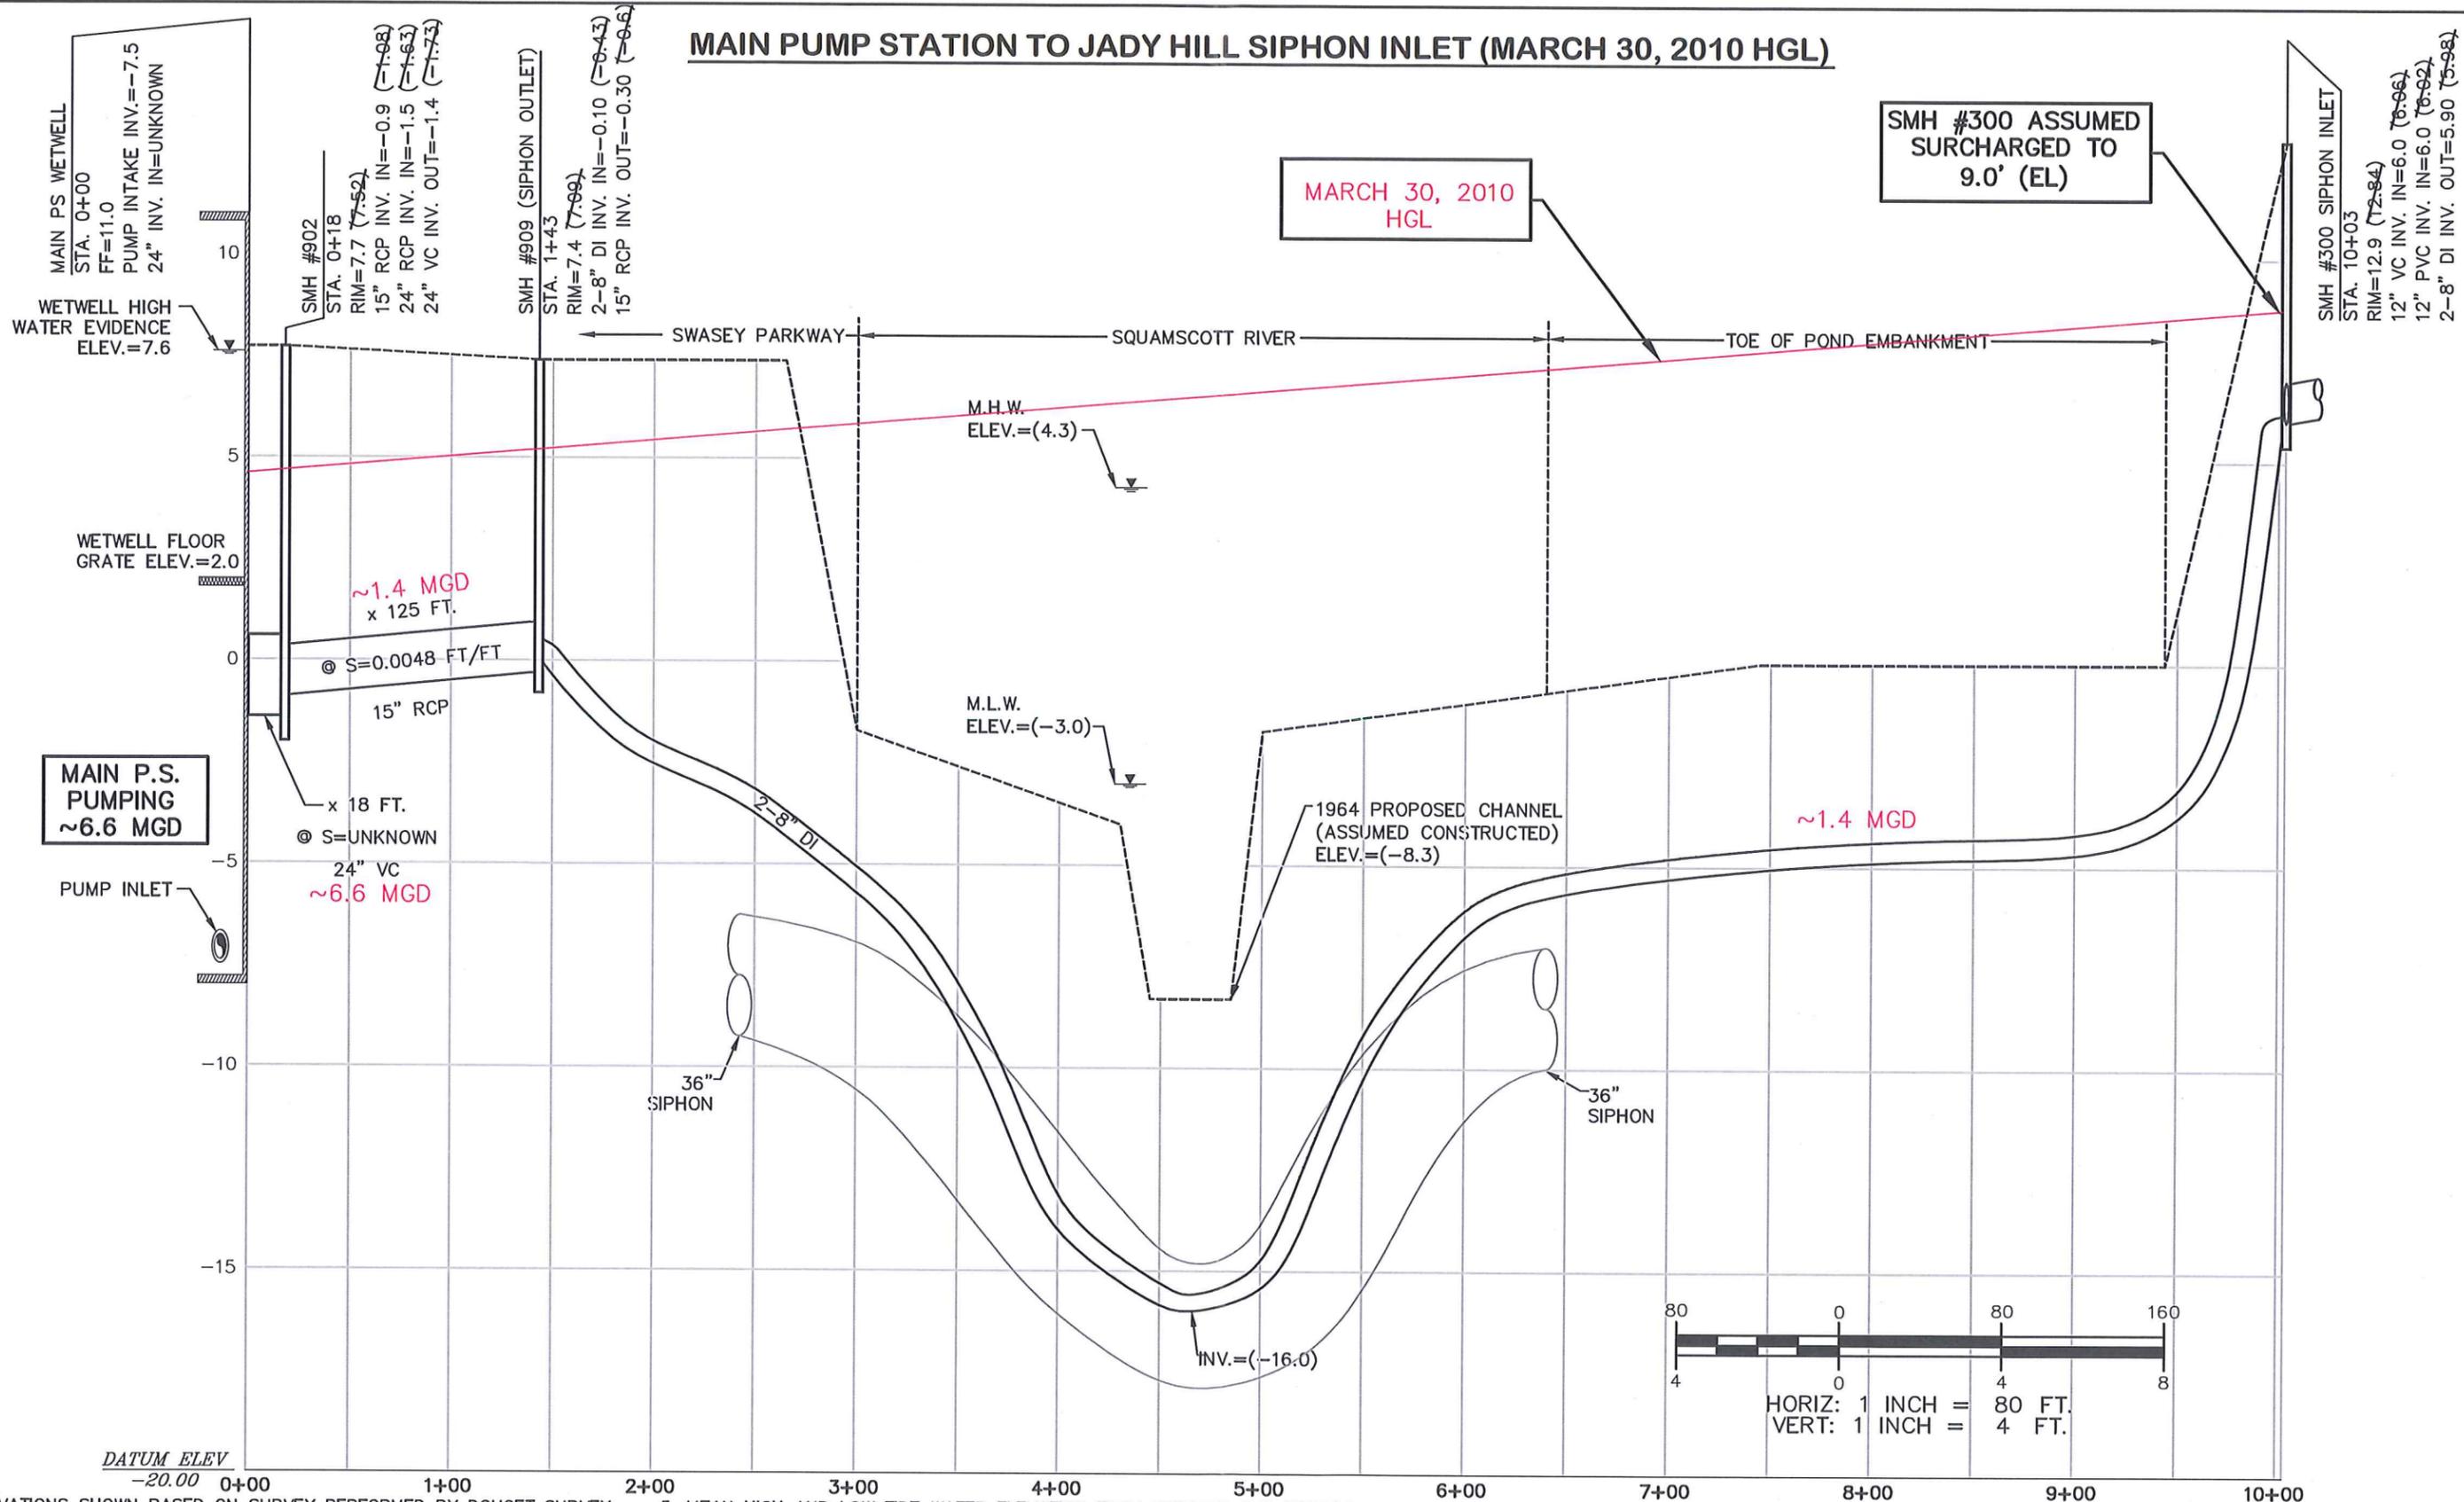
# MAIN PUMP STATION TO JADY HILL SIPHON INLET (MARCH 30, 2010 HGL)

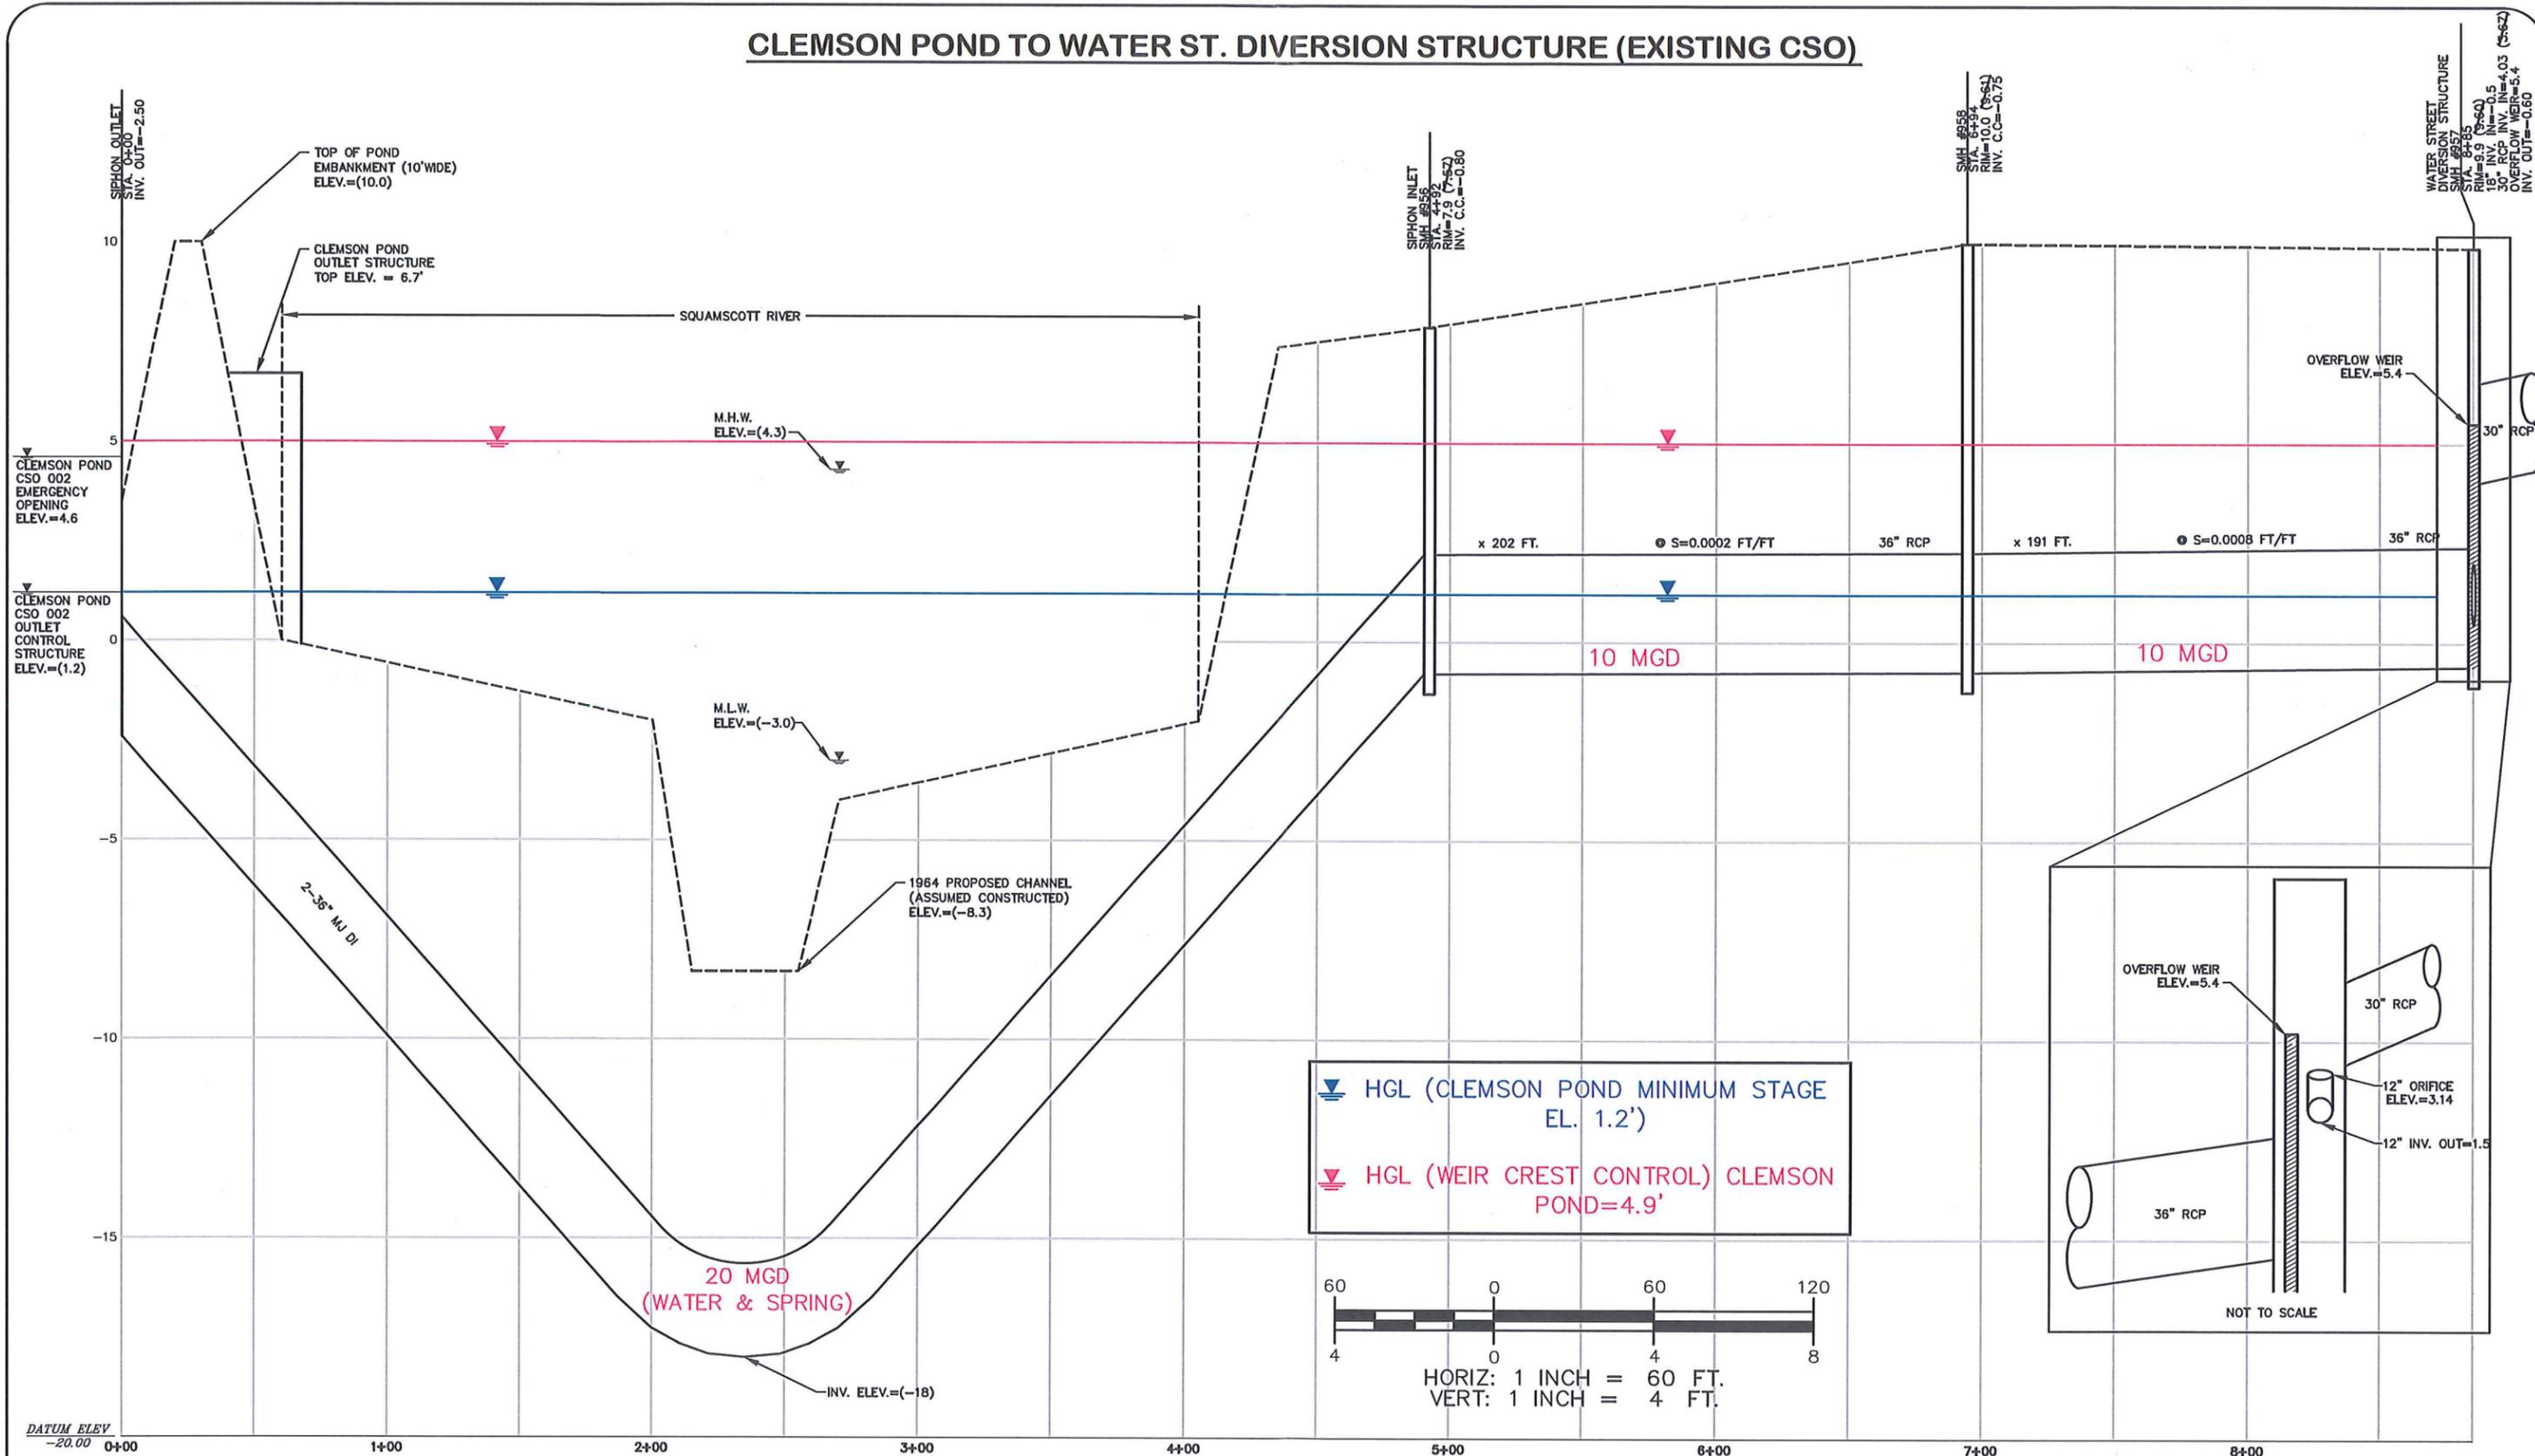
# CLEMSON POND TO WATER ST. DIVERSION STRUCTURE (EXISTING CSO)

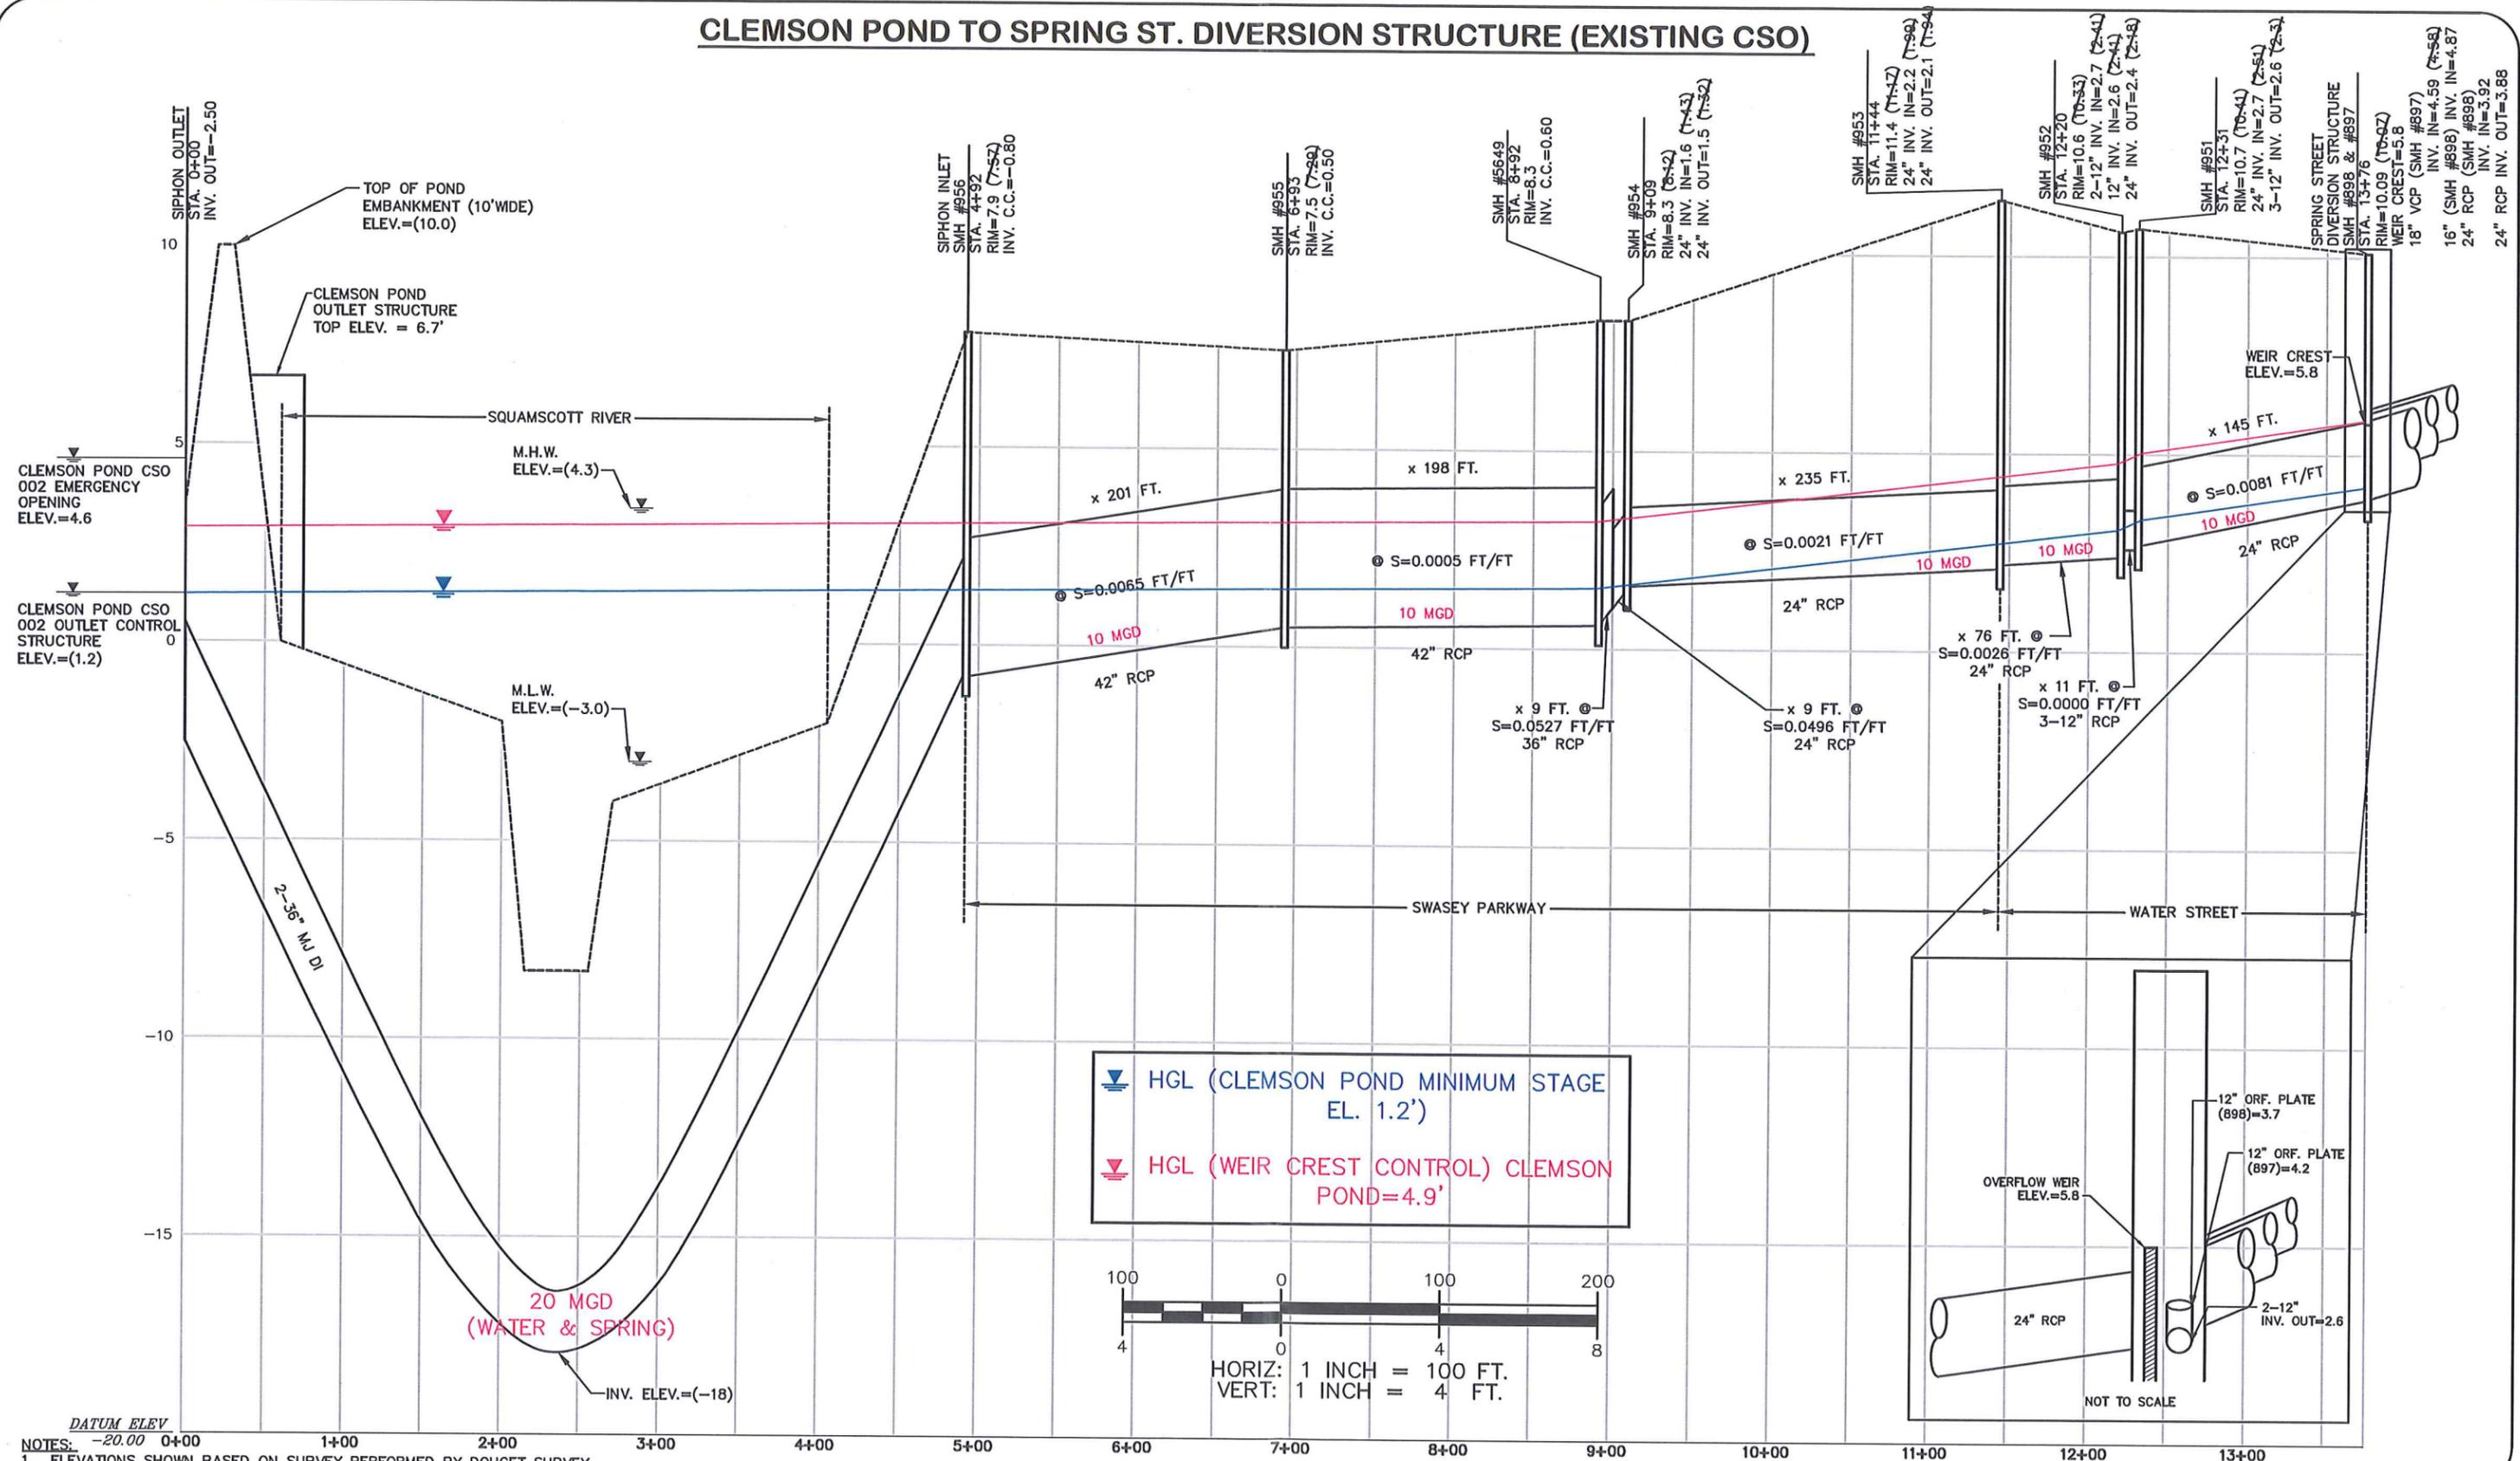
# CLEMSON POND TO SPRING ST. DIVERSION STRUCTURE (EXISTING CSO)

HGL (CLEMSON POND MINIMUM STAGE EL. 1.2')  
 HGL (WEIR CREST CONTROL) CLEMSON POND=4.9'

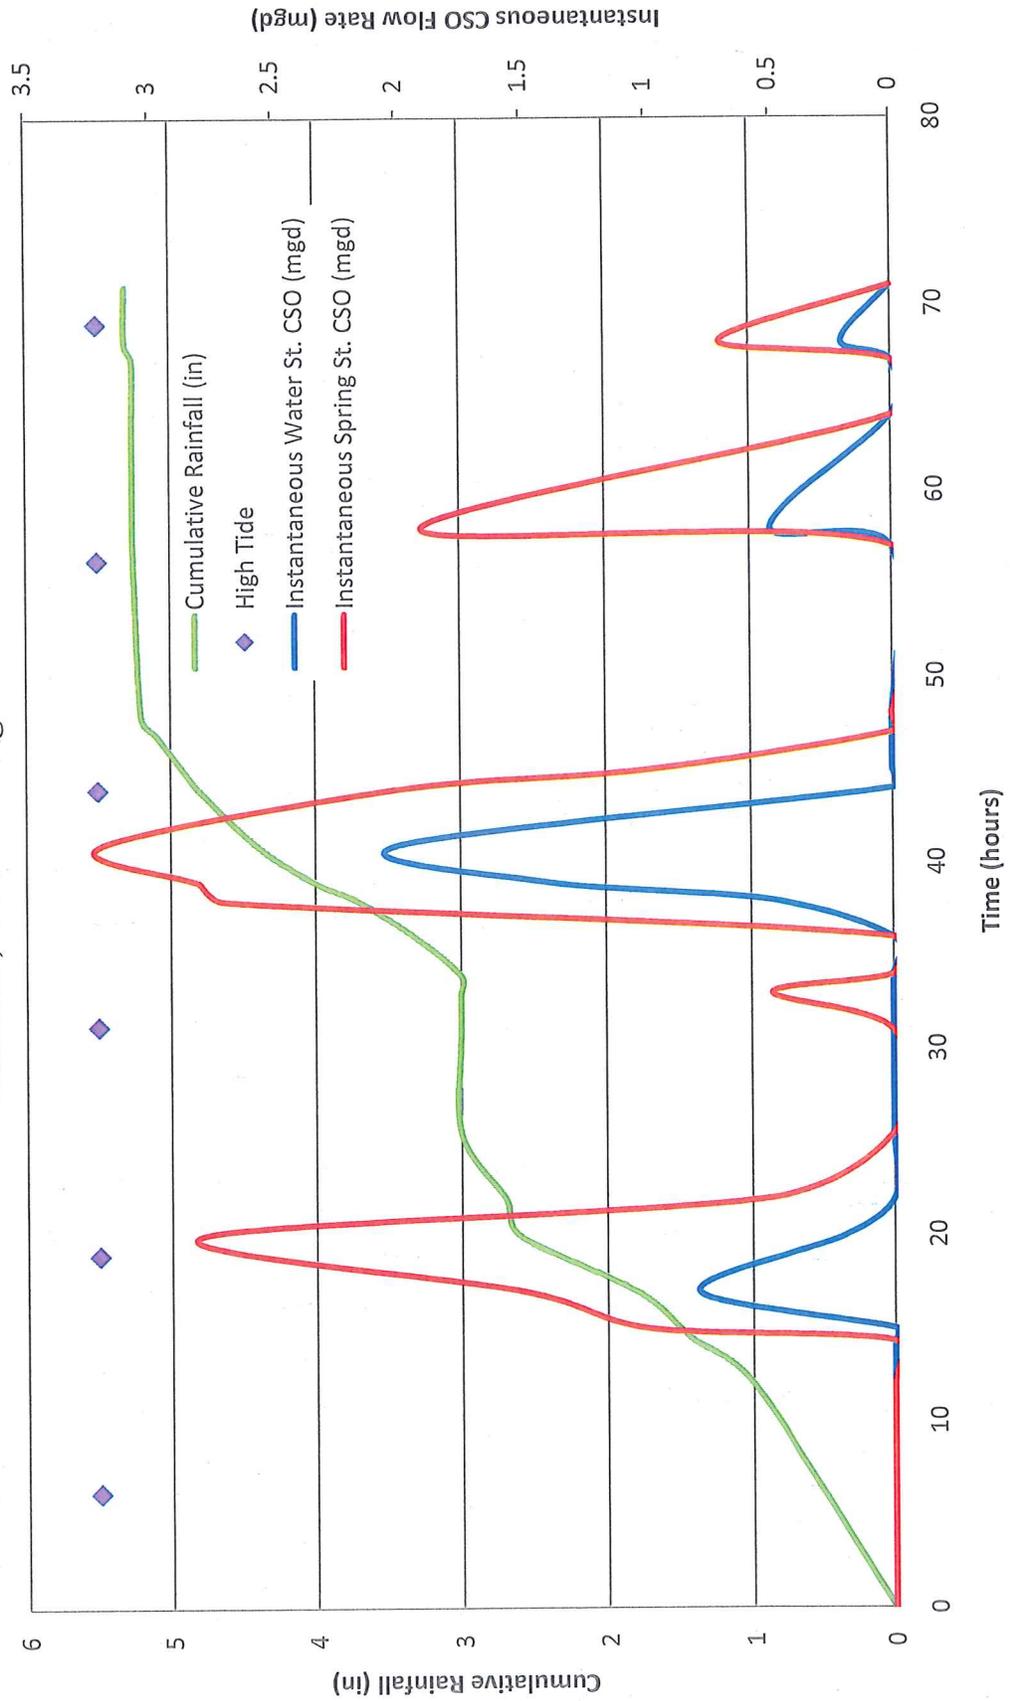
**Figure 7-8**  
**February 24-27, 2010 Storm Event**  
**Rainfall, CSO and High Tide**
