Re: 2022 Annual Post-Closure Report
Cross Road Landfill
Exeter, New Hampshire
DES #198401081
DES-SW-SP-1992-001

Annual Post-Closure Report

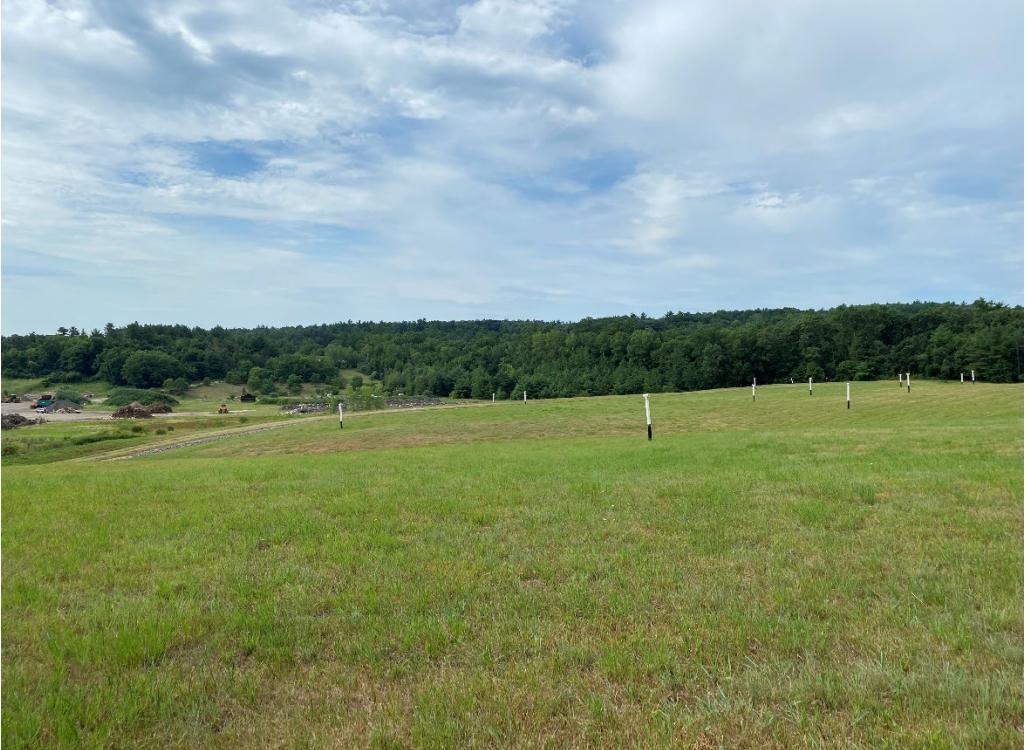
Photo No.: 1	Date: August 2022

Description: Landfill cap as viewed from the northeast corner of the landfill cap facing southwest.

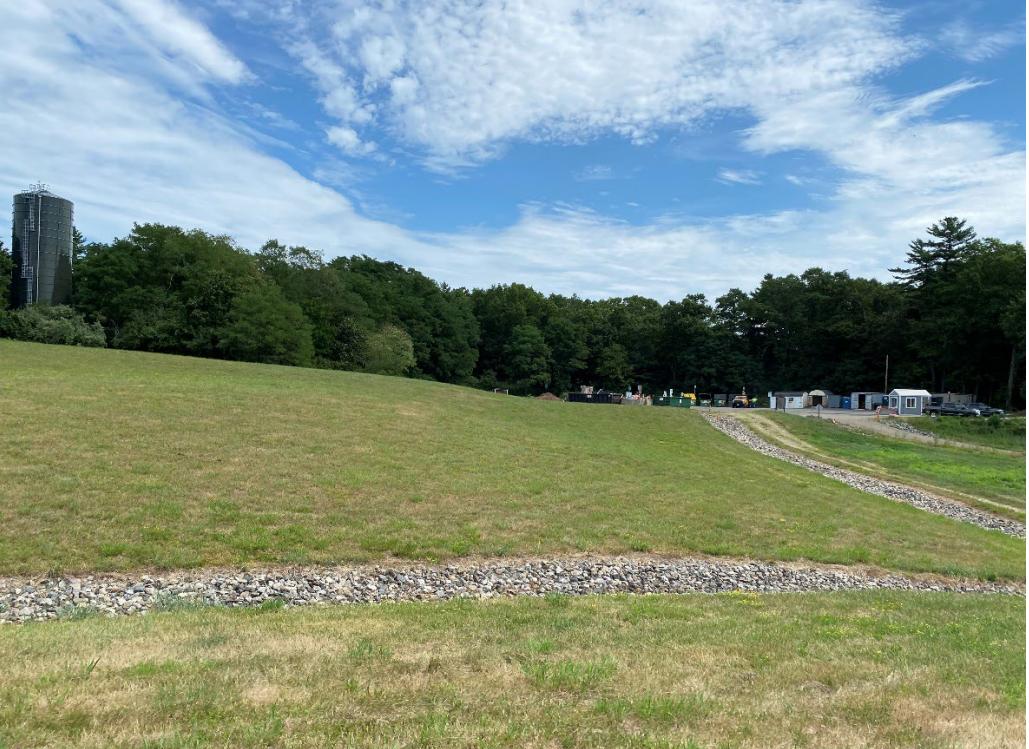
Photo No.: 2	Date: August 2022

Description: Landfill cap as viewed from the southwest corner of the landfill cap facing east.

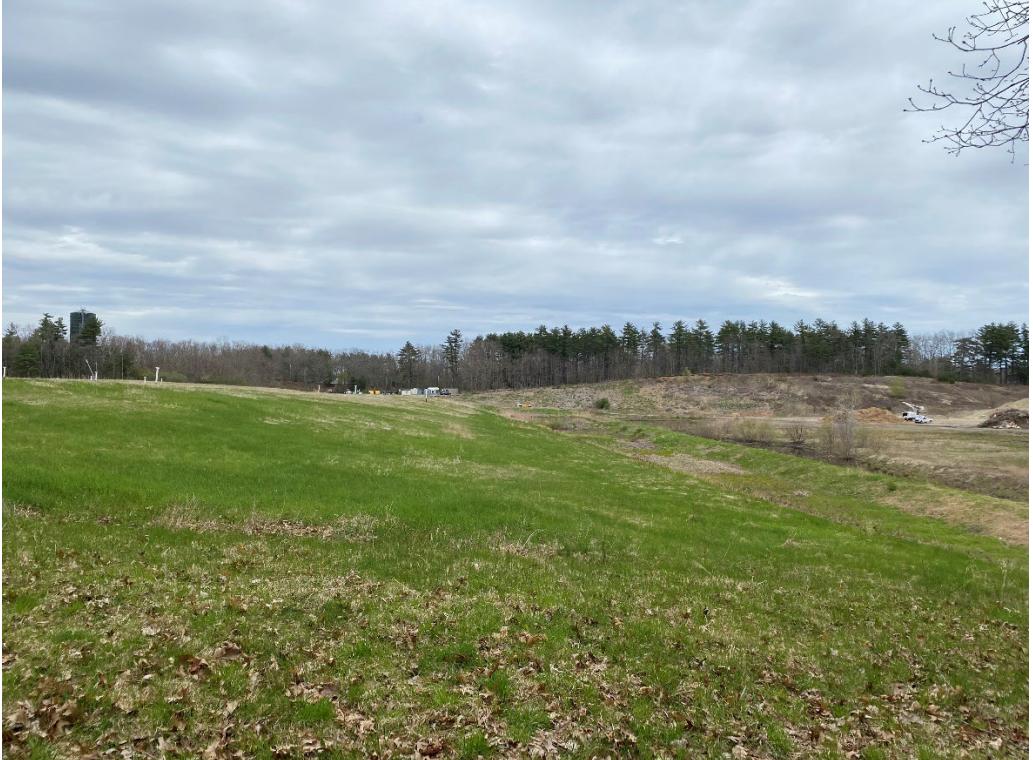
Photo No.: 3	Date: May 2022	Description: Southern slope of landfill cap as viewed from the southwest corner of the landfill cap facing east.

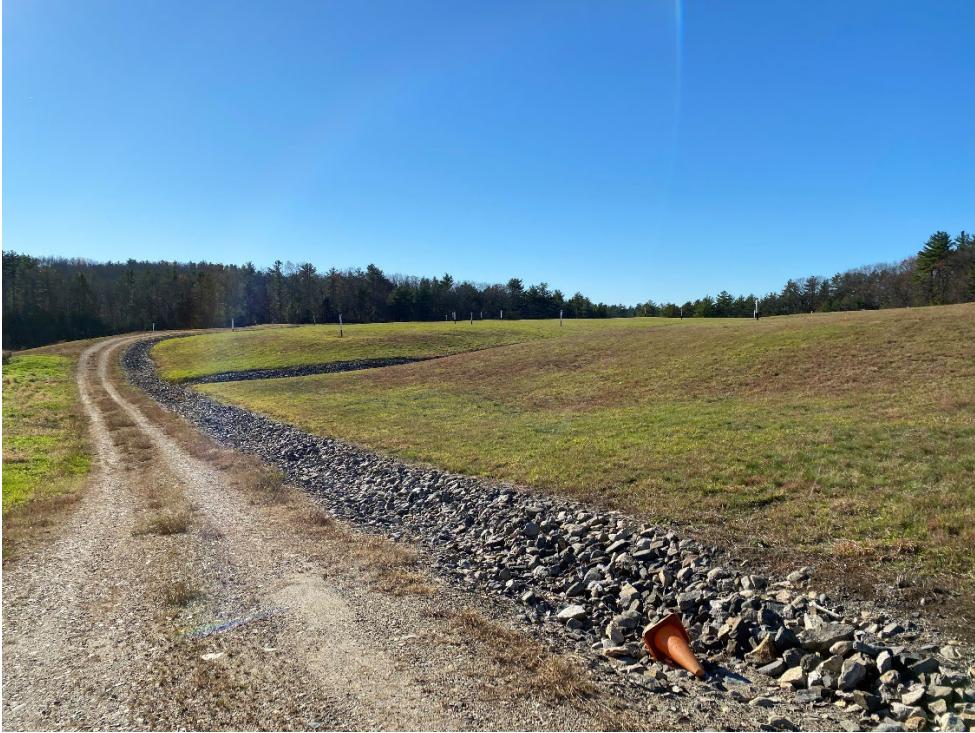
Photo No.: 4	Date: November 2022	Description: Drainage swale adjacent to access road facing east.

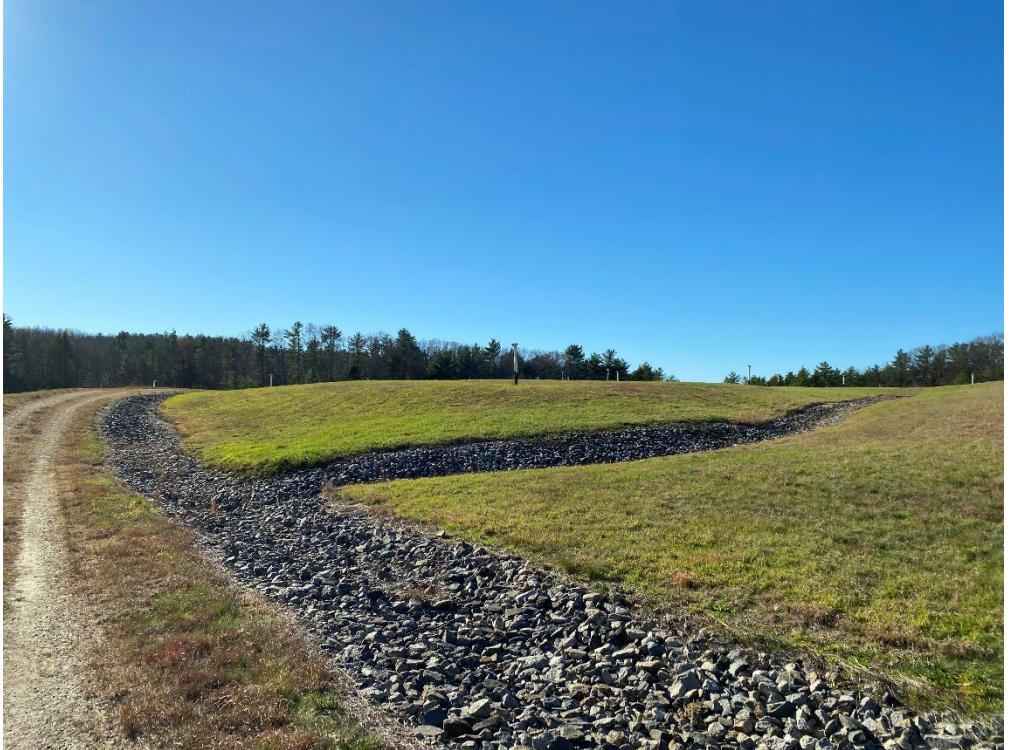
Photo No.: 5	Date: November 2022

Description: Drainage swale in the central portion of cap as viewed from the access road looking west.

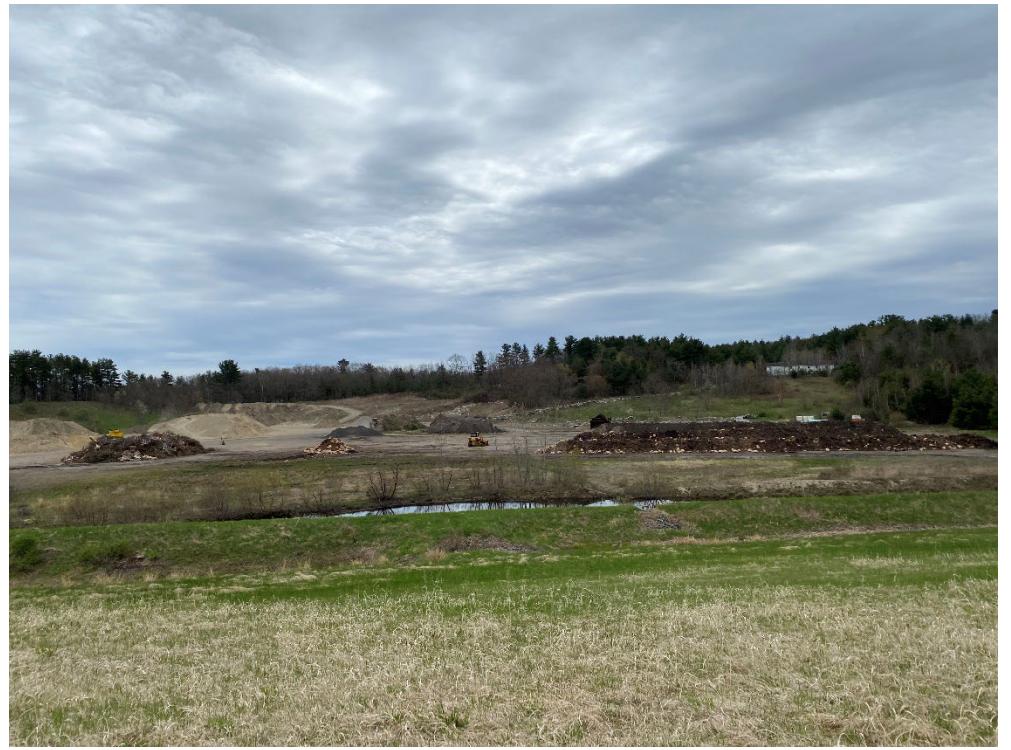
Photo No.: 6	Date: May 2022

Description: Sedimentation basins to the south of the landfill as viewed from the access road on the central-western end of the landfill cap, facing south.

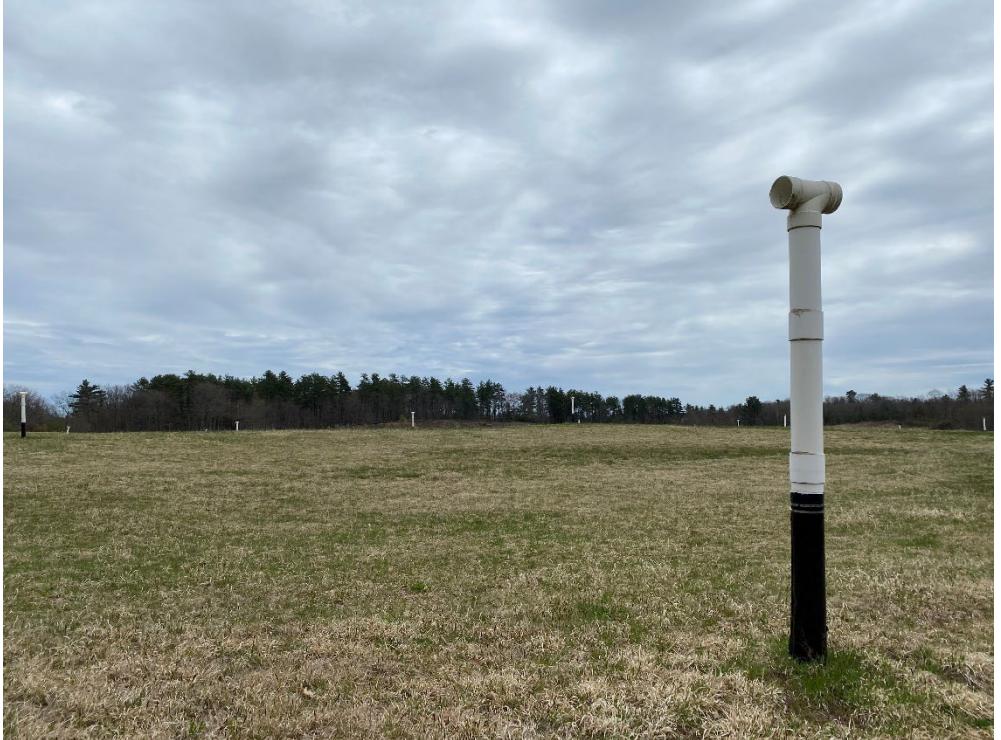
Photo No.: 7	Date: May 2022	Description: Representative landfill gas vent located across top of landfill cap.

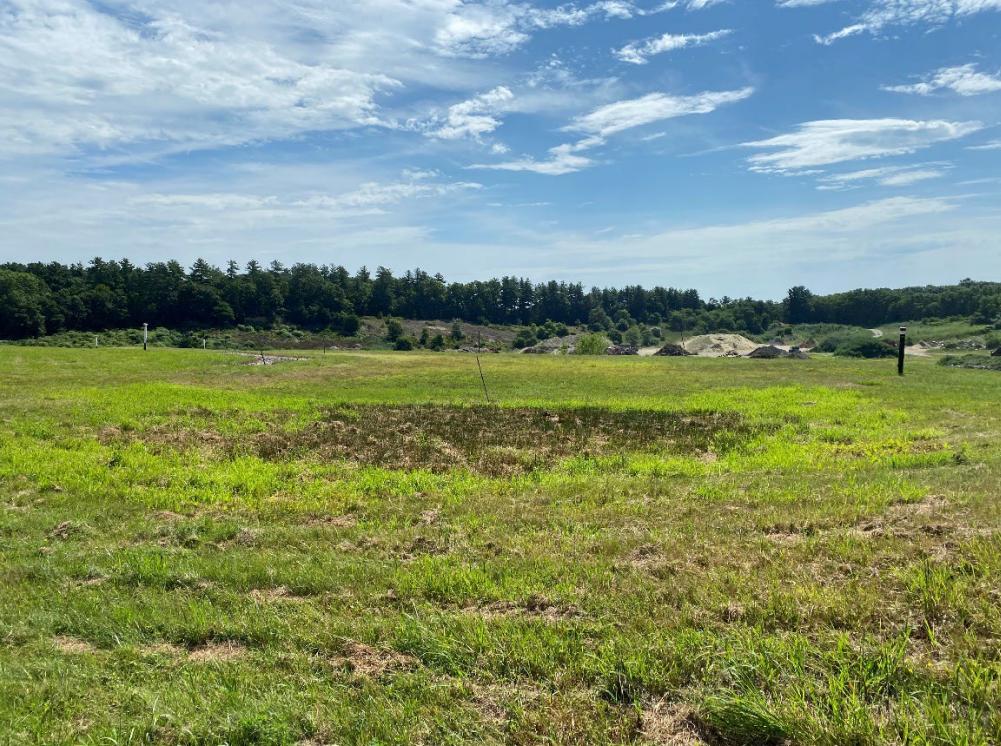
Stressed vegetation in the area of the uneven settlement discussed in Section 4-D4 and 4-D3 below was periodically observed during 2022. This is likely due to the presence of ponding water following snowmelt and rain events (See **Photo 8** and **Photo 9**).

Consistent with past years inspections, during the 2022 site inspections, a depression indicative of uneven settlement of the Landfill cap was observed in the southwestern portion of the Landfill (See **Photo 8 and 9**). Standing water is periodically observed within the depression during and after rain events in the approximately 400-square-foot area (previously reported to NHDES). The area has been inspected for visual evidence of further settlement during each of the three inspections every year since it was first observed. Previously reported smaller areas of ponding have also been observed along the western edge of the cap upgradient of the observed historical erosion described below (See **Photo 10**). An approximate 2,700 square foot area of ponding has also been periodically observed in the northeast/center of the Landfill cap directly upgradient of the central riprap lined drainage swale (See **Photo 11**). Water observed in the northeast/center of the Landfill cap is assumed to drain down through the swale.

Photo No.: 8	Date: August 2022	Description: Depression located on the southwest corner of the landfill cap at the end of the access road, facing south. Refer to Section 7.

drain down through the riprap and sloped areas over time. Repairs to the settled area are scheduled to be completed during 2023 based on the availability of Town funds, to retain its functional integrity. Please refer to **Section 7** for more details.

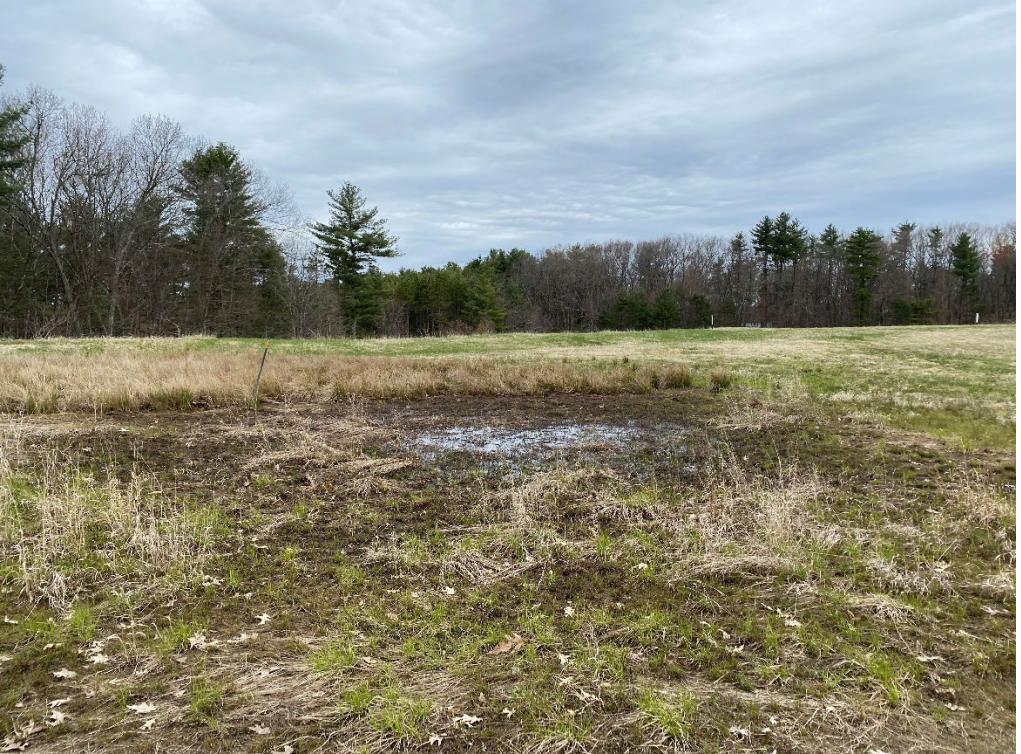
Photo No.: 9	Date: May 2022	Description: Ponding in the depression located on the southwest corner of the landfill cap at the end of the access road looking north. Refer to note in Section 7 .

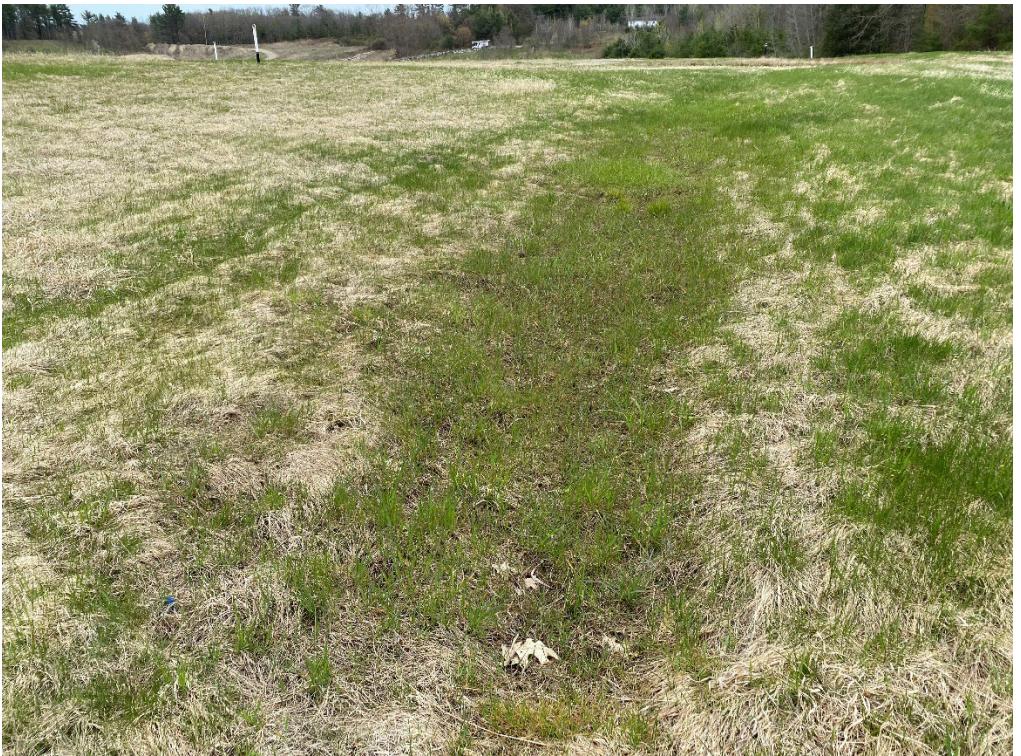
Photo No.: 10	Date: May 2022	Description: Low area along the western edge of the landfill cap facing South. Refer to note in Section 7 .

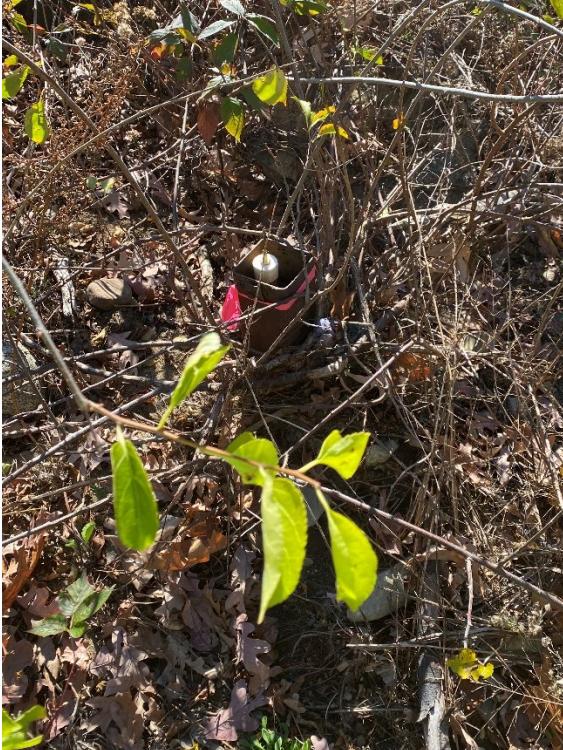
Four soil gas probe standpipes are unsecured (See **Photo 13**). The collection of landfill gas samples was not likely to have been impacted by the above-mentioned condition. GZA recommends that the soil gas standpipes be repaired as soon as practicable.

Photo No.: 13	Date: November 2022	Description: Damaged and unsecured soil gas probe standpipe. Refer to note in Section 7 .
