Pickpocket Dam Removal

River Advisory Committee Project Update #3

May 21, 2026

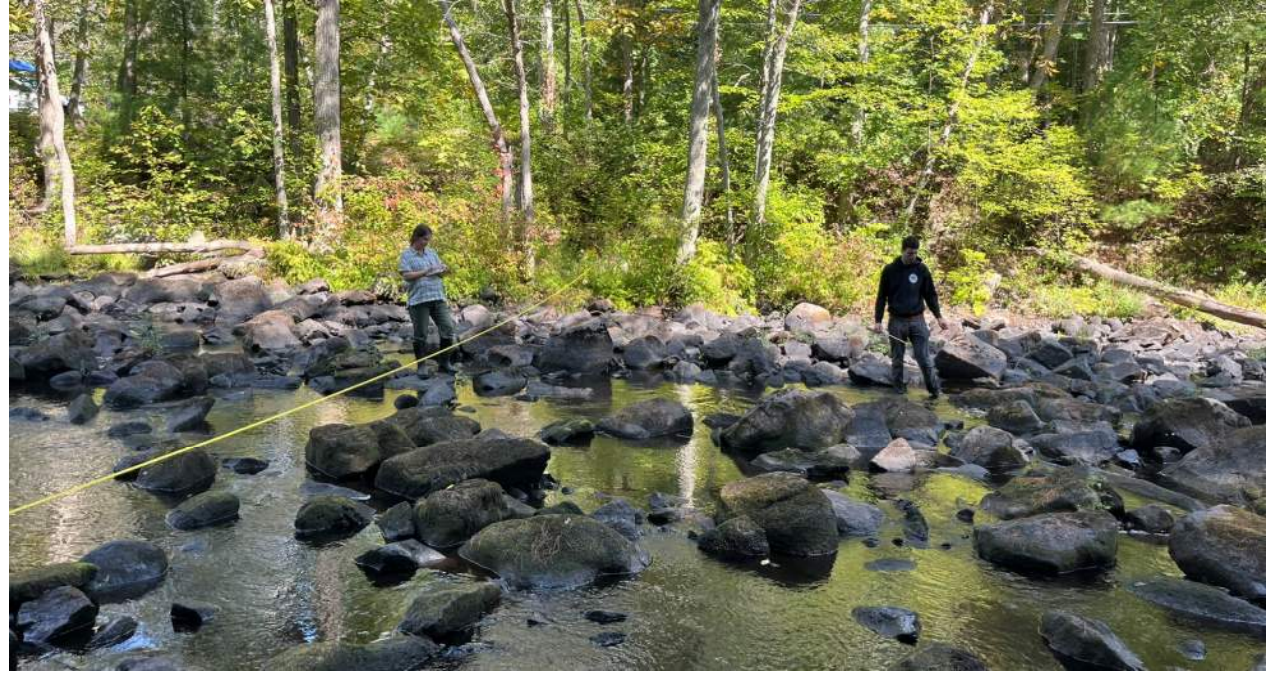
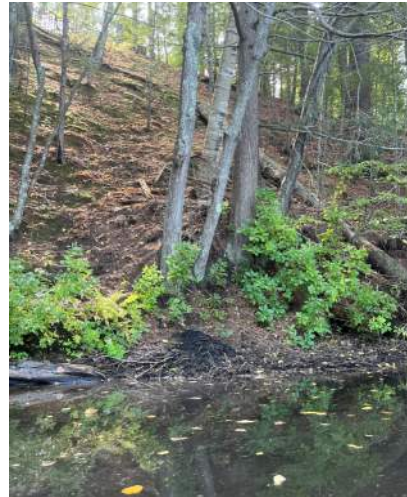
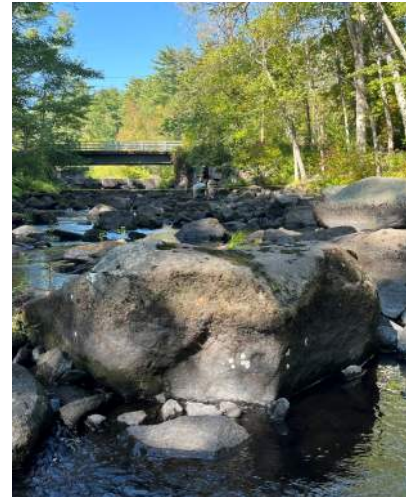
Site Visit

- Reference reach analysis @ downstream of Cross Rd & Haigh Road
 - Channel geometry
 - Pebble count
- Kayak investigation of Stoney Water Road Slope

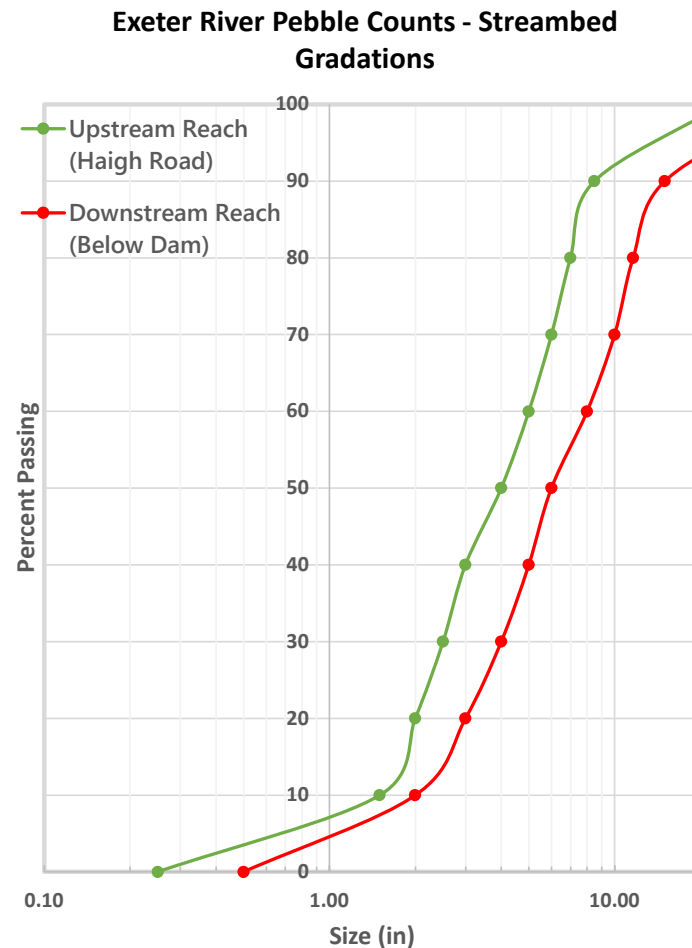
Streambed Gradation

- Pebble Counts were performed below Pickpocket Dam and upstream of the Haigh Road bridge
- Large boulders and bedrock outcrops were noted downstream of the dam
- Smaller boulders and a smaller gradation overall was observed in the Haigh Road reach
- Median pebble size was 6" below the dam and 4" at Haigh Road

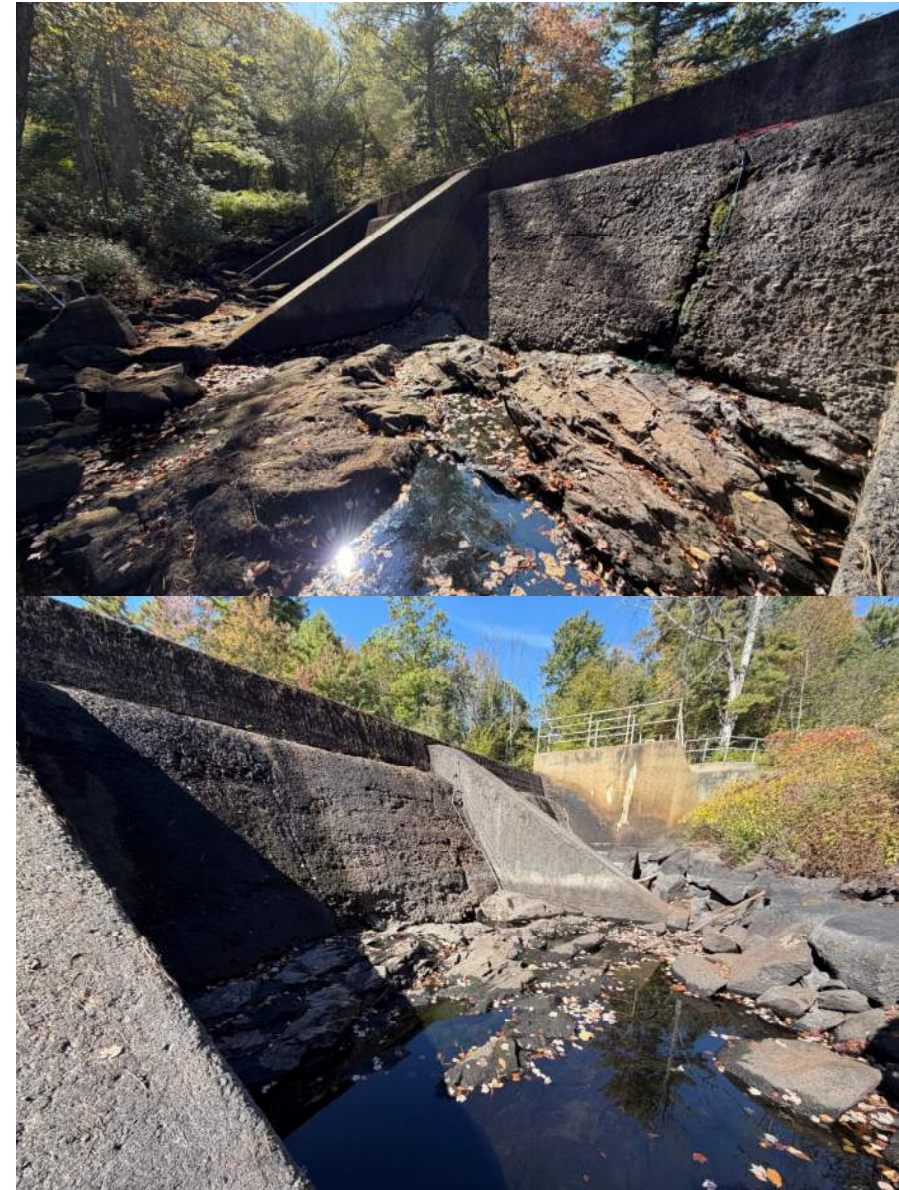
Probing Investigation

- Conducted sediment probing in October
- Completed probes along proposed horizontal alignment to verify that the design vertical depth could be achieved
- Low flow conditions allowed probing in close proximity to the dam
- Results confirmed that the depth is achievable

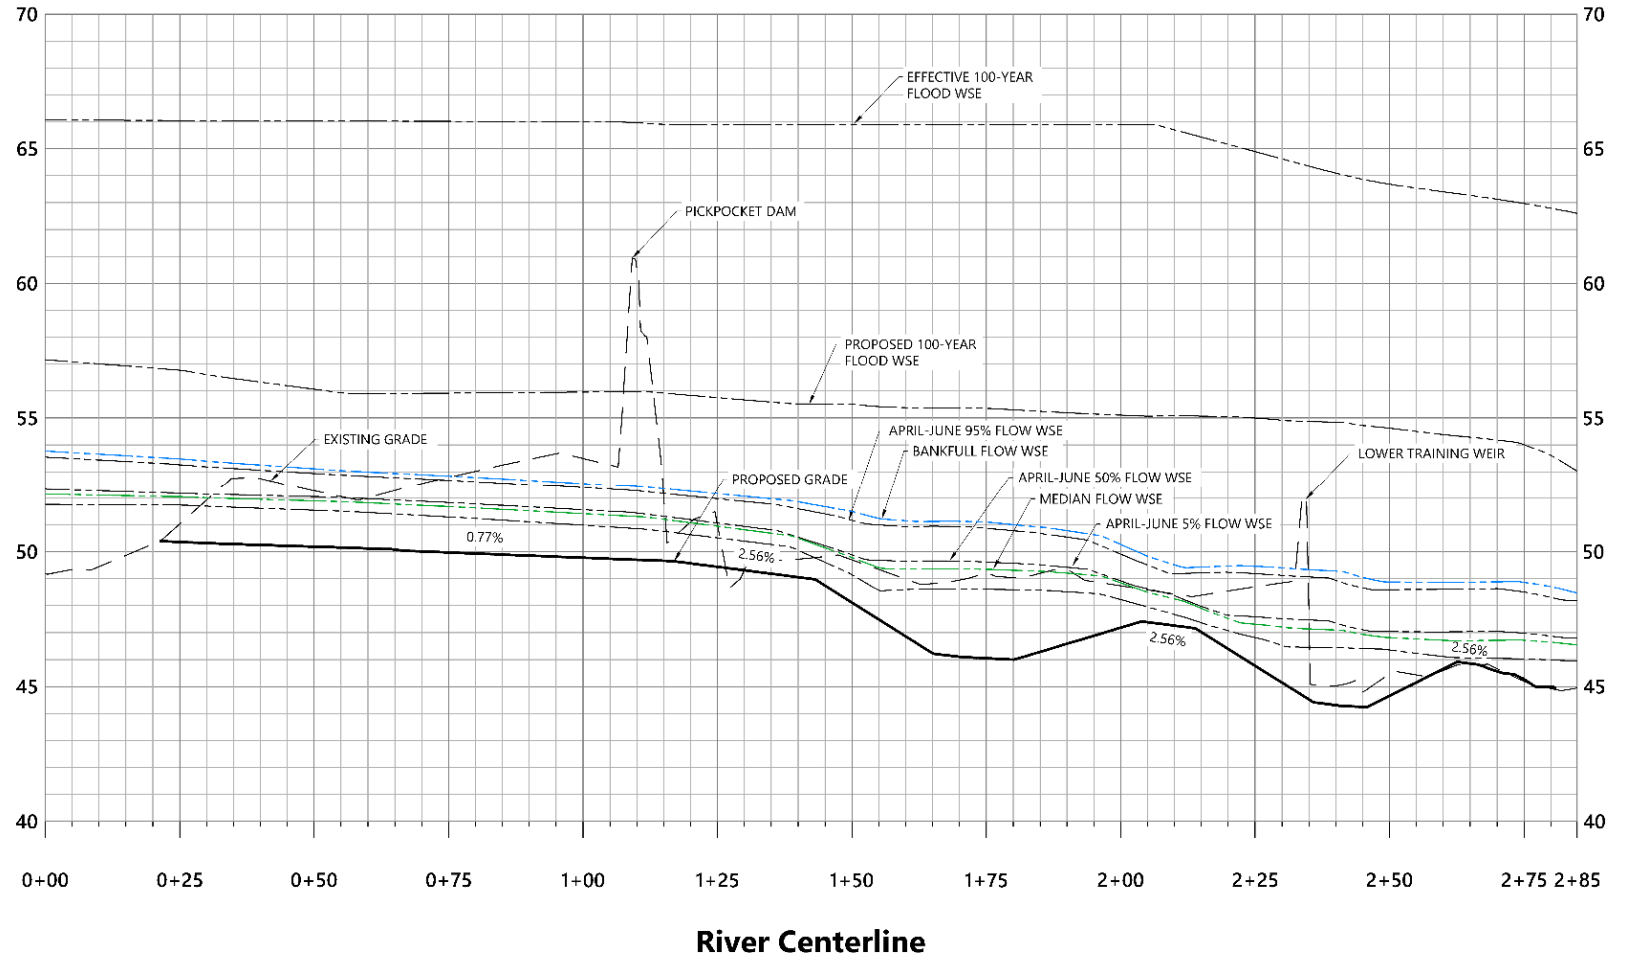
Channel Profile
