Annual Monitoring Report 2018 (Year 2)

Exeter River Great Dam Removal Project

December 2018

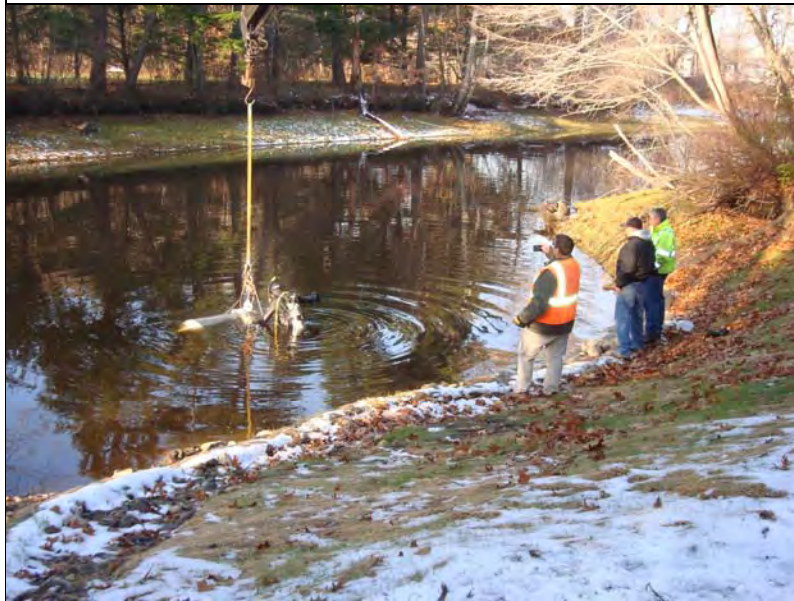
Photo #56:

Location: 8 – Water Intake

Description: Taken 12/12/2016, Tee Installation

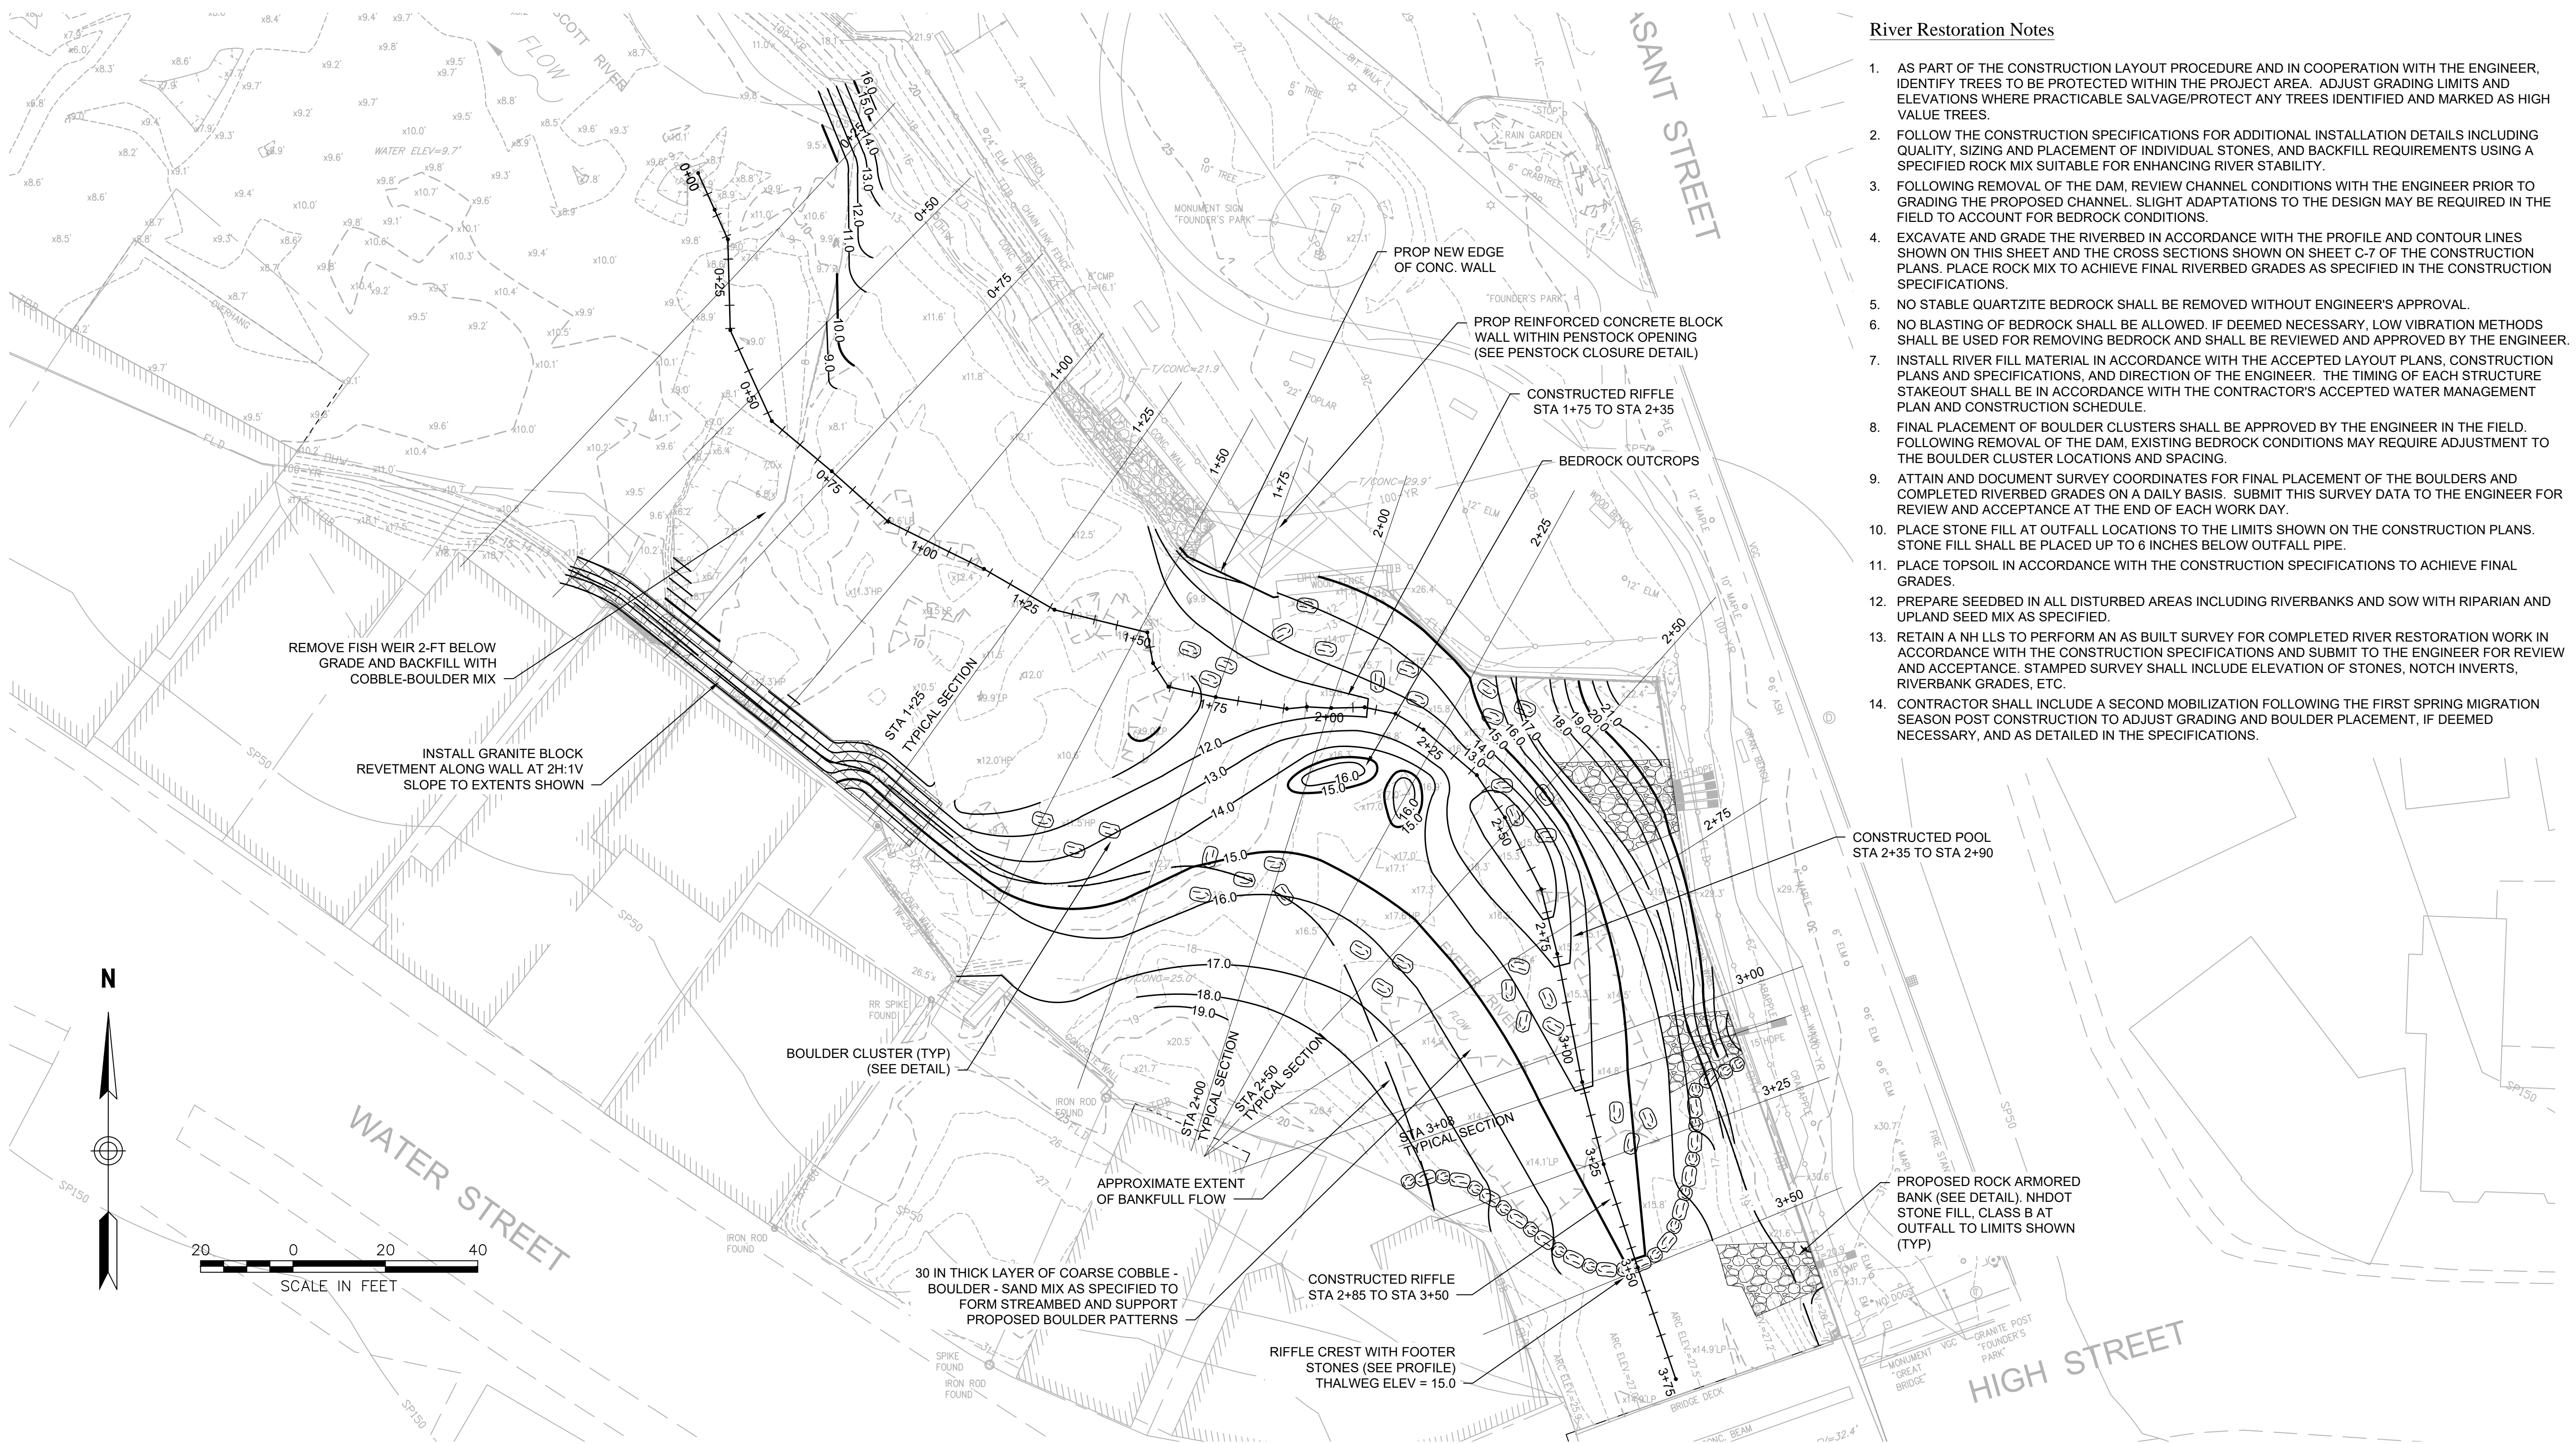
River Channel Grading Plan

- CONTRACTOR SHALL INCLUDE A SECOND MOBILIZATION FOLLOWING THE FIRST SPRING MIGRATION SEASON POST CONSTRUCTION TO ADJUST GRADING AND BOULDER PLACEMENT, IF DEEMED NECESSARY, AND AS DETAILED IN THE SPECIFICATIONS.

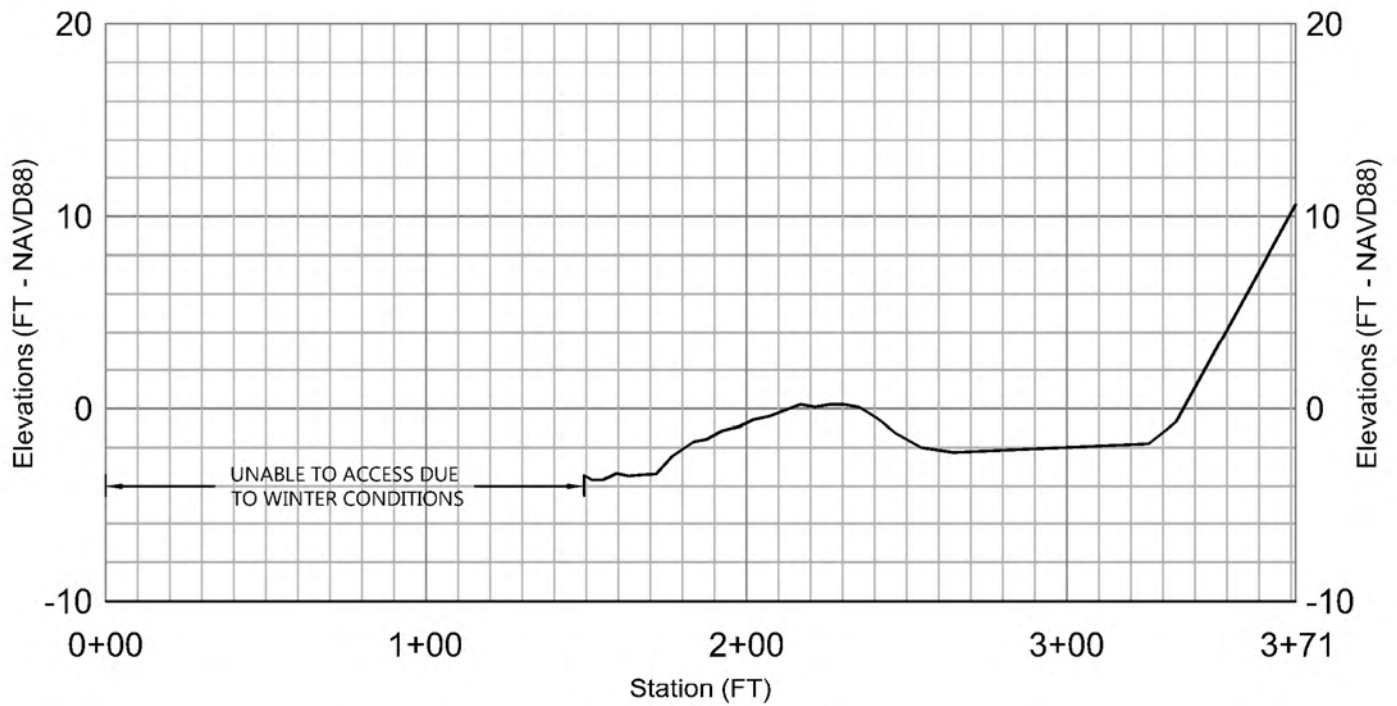
Cross Section 1

Cross Sectional Elevation data obtained by VHB Survey, January, 2017

Horizontal Scale: 1" = 60'
Vertical Scale: 1" = 10'

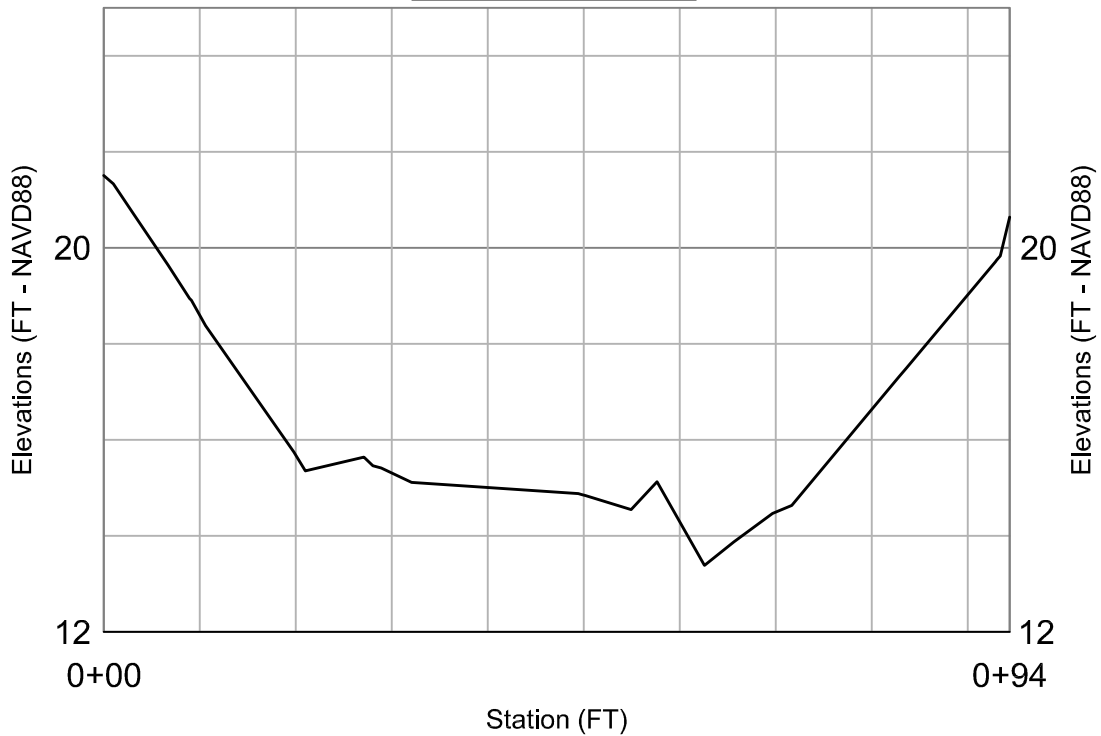
Cross Section 2

Cross Sectional Elevation data obtained from As-Built data from SUMCO ECO Contracting, September 28, 2016

Horizontal Scale: 1" = 20'
Vertical Scale: 1" = 4'

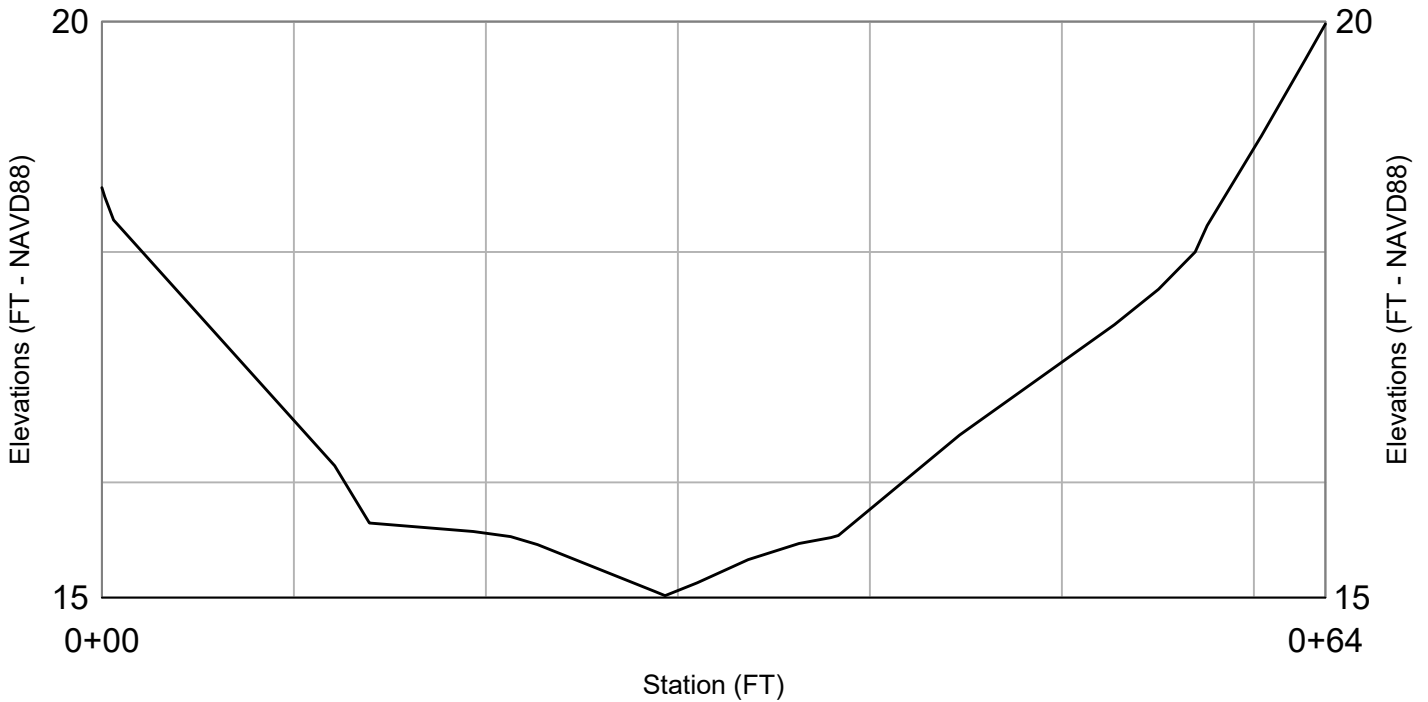
Cross Section 3

Cross Sectional Elevation data obtained from As-Built data from SUMCO ECO Contracting, September 28, 2016

Horizontal Scale: 1" = 10'
Vertical Scale: 1" = 6'

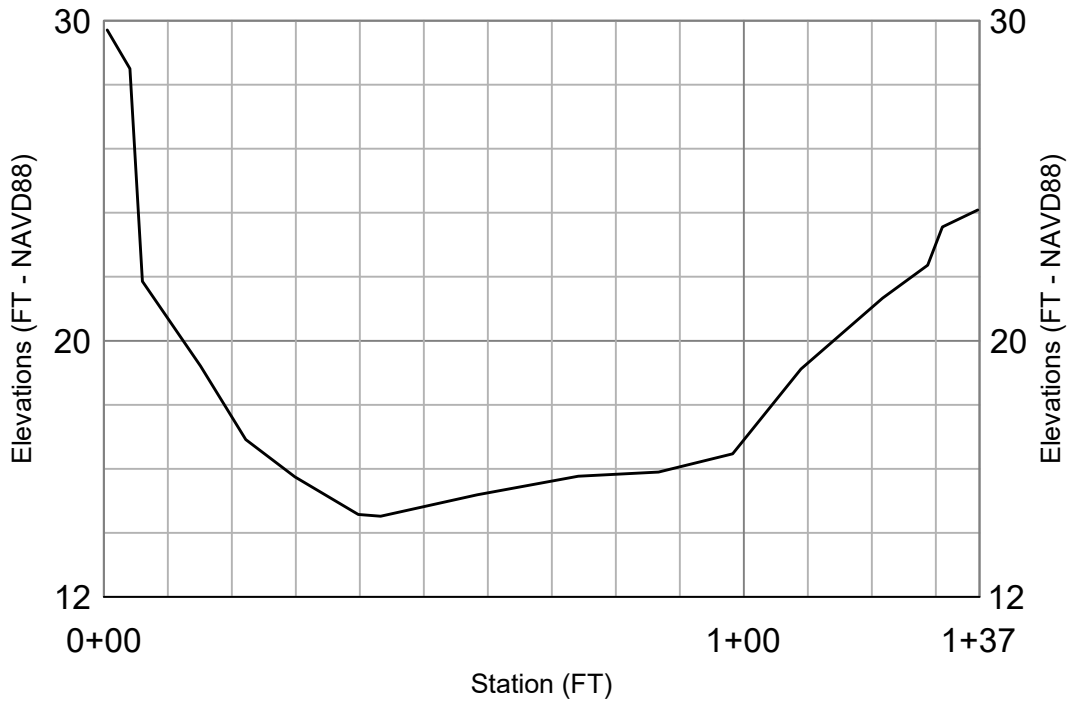
Cross Section 4

Cross Sectional Elevation data obtained by VHB Survey, January, 2017

Horizontal Scale: 1" = 30'
Vertical Scale: 1" = 6'

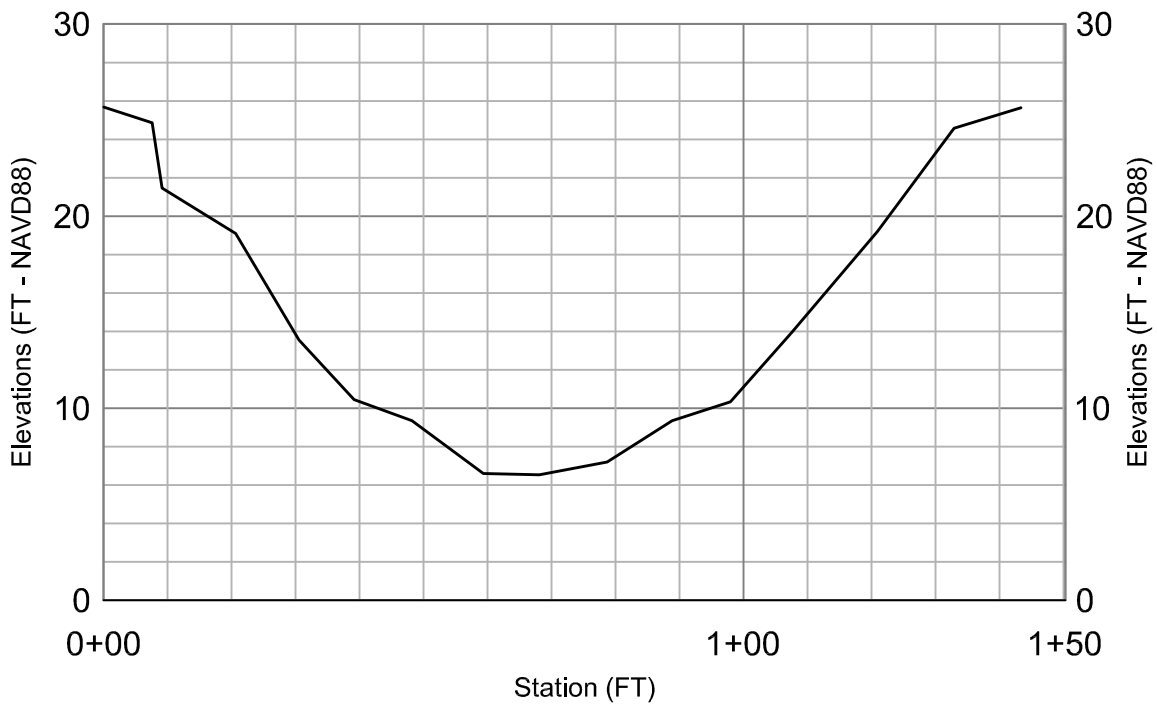
Cross Section 5

Cross Sectional Elevation data obtained by VHB Survey, January, 2017

Horizontal Scale: 1" = 30'
Vertical Scale: 1" = 10'

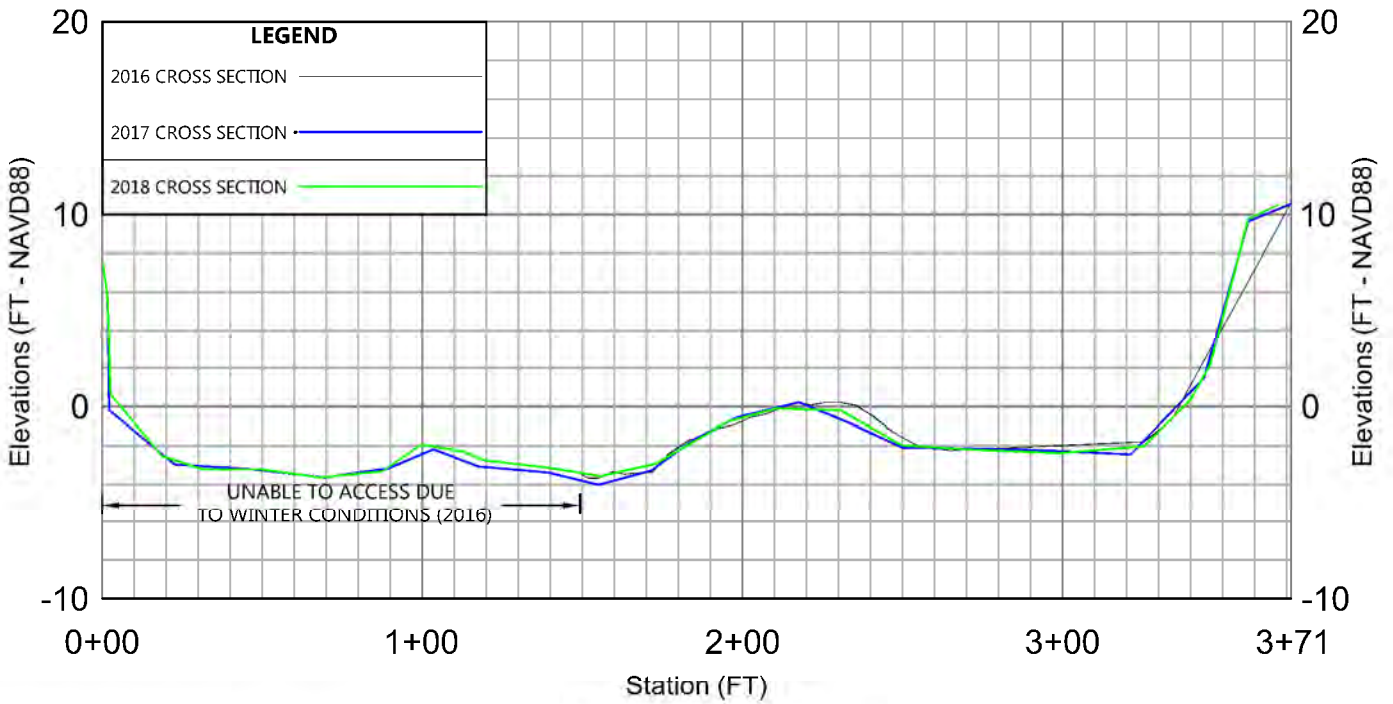
Cross Section 1

Cross Sectional Elevation data obtained by VHB Survey, October, 2017

Horizontal Scale: 1" = 60'
Vertical Scale: 1" = 10'

VHB survey staff re-surveyed all five monumented cross-sections on August 27 through August 29, 2018. Survey profiles indicate that the channel remains stable at all cross-sections, with minimal aggradation and/or degradation observed. Cross-section profiles and data in tabular x, y, z format for each cross-section comparing the 2018 monitoring survey to the year 1 2017 survey and 2016 baseline survey is included in **Appendix D**.

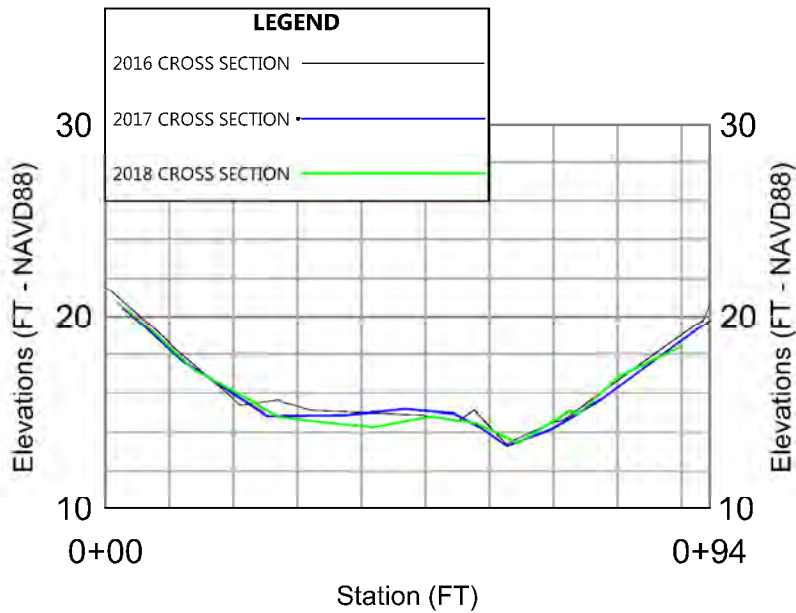
Cross Section 2

Horizontal Scale: 1" = 30'
Vertical Scale: 1" = 10'

Cross Sectional Elevation data obtained by VHB Survey, October, 2017

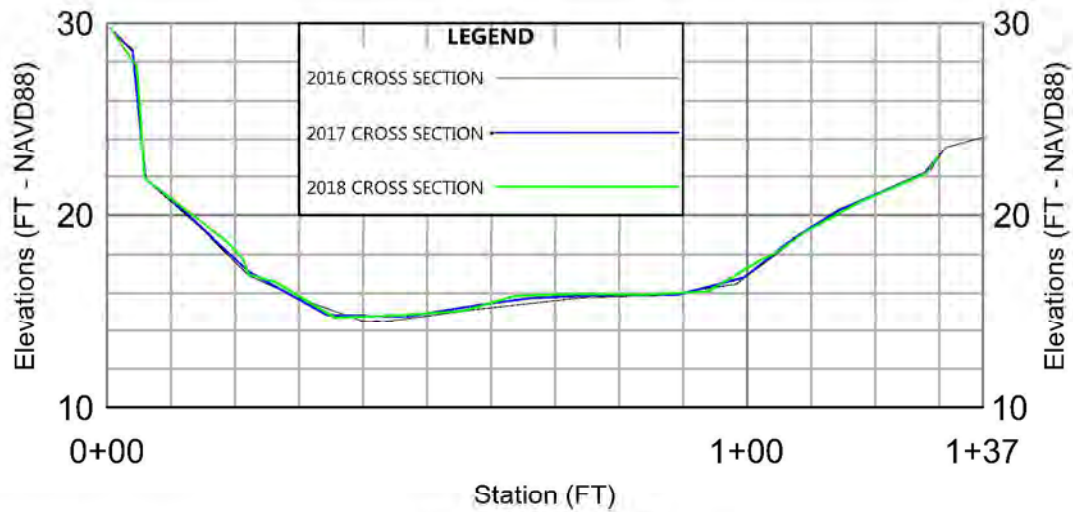
Cross Section 4

Cross Sectional Elevation data obtained by VHB Survey, October, 2017

Horizontal Scale: 1" = 30'
Vertical Scale: 1" = 10'

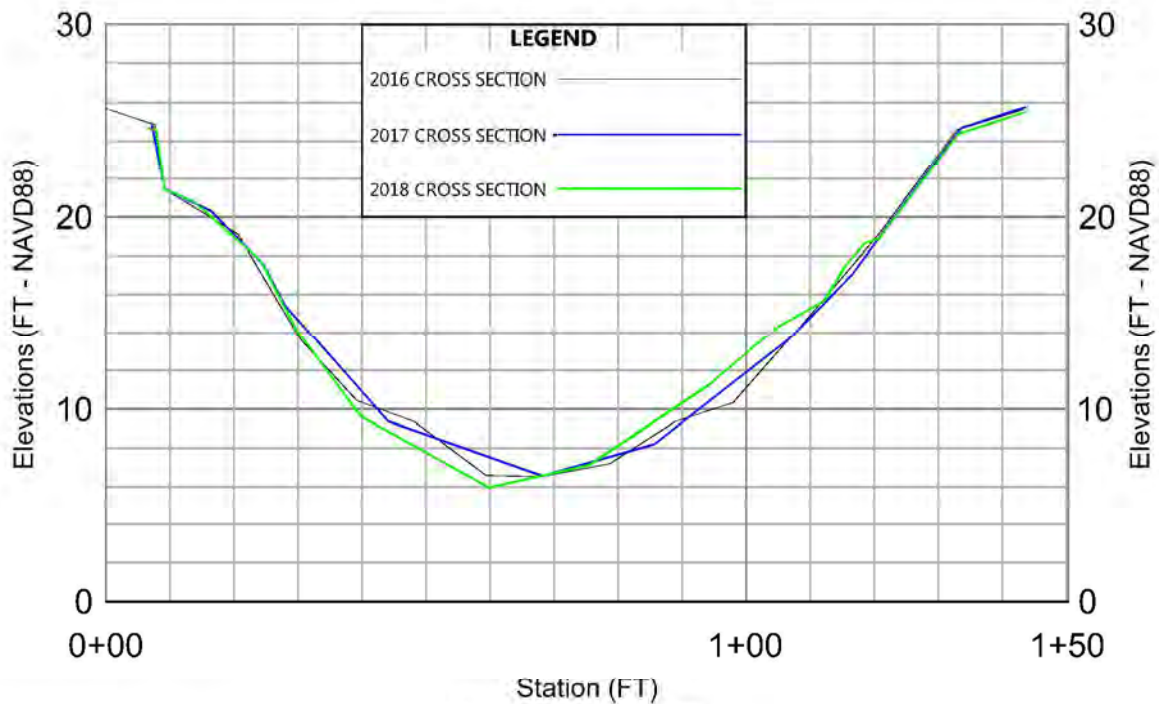
Cross Section 5

Cross Sectional Elevation data obtained by VHB Survey, October, 2017

Horizontal Scale: 1" = 30'
Vertical Scale: 1" = 10'
