Exeter River Great Dam Removal Feasibility and Impact Study

Exeter, New Hampshire

Prepared by **VHB/Vanasse Hangen Brustlin, Inc.**
Bedford, New Hampshire

FINAL - October 2013

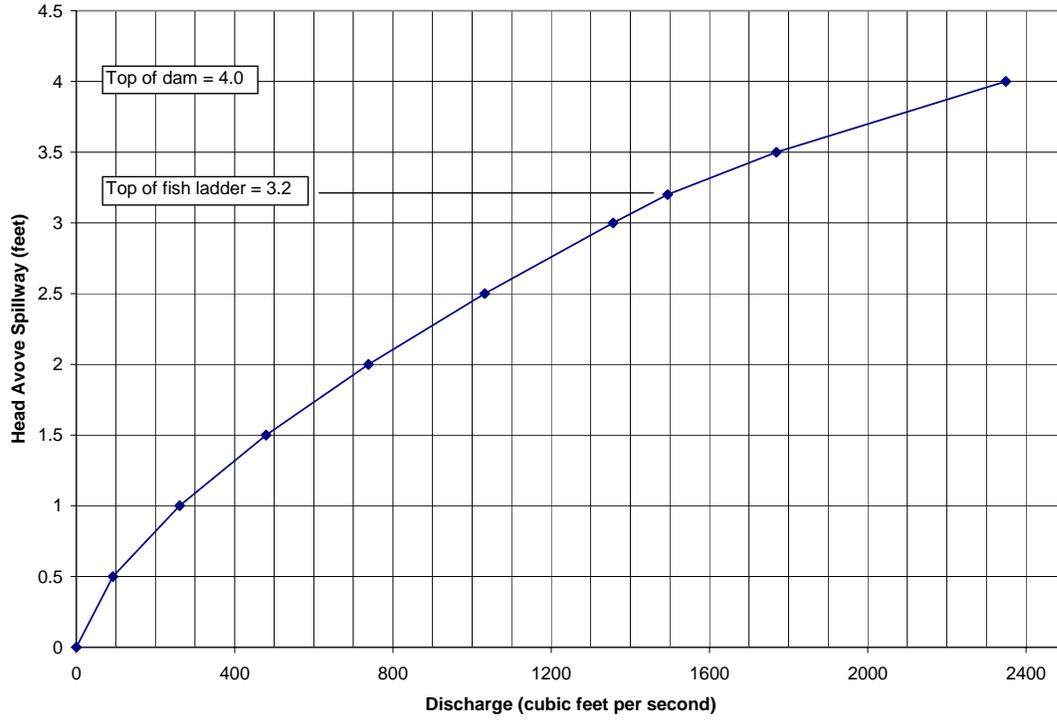
Exeter River Dam - Spillway Rating Curve

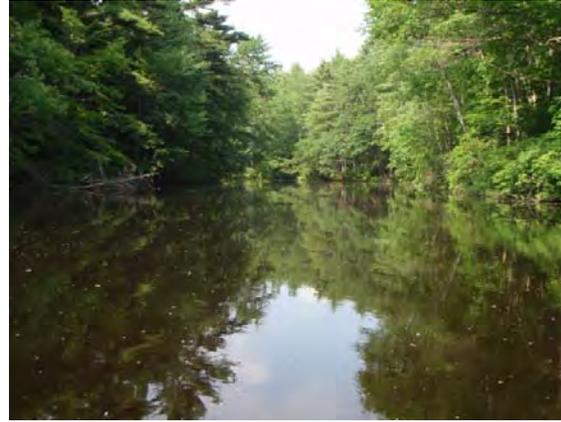
Figure 8.5 Backwater effect of Great Dam in LE02

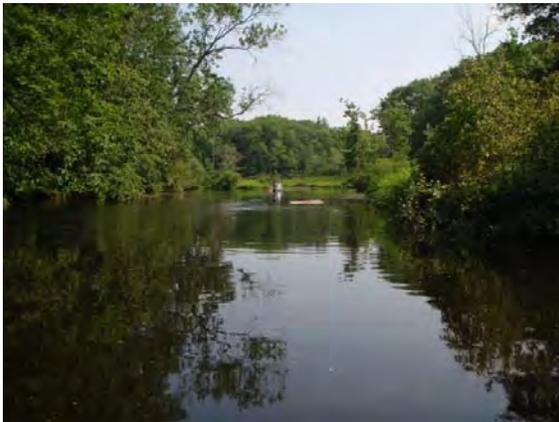
Figure 8.6 Backwater effect of Great Dam in lower LE04

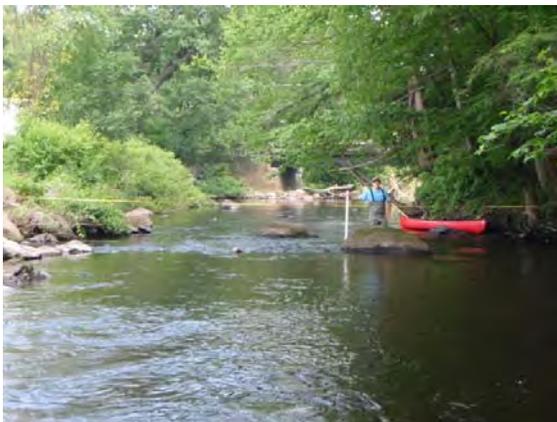
Figure 8.8 Channel cross section in LE05

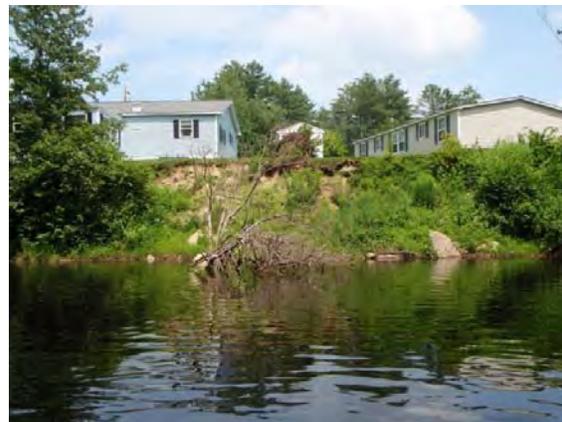
Figure 8.9 Bank failure in upper LE05 at trailer park

One large bank failure was noted along the north bank where adjacent homes have encroached upon the channel corridor and impacted the buffer (Figure 8.9). The soils associated with the failure are non-cohesive and are likely fill from the residential development in the 1970’s. Armoring and encroachment along the north bank limit the ability of the channel to migrate laterally; however given the valley setting and slope, a straight channel is likely natural. Nearly 80 percent of the north bank lacks a riparian buffer greater than 25 feet, which is contributing to increased bank erosion, thermal loading, and generally degraded habitat conditions.

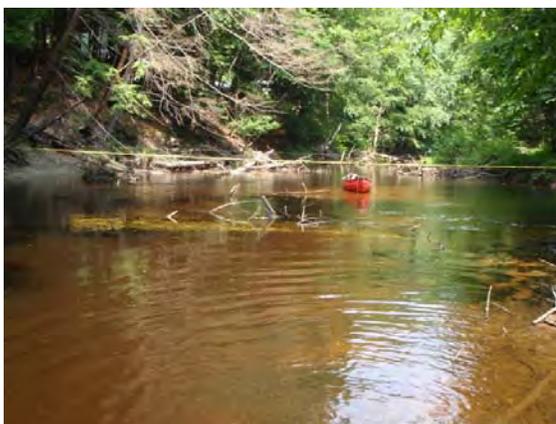
Figure 8.10 Channel cross section in LE06

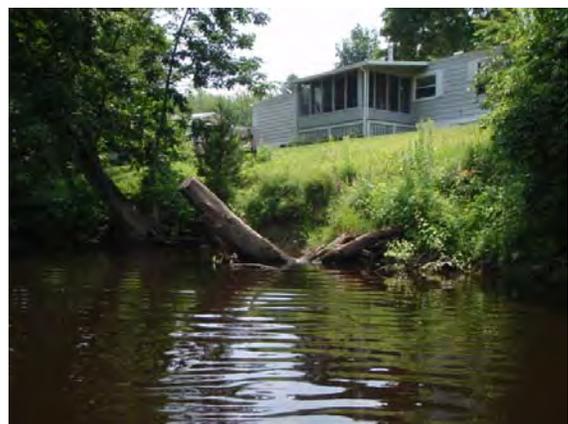
Figure 8.11 Buffer impacts from adjacent trailer park

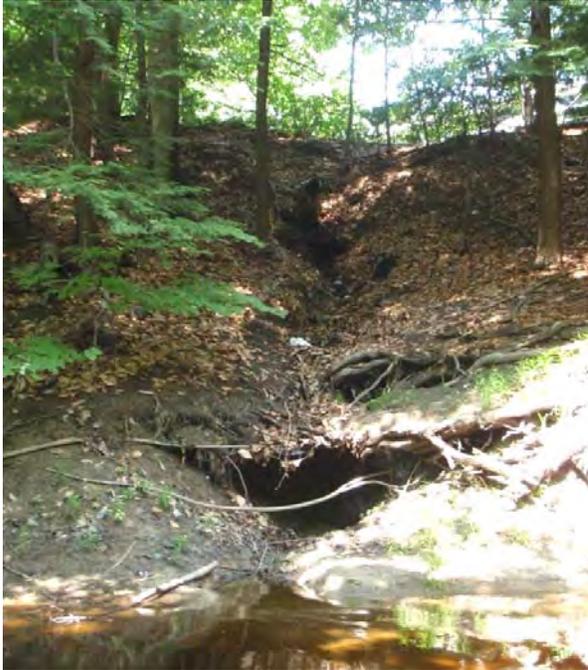
Figure 8.12 Stormwater outfall from trailer park

Two stormwater outfalls originating from the trailer park on the north bank were noted and are aggravating bank erosion. One outfall is perched along the steep side slope leading down to the river, causing gully formation (Figure 8.12) and increased sediment supply to the channel.

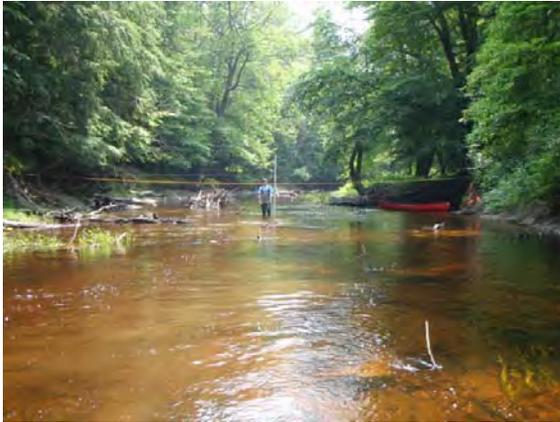
Figure 8.13 Channel cross section in LE07

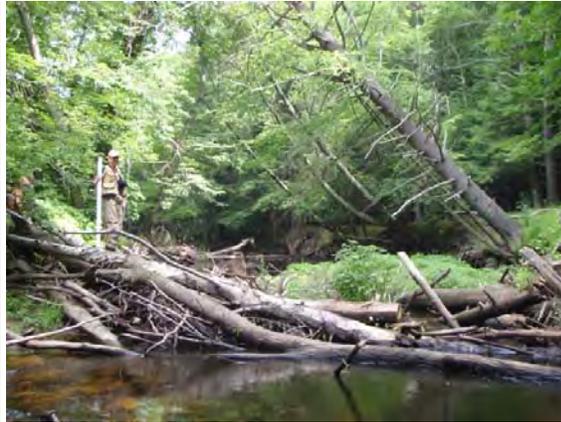
Figure 8.14 Large debris jam in upper LE07

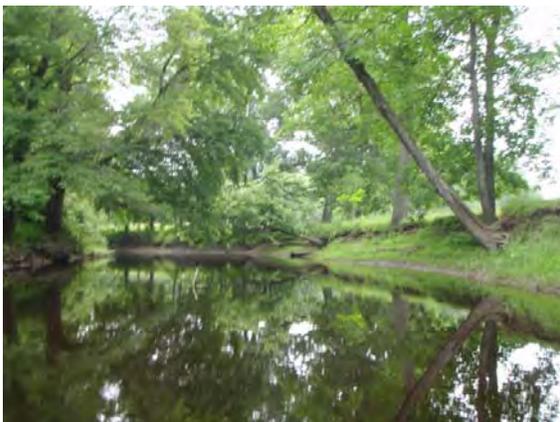
Figure 8.15 Lack of buffer and bank erosion in LE07

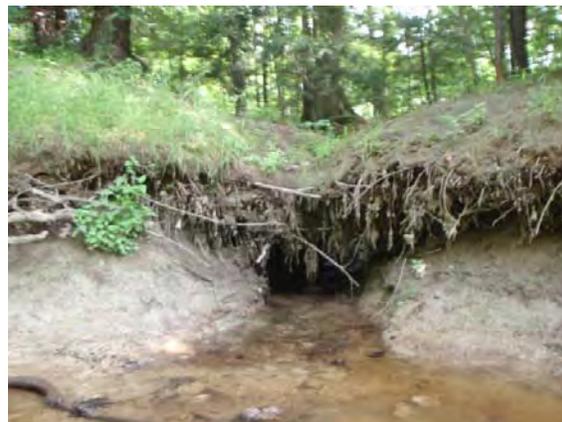
Figure 8.16 Stormwater outfall gully from River Woods

One stormwater outfall originating from the River Woods complex to the north of the river has formed a gully adjacent the channel (Figure 8.16). This outfall is causing increased supply of fine sediment to the channel, and threatens the excellent biotic habitat observed throughout the reach. River Woods, a housing community adjacent to the river, has hired an engineer and a soil scientist to address the problem, which may lead to the design and construction of a stormwater BMP to control runoff from the extensive area of impervious cover upslope.

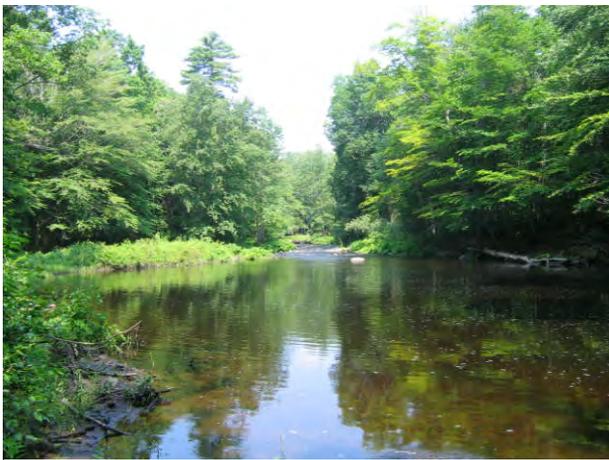
Figure 8.17 The widened area downstream of the grade control

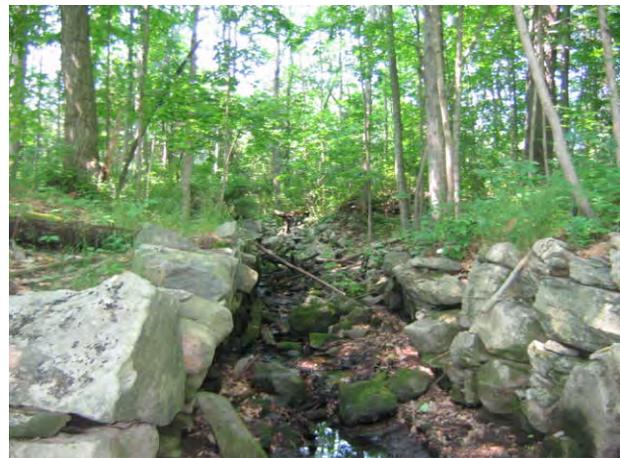
Figure 8.18 A mill sluice or canal observed off the right bank downstream of the grade control

The geomorphic rating of this reach was influenced by the widening observed in the upper and lower sections of this reach as well as some aggradation in the form of mid-channel bars. However, the combined impact of stressors to the stability of the reach remained low and the RGA score was “good.” The aggradational processes follow the D-type channel evolution model. The channel evolution stage was assessed at stage IIc. Downstream of the grade control a historic mill sluice or canal was observed off the south bank (Figure 8.18).

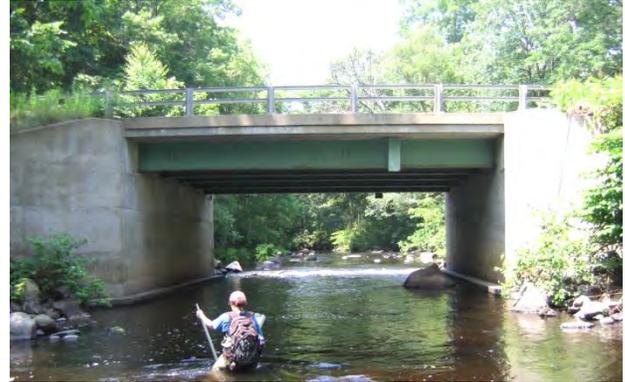
Figure 8.20 Kingston Road crossing with coarse substrate and riffle-pool bedform

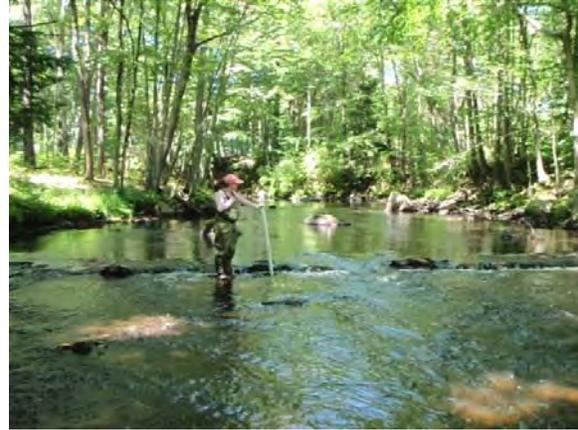
Figure 8.21 An upstream view of the grade control

width to depth ratio ($WDR = 35$) may be natural for the narrow valley setting. A small bedrock grade control was observed mid-segment (Figure 8.21). Downstream of this ledge feature there is a well formed and complete riffle. Upstream of the grade control a calm, shallow backwater was observed. Minor aggradation of fine sediment observed in this area.

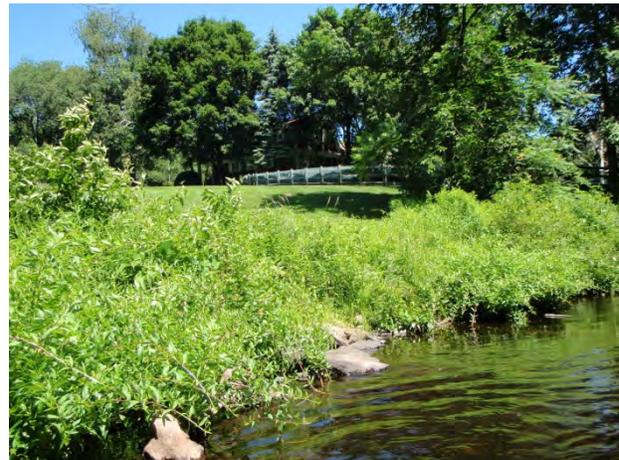
Figure 8.22 Area of low buffer observed in the upper segment

At the reach break with LE10 the riparian buffer is less than 25 feet (Figure 8.22). A lawn is maintained within close proximity of the channel for approximately 125 feet. Just downstream of this some erosion was observed on the south and north banks in the area where the channel meanders to the south. This is one likely source of the sediment that is trapped on the upstream end of the grade control. There was limited woody debris found in this segment ($LWD = 55$ pieces/mile). Since this segment is largely a transport-based system, woody debris is likely transported downstream in large storm events. The overall habitat condition of this reach was rated “fair” because of the low density of woody debris in addition to the areas where buffer and bank integrity was impacted. Some widening and associated with the bank stability caused the geomorphic condition decrease slightly, but still remain in the “good” category. The channel showed little evidence of present or historical incision (CEM stage I).

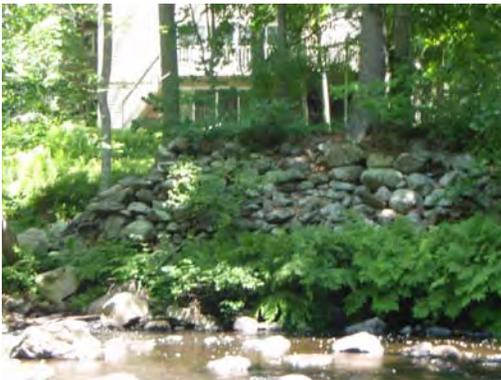
Figure 8.23 Foundation of historic mill observed on the north bank mid-segment

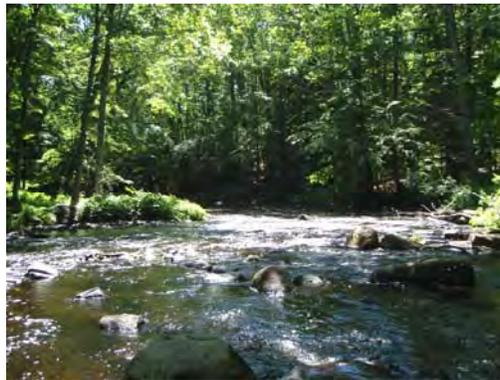
Figure 8.24 A well formed riffle upstream of the bridge abutments

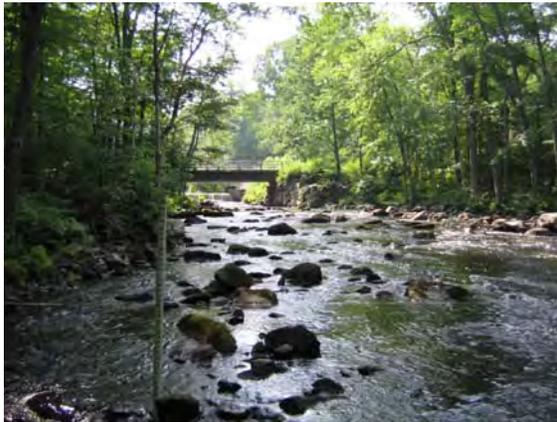
Figure 8.25 Widening downstream of Pickpocket Dam

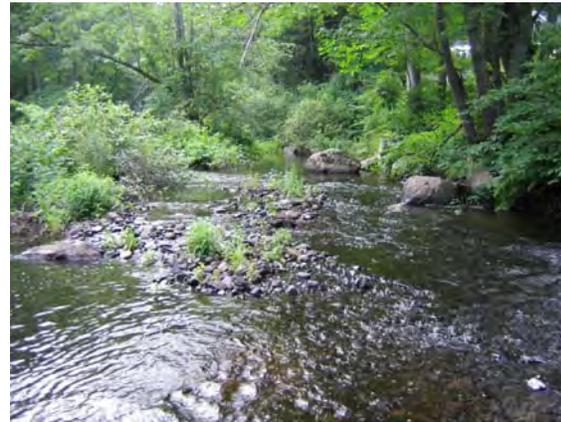
Figure 8.26 Diagonal bar in lower portion of segment

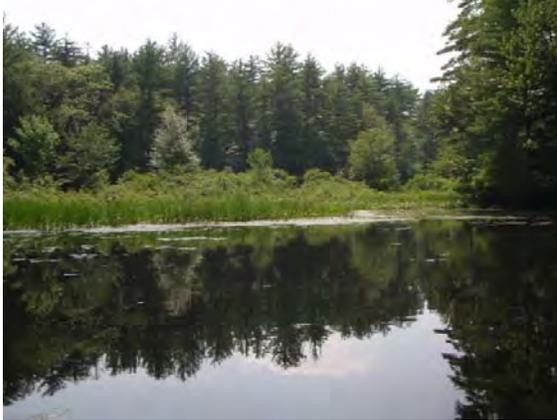
Figure 8.27 Impounded conditions above Pickpocket Dam

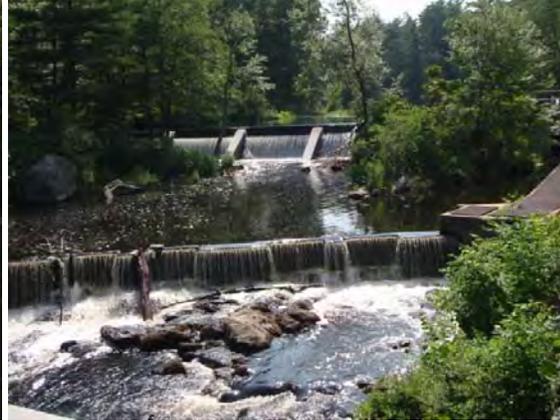
Figure 8.28 Pickpocket Dam

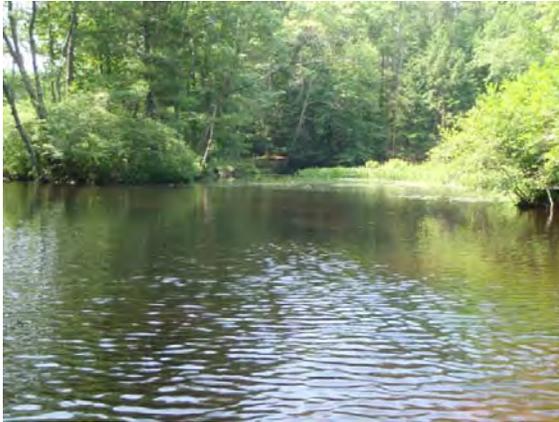
Figure 8.29 Confluence with Little River in LE12

The upstream limit of the Lower Exeter River study area is found at the confluence with the Little River (Figure 8.29). At this point, the drainage area to the river is 74.8 square miles. This reach was accessed for Phase 2 surveys by canoeing downstream from the Haigh Road crossing, located approximately one mile upstream of the Little River. Due to the backwater effect of the Pickpocket Dam, this stretch of river is impounded and is not governed by fluvial geomorphic processes. Channel geometry data originally collected for stream typing and RGA/RHA scoring were not used to develop sensitivity ratings for FEH and other corridor planning purposes, and should not be compared to non-impounded reaches downstream of LE11. An administrative judgment was used to determine RGA and RHA scores of “good” for this reach. Habitat data collected for banks and buffers, LWD densities, debris jams, and undercut banks in upper LE12 suggest that good habitat existed in the reach prior to the flooding caused by the dam.

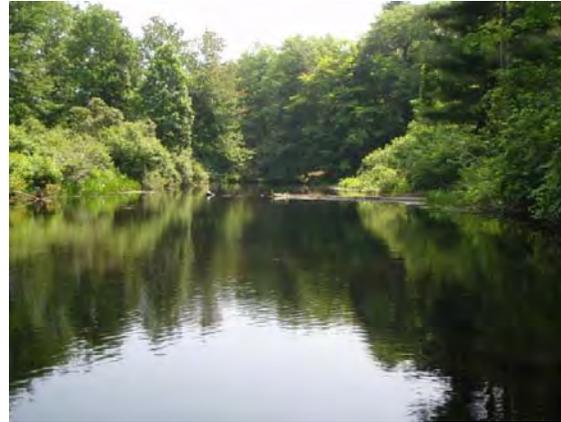
Figure 8.30 Healthy riparian buffer conditions in LE12

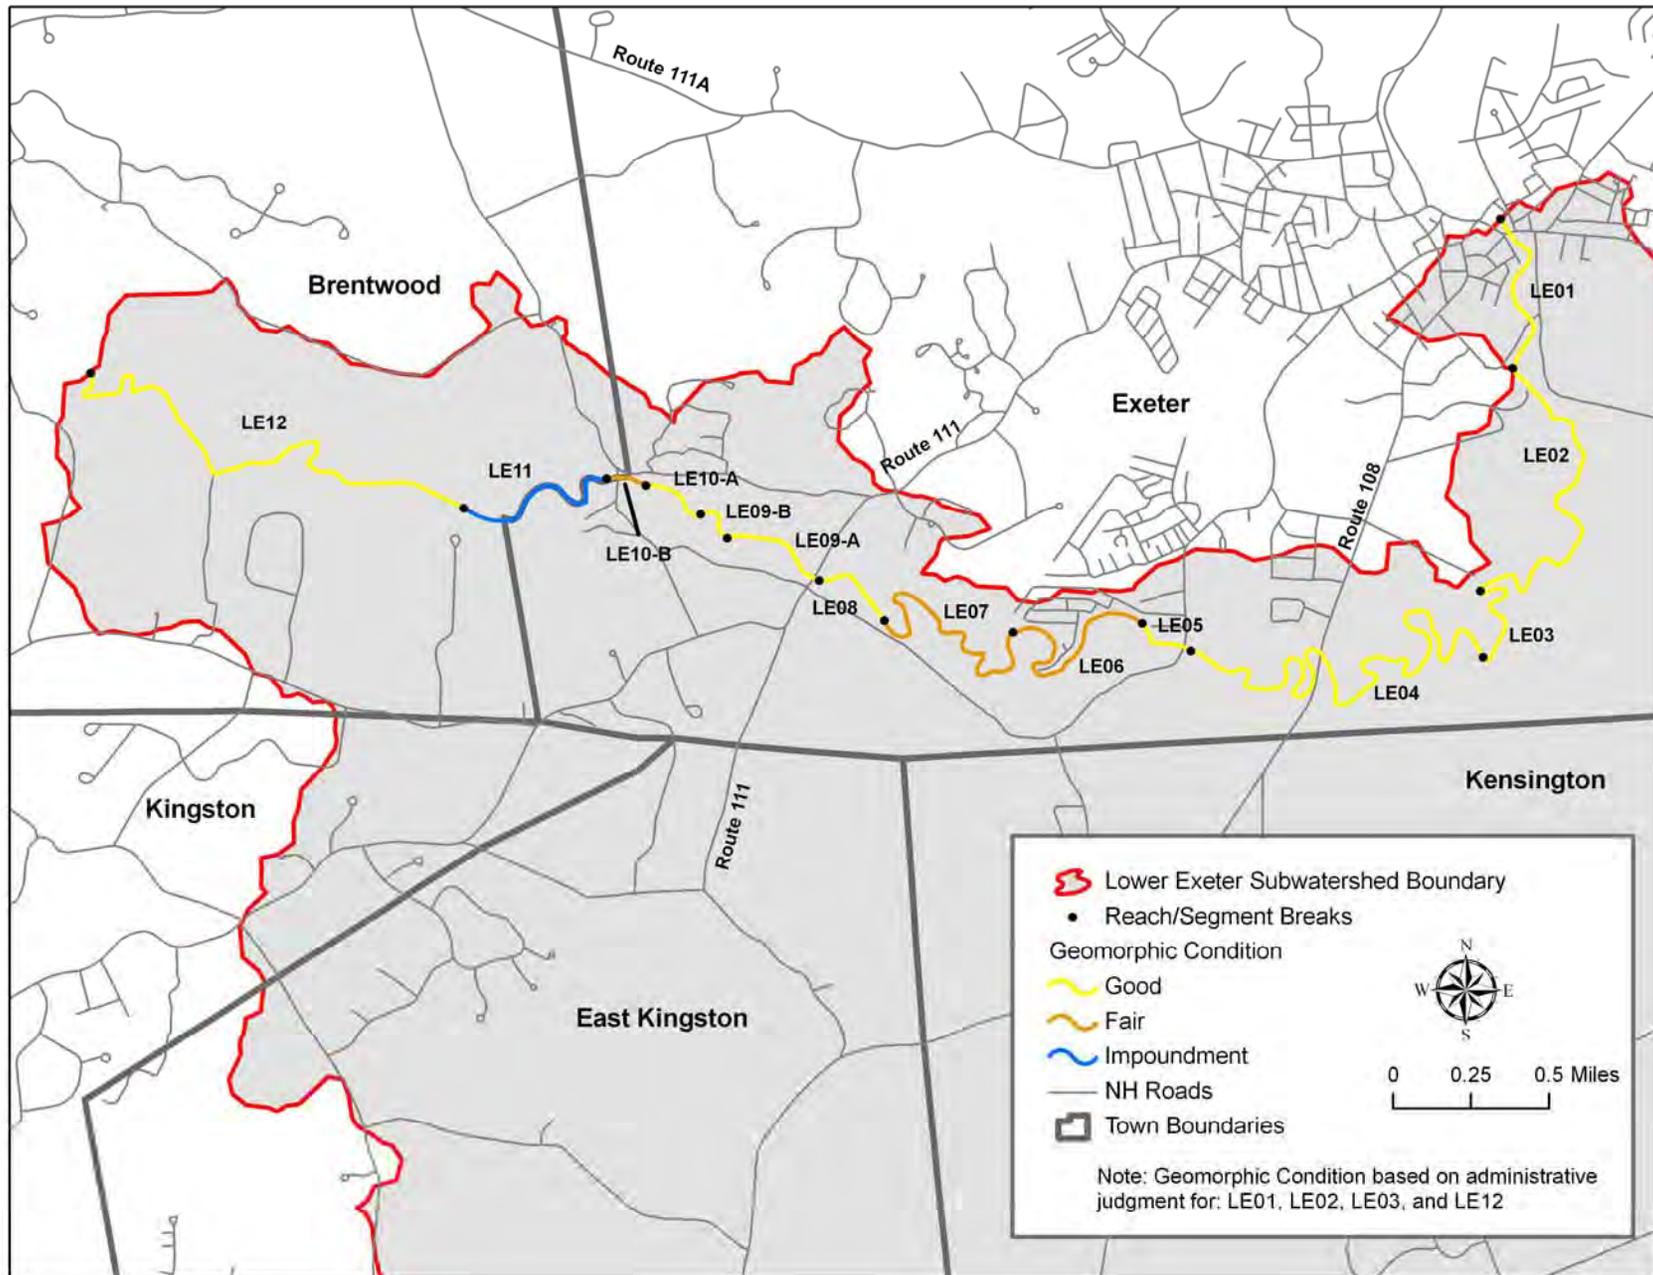
Figure 8.31 Geomorphic condition of assessed reaches in the Lower Exeter subwatershed

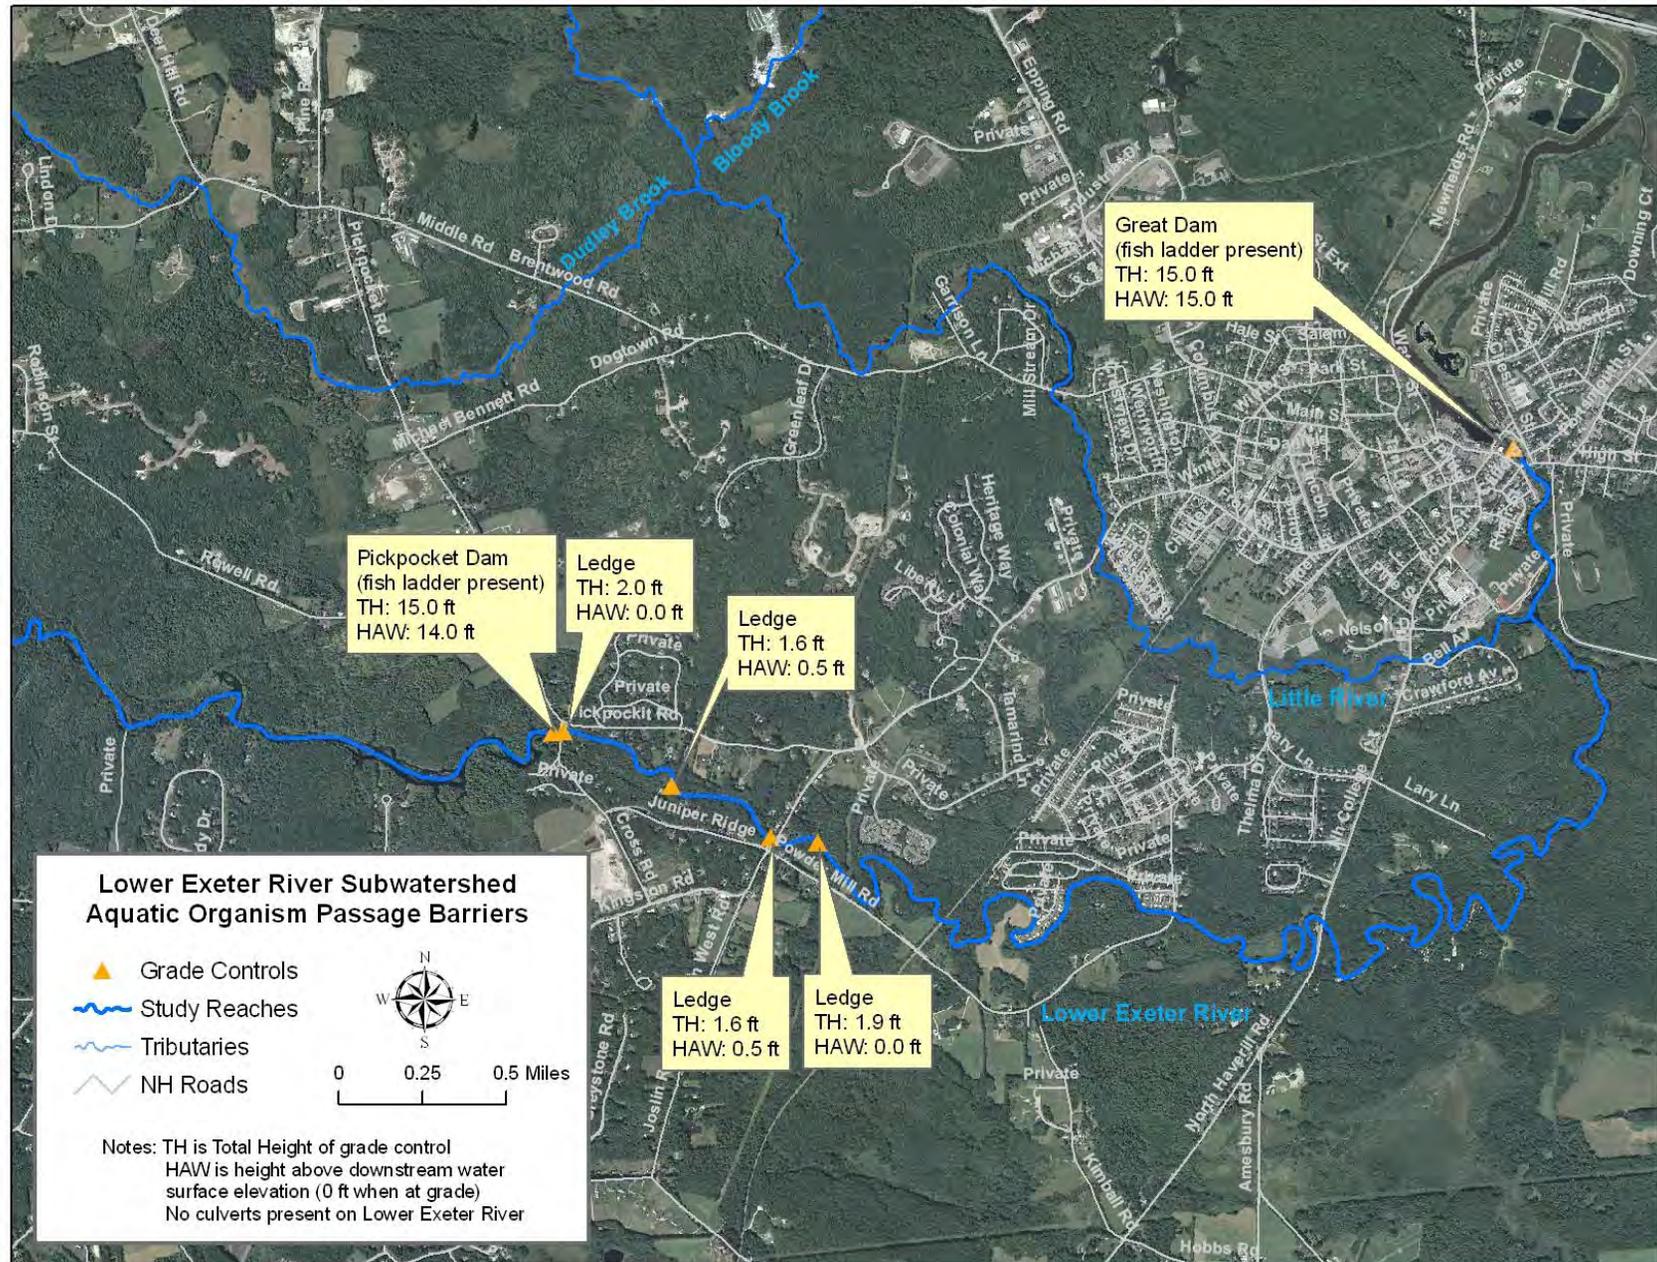
Figure 8.32 Aquatic organism passage barriers in the Lower Exeter subwatershed Page D-20

Figure 8.32 depicts the aquatic organism passage barriers for the Lower Exeter River subwatershed, including dams and grade controls. Two human made grade controls were identified as reducing aquatic organism passage.

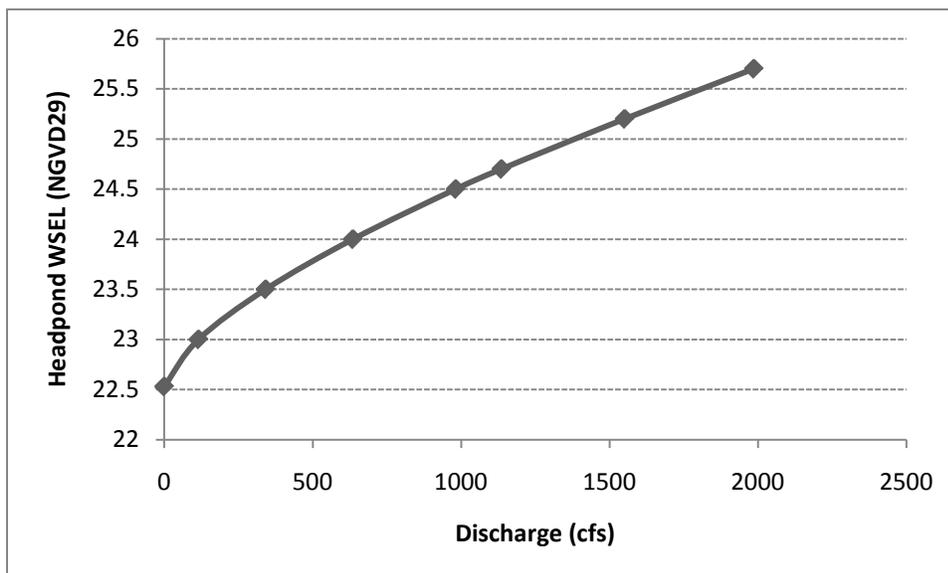
FIGURE 1 GREAT DAM EXISTING CONDITION DISCHARGE RATING CURVE

For the Great Dam to be in compliance with NHDES Dam Bureau regulations, the maximum head pond elevation under the 50 year flood condition is El. 24.7 ft (NGVD29). At this water surface elevation, the spillway discharge capacity is only 1,136 cfs which is approximately 20% of the needed capacity (Figure 1). At approximately 2,000 cfs, the dam overtops the left abutment at El. 25.7. At these flows, we have assumed no flow through the low level gate, no submergence, the main spillway acts as an Ogee-type (coefficient of discharge is approximately 3.9), and a short spillway section next to the right abutment acts as a broad-crested spillway (coefficient of discharge is approximately 2.65). As the flows increase, the tailwater elevations which are affected by the fishway weir submerge the spillway resulting in higher upstream water levels. Therefore, a significant increase in discharge capacity is required to bring the Great Dam into compliance.

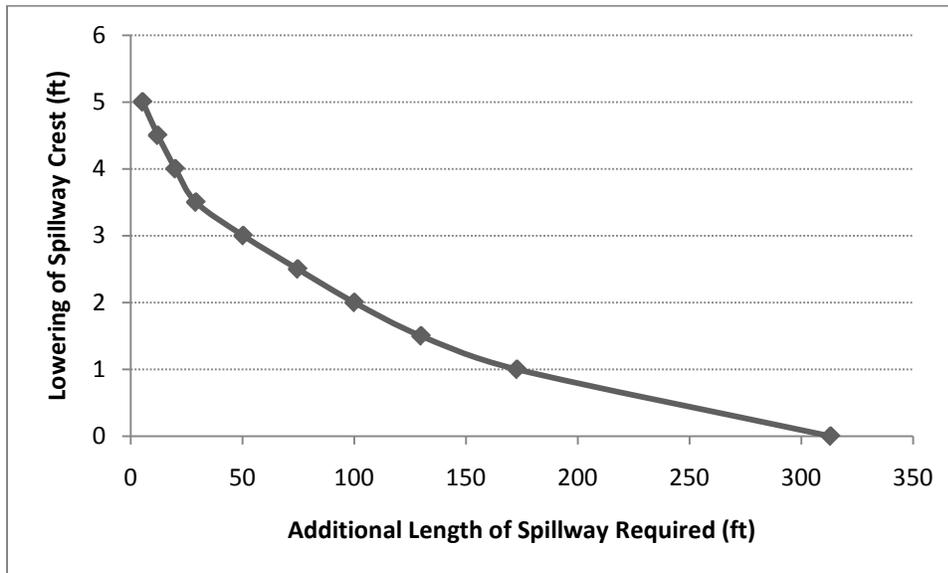
FIGURE 2 ADDITIONAL LENGTH OF SPILLWAY REQUIRED TO PASS THE 50 YR FLOOD AT VARIOUS DECREASES IN SPILLWAY HEIGHT.

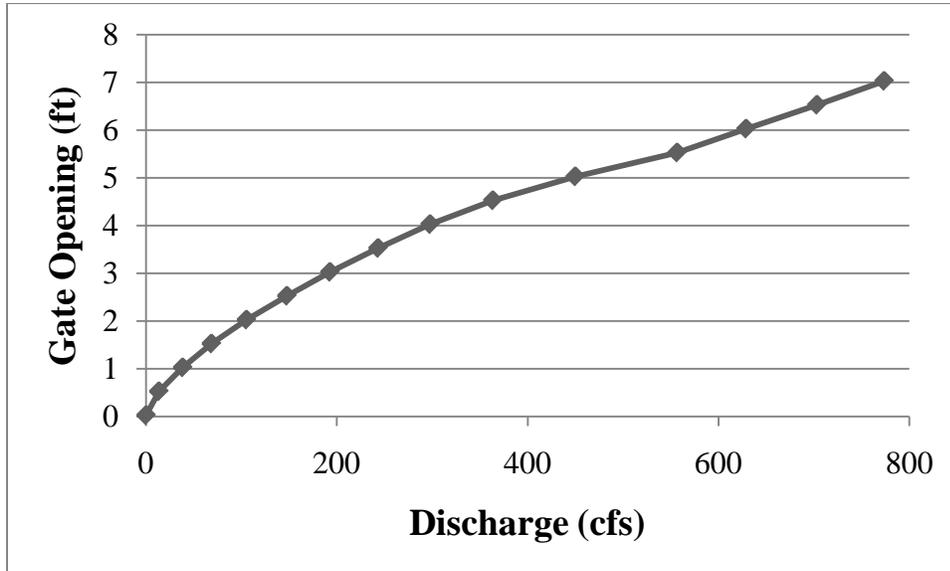
FIGURE 3 DISCHARGE CAPACITY OF THE SIDE GATE AT NORMAL HEAD POND LEVELS.

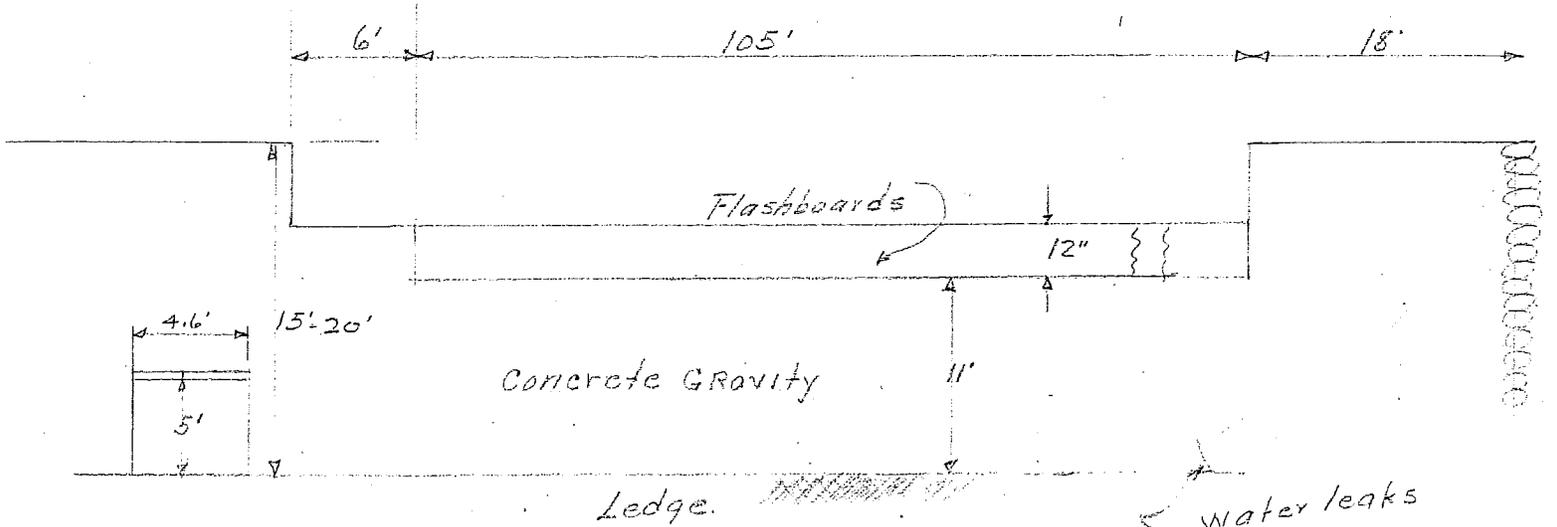
Water leaks thru here below dam

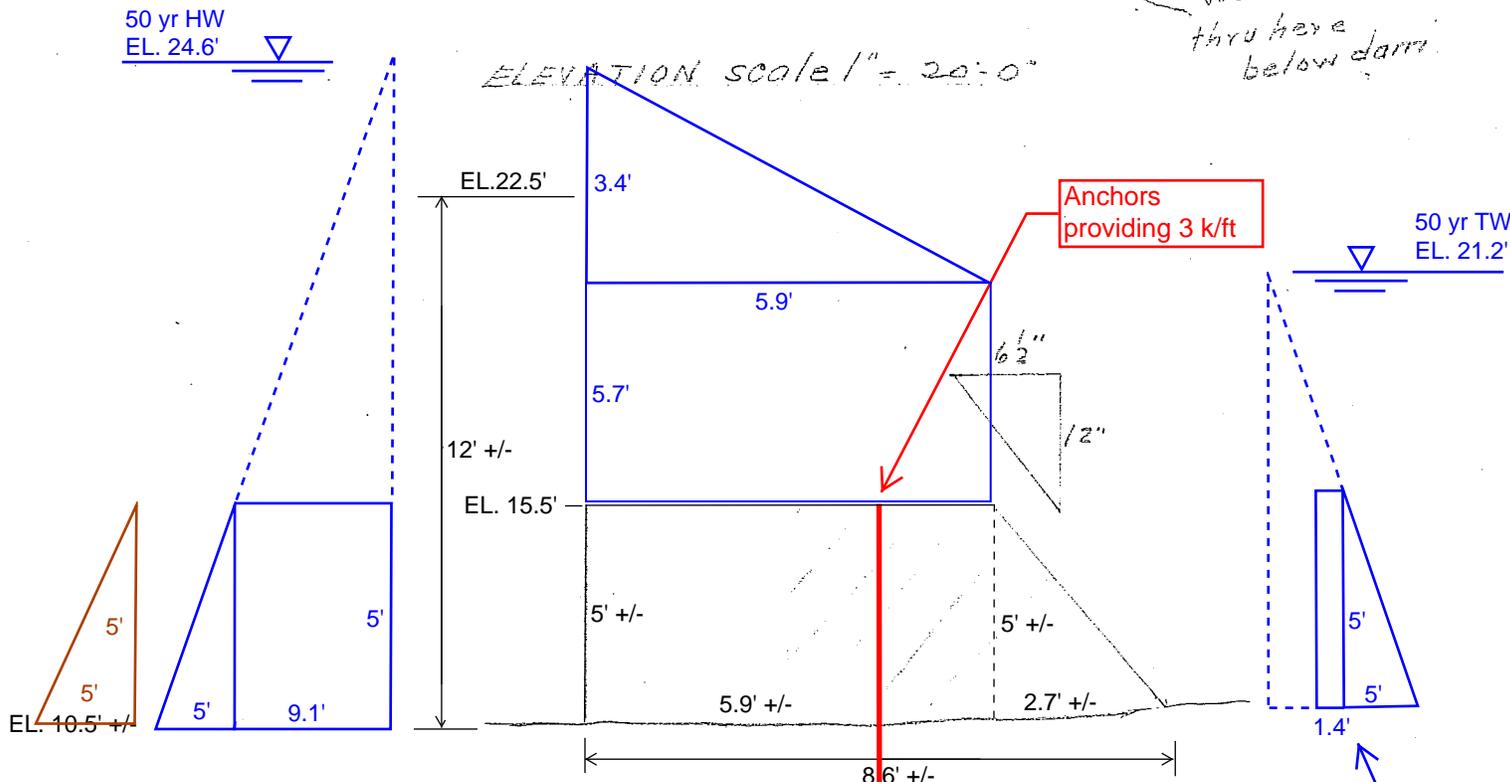
**50 YEAR FLOOD
with
DEEP GATE**

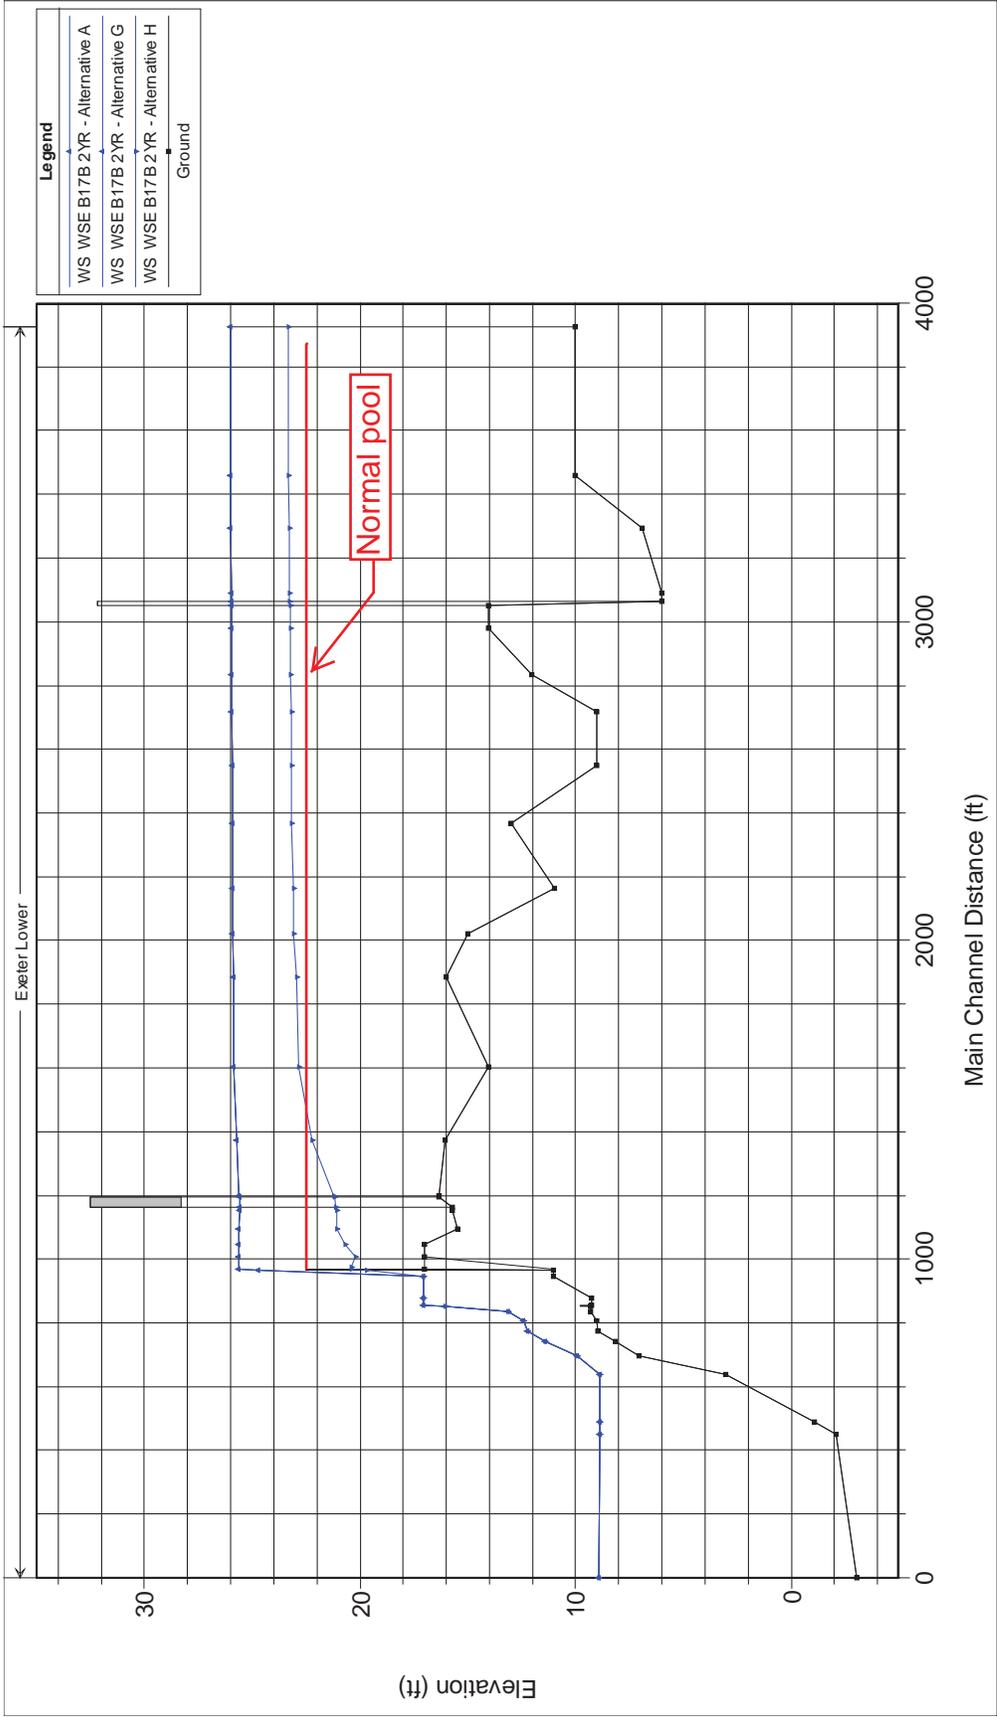
FIGURE G-3-1 WATER SURFACE PROFILE OF THE MODELED RIVER HYDRAULICS FOR THE 2 YEAR FLOOD EVENT FOR EXISTING CONDITIONS (ALTERNATIVE A), ROCK ANCHORS (ALTERNATIVE G), AND GATE/FLASHBOARD SYSTEM (ALTERNATIVE H).

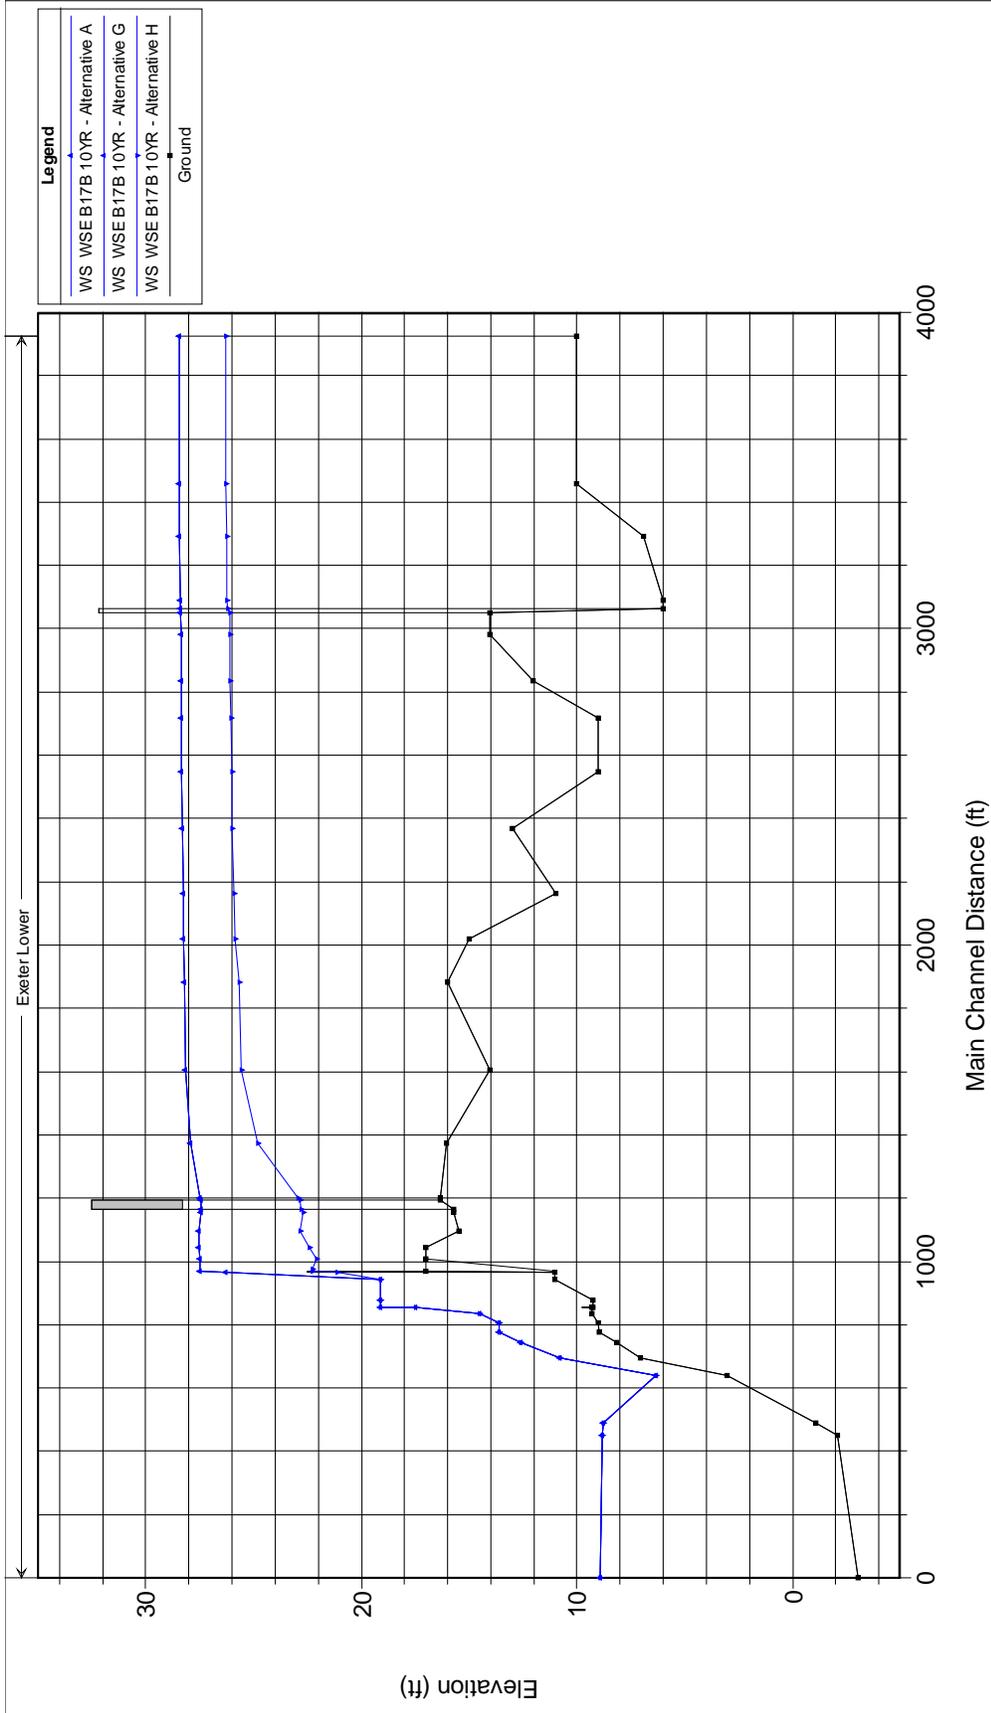
FIGURE G-3-2 WATER SURFACE PROFILE OF THE MODELED RIVER HYDRAULICS FOR THE 10 YEAR FLOOD EVENT FOR EXISTING CONDITIONS (ALTERNATIVE A), ROCK ANCHORS (ALTERNATIVE G), AND GATE/FLASHBOARD SYSTEM (ALTERNATIVE H).

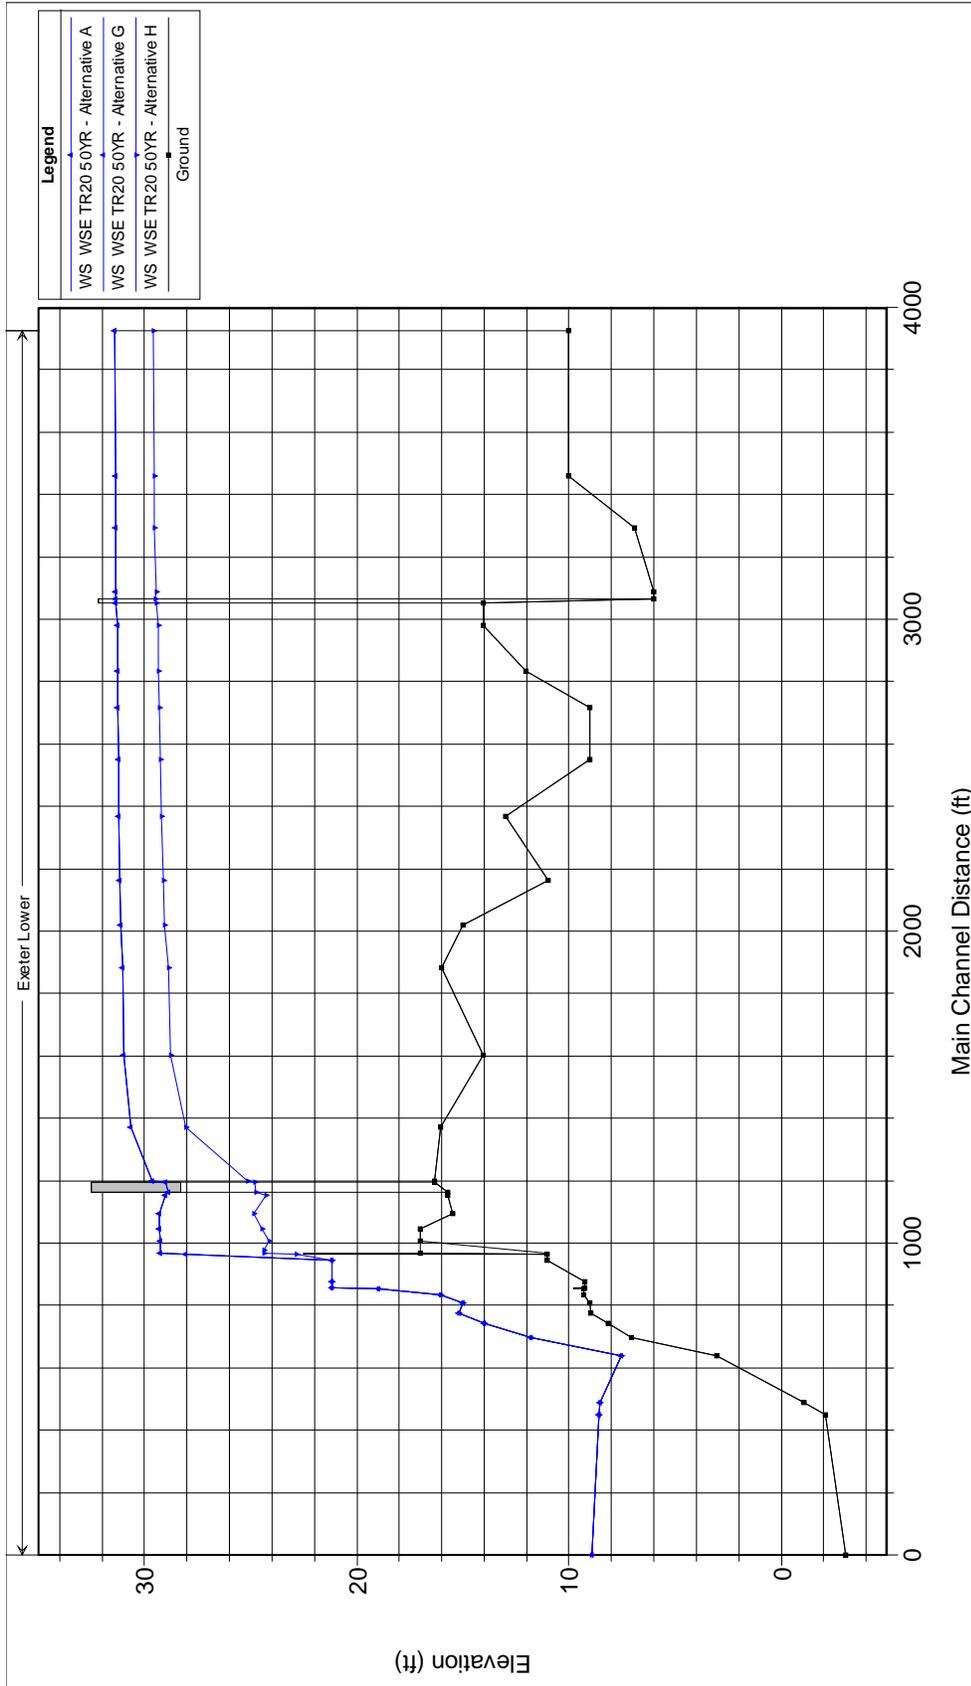
FIGURE G-3-3 WATER SURFACE PROFILE OF THE MODELED RIVER HYDRAULICS FOR THE 50 YEAR FLOOD EVENT FOR EXISTING CONDITIONS (ALTERNATIVE A), ROCK ANCHORS (ALTERNATIVE G), AND GATE/FLASHBOARD SYSTEM (ALTERNATIVE H).
