Exeter River Great Dam Removal Feasibility and Impact Study

Exeter, New Hampshire

Prepared by **VHB/Vanasse Hangen Brustlin, Inc.**
Bedford, New Hampshire

FINAL - October 2013

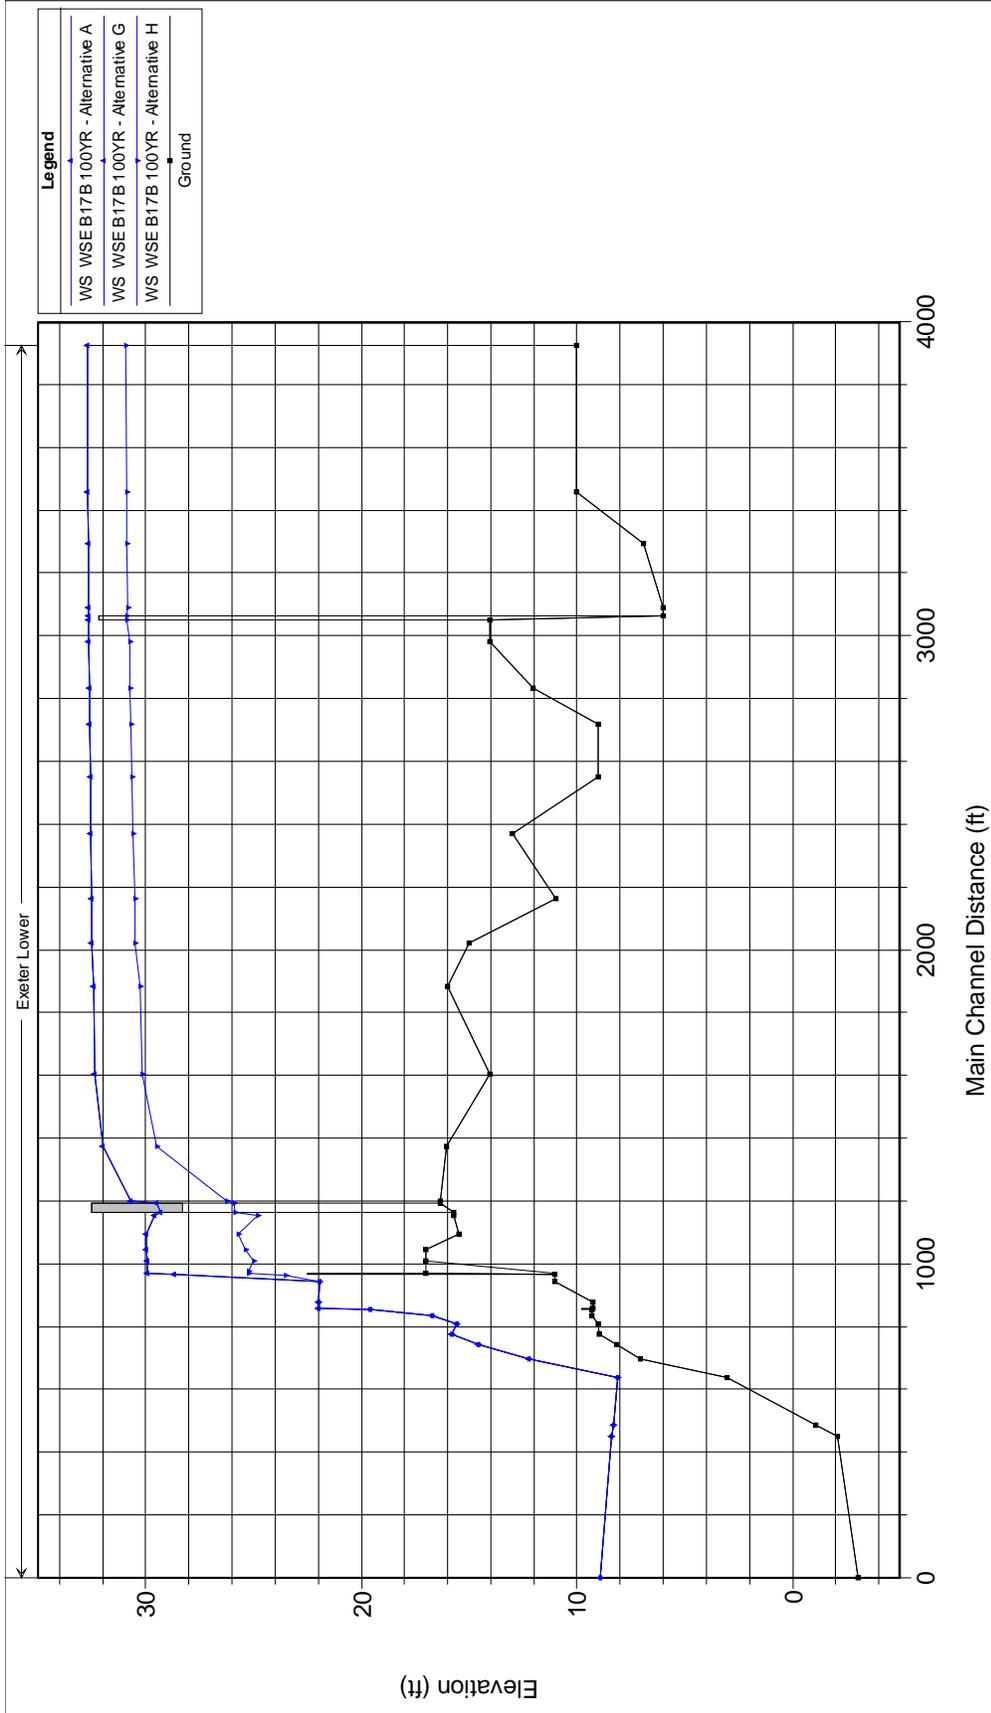
FIGURE G-3-4 WATER SURFACE PROFILE OF THE MODELED RIVER HYDRAULICS FOR THE 100 YEAR FLOOD EVENT FOR EXISTING CONDITIONS (ALTERNATIVE A), ROCK ANCHORS (ALTERNATIVE G), AND GATE/FLASHBOARD SYSTEM (ALTERNATIVE H).

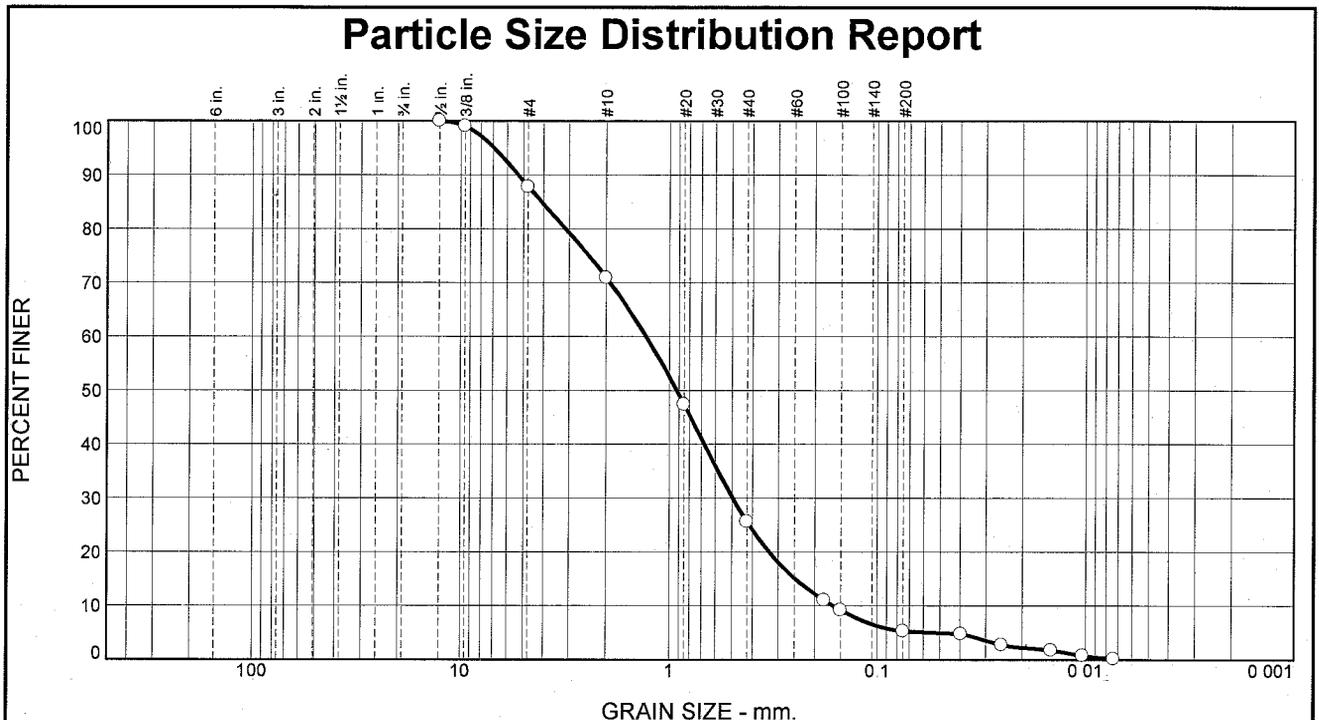
ER-1: Downstream of the Dam

% Cobbles	% Gravel		% Sand			% Fines	
	Coarse	Fine	Coarse	Medium	Fine	Silt	Clay
0.0	0.0	12.2	16.9	45.3	20.3	5.3

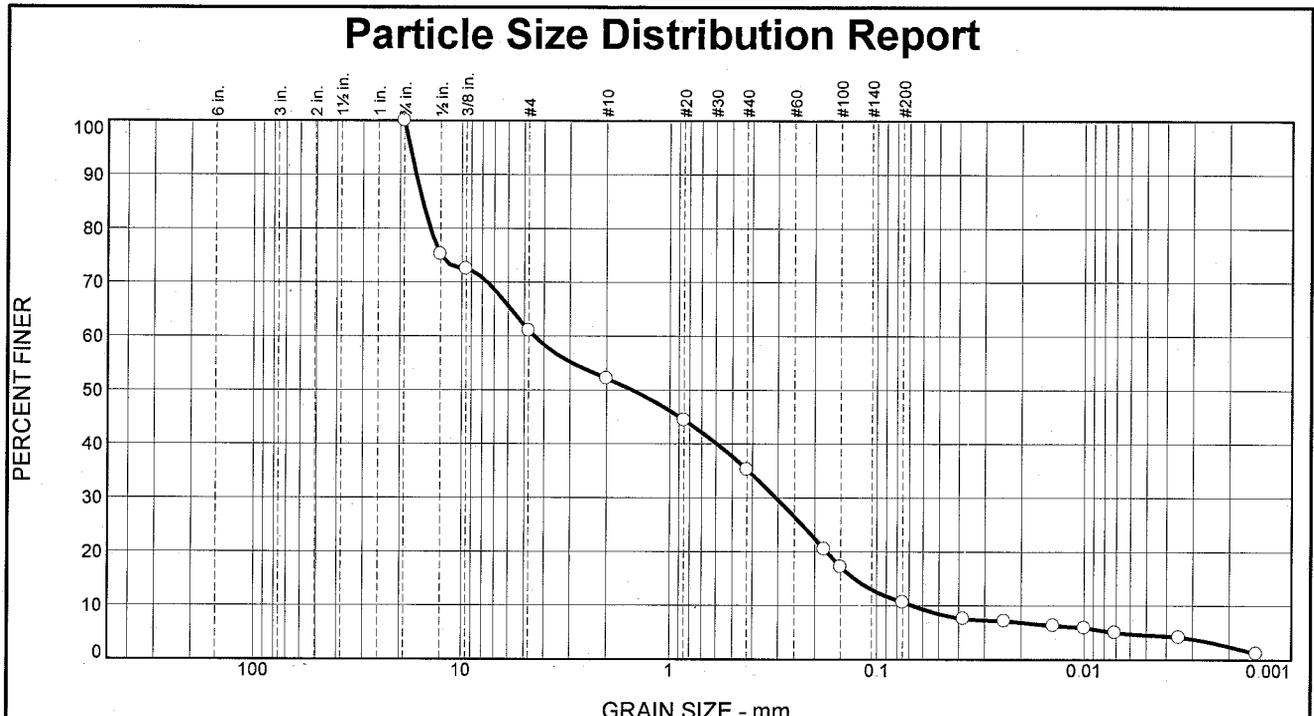
ER-2: Immediately Upstream of the Dam

% Cobbles	% Gravel		% Sand			% Fines	
	Coarse	Fine	Coarse	Medium	Fine	Silt	Clay
0.0	0.0	39.0	8.9	16.9	24.6	6.1	4.5

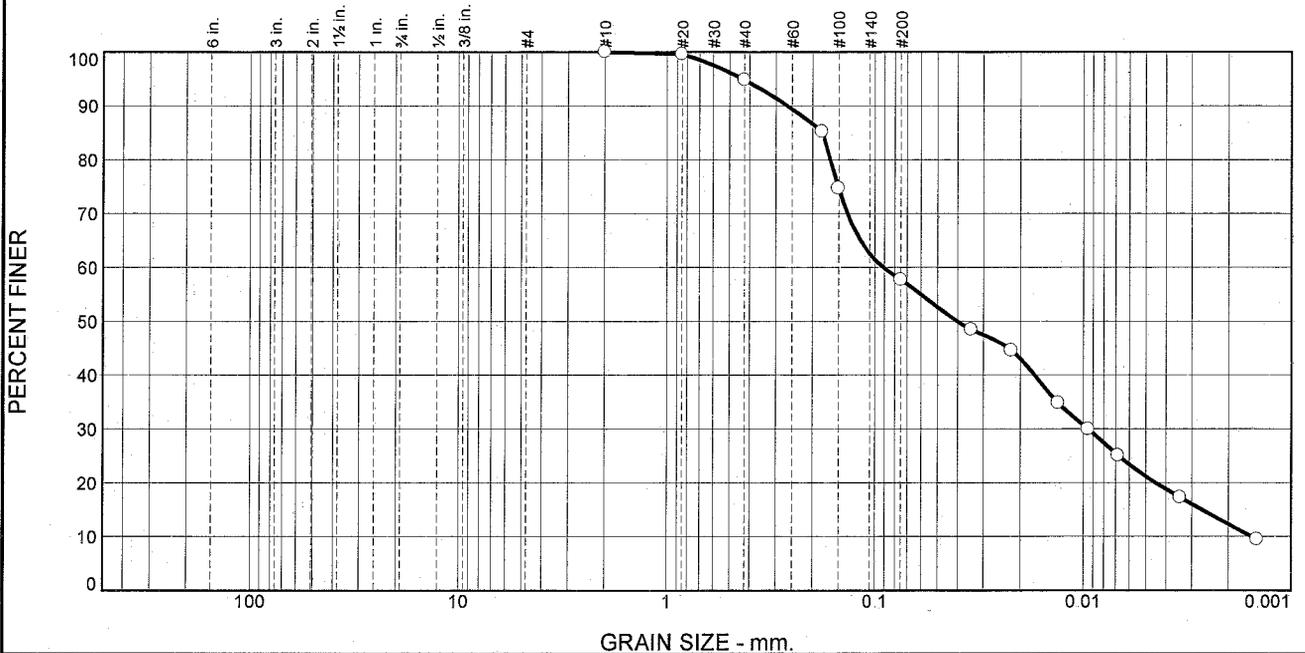
% Cobbles	% Gravel		% Sand			% Fines	
	Coarse	Fine	Coarse	Medium	Fine	Silt	Clay
0.0	0.0	0.0	0.0	5.2	37.1	36.5	21.2

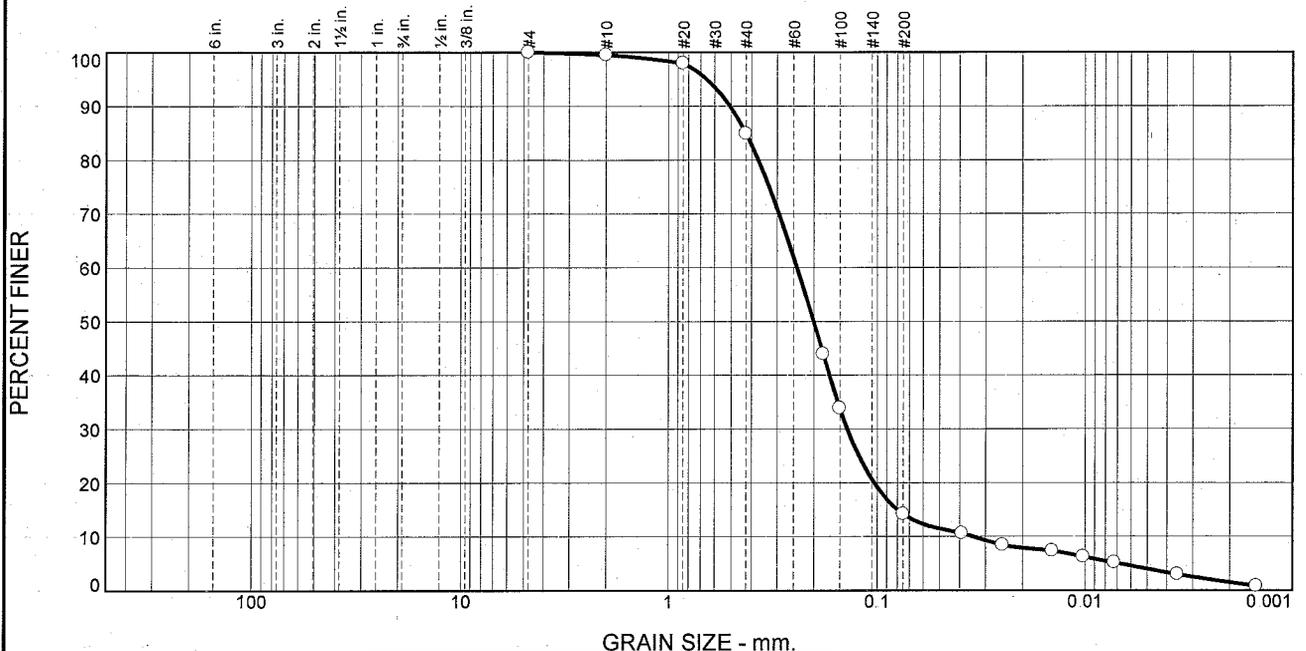
% Cobbles	% Gravel		% Sand			% Fines	
	Coarse	Fine	Coarse	Medium	Fine	Silt	Clay
0.0	0.0	0.0	0.5	14.6	70.7	10.2	4.0

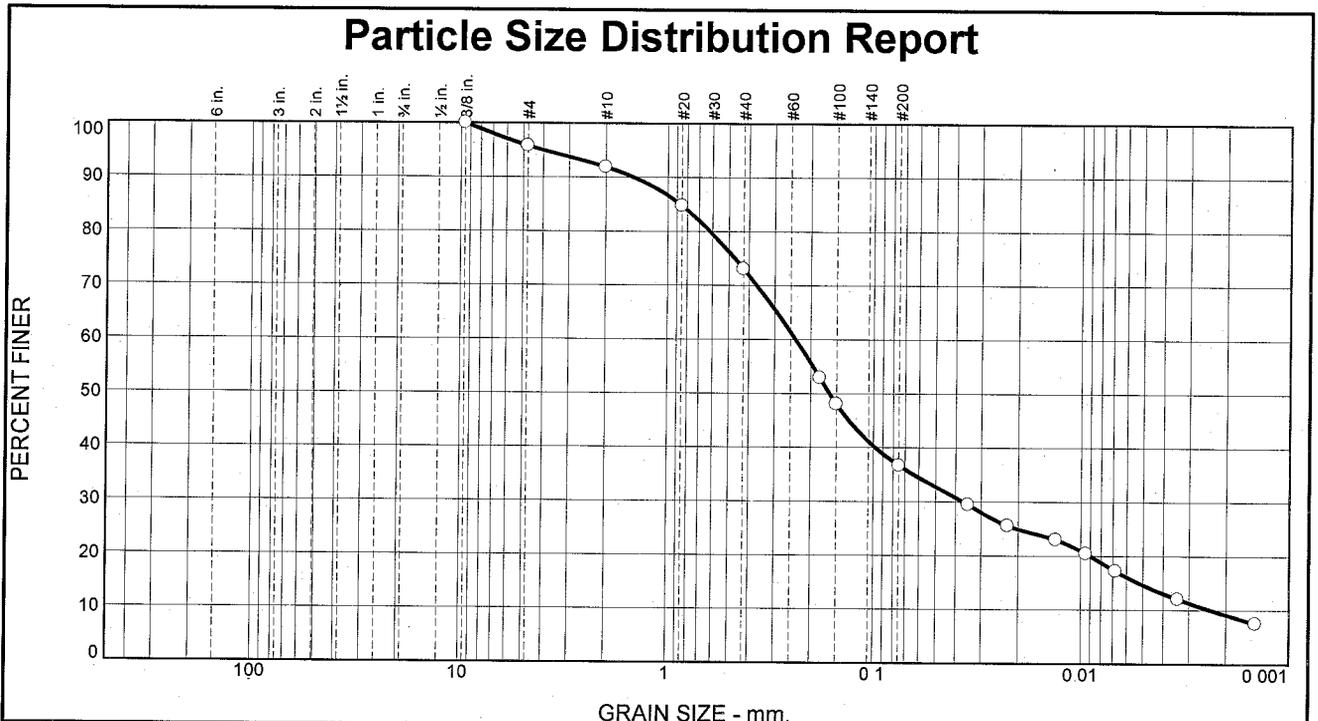
% Cobbles	% Gravel		% Sand			% Fines	
	Coarse	Fine	Coarse	Medium	Fine	Silt	Clay
0.0	0.0	4.2	3.9	18.8	36.4	22.1	14.6

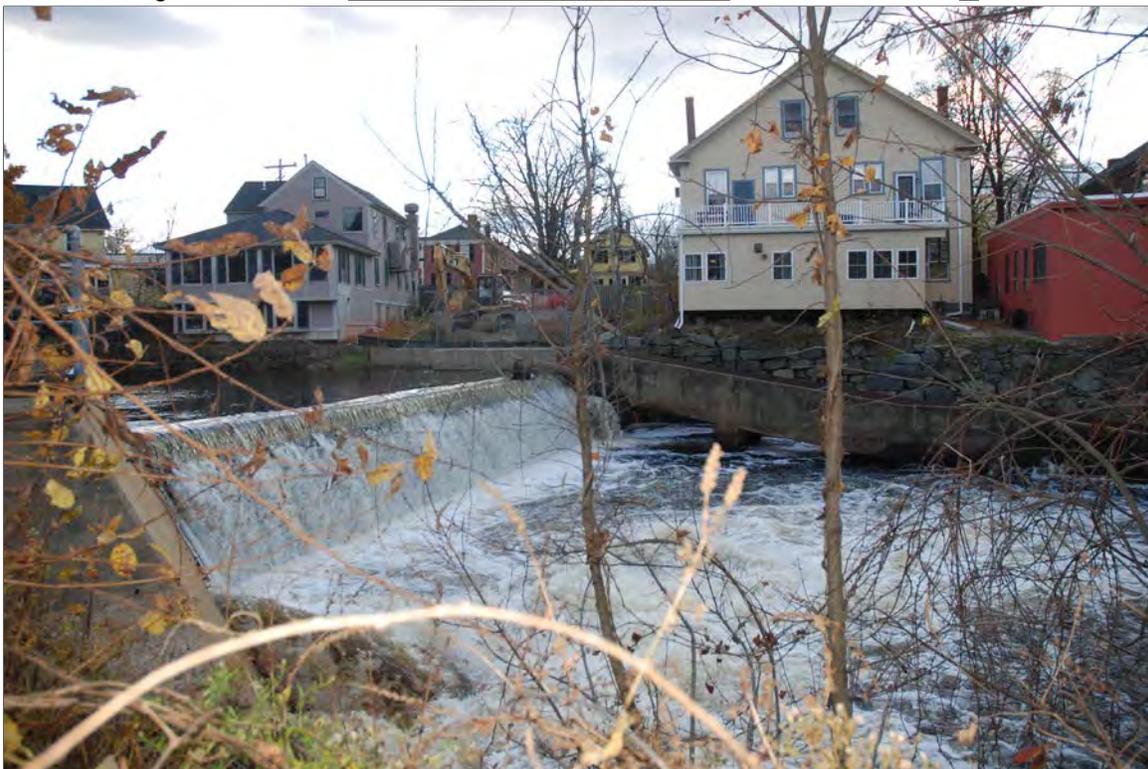
Photo # 7 Description: View of dam and fish passage from east bank of Exeter River
Roll and Frame # OR Digital file name: EXE0043_07 Direction: W

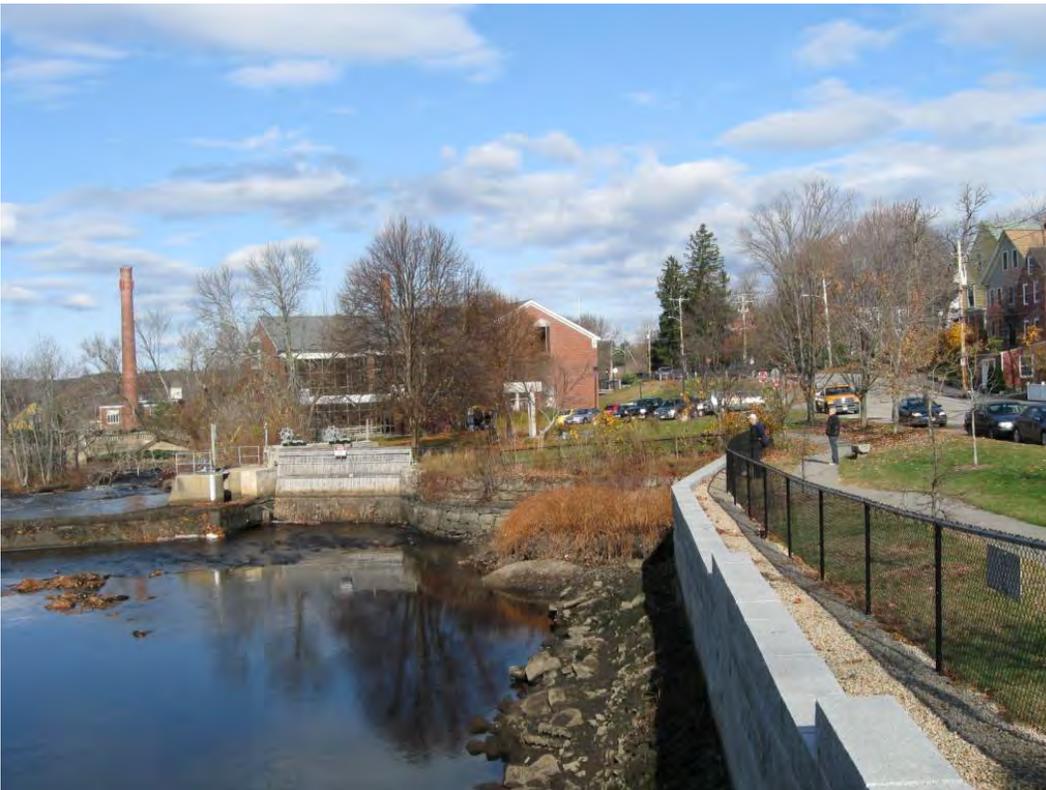
View of dam (on left), low-level gate, and penstock baffle wall, facing NE from Founders' Park
