Annual Monitoring Report 2019 (Year 3)

Exeter River Great Dam Removal Project

December 2019

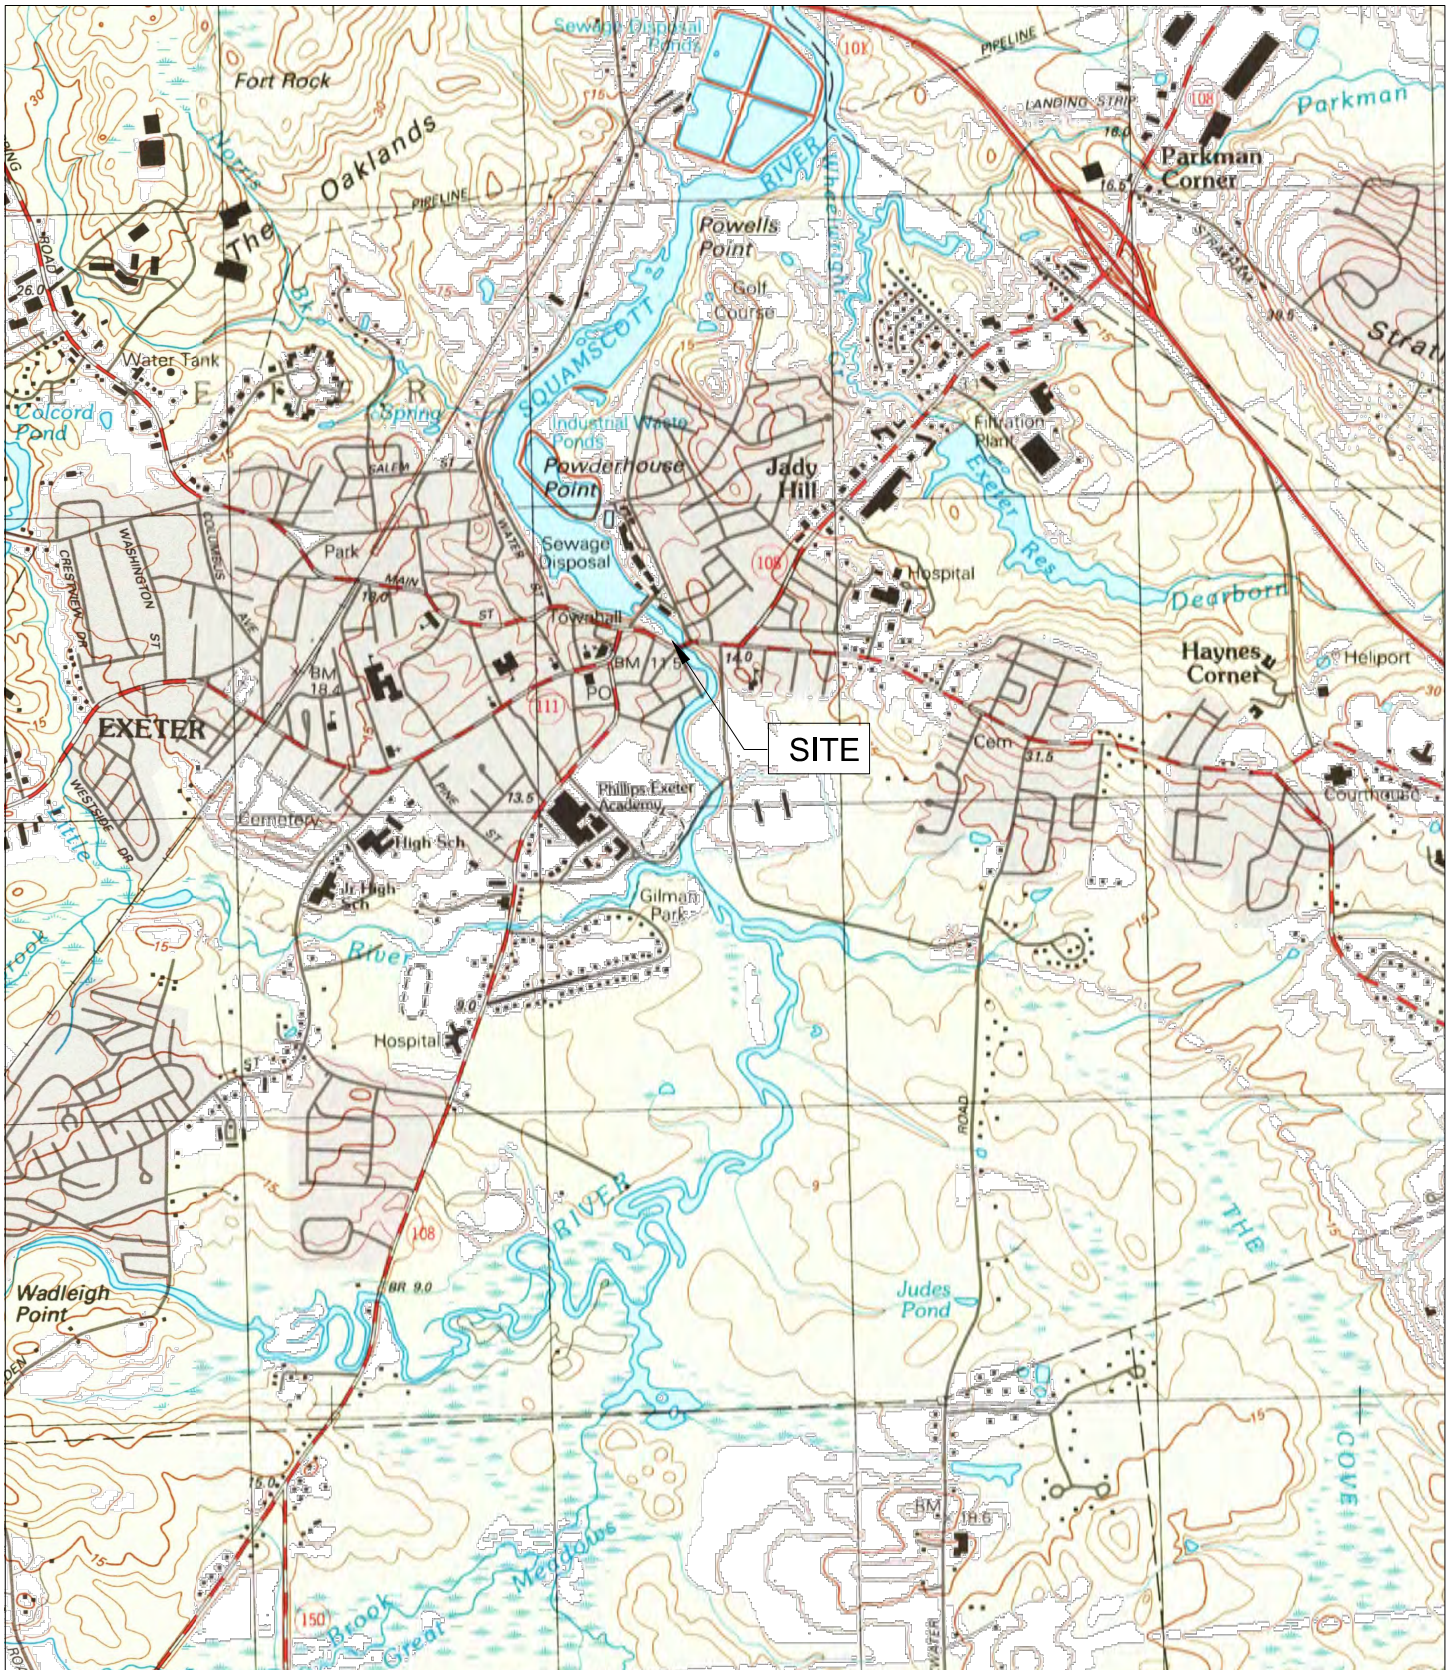
| 2 | Exeter Great Dam Monitoring Cross-Sections Plan |

On behalf of the Town, VHB survey staff established five (5) cross-sections with permanent monuments in the locations depicted in **Figure 2**. Cross sections were proposed in locations that would provide good long-term monitoring of stream geomorphology and would allow safe access by survey teams. The locations were discussed with NHDES, NHFGD and NOAA habitat restoration specialists and approved by NHDES on November 8, 2016.

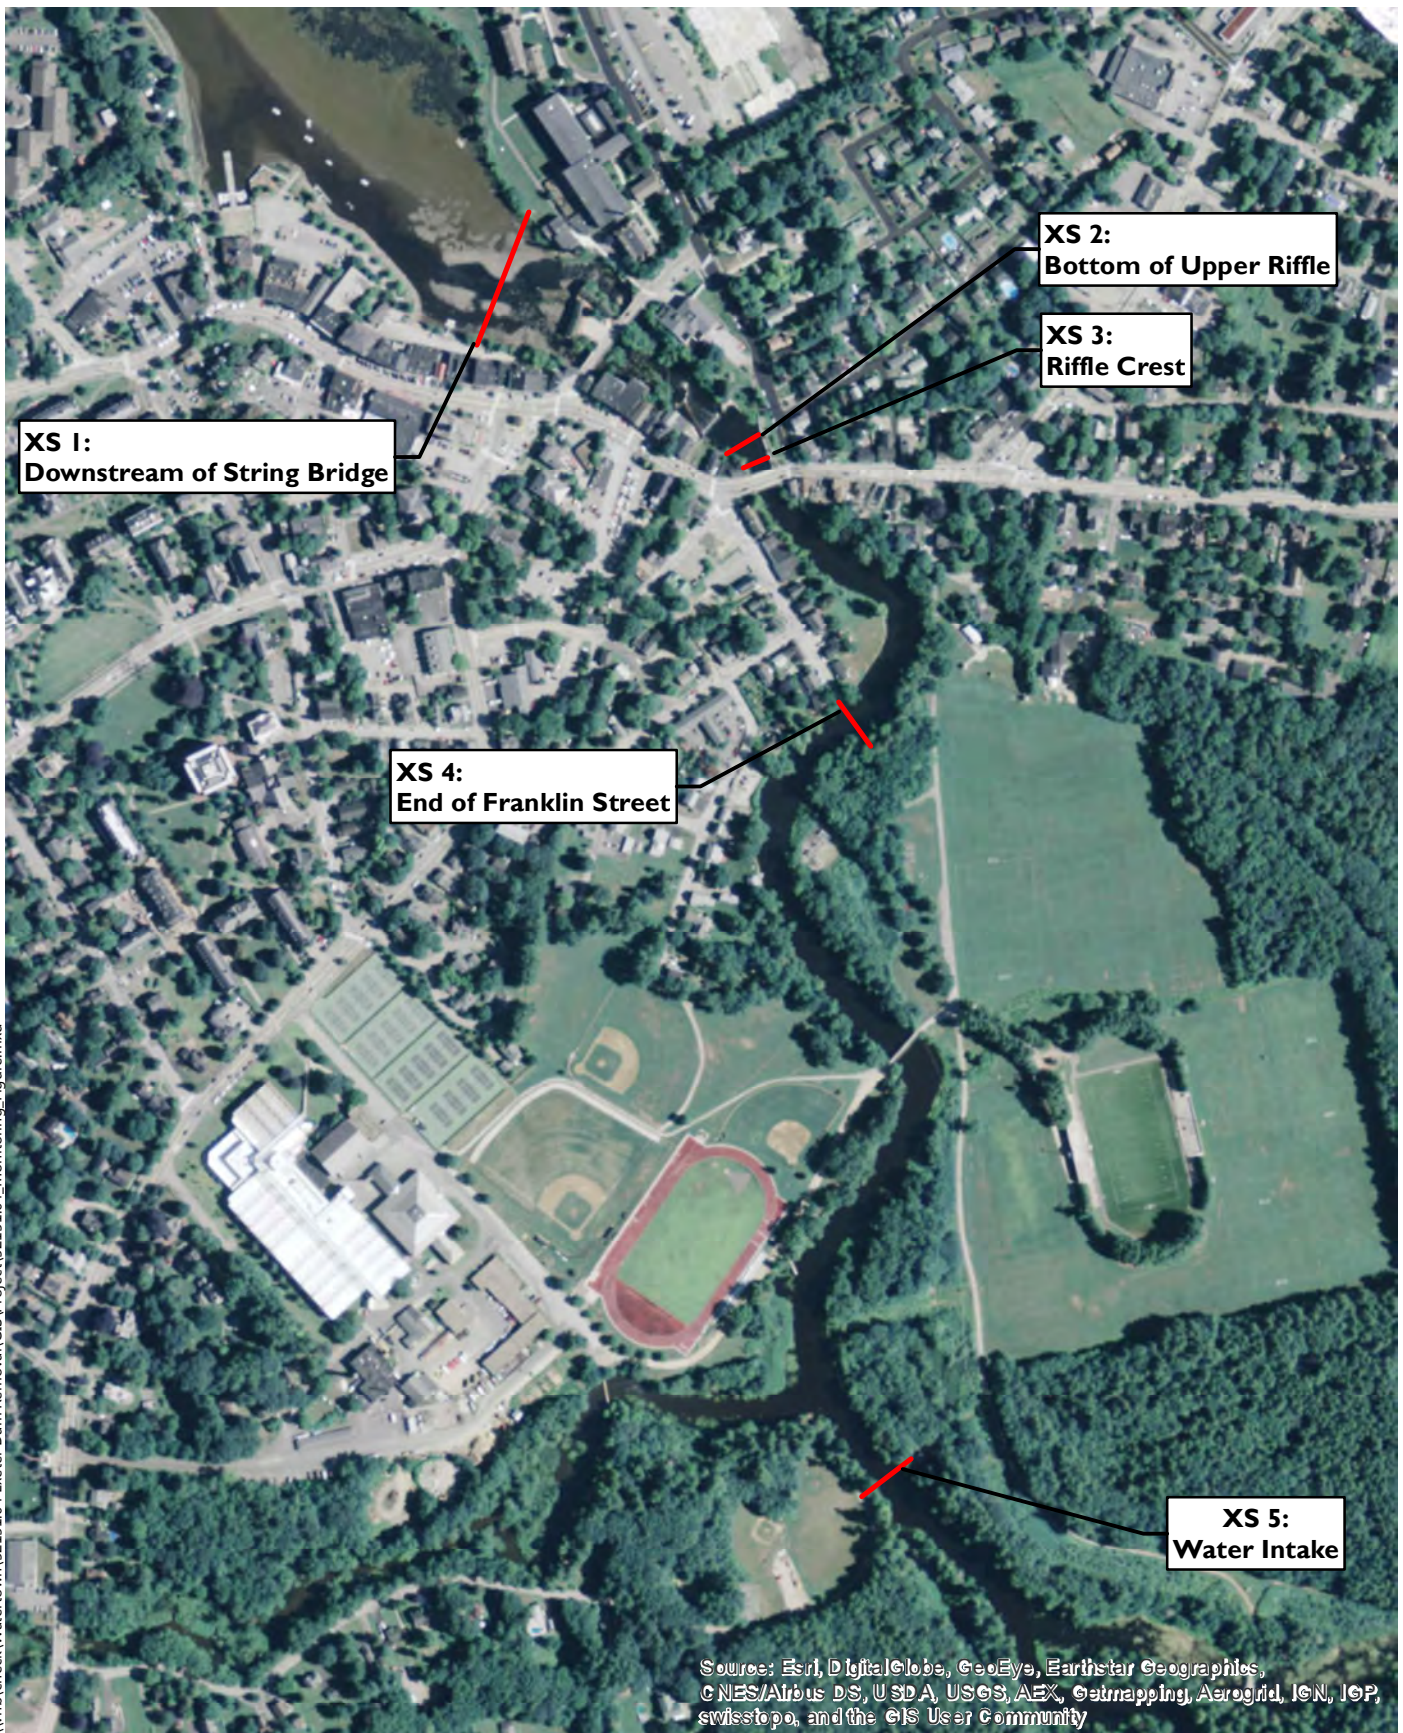
The first cross section is located downstream of the String Bridge through a gravel bar within the tidal reach of the Squamscott River. The second and third cross sections are located at the downstream and upstream limits of the restored upper riffle, and will allow long term evaluation of the restored stream slope through this section. The fourth cross section is located at the end of the Franklin Street in a section of river that was identified as a geomorphic area of concern during development of the Feasibility Study. This location was previously surveyed during the design phase of the project and will provide a baseline for long-term monitoring. The fifth cross section is located at the Town water supply intake, which is a critical interest area for the Town, and this location was also previously surveyed and will provide a baseline for long-term monitoring.

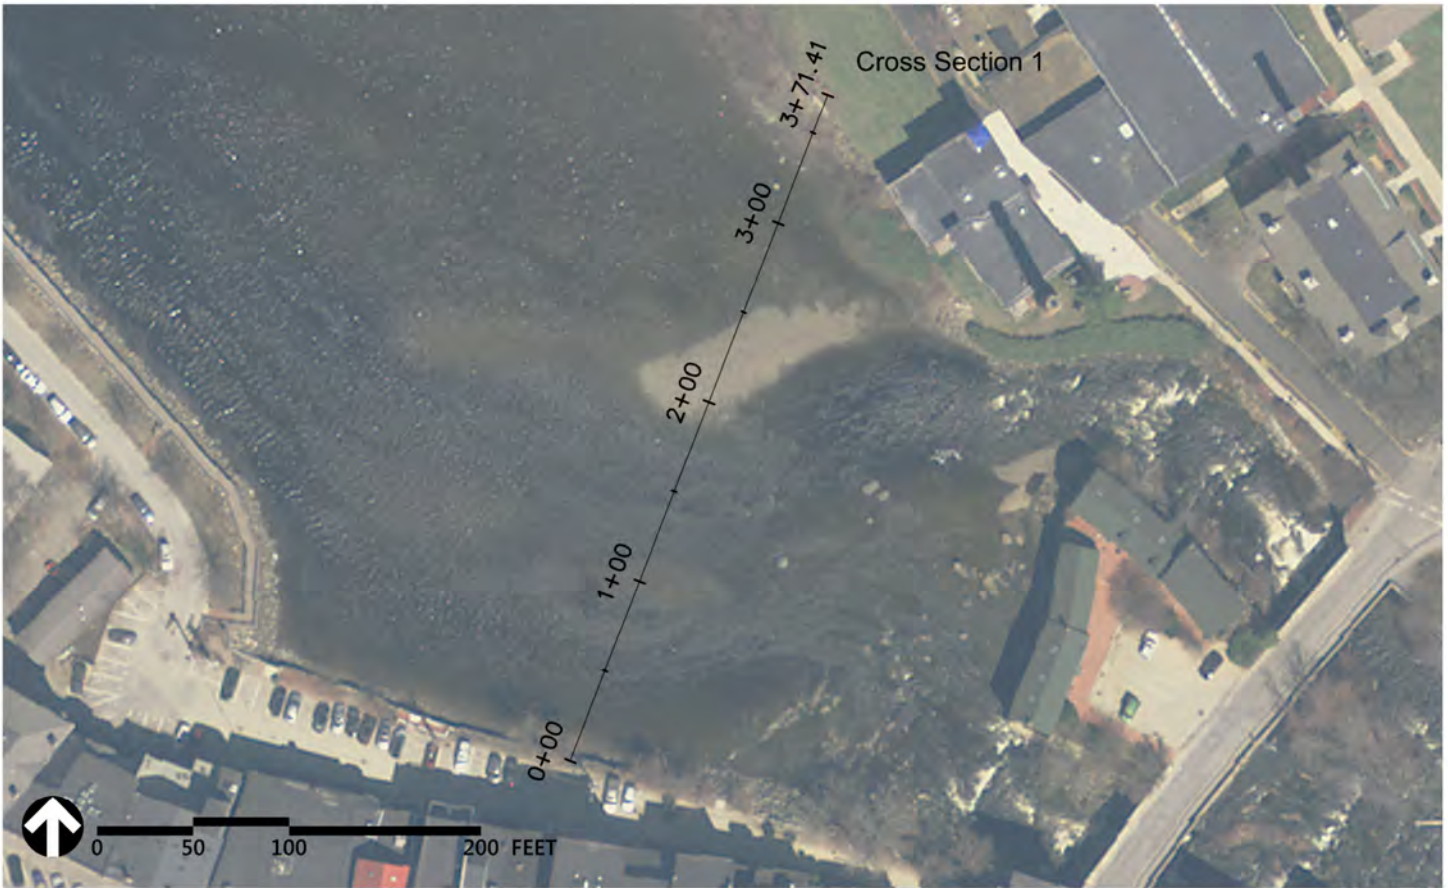
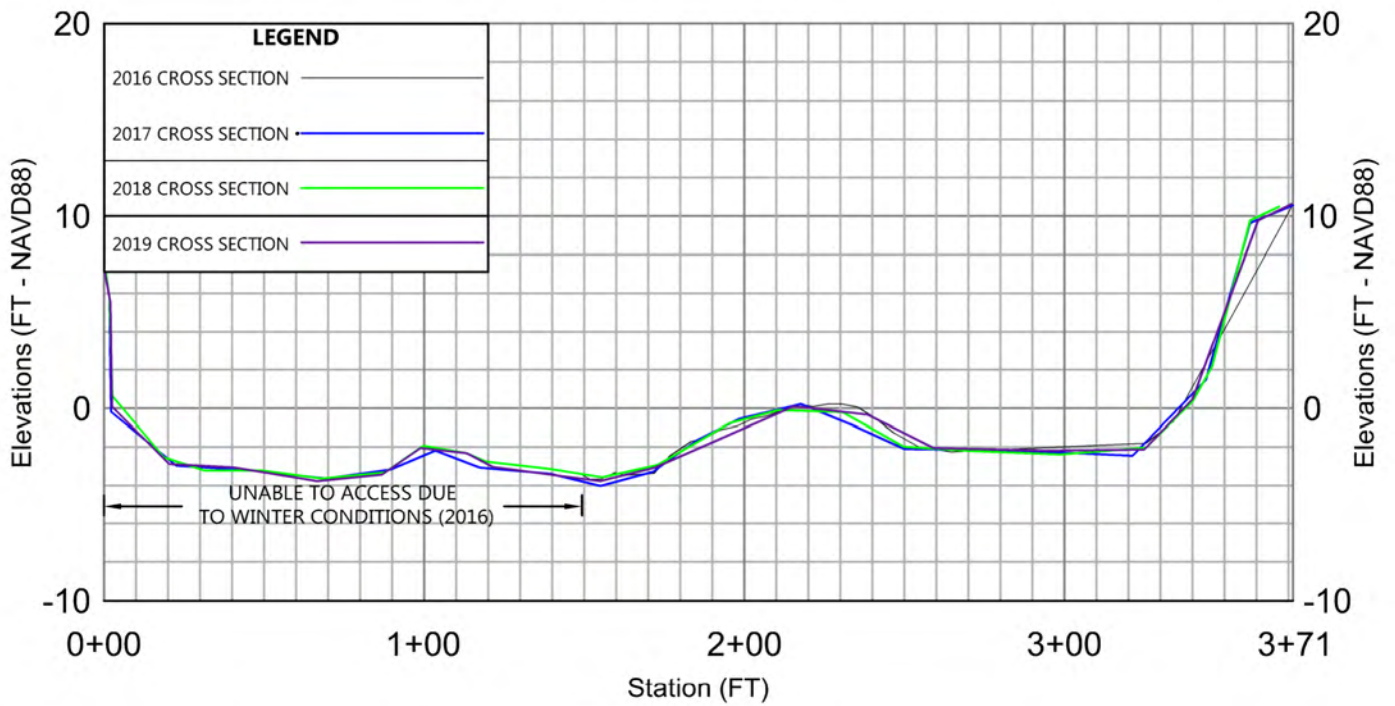
Cross Section 1

VHB survey staff re-surveyed all five monumented cross-sections on September 26 through September 30, 2019. Survey profiles indicate that the channel remains effectively stable at all cross-sections (accounting for minor deviations in survey point placement), with minimal aggradation and/or degradation observed. Cross-section profiles and data in tabular x, y, z format for each cross-section comparing the 2019 monitoring survey to the 2018 Year 2 survey, 2017 Year 1 survey, and 2016 baseline survey, is included in **Appendix D**.

Cross Sectional Elevation data obtained by VHB Survey, September 2019

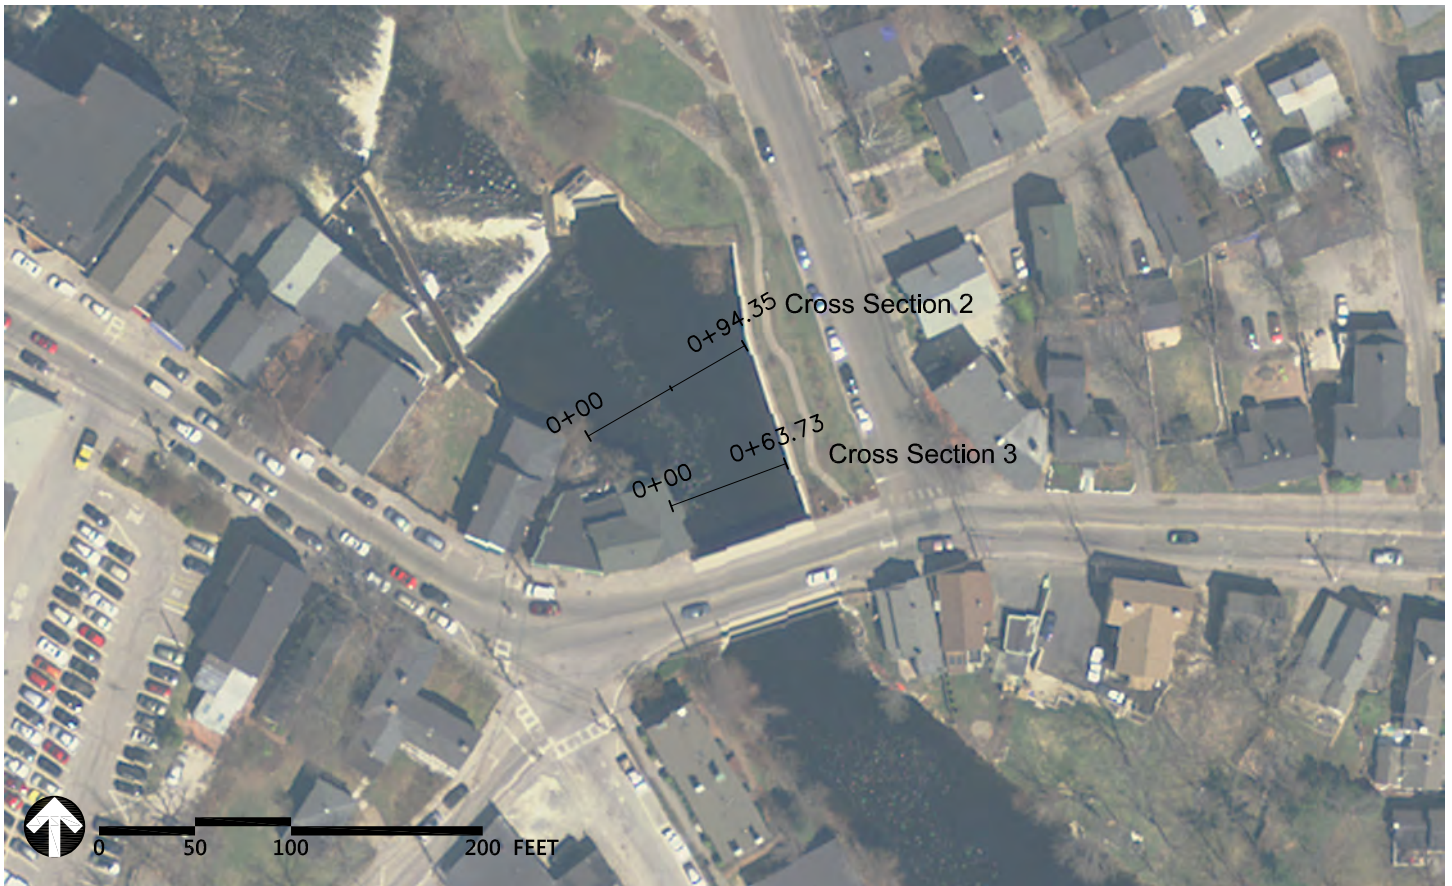
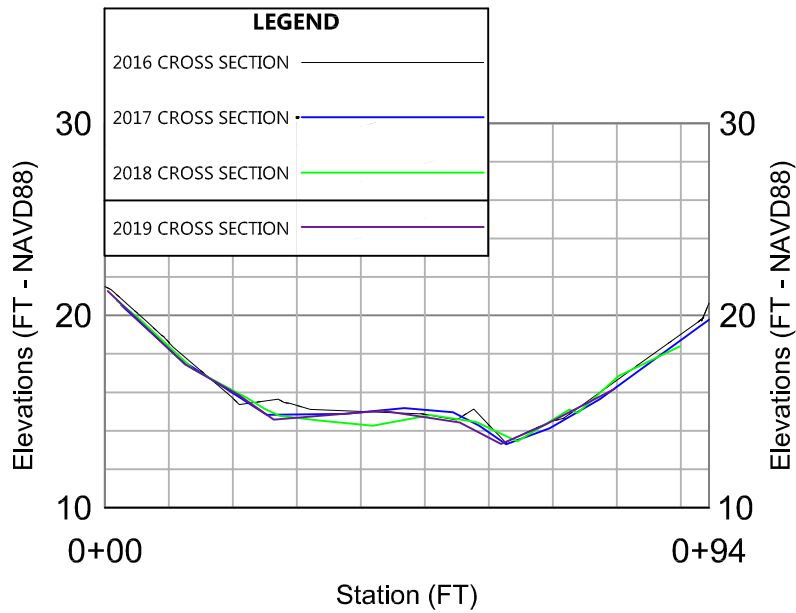
Cross Section 2

Cross Sectional Elevation data obtained by VHB Survey, September 2019

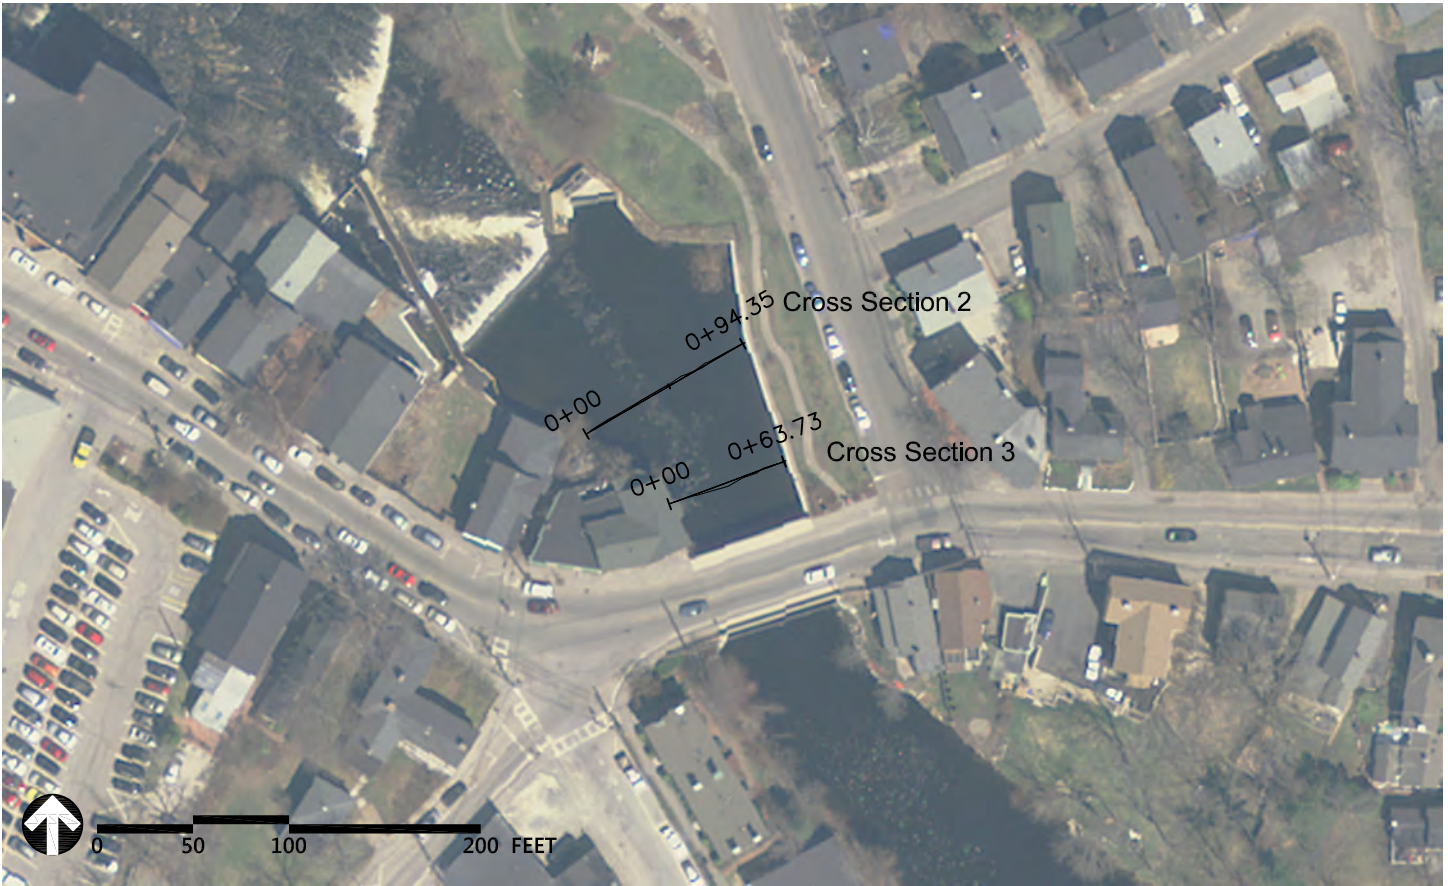
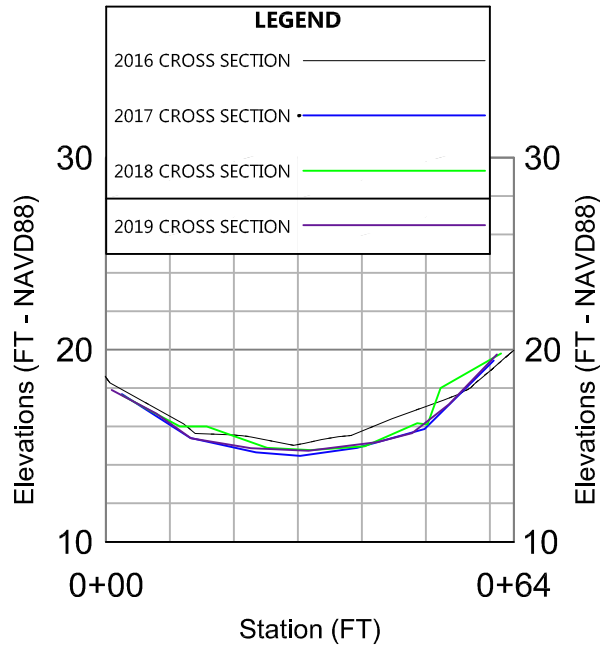
Cross Section 3

Cross Sectional Elevation data obtained by VHB Survey, September 2019

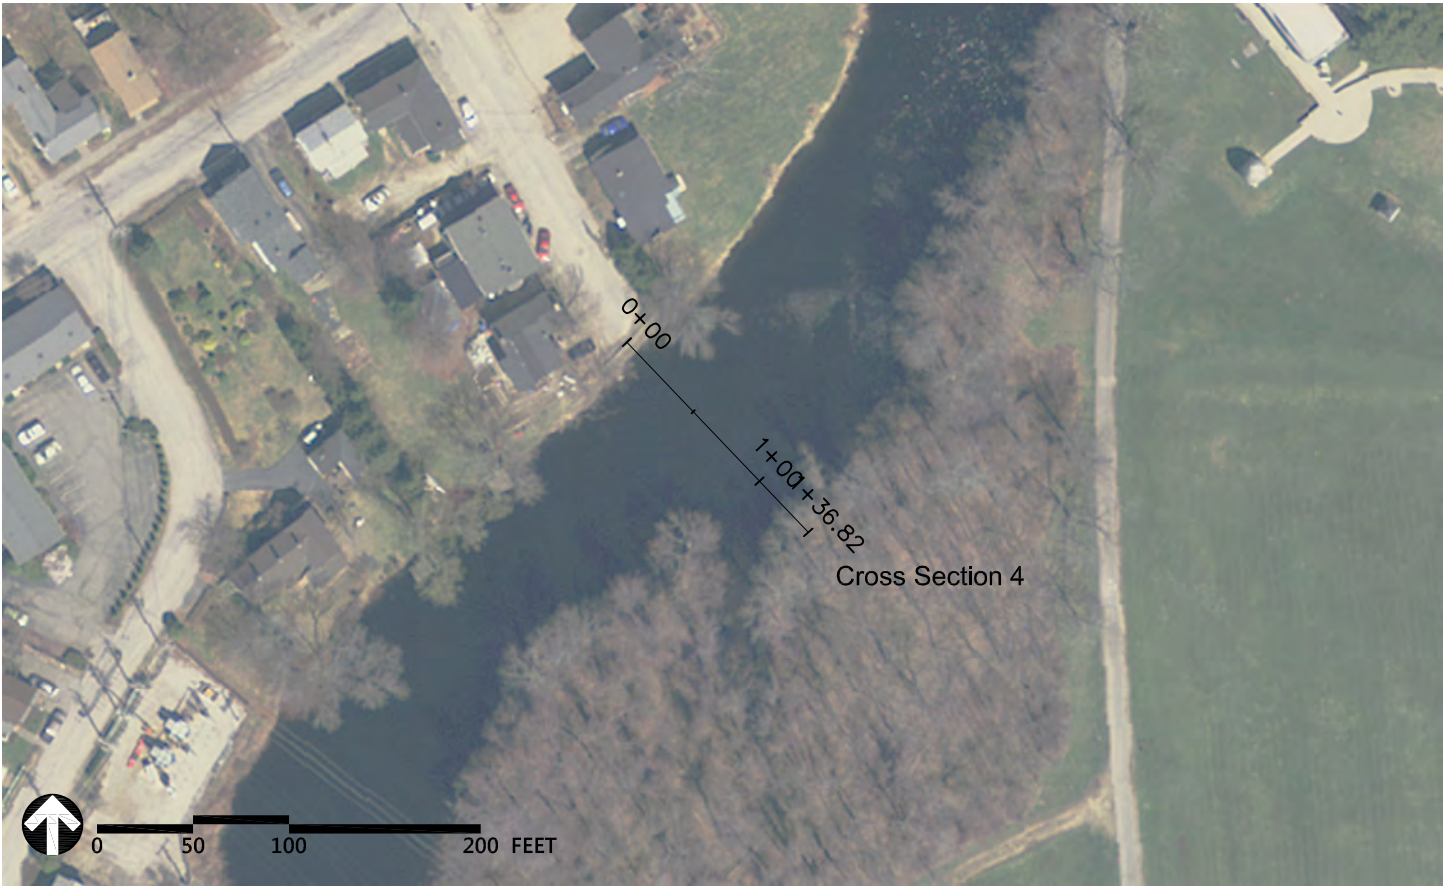
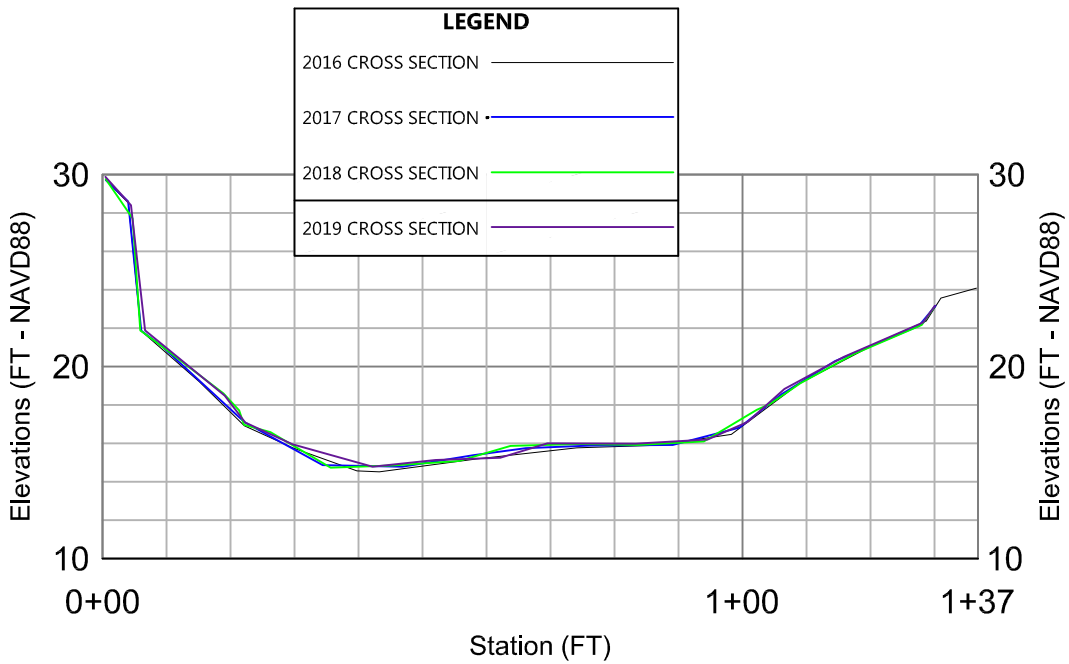
Cross Section 4

Cross Sectional Elevation data obtained by VHB Survey, September 2019

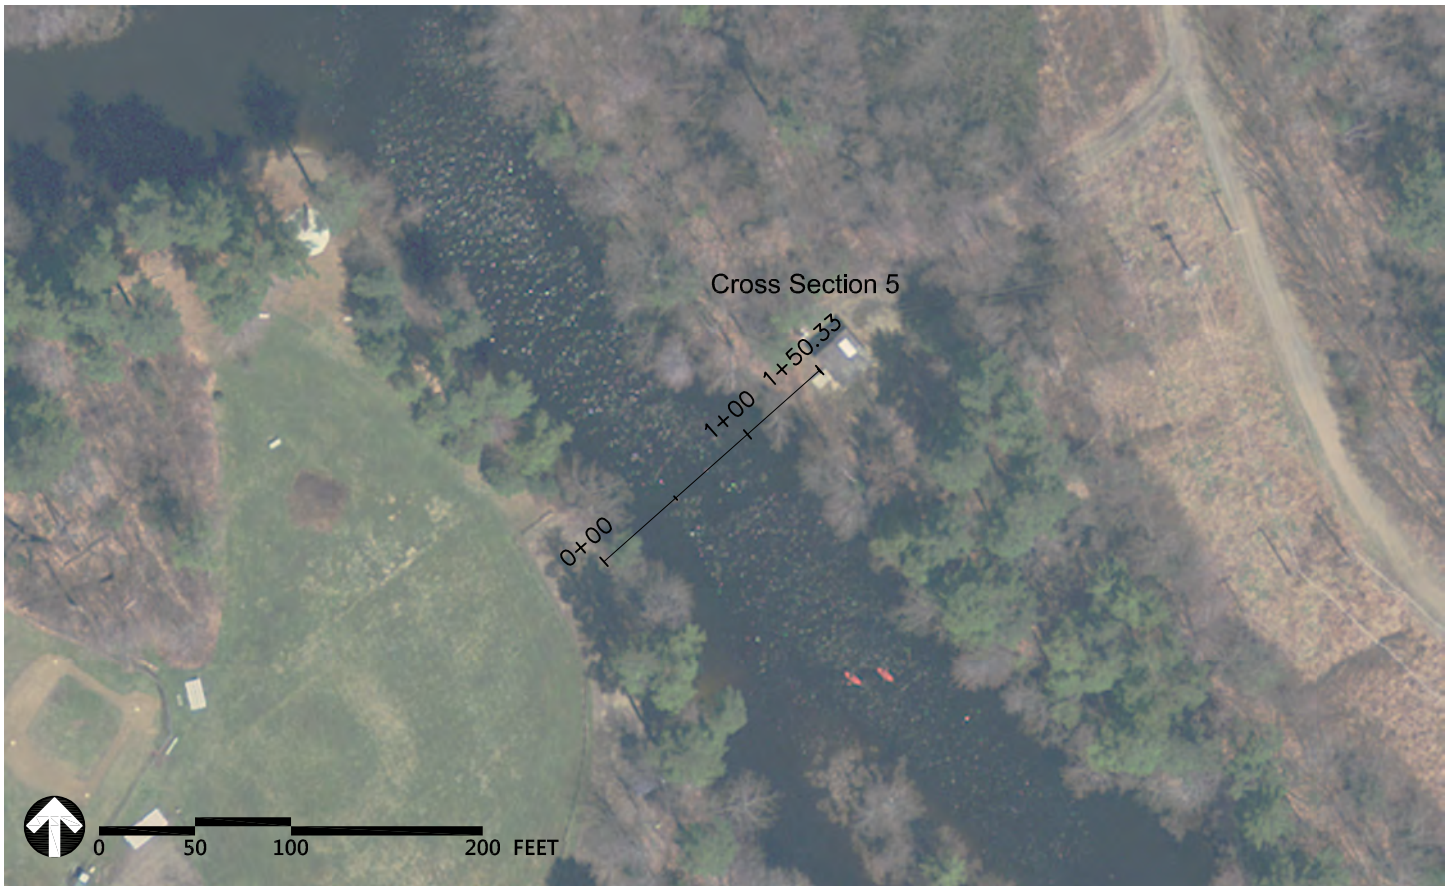
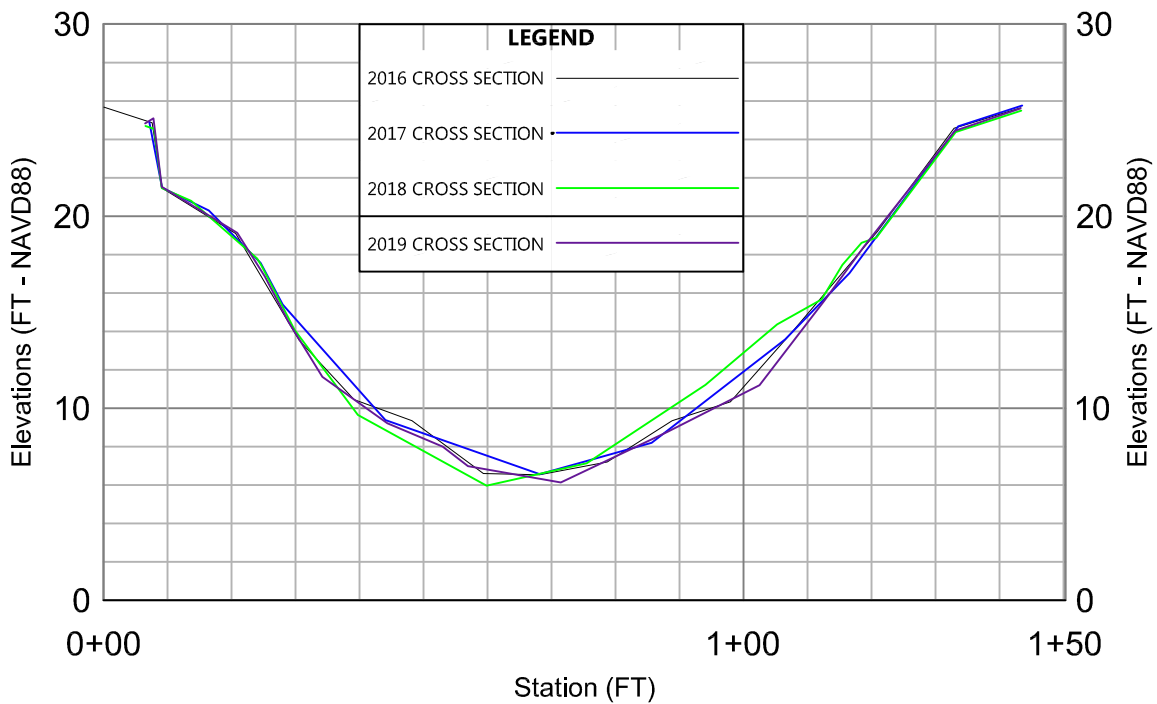
Cross Section 5

Cross Sectional Elevation data obtained by VHB Survey, September 2019

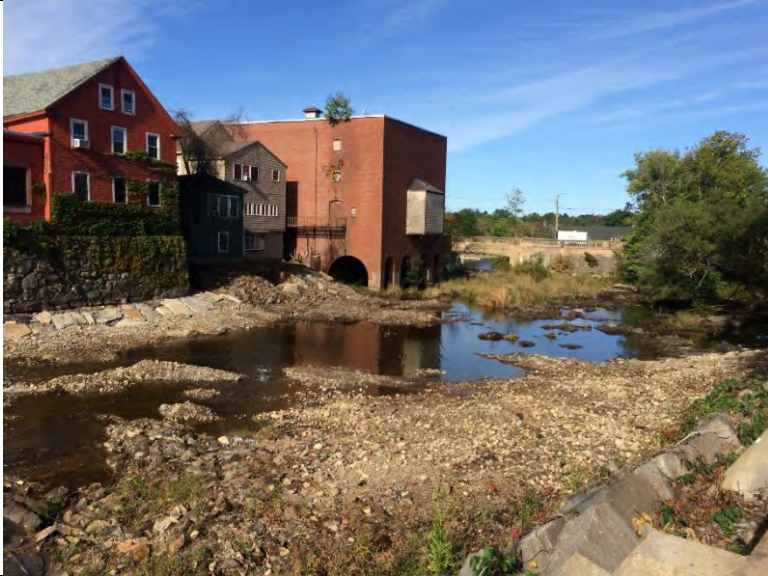
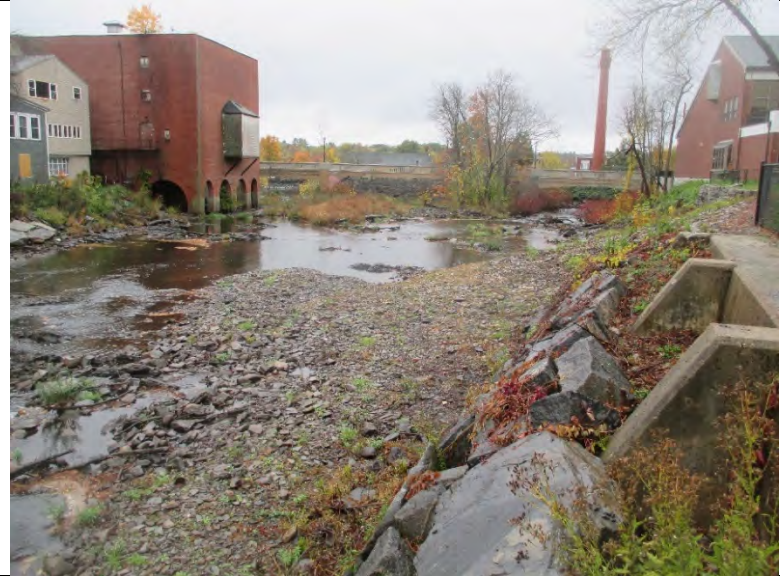
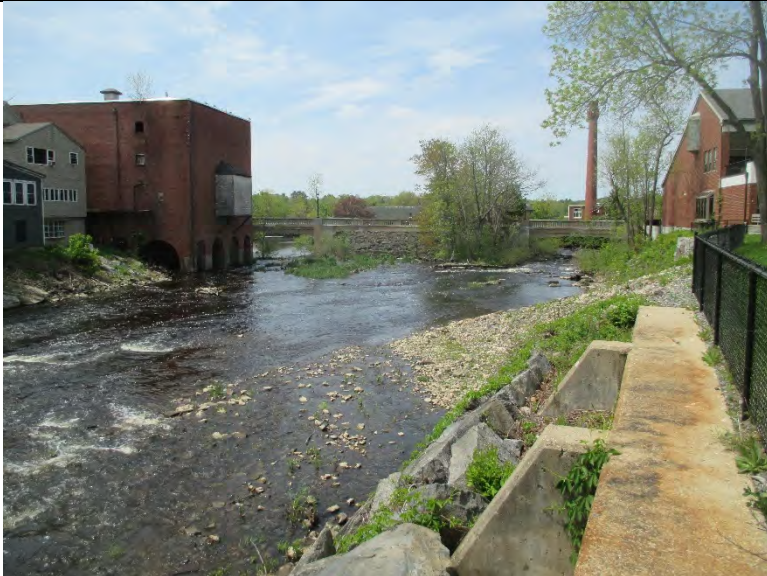
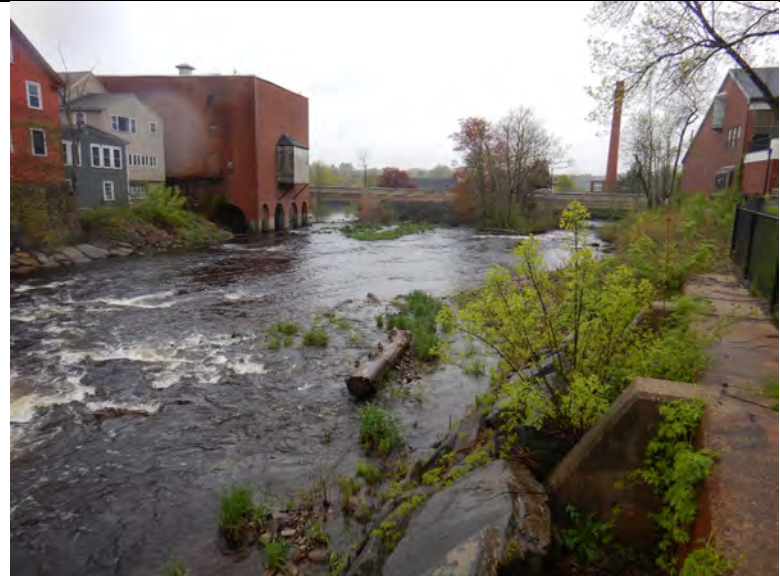
Location 1 – Downstream of Dam

Description: Post-Construction, taken 9/21/2016

Description: 1-year Monitoring, taken 10/25/2017

Description: 2-year Monitoring, taken 5/16/2018

Description: 3-year Monitoring, taken 5/17/2019

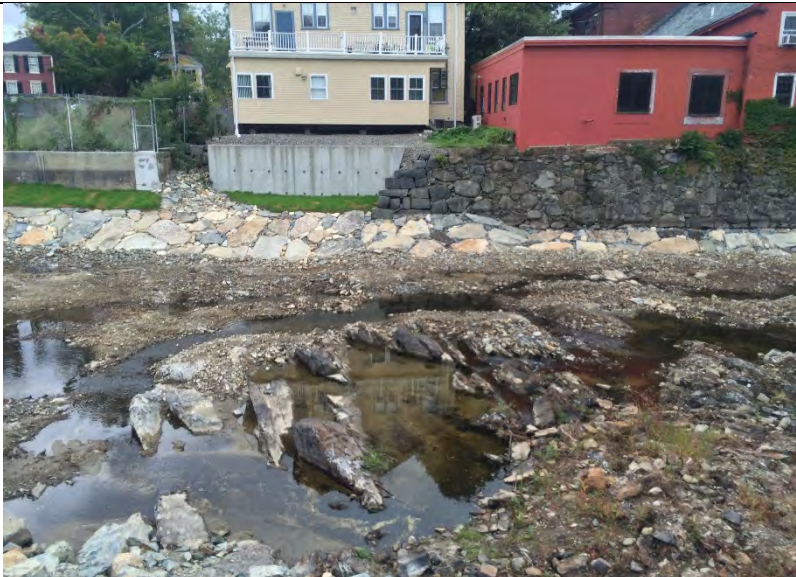
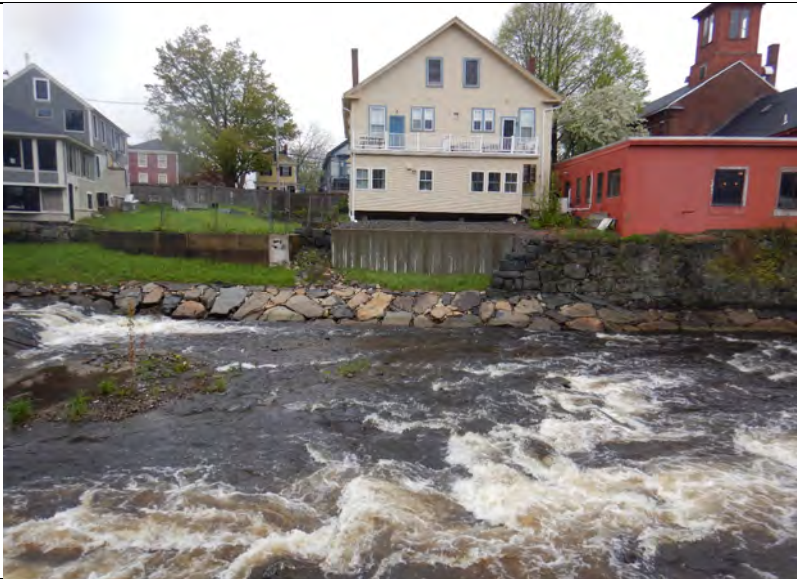
Location 2 – From Dam Towards Left Bank

Description: Post-Construction, taken 9/21/2016		Description: 1-year Monitoring, taken 10/25/2017
Photo #3:

Description: 2-year Monitoring, taken 5/16/2018		Description: 3-year Monitoring, taken 5/17/2019

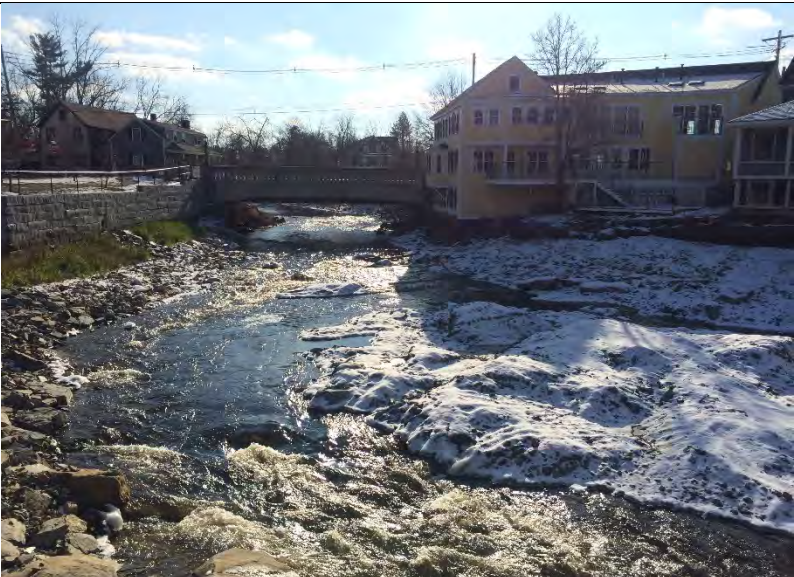
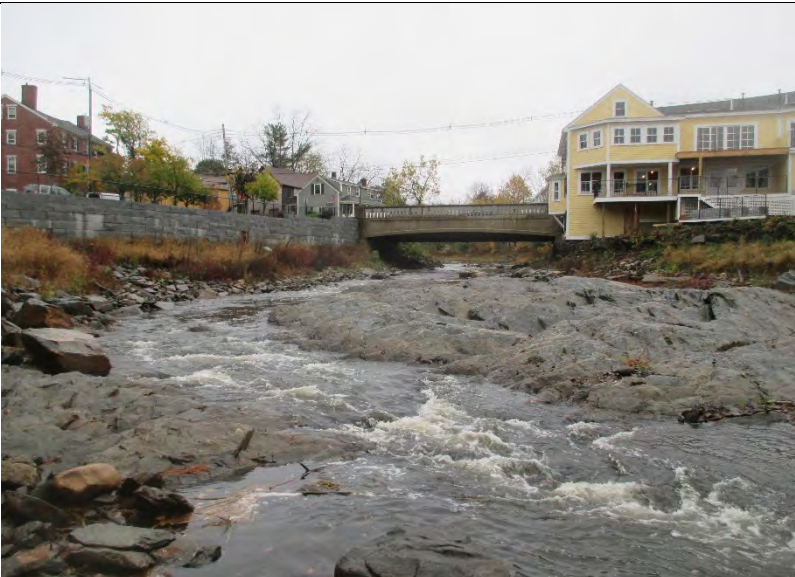
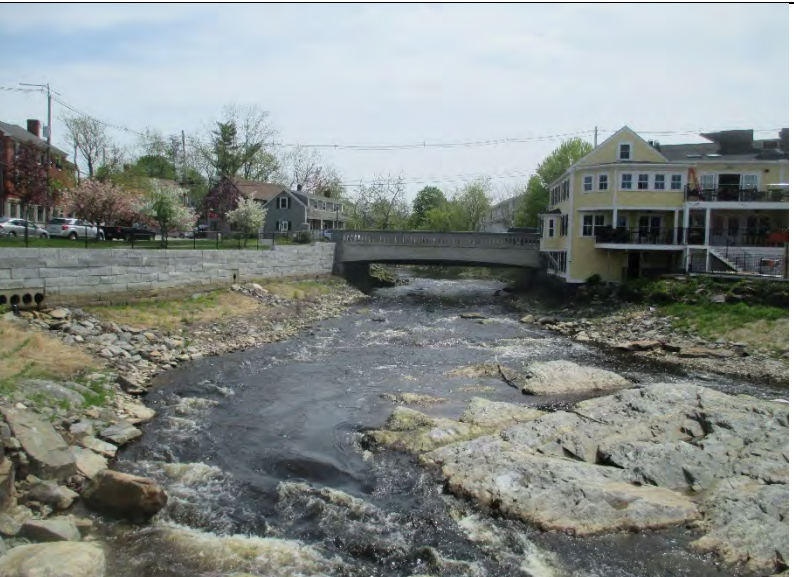
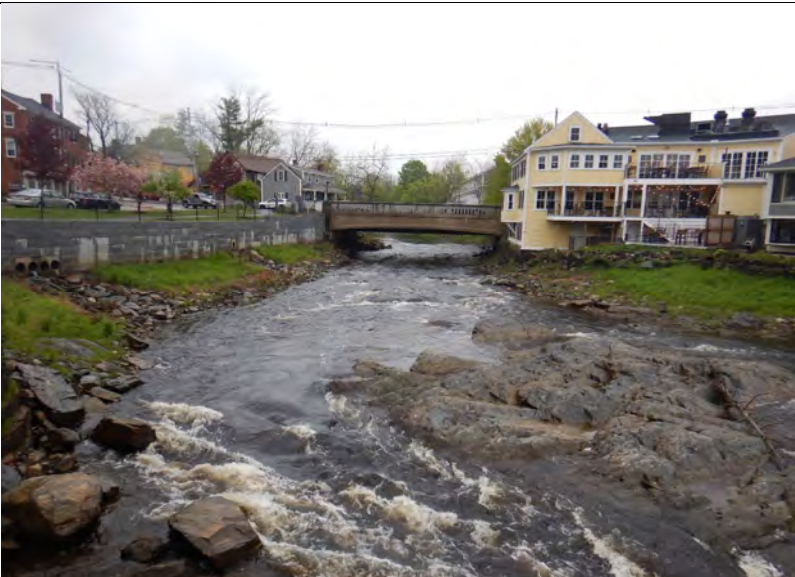
Location 3 – From Dam Towards High Street

Description: Post-Construction, taken 9/21/2016		Description: 1-year Monitoring, taken 10/25/2017
Photo #3:

Description: 2-year Monitoring, taken 5/16/2018		Description: 3-year Monitoring, taken 5/17/2019

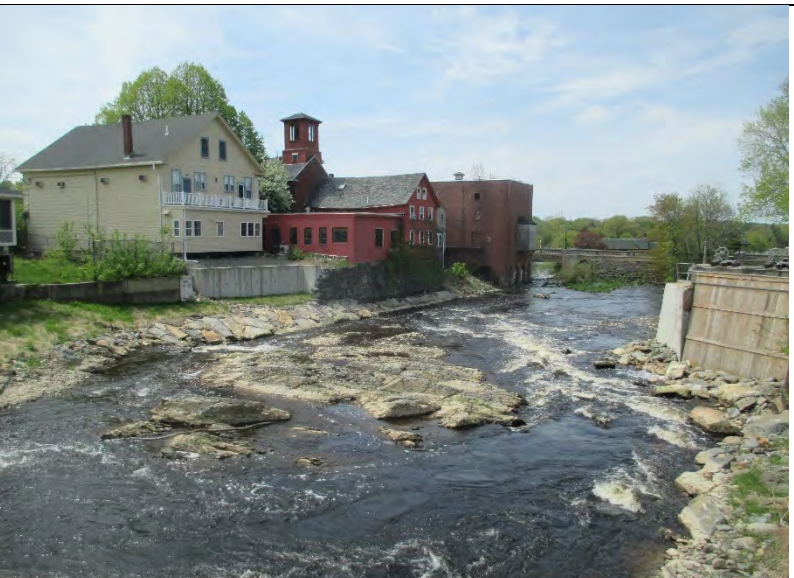
Description: Post-Construction, taken 9/21/2016		Description: 1-year Monitoring, taken 10/25/2017
Photo #3:

Description: 2-year Monitoring, taken 5/16/2018		Description: 3-year Monitoring, taken 5/17/2019

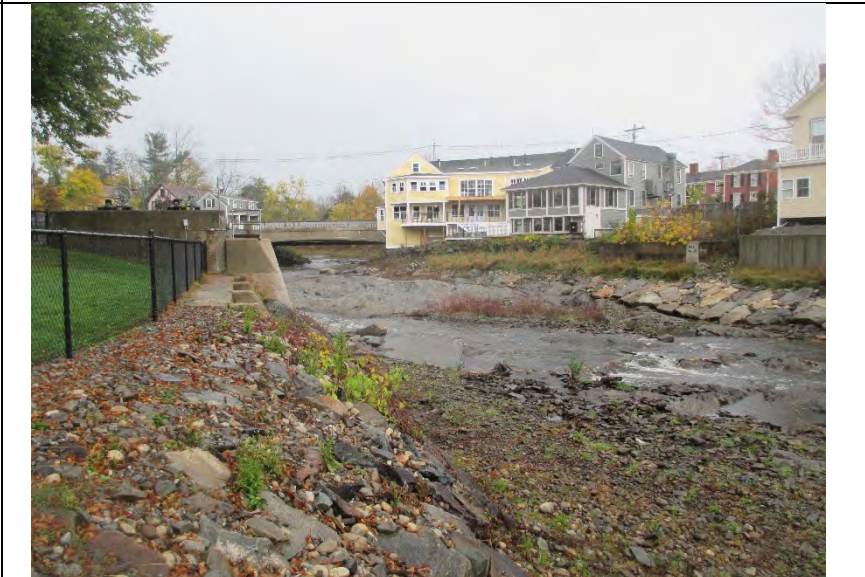
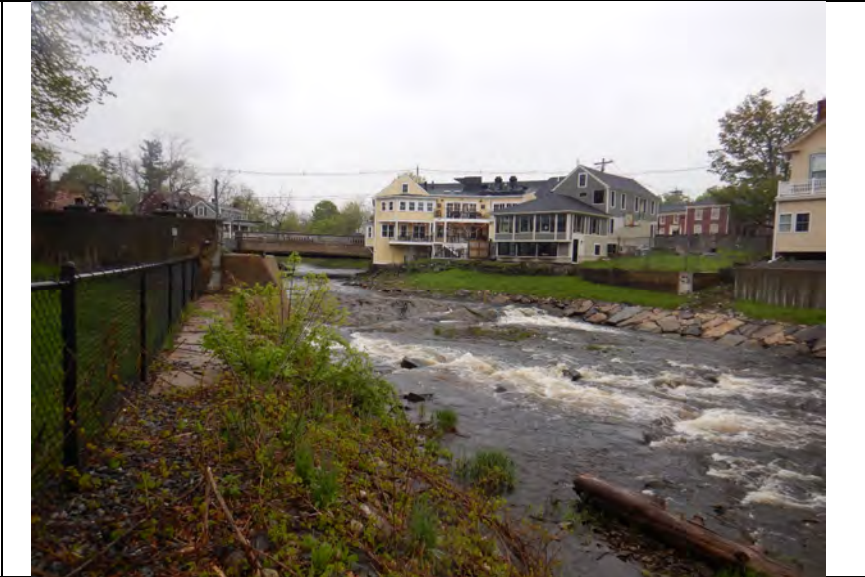
Location 6 – From Right Bank Looking Upstream

Description: Post-Construction, taken 9/21/2016		Description: 1-year Monitoring, taken 10/25/2017
Photo #3:

Description: 2-year Monitoring, taken 5/16/2018		Description: 3-year Monitoring, taken 5/17/2019
