DRAFT TECHNICAL REPORT
FEBRUARY 20, 2024

Pickpocket Dam Feasibility Study

Exeter, New Hampshire

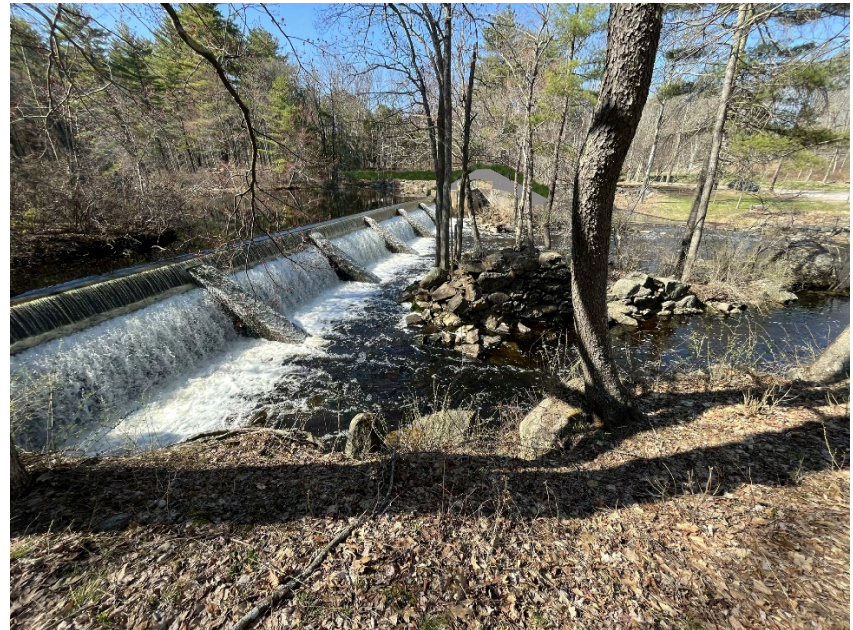
An oblique view of Pickpocket Dam primary spillway with Alternative 1, looking from the right bank

Alternative 1 would include maintaining the existing spillway discharge structure and raising the top of the dam elevation such that the design storm is contained with 1 foot of freeboard remaining. Both the left and right training walls at the spillway would be extended to meet the required top of walls. To prevent overtopping of the abutments beyond the limits of the existing dam, earthen embankments would be constructed to impound high water during design storm events. The dam's low-level gate would need to be repaired as part of this alternative, but there would be no other impacts to the dam's appurtenances.

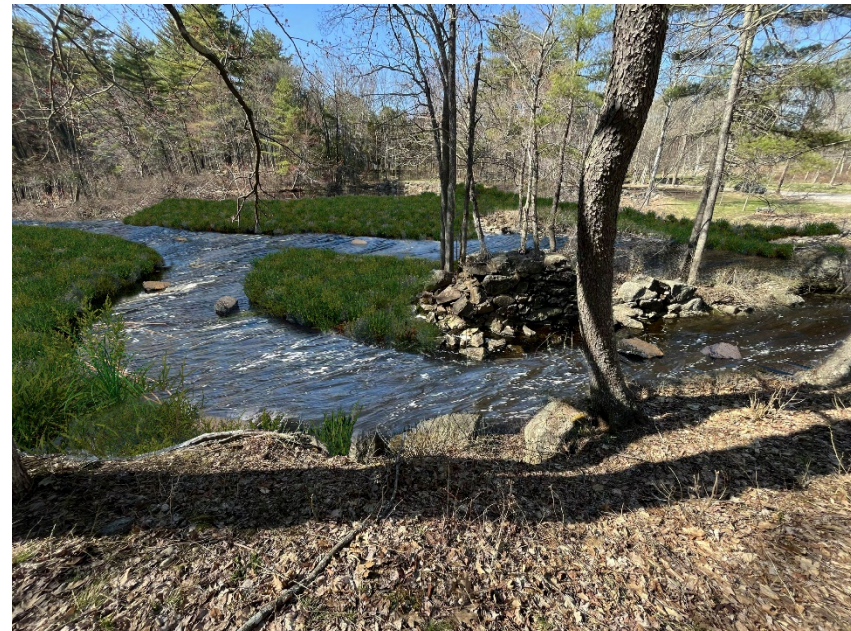
An oblique view of Pickpocket Dam removed, looking from the right bank

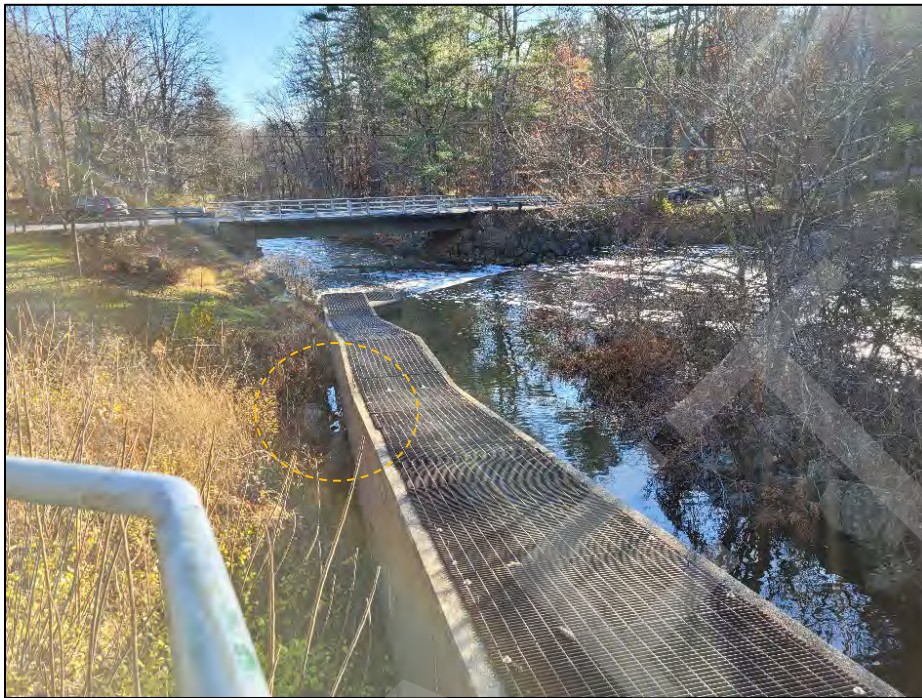
Photo No. 5.: Minor leakage between the left downstream slope and fish ladder.

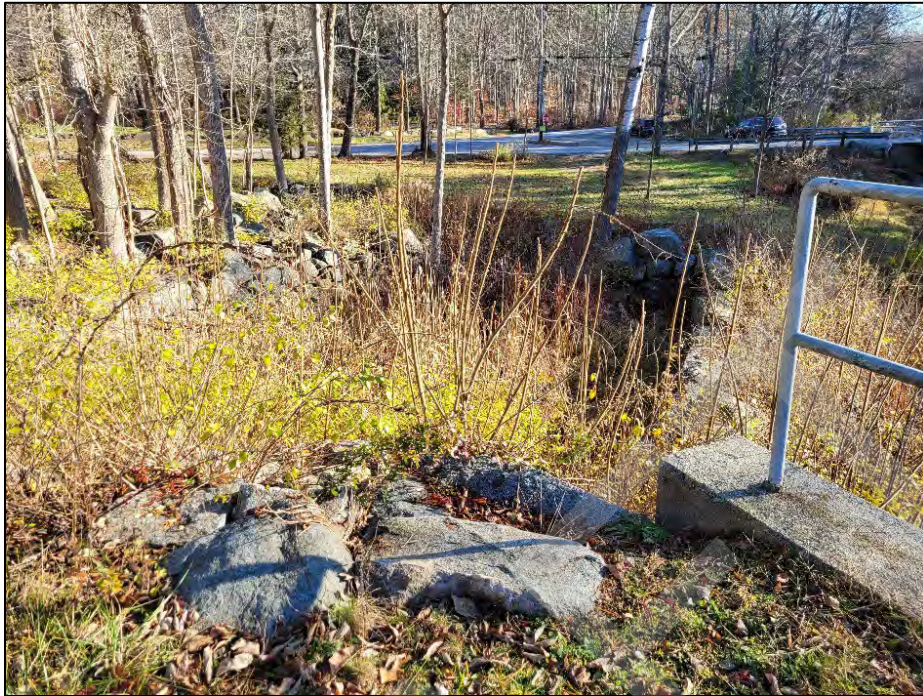
Photo No. 11.: Downstream slope from the edge of left training wall. Note the vegetation growth within the rip rap and abandoned stone foundation.

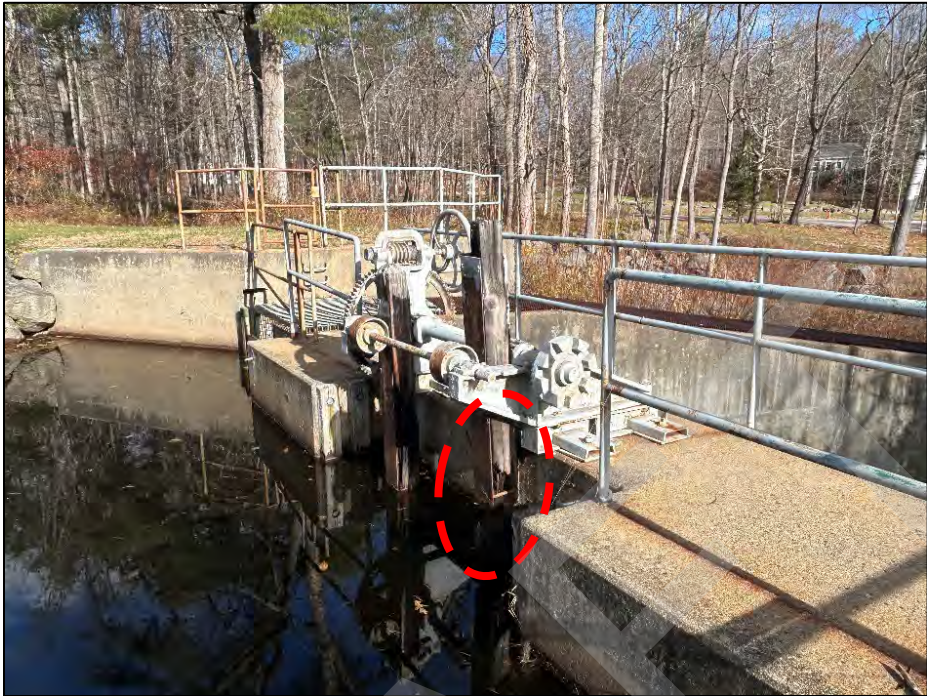
Photo No. 17.: View of the low-level outlet operator/approach. The gate is inoperable due to deteriorated timber stems (circled).

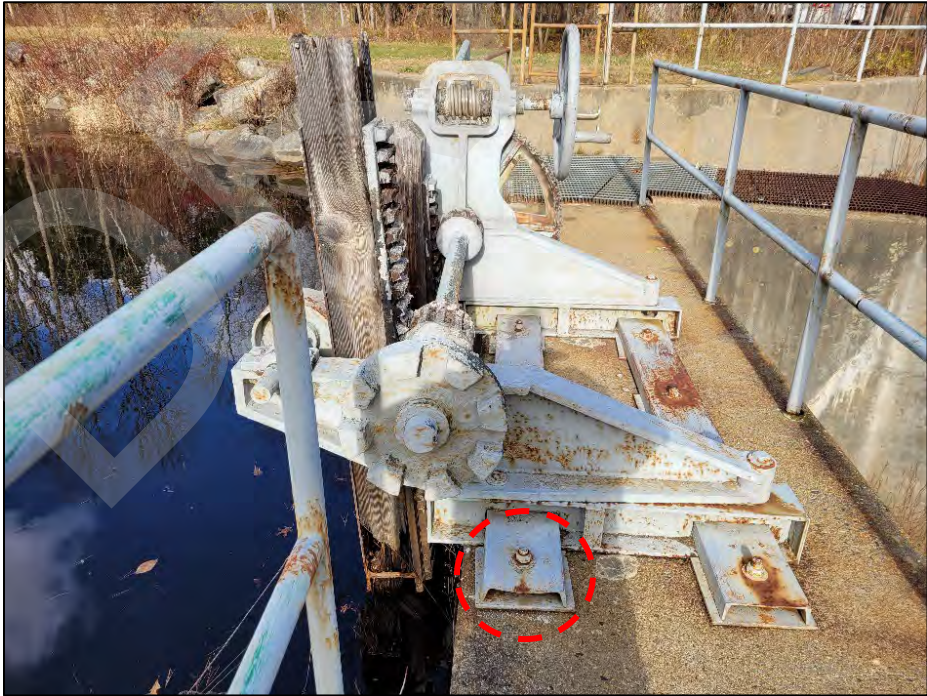
Photo No. 18.: A bent channel support (circled) for the low-level outlet gate and gears for the stems are corroded.

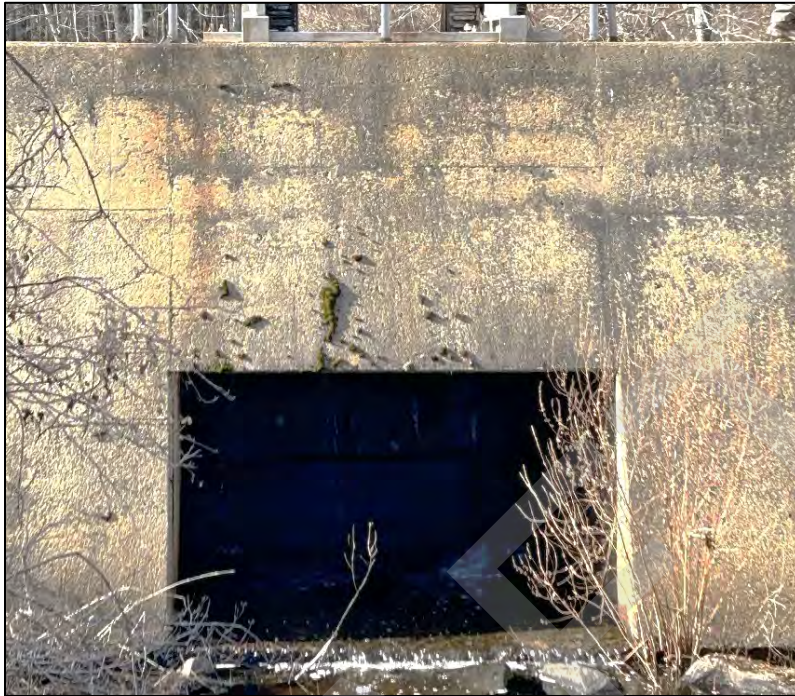
Photo No. 19.: Discharge for the low-level outlet from downstream channel. The gate is leaking from the left side of the structure.

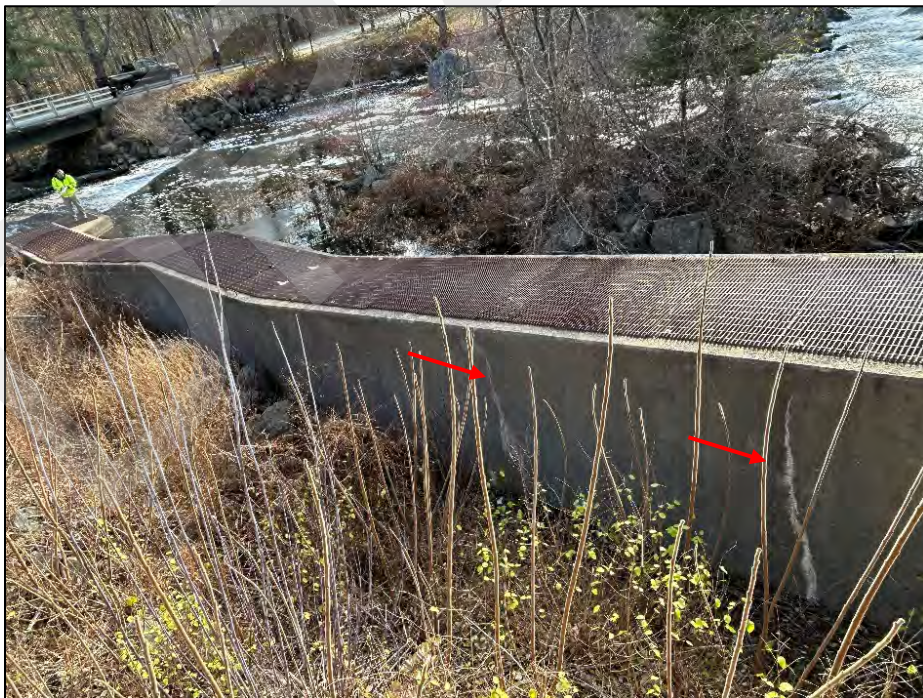
Photo No. 22.: Fish ladder looking downstream from left training wall of the spillway. Note cracks (arrows) with efflorescent staining along the walls.

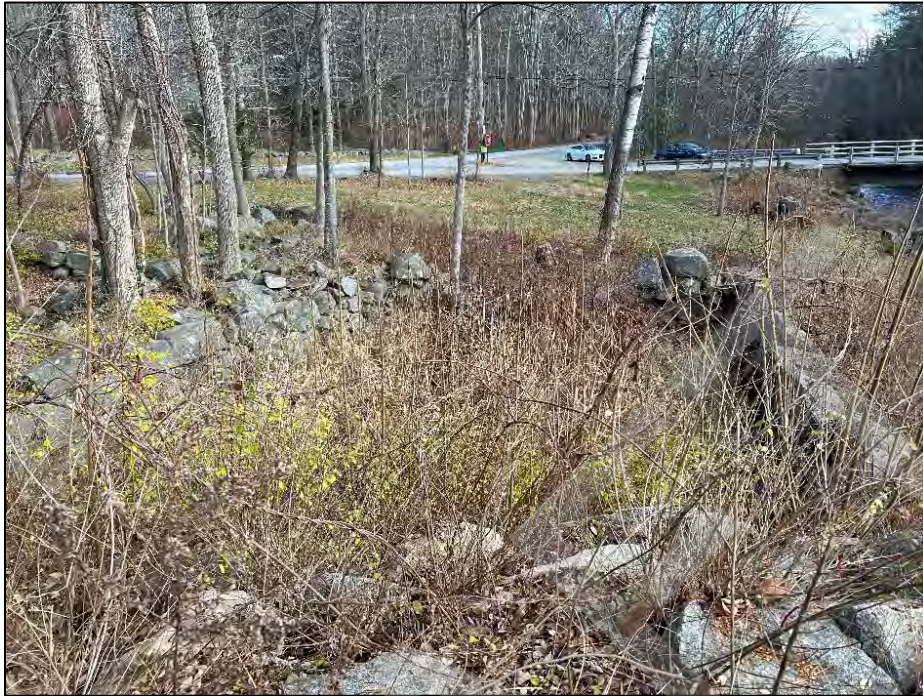
Photo No. 27.: The remnants of an old stone foundation left of the fishway. Wet areas inside the foundation were noted.
