# **Project Funding**

## Background

# Feasibility Study Components

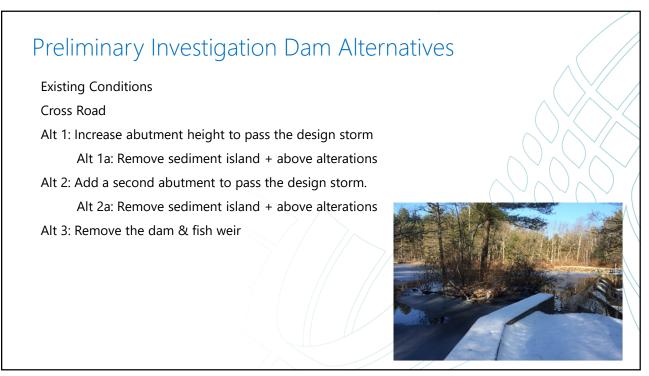
# Existing Conditions Existing Abutment Elevation: 66.00 Current dam consists of a crest, abutment, fish weir and ladder Portion of existing crest is obstructed by a sediment island Climate Change 2.5 x 100-yr WSE Elev. = 66.07 Current Day 100-yr WSE Elev. = 66.17 Low-Lavel Gate (closed) Fish Ladder Pickpocket Bom Crest Elev. = 68.17
