FINAL TOWN WIDE FACILITIES PLAN

TOWN OF EXETER

SPACE NEEDS AND BUILDING ASSESSMENTS

DECEMBER 16, 2015

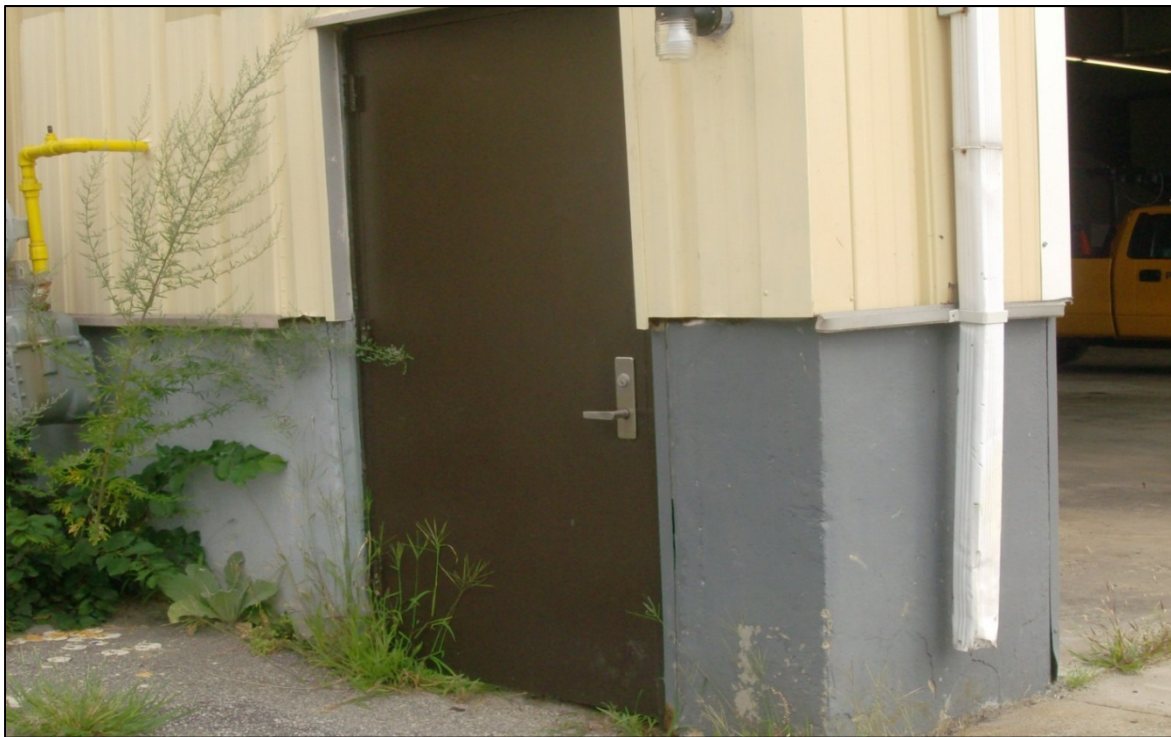
Little used pass door at west side of building.

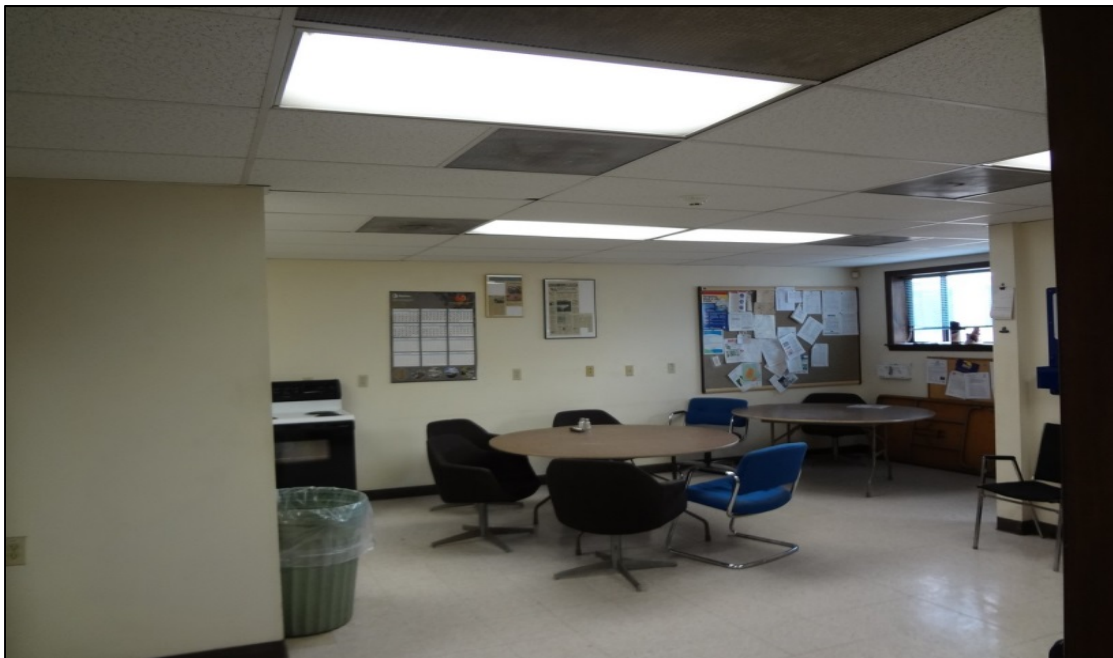
Break room. Note stove with no vent hood.

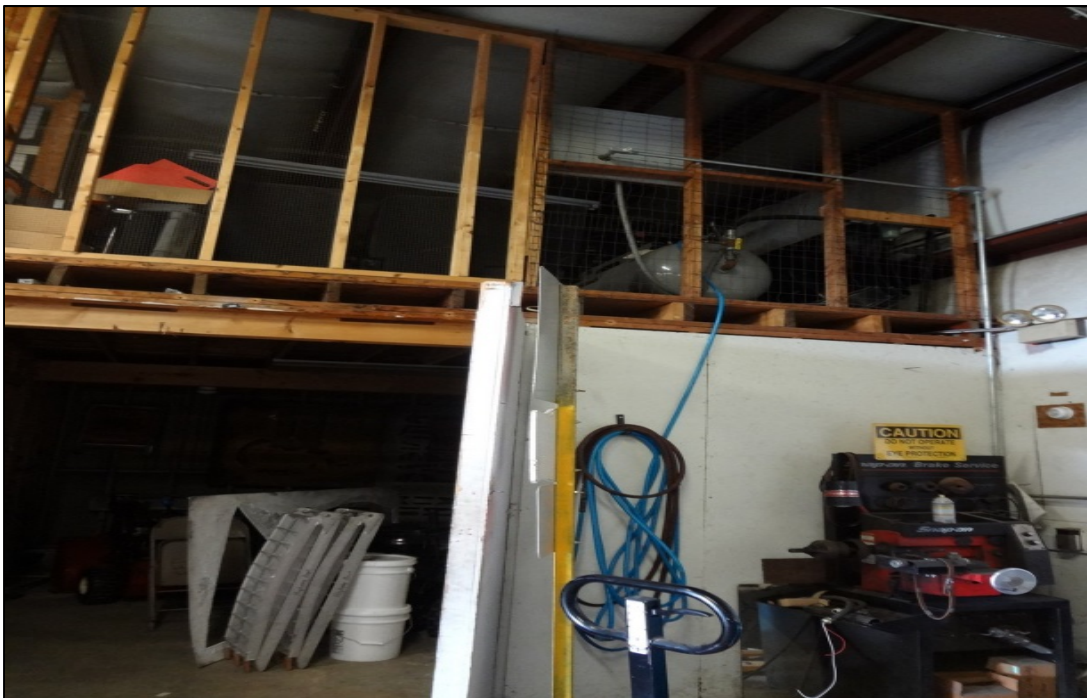
Storage Mezzanine. Note lack of proper handrail.

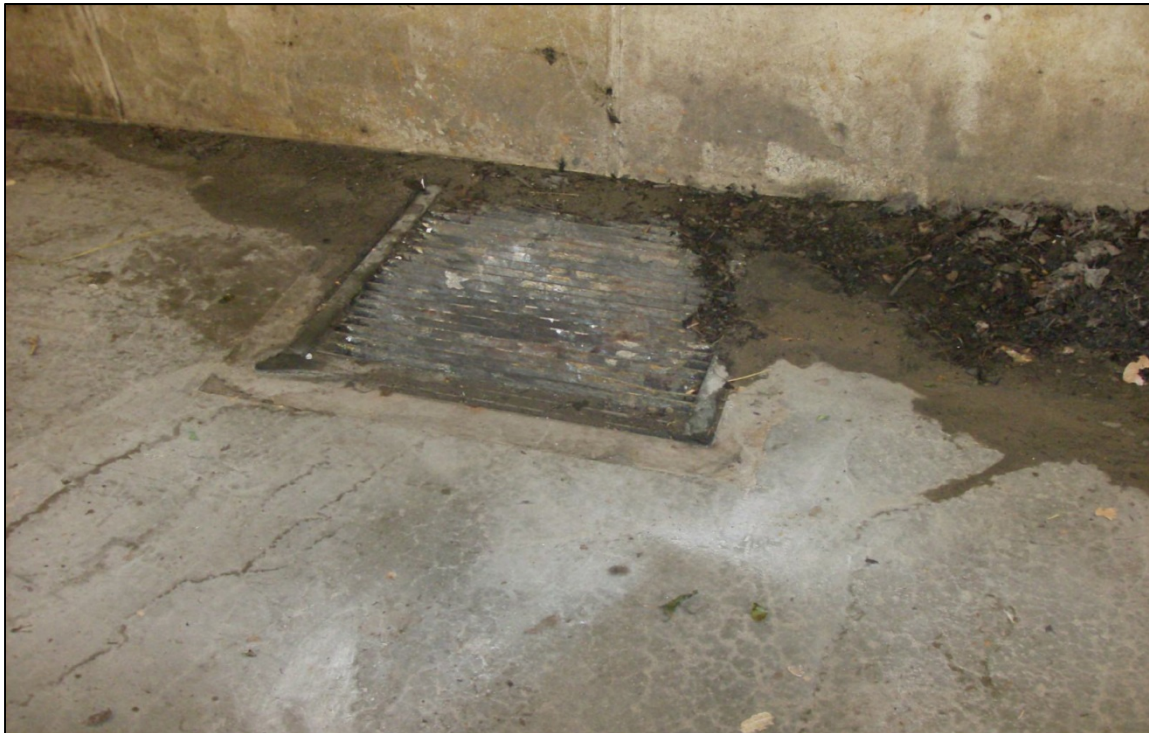
Wash-bay catch basin and accumulation of debris.

- Paint outdoor gas piping.
- Repair and clean floor drain in wash-bay.
- Provide storage racks for the wash-bay hoses and spray wands.

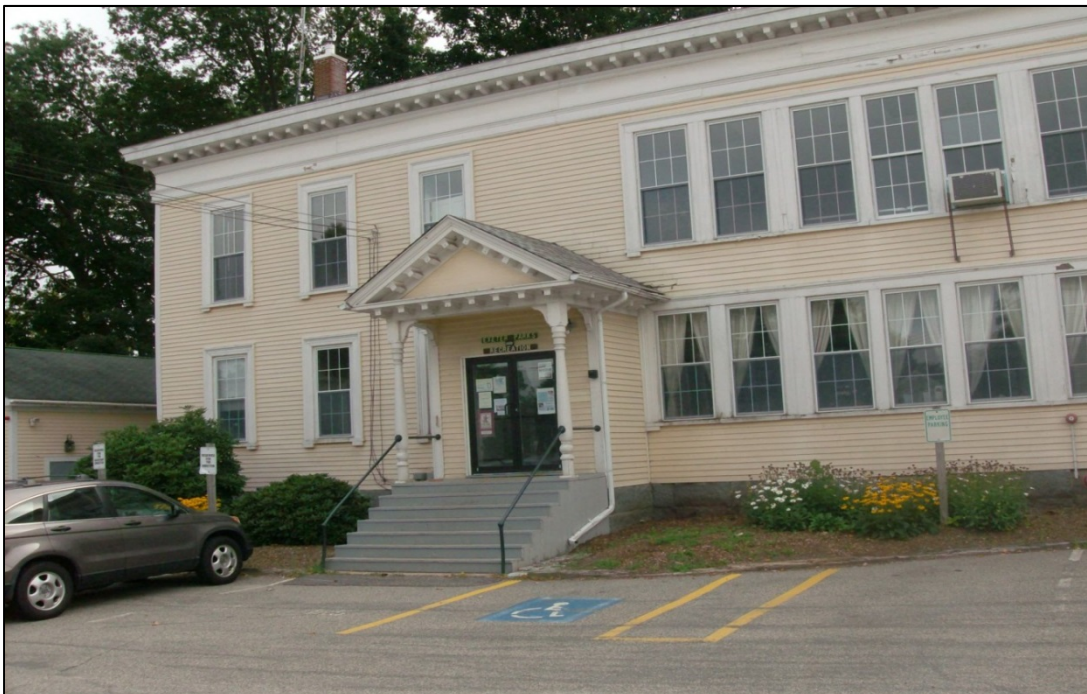
Main entrance from parking lot. Note handicap parking, but entrance is not accessible.

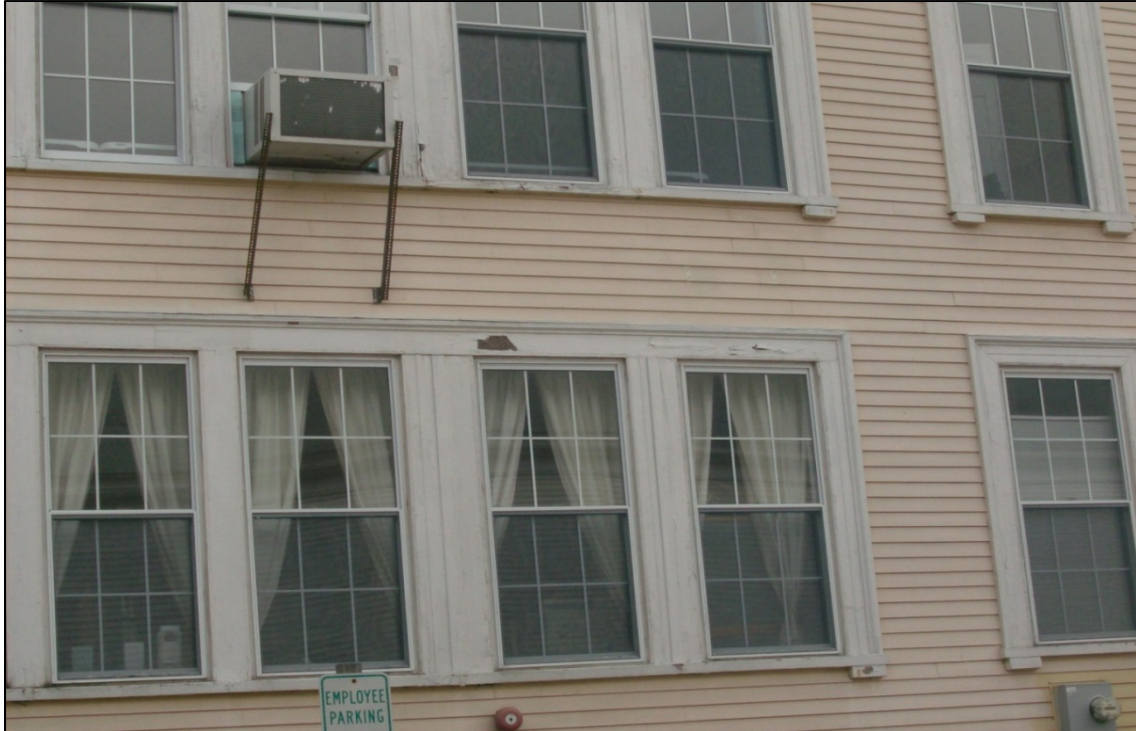
Peeling paint on trim, typical on all sides of the building (including some of the siding).

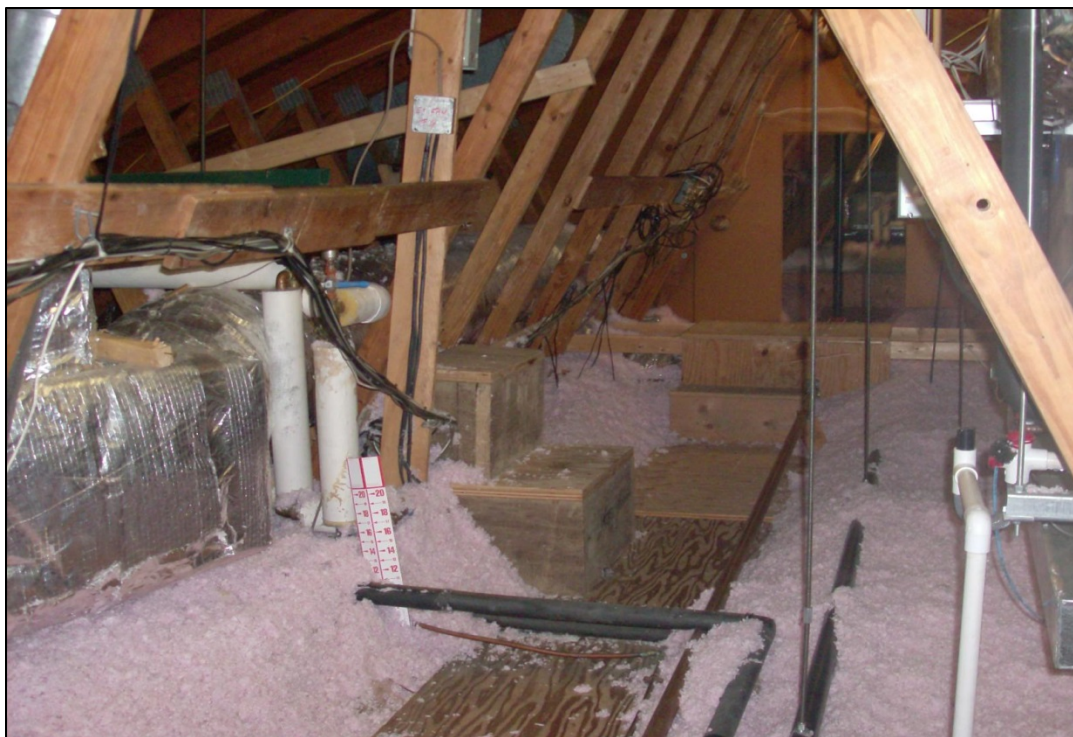
The building is mostly 1970s vintage, with modest insulation. The open area of the attic has added 12-inch deep, loose-fill insulation in most areas except walkways.

Attic area with ample blown-in insulation.

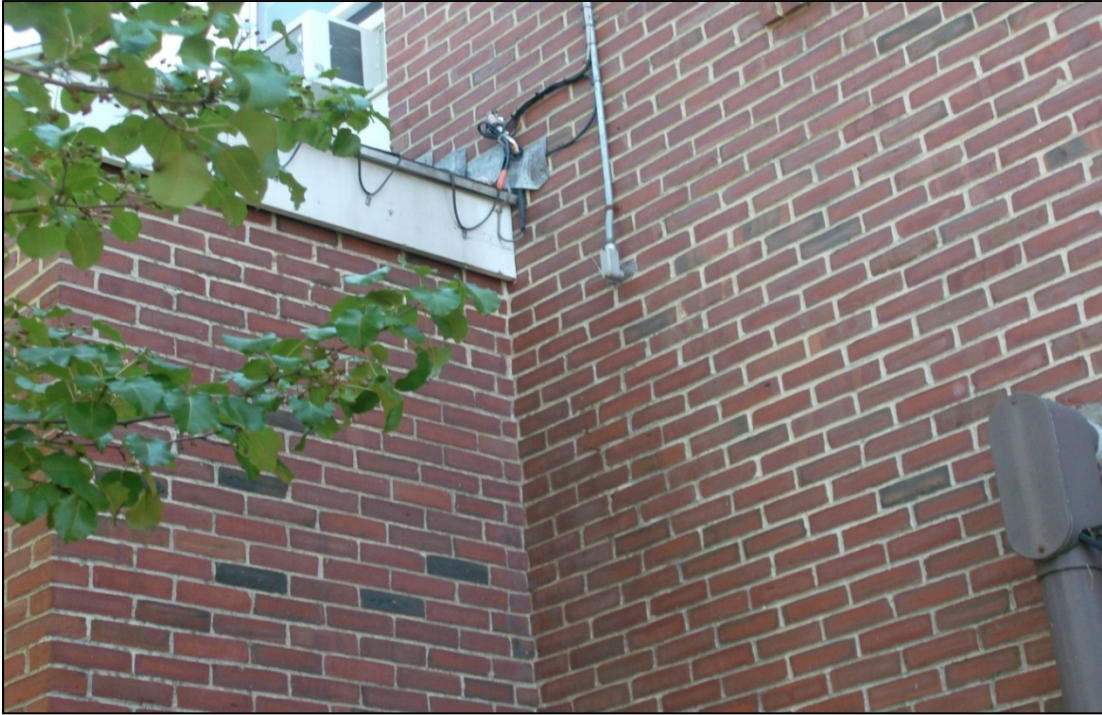
Valley over main entrance. Ice dams are a constant problem, note heat tape.

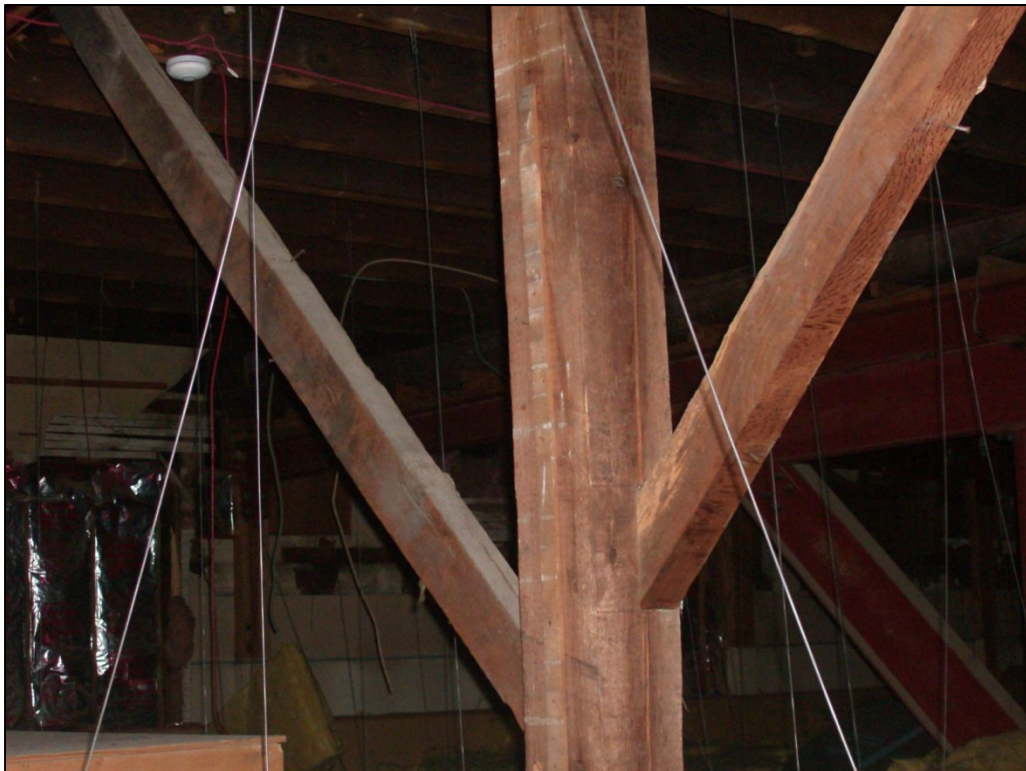
New framing in attic area above Senior Center. Note steel truss in background that was added when second floor walls and floor were removed, and the roof was lowered.

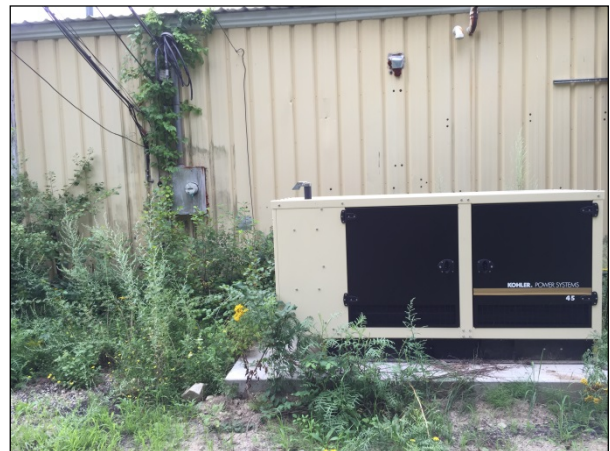
Standby Generator

The building is backed-up by an exterior pad mounted 45 kw, 120/208, 3P natural gas generator located at the back of the building manufactured by Kohler. The generator has a weatherproof enclosure and appears to be in good condition. Automatic transfer switch is located within the back corridor. The ATS switch is manufactured by Kohler.

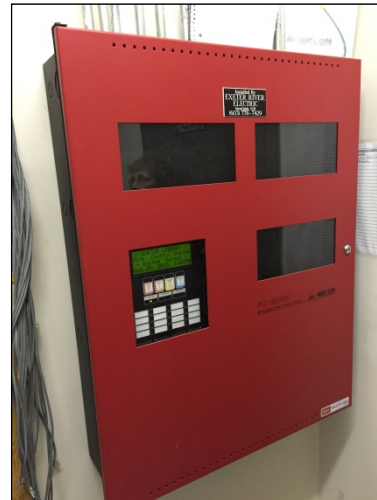
Existing Fire Alarm Control Panel

The fire alarm system is a Mircom addressable fire alarm control panel located on the ground level in the main electric room with an exterior masterbox for connection with the local Fire Department. The FACP appears to be in good condition. The Library is sprinklered. The smoke/heat detector coverage appears to be adequate.

The fire alarm initiation and notification devices were newer ADA type and the coverage was not sufficient. Additional devices shall be provided in bathrooms, office areas, breakrooms and corridors.

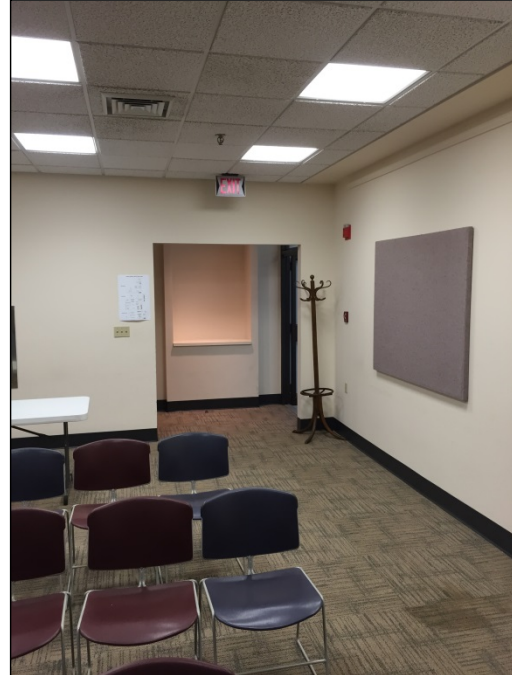
General Recessed Mounted Outlets

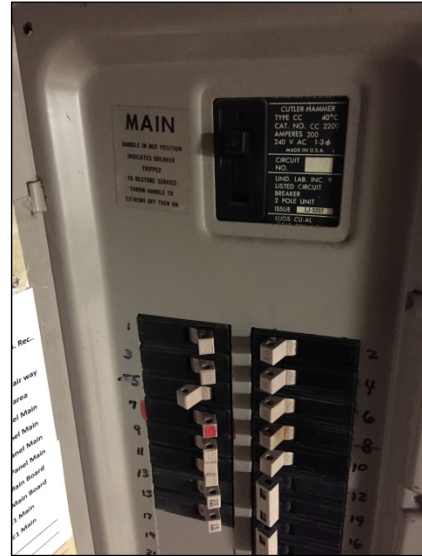
The main electrical service is a 200A, 120/240V, 1-phase, 3W. The service enters the building via overhead utility pole. The electrical switch service equipment manufactured by Cutler Hammer with sub-panels located throughout the facility. The sub-panels are in good condition. The main electrical switch gear consisted of a 200A main circuit breaker and various sub-circuit breakers. The electrical panel has space and spares.

Main Electrical Service Panelboard

It is recommended that the main electrical switch gear remain as installed and updated directory cards be updated for circuit breakers. Load tests shall be performed to provide actual load to determine future expansion, compared with PSNH utility bills.

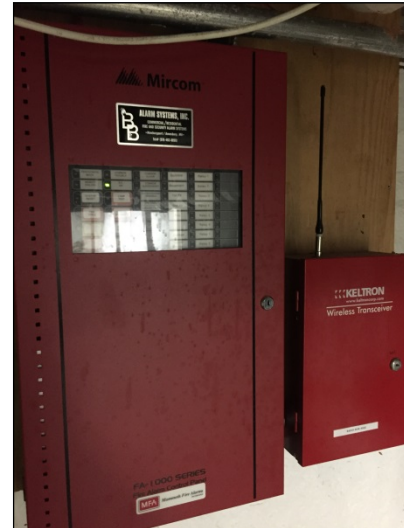
The fire alarm system is a Mircom zoned fire alarm control panel located on the ground level in the main electric room with a radio masterbox for connection with the local Fire Department. The FACP appears to be in good condition. The center is sprinklered. The smoke/heat detector coverage appears to be adequate. The fire alarm initiation and notification devices were newer ADA type, but the coverage was not sufficient.

Existing Fire Alarm Control Panel

No action as this time.

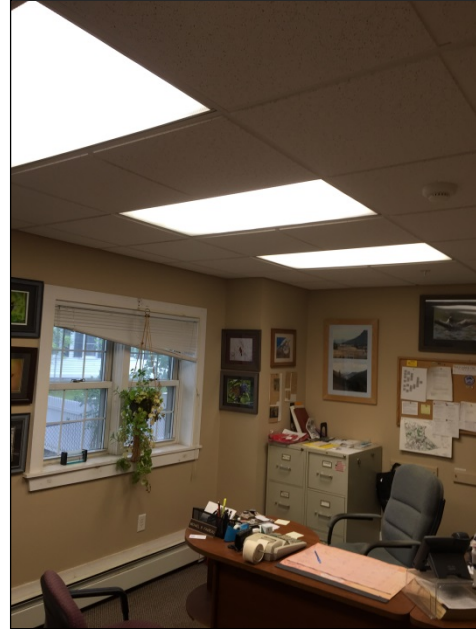
The lighting fixture types consisted of 2x4 recessed mounted fluorescent fixtures. The lighting throughout was in fair condition. Existing fixtures shall be cleaned, re-lamped and ballasted as required for best performance.

Recessed Mounted Fluorescent Fixtures

It is recommended that lights are checked for lamping outage and exterior fixtures cleaned for optimal efficiency. Existing Metal Halide fixtures may be replaced with high efficient LED style lamping. The Town shall review rebate options with PSNH for replacement.

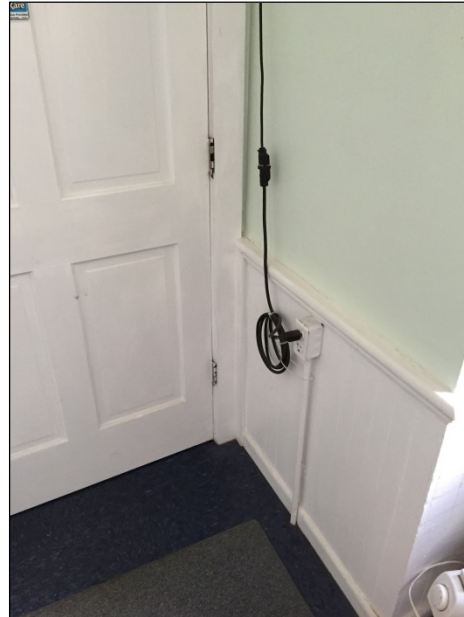
General Surface Mounted Outlets

It is recommended that additional devices be installed where extension cord and power strips are being utilized.

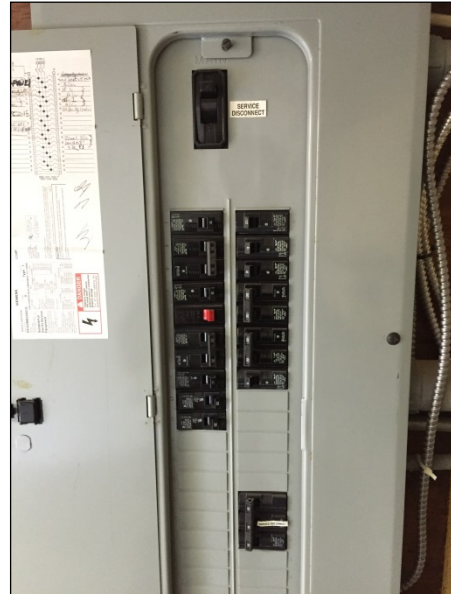
The main electrical service is a 200A, 120/208V, 3-phase, 4W. The service enters the building via overhead utility pole. The electrical switch service equipment manufactured by Square D with sub-panels located throughout the facility. The sub-panels are in good condition. The main electrical switch gear consisted of a 200A main circuit breaker and various sub-circuit breakers. The electrical panel has space and spares.

Main Electrical Service Panelboard

It is recommended that the main electrical switch gear remain as installed and updated directory cards be updated for circuit breakers. Load tests shall be performed to provide actual load to determine future expansion, compared with PSNH utility bills.

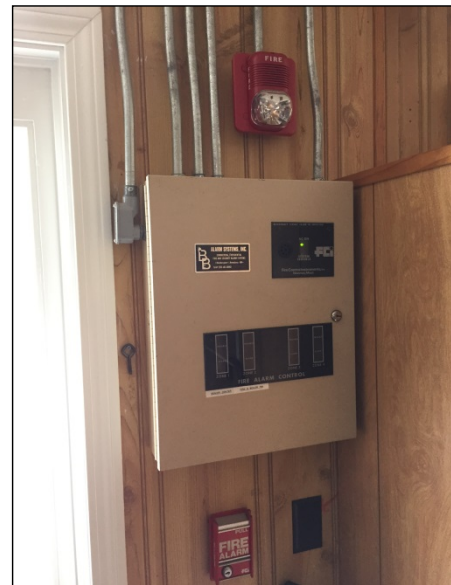
The fire alarm system is a FCI 4-Zone fire alarm control panel located on the ground level in the main electric room with an exterior masterbox for connection with the local Fire Department. The FACP appears to be in good condition. The center is not sprinklered. The smoke/heat detector coverage appears to be adequate. The fire alarm initiation and notification devices were newer ADA type, but the coverage was not sufficient.

Existing Fire Alarm Control Panel

No action as this time.

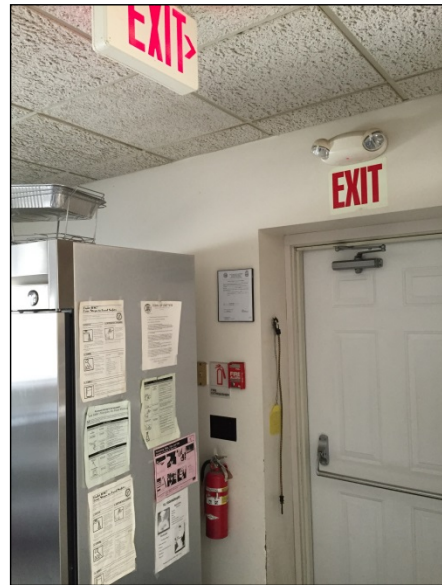
There were LED exit signs in good condition and the coverage was adequate throughout.

Exit Sign and Remote Battery Unit Heads

All existing life safety lighting shall be checked as part of an annual maintenance schedule and replaced as

required. All egress doors shall be provided with illuminated battery backed-up LED type exit signs. Provide additional emergency battery units to provide general egress lighting.

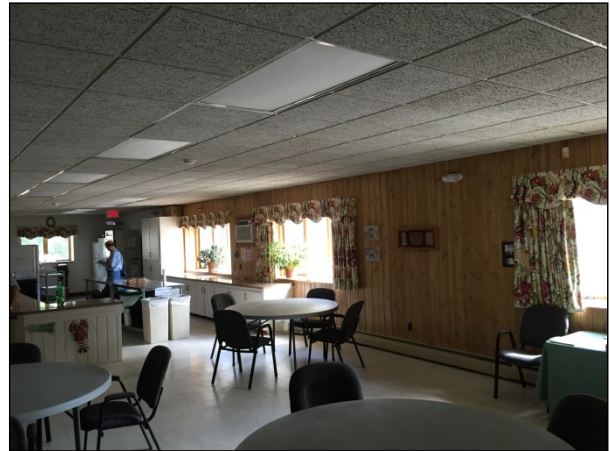
General Recessed and Surface Mounted Outlets

It is recommended that additional devices be installed where extension cord and power strips are being utilized.

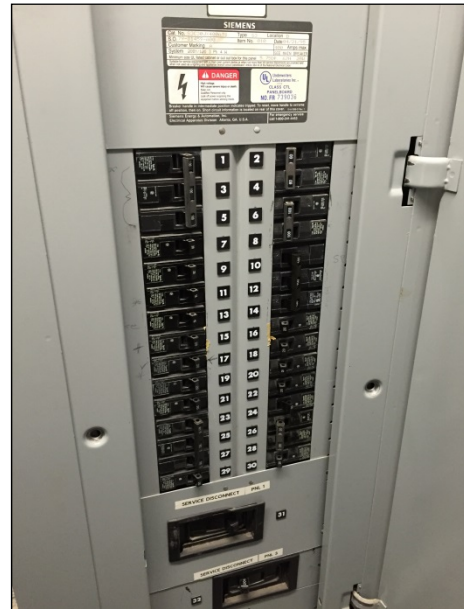
The main electrical service is a 400A, 120/208V, 3-phase, 4W. The service enters the building at the basement level via underground duct bank conduit from an overhead utility pole. The electrical switch gear was new service equipment manufactured by Siemens with older sub-panels located throughout the facility. The sub-panels are in good condition. Currently, there is new panelboard upgrades happening on the 2nd floor and the attic space. The main electrical switch gear consisted of a 400A main circuit breaker with various circuit breakers. The electrical panel has no space and no spares.

Main Electrical Service Panelboard

It is recommended that the main electrical switch gear remain as installed and updated directory cards be updated for circuit breakers. Load tests shall be performed to provide actual load to determine future expansion, compared with PSNH utility bills.

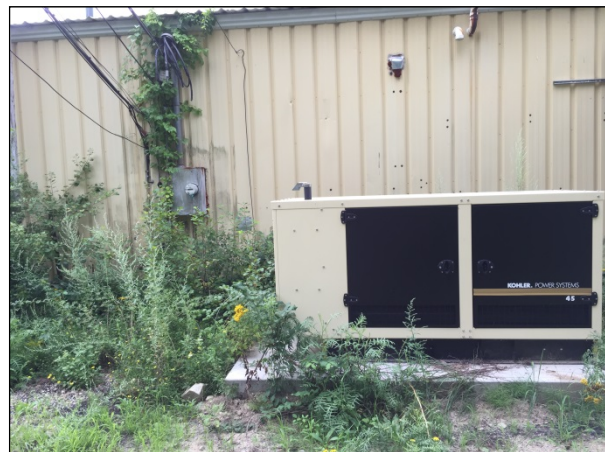
The building is backed-up by an exterior pad mounted 45 kw, 120/208, 3P natural gas generator located at the back of the building. The generator has a weatherproof enclosure and appears to be in good condition. The automatic transfer switch is located within the back corridor. The ATS switch is manufactured by Kohler.

Standby Generator

It is recommended that the standby generator shall exercise on a set schedule by the manufacturer and serviced as required. A load test should be performed to pull data for the amount of load on the generator to allow for any expansion as required. The exhaust for the generator discharges within the enclosure. This unit is adjacent to operable windows and HVAC air intakes. The generator exhaust shall run to above the roofline with a stack. International Building and International Mechanical codes required exhaust to discharge more than 10'-0" from operable windows and/or fresh air intakes.

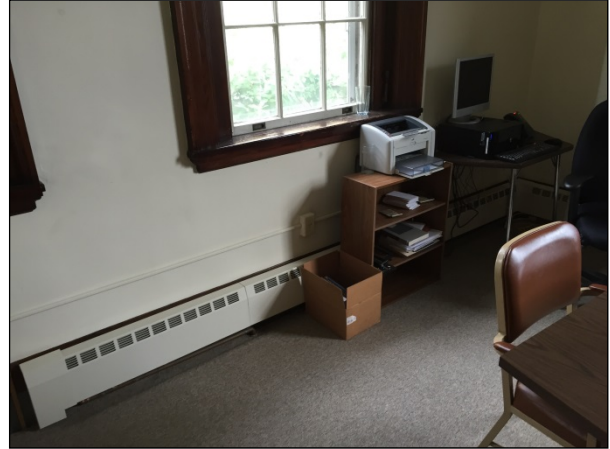
General Surface Mounted Outlet

It is recommended that additional devices be installed where extension cord and power strips are being utilized.

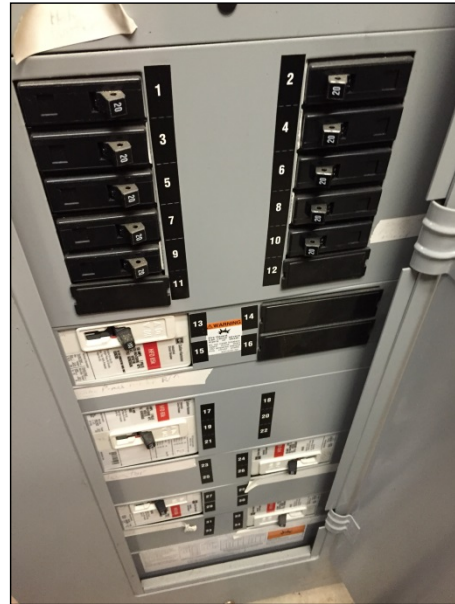
The main electrical service is a 400A, 120/208V, 3-phase, 4W. The service enters the building at the basement level via underground duct bank conduit from an overhead utility pole. The electrical switch gear was new service equipment manufactured by Siemens with older sub-panels located throughout the facility. The sub-panels are in good condition. The main electrical switch gear consisted of a 400A main circuit breaker with various circuit breakers. The electrical panel has few spaces for future breakers.

Main Electrical Service Panelboard

It is recommended that the main electrical switch gear remain as installed and updated directory cards be updated for circuit breakers. Load tests shall be performed to provide actual load to determine future expansion, compared with PSNH utility bills.

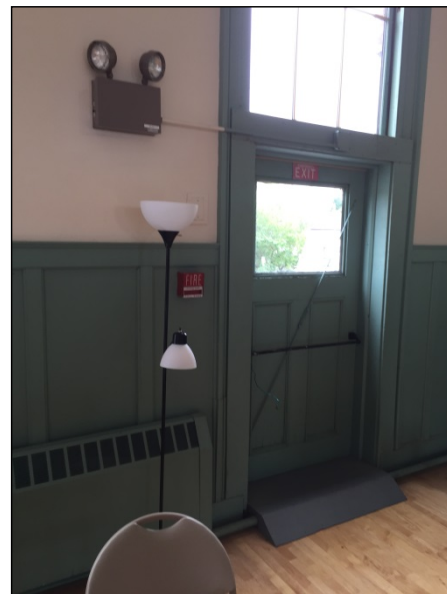
The fire alarm system is a Gamewell FCI zoned fire alarm control panel FACP located in the basement. There is a remote annunciator with indicator lights in the front lobby. A radio masterbox for connection with the local Fire Department is located adjacent to the FACP. The FACP is in fair condition. The building is sprinklered. The smoke/heat detector coverage was adequate except for common corridors. The fire alarm initiation and notification devices appear to be in good condition, but the coverage was not sufficient. The pull stations were noted to be mounted too high to meet ADA requirements. Additional devices shall be provided in bathrooms, office areas, breakrooms and corridors.

Existing Fire Alarm Pull Station

It is recommended additional notification devices be added to meet NFPA coverage requirements. Existing pull stations shall be relocated to 48" to meet ADA requirements.

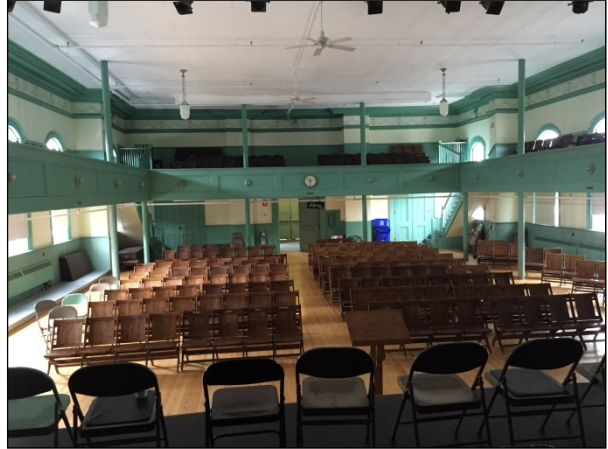
The lighting fixture types consisted of surface mounted pendant fixtures, track lighting, surface mounted strip fixtures. Lighting fixtures contained T8 fluorescent lamps and incandescent lamping. The lighting throughout was in fair condition. Existing fixtures shall be cleaned, re-lamped and ballasted as required for best performance.

Surface Mounted Track and Pendant Mounted Fixtures

It is recommended that lights are checked for lamping outage and exterior fixtures cleaned for optimal efficiency. Existing Metal Halide fixtures may be replaced with high efficient LED style lamping. The Town shall review rebate options with PSNH for replacement.

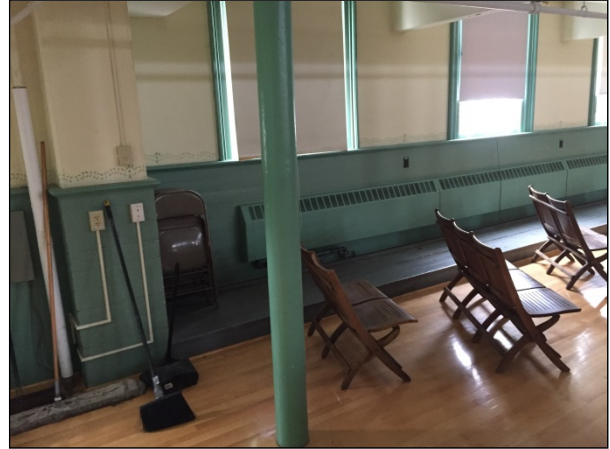
General Surface and Recessed Mounted Outlets

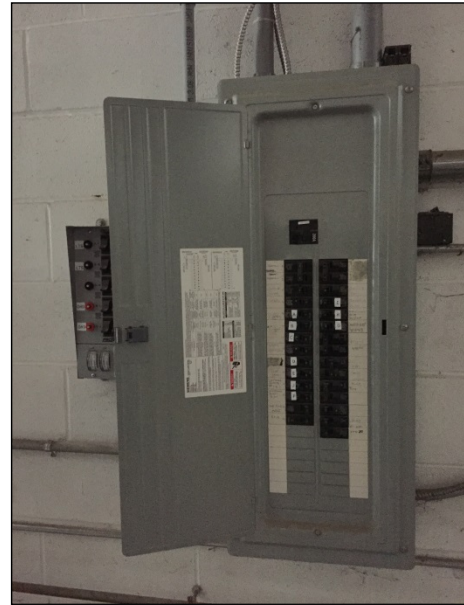
Main Electrical Service Panelboard

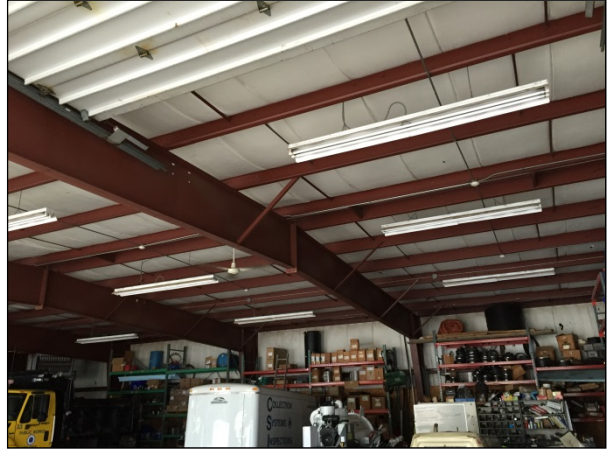
Pendant Mounted Fluorescent Fixtures

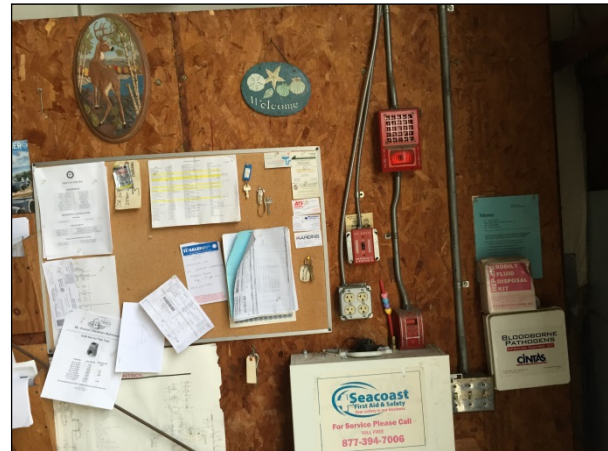
General Surface Mounted Outlet
