**WINTER STREET CEMETERY  
CONSERVATION TREATMENT REPORT  
EXETER, NEW HAMPSHIRE**

**Submitted By:**            Conserve ART LLC  
                                  Francis Miller, Conservator  
                                  19 Lansdowne Avenue  
                                  Hamden, CT 06517  
                                  Cell:     203-506-6846  
                                  Email:   conserveartllc@gmail.com

**Date:**                        January 18, 2017

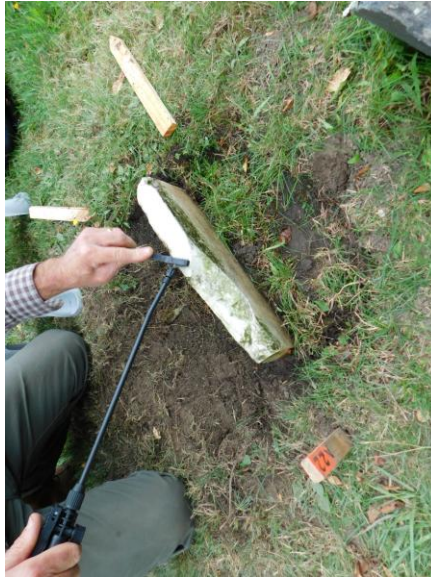
5. EWSC A22. DT Cleaning mating sections.

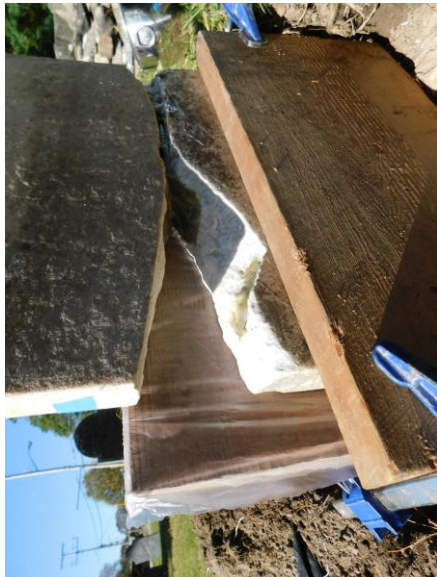
7. EWSC A22. DT View of loss before fill.

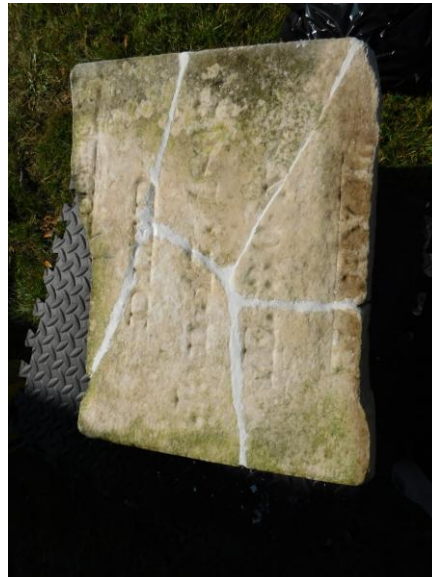
8. EWSC. A29. DT. Fills of misaligned previous repairs.

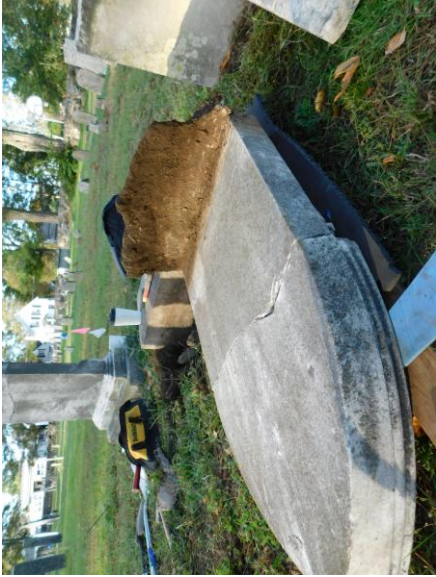
4. EWSC. A30. DT. Concrete poured around marble.

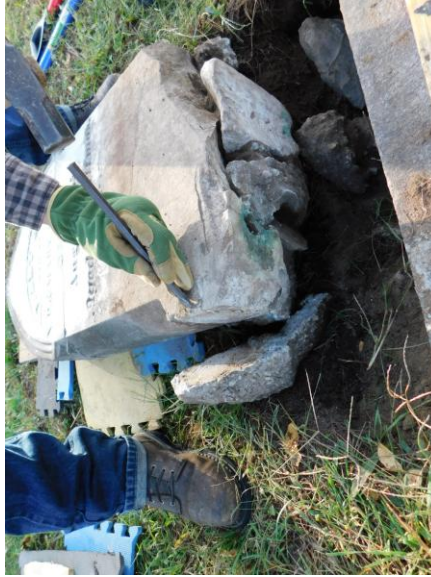
5. EWSC. A30. DT. Removing concrete and marble fragments around marble.

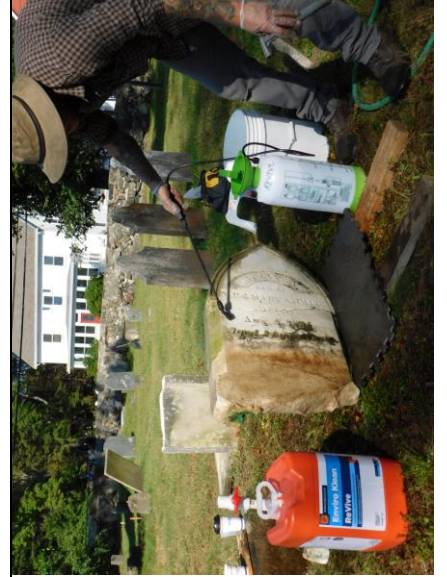
6. EWSC. A30. DT. Cleaning soiled marble.

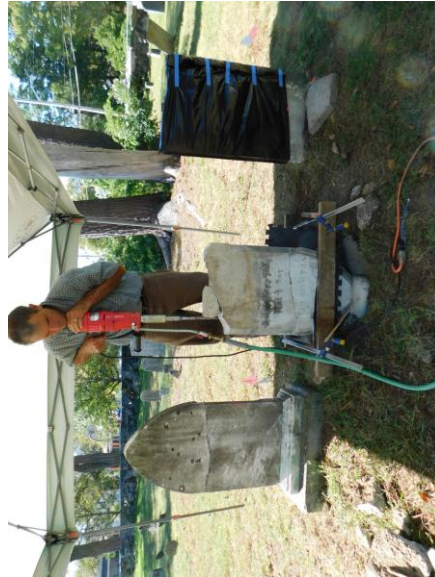
8. EWSC. A30. DT. Coring beyond crack to set pins.

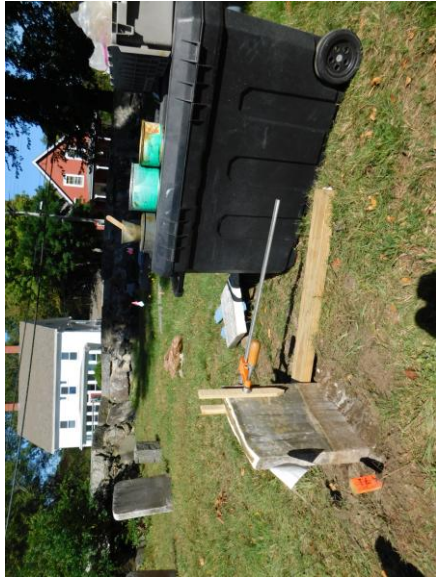
3. EWSC. A71. DT. Overview of epoxy preparation for mends.

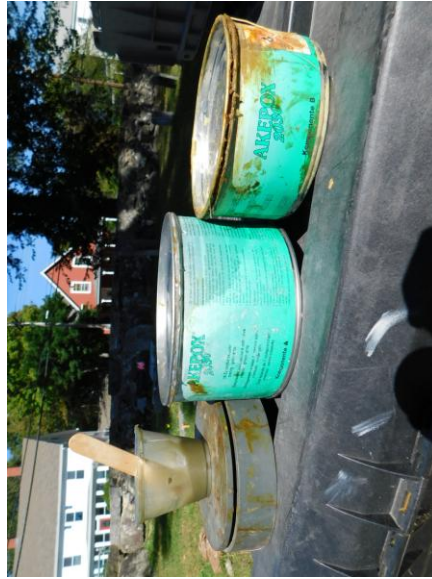
4. EWSC. A71. DT. Detail of epoxy preparation for mends.

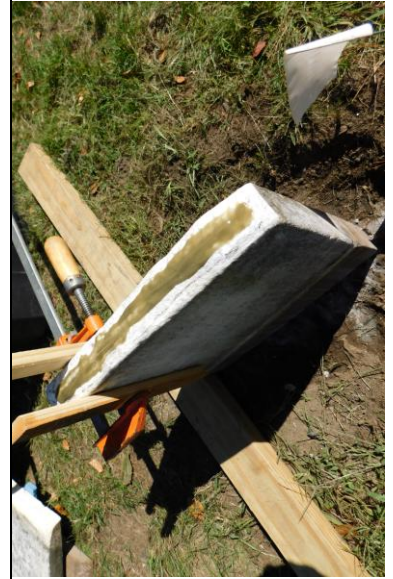
5. EWSC. A71. DT. Epoxy application on bottom stone.

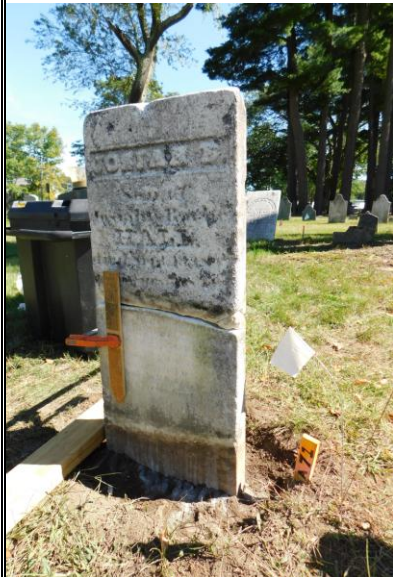
6. EWSC. A71. DT. Sections clamped for epoxy set.

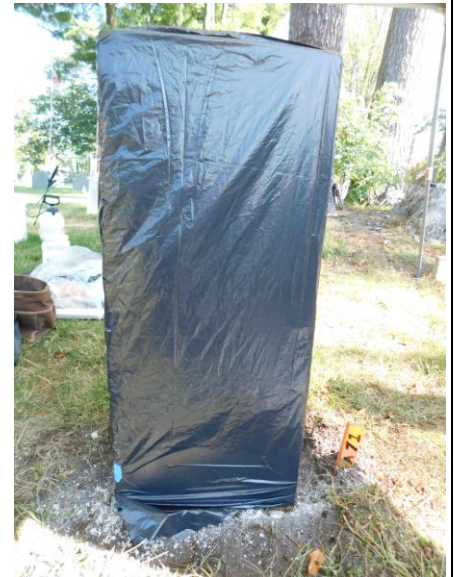
8. EWSC. A71. DT. Marker covered with plastic for mortar cure.

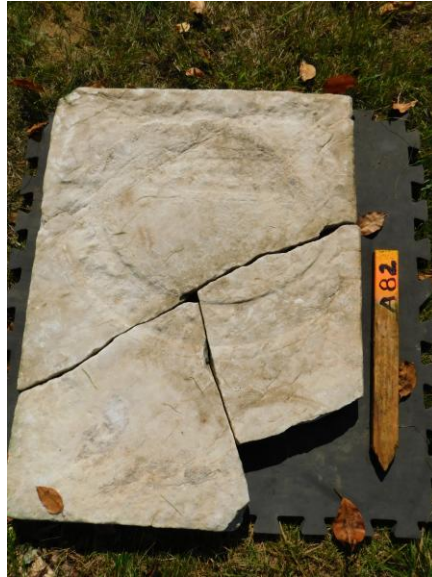
4. EWSC. A82. DT. Cleaned marble sections with ReVive.

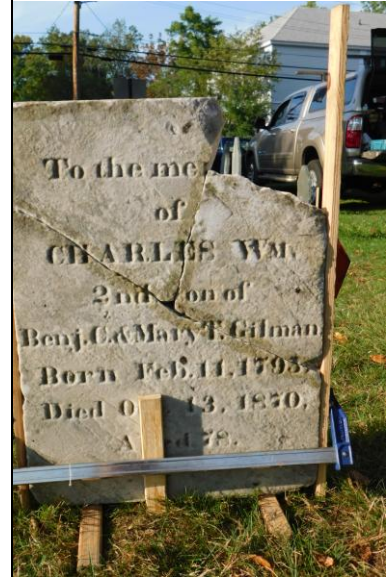
5. EWSC. A82. DT. Joining sections with epoxy and resist on marble faces.

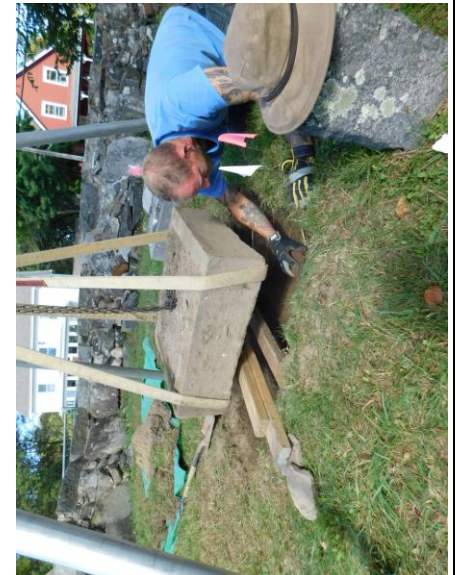
9. EWSC. A82. DT. Leveling granite base on crushed stone.

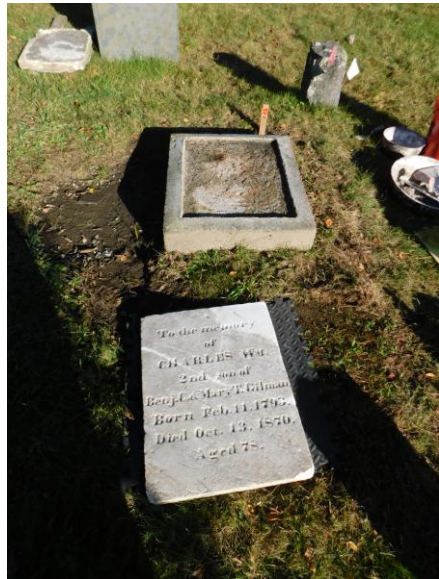
10. Marble prior to setting in mortar bed on granite base.

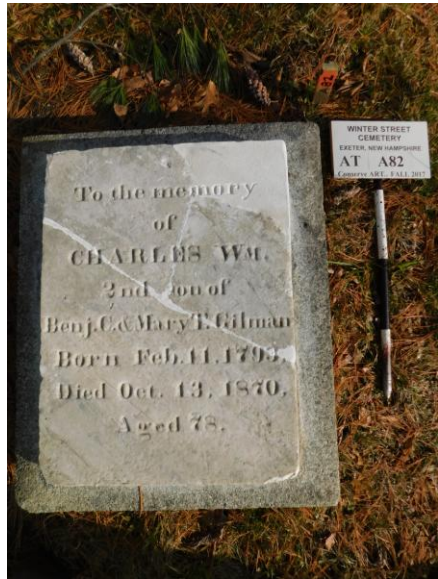
11. EWSC. A82. AT. Top view of the marble and granite after treatment.

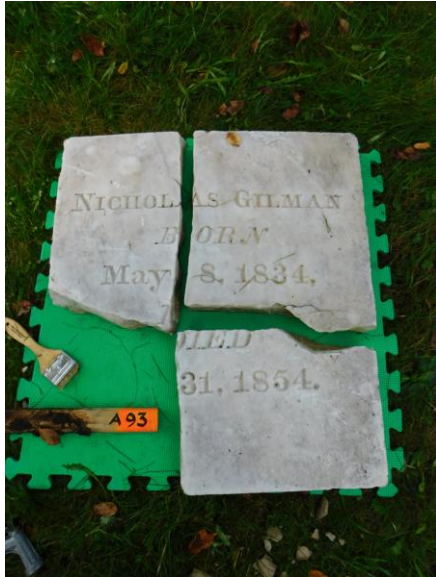
3. EWSC. A93. DT. Cleaning marble sections.

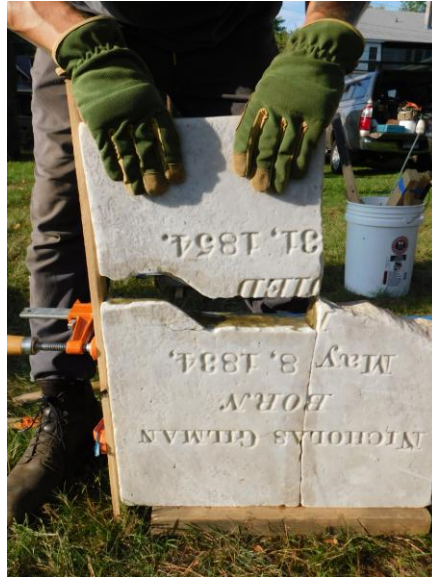
4. EWSC. A93. DT. Adhering marble sections with epoxy.

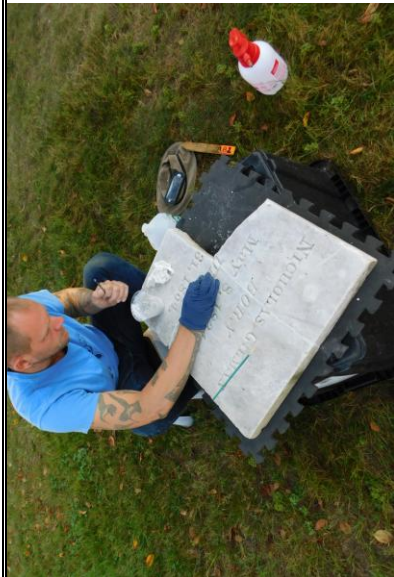
6. EWSC. A93. DT. Filling losses with Jahn mortar.

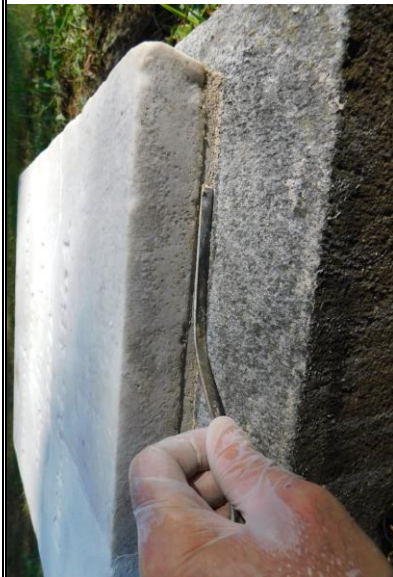
12. EWSC. A93. DT. Pointing the edges of the mortar joint.

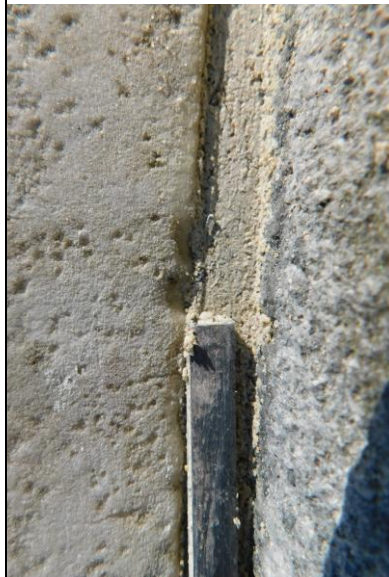
13. EWSC. A93. DT. Detail, pointing the edges of the mortar joint.

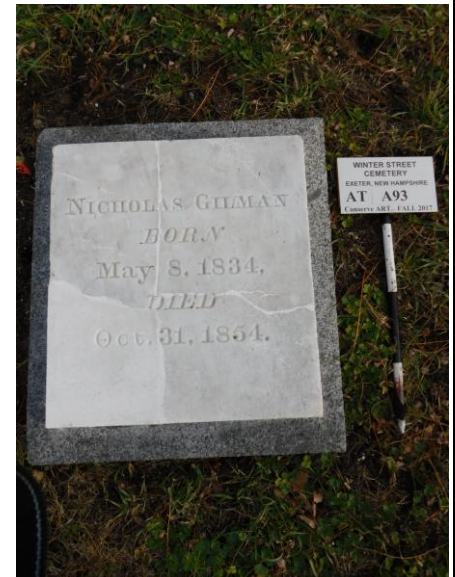
14. EWSC. A93. AT. Top view after treatment of the marble and granite base.

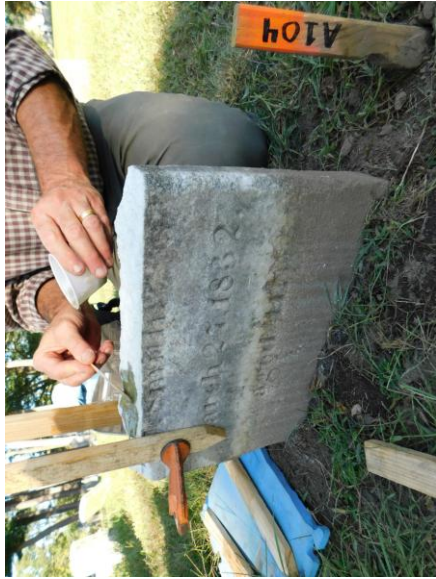
3. EWSC. A104. DT. Application of epoxy to lower stone.

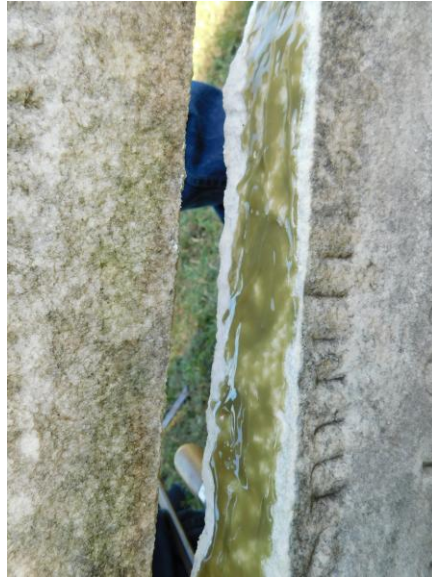
4. EWSC. A104. DT. Detail of mating surfaces with epoxy.

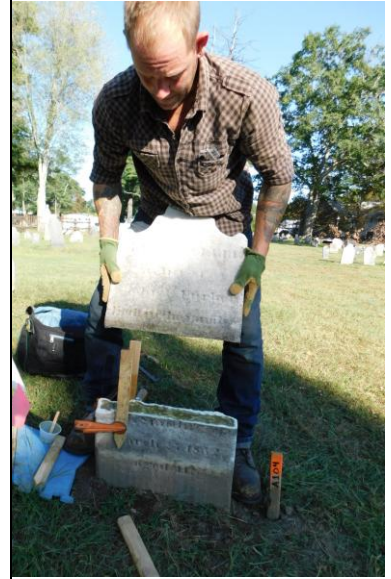
5. EWSC. A104. DT. Joining stones with epoxy.

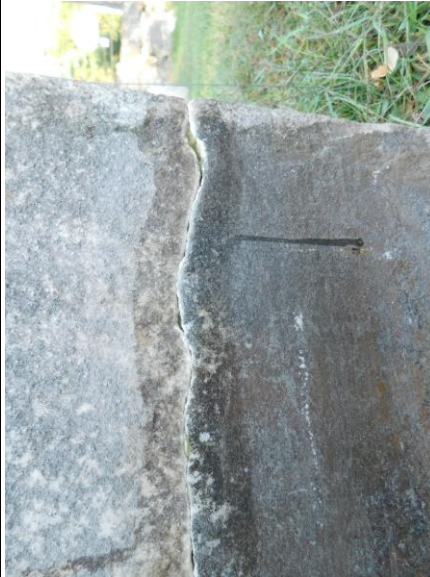
7. EWSC. A104. DT. Release on marble faces and epoxy filling crack.

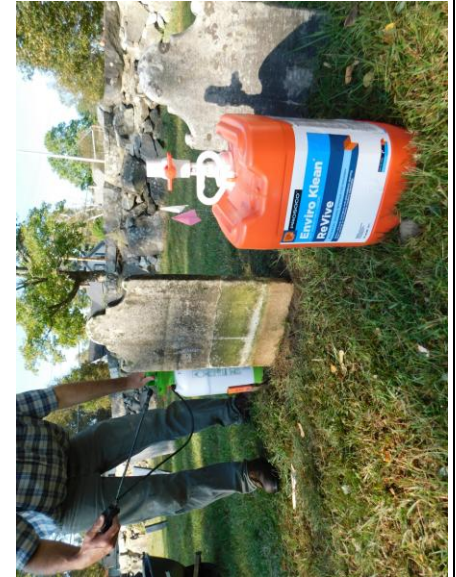
8. EWSC. A104. DT. Cleaning marble with ReVive.

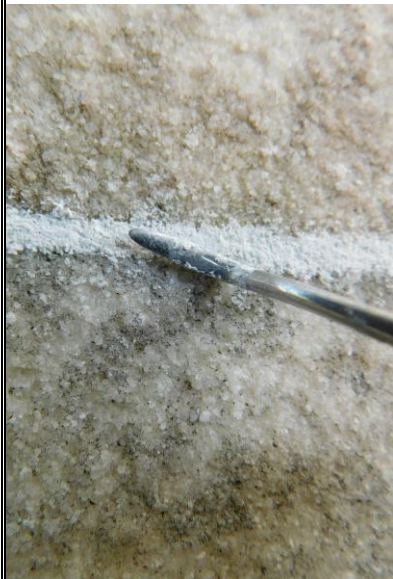
12. EWSC. A104. DT. Detail of break-line during fills.

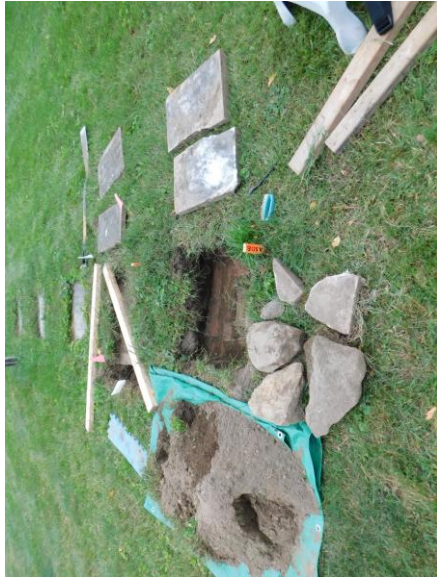
3. EWSC. A108. DT. Overview of area after removal and removal of foundation materials.

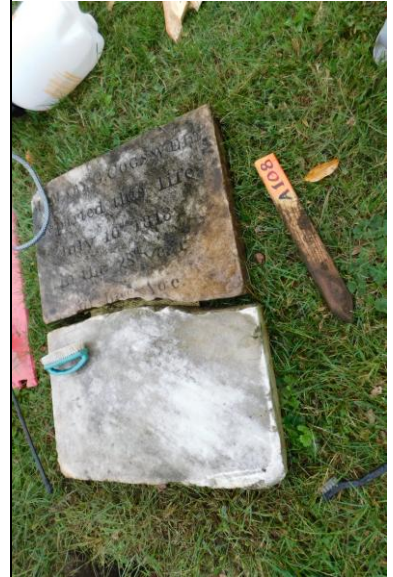
5. EWSC. A108. DT. Cleaning marble with ReVive.

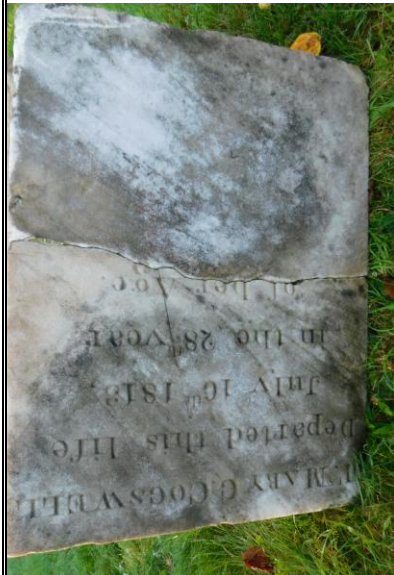
6. EWSC. A108. DT. View of adhered stone.

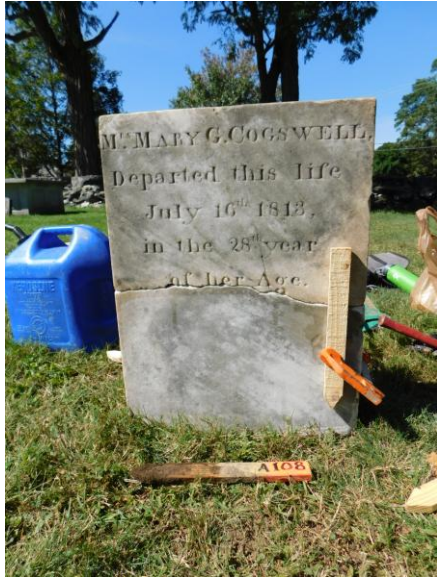
9. EWSC. A108. DT. Bonding stone with epoxy.

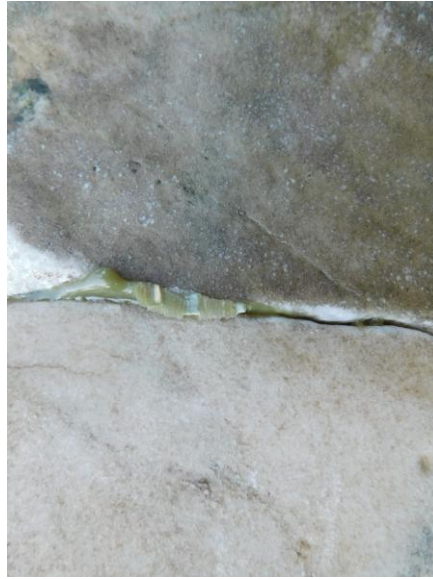
10. EWSC. A108. DT. Detail of excess epoxy.

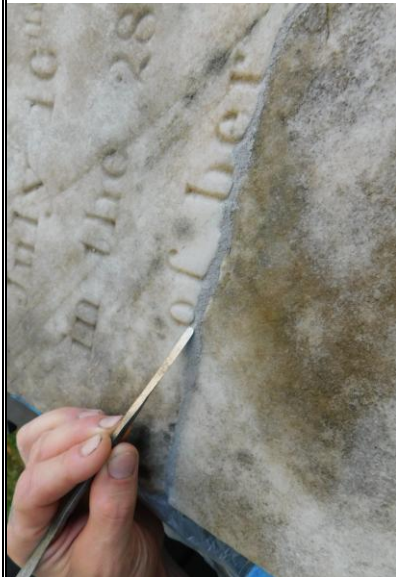
12. EWSC. A108. DT. Mortar fill along break-line.

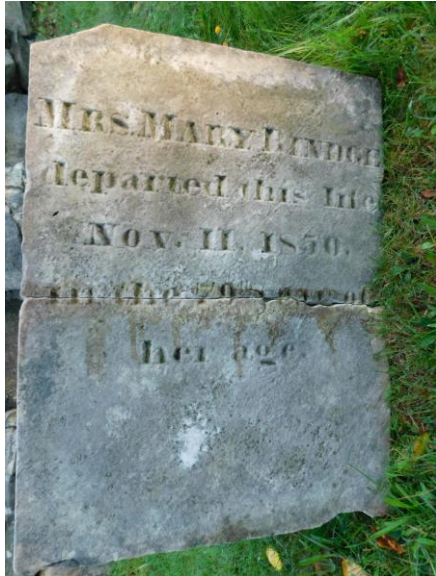
4. EWSC. A109. DT. Two marble sections bonded with epoxy.

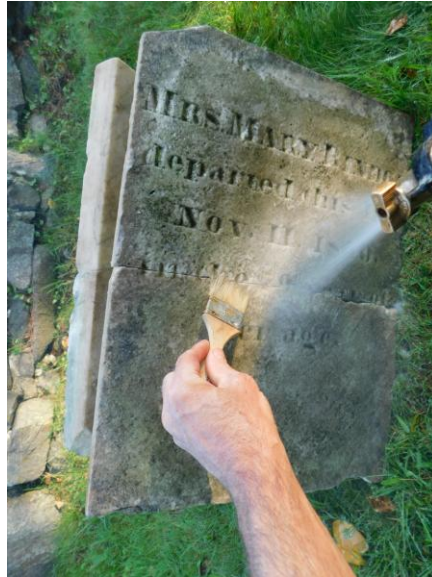
5. EWSC. A109. DT. Cleaning the marble with ReVive.

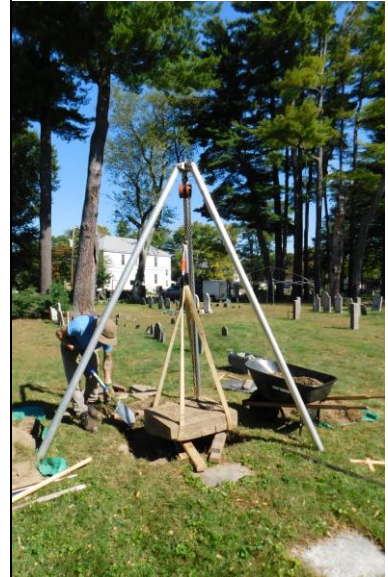
6. EWSC. A109. DT. Removal of base for crushed stone bed.

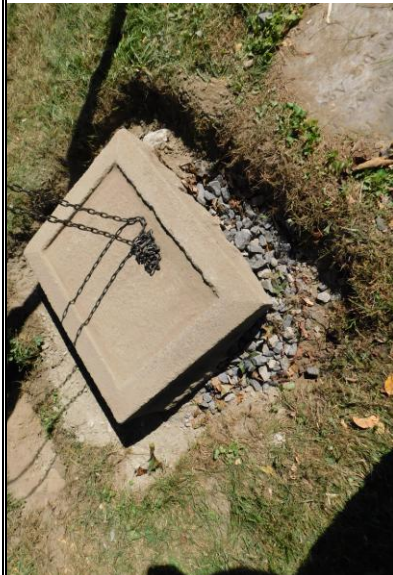
7. EWSC. A109. DT. Setting granite base on crush stone.

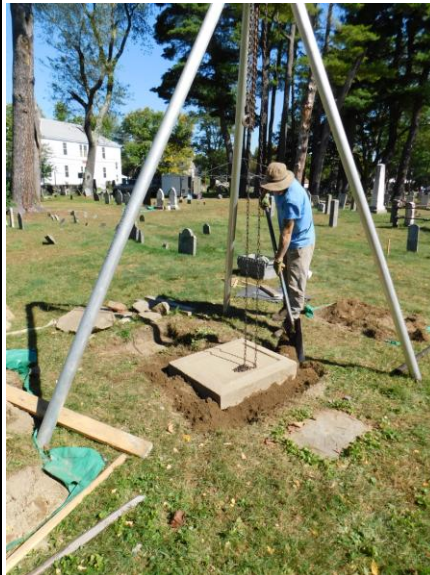
8. EWSC. A109. DT. Packing earth around the granite.

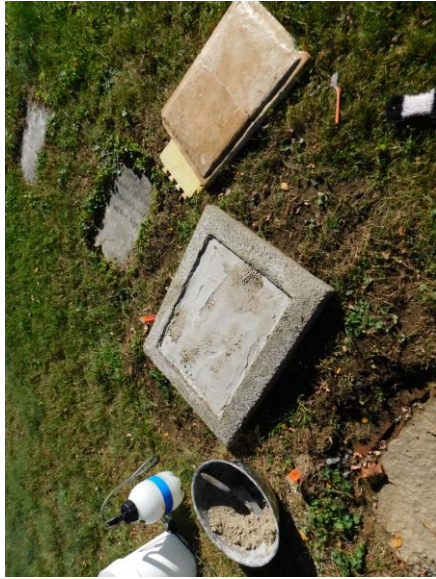
10. EWSC. A109. DT. Overview of granite and marble ready for setting in mortar.

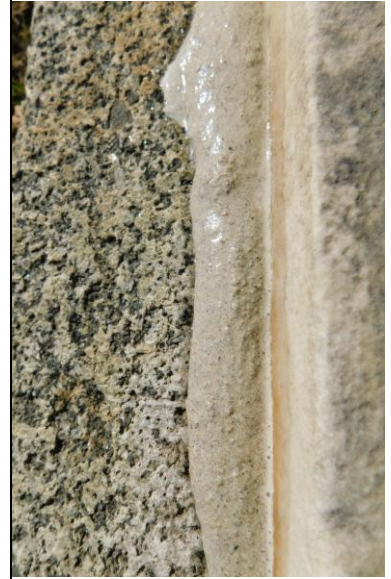
12. EWSC. A109. DT. Detail of mortar extruding from below marble.

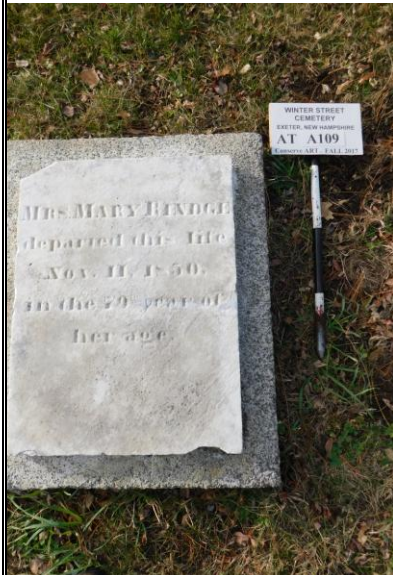
13. EWSC. A109. AT. Top view of granite and marble.

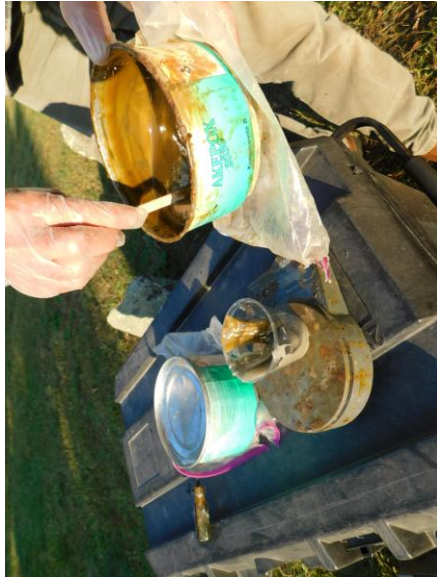
3. EWSC. A126. DT. Mixing epoxy for repair.

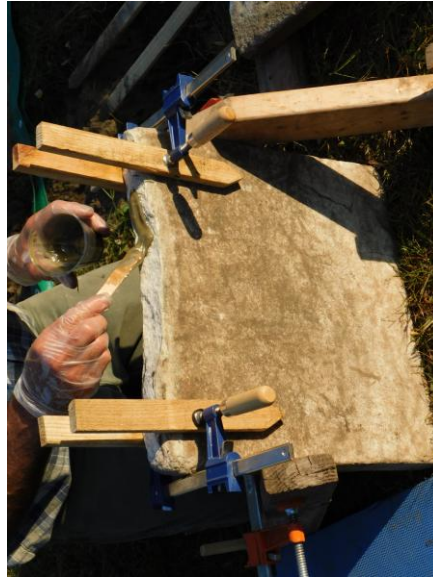
4. EWSC. A126. DT. Application of epoxy for repair.

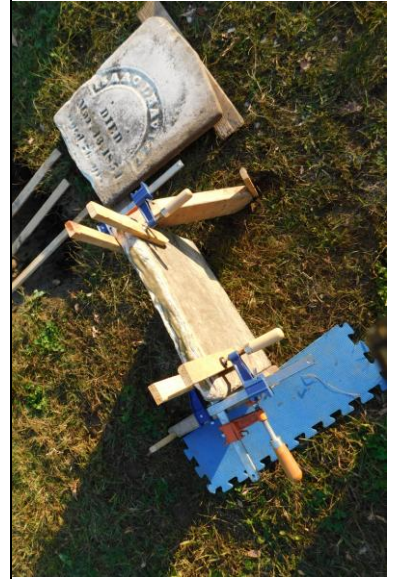
5. EWSC. A126. DT. .Epoxy applied to lower stone.

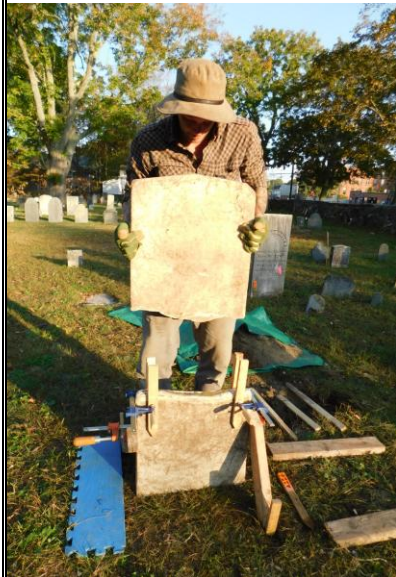
6. EWSC. A126. DT. Joining broken sections

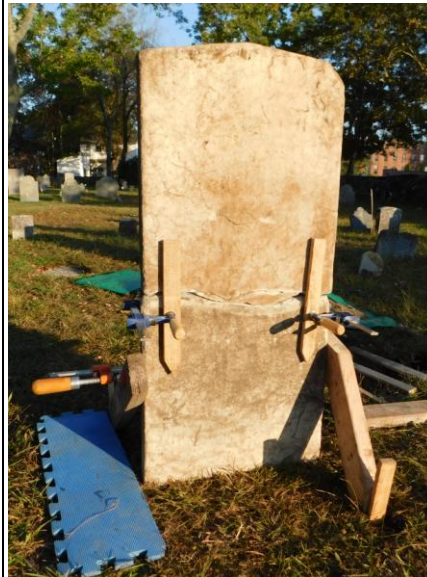
7. EWSC. A126. DT. Sections joined with epoxy during cure.

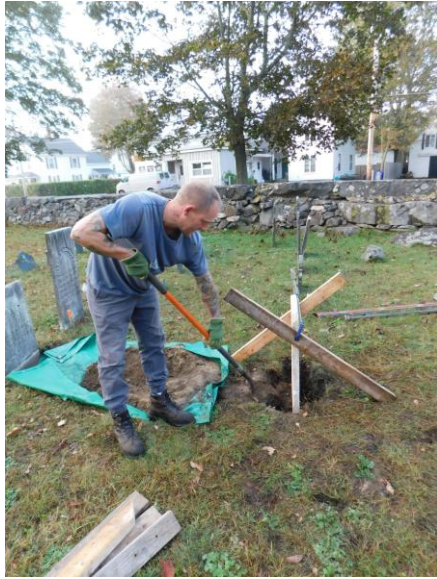
9. EWSC. A126. DT. Backfilling with earth.

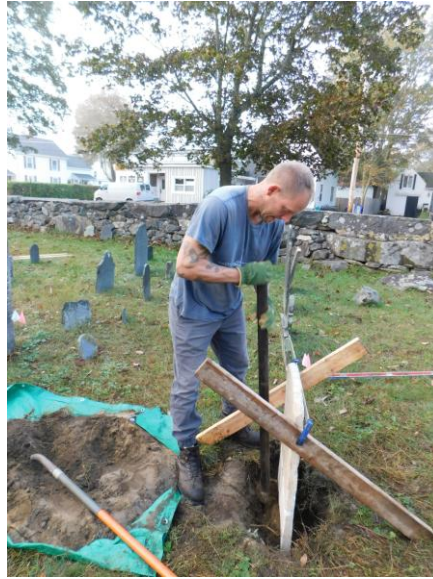
10. EWSC. A126. DT. Tamping earth around marble.

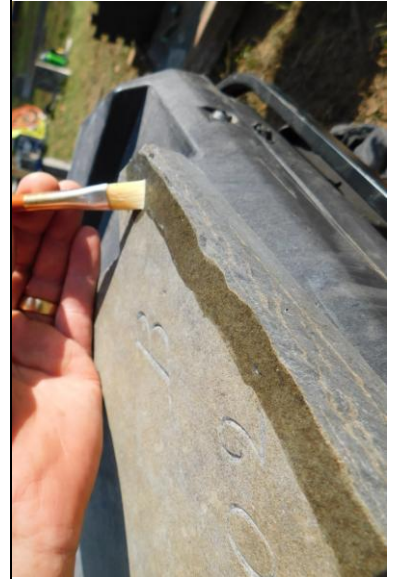
6. EWSC. A145 FS. DT. Application of Orvus resist prior to epoxy mend.

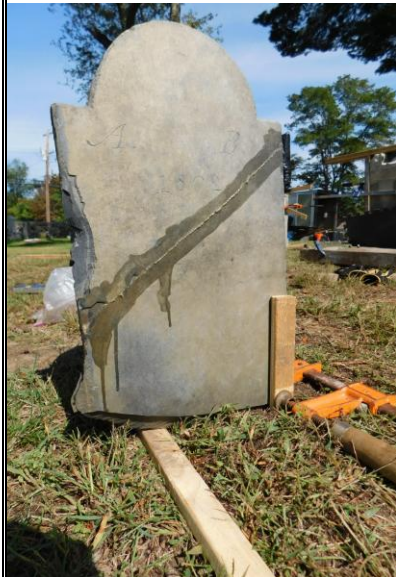
7. EWSC. A145 FS. DT. Sections joined with epoxy.

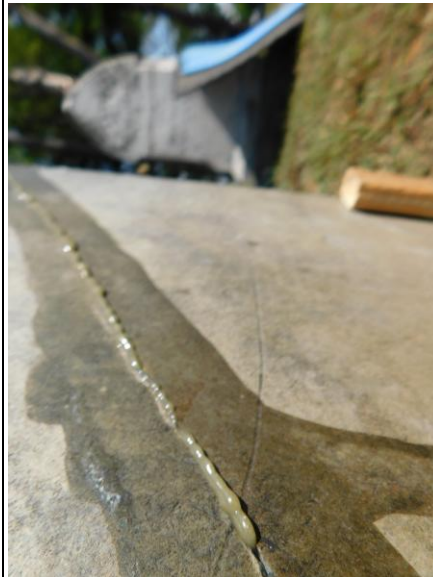
8. EWSC. A145 FS. DT. Detail of excess epoxy and resist.

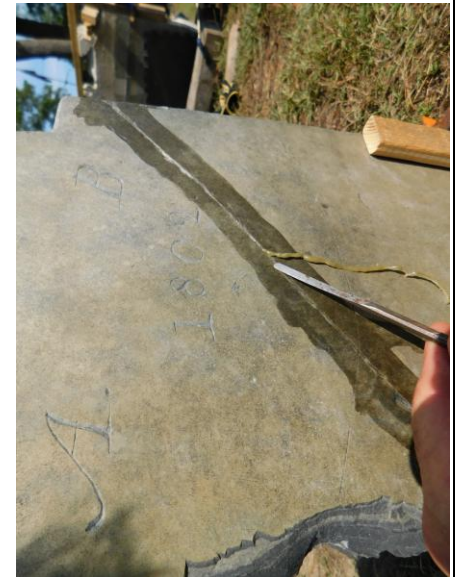
9. EWSC. A145 FS. DT. Removal of excess epoxy prior to full gel.

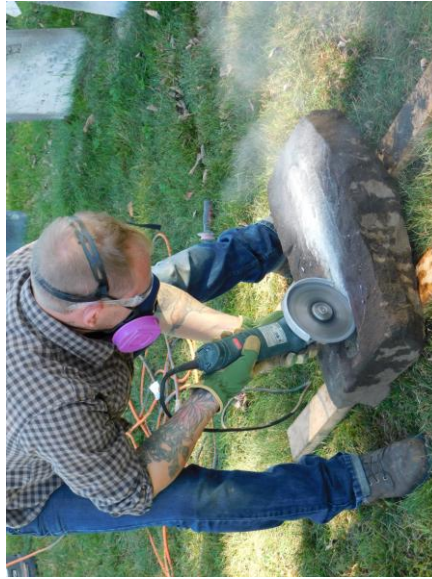
4. EWSC. B71. DT. Removing marble in mortise.

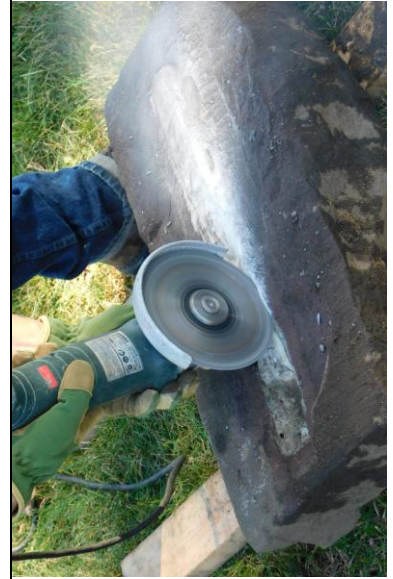
5. EWSC. B71. DT. Removing marble in mortise with diamond wheel.

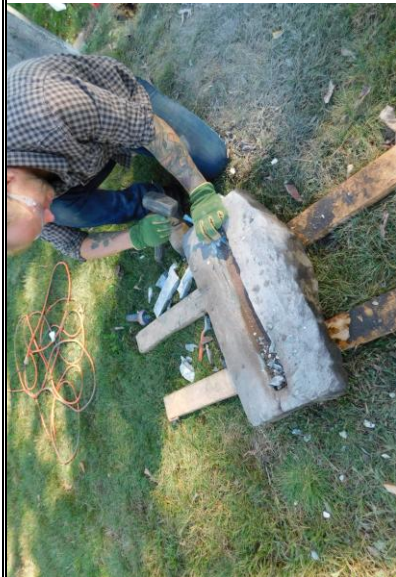
6. EWSC. B71. DT. Removing marble fragments with hammer and chisel.

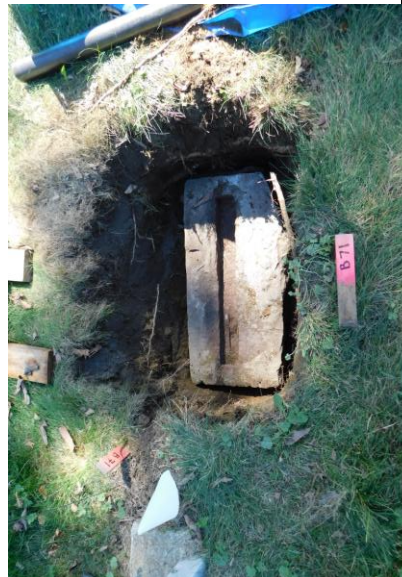
7. EWSC. B71. DT. Mortise cleaned of debris.

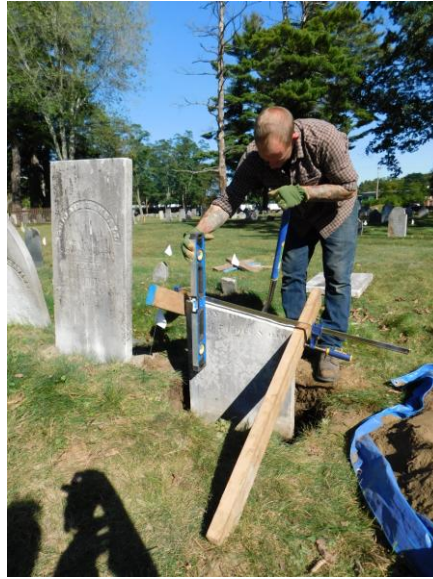
10. EWSC. B71. DT. Plumbing lower section of marble in base.

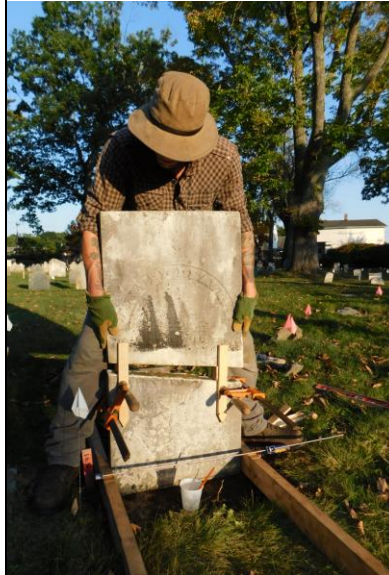
13. EWSC. B71. DT. Joining two sections with epoxy.

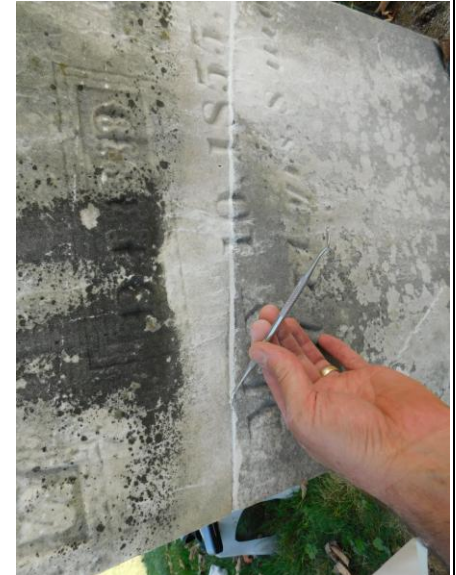
14. EWSC. B71. DT. Application of Jahn mortar in break-line mend.

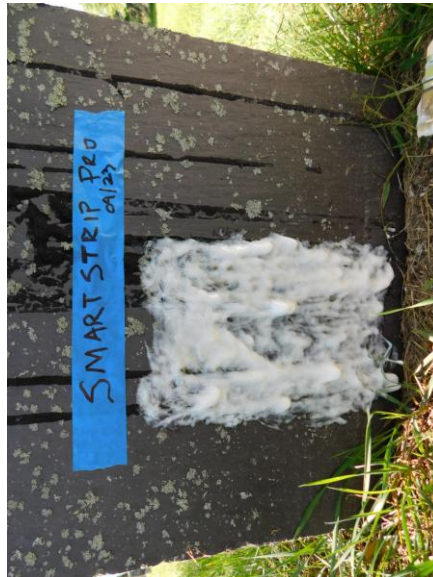
5. EWSC. F80. DT. First stripping test with Smart Strip Pro, detail.

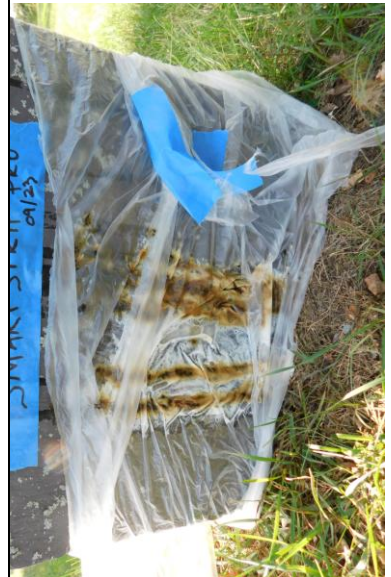
6. EWSC. F80. DT. First stripping test covered with plastic.

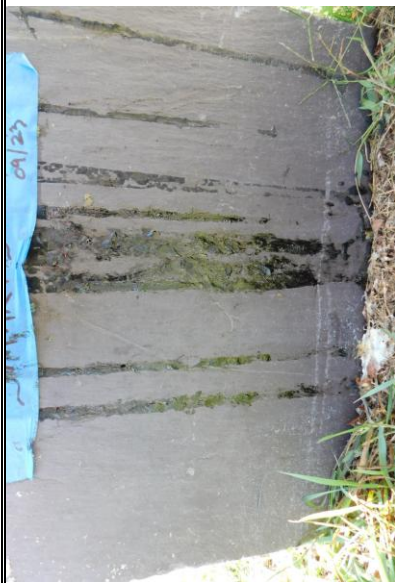
7. EWSC. F80. DT. View of first stripping test. Thick accumulations were removed with popsicle sticks.

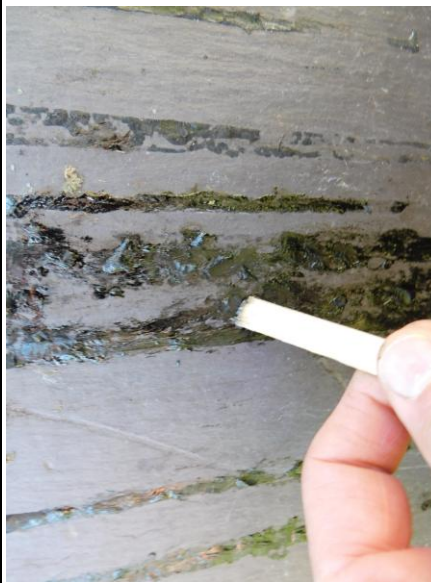
8. EWSC. F80. DT. Detail of scraping tar on back removal test.

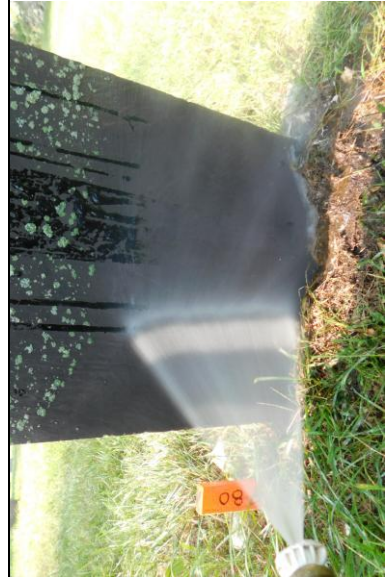
12. EWSC. F80. DT. Rinsing stripper with wide fan spray.

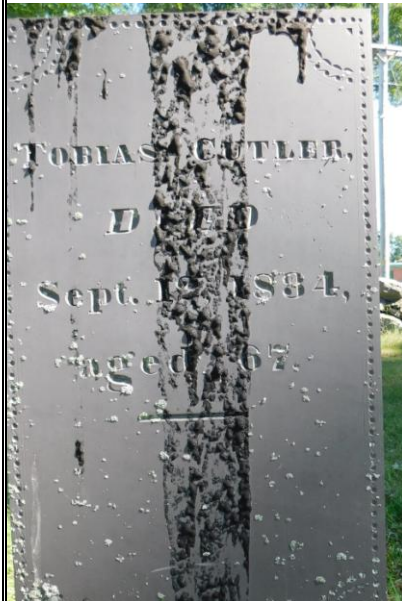
13. EWSC. F80. DT. Detail of upper front slate before scraping tar with wood popsicle stick.

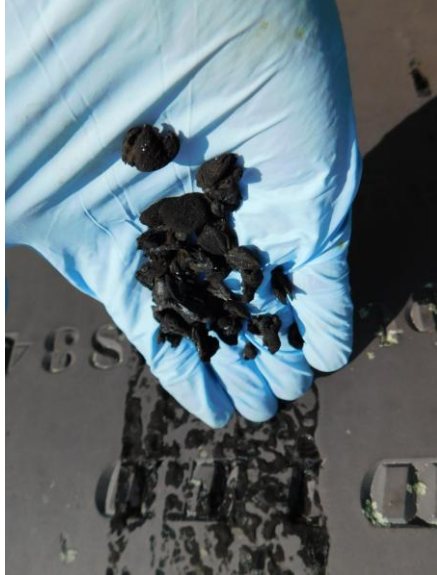
16. EWSC. F80. DT. Holding tar scappings from front of slate.

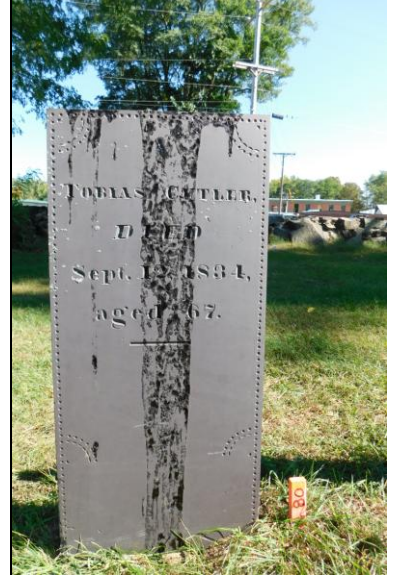
18. EWSC. F80. DT. Overview of front after scrapping with wood popsicle sticks.

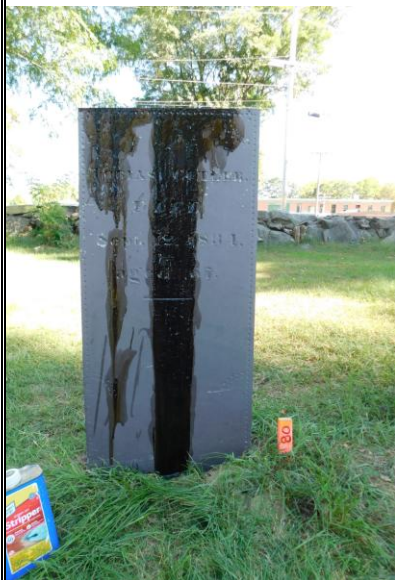
19. EWSC. F80. DT. Application of stripper after scrapping.

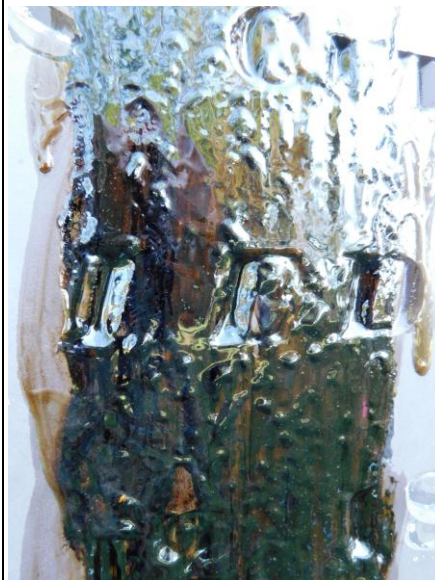
20. EWSC. F80. DT. Application of stripper after scrapping, detail.

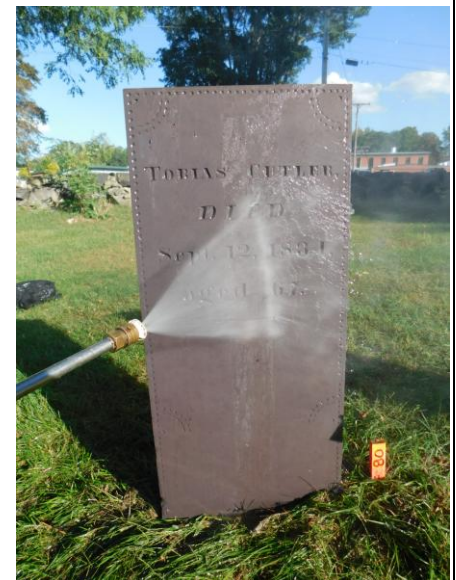
21. EWSC. F80. DT. Rinsing stone with water using a wide fan spray.

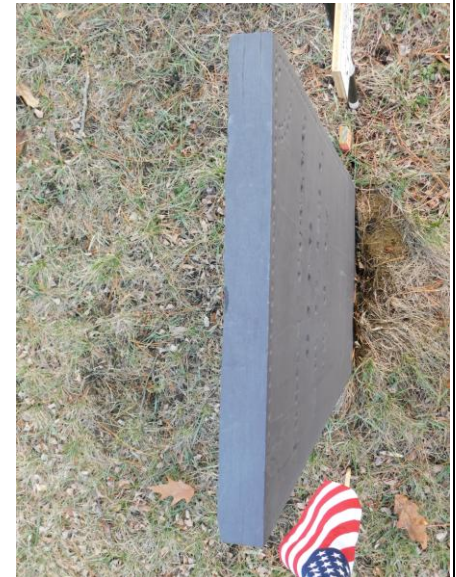
27. EWSC. F80. AT. Top overview after treatment.
