# Leathers & Associates

## Playground Name & Location

Inspected Date: 03/31/2016

Planet Playgroud - Exeter, NH

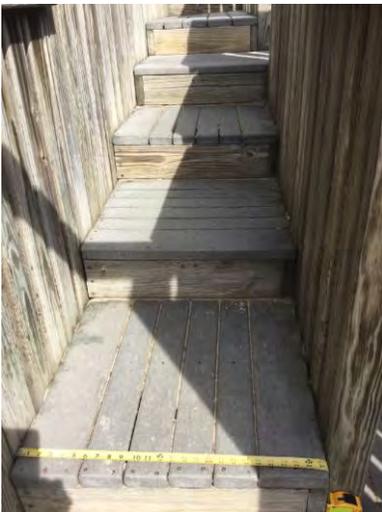
**Maze Cube Condition**

The maze cubes are in medium condition (minor splintering & wear).

Rebuild with current style larger maze cubes using structural plastic framing and recycled plastic decking.

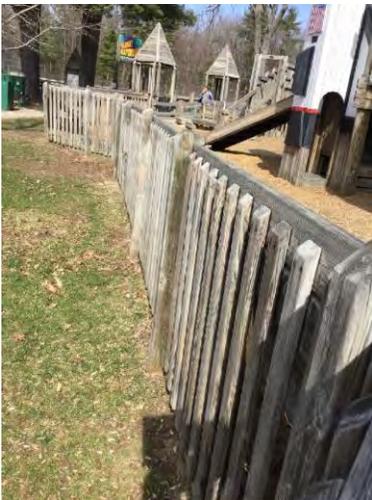
**Fence Condition**

The fence is in poor condition (major splintering, missing pickets and wear).

Replace with new all plastic fence.

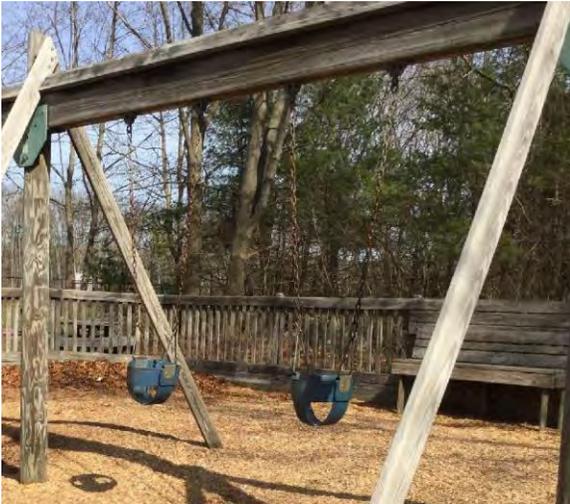
This piece of equipment needs maintenance. Replace S hooks with clevis hangers.

Swing support brackets and swing beams show the wear of 18 years of use. We recommend replacing all swing supports and swings with new powder coated steel manufactured apparatus.

Hangers show the wear of 18 years of use.

Swing chains are rusted.

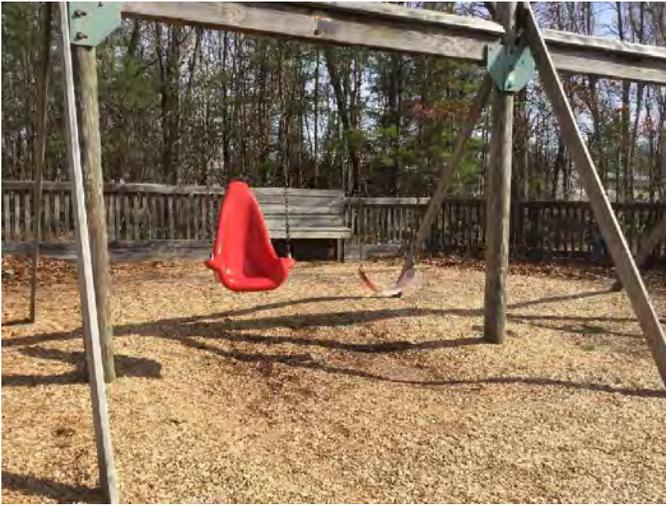
Swing support brackets and swing connected swing beams show sagging and wear due to 18 year of use. We recommend a full replacement.

Swing chains are rusted.

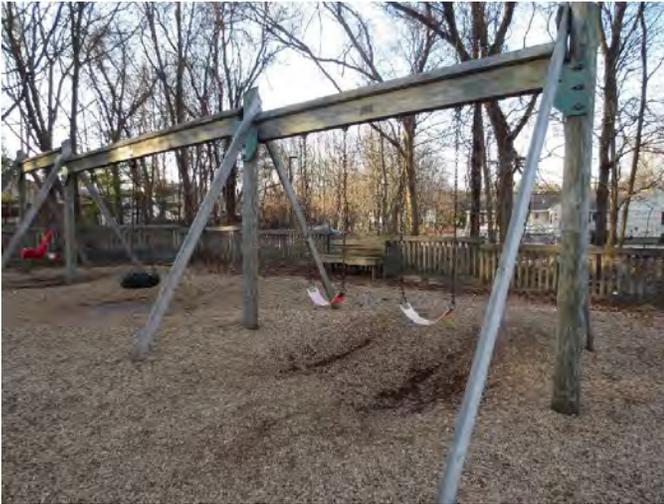
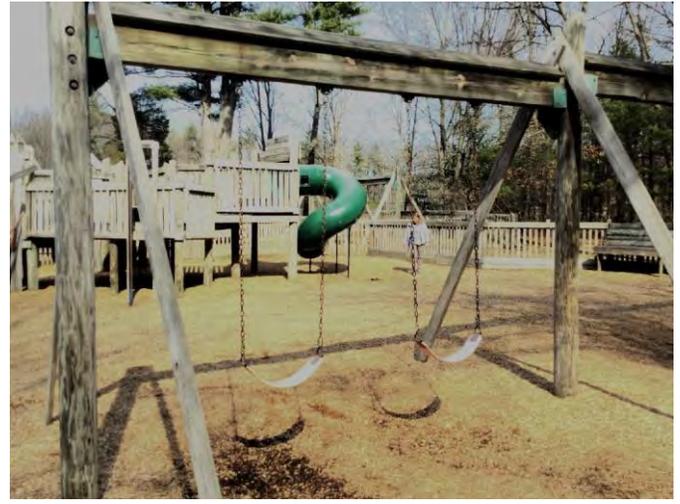
Swing beam brackets and beams show wear after 18 years of use.

Swing hangers show signs of wear after 18 years of use.

Replace with new manufactured equipment

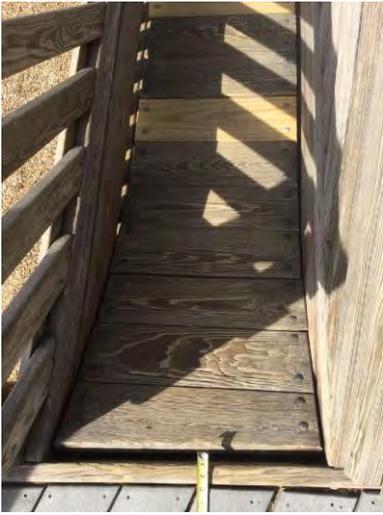
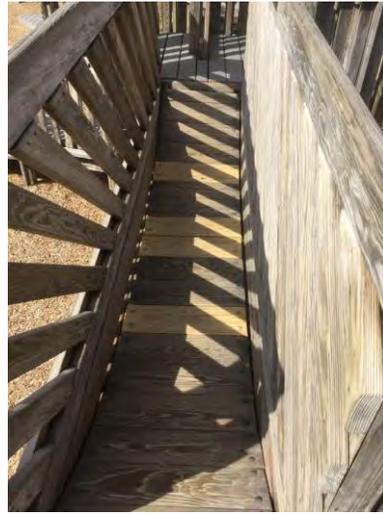
This piece of equipment is non-compliant. This piece of equipment needs maintenance and should no longer used. We recommend replacing with newer play element.

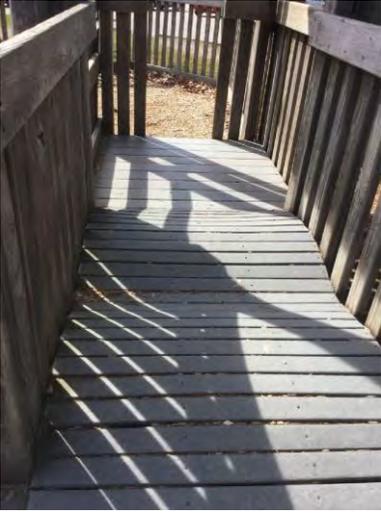
This is a unique bridge and will be replaced with a newly designed component.

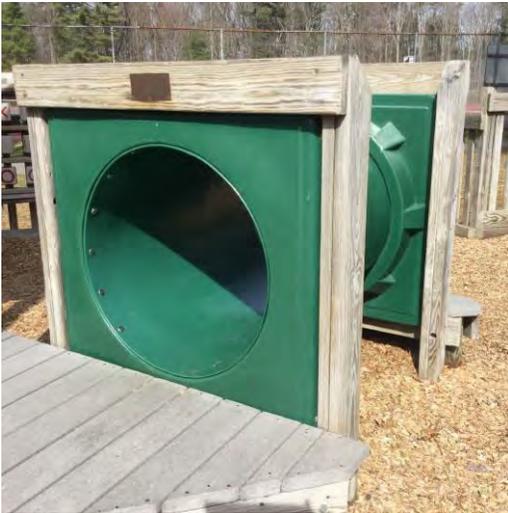
This piece of equipment is compliant. Reuse in new design.

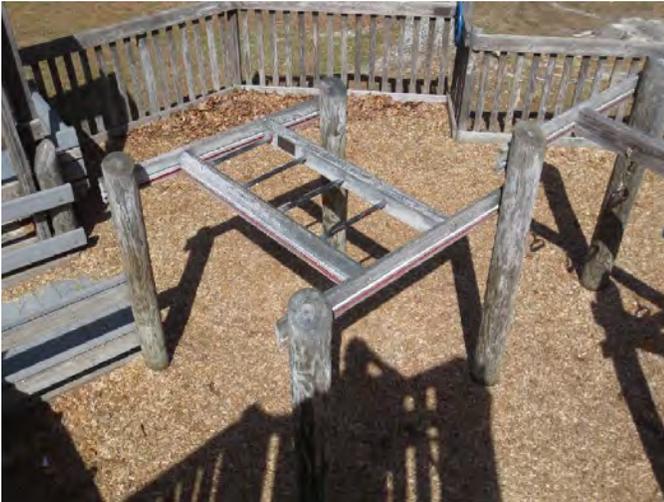
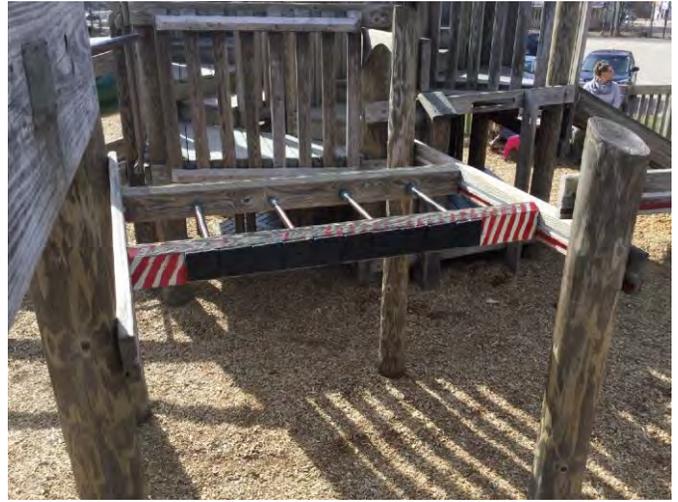
There are 2 low ladders. Replace both with new manufactured equipment.

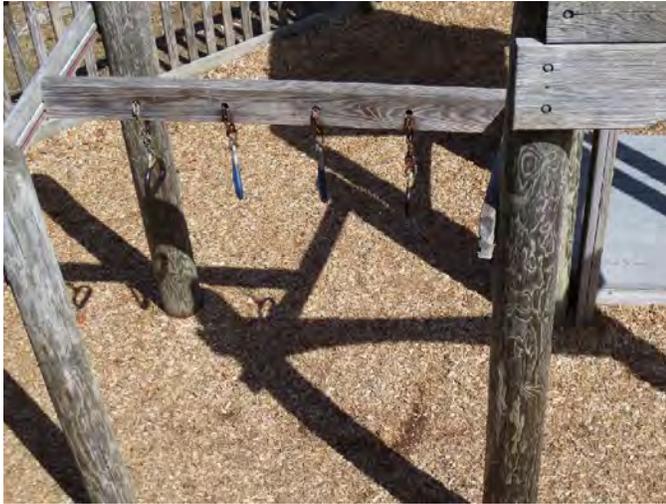
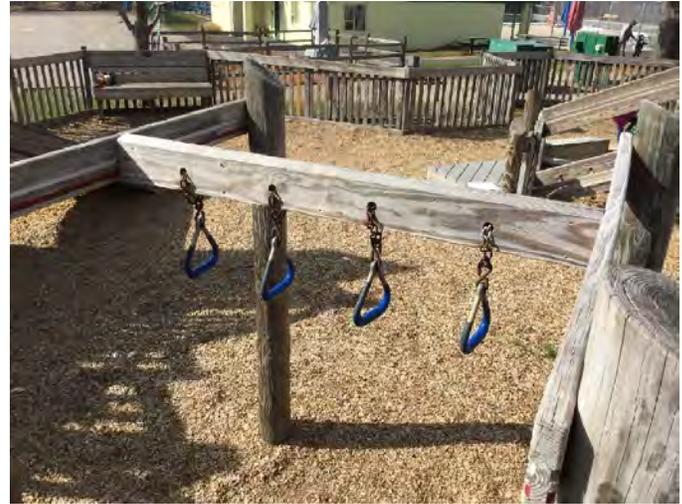
There are 2 sets of low rings. Replace both with new manufactured equipment. Replace with new manufactured equipment

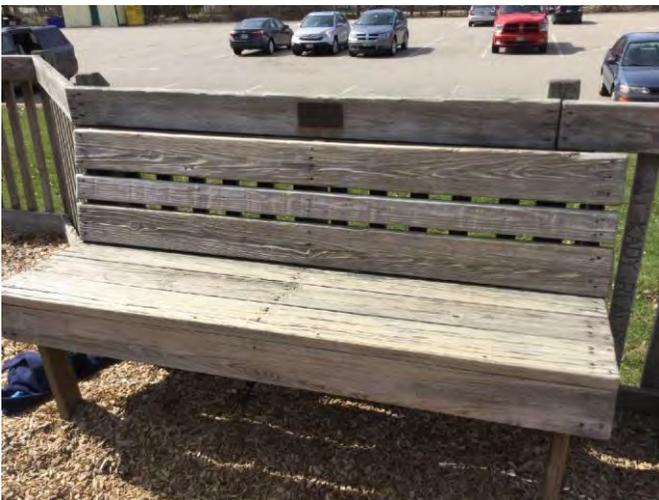
Replace with new. All benches are in very poor condition.
