STRUCTURAL ANALYSIS OF ROOF SUPPORT STRUCTURE
TO DETERMINE SAFE LOAD CARRYING CAPACITY

Structural Analysis of Roof Support Structure to Determine Safe Load Carrying Capacity

Main Department of Public Works Garage and the Water Department Garage

January 2016

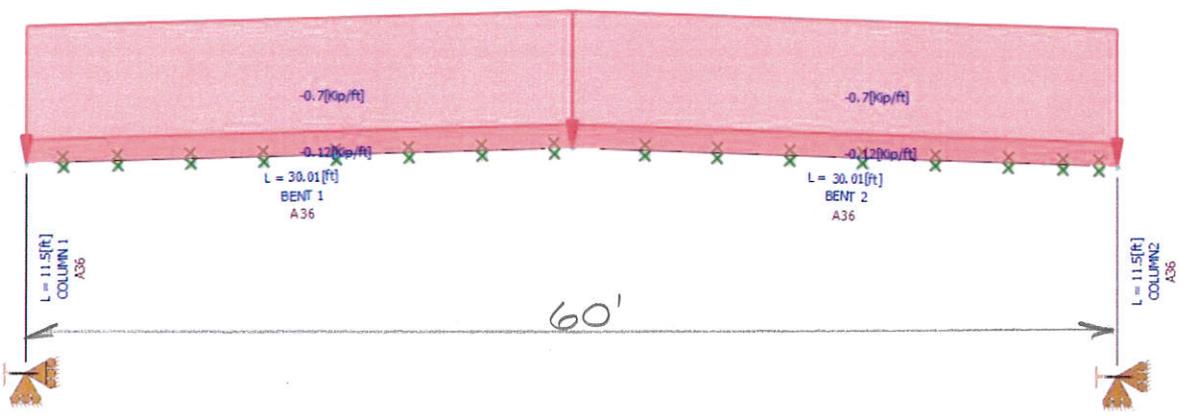
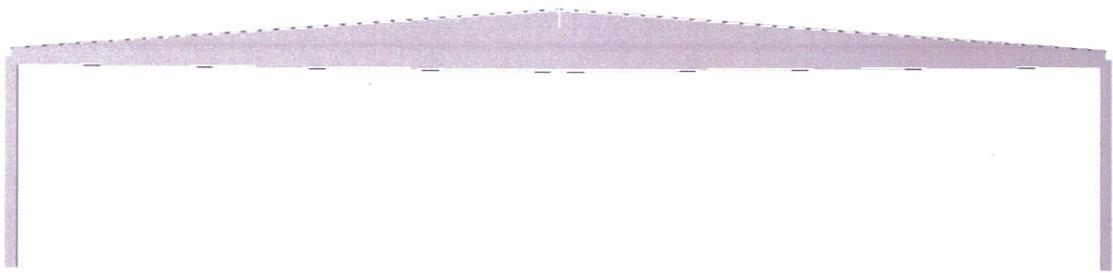
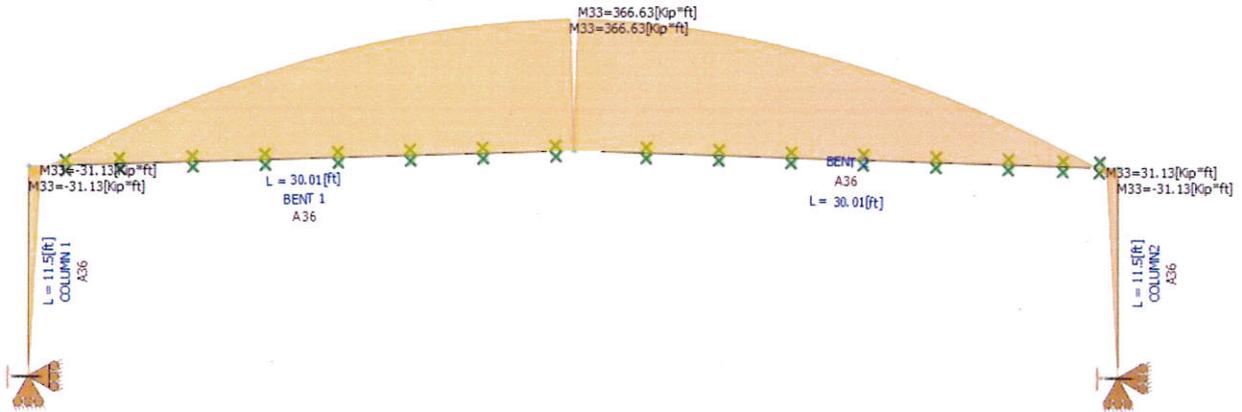
BAY 1: STRUCTURAL ANALYSIS RESULTS (CONSTRUCTED LATE 1960'S-EARLY 1970'S)

The structural analysis of the 8-inch deep girts, which span from bent-to-bent, indicates that the girts are capable of safely supporting a live load of approximately 20 pounds per square foot or about 57% of the current code mandated snow load of 35 psf.

The horizontal bents which span across the full 60-foot width of the building are 42 inches deep at centerline and taper down to 11-3/8" at the exterior walls. The top and bottom flange widths are constant at 10 inches wide. The structural analysis of this portion of the bent indicates that the member is capable of safely supporting the current code mandated snow load of 35 pounds per square foot.

$F_y = 36 \text{ ksi (TYP. FOR ERA)}$
 $W_D = 120 \text{ lb/ft} = .12 \text{ k/ft}$
 $W_{SNOW} = 700 \text{ lb/ft} = .70 \text{ k/ft (based on current NH snow load)}$
35psf SNOW LOAD

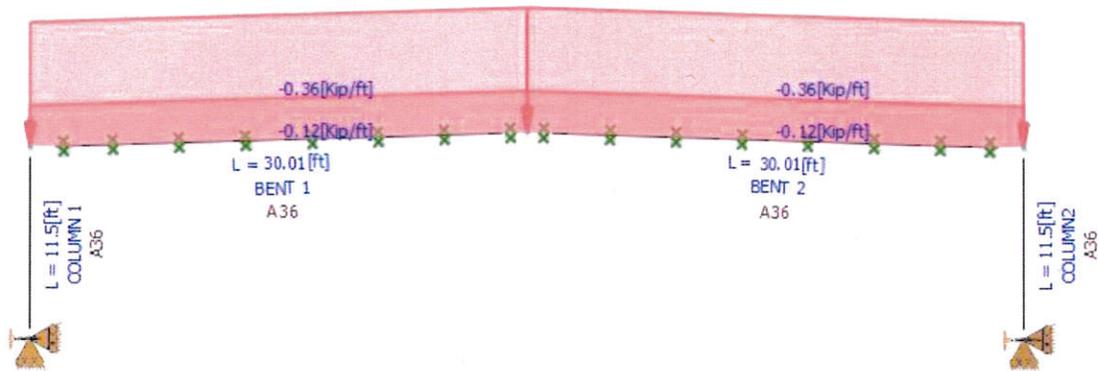
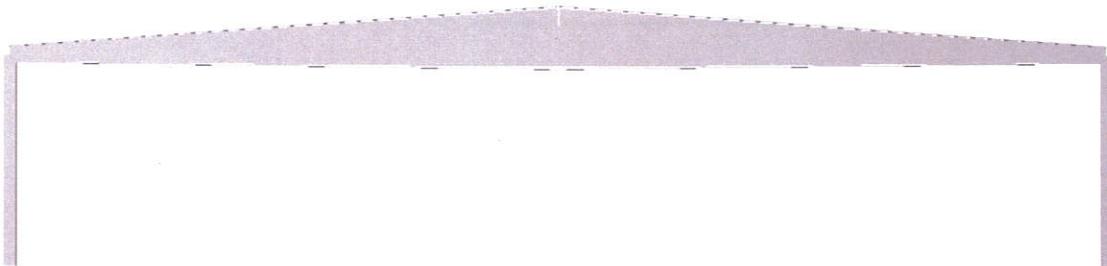
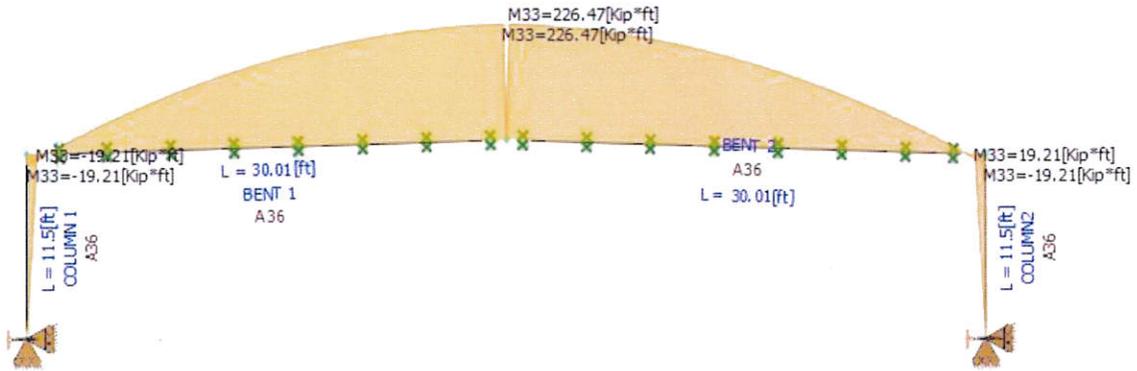
BAY 1: STRUCTURAL RATING ANALYSIS (CONSTRUCTED LATE 1960'S-EARLY 1970'S)

The columns are 4" x 8" members and the structural analysis of the columns supporting the bents indicate that they are capable of safely supporting a live load of only 18 pounds per square foot or about 50% of the current code mandated snow load.

The horizontal portion of the bent could support up to 45 pounds per square foot, but the capacities of the girts and the columns limit the safe live load carrying capacity for the structure. The live load limit for the 1969 section of the DPW Garage roof is between 18 and 20 pounds per square foot. This is equivalent to about 18 inches of moderately heavy snow. The analysis results are included in the appendices.

$F_y = 36 \text{ ksi}$
 $W_D = 120 \text{ lb/ft} = .12 \text{ k/ft}$
 $W_{\text{SNOW}} = 18 \text{ psf} * (20') = 360 \text{ lb/ft}$

18psf Snow Load

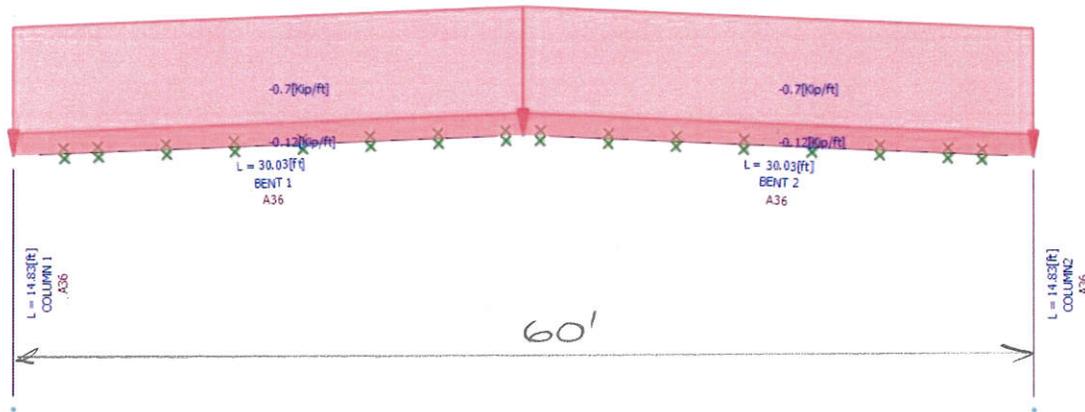
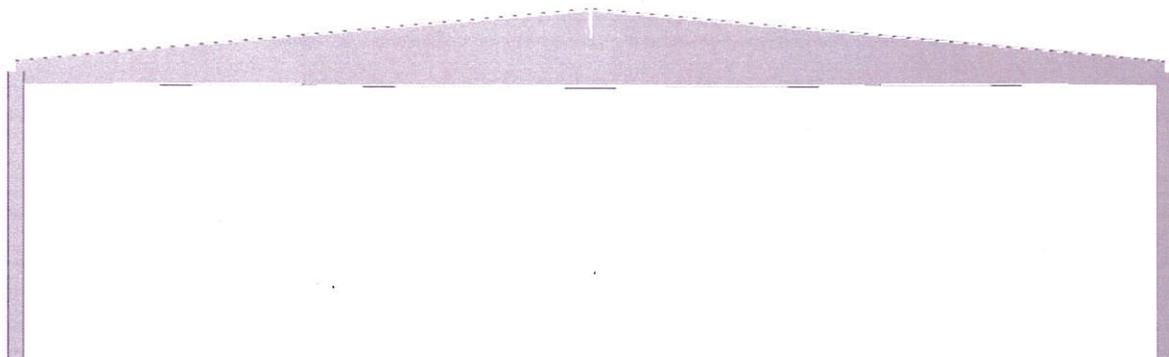
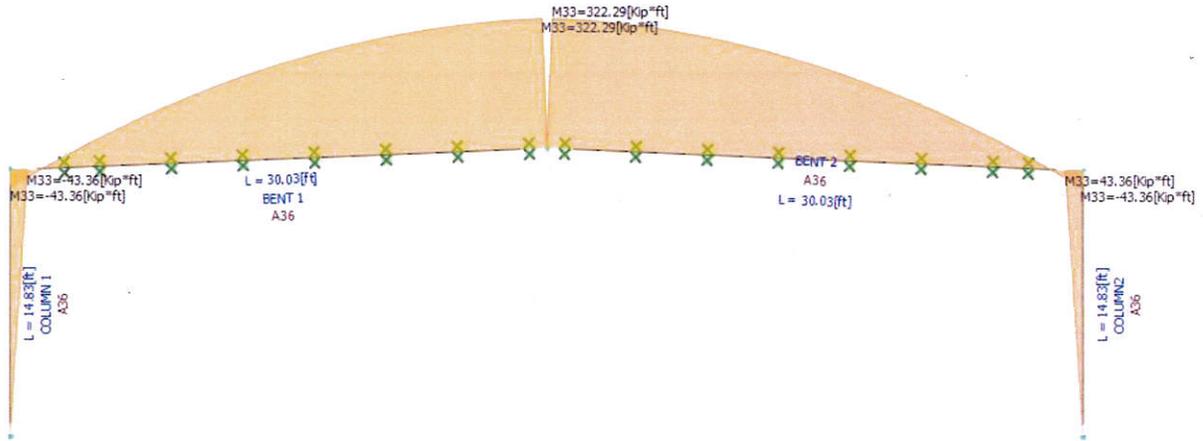
BAY 2: STRUCTURAL ANALYSIS RESULTS
(CONSTRUCTED LATE MID TO LATE 1970'S)

$W_{SNOW} = 700 \text{ lb/ft} = .70 \text{ k/ft (based on current NH snow load [35PSF])}$

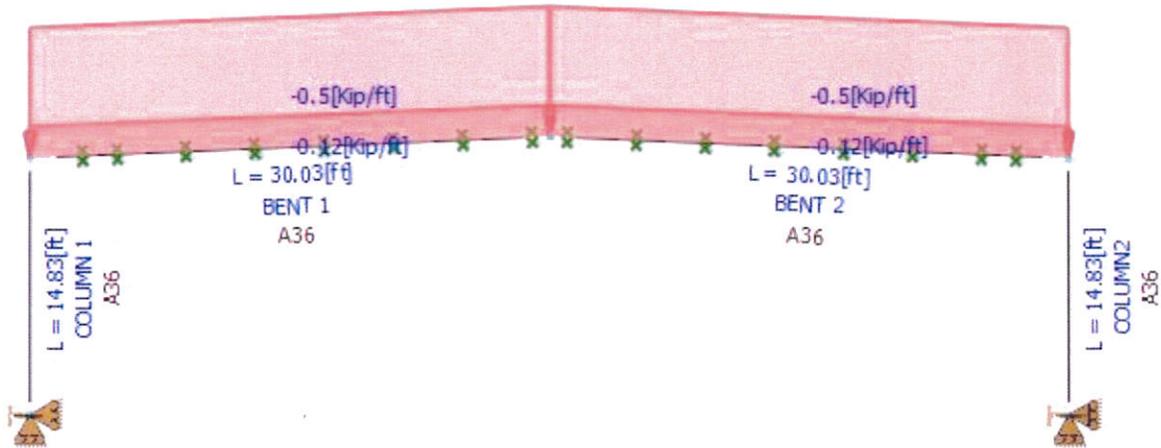
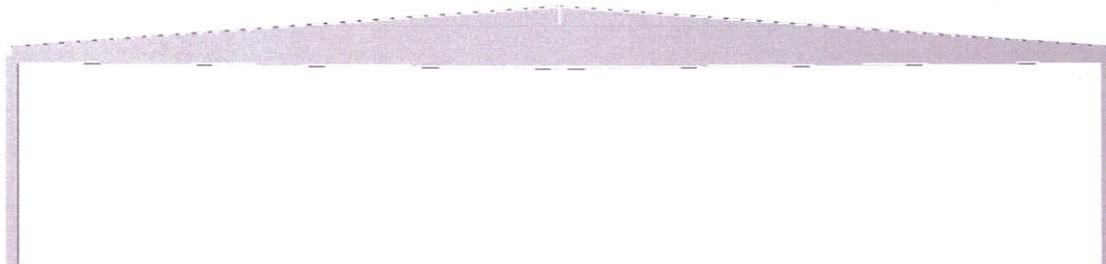
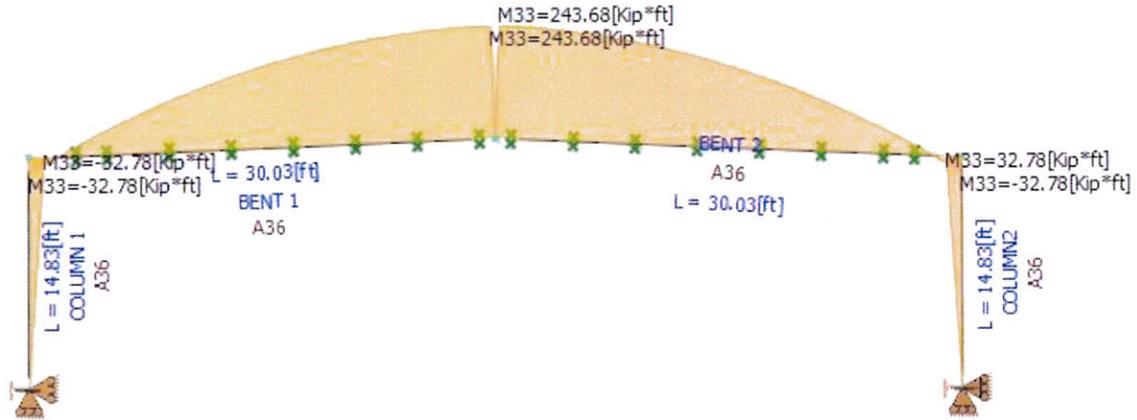
BAY 2: STRUCTURAL RATING ANALYSIS (CONSTRUCTED MID TO LATE 1970'S)

$F_y = 36 \text{ ksi}$
 $W_D = 120 \text{ lb/ft} = .12 \text{ k/ft}$
 $W_{\text{SNOW}} = 25 \text{ psf} * (20') = 500 \text{ lb/ft}$

25 psf snow load

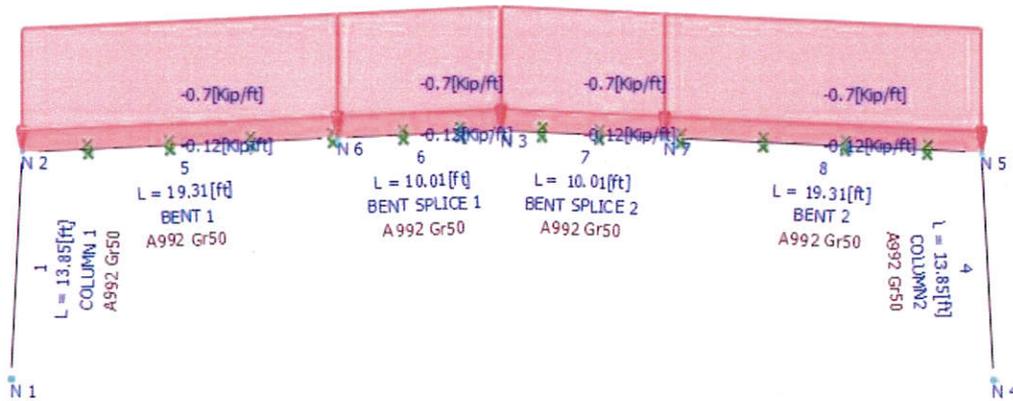
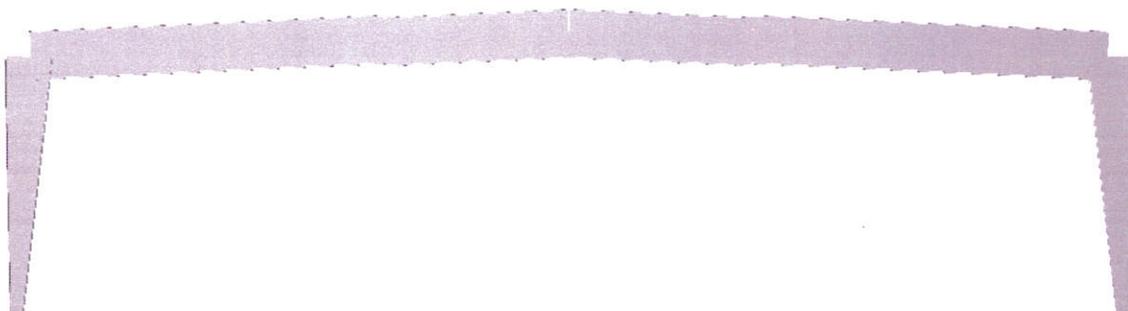
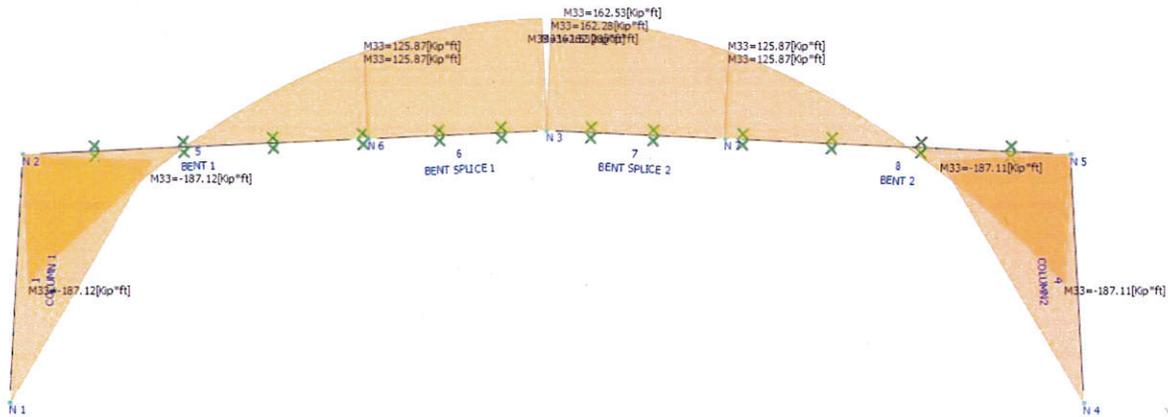
BAY 3: STRUCTURAL ANALYSIS RESULTS (CONSTRUCTED LATE 1980'S)

35 psf Snow Load

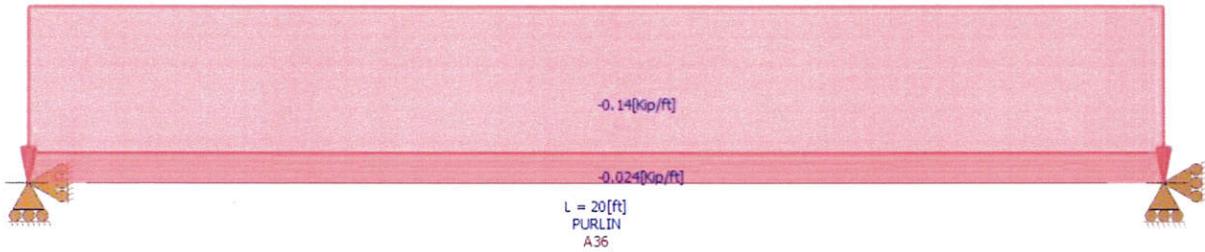
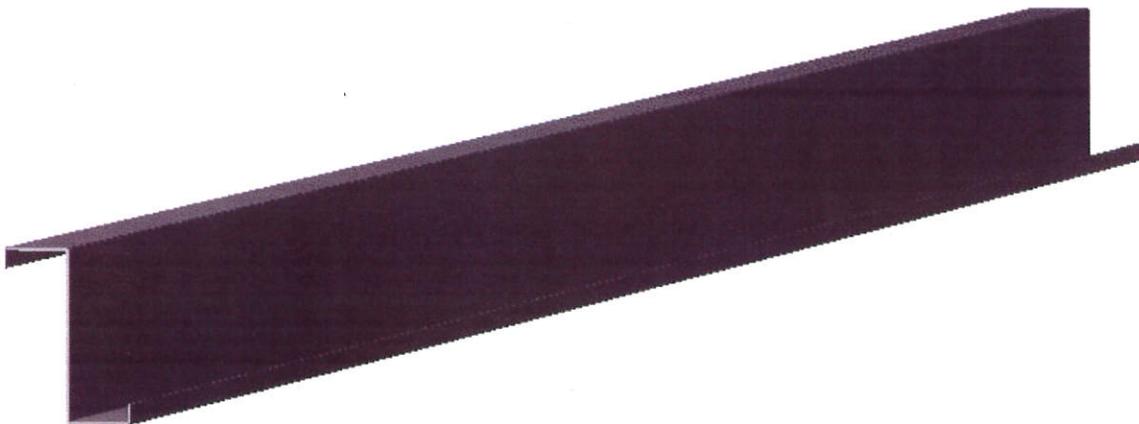
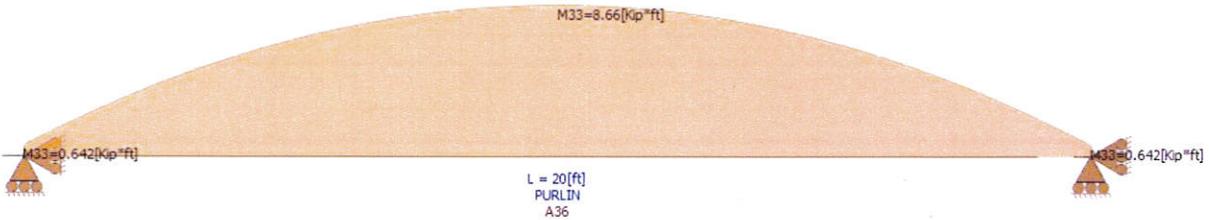
PURLIN BAY 1&2: STRUCTURAL ANALYSIS RESULTS

$F_y = 36$ ksi (TYP. FOR ERA)
 $W_D = 24$ lb/ft = 0.024 k/ft
 $W_{SNOW} = 140$ lb/ft = 0.14 k/ft (based on current NH snow load [35 PSF])

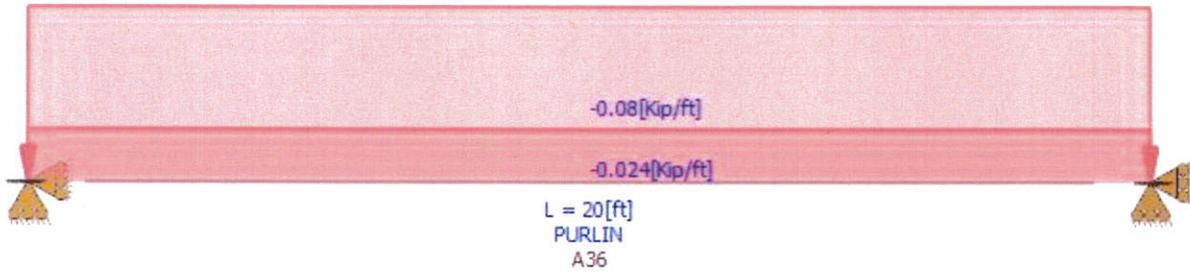
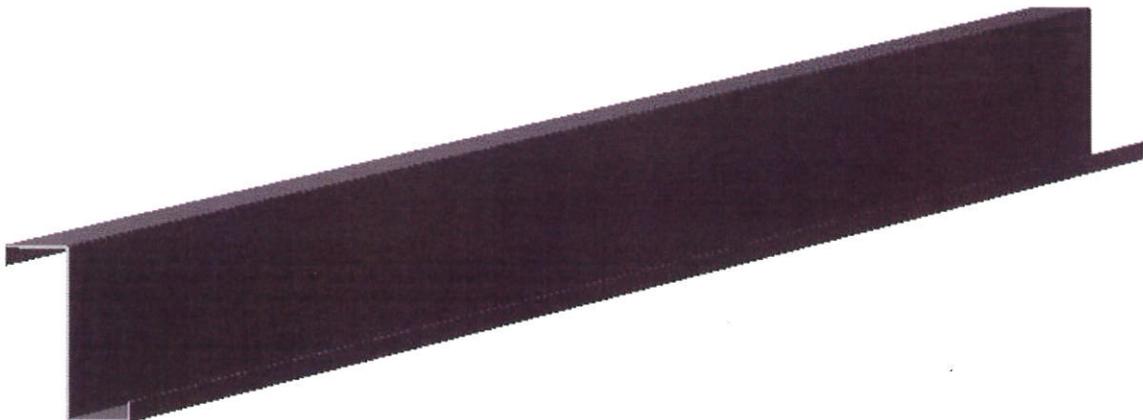
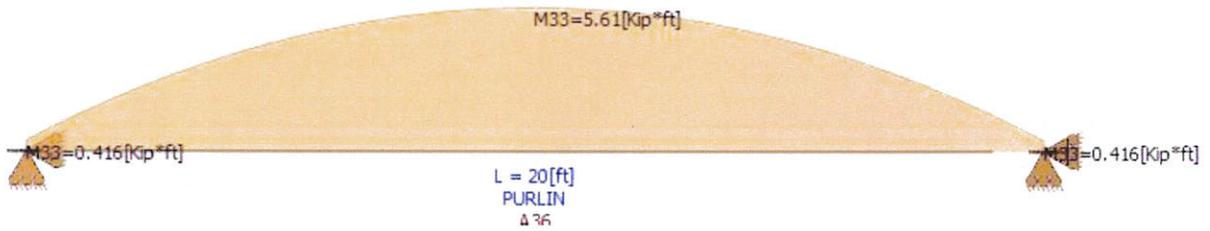
PURLIN BAY 1&2: STRUCTURAL RATING ANALYSIS

$F_y = 36$ ksi
 $W_D = 24$ lb/ft = 0.024 k/ft
 $W_{SNOW} = 20$ psf * (4') = 80 lb/ft

20 psf snow load

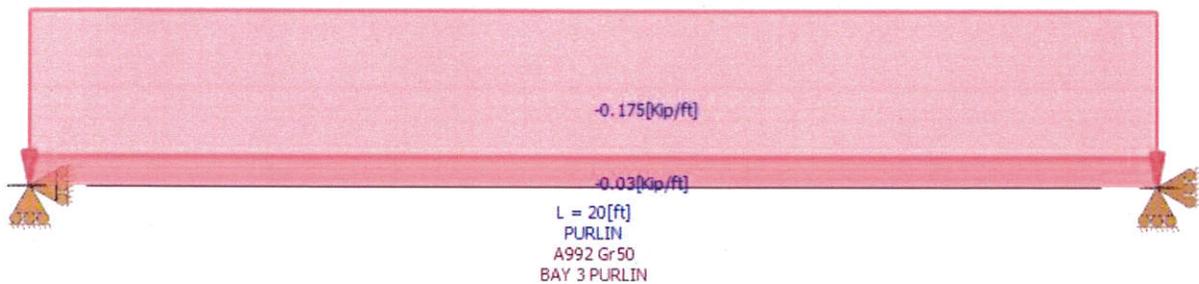
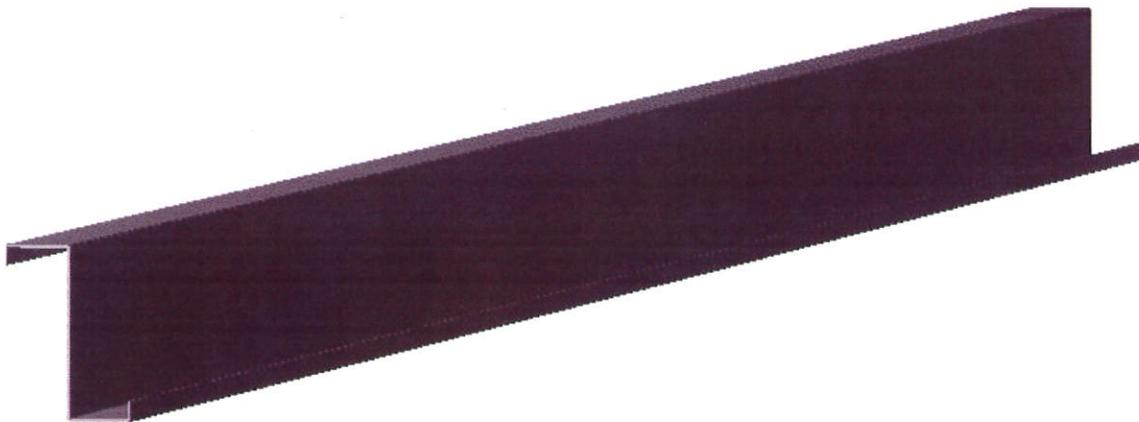
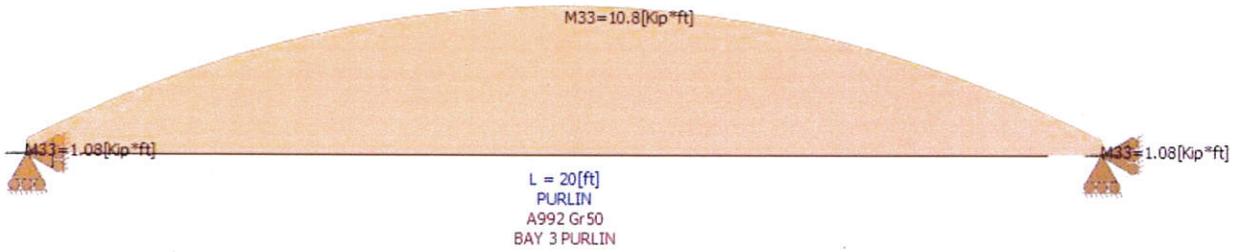
PURLIN BAY 3: STRUCTURAL ANALYSIS RESULTS

$W_{SNOW} = 175$ lb/ft = 0.175 k/ft (based on current NH snow load [35 PSF])

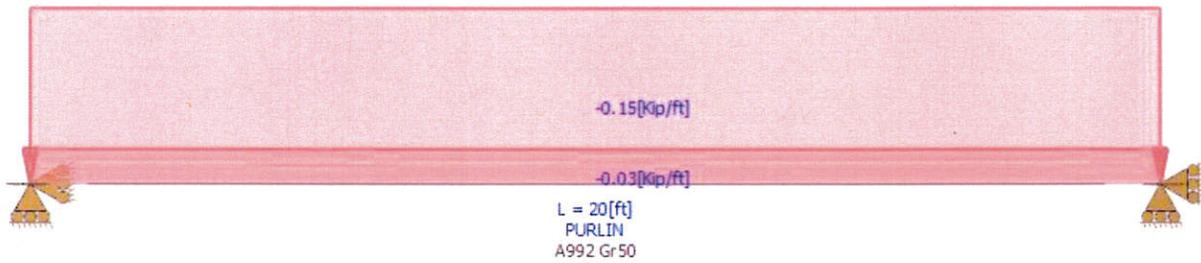
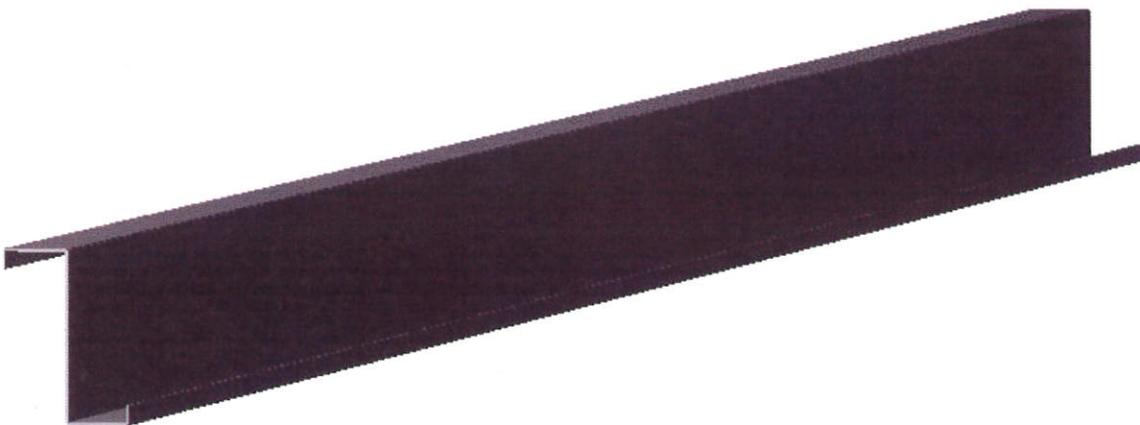
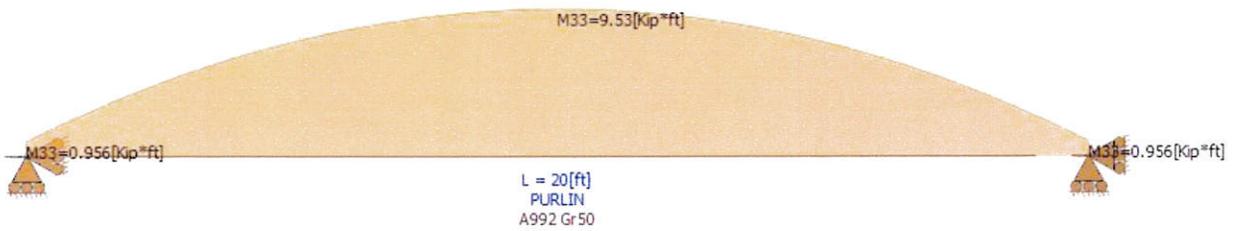
PURLIN BAY 3: STRUCTURAL RATING ANALYSIS

$F_y = 50 \text{ ksi}$
 $W_D = 30 \text{ lb/ft} = 0.03 \text{ k/ft}$
 $W_{\text{SNOW}} = 30 \text{ psf} * (5') = 150 \text{ lb/ft}$

30psf Snow Load
