**WESTSIDE DRIVE SEWER PLANNING
NHDES Project No. D2020-0607**

EXETER, NEW HAMPSHIRE

FINAL - MAY 23, 2022

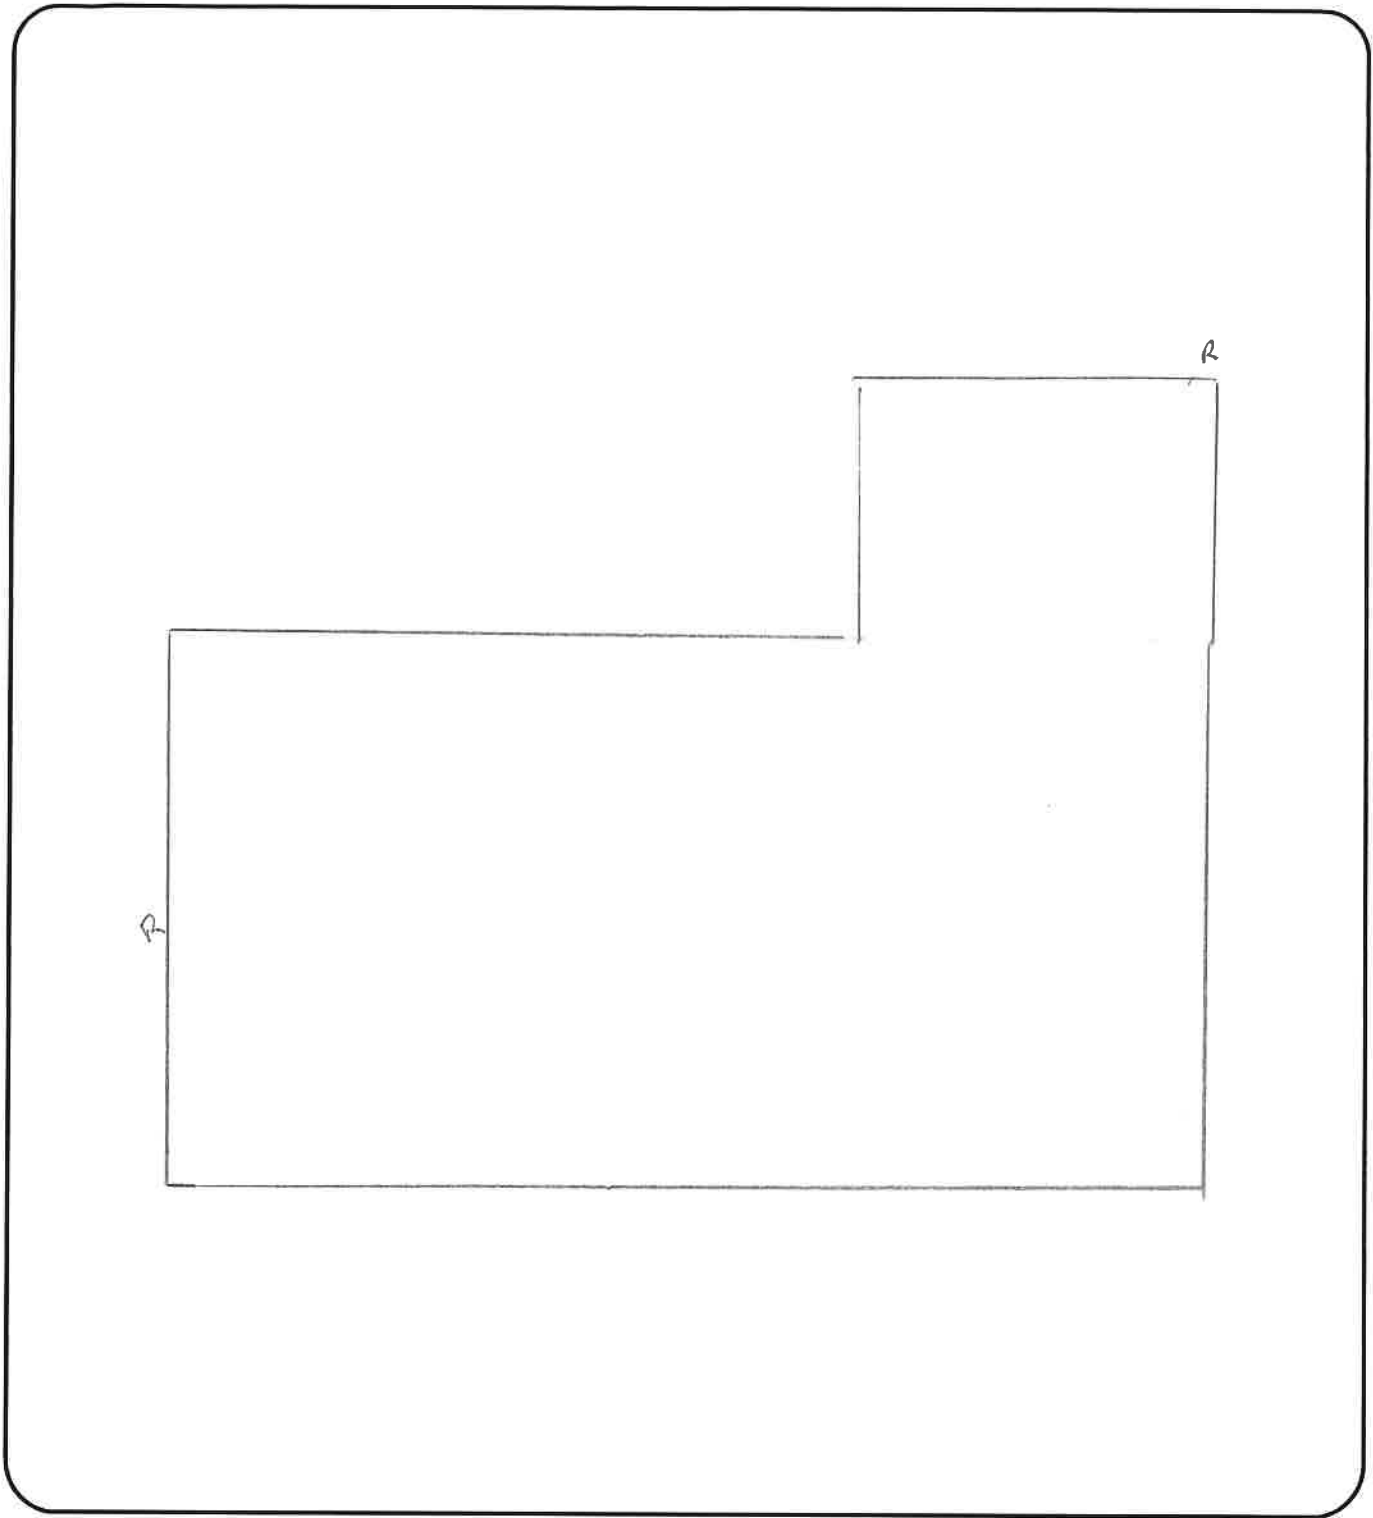
General Comments: House built on a slab, no basement. Home owner did not know where water meter or sewer were located.

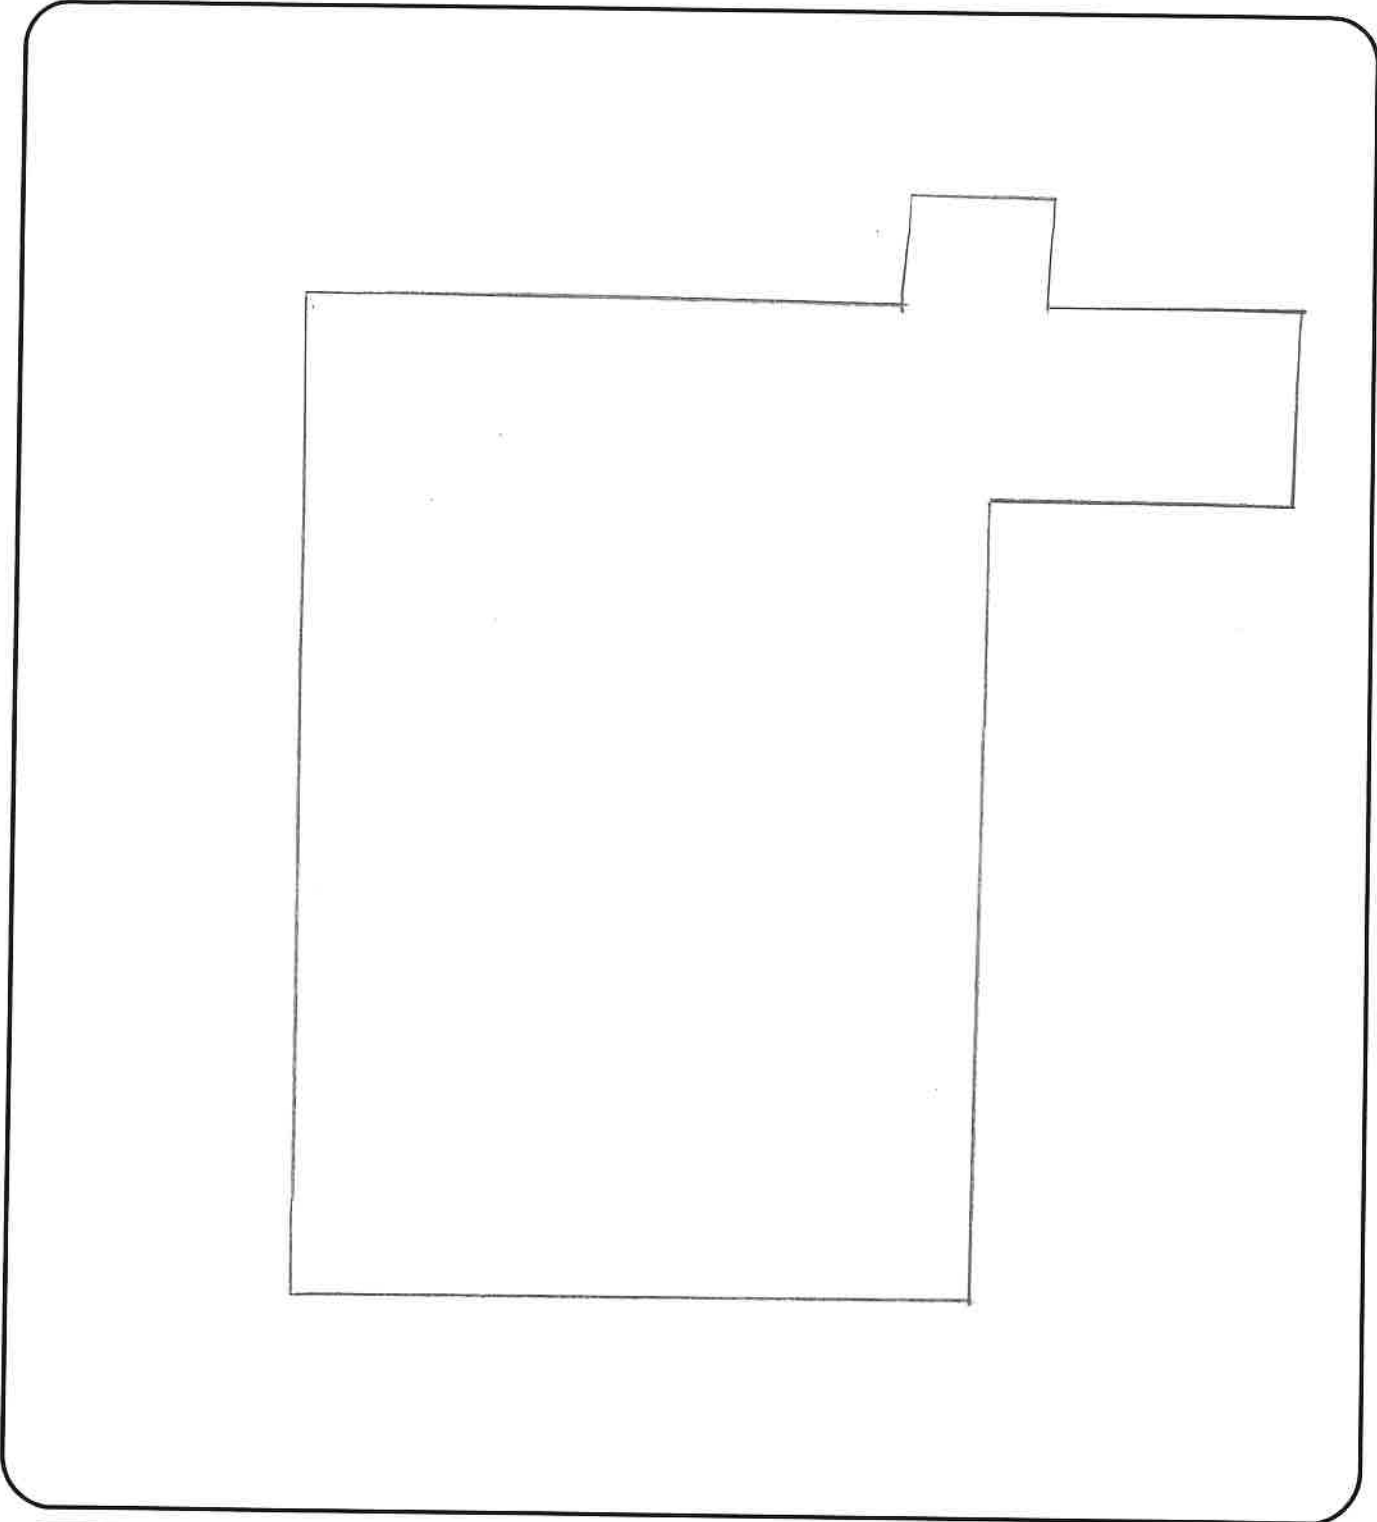
General Comments: Refusal due to Covid.

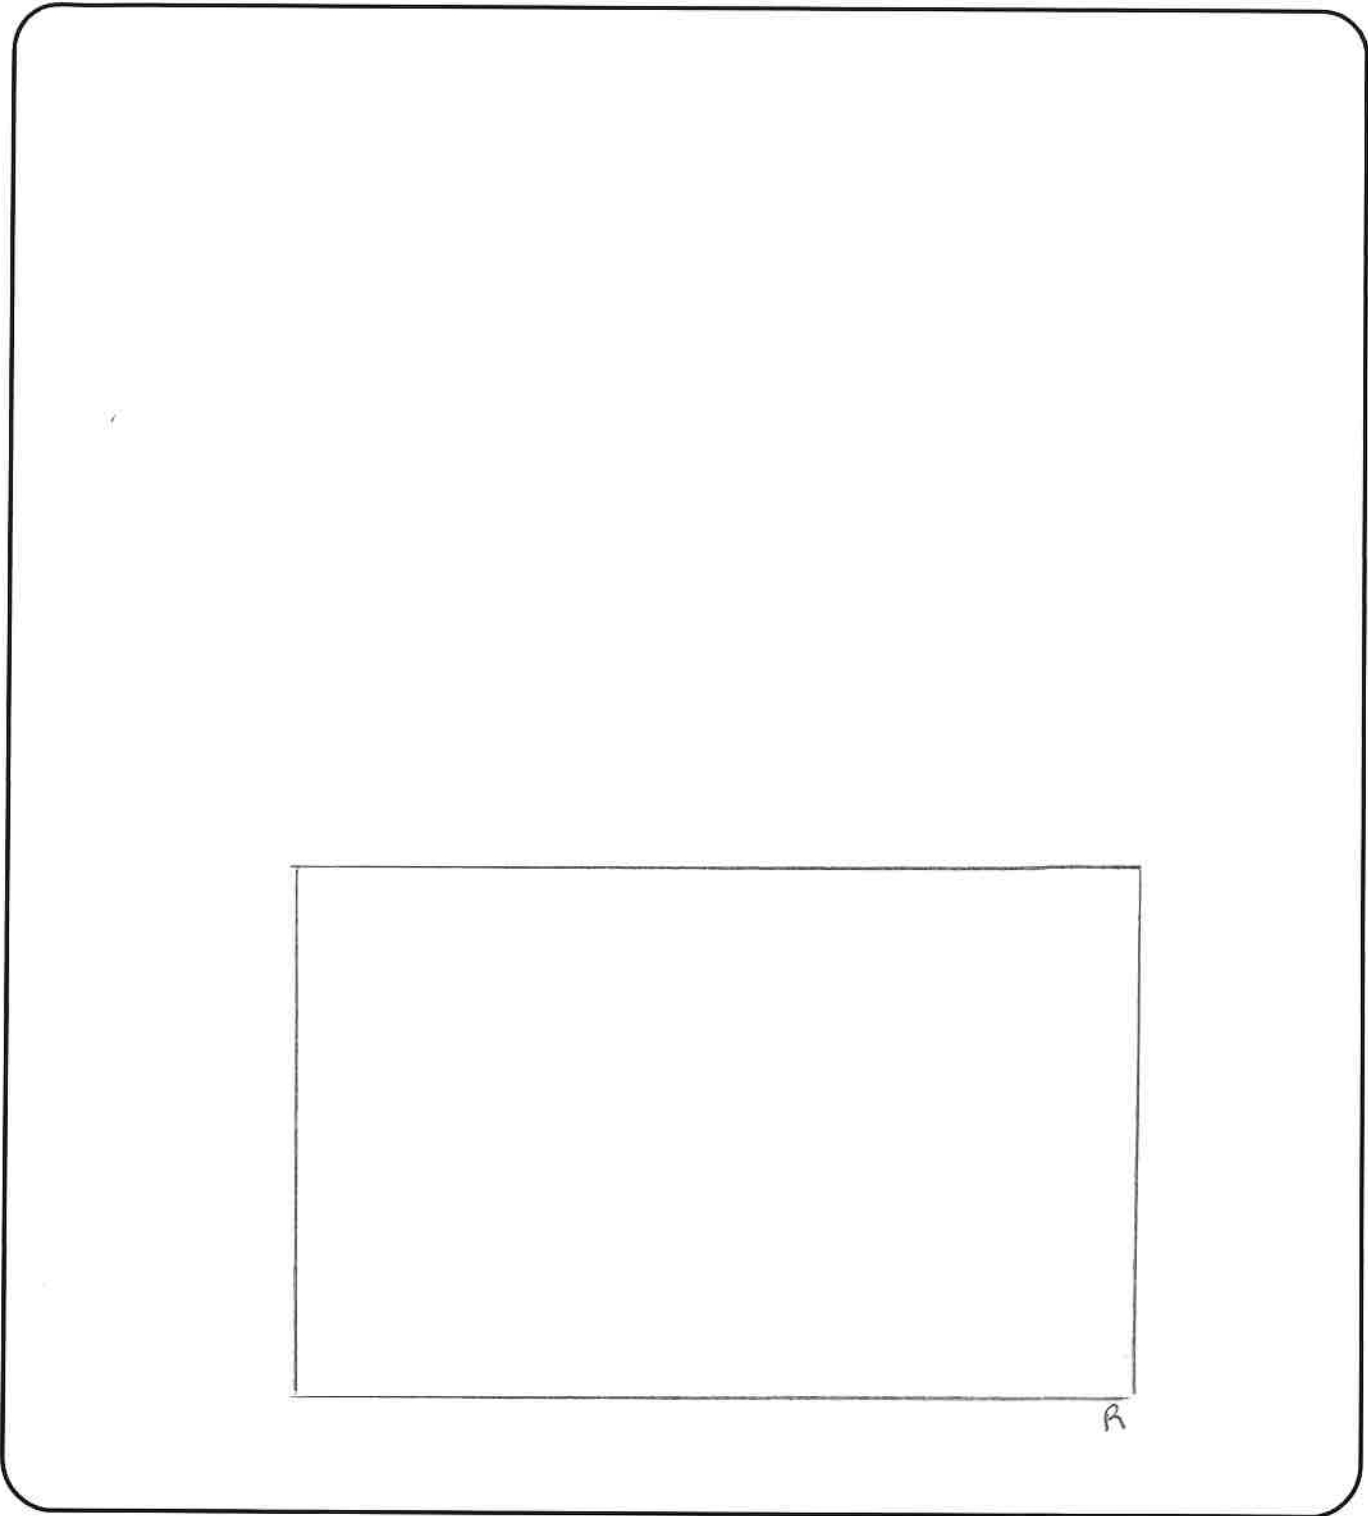
Told him it was OK to do outside insp. only

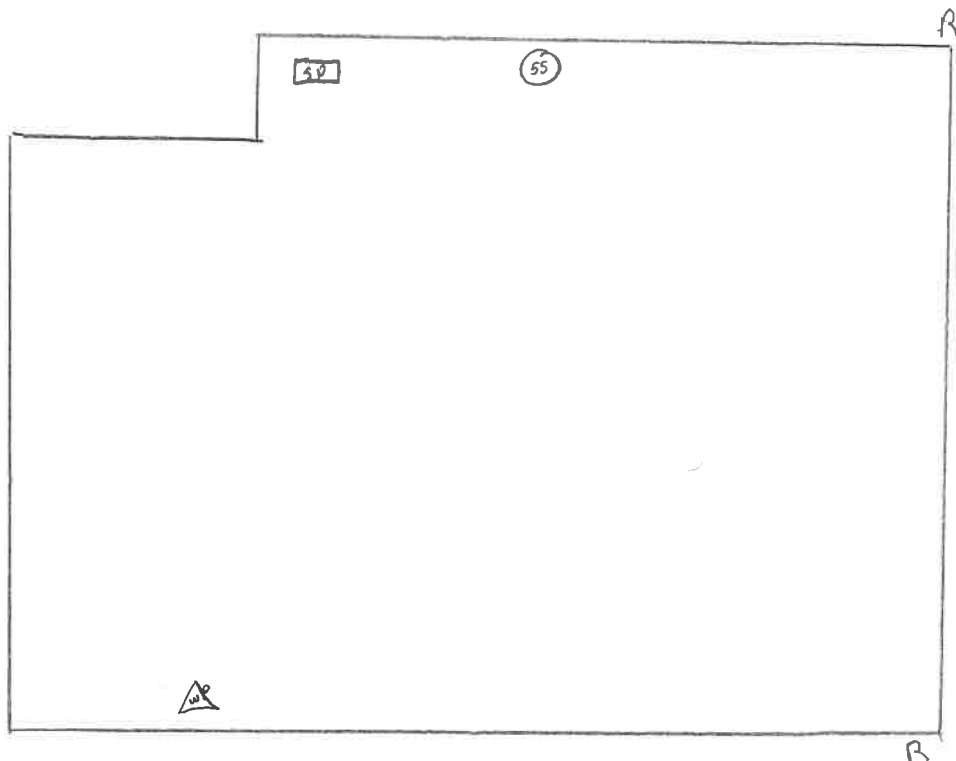
General Comments: Basement has been converted into an apartment. Can not locate any of above items

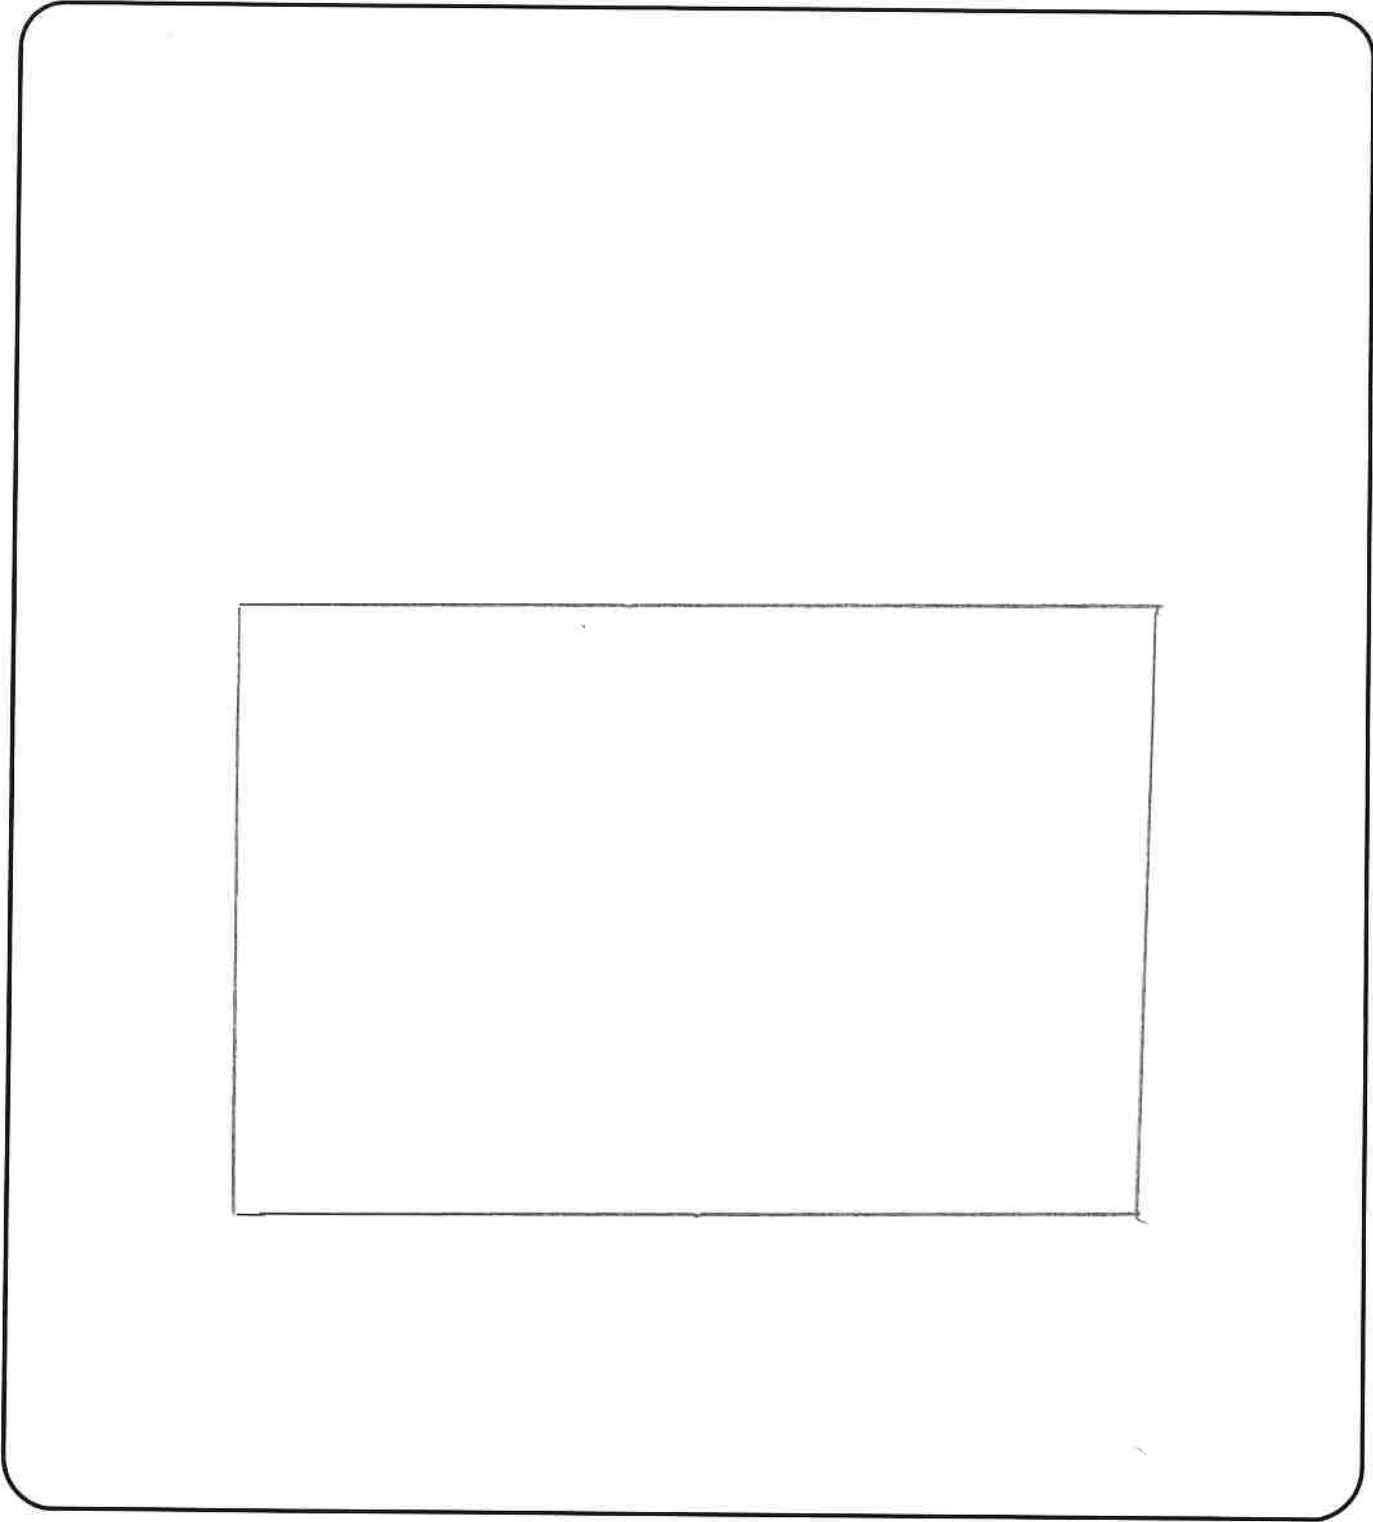
General Comments: home owner took flyer and states she will make an appointment
Large dogs very aggressive not comfortable with out side insp

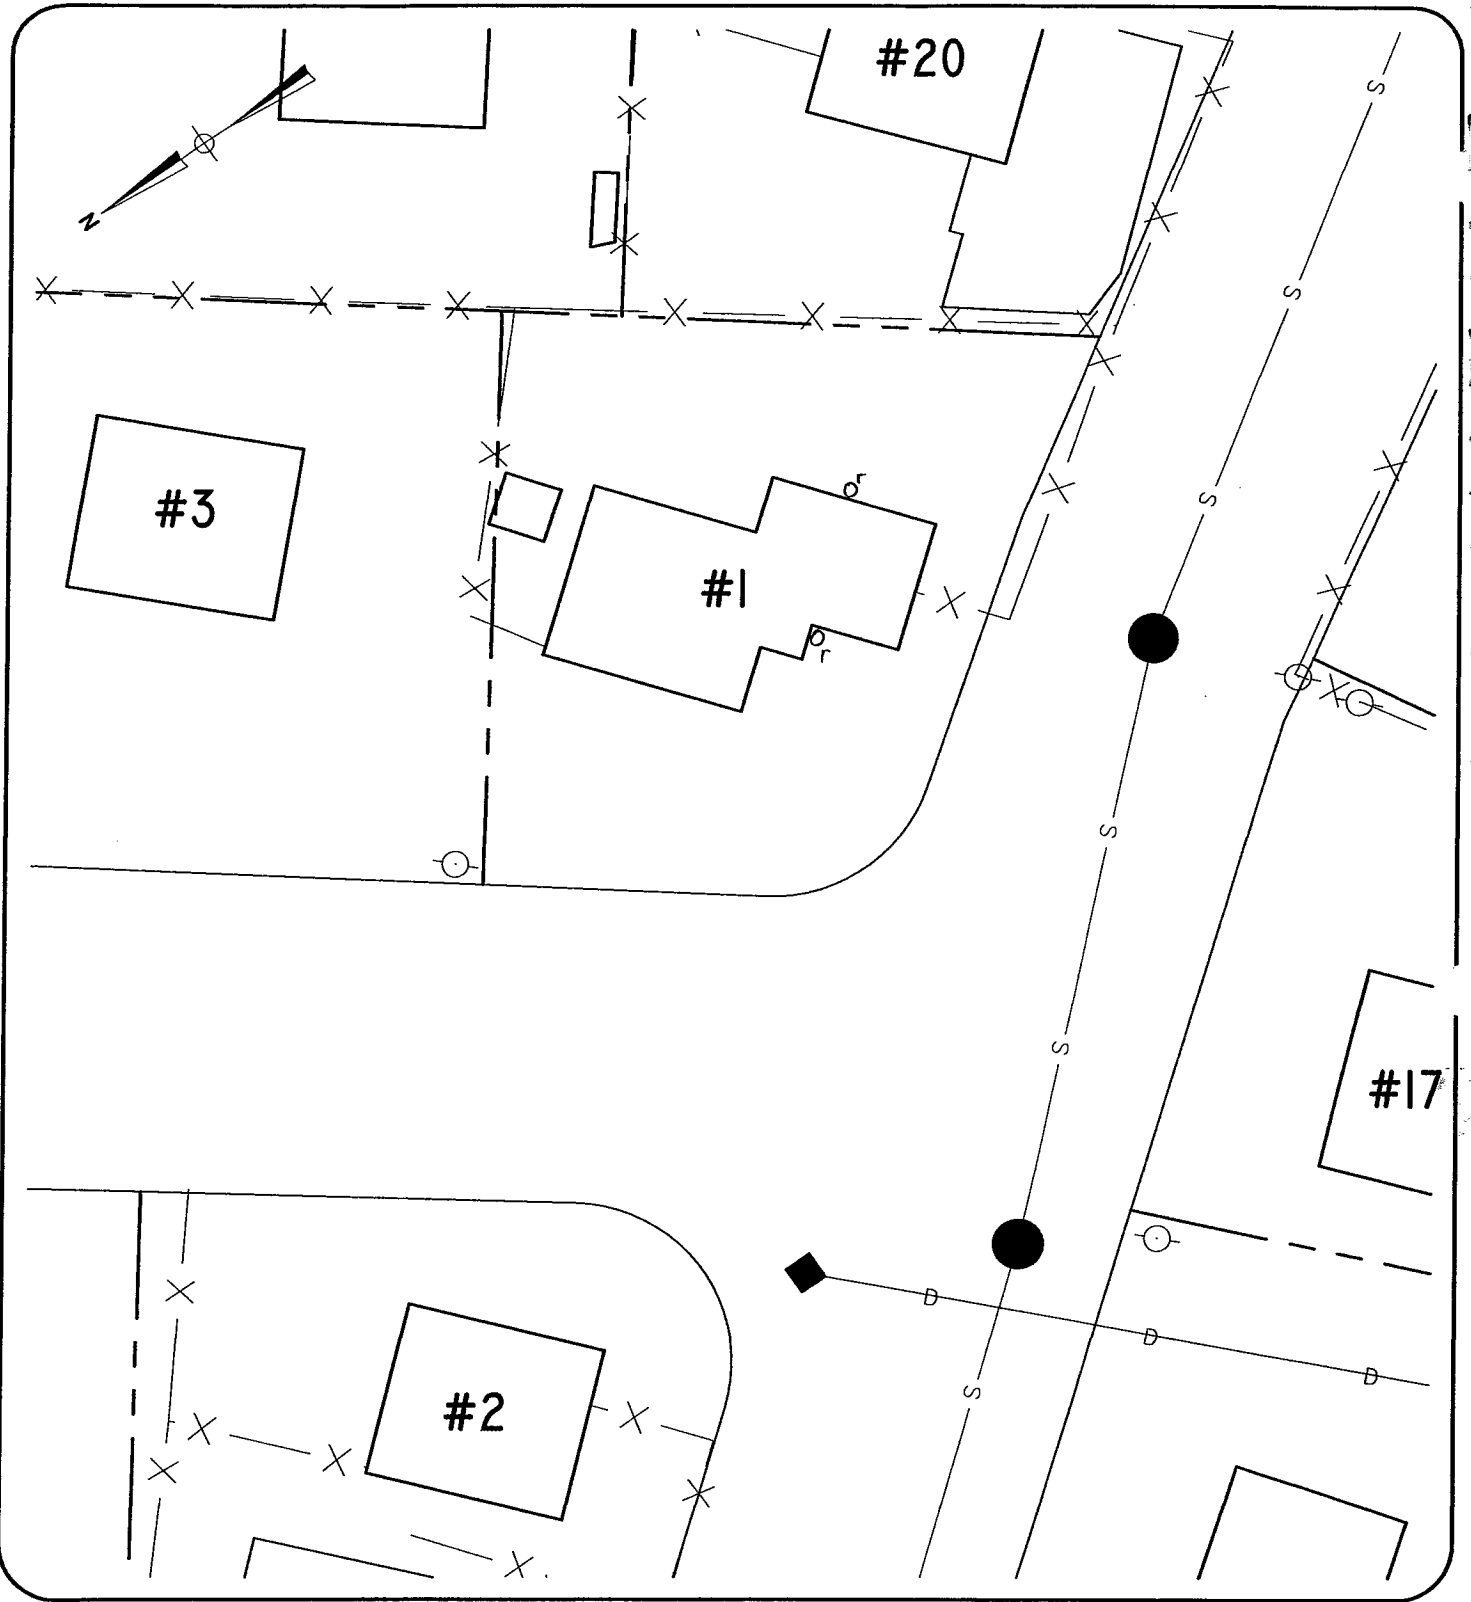
Comments: power outage sump pump failed. 4" of water in basement.

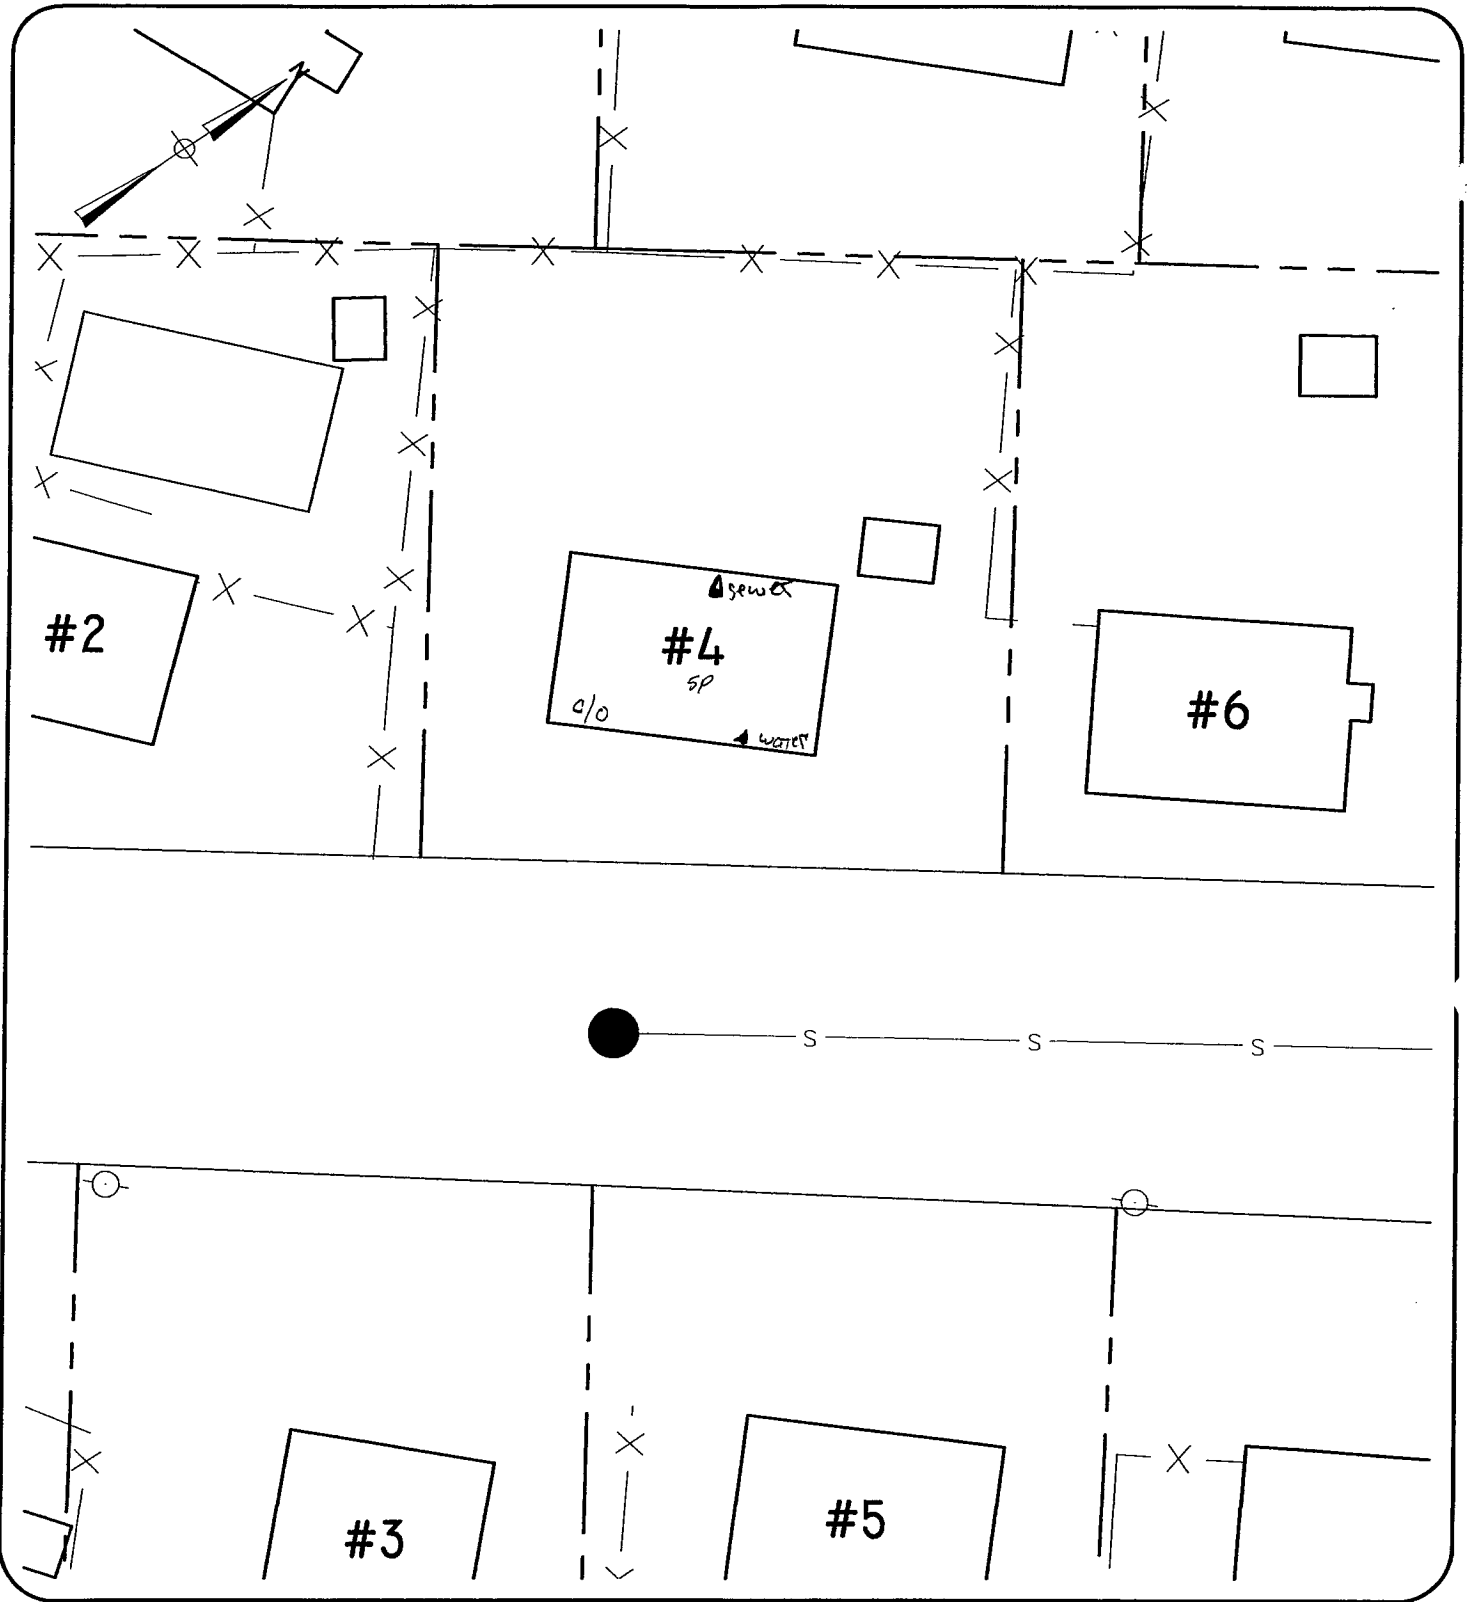
General Comments: ReFused Access By owner.

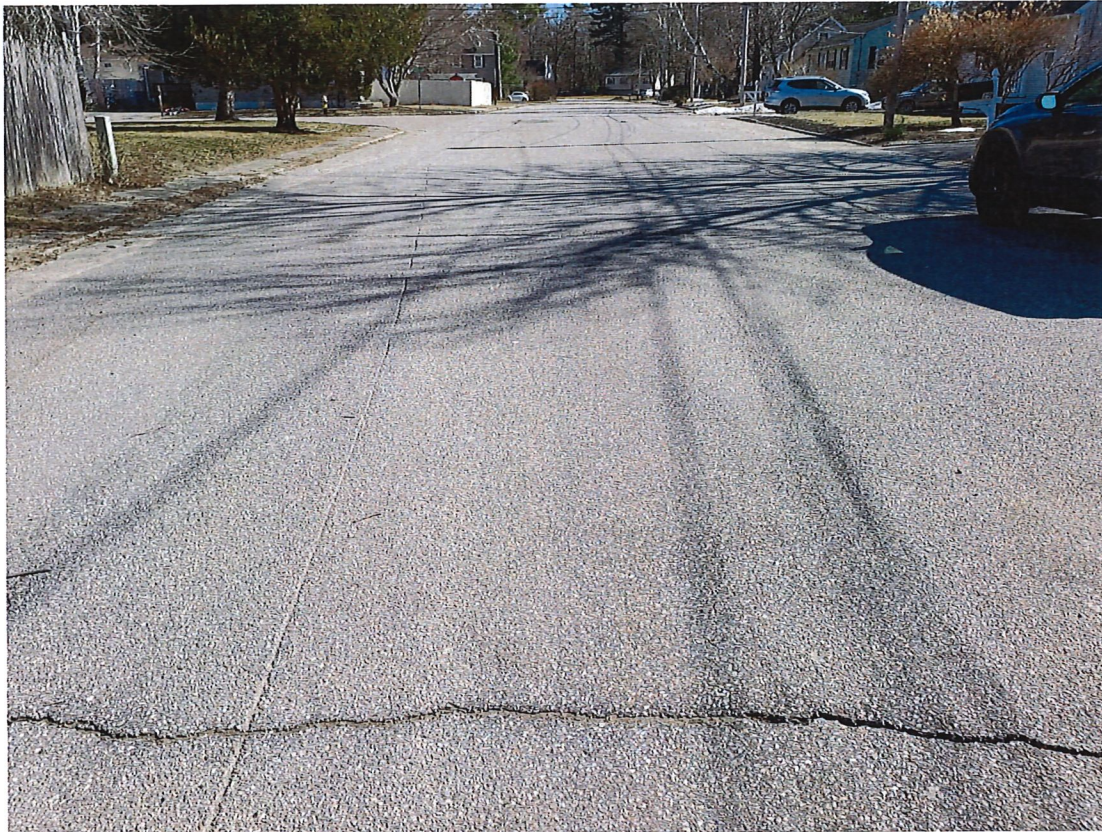
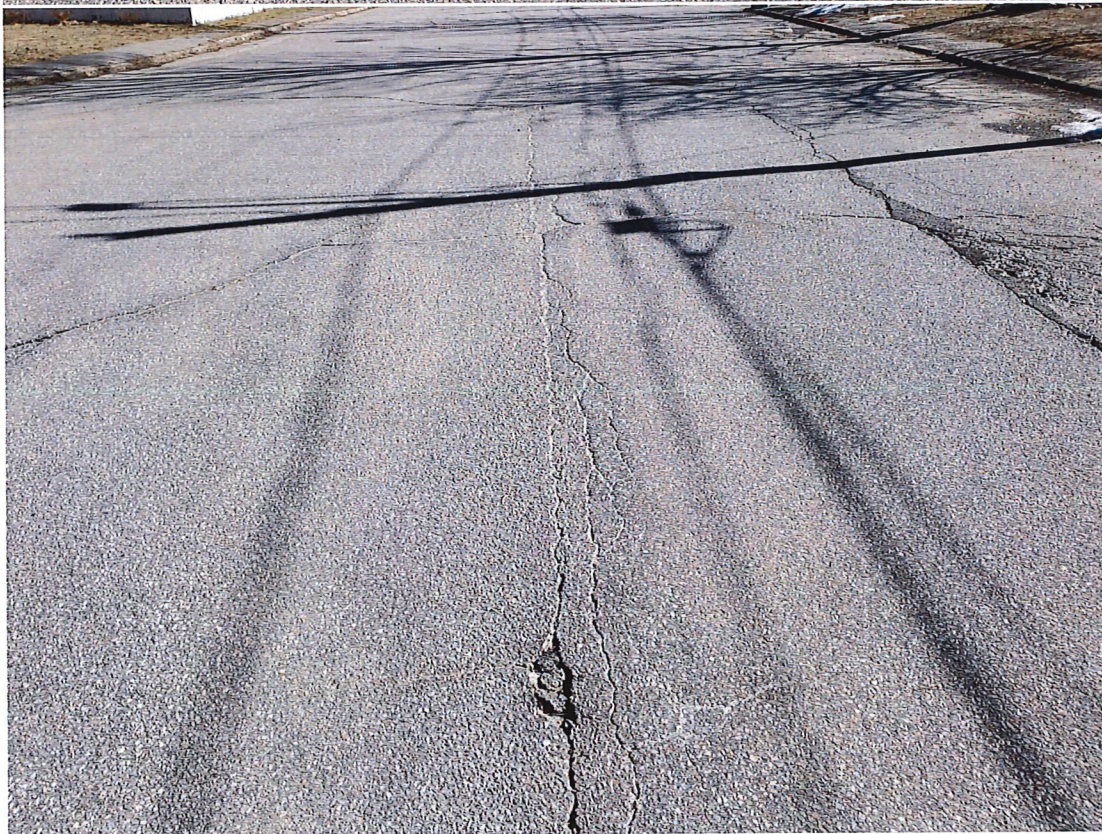
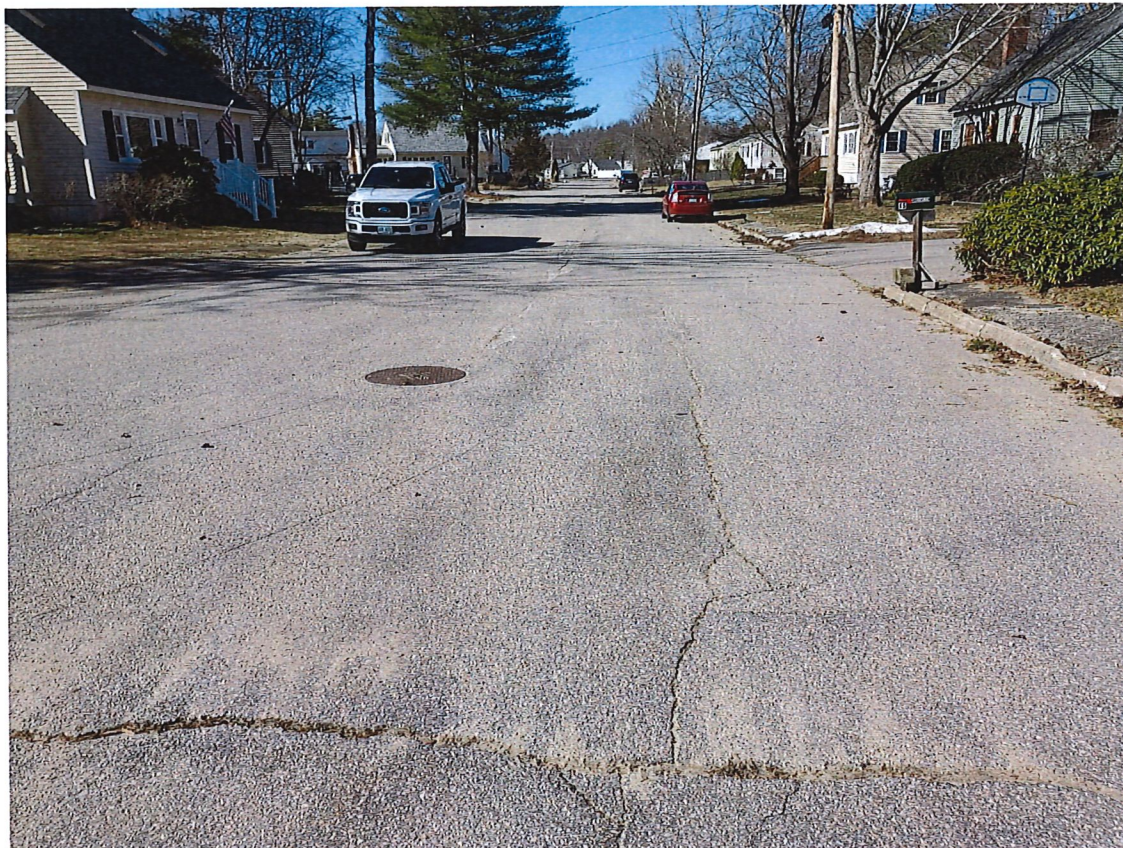
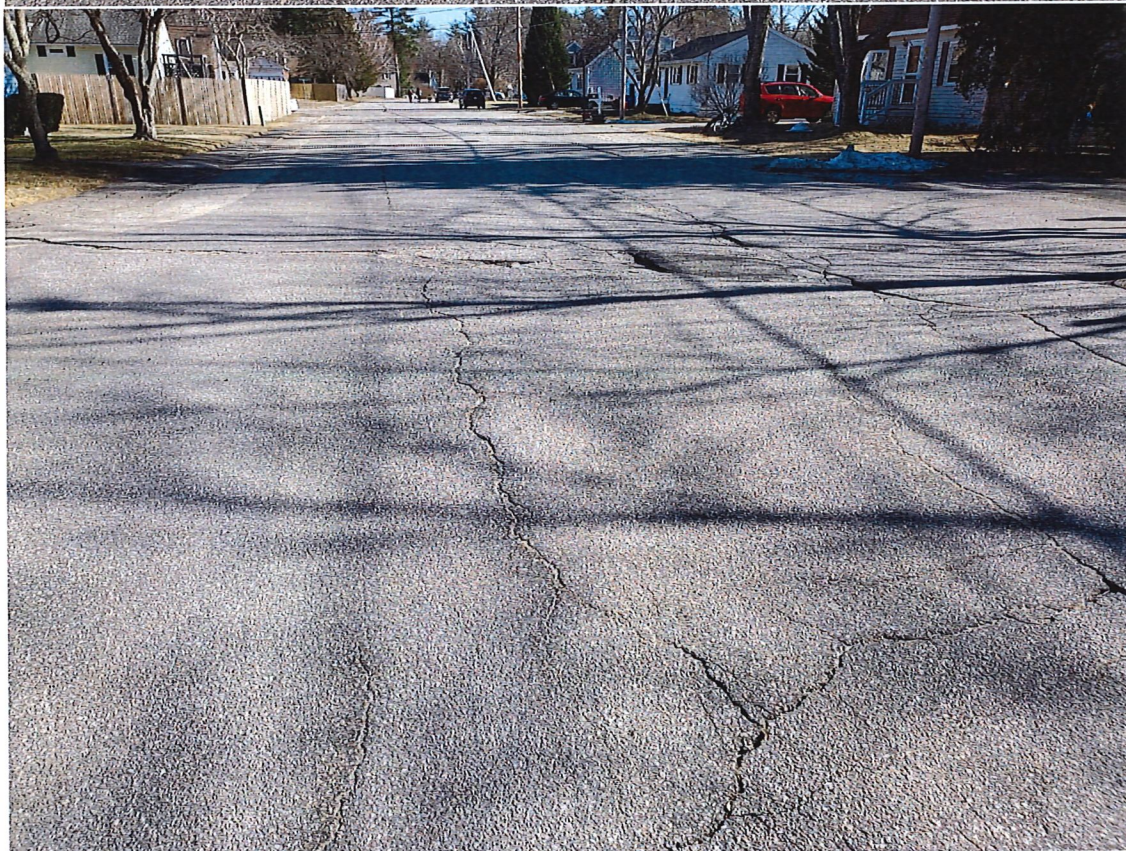
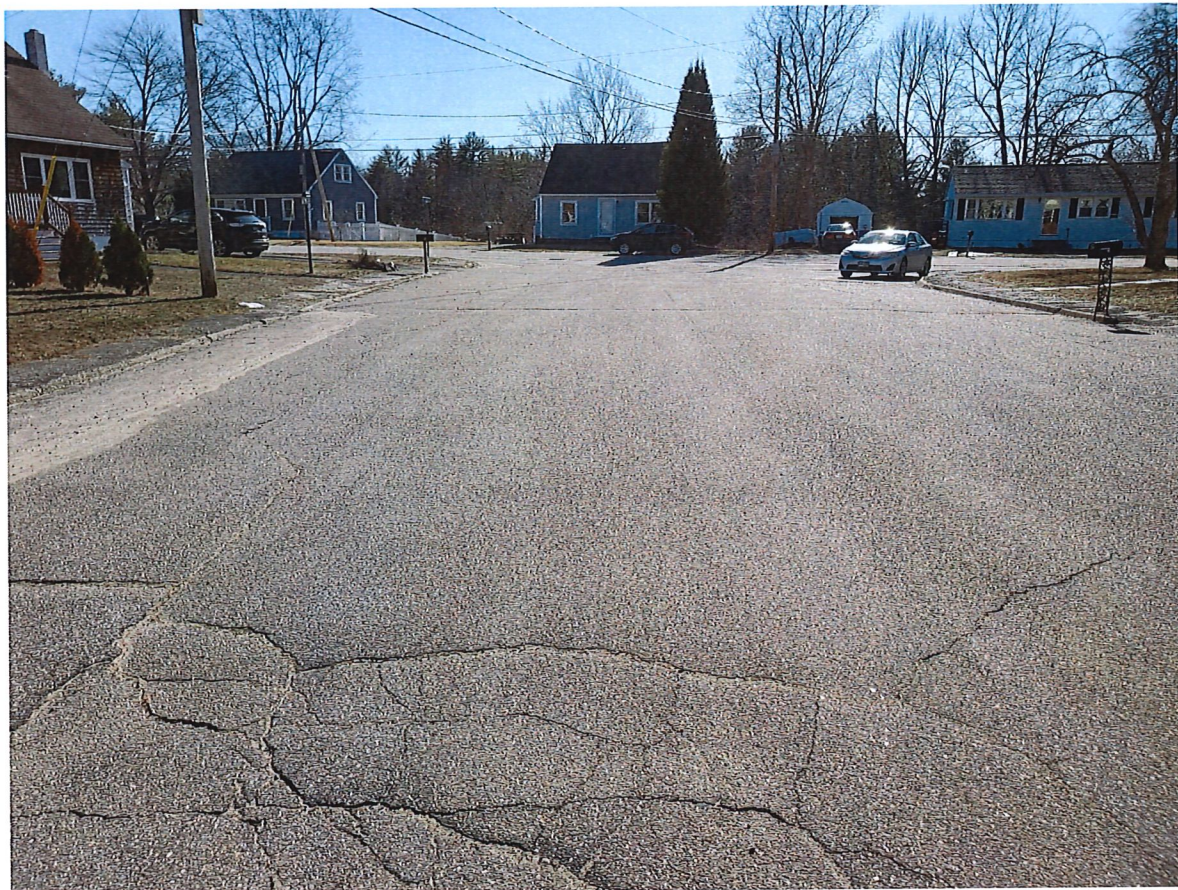
Westside Drive and Cross Streets Photos

Comments: Road conditions were fairly consistent through the area. Transverse cracking seemed consistently spaced, longitudinal cracking evident. Not much alligator cracking or potholes/patches
