**WESTSIDE DRIVE SEWER PLANNING
NHDES Project No. D2020-0607**

EXETER, NEW HAMPSHIRE

FINAL - MAY 23, 2022

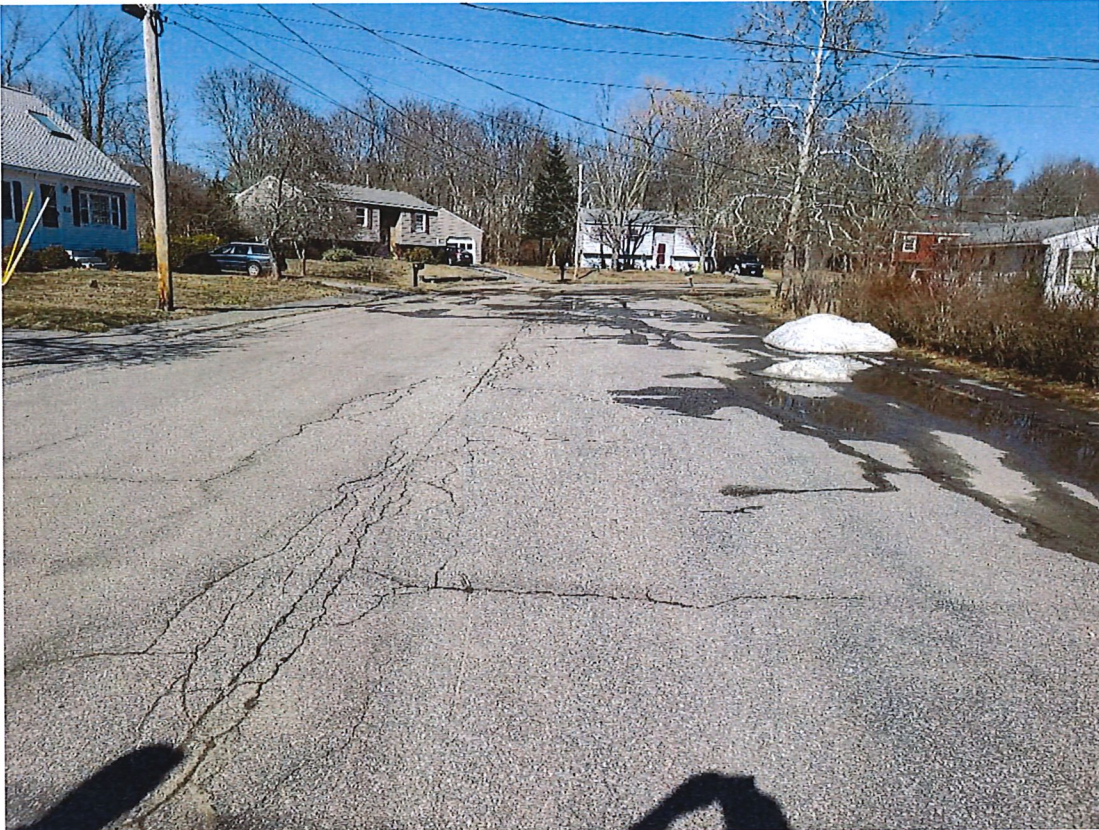
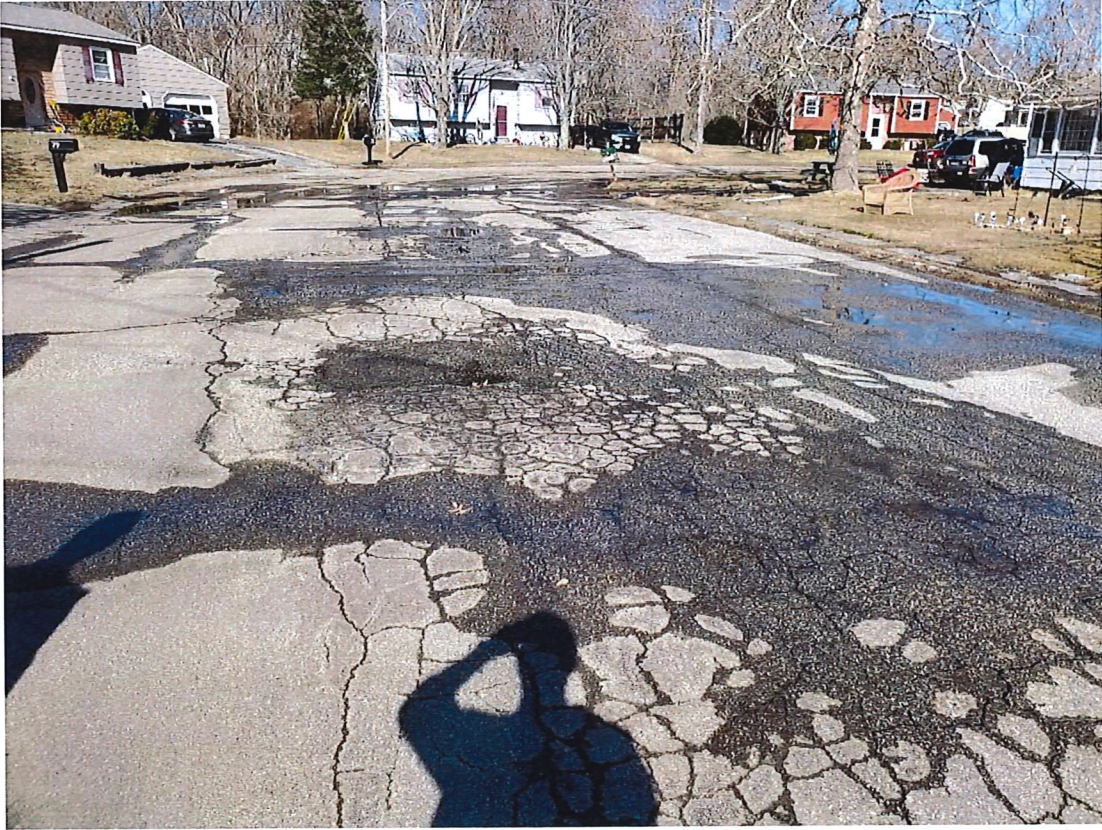
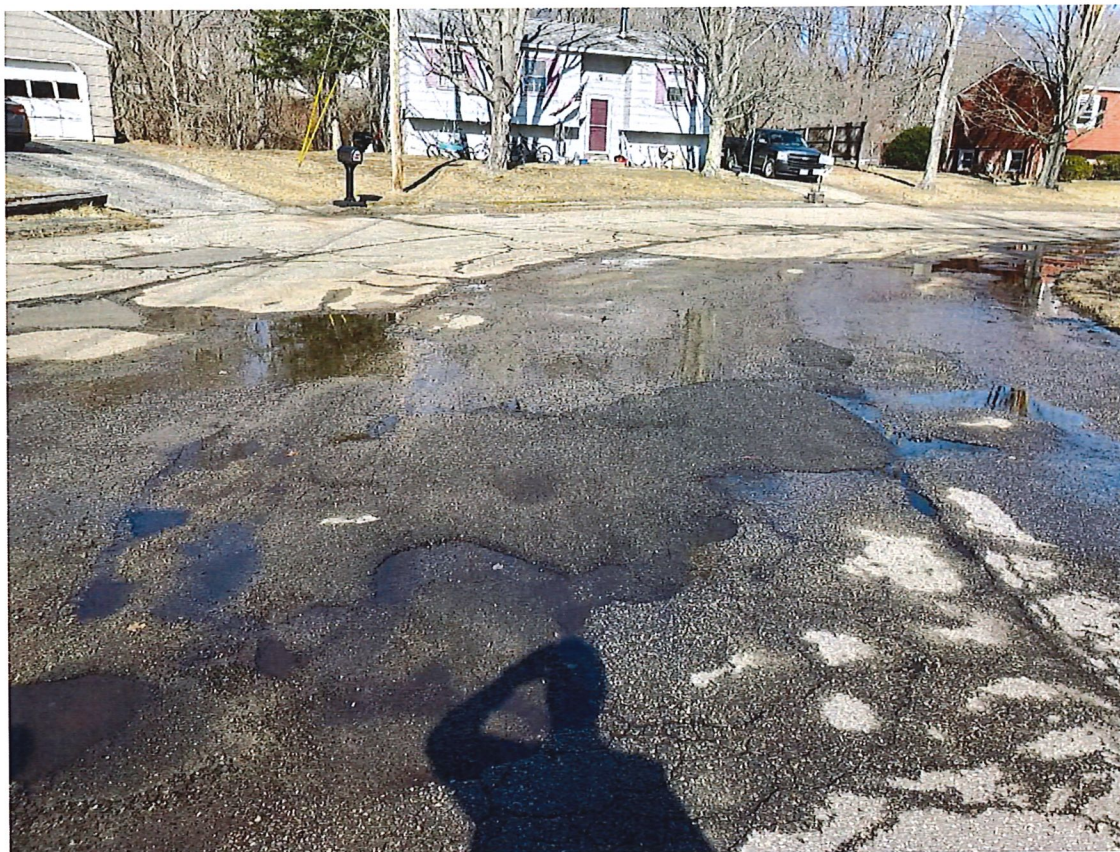
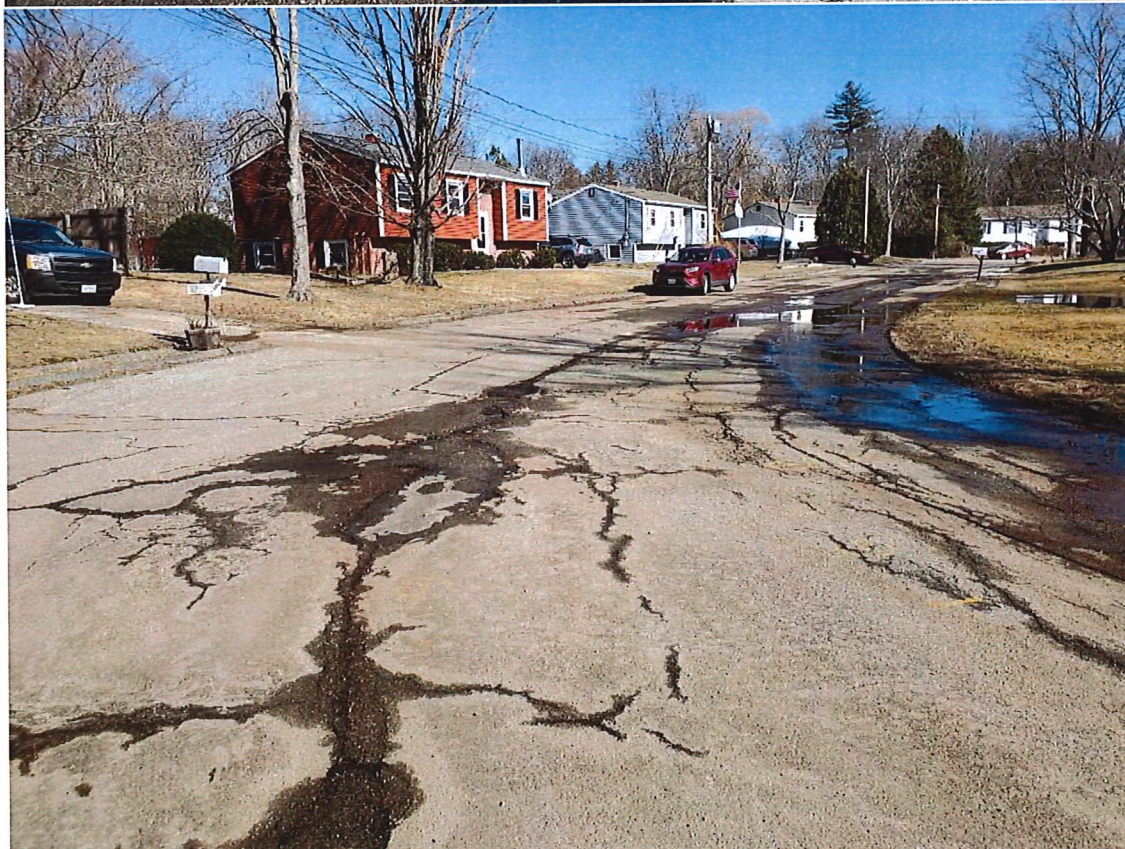
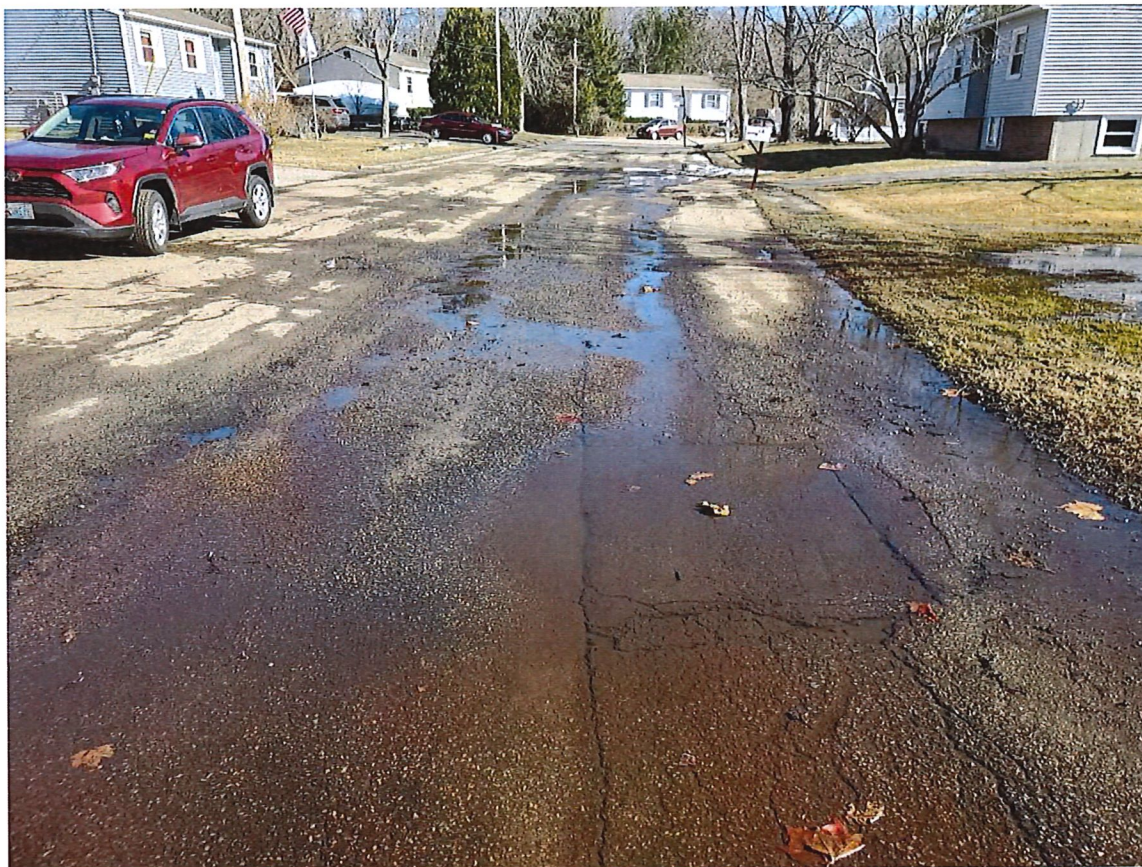
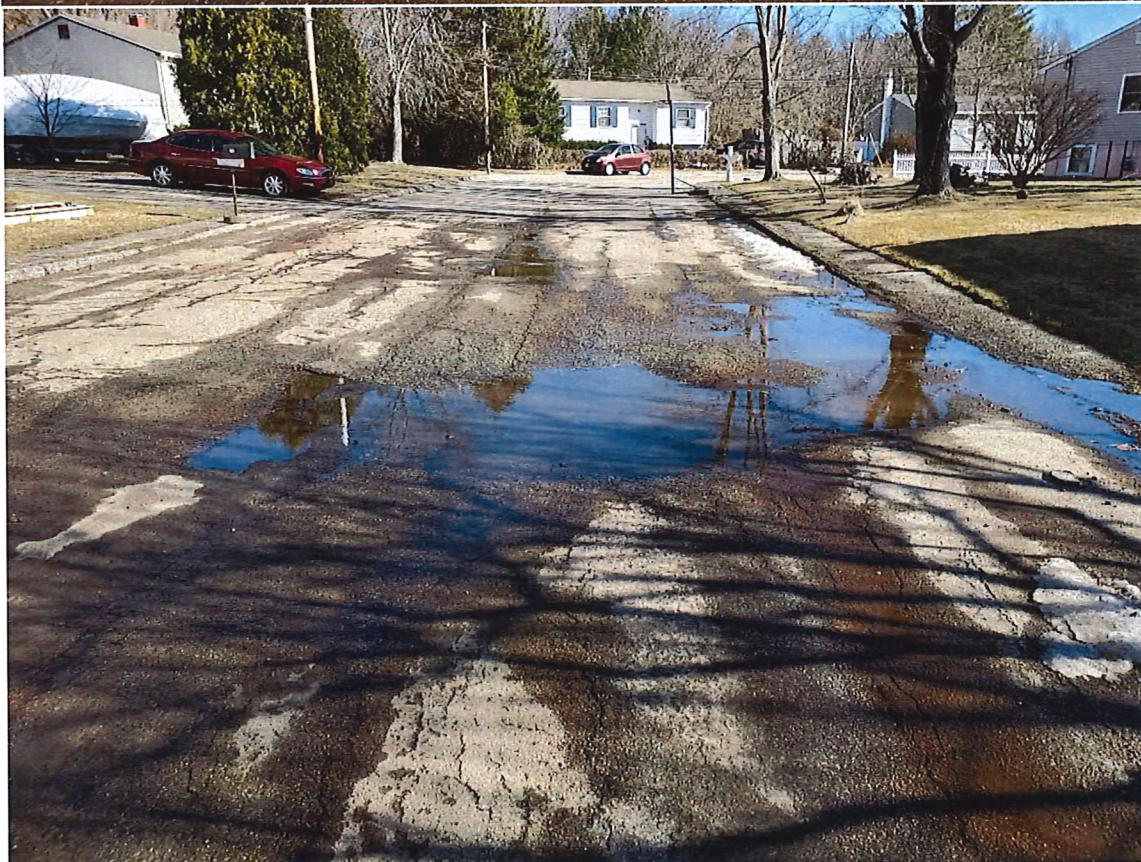
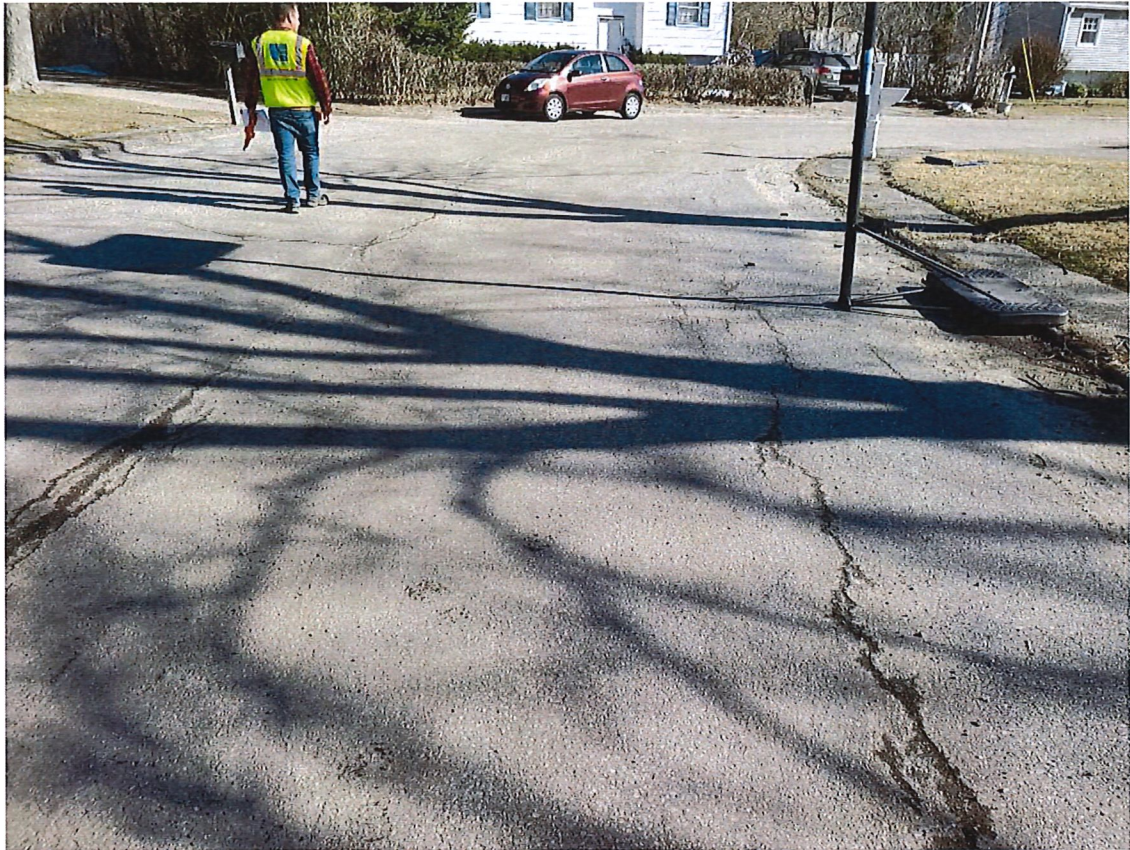
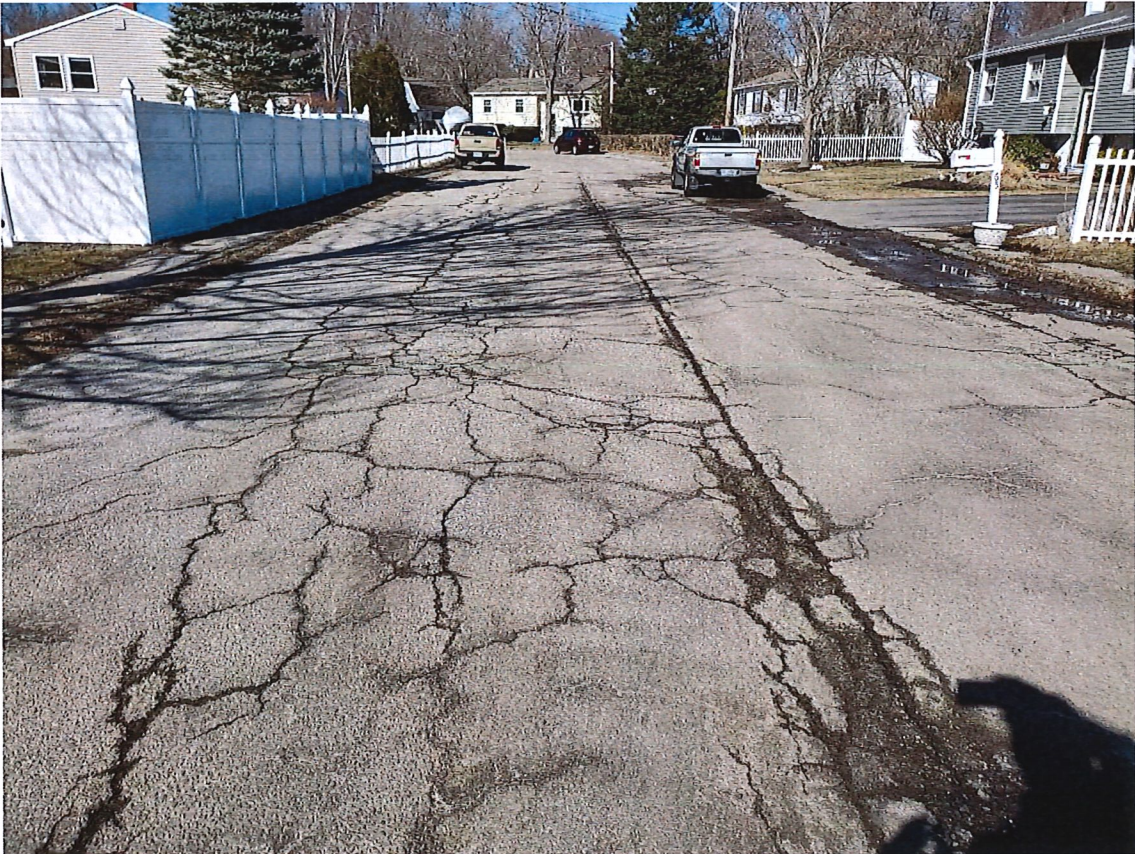
Westside Drive Northern Loop Photos

Comments: Area includes the northern Loop of Westside Pr.
Alligator Cracking is more prevalent as well as pot holes.
Ponding throughout, appears to be groundwater coming up. Rust
stains on pavement in NE corner.

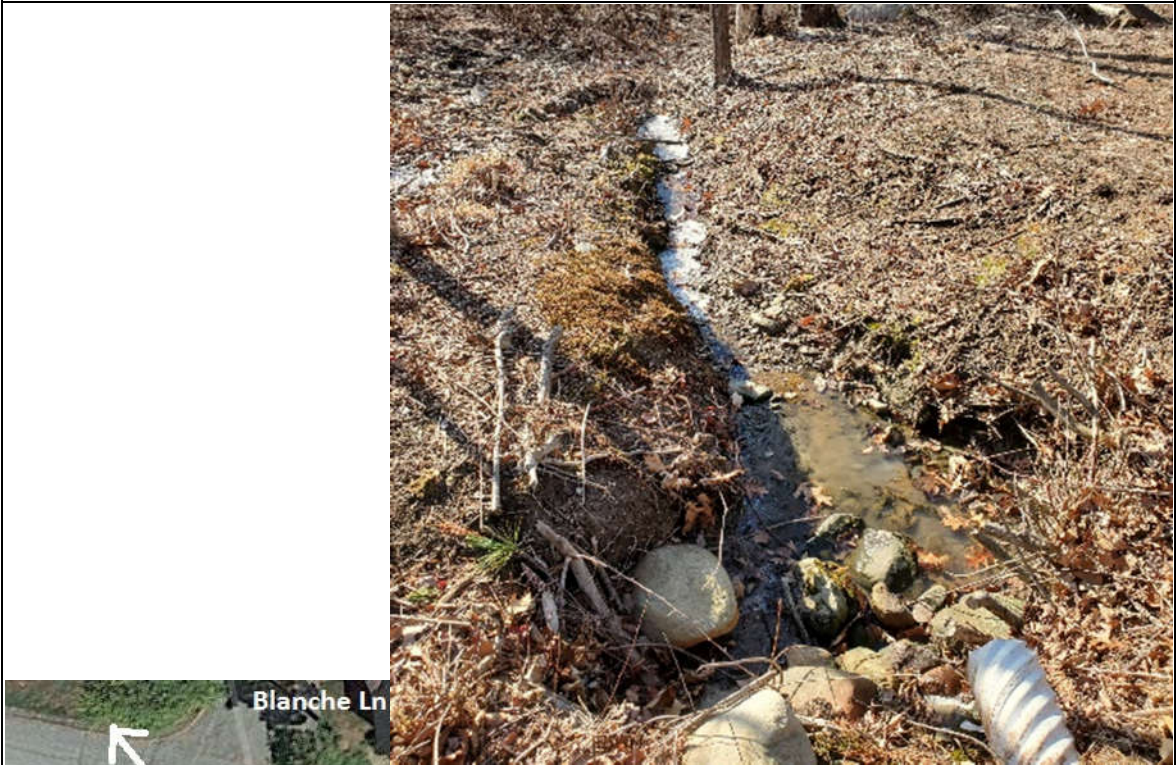
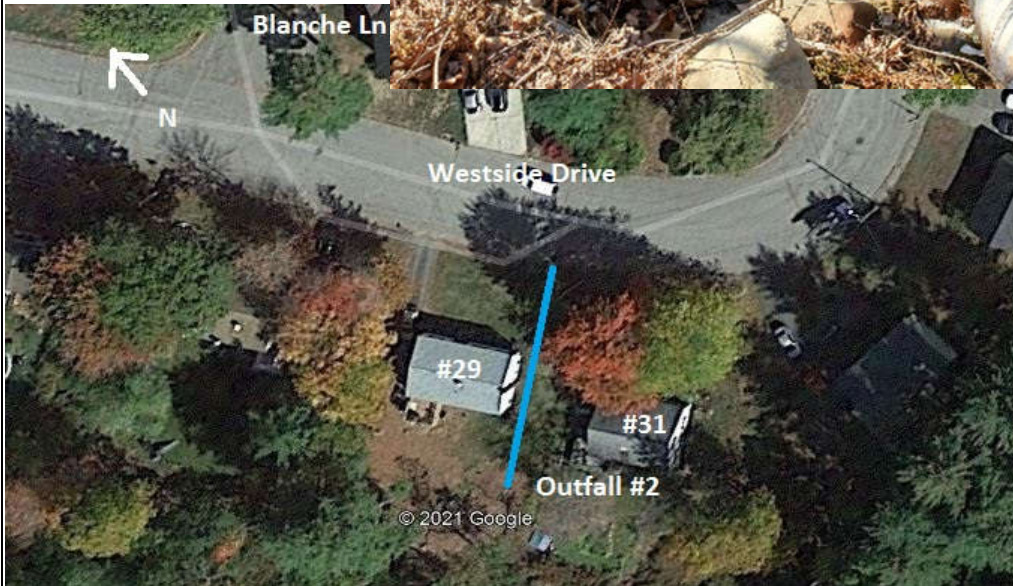
Date Inspected	1/22/2021
2588 Westside Drive Conceptual Improvements, Exeter NH	
Outfall ID	#2
Location	Discharges to the Swale behind 29 Westside Drive
Size	6"
Material	CMP
Condition	No Visible Damage to pipe, no visible blockage

Approximately 13" of the pipe is exposed and discharges to a swale in the backyard and eventually into the Little River

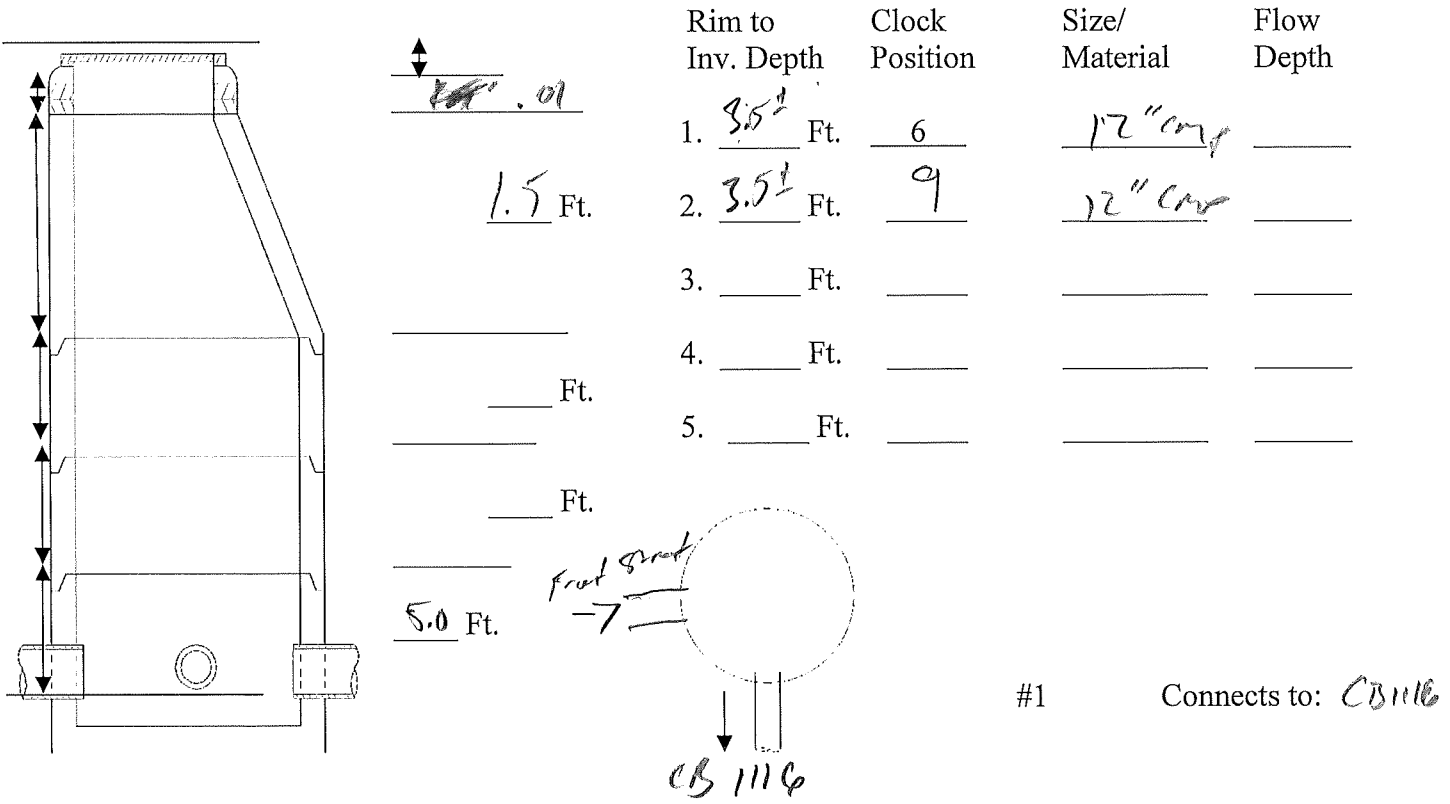
Location: Westside North ID No. CB1117
 Dia. 4 Ft. Material: Brick / Precast By: EBW Date: 8/12/21
 Clear Opening: _____ In. Corbel: .01' In. Frame 9 In. Potential: _____ S.F.

Notes: 1 1/2 Precast Top, Brick Base, Lower 2' not visible, Standing water in CB. SEE Survey for actual Inverts

Observations	Material	Condition Rating	Notes
Frame/Cover:	<u>AL</u>	<u>2</u>	<u>Square Grate, 1.8' x 2'</u>
Corbel:	<u>AL</u>	<u>4</u>	
Cone/Slab Top		<u>2</u>	
Walls		<u>2</u>	<u>Brick</u>
Invert/Shelf

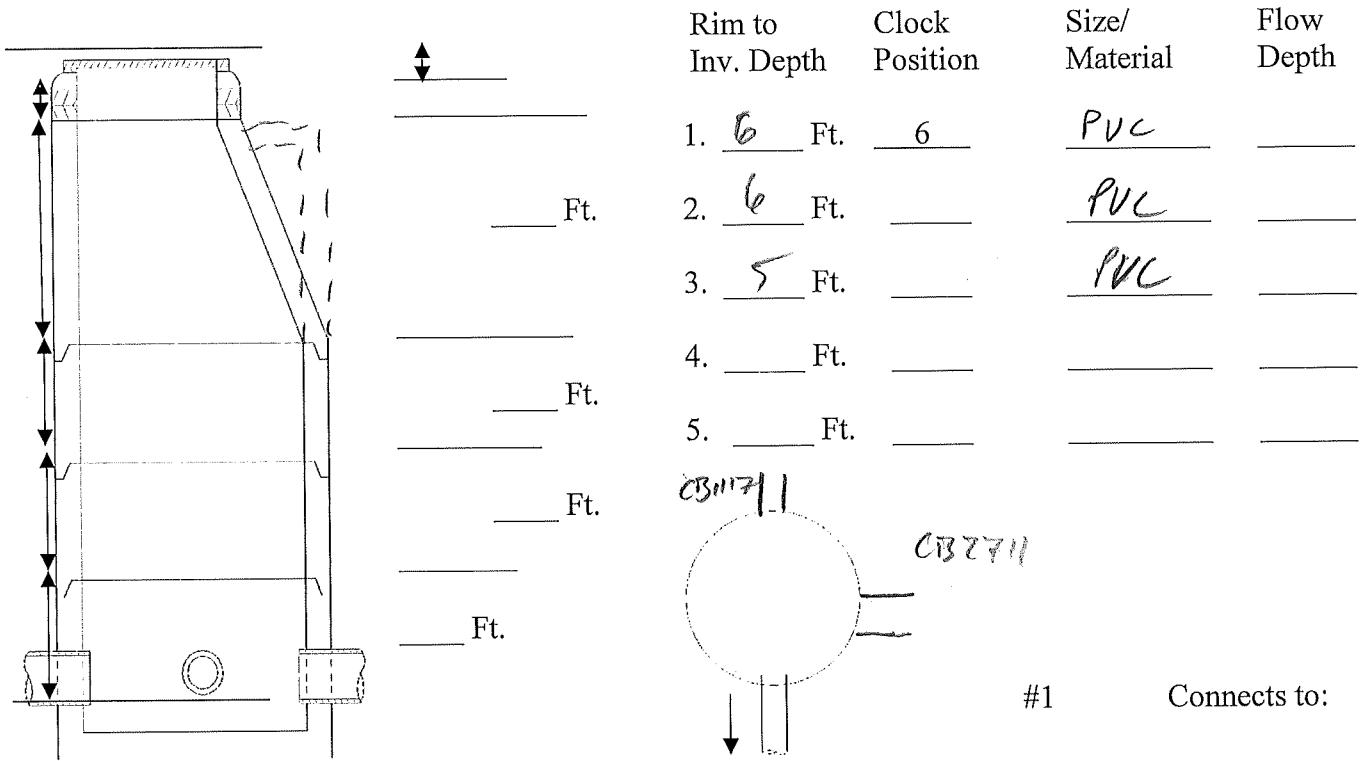
Location: West side + Laperle ID No. CB1116
 Dia. 4 Ft. Material: Precast By: EBN Date: 3/12/21
 Clear Opening: 24 In. ^{Riser} Corbel: 6 In. Frame 9 In. Potential: _____ S.F.
 Notes: Flat Top CB .7' Thick Sediment 7.5' (Top), 8' to Sample
based on flow, Water @ 5.5' from Rim

Observations	Material	Condition Rating	Notes
Frame/Cover:	<u>GS</u>	<u>3</u>	<u>Rusted</u>
Corbel:	<u>Precast</u>	<u>None</u>	
Cone/Slab Top	<u>Precast</u>	<u>2/3</u>	
Walls	<u>Precast</u>	<u>2/1</u>	
Invert/Shelf	<u>Precast</u>

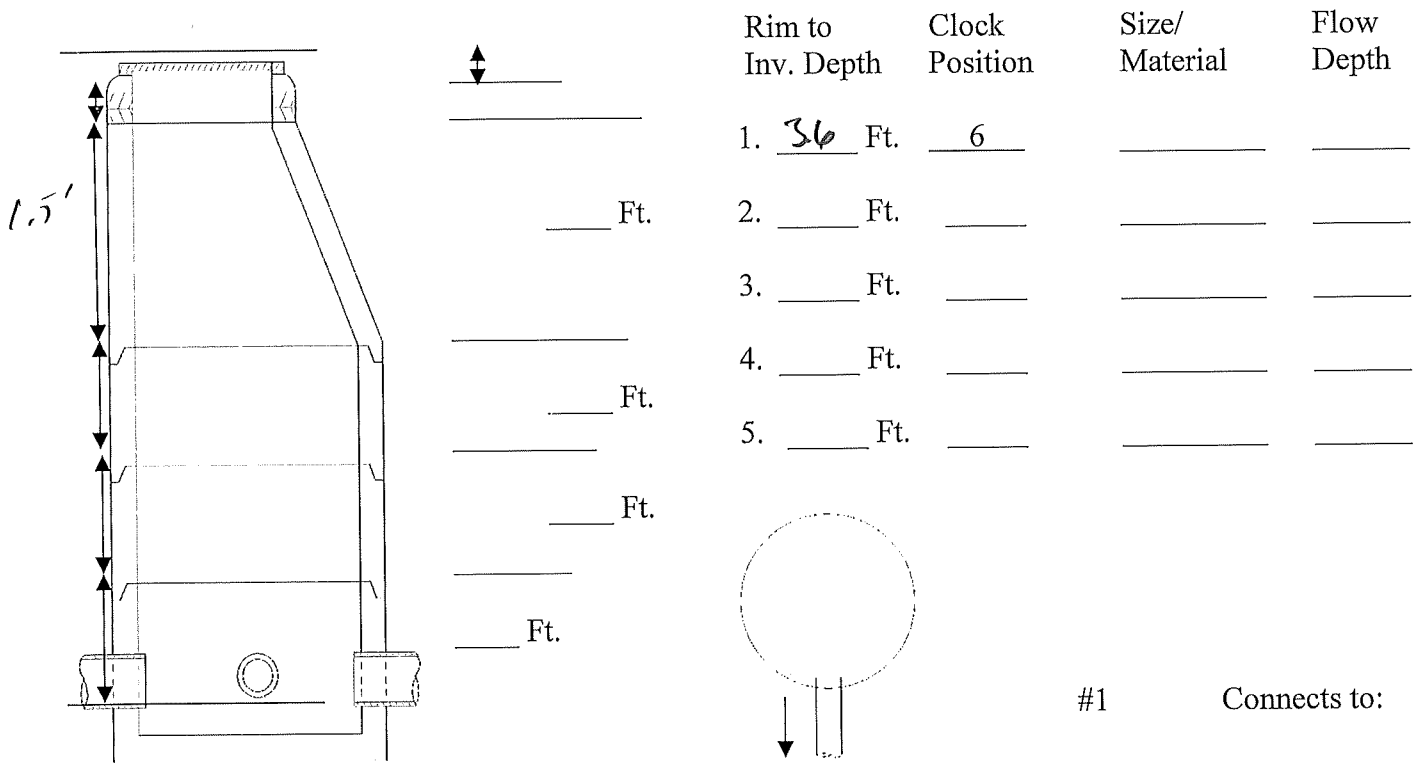
Location: Laperte ID No. CB 2711
 Dia. _____ Ft. Material: Precast By: EBA Date: _____
 Clear Opening: _____ In. Corbel: .4' In. Frame .7' In. Potential: _____ S.F.

Notes: 1' Riser w/ Brick walls and possible cut in place
Setback @ 8', Survey @ 9.5 not found

Observations	Material	Condition Rating	Notes
Frame/Cover:		<u>3</u>	
Corbel:		<u>4</u>	<u>Brick</u>
Cone/Slab Top		<u>4</u>	<u>Aggregate Visible + Missing, Cracking</u>
Walls			
Invert/Shelf

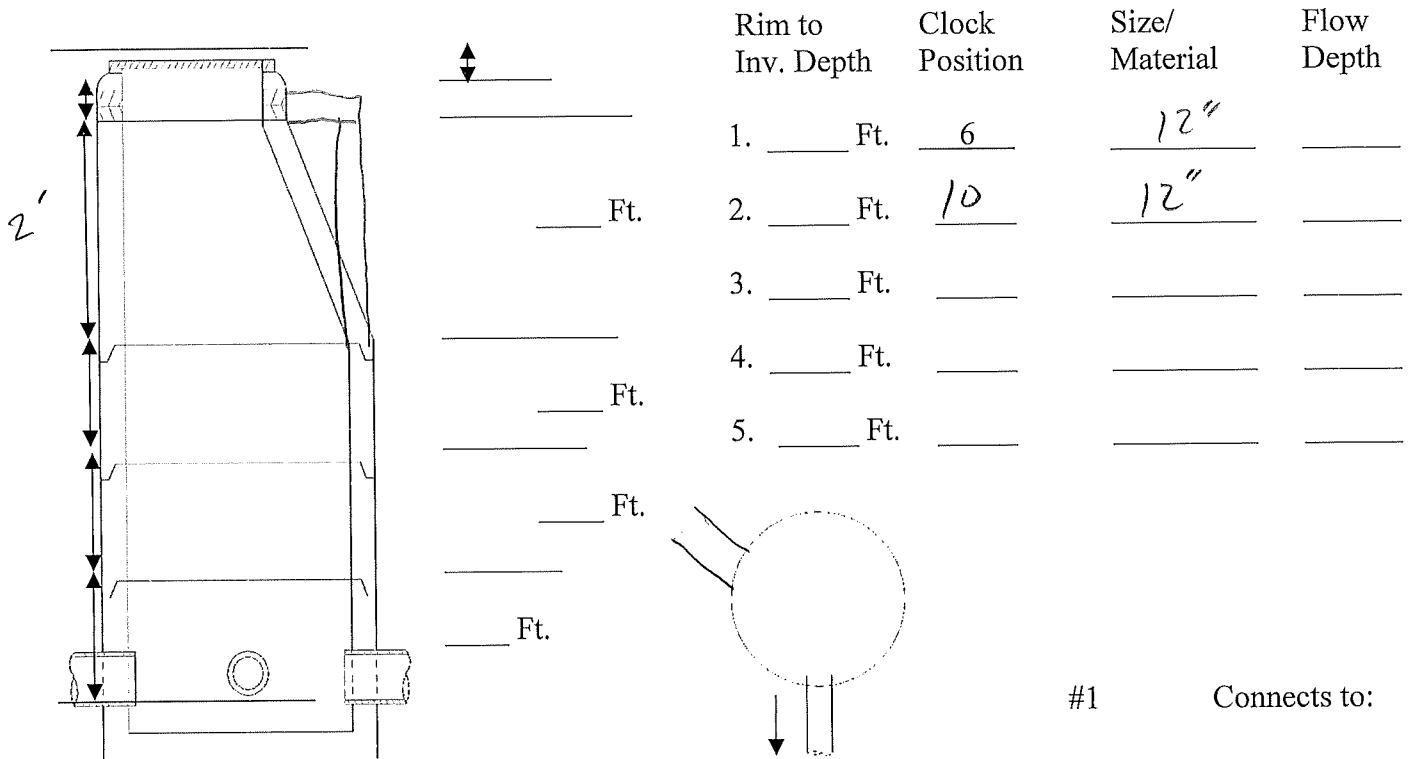
Location: Westside ID No. 1180
 Dia. 4 Ft. Material: Precast By: EBW Date: _____
 Clear Opening: 24 In. ^{Riser} Corbel: .5 In. Frame 4 In. Potential: _____ S.F.
 Notes: Flat Top, Water level @ 6.6', 9' solid bottom, 2.5' sup

Observations	Material	Condition Rating	Notes
Frame/Cover:		<u>2</u>	
Corbel:		<u>None</u>	
Cone/Slab Top		<u>2</u>	
Walls		<u>2</u>	
Invert/Shelf

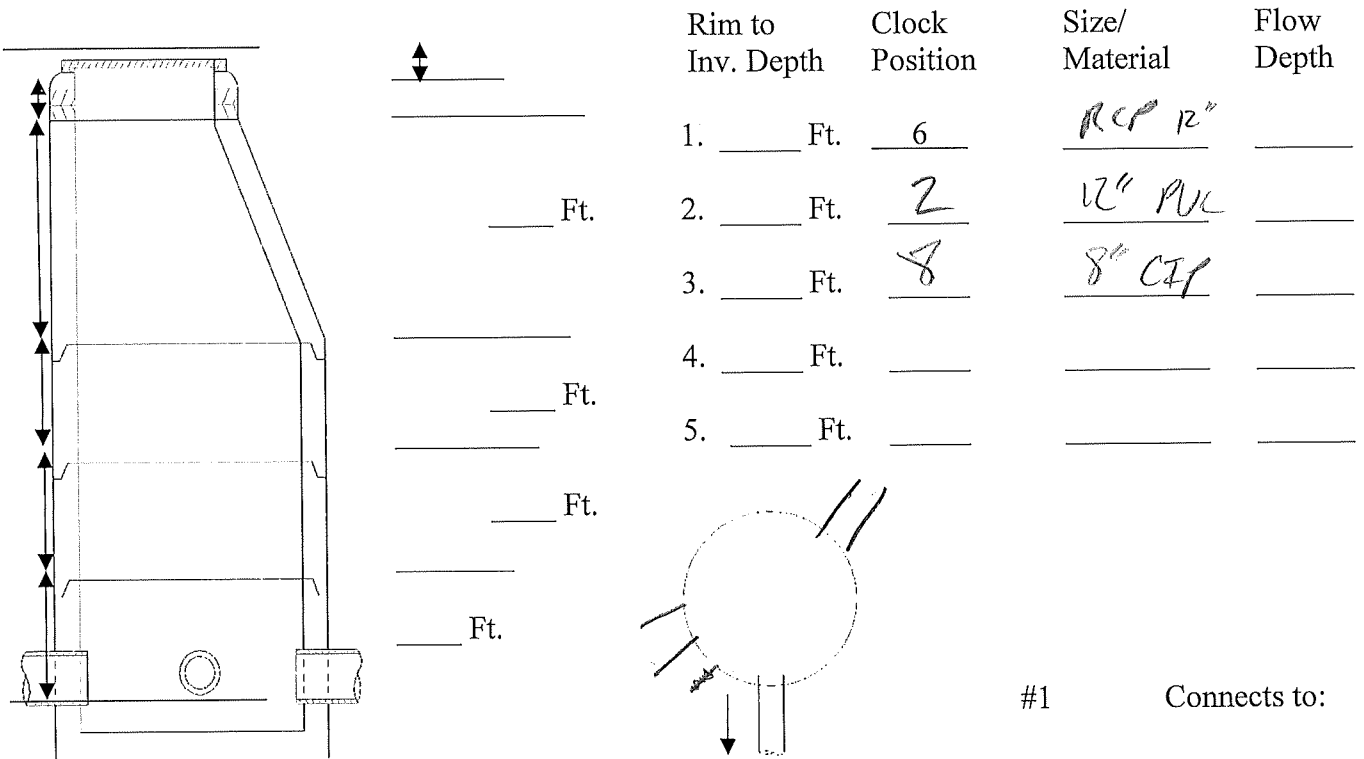
Location: Westside & Front Street ID No. 1191
 Dia. 4 Ft. Material: Pre cast By: EBW Date: 3/12/21
 Clear Opening: 24 In. Corbel: In. Frame 8 In. Potential: S.F.
 Notes: Flat Top, Water @ 6.3', sediment @ 8' hard bottom

Observations	Material	Condition Rating	Notes
Frame/Cover:	<u>CI</u>	<u>2</u>	
Corbel:	<u>Concrete</u>	<u>4</u>	<u>Exposed stone</u>
Cone/Slab Top <u>flat</u>			
Walls		<u>4</u>	<u>Missing pieces of wall</u>
Invert/Shelf

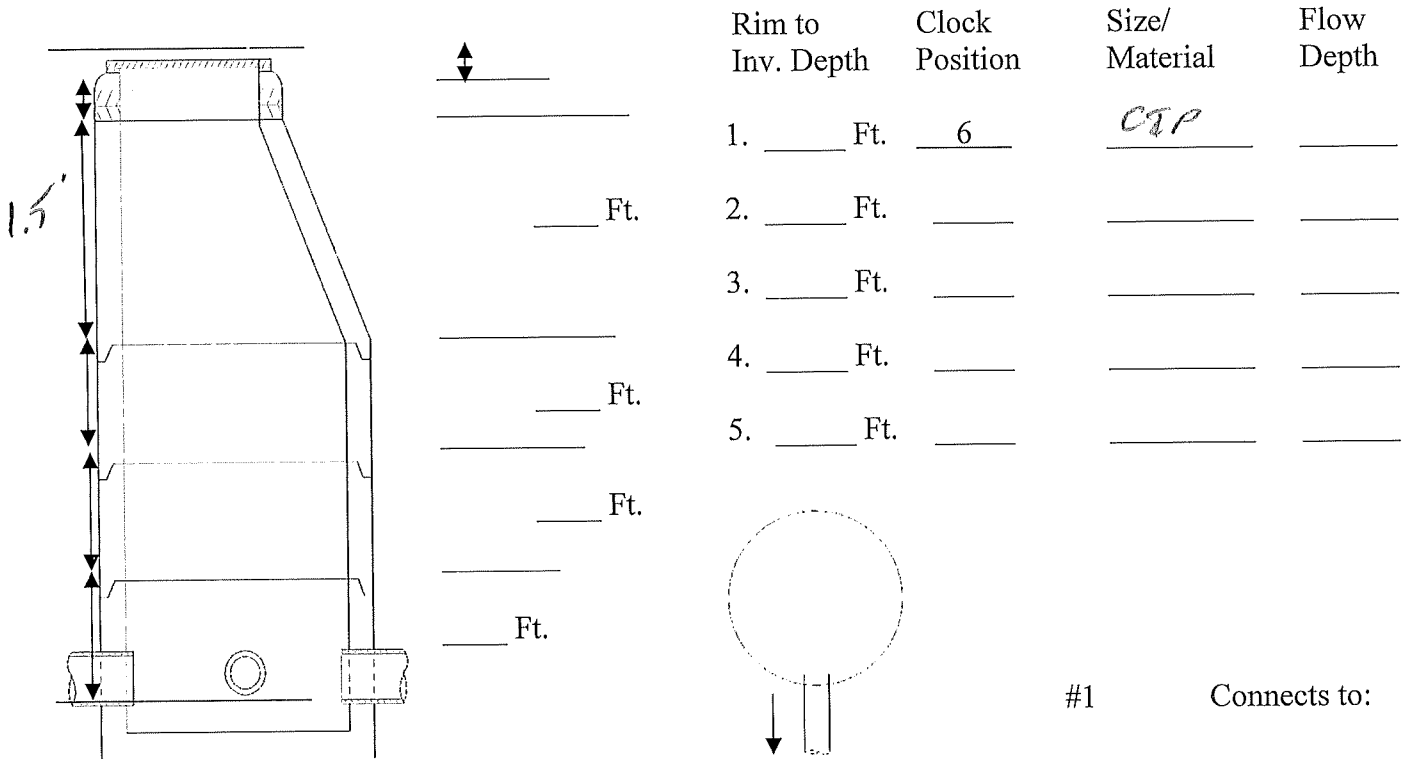
Location: Summer & Westside Drive ID No. 1618
 Dia. 4 Ft. Material: Precast By: EBW Date: _____
 Clear Opening: 24 In. Corbel: 6 In. Frame 9 In. Potential: _____ S.F.
 Notes: Water @ 3.5', 6" to sediment, 6.8' to ramp

Observations	Material	Condition Rating	Notes
Frame/Cover:	<u>CR</u>	<u>2</u>	
Corbel:	<u>Brick</u>	<u>3</u>	<u>Missing bricks</u>
Cone/Slab Top		<u>3</u>	<u>Missing Aggregate</u>
Walls	<u>PC</u>	<u>3</u>	<u>Aggregate Visible</u>
Invert/Shelf

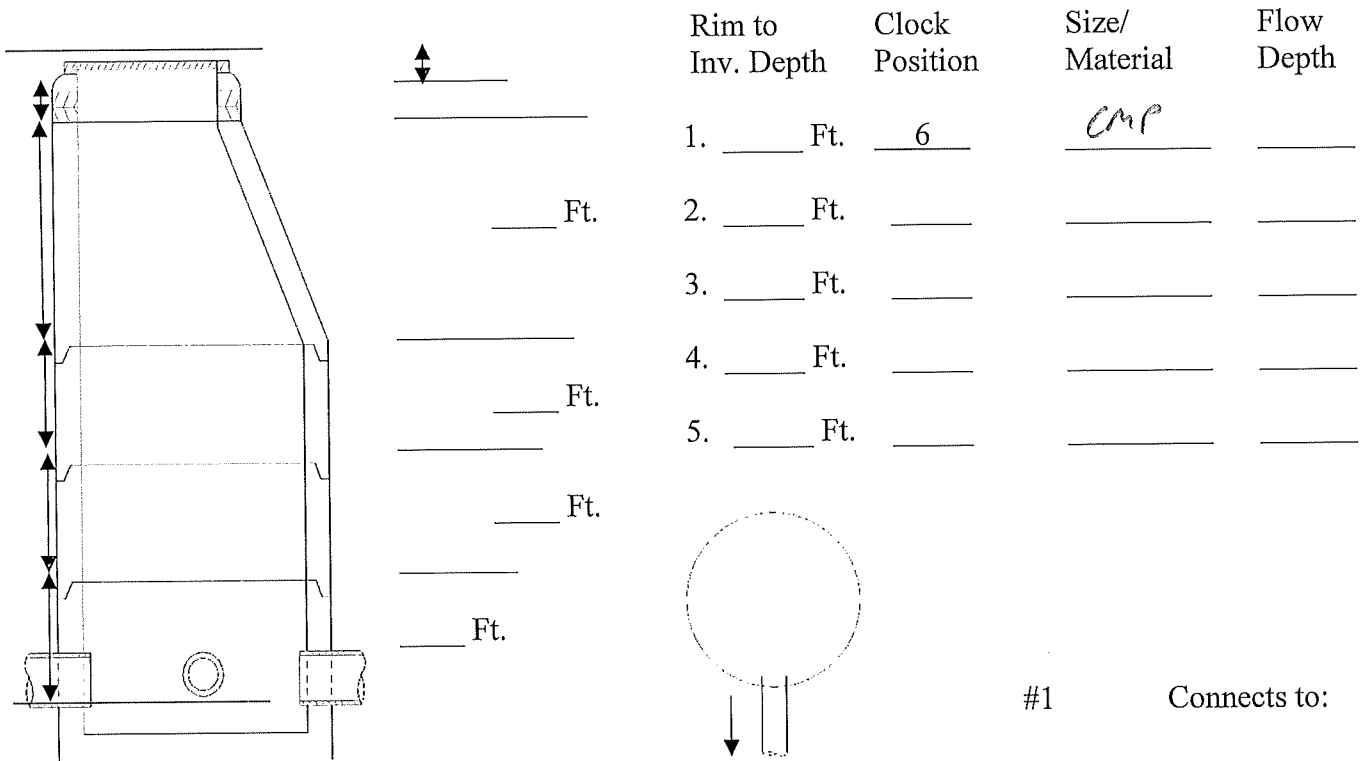
Location: Westside North + Blanche ID No. 2928
 Dia. 4 Ft. Material: Precast By: ECN Date: _____
 Clear Opening: _____ In. Corbel: .5 In. Frame 4 In. Potential: _____ S.F.
 Notes: 2' Deep Inlet, Water @ 3', 4.2' to bottom

Observations	Material	Condition Rating	Notes
Frame/Cover:		<u>3</u>	
Corbel:		<u>4</u>	
Cone/Slab Top			
Walls		<u>3</u>	
Invert/Shelf

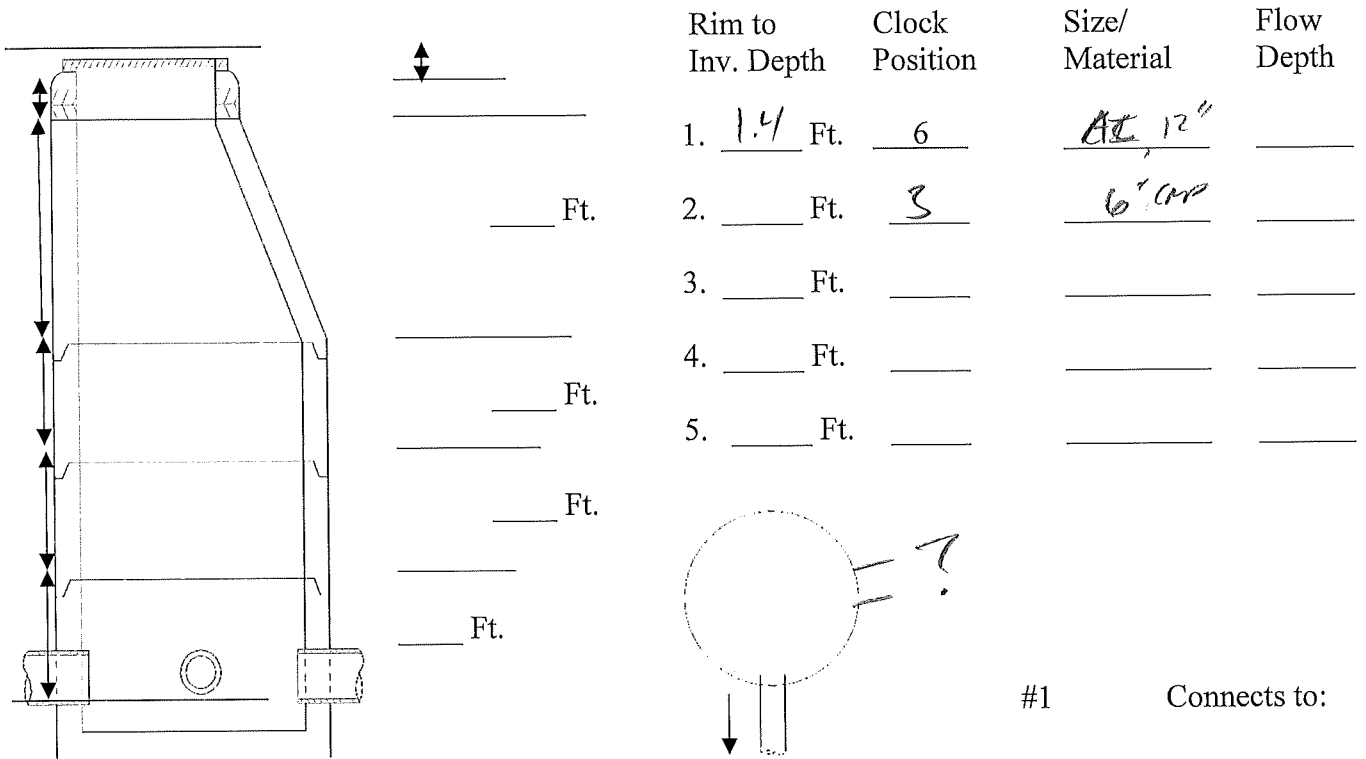
Location: Westside A. ID No. 2588
 Dia. 4 Ft. Material: Precast By: EBN Date: _____
 Clear Opening: 2 In. Corbel: _____ In. Frame _____ In. Potential: _____ S.F.
 Notes: 2' Prop Inlet, 4' To bottom

Observations	Material	Condition Rating	Notes
Frame/Cover:	<u>CR</u>	<u>2</u>	
Corbel:		<u>3</u>	
Cone/Slab Top		<u>.</u>	
Walls		<u>4</u>	
Invert/Shelf
