FACILITY CONDITION ASSESSMENT

Town of Exeter New Hampshire
10 Front Street
Exeter, New Hampshire 03833-2737
Russell Dean

Public Works Campus
13 Newfields Road
Exeter, New Hampshire 03833

July 28, 2023

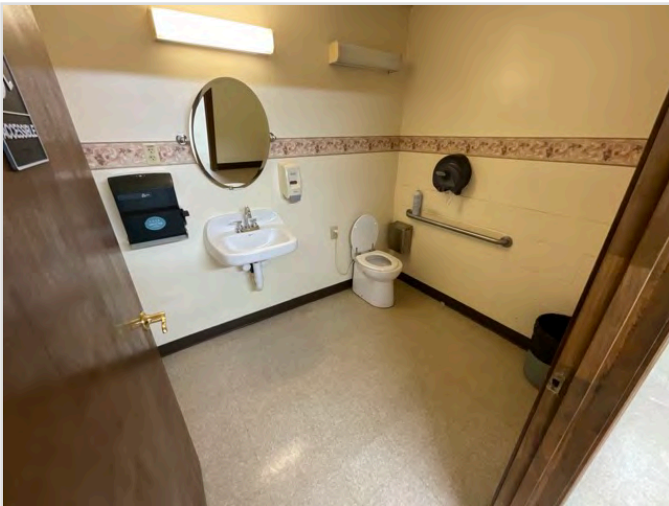
TOILET STALL OVERVIEW
