FACILITY CONDITION ASSESSMENT

Parks/Recreation Building (Court Street)
32 Court Street
Exeter, New Hampshire 03833

157332.22R000-009.354

April 26, 2023

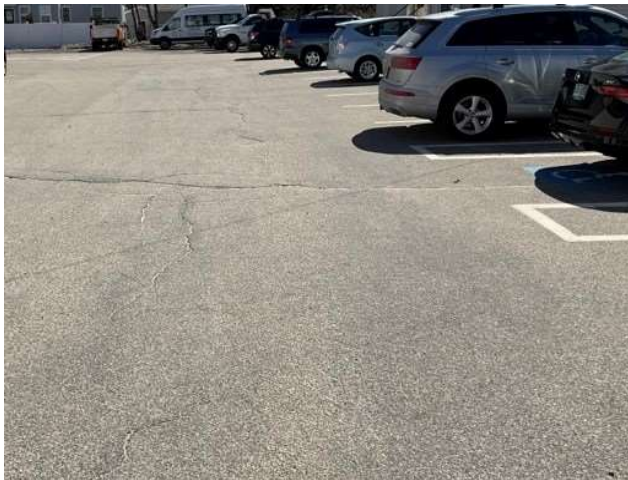
21 - PARKING LOTS

The site shares its parking lot with the Senior Center. It looks to be at midlife with some transvers cracking near the entrance and slightly more alligator cracking in the second lot behind the senior center. There is a new brick paver seating area with benches and a picnic table at the main entrance. The grass area behind the building could use re-seeding.
