**WESTSIDE DRIVE SEWER PLANNING  
NHDES Project No. D2020-0607**

**EXETER, NEW HAMPSHIRE**

**FINAL - MAY 23, 2022**

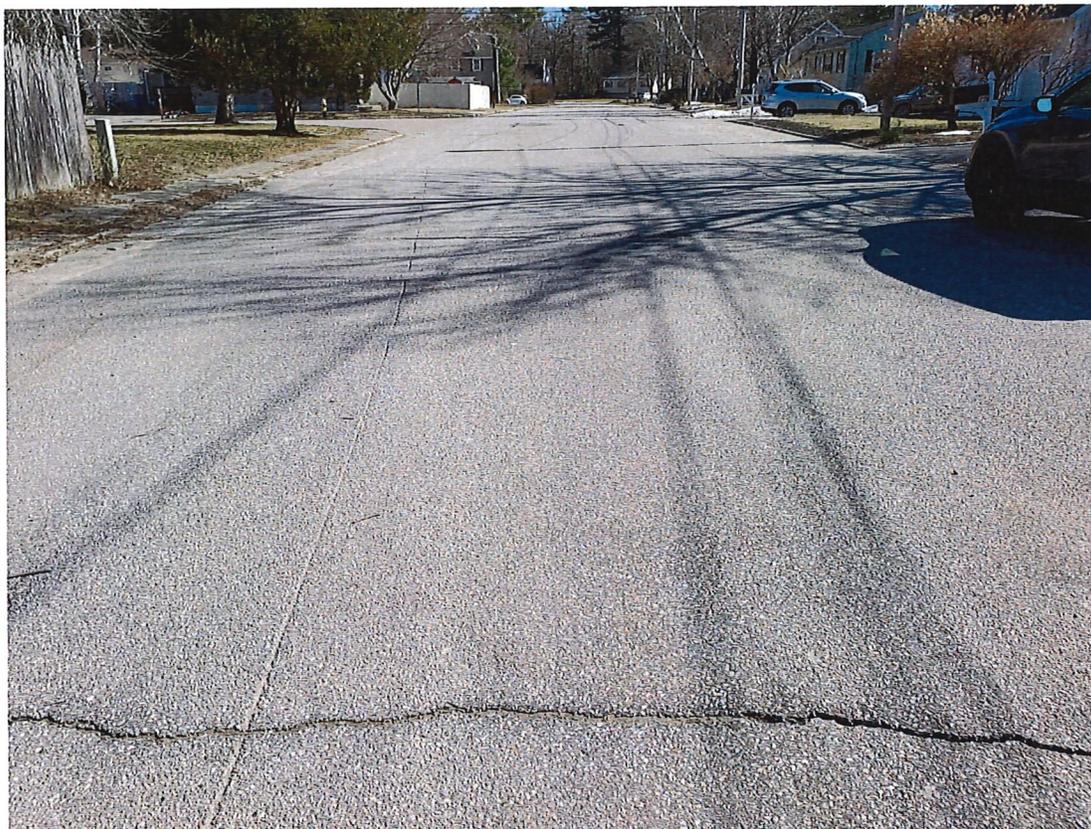
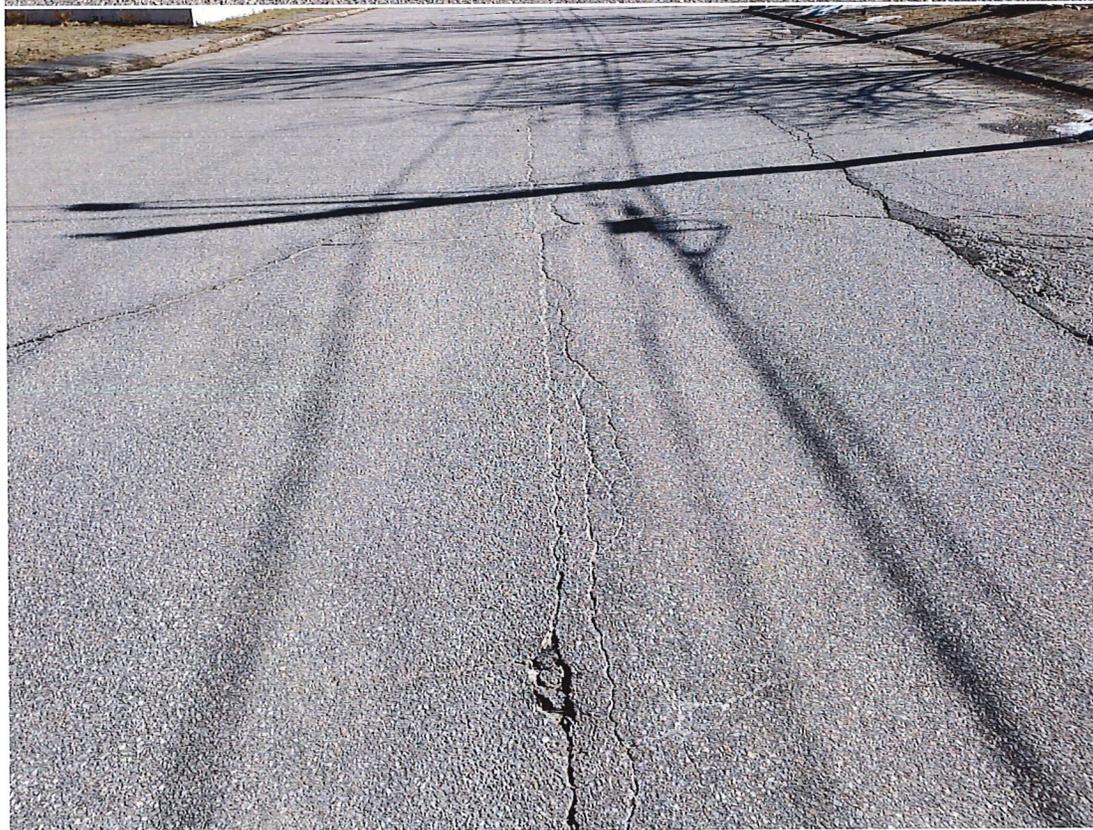
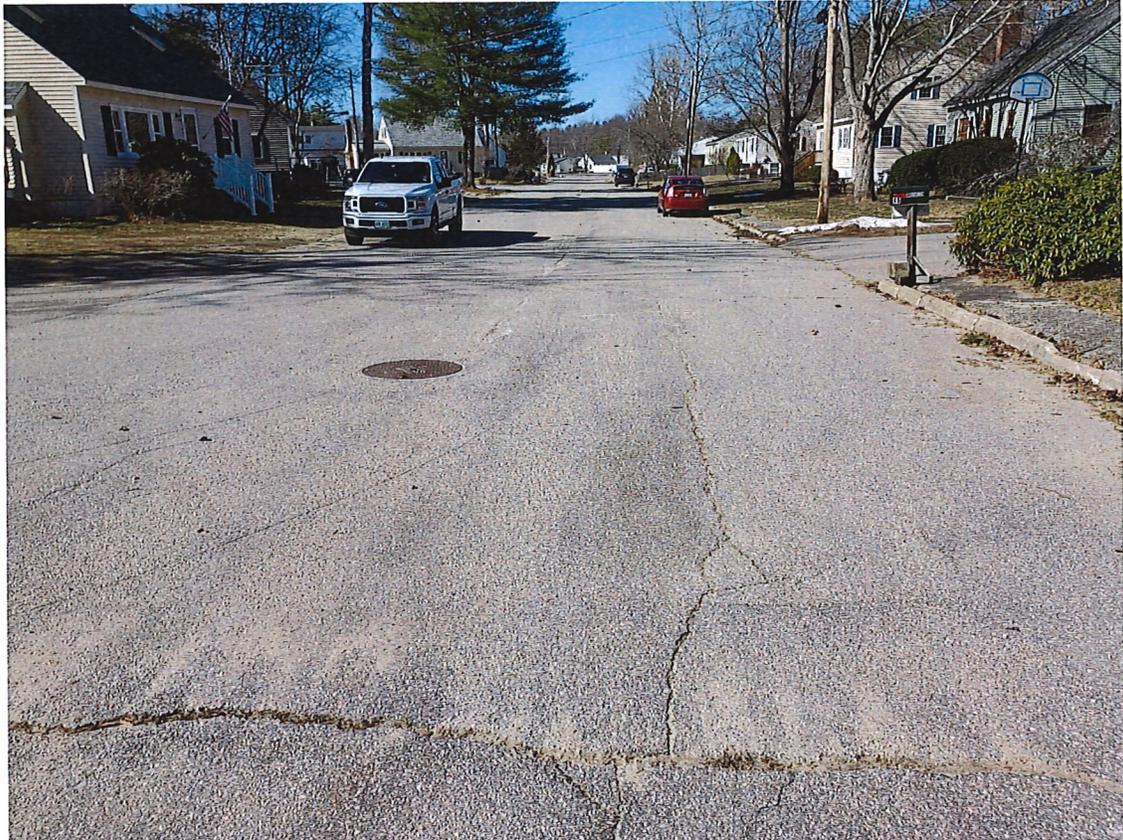
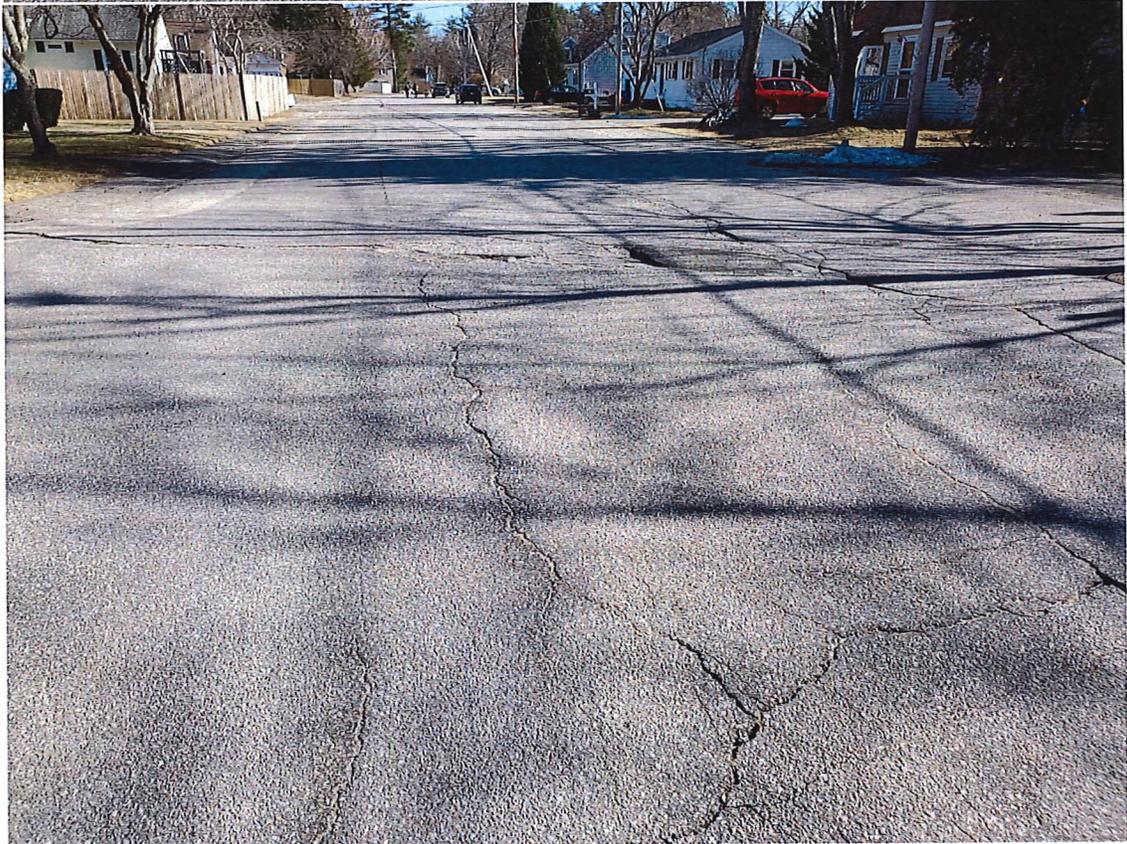
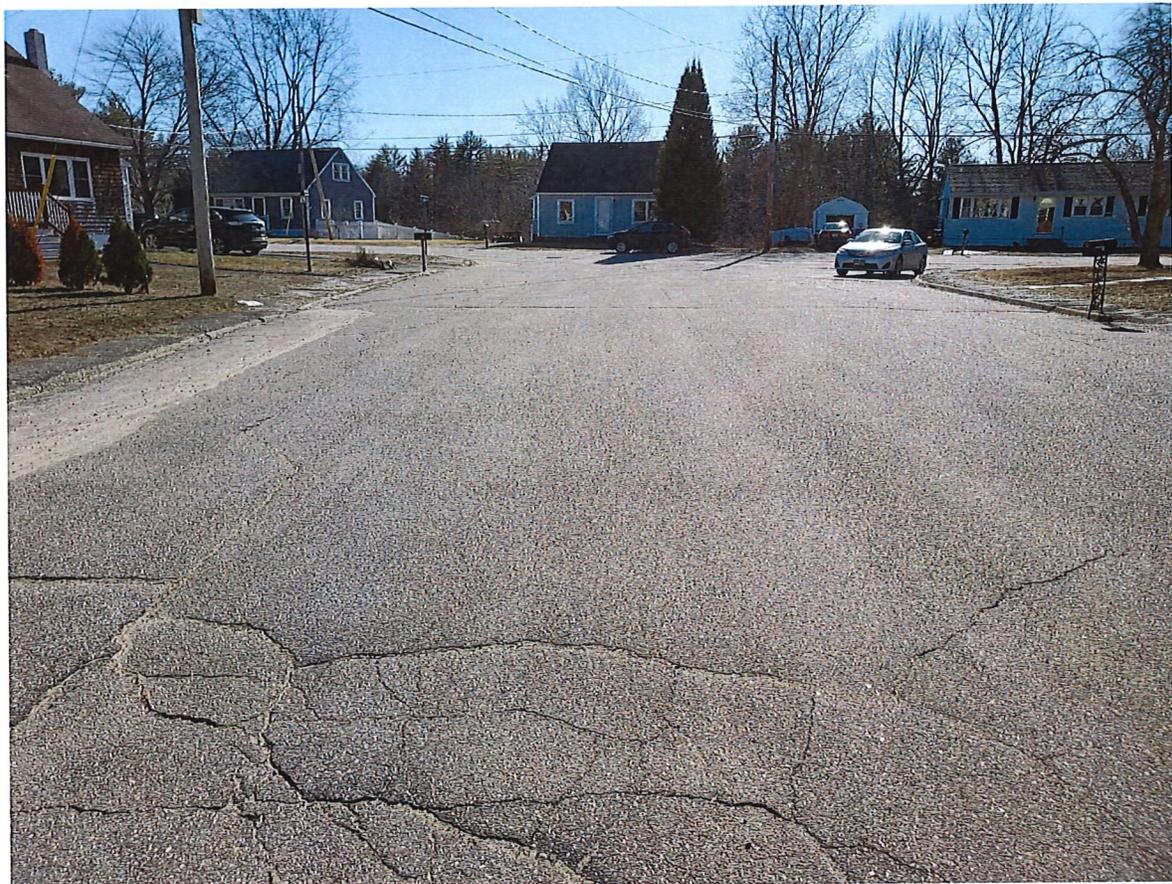
Westside Drive and Cross Streets Photos

Comments: Road conditions were fairly consistent through the area. Transverse cracking seemed consistently spaced, longitudinal cracking evident. Not much alligator cracking or potholes/patches

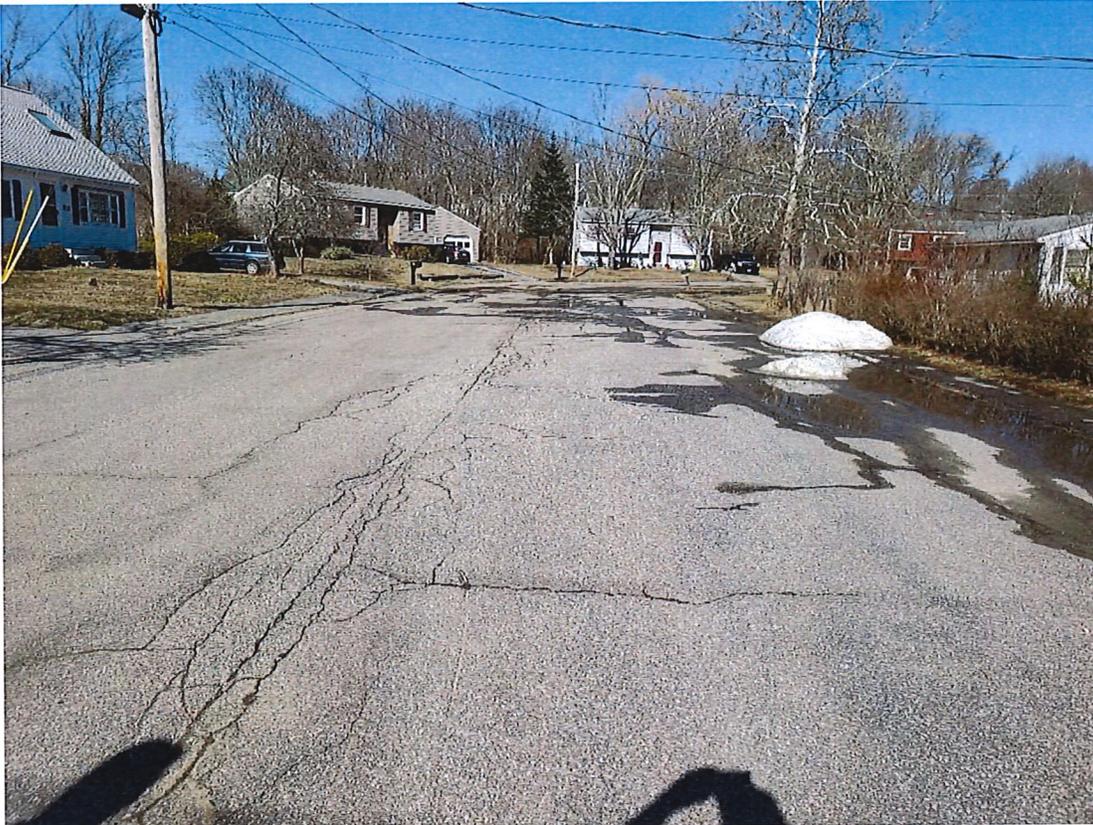
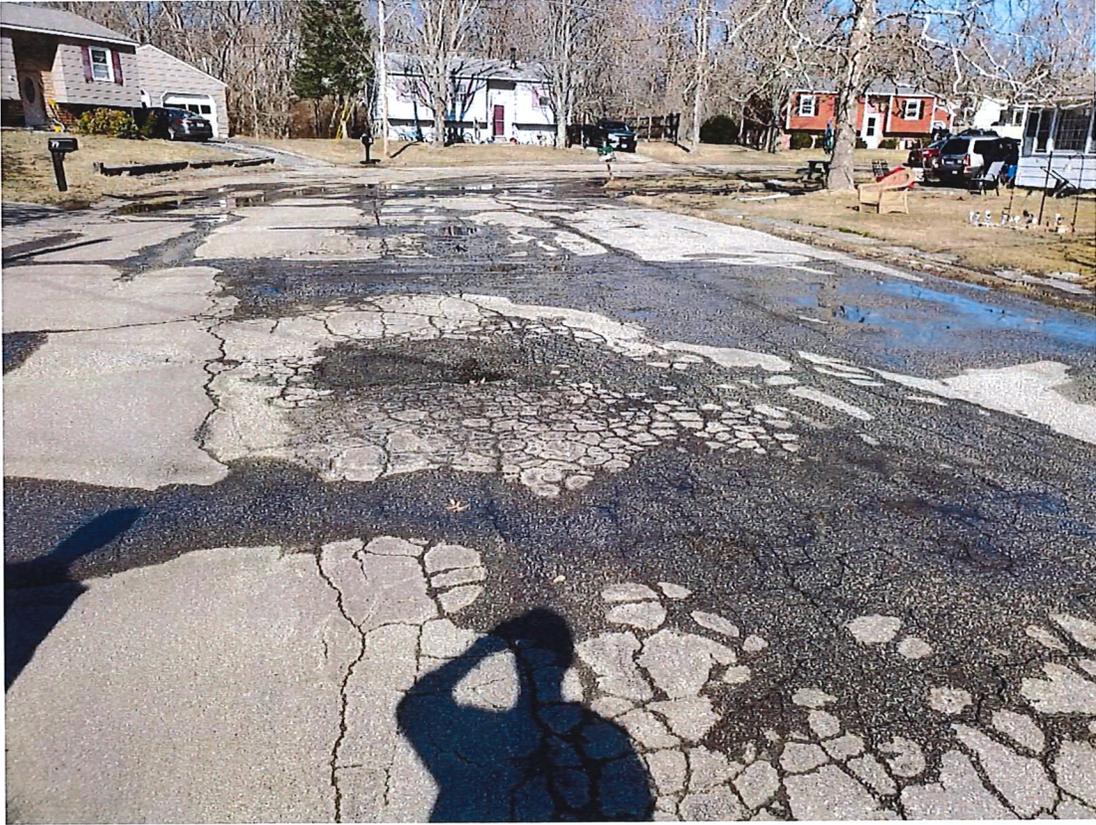
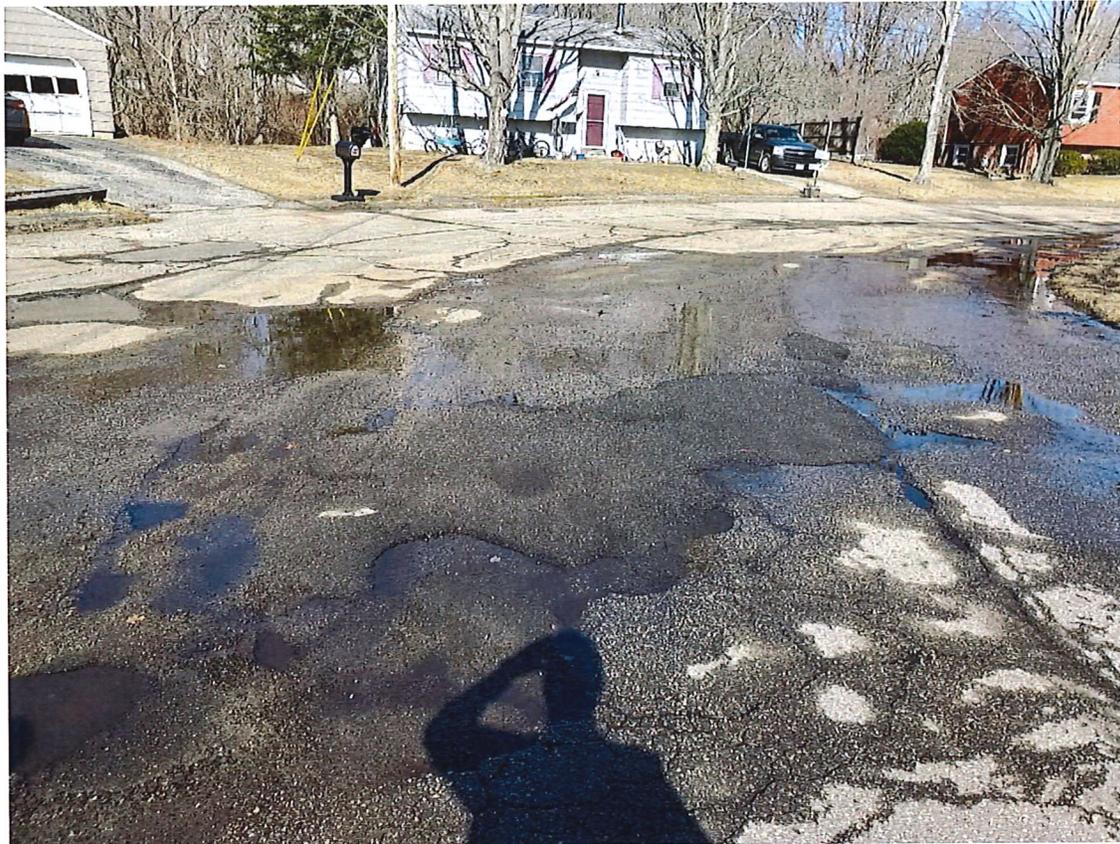
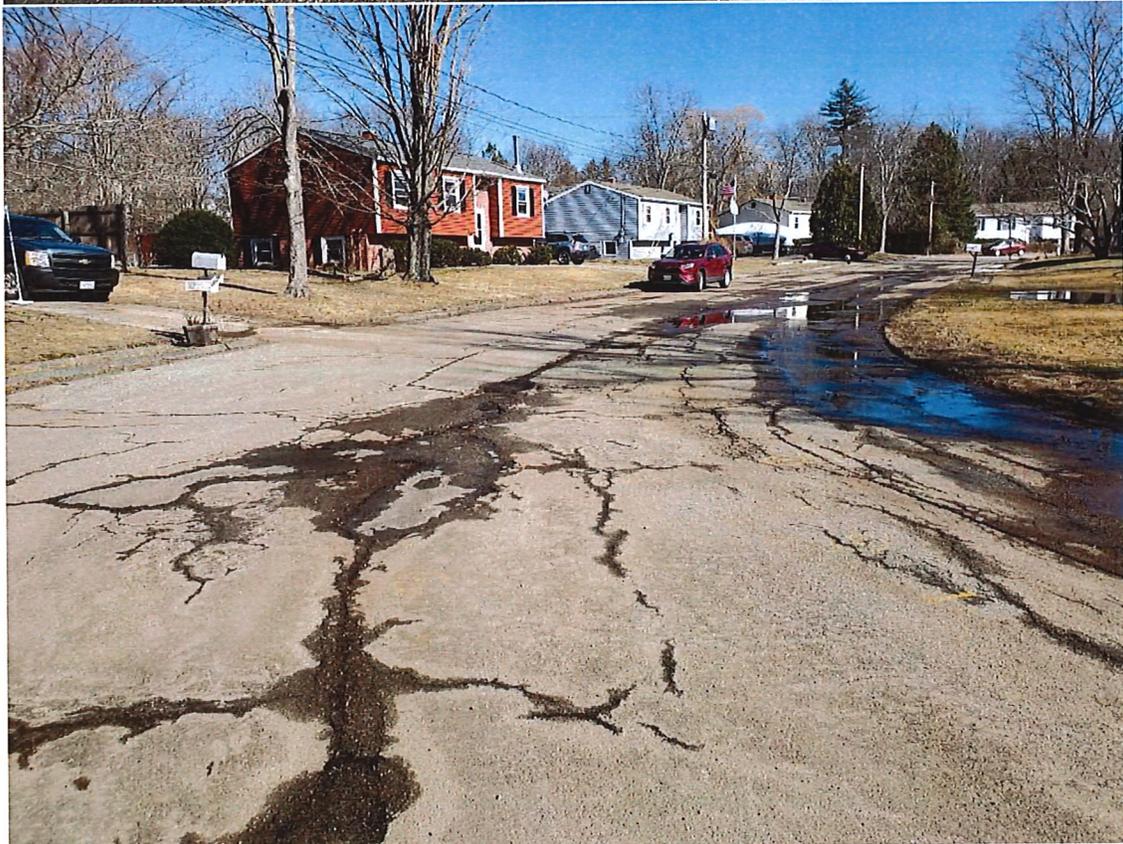
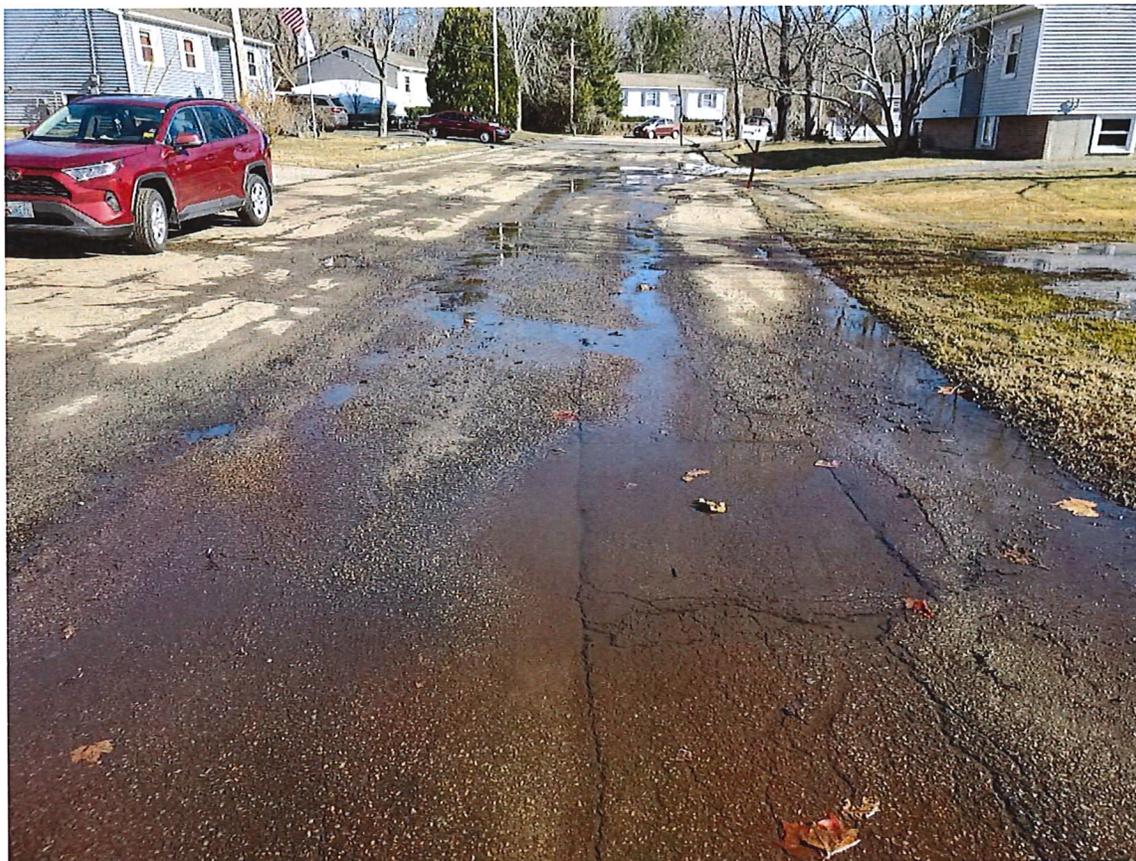
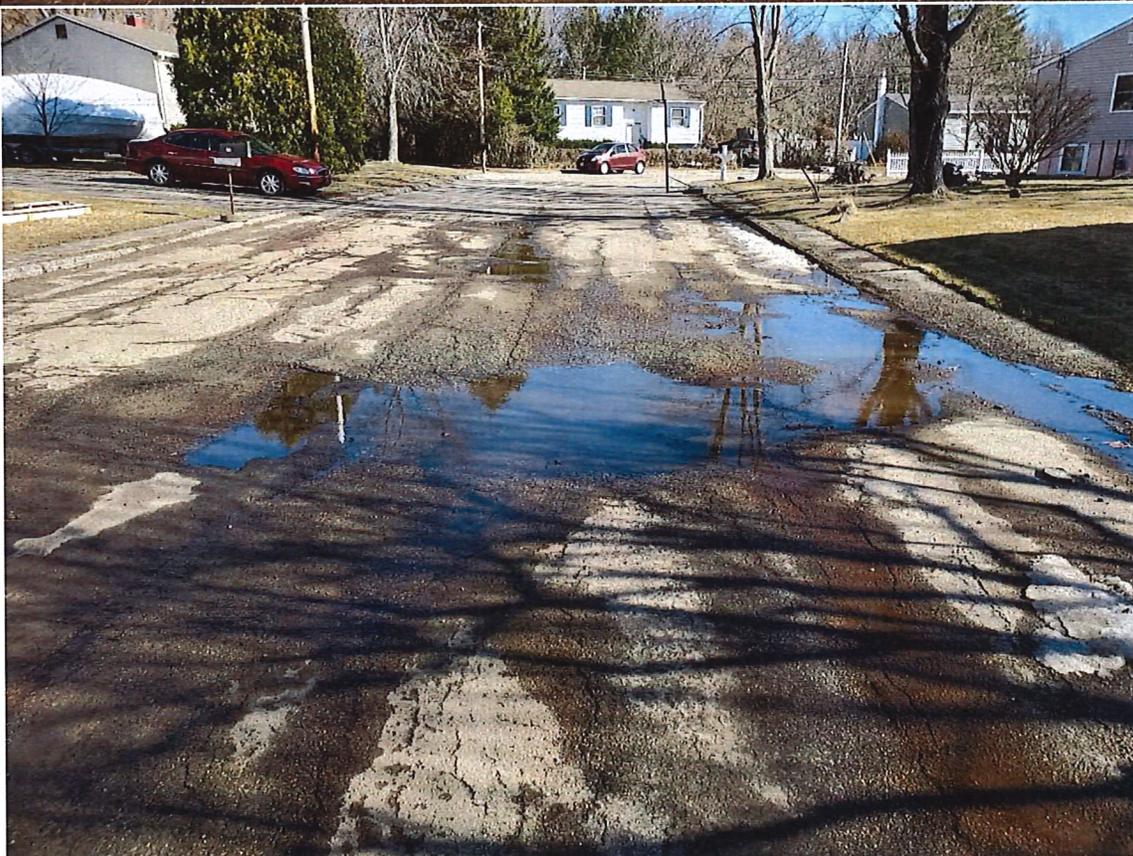
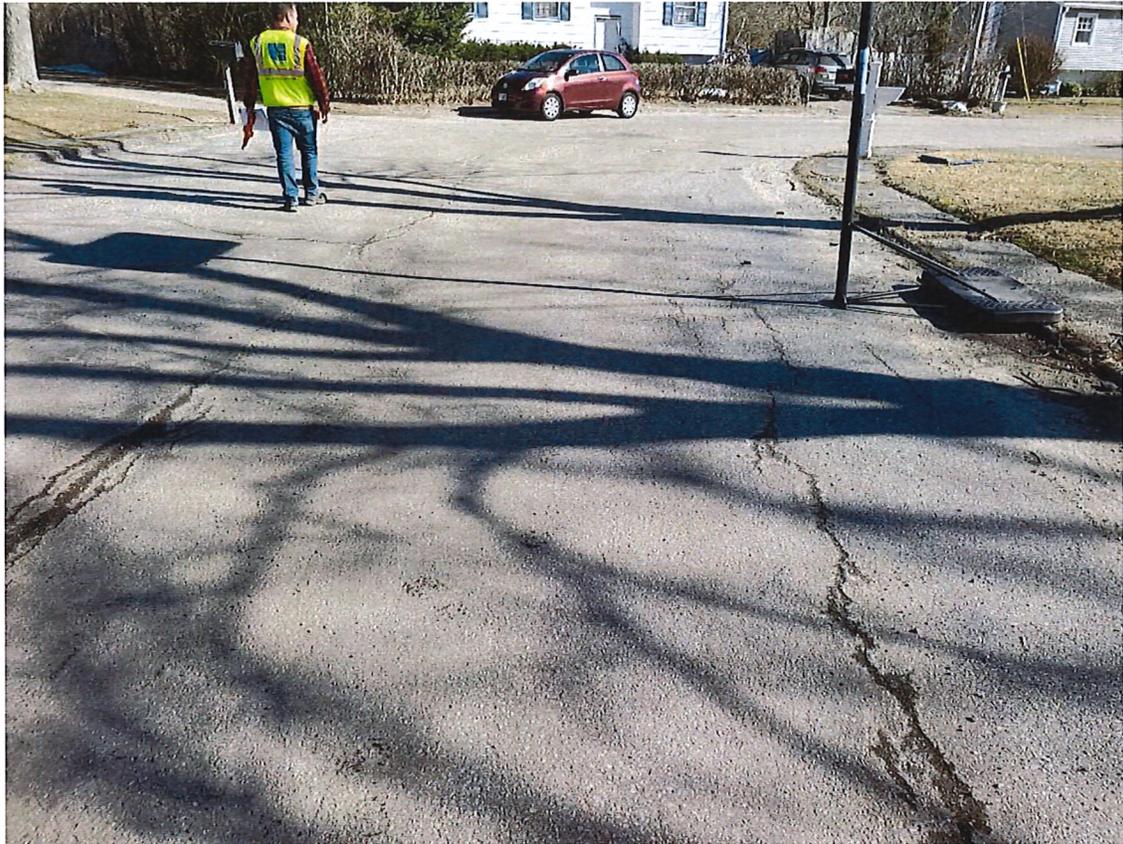
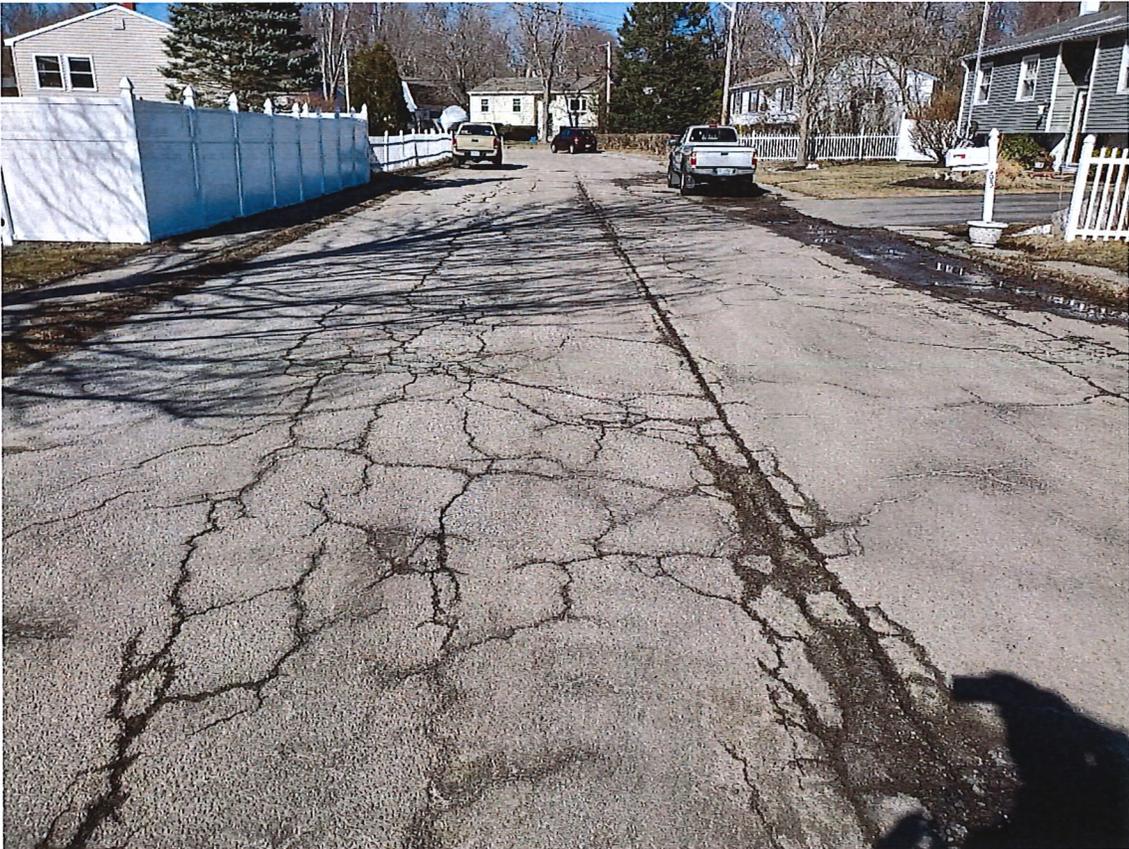
Westside Drive Northern Loop Photos

Comments: Area includes the northern Loop of Westside Pr.  
Alligator Cracking is more prevalent as well as pot holes.  
Ponding throughout, appears to be groundwater coming up. Rust  
stains on pavement in NE corner.

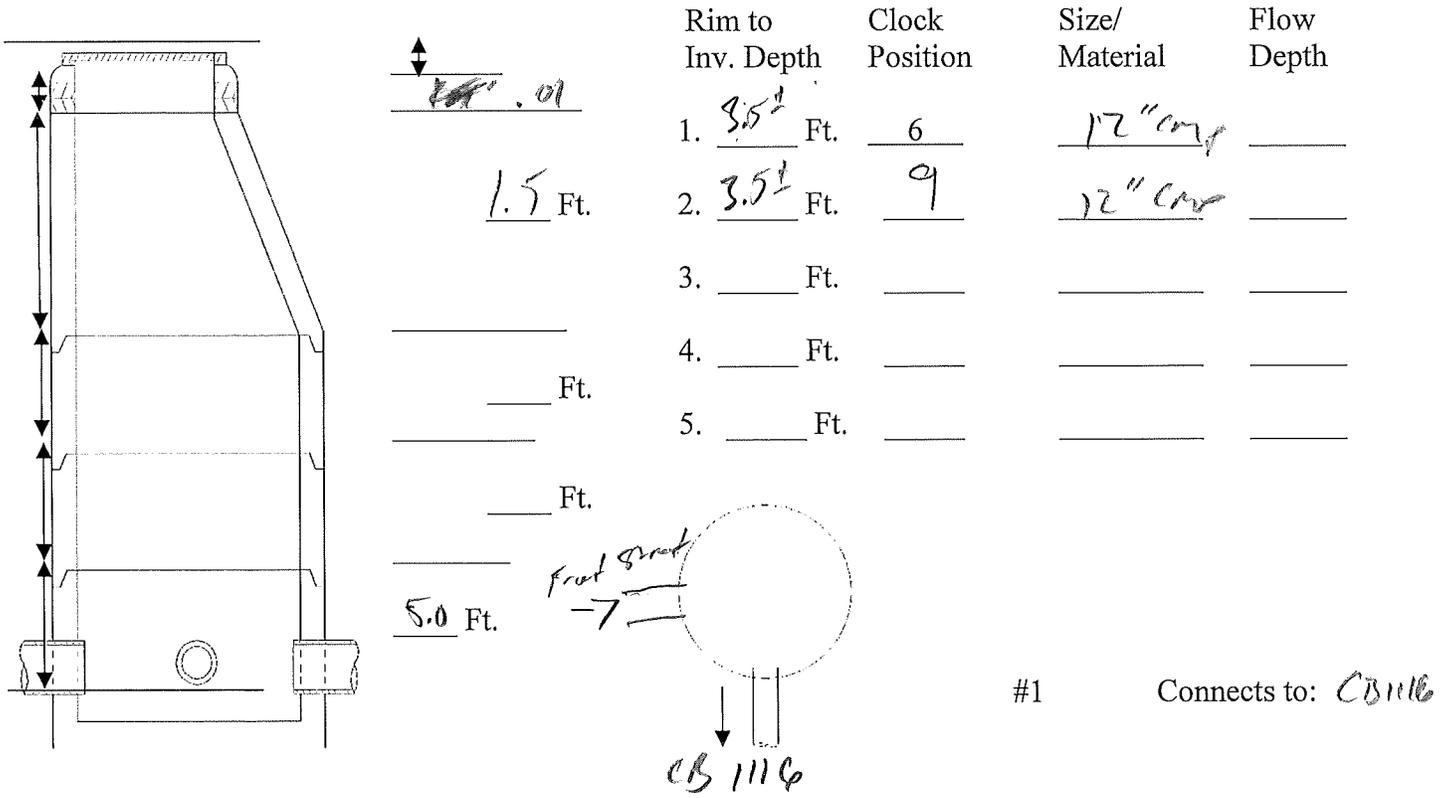
Location: Westside North ID No. CB1117  
 Dia. 4 Ft. Material: Brick / Precast By: EBW Date: 8/12/21  
 Clear Opening: \_\_\_\_\_ In. Corbel: .01' In. Frame 9 In. Potential: \_\_\_\_\_ S.F.

Notes: 1 1/2 Precast Top, Brick Base, Lower 2' not visible, Standing water in CB. SEE Survey for actual Inverts

Observations	Material	Condition Rating	Notes
Frame/Cover:	<u>AL</u>	<u>2</u>	<u>Square Grate, 1.8' x 2'</u>
Corbel:	<u>AL</u>	<u>4</u>	
Cone/Slab Top		<u>2</u>	
Walls		<u>2</u>	<u>Brick</u>
Invert/Shelf

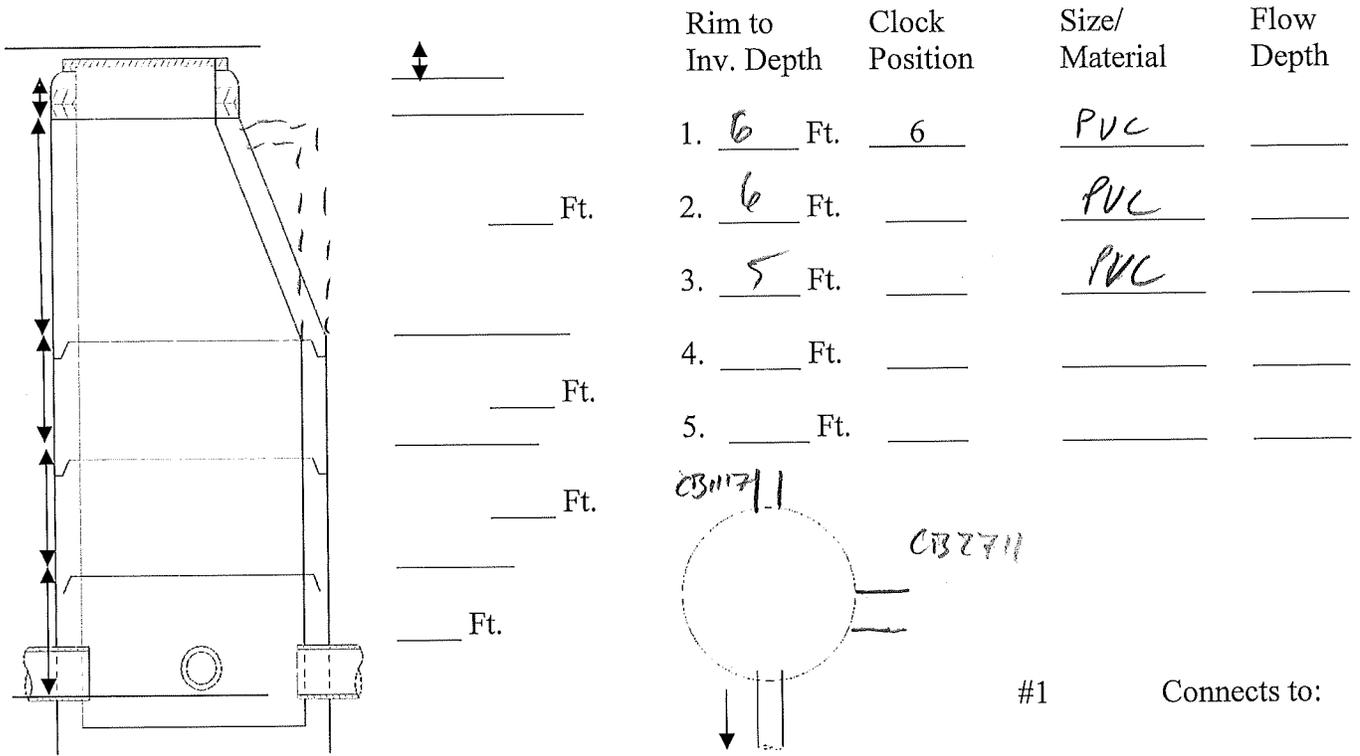
Location: West side + Laperle ID No. CB1116  
 Dia. 4 Ft. Material: Precast By: EBN Date: 3/12/21  
 Clear Opening: 24 In. <sup>Riser</sup> Corbel: 6 In. Frame 9 In. Potential: \_\_\_\_\_ S.F.  
 Notes: Flat Top CB .7' Thick Sediment 7.5' (Top), 8' to Sample  
level on top, Water @ 5.5' from rim

Observations	Material	Condition Rating	Notes
Frame/Cover:	<u>GS</u>	<u>3</u>	<u>Rusted</u>
Corbel:	<u>Precast</u>	<u>None</u>	
Cone/Slab Top	<u>Precast</u>	<u>2/3</u>	
Walls	<u>Precast</u>	<u>2/1</u>	
Invert/Shelf	<u>Precast</u>

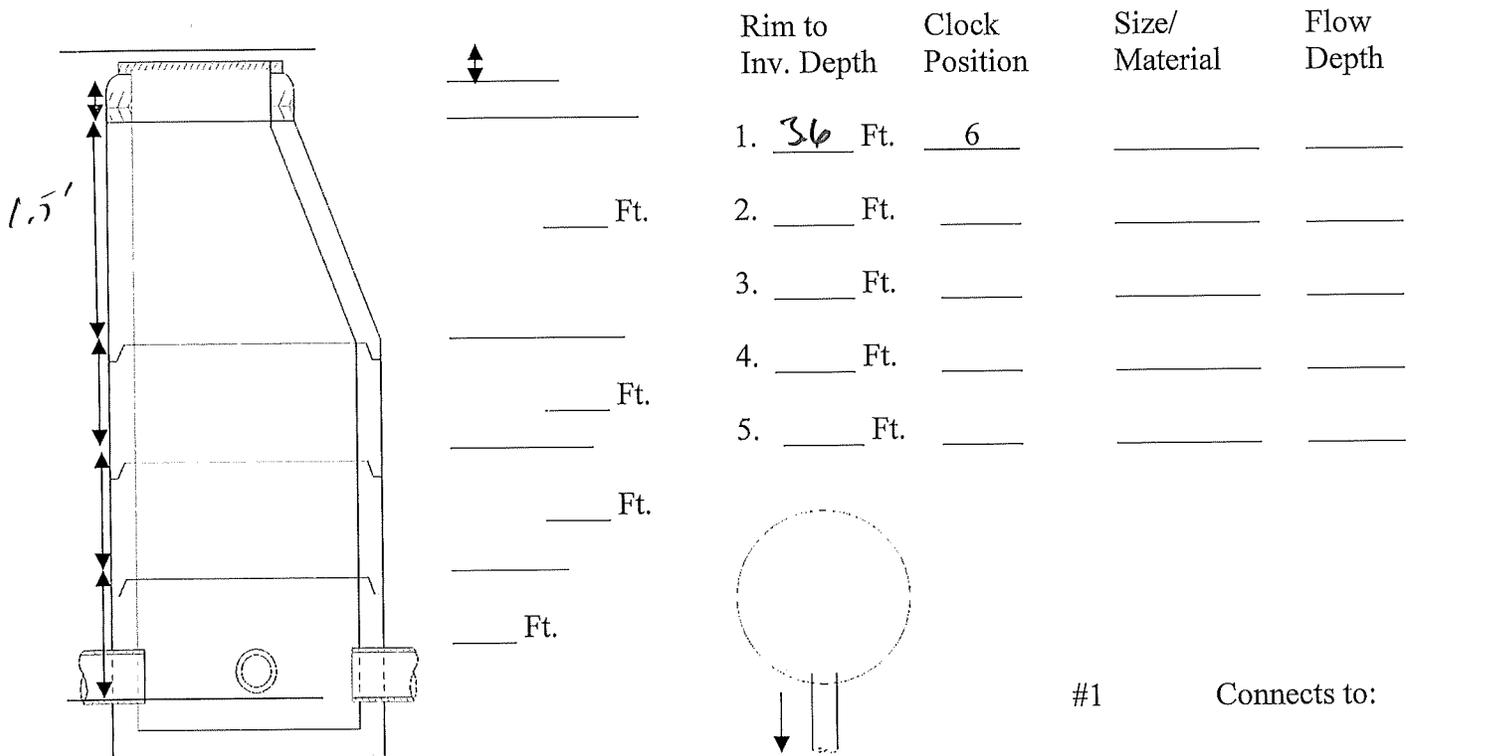
Location: Lapeere ID No. CB 2711  
 Dia. \_\_\_\_\_ Ft. Material: Precast By: EBA Date: \_\_\_\_\_  
 Clear Opening: \_\_\_\_\_ In. Corbel: .4' In. Frame .7' In. Potential: \_\_\_\_\_ S.F.

Notes: 1' Riser w/ Brick walls and possible cut in place  
Setback @ 8', Survey @ 9.5 not found

Observations	Material	Condition Rating	Notes
Frame/Cover:		<u>3</u>	
Corbel:		<u>4</u>	<u>Brick</u>
Cone/Slab Top		<u>4</u>	<u>Aggregate Visible + Missing, Cracking</u>
Walls			
Invert/Shelf

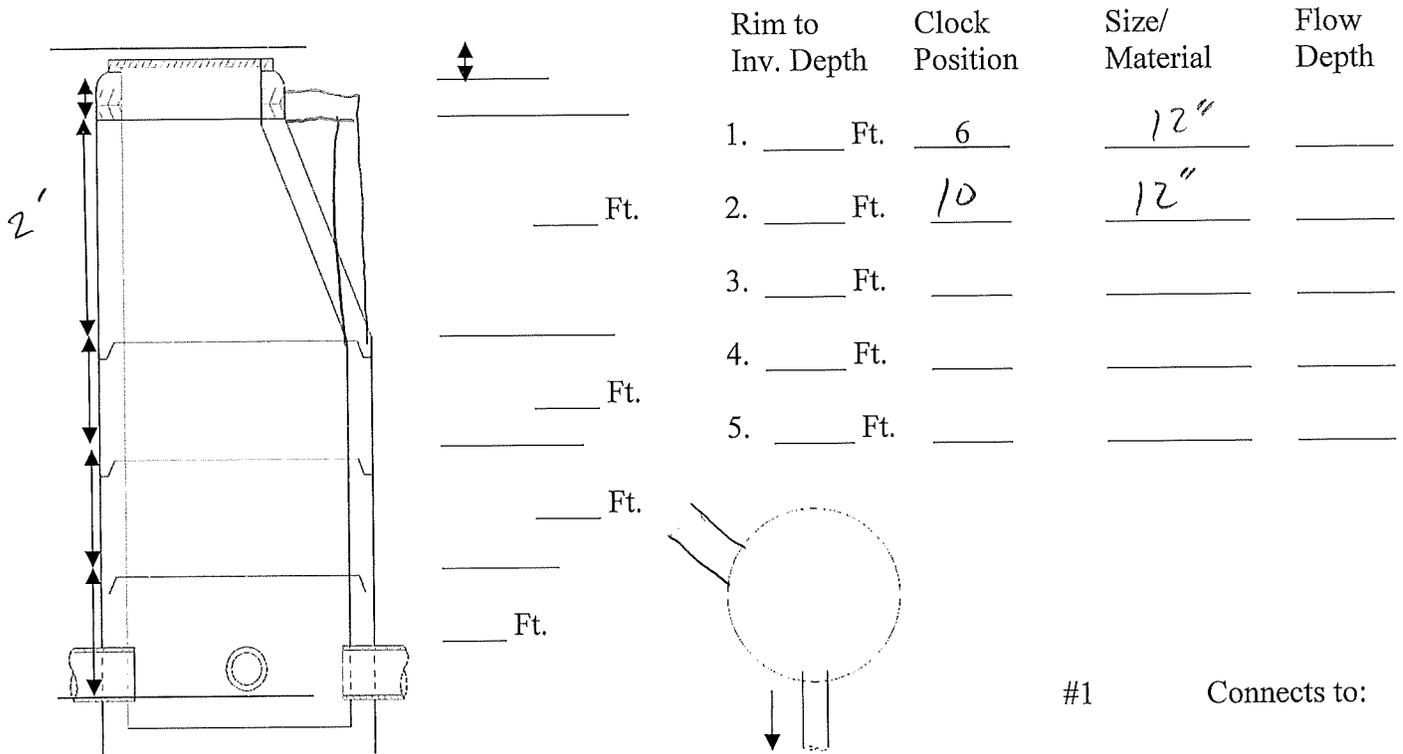
Location: Westside ID No. 1180  
 Dia. 4 Ft. Material: Precast By: EBW Date: \_\_\_\_\_  
 Clear Opening: 24 In. <sup>Riser</sup> Corbel: .5 In. Frame 4 In. Potential: \_\_\_\_\_ S.F.  
 Notes: Flat Top, Water level @ 6.6', 9' solid bottom, 2.5' sup

Observations	Material	Condition Rating	Notes
Frame/Cover:		<u>2</u>	
Corbel:		<u>None</u>	
Cone/Slab Top		<u>2</u>	
Walls		<u>2</u>	
Invert/Shelf

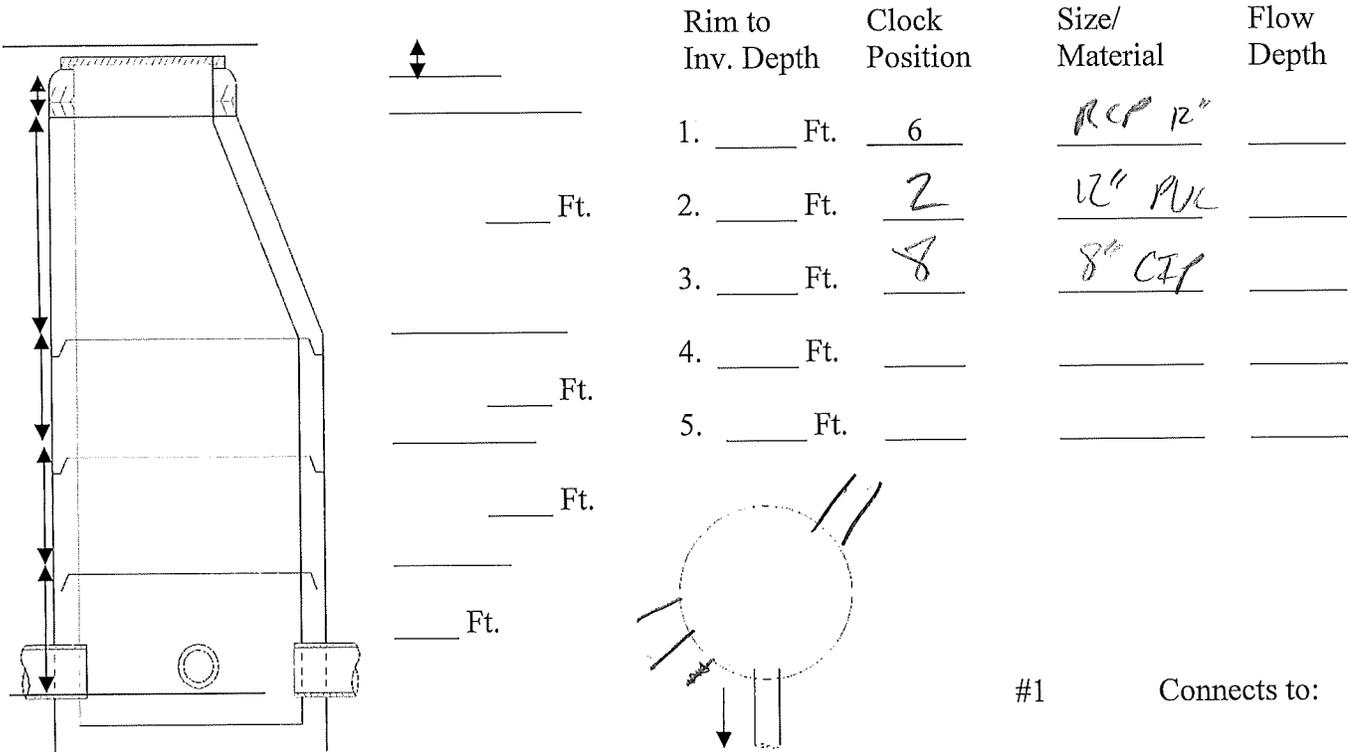
Location: Westside & Front Street ID No. 1191  
 Dia. 4 Ft. Material: Pre cast By: EBW Date: 3/12/21  
 Clear Opening: 24 In. Corbel:      In. Frame 8 In. Potential:      S.F.  
 Notes: Flat Top, Water @ 6.3', sediment @ 8' hard bottom

Observations	Material	Condition Rating	Notes
Frame/Cover:	<u>CI</u>	<u>2</u>	
Corbel:	<u>Concrete</u>	<u>4</u>	<u>Exposed stone</u>
Cone/Slab Top <u>flat</u>			
Walls		<u>4</u>	<u>Missing pieces of wall</u>
Invert/Shelf

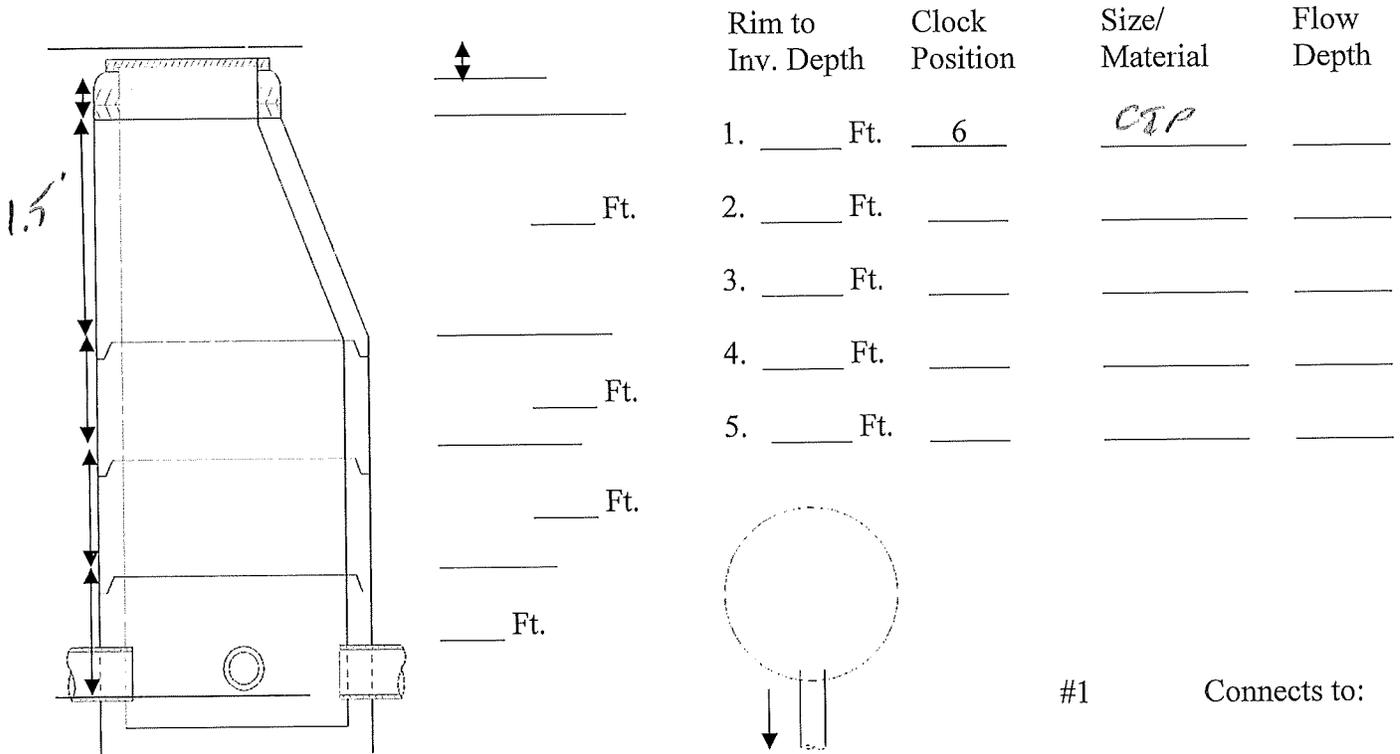
Location: Summer & Westside Drive ID No. 1618  
 Dia. 4 Ft. Material: Precast By: EBW Date: \_\_\_\_\_  
 Clear Opening: 24 In. Corbel: 6 In. Frame 9 In. Potential: \_\_\_\_\_ S.F.  
 Notes: Water @ 3.5', 6" to sediment, 6.8' to ramp

Observations	Material	Condition Rating	Notes
Frame/Cover:	CI	2	
Corbel:	Brick	3	Missing bricks
Cone/Slab Top		3	Missing Aggregate
Walls	PC	3	Aggregate Visible
Invert/Shelf

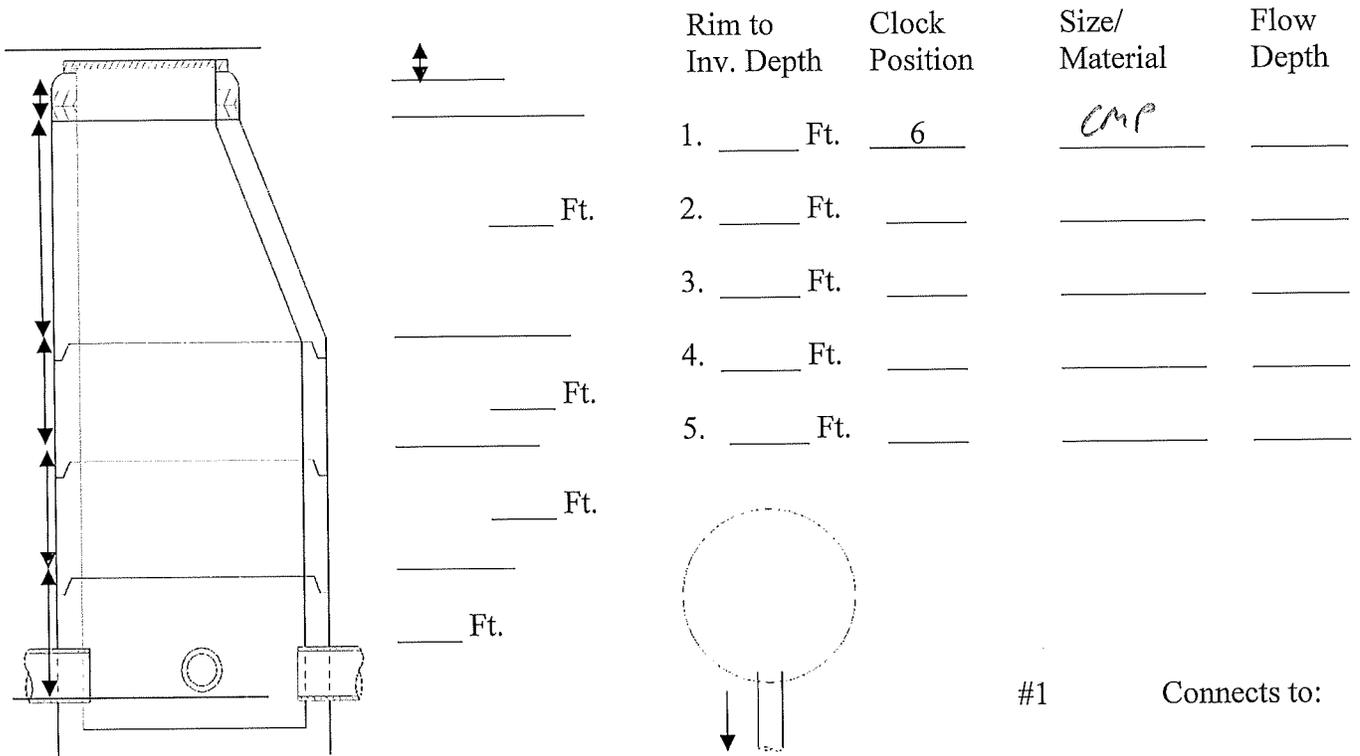
Location: Westside North + Blanche ID No. 2928  
 Dia. 4 Ft. Material: Precast By: ECN Date: \_\_\_\_\_  
 Clear Opening: \_\_\_\_\_ In. Corbel: .5 In. Frame 4 In. Potential: \_\_\_\_\_ S.F.  
 Notes: 2' Deep Inlet, Water @ 3', 4.2' to bottom

Observations	Material	Condition Rating	Notes
Frame/Cover:		4 3	
Corbel:		4	
Cone/Slab Top			
Walls		2 3	
Invert/Shelf

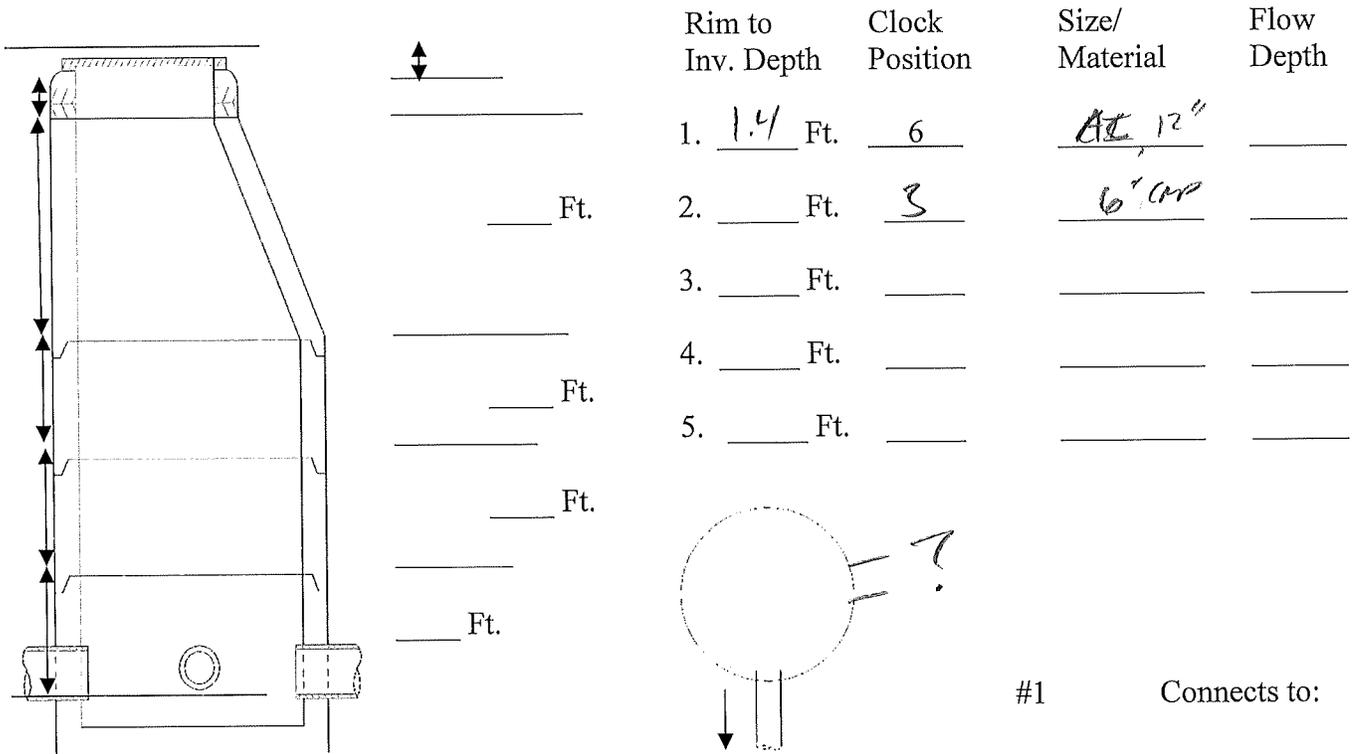
Location: Westside A. ID No. 2588  
 Dia. 4 Ft. Material: Precast By: EBN Date: \_\_\_\_\_  
 Clear Opening: 2 In. Corbel: \_\_\_\_\_ In. Frame \_\_\_\_\_ In. Potential: \_\_\_\_\_ S.F.  
 Notes: 2' Prop Inlet, 4' To bottom

Observations	Material	Condition Rating	Notes
Frame/Cover:	<u>CR</u>	<u>2</u>	
Corbel:		<u>3</u>	
Cone/Slab Top		<u>.</u>	
Walls		<u>4</u>	
Invert/Shelf
