NOTICE OF SPECIAL MEETING

48 PRESERVATION BRIEFS

Preserving Grave Markers in Historic Cemeteries

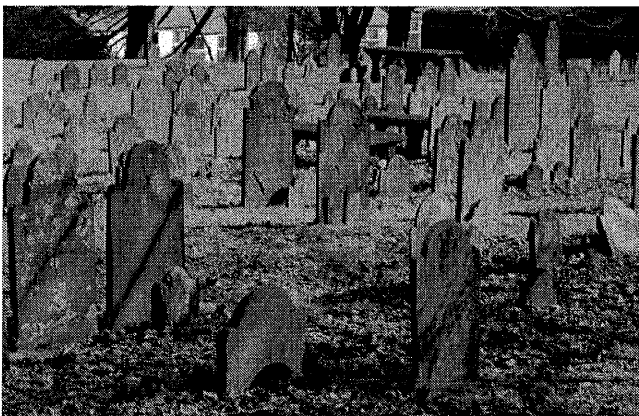
Figure 1. Sandstone and slate grave markers in the Ancient Burying Ground in New London, CT, display a variety of weathering conditions. Markers in the cemetery date from the mid-17th to the early 19th centuries. Photo: Jason Church.

While cemeteries are often considered to be perpetual, their most prominent feature—the grave markers—are not. They weather, naturally decay, often are poorly maintained and repaired and, on occasion, are vandalized (Fig. 1). Grave markers are usually noteworthy not only for their inscriptions but also for their craftsmanship. Exceptional markers are considered works of art.

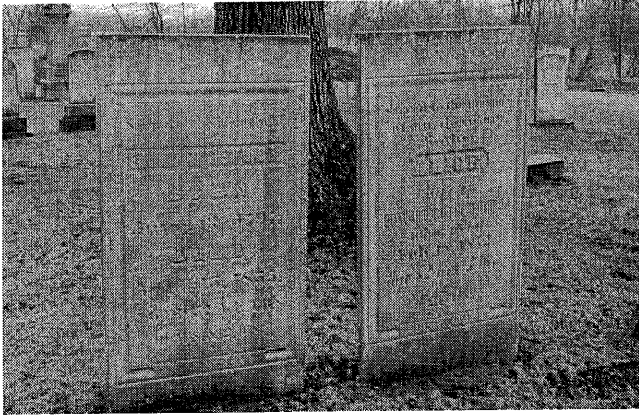
Figure 2. These mid-19th century, single-element stone grave markers in the Grove Cemetery in Bath, NY, are set in a vertical position. Photo: Jason Church.

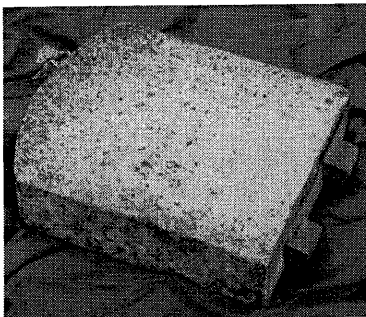
Figure 3. A multi-element grave marker from the early 19th century in the St. Michael's Cemetery, Pensacola, FL, consists of a vertical element with tabs (left image) into a slotted base (right image). Photo: Fran Gale.

Multiple-element grave markers are found in a number of different forms (Fig. 3). In the most typical form, a grave marker would consist of two stones—an upper headstone placed on top of a base stone. The upper headstone may be secured in a number of different ways to the base. In the simplest of forms, the upper stone was placed on the base, set in a bed of mortar on top of the base, or joined with pins and mortar. With a “tab-and-

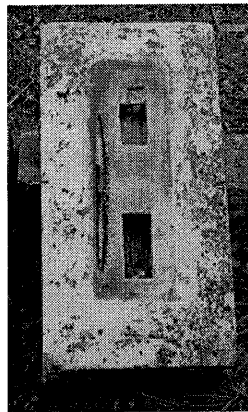
Figure 4. This sandstone table tomb, located in Cedar Grove Cemetery, New London, CT, is an engineered grave marker structure consisting of a horizontal stone tablet supported by four vertical table "legs" with a central column,. Photo: Jason Church.

Grave markers can also be engineered structures. Examples of grave marker structures include masonry arches, box tombs, table tombs, grave shelters, and mausoleums (Fig. 4). The box tomb is a rectangular structure built over the gravesite. The human remains are not located in the box itself as some believe, but rather in the ground beneath the box structure. The table tomb is constructed of a horizontal stone tablet

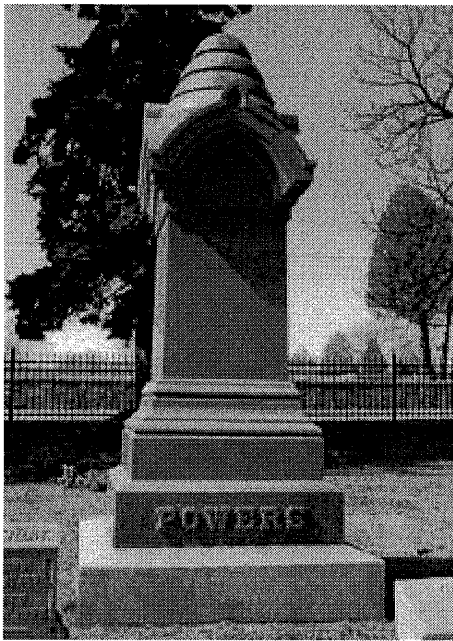
Figure 5. A variety of colors of natural stone are found in historic cemeteries, such as this pink granite marker in the Cedar Grove Cemetery, New London, CT. Photo: Jason Church.

Stone is a naturally occurring material with a wide range of properties and is available in a variety of colors (Fig. 5). Geologists classify stone according to the way in which it was formed with the three categories being igneous, sedimentary and metamorphic rock. Stone found in cemeteries is predominantly quarried, though the use of field stones is not uncommon. The mineralogy and chemical composition of stones vary. Some are composed primarily of silicate minerals; granites, sandstones, slate, and schist are examples. Other stones contain calcium carbonate with marble and limestone in this group. Mineralogy, chemical composition, and physical structure of the stone influence weathering and

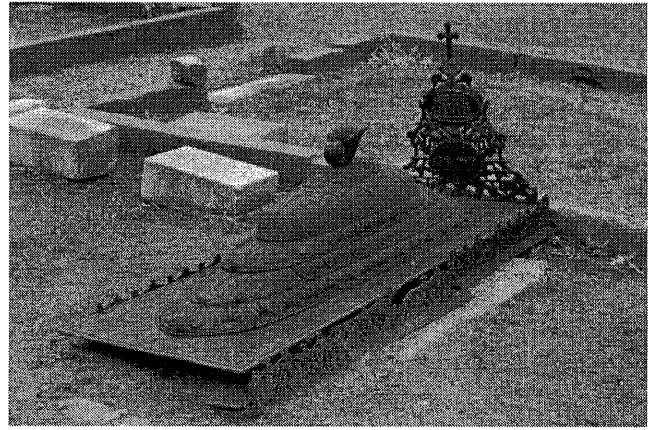
Figure 6. Decorative cast-iron grave markers like this late-19th century one in Oakland Cemetery in Shreveport, LA, are produced by heating the iron alloy and casting the liquid metal into a mold. Photo: Jason Church.

Metals are solid materials that are typically hard, malleable, fusible, ductile, and often shiny when new (Fig. 6). A metal alloy is a mixture or solid solution of two or more metals. Metals are easily worked and can be melted or fused, hammered into thin sheets, or drawn into wires. Different metals have varying physical

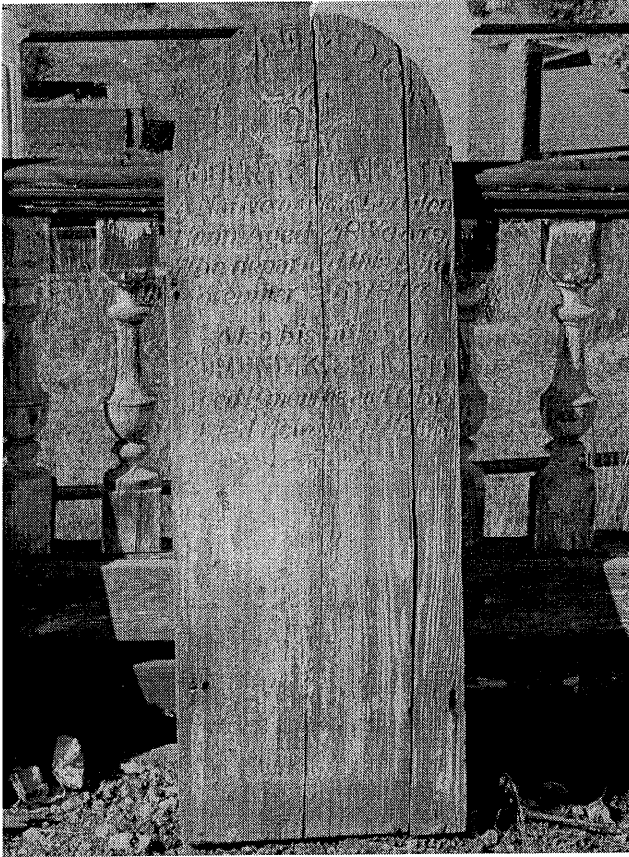
Figure 7. As shown by this 1877 marker in Silver Terrace Cemetery, Virginia City, NV, exposure to sunlight can damage wood grave markers, making the wood more susceptible to water damage and cracking. Photo: Jason Church.

appearance and influence wood properties. Wood-cell walls and cavities contain moisture. Oven drying reduces the moisture content of wood. After the drying process, the wood continues to expand and contract with changes in moisture content. The loss of water from cell walls causes wood to shrink, sometimes distorting its original shape (Fig. 7).

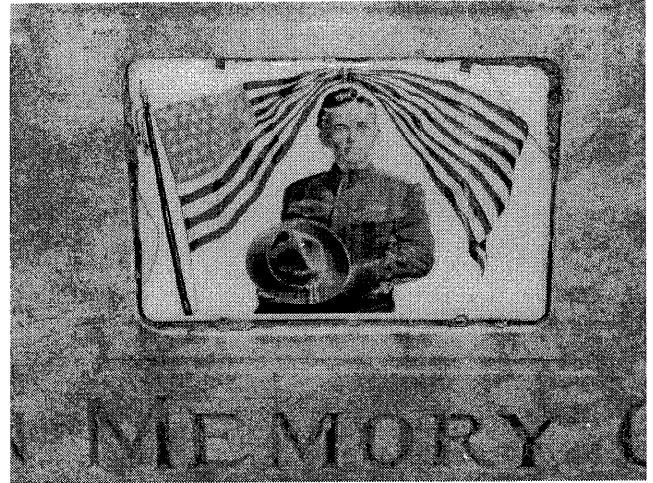
Figure 8. A fired ceramic, this cameo is set in a marble grave marker, located in Elmwood Cemetery, Memphis, TN. Different materials may require different conservation approaches. Photo: Mary Striegel.

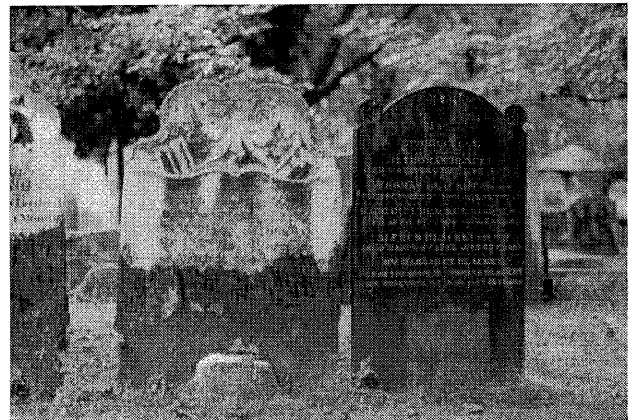
Figure 9. The limestone and sandstone grave markers in this historic cemetery have different weathering processes. On the left, the limestone shows surface loss in areas exposed to rainwater and gypsum crust formation below. The sandstone marker on the right displays uniform soiling, but surface hardening may be occurring. Photo: Fran Gale.

All grave marker materials deteriorate when they are exposed to weathering such as sunlight, wind, rain, high and low temperatures, and atmospheric pollutants (Fig. 9). If a marker is composed of several materials, each may have a different weathering rate. Some weathering processes occur very quickly, and others gradually affect the condition of materials. Weathering results in deterioration in a variety of ways. For example, when exposed to rainwater some stones lose surface material while others form harder outer crusts that may detach from the surface.

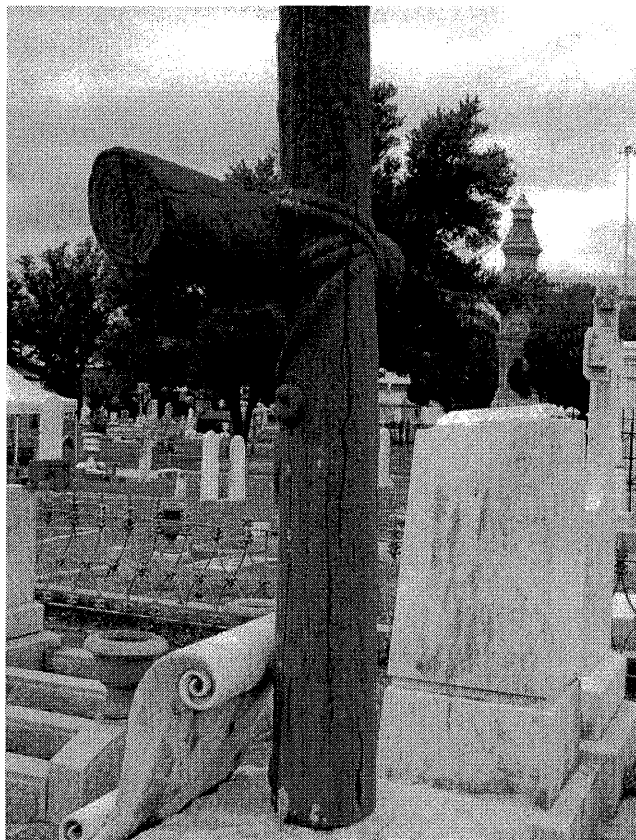
Figure 10. The sandstone cross (carved to look like wood) in this grave marker in St. Michael's Cemetery in Pensacola, FL, provides an example of inherent vice – the severe delamination affecting the sandstone has occurred along its natural bedding planes. Photo: Fran Gale.

The term "inherent vice" is used to describe a material with a naturally occurring problem that leads to premature deterioration (Fig. 10). An example of this problem is marble that has cracked due to natural locked-in stresses. Inherent vice also describes grave markers that are composed of incompatible materials, where decay is accelerated in one or both materials because of chemical interactions caused by their close proximity. An example is the galvanic corrosion that occurs when dissimilar metals, such as copper and iron, are in contact and exposed to moisture.

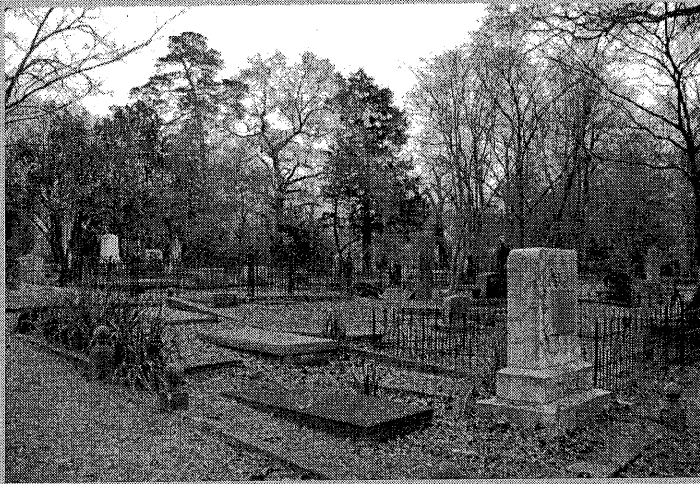
Figure A. Cemeteries are cultural landscapes made up of a variety of features. Grave markers are but one component of cemeteries that also include walkways, drives, fences, coping, trees, shrubs, and other vegetation. Each component adds to the understanding of the cemetery landscape. Photo: Debbie Dietrich Smith.

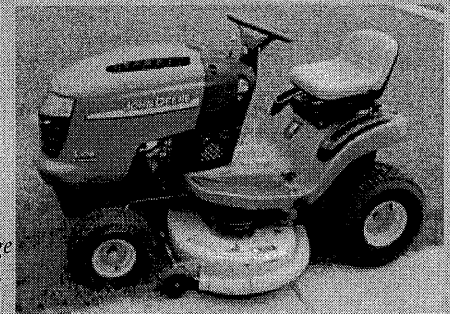
Figure B. A pool 'noodle' can be fitted to the deck of a lawnmower to prevent damage to grave markers. Photo: Debbie Dietrich Smith.

Regarding lawn care, historic cemeteries were not designed for today's large riding lawnmowers, yet this is the mower of choice for many cemeteries, as mowing is one of the most time-consuming and costly maintenance tasks generally undertaken. Mowing between tight spots with a large riding mower deck is destined to cause damage. Best practices include using a smaller, push mower between particularly sensitive features, and outfitting riding mower decks with protective bumpers. Low-cost options include using fire hose padding or a foam swimming 'noodle' (Fig. B). Additional damage is caused by riding over low stones or coping, especially when the blade height is set low. If rolling over these features is unavoidable, many riding mowers have a hand-control adjustment to temporarily raise and lower the blade height.

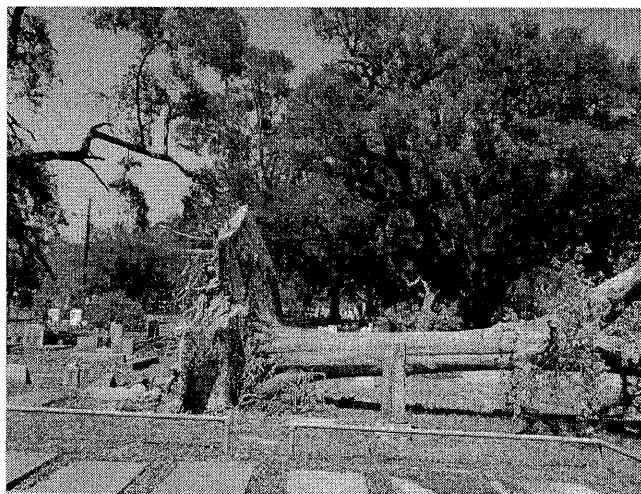
Figure 11. Woody vegetation can damage grave markers and pose a risk to visitors unless well managed and maintained. Photo: Jason Church.

Woody vegetation can damage grave markers in a variety of ways (Fig. 11). Trees, bushes, and vines can shade grave markers, extending the time that the markers are exposed to moisture. Tendrils and roots may burrow into mortar joints and openings, causing mechanical damage and large plants may lift up or shift markers. Even leaves and twigs, when allowed to collect on the ground near grave markers, can affect water drainage and evaporation (Fig. 12).

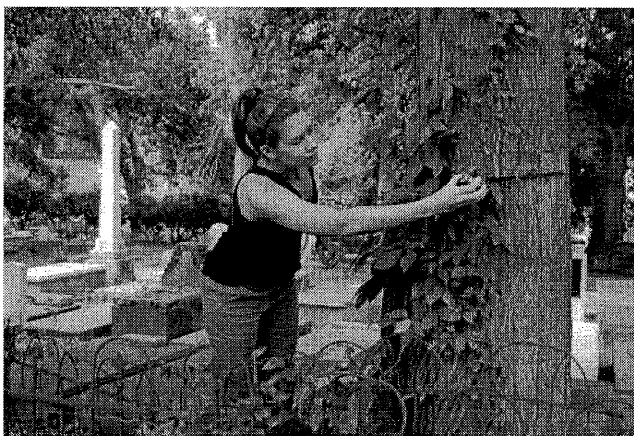
Figure 12. A cemetery professional undertakes a tree inventory in American Cemetery, Natchitoches, LA, to determine the health of trees in the cemetery. Management decisions for trimming or removal are based on the inventory. Photo: Debbie Dietrich Smith.

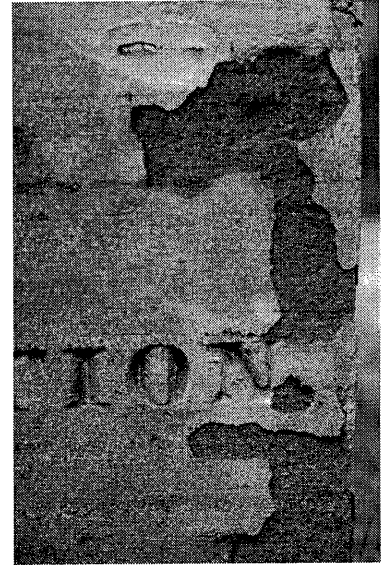
Figure 13. The impervious coating used to "protect" this sandstone grave marker trapped moisture within the stone, eventually resulting in deterioration and surface loss. Photo: Fran Gale.

Repointing masonry grave markers using Portland cement mortars that are harder than historic mortars often results in accelerated deterioration of the masonry material. Mortar should be softer than the adjacent masonry, enabling trapped moisture to migrate out, and serve as the sacrificial material when cracking occurs to relieve excessive stress. Problems also result when using impervious "protective" coatings that can trap moisture within the masonry, resulting in damage during wet/dry and freeze/thaw cycles (Fig. 13).

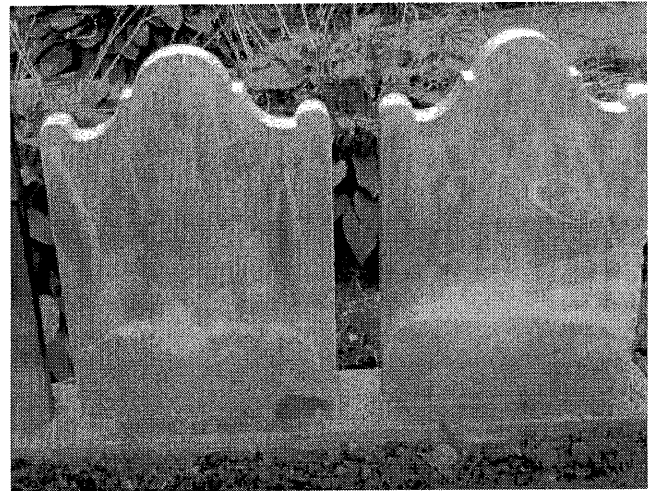
Figure 14. High-pressure water washing can damage grave markers. The photograph shows "wand marks" on the headstones produced by inappropriate pressure washing. Photo: Jason Church.

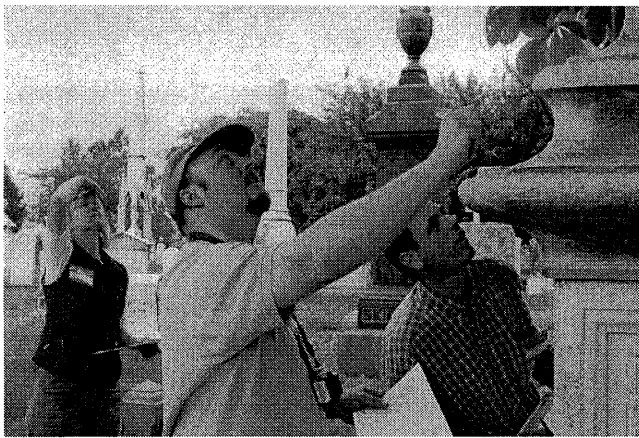
Figure 15a. Condition surveys are undertaken to document current conditions, determine safety issues, and plan both emergency stabilization and future treatment plans. There are a variety of survey forms available that can be tailored to the specific cemetery. Photo: Mary Striegel.

Depending upon the size of the cemetery and funding available, the initial assessment may be carried out by a team consisting of cemetery staff, a materials conservator, and, where necessary, an architect or structural engineer for cases involving large monuments and mausoleums (Figs. 15a and 15b). For smaller cemeteries without large monuments and mausoleums, and where funding is problematic, volunteers can be trained to prepare a condition assessment under the guidance of an experienced individual.

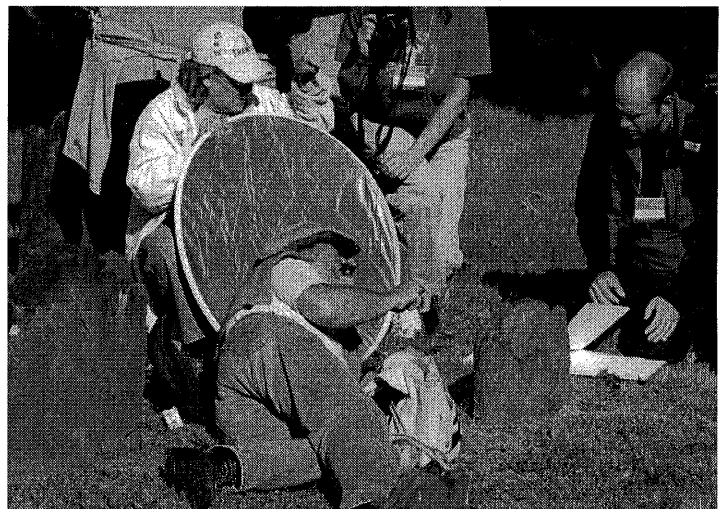
Figure 15b. Photographs are used to document the condition of the grave marker as part of a condition assessment. Photo: Fran Gale.

A tool kit for the condition assessment may include binoculars, digital camera, magnifying glass, measuring tape, clipboard, carpenter's rule, level, magnet, and flashlight. For large monuments, a ladder or aerial lift may be required. Photographs of each marker, including overall shots and close-up details, are an essential part of the documentation process. Photo logs are helpful for

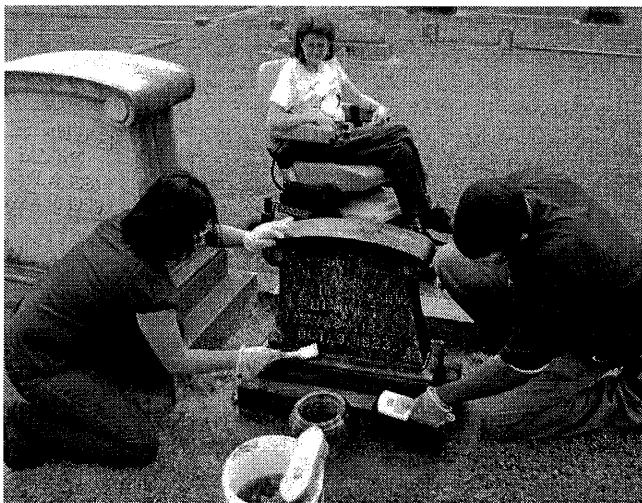
Figure 17. Volunteers can undertake cleaning of grave markers once they have received initial training. Cleaning methods may include wetting the stone, using a mild chemical cleaner, gently agitating the surface with a soft bristle brush, and thoroughly rinsing the marker with clean water. Photo: Jason Church.

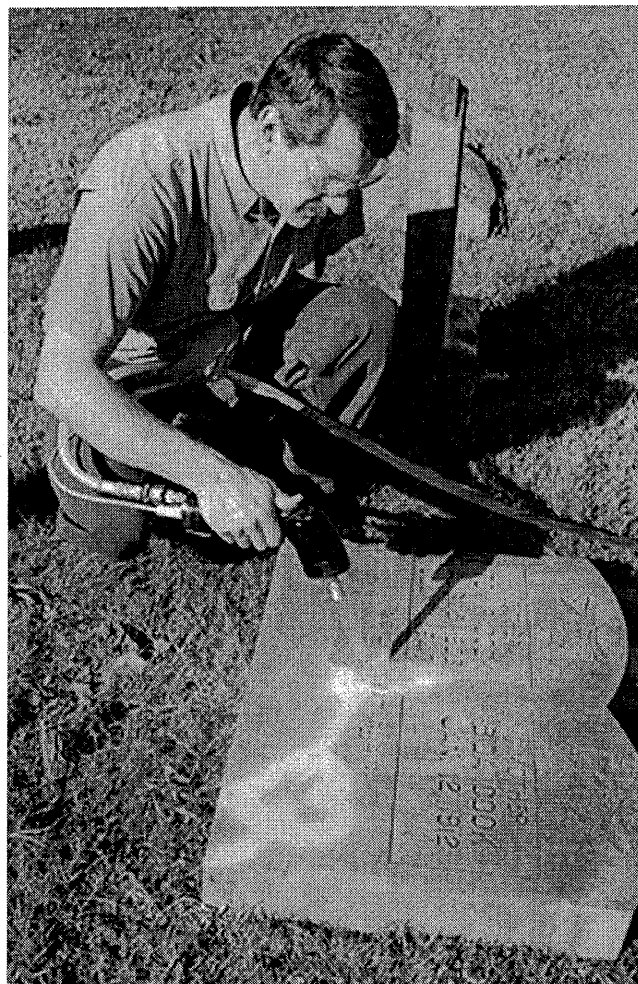
Figure 18. Graffiti is carefully removed using a low-pressure dry-ice misting instrument. Photo: Jason Church.

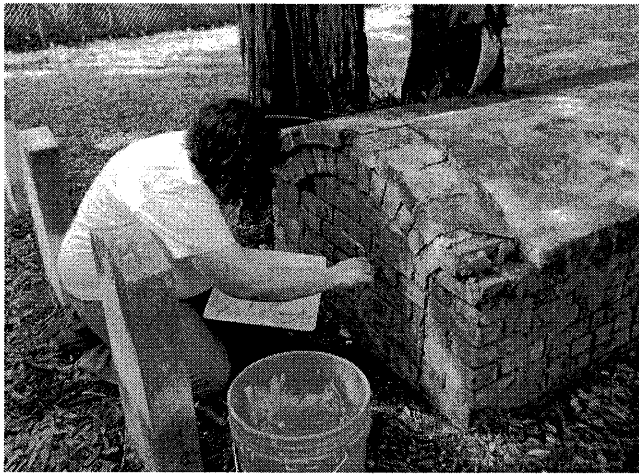
Figure 19. Masonry markers like this box tomb may require the repointing of mortar joints. It is important to use a mortar that is softer than the historic brick. In this case a conservator uses a lime putty-based mortar to repoint. Photo: Jason Church.

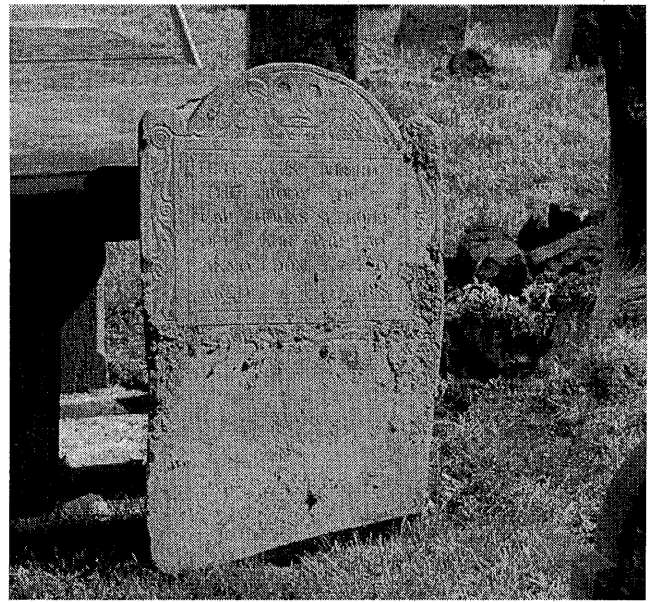
Figure 20a. This slate grave marker in the Ancient Burying Ground in Hartford, CT, is a ground-support stone. Resetting requires digging a hole that will hold the base of the stone and then compacting the soil at the bottom of the hole by hand. Photo: Fran Gale.

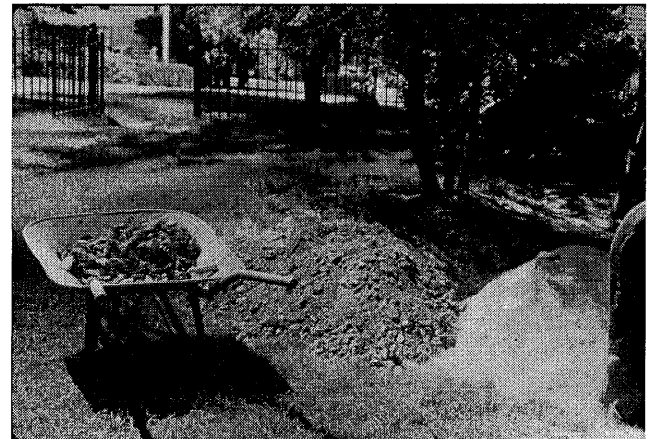
Figure 20b. To facilitate drainage, crushed stone, gravel, and sharp sand line the hole and are hand-tamped around the stone after placement. Photo: Fran Gale.

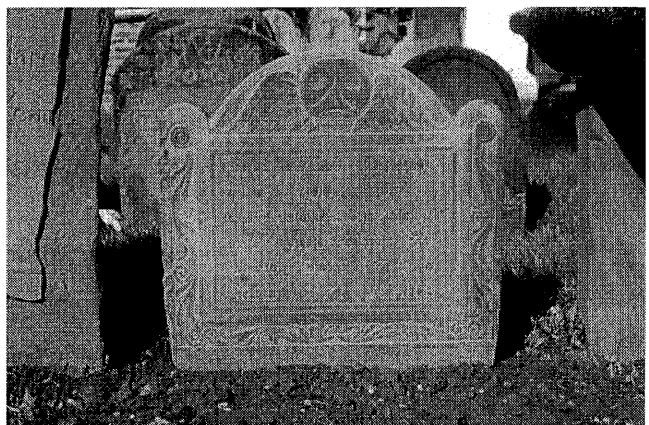
Figure 20c. The reset ground-supported grave marker should be level and plumb. Photo: Fran Gale.

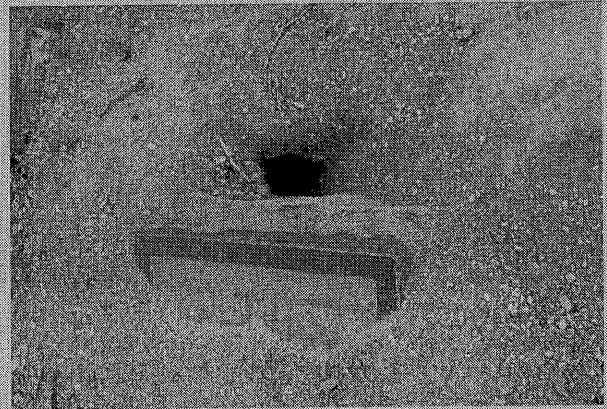
Figure C. Gophers and other burrowing animals produce uneven ground and holes that are trip and falling hazards to visitors and staff of historic cemeteries. Photo: Jason Church.

Trip and falling hazards include uneven ground, holes, open graves, toppled grave markers, fallen tree limbs, and other debris (Fig. C). Sitting, climbing, or standing on a grave marker should be avoided since the additional weight may cause

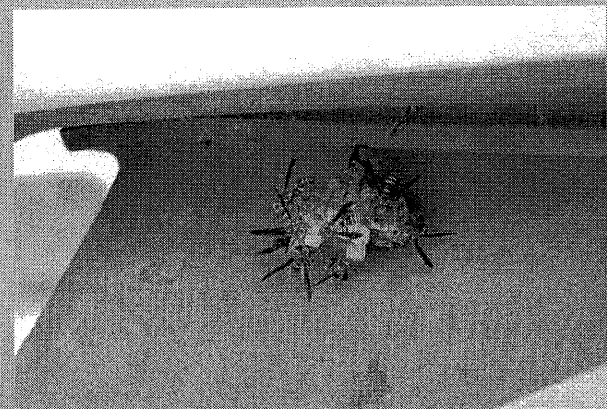
Figure D. Yellow jackets that are nesting below the projecting molding of this grave marker pose a hazard to visitors and staff because, if disturbed, they will vigorously defend their nest. Yellow jacket, paper wasp and hornet nests should be removed from grave markers by trained staff or specialists. Photo: Jason Church.

Snakes, wasps, and burrowing animals inhabit historic cemeteries (Fig. D). Snakes sun on warm stones and hide in holes and ledges, so it is important to be able to identify local venomous snakes. An appropriate venomous snake management plan should be in place, and

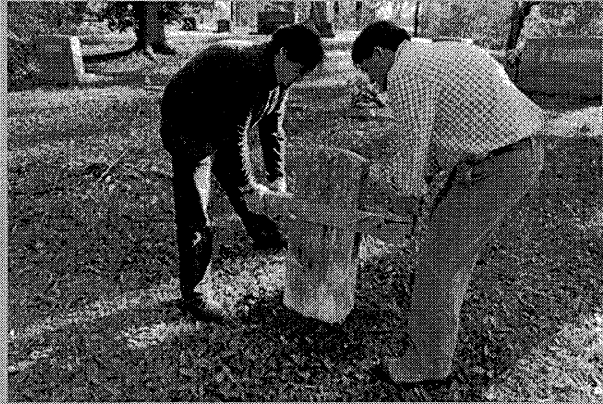
Figure E1. The simple wooden clamp system allows two people to safely lift a marble grave marker. Photo: Sarah Jackson.

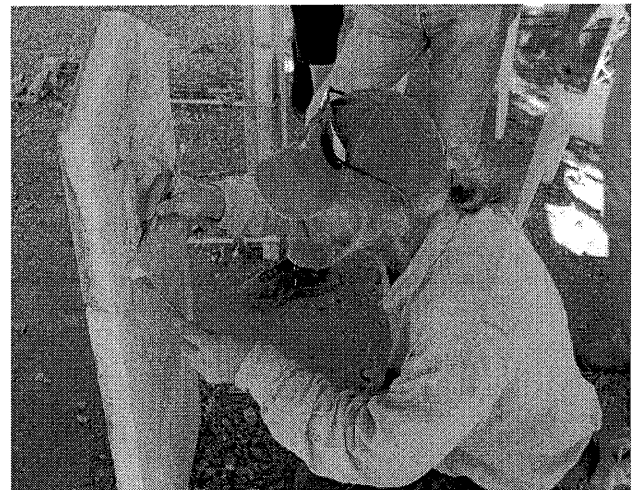
Figure 21. Cracks in a stone marker should be filled to keep water and debris out and prevent the crack from becoming larger. A patching mortar is designed to be used, in this case, with historic marble. Photo: Mary Striegel.

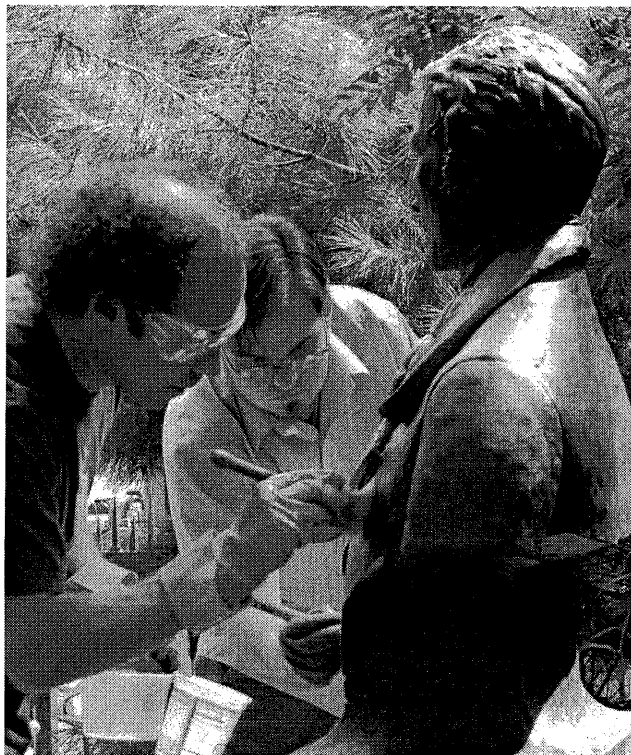
Figure 22. A protective coating must be maintained on metal elements. Wax or lacquer coatings help preserve the bronze patina and slow corrosion. Conservators apply a microcrystalline wax to this bust at St. Mark's Church in-the-Bowery, New York, NY. Photo: John Scott.

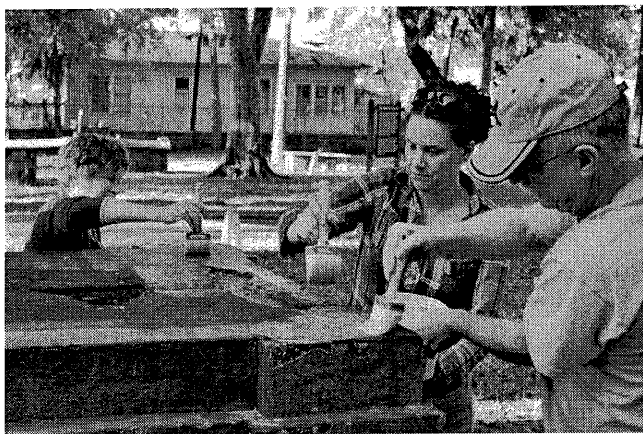
Figure 23. Limewash is a breathable coating sometimes used to protect the surface of the grave marker and provide a decorative finish. Limewash is applied by brush in five to eight thin coats (with each coat about the consistency of skim milk). The surface is allowed to slowly dry between coats. Sometimes the surface is covered by damp burlap to slow the drying process. Photo: Sarah Jackson.

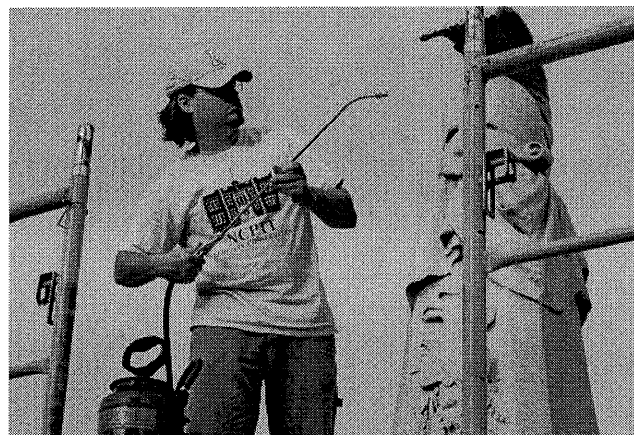
Figure 24. A severely deteriorating monument or grave marker can be treated with a stone consolidant. The treatment is usually applied using a spray system. The consolidant soaks into the stone and replaces mineral binders that hold the stone together. On-site and laboratory testing and evaluation are performed prior to using this non-reversible type of treatment. Photo: Lucas Flickinger.
