Re: Ioka Theater Marquee

I visited the property on May 28, 2020 to view the overall condition and structural integrity of the existing marquee.

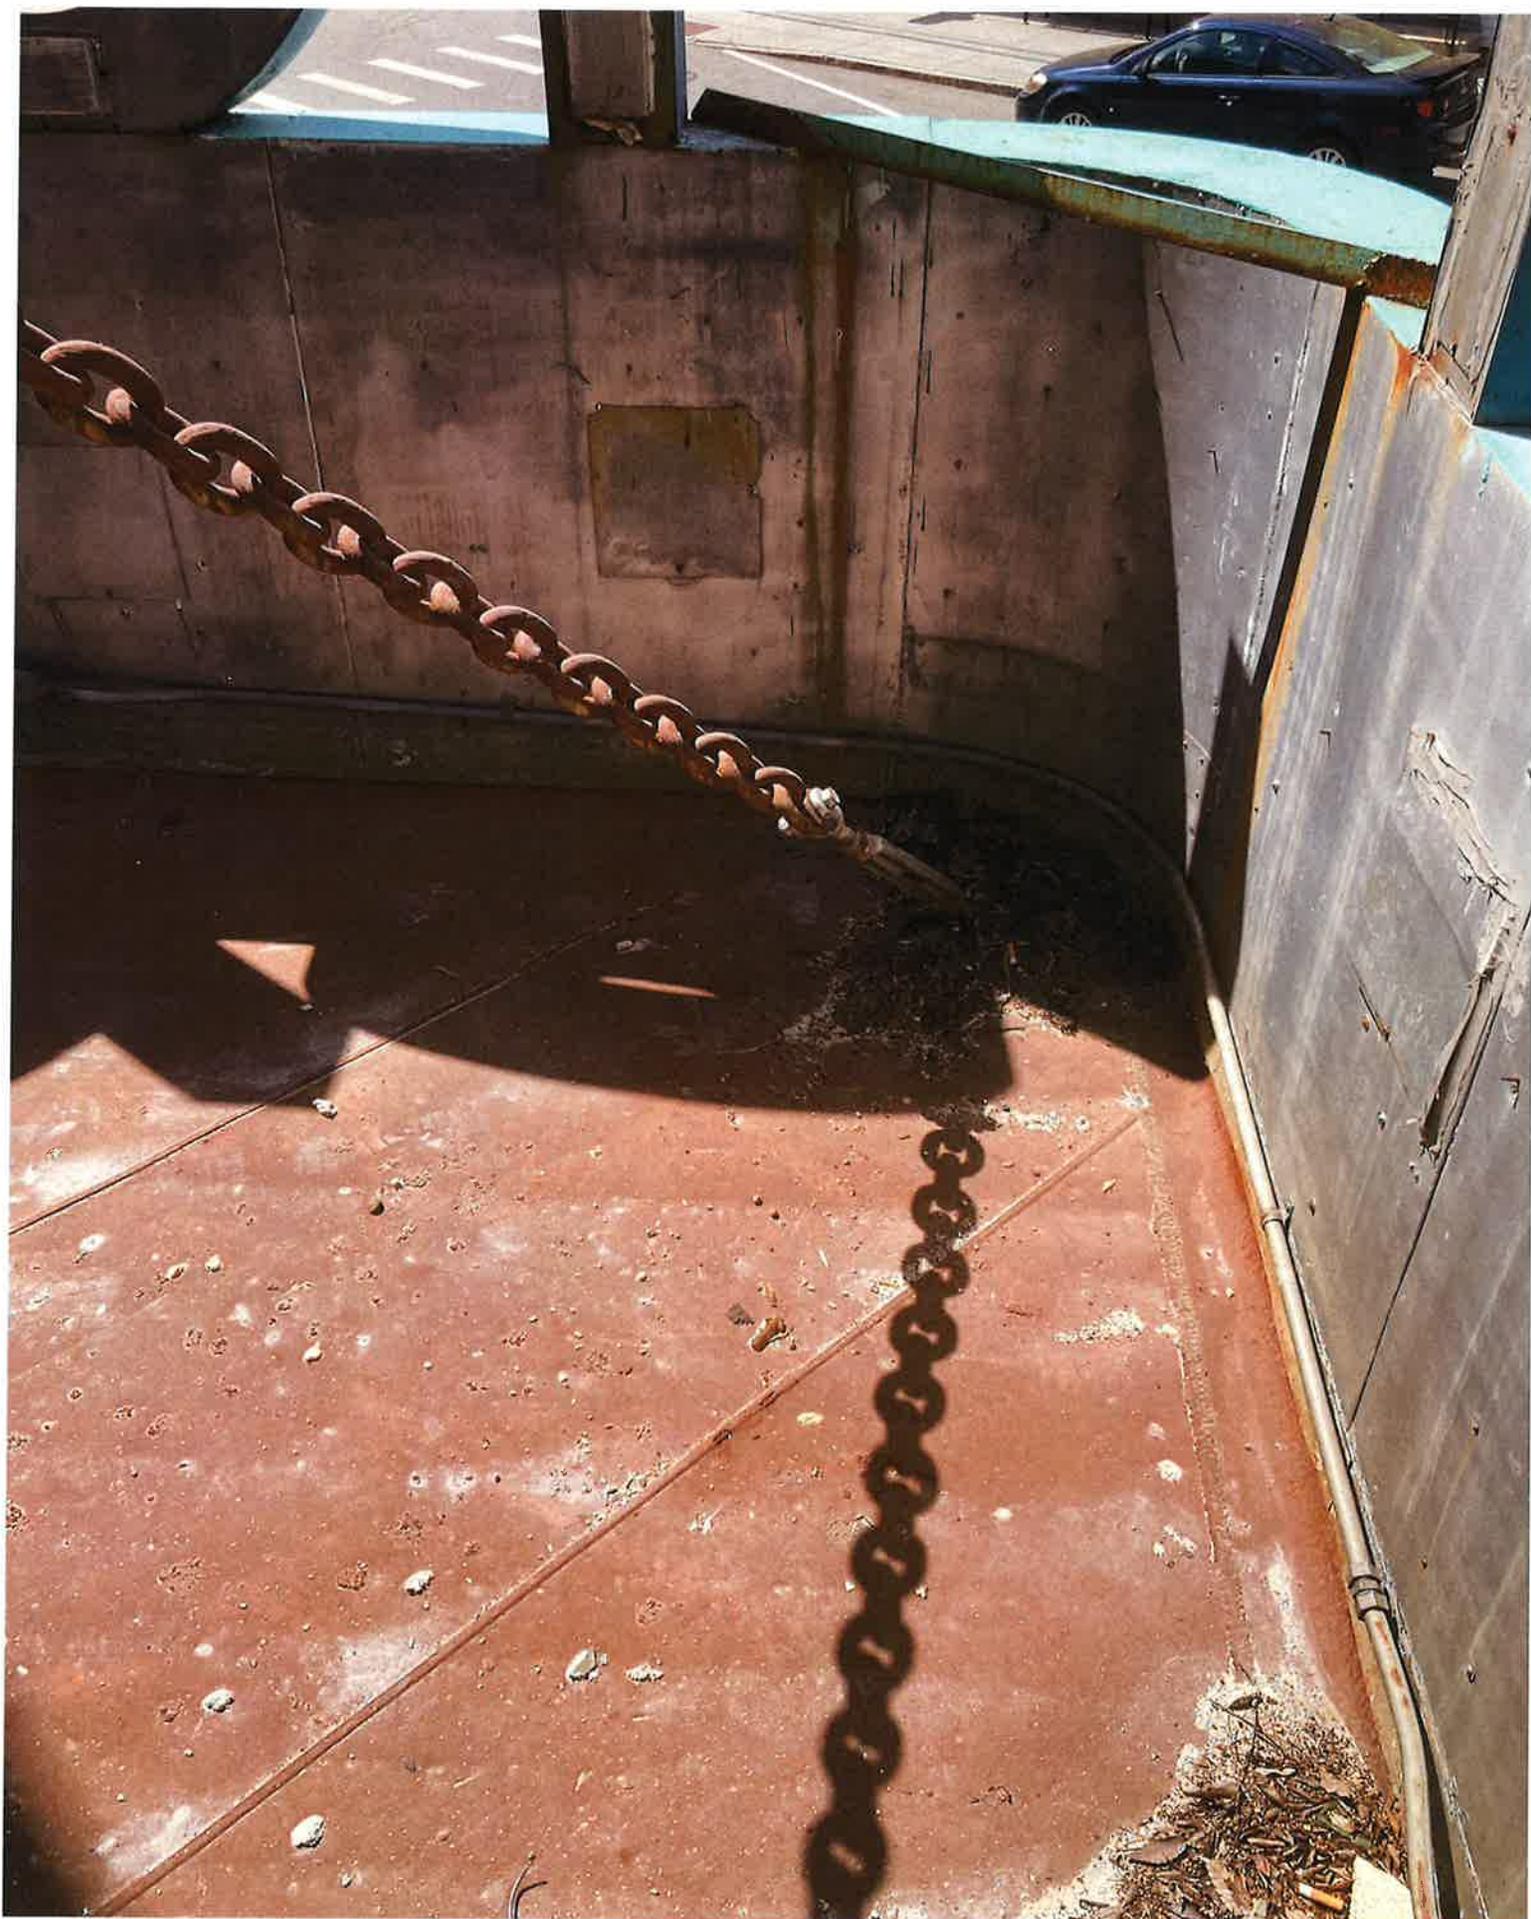
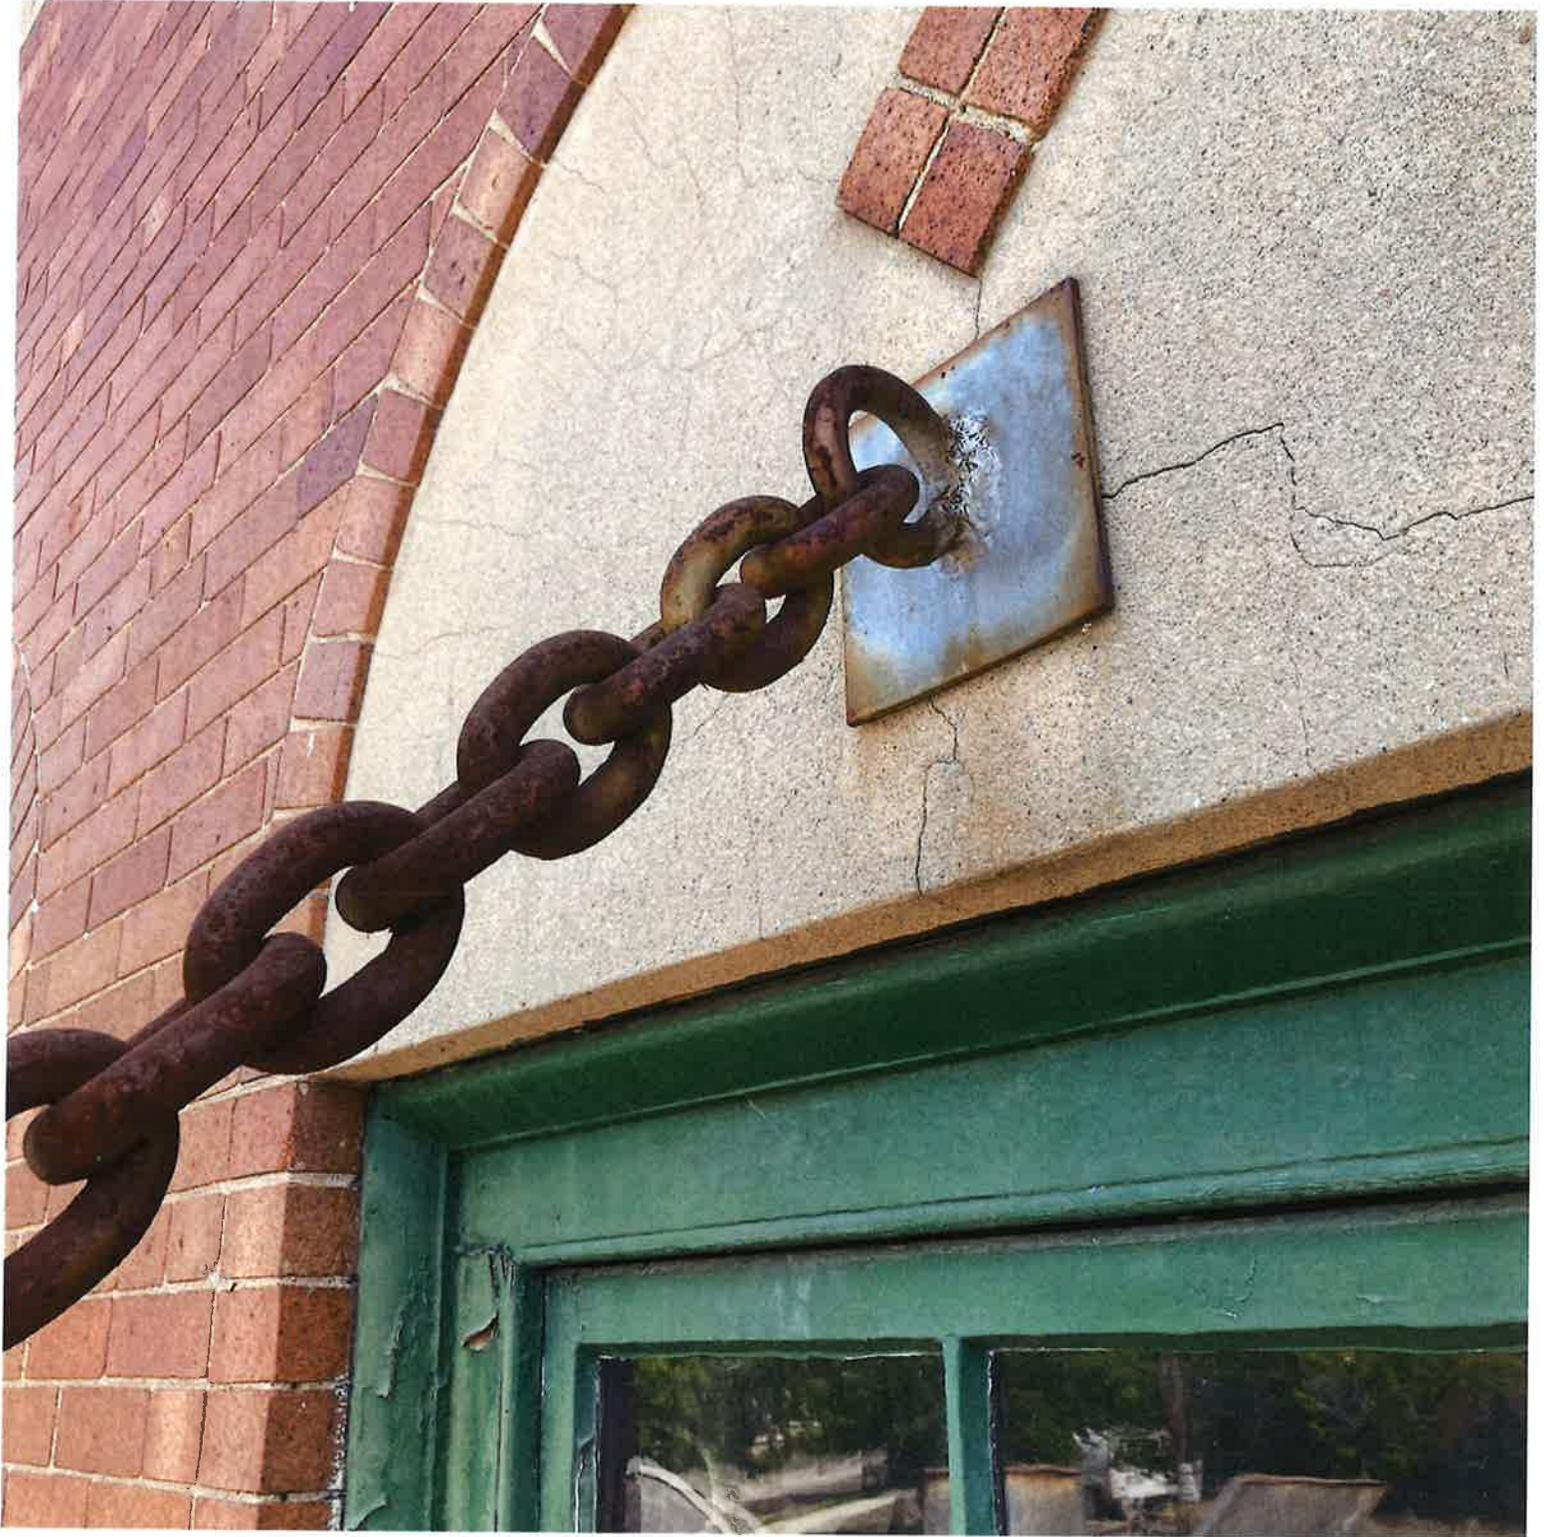
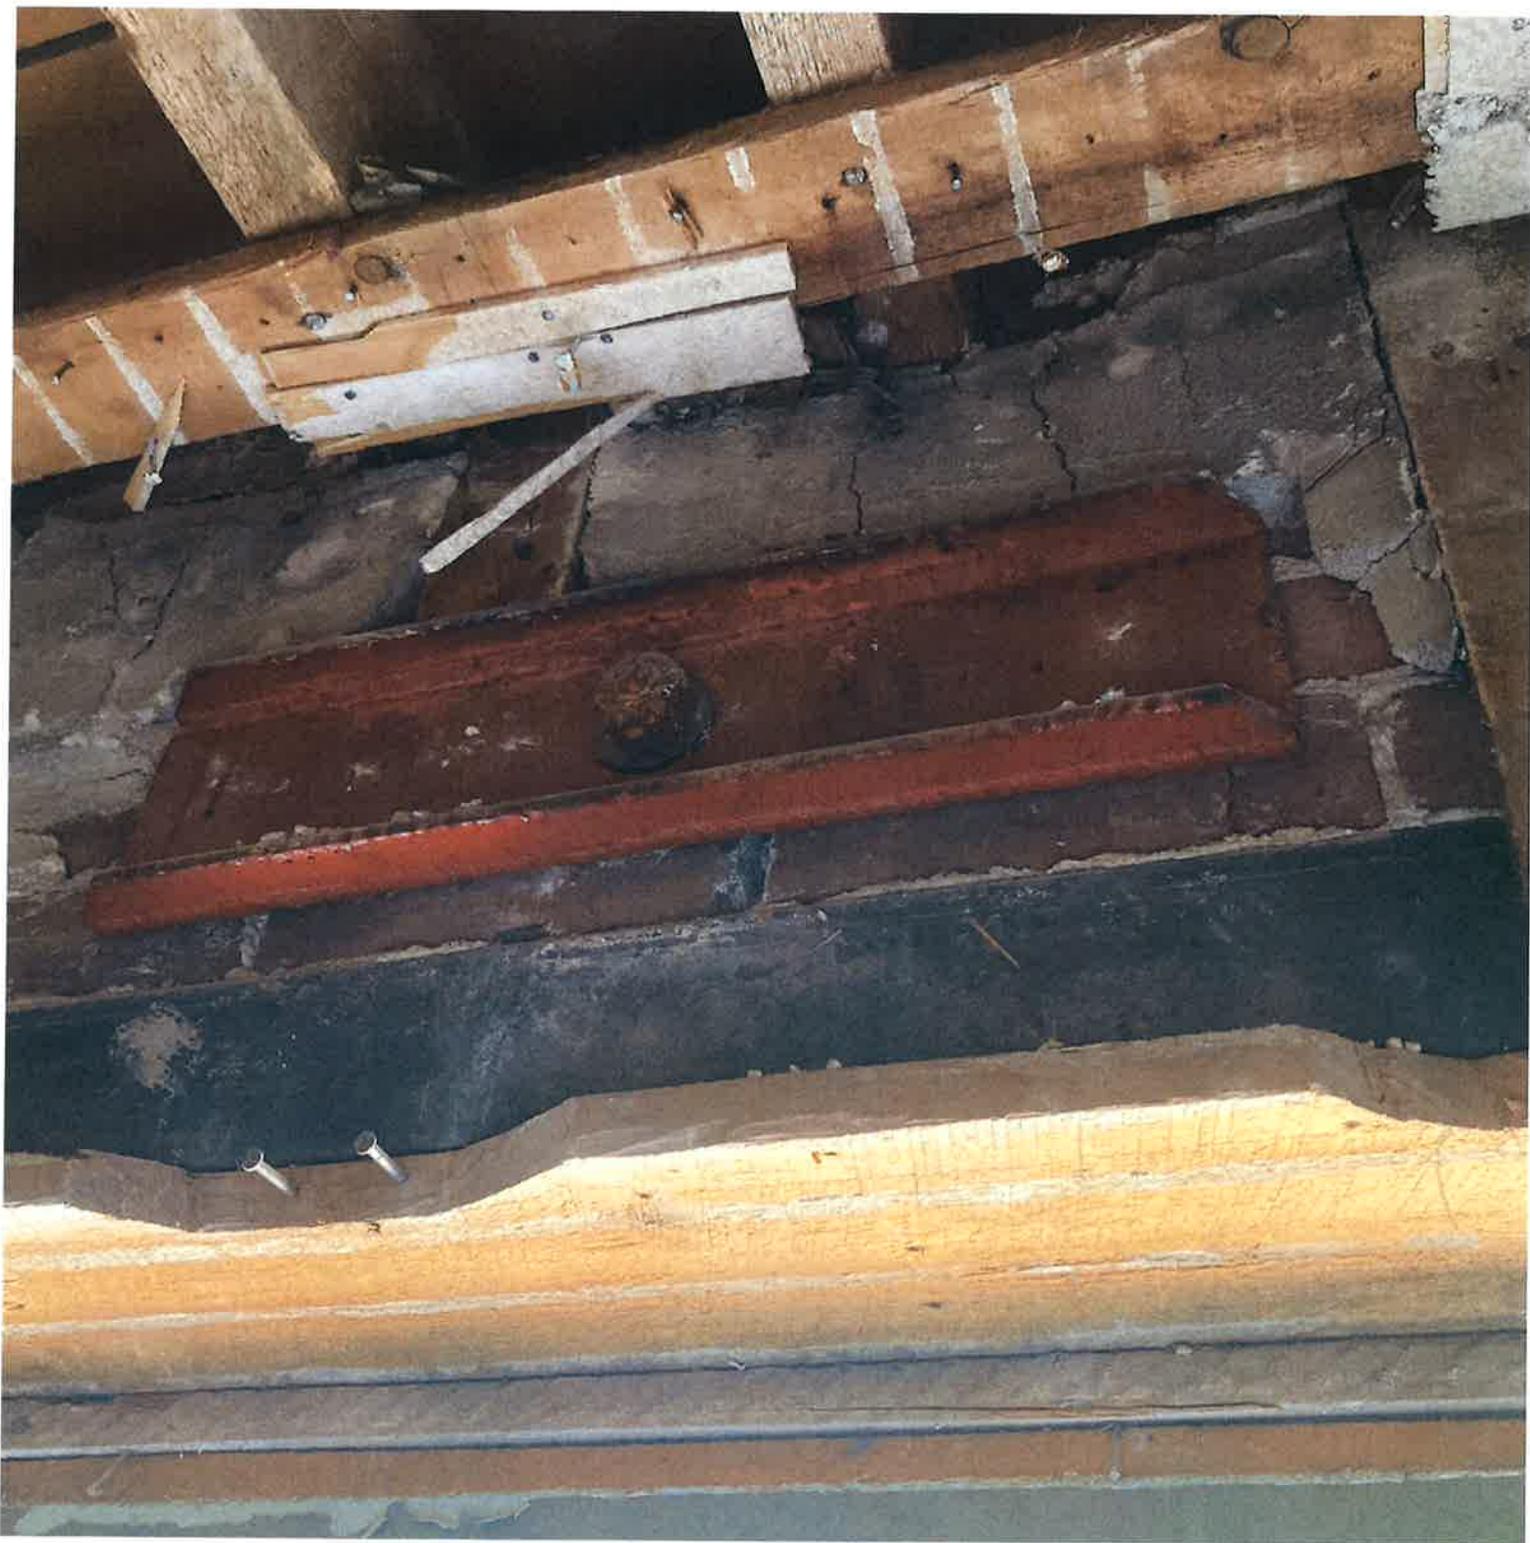
Aside from several dents and other minor damage, the face of the marquee appears to be in relatively good condition, however the backside of the structure is in worse condition. There is significant rust damage to the sheet metal cladding and mostly likely to the internal support structure. The upper anchor point of the support chain appears to be failing as the masonry around the escutcheon plate is cracked and spalled. Furthermore, the backing plate for the anchor is undersized and is only supported by the brick face of the building.

In our opinion, the damage to the masonry is most likely from excessive snow and water loads over the years and the lack of adequate drainage. This has also lead to the rust issues previously mentioned. Based on our review, we feel the marquee would need to be removed and replaced because the existing structure and related attachment points are inadequate and cannot meet the loading requirements of current building code.
