**WINTER STREET CEMETERY  
CONSERVATION TREATMENT REPORT  
EXETER, NEW HAMPSHIRE**

**Submitted By:**            Conserve ART LLC  
                                  Francis Miller, Conservator  
                                  19 Lansdowne Avenue  
                                  Hamden, CT 06517  
                                  Cell:     203-506-6846  
                                  Email:   conserveartllc@gmail.com

**Date:**                        January 18, 2017

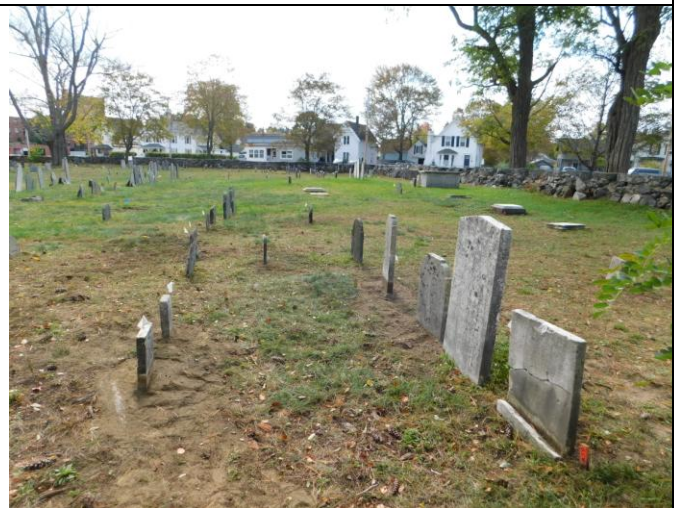
EWSC Workshop. 4. Overview looking toward play lot wall and Front Street after workshop. Note marker A 59 in foreground.

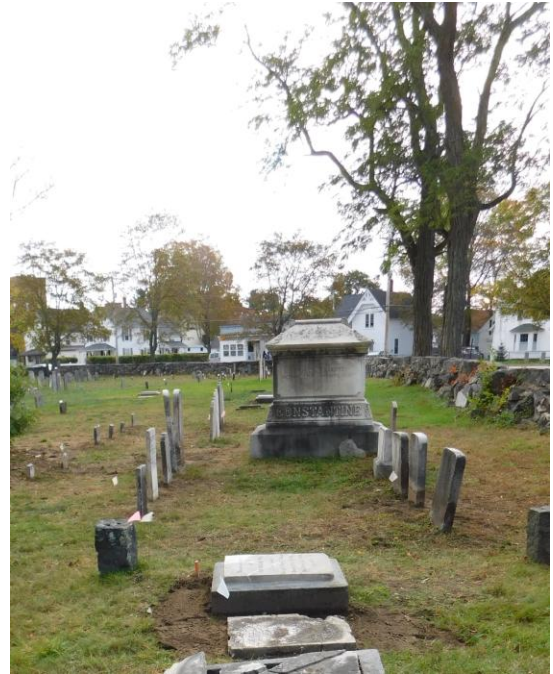
EWSC Workshop. 6. View from Winter Street facing Front Street after Workshop. Note markers 81 and 82 in foreground.

Flush marker A81 and headstone A135 were badly deteriorated and reset flush on gravel beds to slightly lift the stone from below grade and provide drainage. Marker B45 is a large marble that was leaning and was reset to allow for the resetting of B44. Markers B106 headstone and accompanying B106 footstone were displaced markers whose burial place was identified in the workshop. The headstone required a cast concrete base for support. These markers are documented and included in the Reset Images.

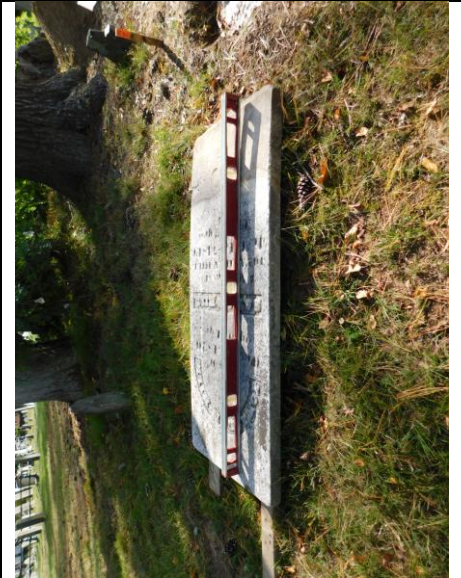
EWSC A39 3. During Reset. Warped stone.

All designated makers were reset. Marker A 39 required a cast concrete base. Markers D53, F29 and F73 have below grade conditions that require additional treatment. These markers were reset plumb but are not ideal and should be addressed in future treatment campaigns. *Before* and *After* treatment images are included in the report. *During* treatment images were included to provide additional information as needed.

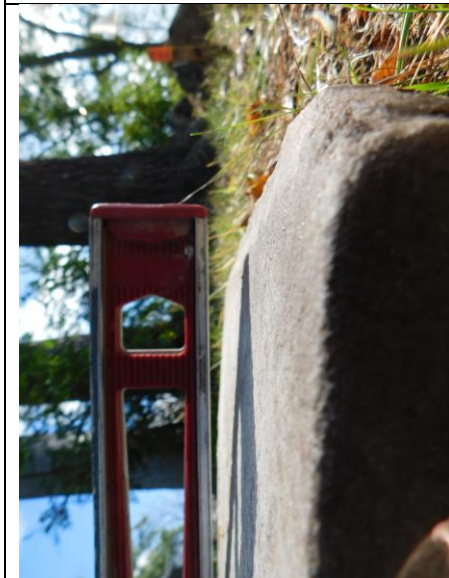
EWSC A39 4. During Reset. Warped stone, detail.

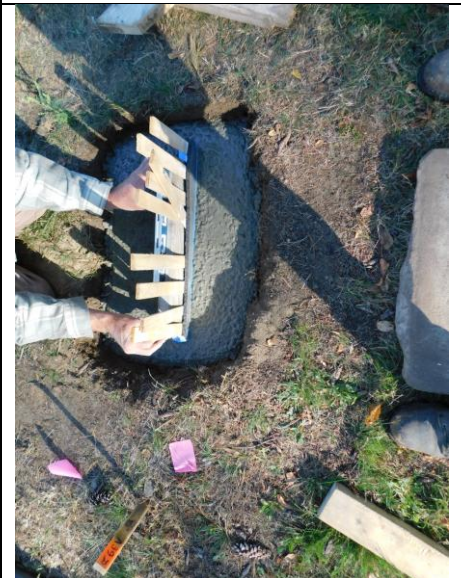
EWSC A39 6. During Reset. Concrete base.

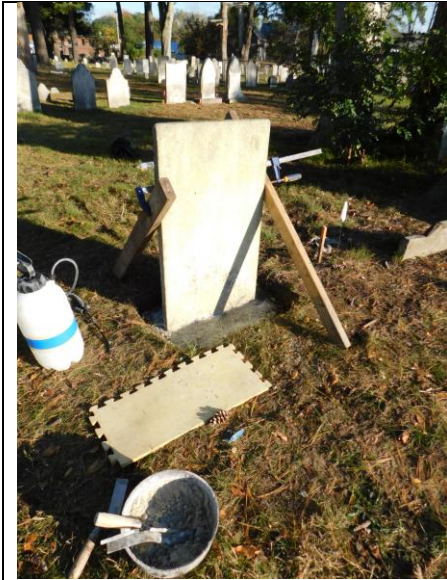
EWSC A39 7. During Reset. Braced marble in concrete base.

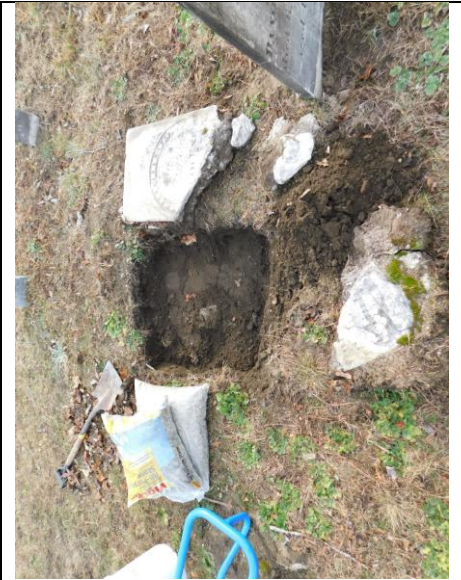
- **86% fallen marker** - 6 of 7 fallen markers remaining after conservation treatment were reset (it would **have** been 100%, but marker 135 was too deteriorated to reset vertically).

EWSC A135 1. During Reset. Compromised marble set on gravel for better drainage.

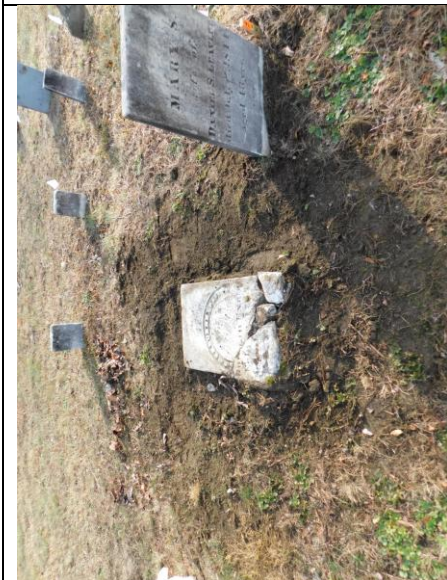
EWSC A135 2. After Reset. Compromised marble set on gravel for better drainage.

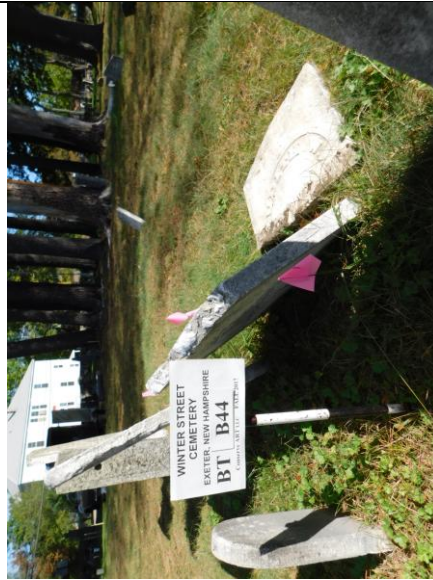
EWSC B44 and B45 1. Before Reset. Note the stone is behind 43, not part of original proposal.

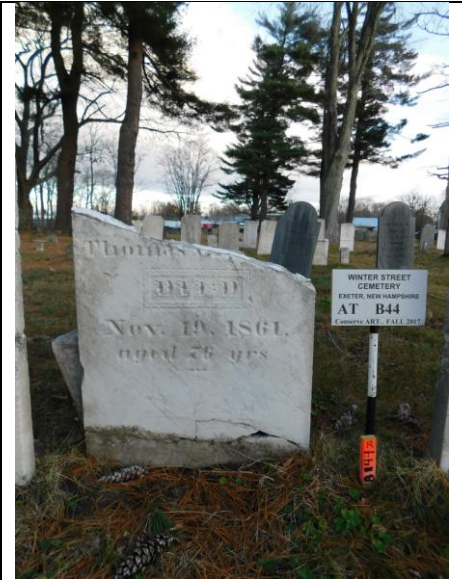
EWSC B44 2. Reset After.

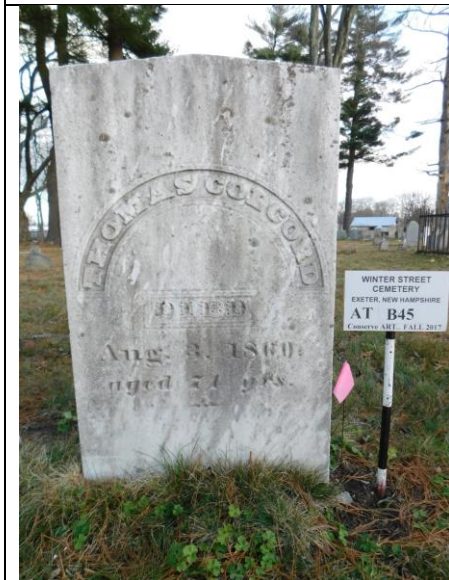
EWSC B45 2. Reset After.

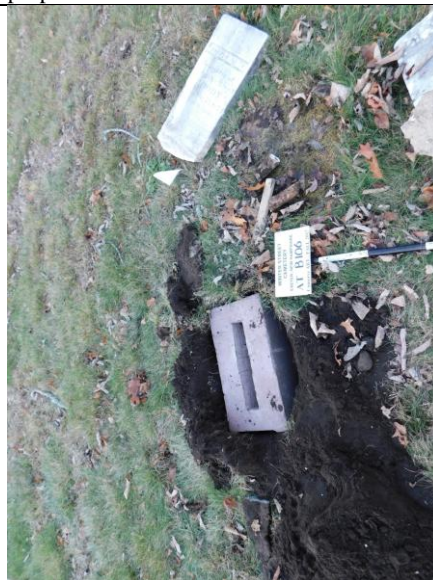
EWSC B106 1. During Reset. Cast concrete base for headstone.

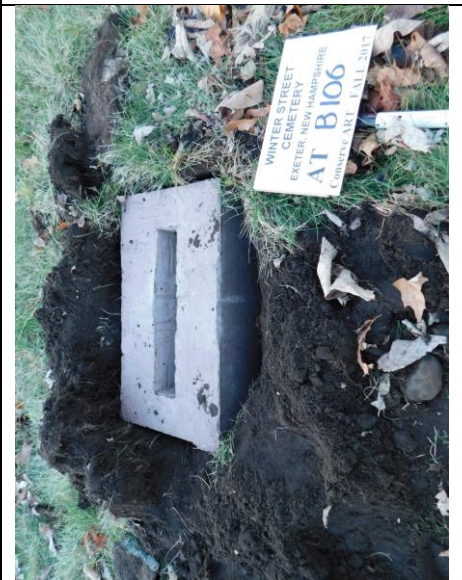
EWSC B106 2. During Reset. Detail of cast concrete base for headstone.

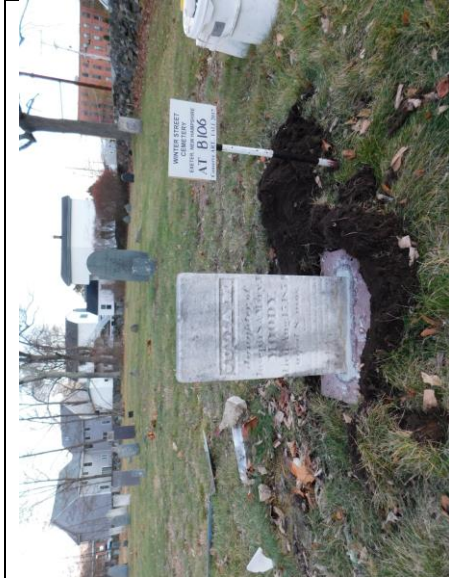
EWSC B106 3. During Reset. Set in mortar in concrete base for headstone.

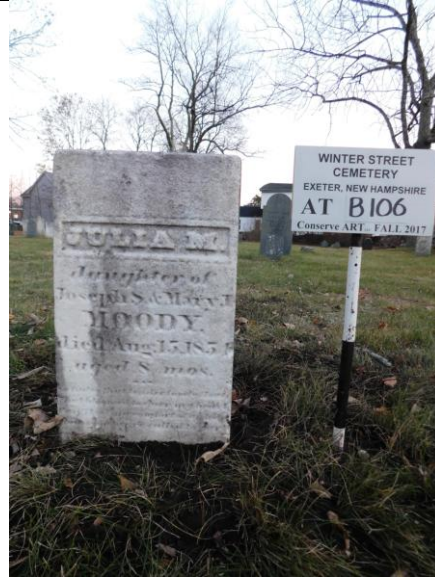
EWSC B106 4. After Reset.

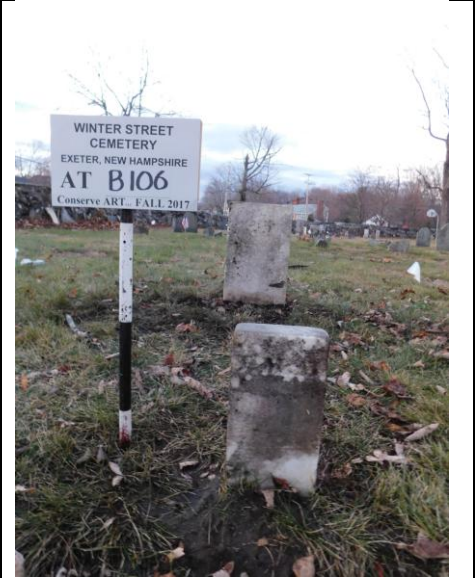
EWSC B106 5. After Reset, footstone.

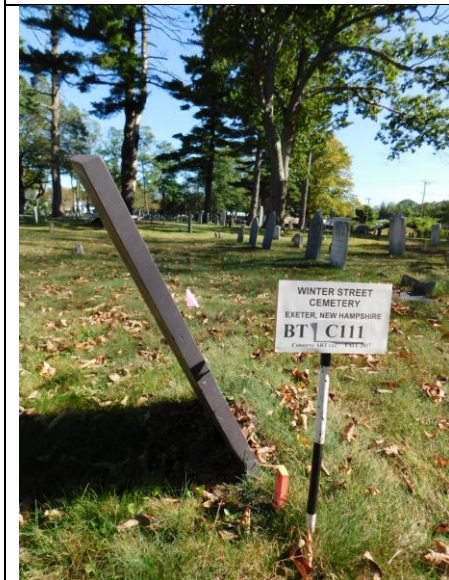
EWSC C111 1. Before Reset

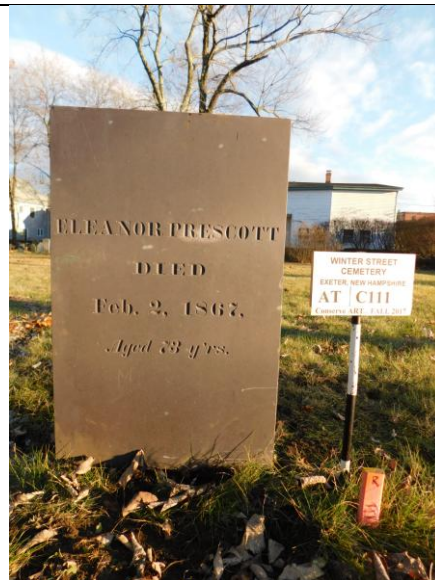
EWSC C111 2. After Reset.

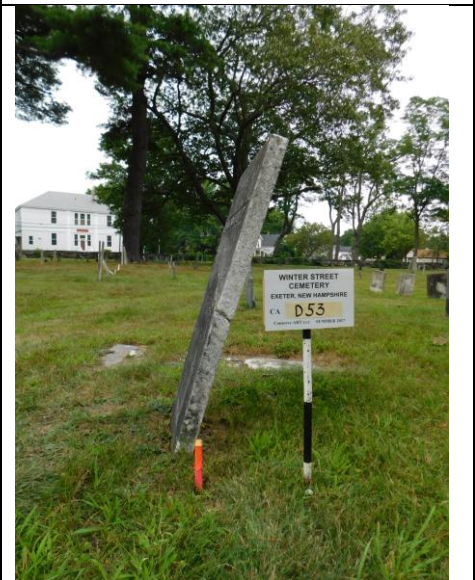
EWSC D53 1. Before Reset.

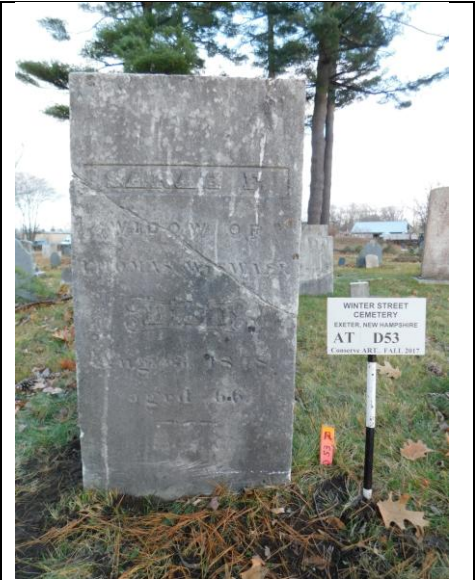
EWSC D53 4. Reset After.

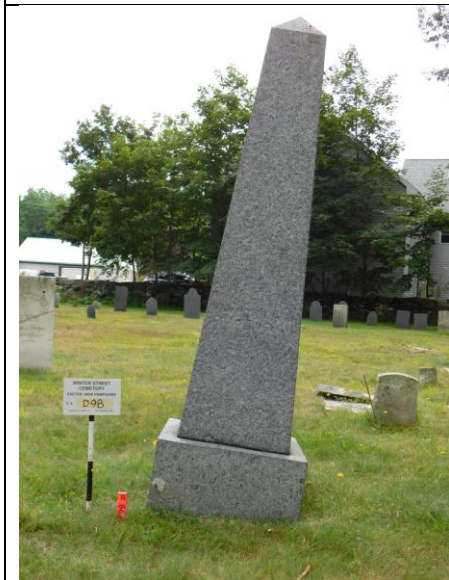
EWSC D98 1. Before Reset.

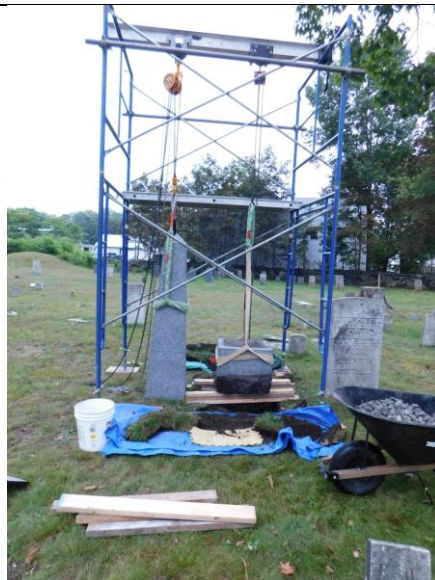
EWSC D98 2. During Reset. Separated with gantry.

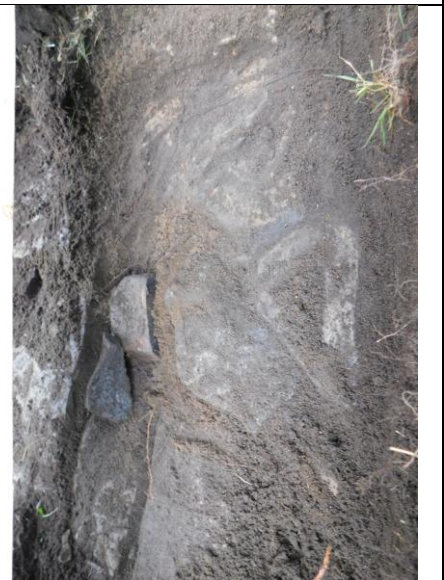
EWSC D98 3. During Reset. Removal of earth to original stone foundation.

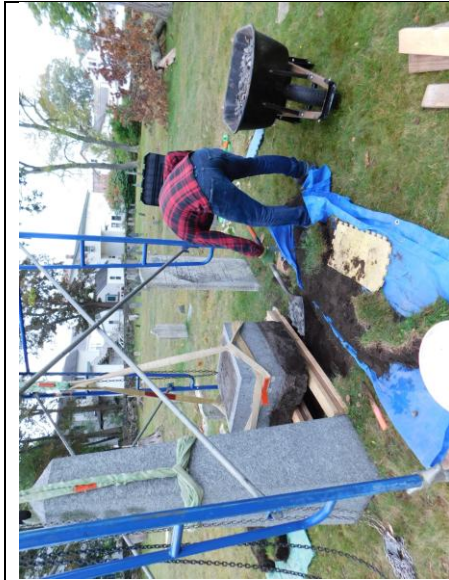
EWSC D98 4. During Reset. Adding 2 inch crushed stone above original stone foundation.

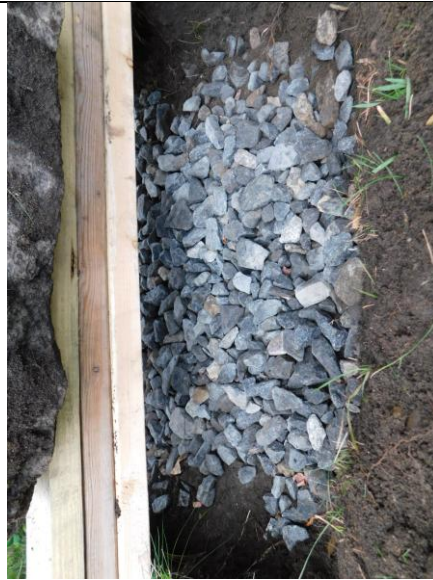
EWSC D98 5. During Reset. Detail of crushed stone above original stone foundation.

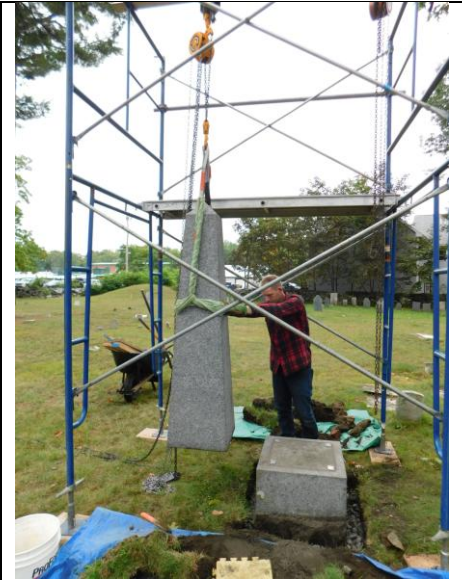
EWSC D98 6. During Reset. Rigging obelisk onto lead shims on leveled base.

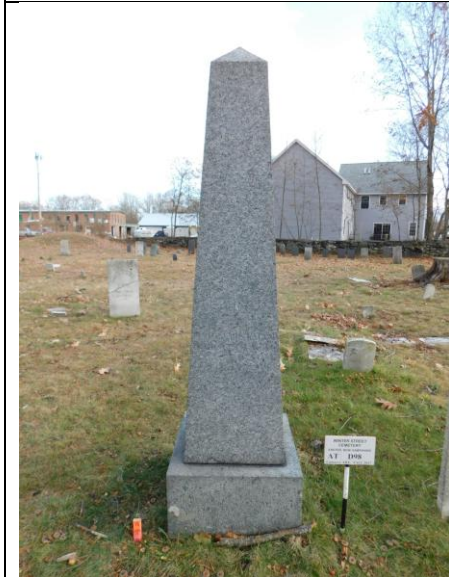
EWSC D98 7. Reset After.

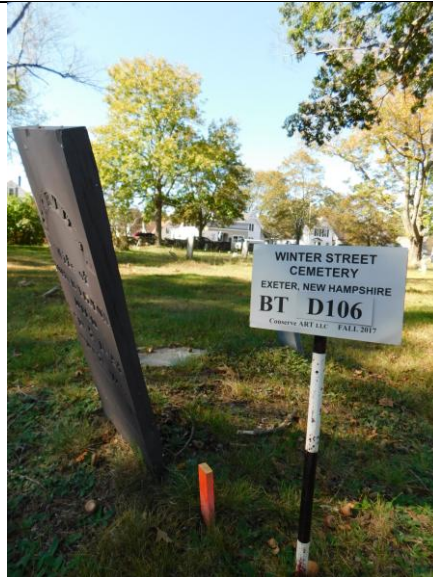
EWSC D106 1. Before Reset.

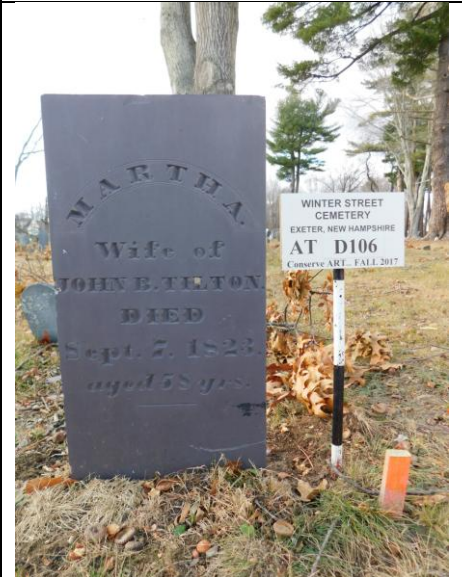
EWSC D106 2. Reset After.

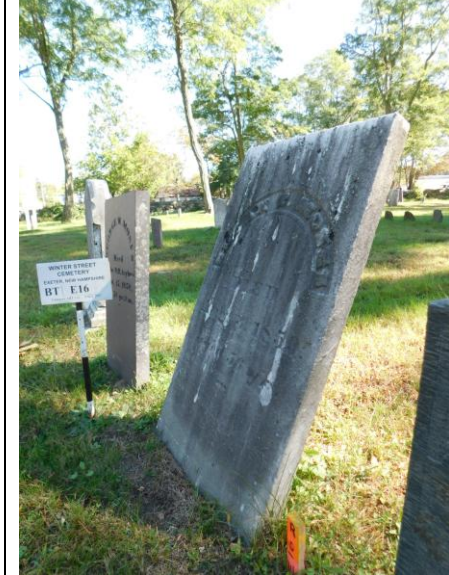
EWSC E16 1. Before Reset.

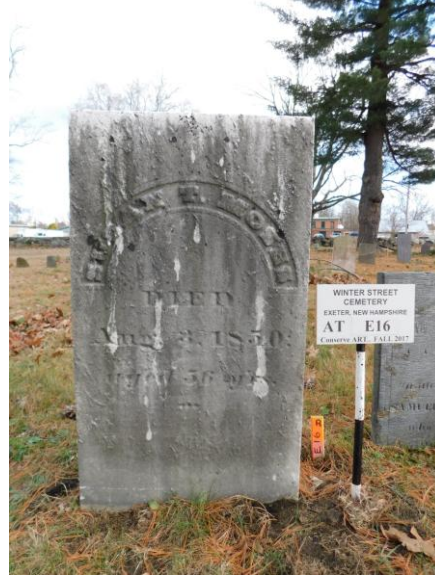
EWSC E16 2. Reset After.

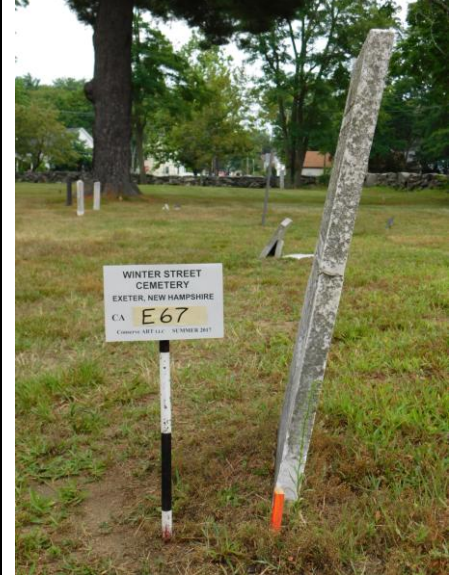
EWSC E67 1. Before Reset.

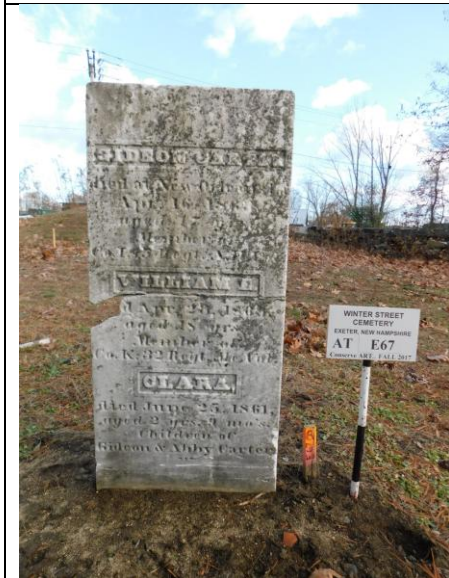
EWSC E67 2. Reset After.

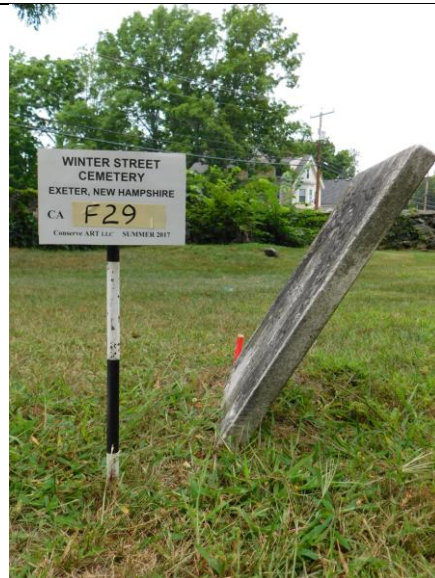
EWSC F29 1. Before Reset.

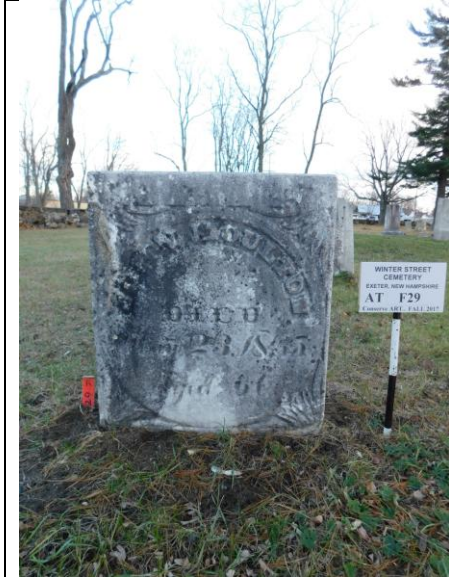
EWSC F29 3. Reset After.

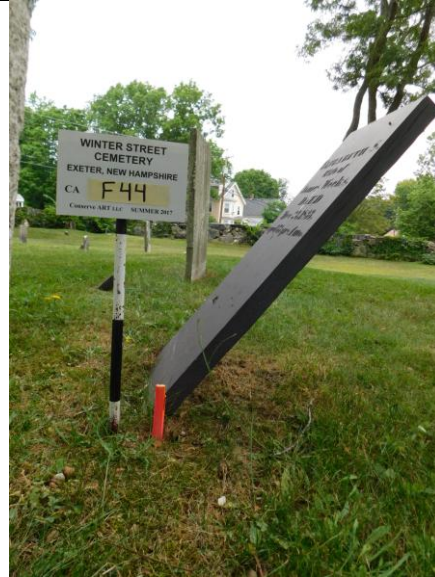
EWSC F44 1. Before Reset.

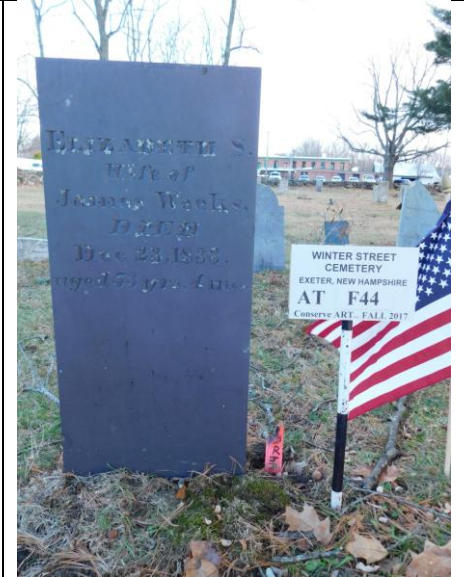
EWSC F44 2. Reset After.

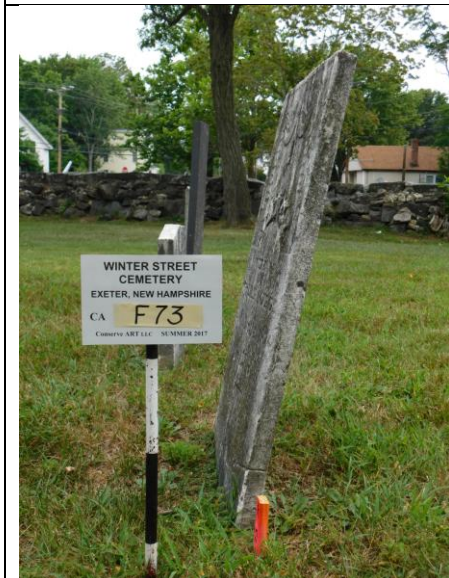
EWSC F73 1. Before Reset.

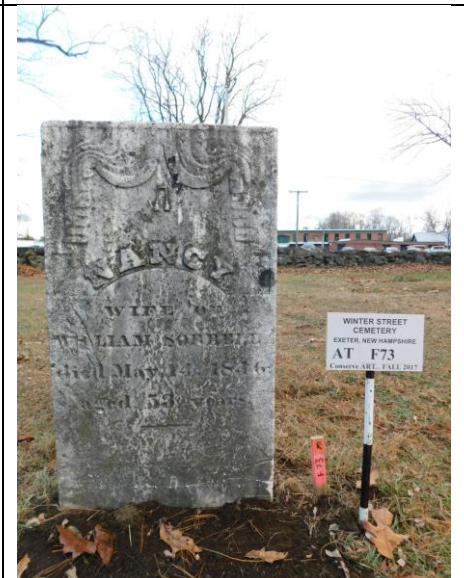
EWSC F73 3. Reset After.

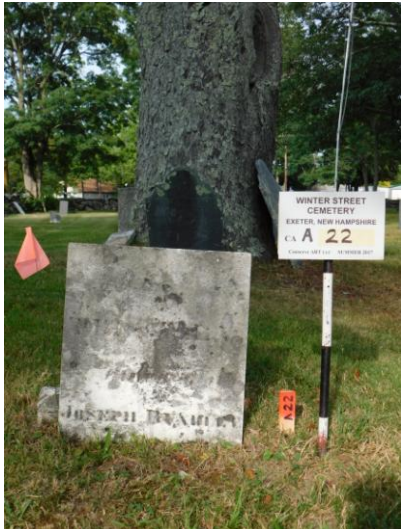
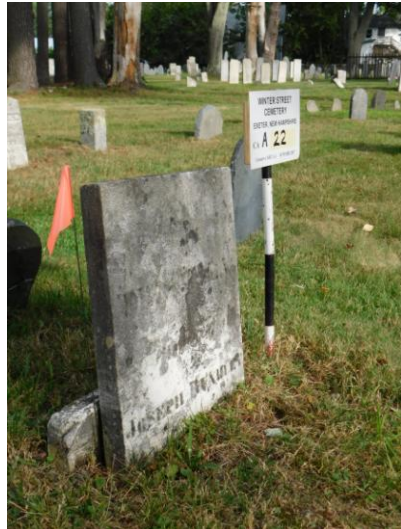
1. EWSC A22. BT Front overview before treatment.		2. EWSC A22. BT Proper left overview before treatment.

- **Surface Growth/Soiling:** Minor biological growths over the surfaces and in grain boundaries.
- **Stains:** There are soil stains on portions buried below grade.
- **Friable Stone:** Fine grain marble is lightly sugary to the touch, otherwise stone is sound.
- **Spalls:**
- **Cracks:** There is a small crack on the lower proper right, lower edge.
- **Breaks:** Stone has been broken into two sections.
- **Losses:** There are losses along the break-line and a large loss to the proper left side.
- **Hazardous Alignment:**
- **Previous Repairs:** There is failed epoxy along break-line from previous repair.

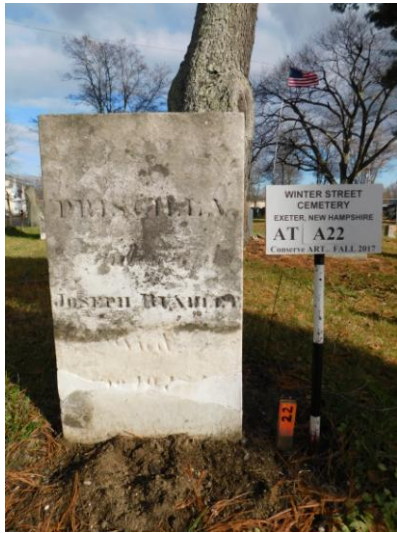
<p>3. EWSC A22. AT Front overview after treatment.</p>	
<input checked="" type="checkbox"/> <b>Cleaning:</b>	ProSoCo ReVive, Orvus	<input type="checkbox"/> <b>Patch:</b>	Jahn M120		
<input type="checkbox"/> <b>Stain Removal:</b>		<input type="checkbox"/> <b>Aggregate:</b>	Graded silica sand		
<input checked="" type="checkbox"/> <b>Consolidant:</b>	ProSoCo HCT	<input type="checkbox"/> <b>Lime:</b>	St. Astier 3.5		
<input checked="" type="checkbox"/> <b>Adhesive:</b>	Akemi Akepox 2030	<input type="checkbox"/> <b>Cement:</b>	White Portland		
<input type="checkbox"/> <b>Dowel(s):</b>		<input checked="" type="checkbox"/> <b>Fills:</b>	Jahn M-120		
<input type="checkbox"/> <b>Injection:</b>	Jahn M-31	<input checked="" type="checkbox"/> <b>Pigment:</b>	Bayferrox and Solomon Grind		
<input type="checkbox"/> <b>Other:</b>		<input type="checkbox"/> <b>Foundation:</b>	Crushed Stone

■ **General Soiling & Biological Growth Removal:** Surfaces washed with ProSoCo ReVive biological and atmospheric stain remover followed by water rinse.

■ **Consolidation:** Marble was treated with ProSoCo HCT (Hydroxylating Conversion Treatment) a water borne treatment that provides bonds between weakened calcium carbonate stone grains. The material was applied in three cycles following the manufacturer’s recommended procedures.

■ **Crack Injection:** All cracks were flushed with pressurized water (100 psi max.), using appropriate stainless steel needle gauge for crack opening and fragility of stone. Prewet cracks with 10% ethanol and water solution allowed for successful injection of Jahn M-31, tinted with pigments.

■ **Repairs:** Stone fragments were mended using Akemi Akepox 2030 two part epoxy. Epoxy was allowed to cure to taffy like consistency and excess was trimmed back using a stainless steel scalpel for mortar fills.

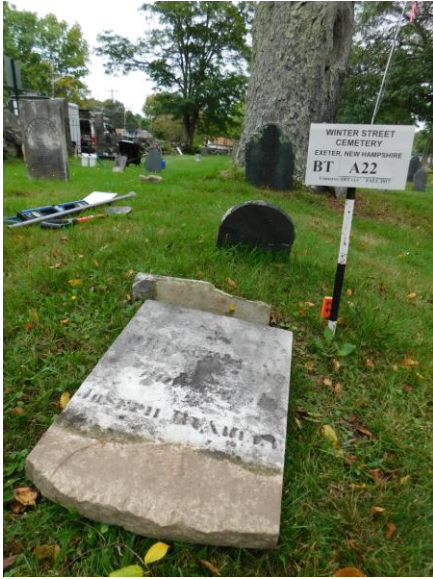
4. EWSC A22. DT View of unearthed stone.

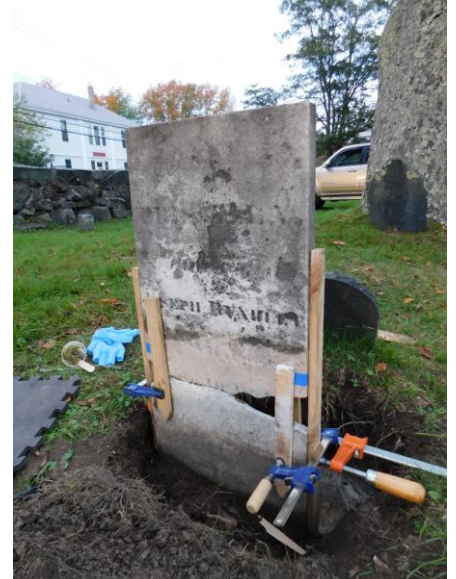
6. EWSC A22. DT Mending stone with epoxy.

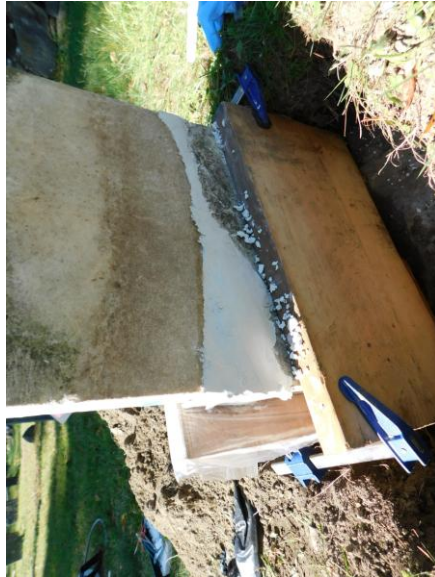
8. EWSC A22. DT Loss replacement with Jahn 120.

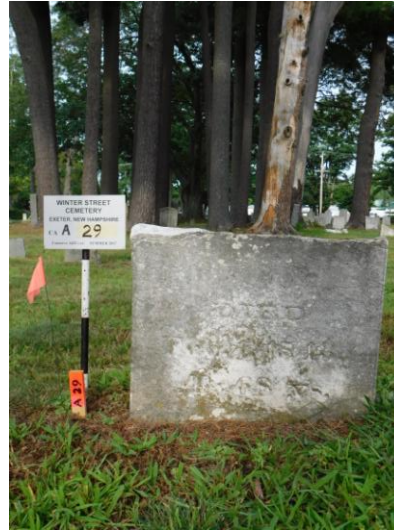
1. EWSC. A29. BT. Front overview before treatment.

- **Surface Growth/Soiling:** Minor biological growths over the surfaces and grain in boundaries.
- **Stains:** There are soil stains on portions buried below grade.
- **Friable Stone:** Fine grain marble is lightly sugary to the touch, otherwise stone is sound.
- Spalls:**
- **Cracks:** There is a small crack on the lower proper right, lower edge.
- **Breaks:** Stone has been broken into two sections. There are pre-existing breaks
- **Losses:** There are losses along the break-line and a large loss to the proper left side.
- Hazardous Alignment:**
- Other:**
- **Previous Repairs:** The stone has numerous breaks that were mended with a cement adhesive. The repairs are misaligned and the mating areas not filled well with adhesive nor filled with patching mortar to shed water..

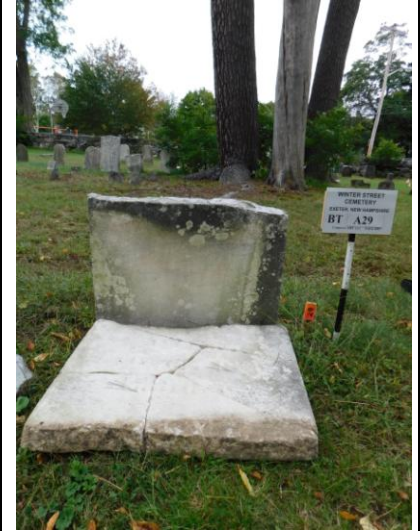
2. EWSC. A29. BT. Back overview before treatment.

**Repairs:** Failed adhesive removed by hammer and chisel and by Dremel. Stone fragments were mended using Akemi Akepox 2030 two part epoxy. Epoxy was allowed to cure to taffy like consistency and excess was trimmed back using a stainless steel scalpel for mortar fills.

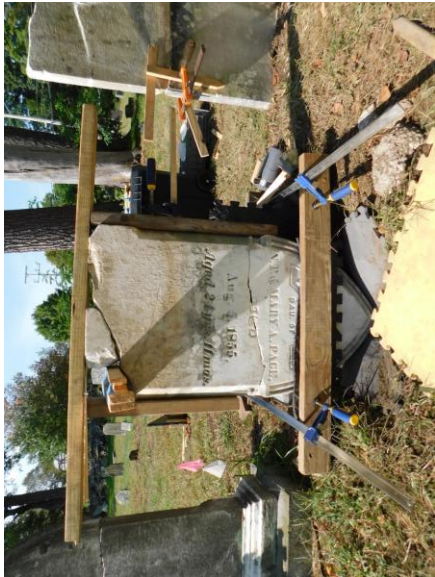
7. EWSC. A30. DT. Aligning fragment for coring pins.

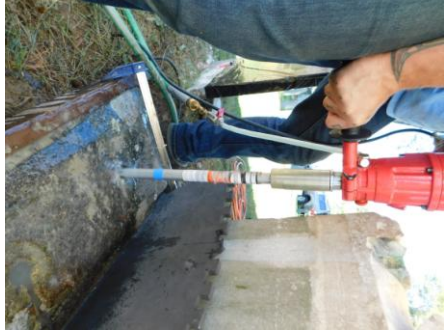
10. EWSC. A30. DT. Core removal of failed pins in granite.

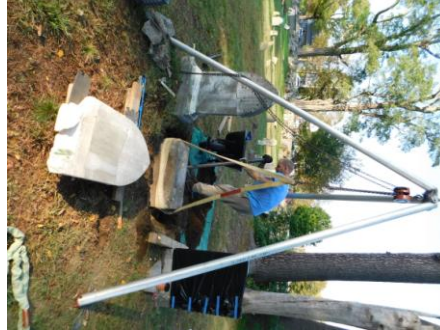
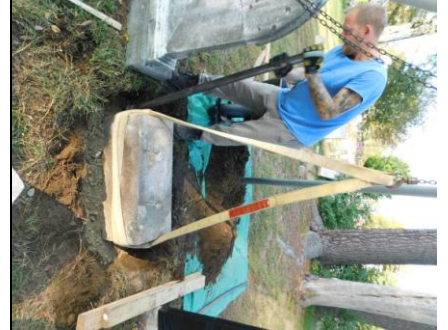
11. EWSC. A30. DT. Setting granite base on crushed stone.

12. EWSC. A30. DT. Setting granite base on crushed stone.

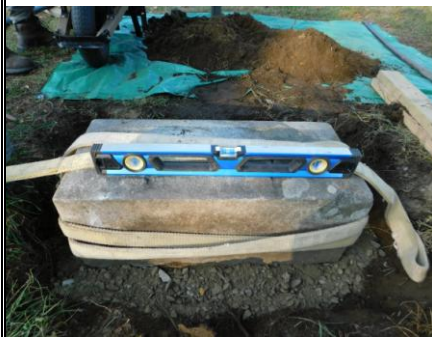
13. EWSC. A30. DT. Setting granite base using level.

14. EWSC. A30. DT. Setting granite base using level.

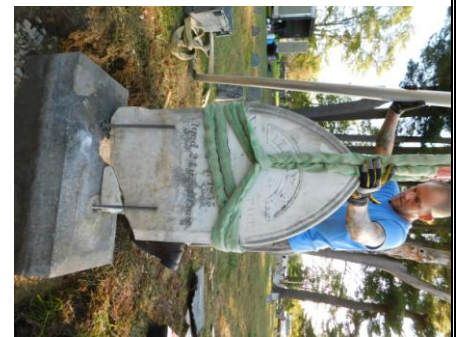
15. EWSC. A30. DT. Setting marble with stainless anchors.

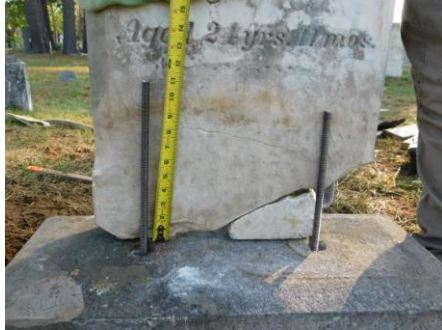
16. EWSC. A30. DT. Setting marble with stainless anchors extending past crack.

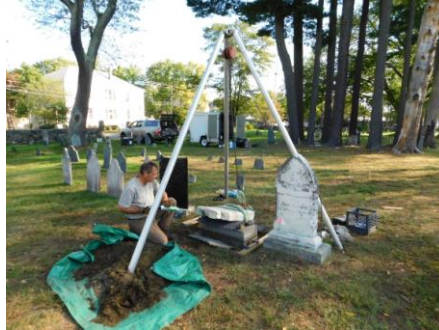
17. EWSC. A30. DT. Setting stainless anchors with structural epoxy.

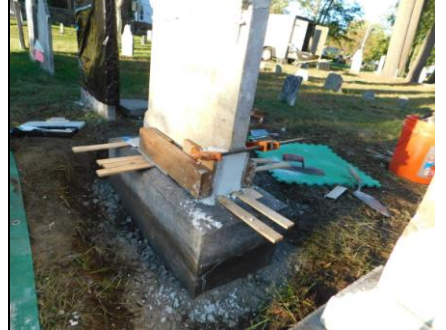
18. EWSC. A30. DT. Patching large losses with Jahn M120.

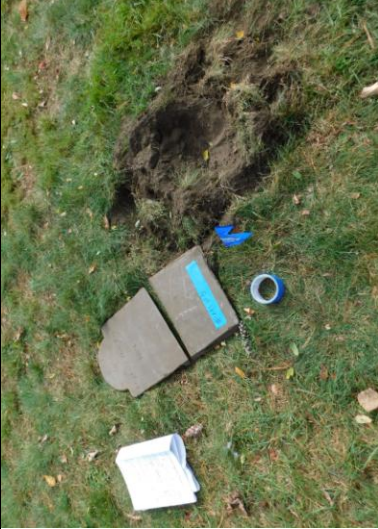
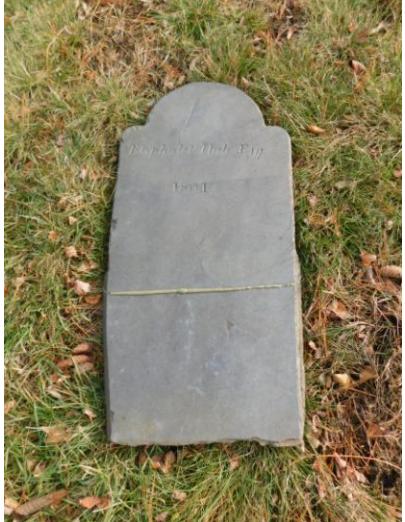
<p><b>Dimensions: H:</b> 12"    <b>W:</b> 9"    <b>D:</b> ¾"</p>		<p>1. EWSC. A41 FS. BT. Front overview before treatment.</p> <p>2. EWSC. A41 FS. DT. Front overview after bonding.</p>

- Surface Growth/Soiling:** There are soil stains on portions buried below grade.
- Stains:**
- Friable Stone:** Fine grain marble is lightly sugary to the touch, otherwise stone is sound.
- Spalls:**
- Cracks:** There are hairline cracks in the slate along stone anomalies.
- Breaks:** Stone has a central break below grade.
- Losses:**
- Hazardous Alignment:**
- Other:** The broken marker was located below grade by probing the area during the community preservation workshop.

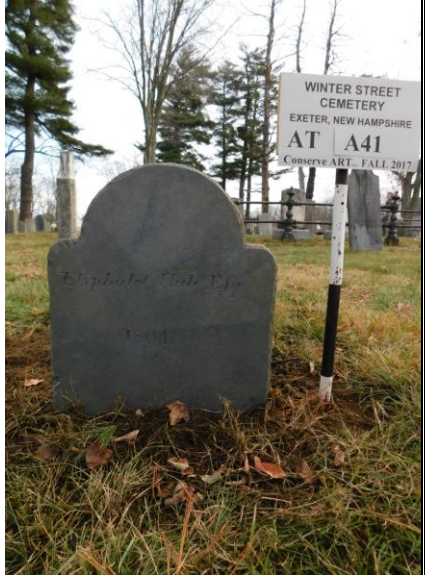
3. EWSC. A41 FS. AT. Front overview after treatment.

<b>PERSONNEL</b>	Francis Miller, Silas Finch	
<b>PROJECT DATES</b>	<b>Begin:</b> Summer 2017 <b>Complete:</b> Fall 2017	
<p><b>MARKER TREATMENTS</b></p> <p>■ <b>General Soiling &amp; Biological Growth Removal:</b> Surfaces washed with ProSoCo ReVive biological and atmospheric stain remover followed by water rinse.</p> <p>□ <b>Consolidation:</b></p> <p>□ <b>Crack Injection:</b></p> <p>■ <b>Repairs:</b> Stone fragments were mended using Akemi Akepox 2030 two part epoxy. The mend is below grade; epoxy was not trimmed back</p> <p>□ <b>Fills/patches:</b></p> <p>■ <b>Resetting:</b> Reset in the earth in found location behind headstone.</p>

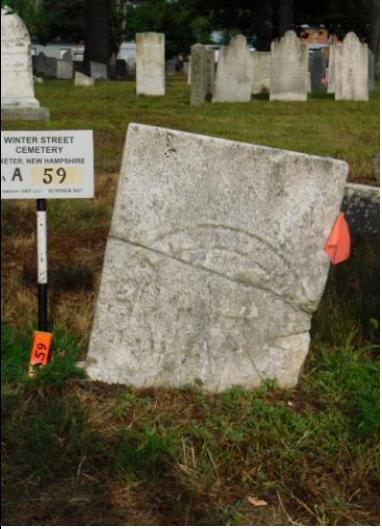
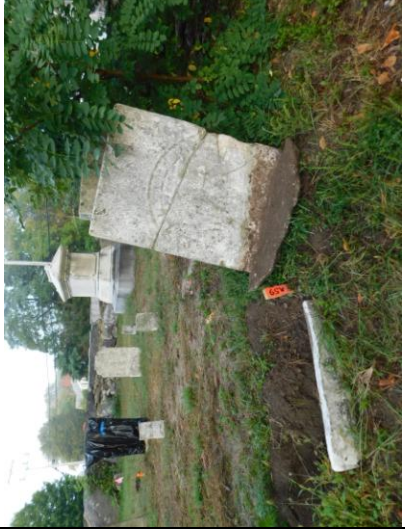
1. EWSC. A59. BT. Front overview before treatment.		2. EWSC. A59. DT. Unearthing revealed concrete poured around the stone.

- Surface Growth/Soiling:** There are soil stains on portions buried below grade.
- Stains:**
- Friable Stone:** Fine grain marble is lightly sugary to the touch, portions have lost all cohesion.
- Spalls:**
- Cracks:** Portions of the stone riddled with cracks.
- Breaks:** Stone has a central break at grade and pre-existing breaks.
- Losses:**
- Hazardous Alignment:**
- Previous Repairs:** The marker has repairs to previous rates.
- Other:** Unearthing stone for repairs uncovered below grade concrete. Given the fragility of the stone and unknown loss associated with the concrete, the marker was reset and no further work done. The marker can be treated in a future campaign where the treatment duration permits full OH-100 consolidation.

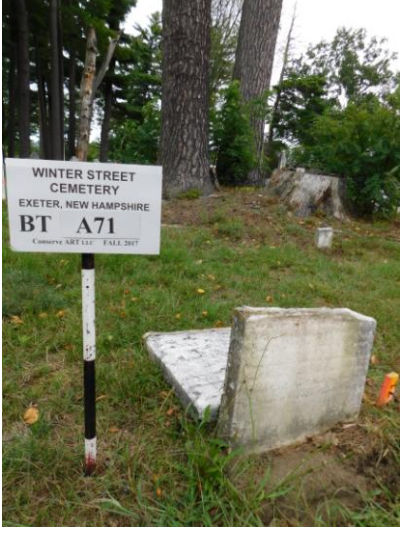
<b>Dimensions:</b> H: 24"    W: 13"    D: 1 3/4"			1. EWSC. A71. BT. Overview before treatment.

- **Surface Growth/Soiling:** Minor biological growths over the surfaces and grain boundaries.
- **Stains:** There are soil stains on portions buried below grade.
- **Friable Stone:** Fine grain marble is lightly sugary to the touch, otherwise stone is sound.
- **Spalls:** The stone has small spall on the upper portion.
- Cracks:**
- **Breaks:** Stone has been broken into two sections.
- **Losses:** There are losses along the break-line.
- Hazardous Alignment:**
- Other:** The stone was buried too deeply to read the text.
- **Previous Repairs:** There is failed epoxy along break-line from previous repair.

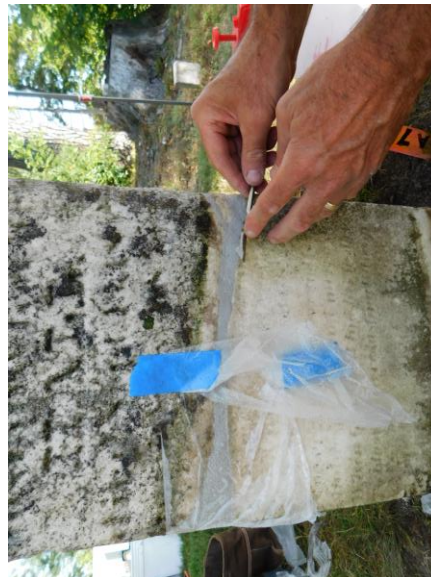
7. EWSC. A71. DT. Filling losses along break-line with Jahn M120.

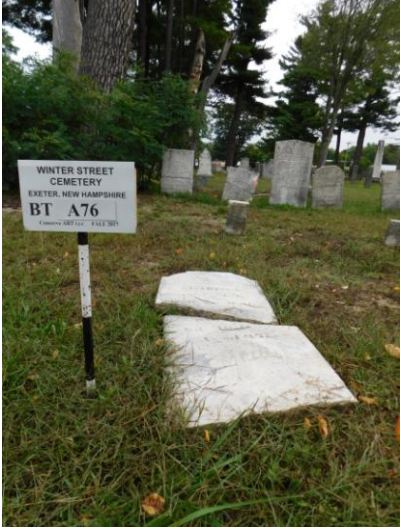
<b>Dimensions: H:</b> 36" <b>W:</b> 16 1/2" <b>D:</b> 1 3/4"			1. EWSC. A76. BT. Overview before treatment.

- **Surface Growth/Soiling:** Minor biological growths over the surfaces and grain boundaries.
- **Stains:** There are soil stains on portions buried below grade.
- **Friable Stone:** Fine grain marble is lightly sugary to the touch, otherwise stone is sound.
- Spalls:**
- Cracks:**
- **Breaks:** Stone has a break at grade and a break at mid-stone.
- **Losses:** There are losses along the break-line.
- Hazardous Alignment:**
- Other:** The stone was buried too deeply to read the text.
- **Previous Repairs:** There is failed epoxy along break-line at grade from previous repair.

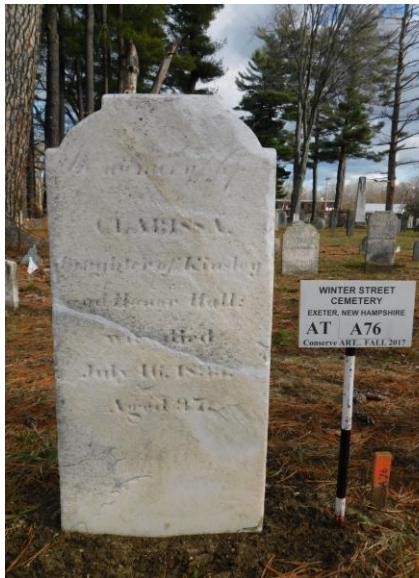
2. EWSC. A76. AT. Overview before treatment.

<b>PERSONNEL</b>		Francis Miller, Silas Finch				
<b>PROJECT DATES</b>		<b>Begin:</b> Summer 2017		<b>Complete:</b> Fall 2017		
<p><b>MARKER TREATMENTS</b></p> <p><input checked="" type="checkbox"/> <b>General Soiling &amp; Biological Growth Removal:</b> Surfaces washed with ProSoCo ReVive biological and atmospheric stain remover followed by water rinse.</p> <p><input checked="" type="checkbox"/> <b>Consolidation:</b> Marble was treated with ProSoCo HCT (Hydroxylating Conversion Treatment) a water borne treatment that provides bonds between weakened calcium carbonate stone grains. The material was applied in three cycles following the manufacturer's recommended procedures.</p> <p><input type="checkbox"/> <b>Crack Injection:</b></p> <p><input checked="" type="checkbox"/> <b>Repairs:</b> Stone fragments were mended using Akemi Akepox 2030 two part epoxy. Epoxy was allowed to cure to taffy like consistency and excess was trimmed back using a stainless steel scalpel for mortar fills.</p> <p><input checked="" type="checkbox"/> <b>Fills:</b> Losses were filled flush using Jahn M-120, lightly tinted with pigments, covered with plastic and misted for a minimum of three days. All original, decorative surfaces kept clean of over-smear.</p> <p><input type="checkbox"/> <b>Resetting:</b></p>

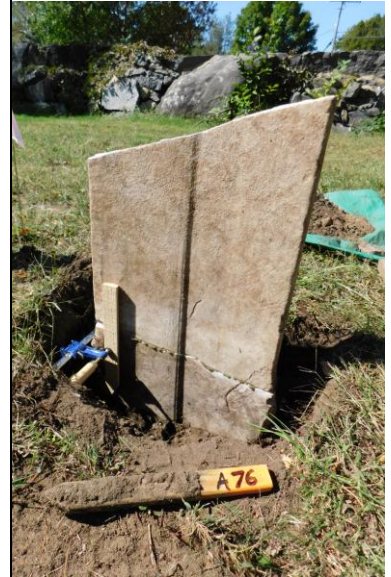
5. EWSC. A76. DT. Mending lower break.

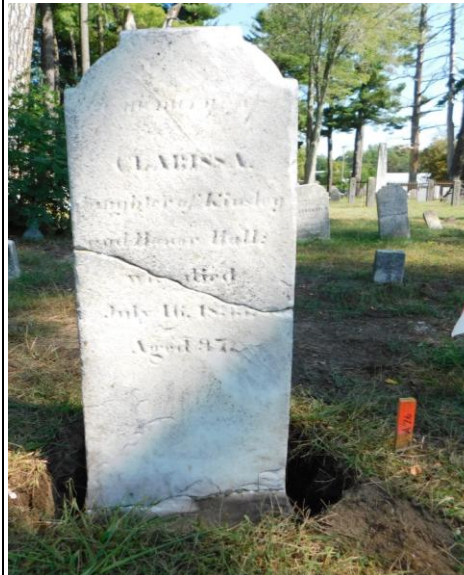
7. EWSC. A76. DT. Front view after mending.

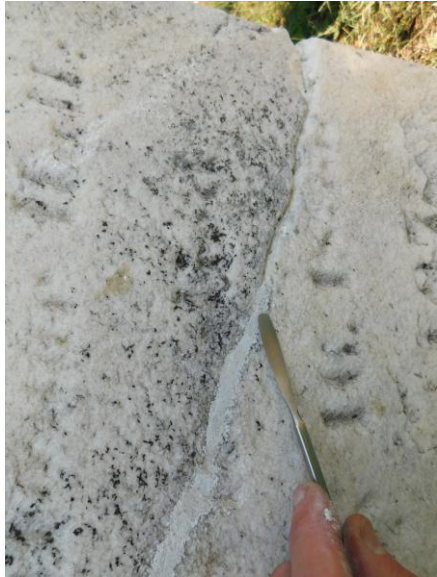
9. EWSC. A76. DT. Filling break-line with Jahn M120.

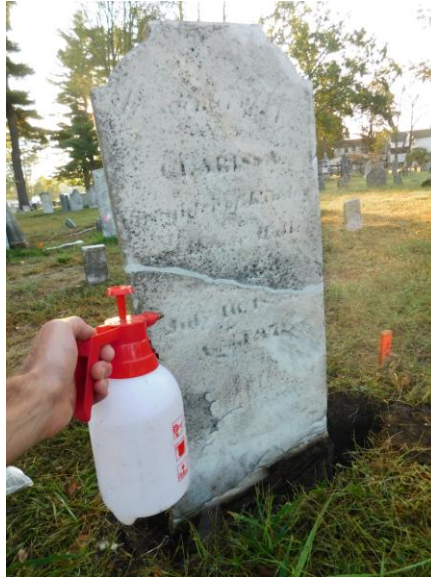
10. EWSC. A76. DT. Misting fills for cure.

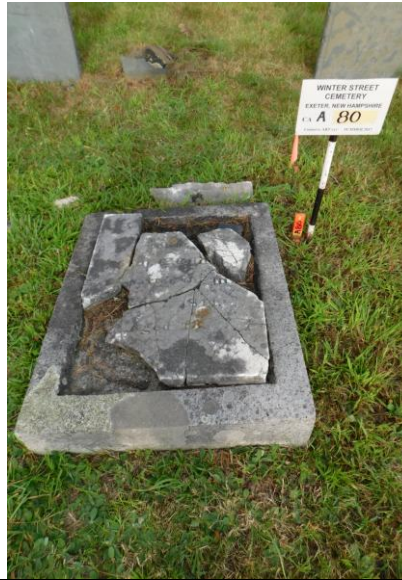
1. EWSC. A80. BT. Overview before treatment.

- Surface Growth/Soiling:** Minor biological growths over the surfaces and grain boundaries.
- Stains:** There are soil stains on portions buried below grade.
- Friable Stone:** Fine grain marble is lightly sugary to the touch, otherwise stone is sound.
- Spalls:**
- Cracks:** The fragmented marble is riddled with cracks.
- Breaks:** The marble is broken into at least 7 sections. 4 sections were found on the base.
- Losses:** There are losses along the break-lines. The bottom, proper left corner is missing and the top proper right.
- Hazardous Alignment:** The granite is misaligned.
- Other:** The marker was an alternate and required too much treatment for the 2017 treatment period. The marker was brought to Hamden, CT for treatment over the winter.

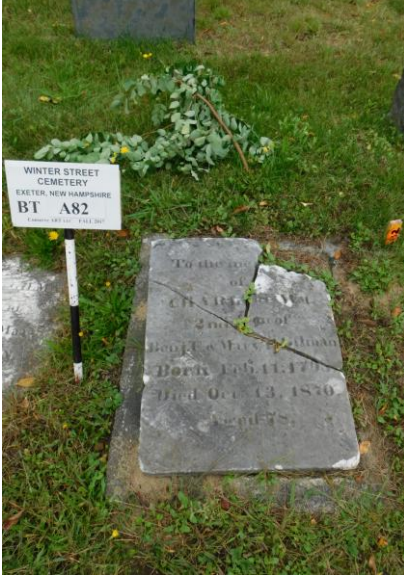
<b>Dimensions:</b> H: $\frac{18''}{24''}$ W: $\frac{24''}{30''}$ D: $\frac{2''}{7''}$				1. EWSC. A82. BT. Overview before treatment.		
<b>MARKER CONDITION</b>						
<p><input checked="" type="checkbox"/> <b>Surface Growth/Soiling:</b> Minor biological growths over the surfaces and in grain boundaries.</p> <p><input type="checkbox"/> <b>Stains:</b> There are soil stains on portions buried below grade.</p> <p><input checked="" type="checkbox"/> <b>Friable Stone:</b> Fine grain marble is lightly sugary to the touch, otherwise stone is sound.</p> <p><input type="checkbox"/> <b>Spalls:</b></p> <p><input type="checkbox"/> <b>Cracks:</b></p> <p><input checked="" type="checkbox"/> <b>Breaks:</b> The marble is broken into at least four sections; three were located on the base.</p> <p><input checked="" type="checkbox"/> <b>Losses:</b> There are losses along the break-line. The top proper left corner is missing.</p> <p><input checked="" type="checkbox"/> <b>Hazardous Alignment:</b> The granite is misaligned.</p> <p><input type="checkbox"/> <b>Other:</b> The stone was buried too deeply to read the text.</p> <p><input type="checkbox"/> <b>Previous Repairs:</b> There is failed epoxy along break-line at grade from previous repair.</p>

<b>MARKER #:</b> A82		<b>NAME:</b> CHARLES GILMAN		<b>DATE:</b> 1835	
<p><b>MATERIALS</b></p> <ul style="list-style-type: none"> <li>■ <b>Cleaning:</b> ProSoCo ReVive, Orvus</li> <li>□ <b>Stain Removal:</b></li> <li>■ <b>Consolidant:</b> ProSoCo HCT</li> <li>■ <b>Adhesive:</b> Akemi Akepox 2030</li> <li>□ <b>Dowel(s):</b></li> <li>□ <b>Injection:</b> Jahn M-31</li> <li>□ <b>Other:</b></li> </ul>				<ul style="list-style-type: none"> <li>■ <b>Patch:</b> Jahn M120</li> <li>■ <b>Aggregate:</b> Graded silica sand</li> <li>■ <b>Lime:</b> St. Astier 3.5</li> <li>□ <b>Cement:</b> White Portland</li> <li>■ <b>Fills:</b> Jahn M-120</li> <li>■ <b>Pigment:</b> Bayferrox and Solomon Grind</li> <li>■ <b>Foundation:</b> Crushed Stone</li> <li>□ <b>Other:</b></li> </ul>	
<b>PERSONNEL</b>		Francis Miller, Silas Finch			
<b>PROJECT DATES</b>		<b>Begin:</b> Summer 2017		<b>Complete:</b> Fall 2017	
<p><b>MARKER TREATMENTS</b></p> <ul style="list-style-type: none"> <li>■ <b>General Soiling &amp; Biological Growth Removal:</b> Surfaces washed with ProSoCo ReVive biological and atmospheric stain remover followed by water rinse.</li> <li>■ <b>Consolidation:</b> Marble was treated with ProSoCo HCT (Hydroxylating Conversion Treatment) a water borne treatment that provides bonds between weakened calcium carbonate stone grains. The material was applied in three cycles following the manufacturer's recommended procedures.</li> <li>□ <b>Crack Injection:</b></li> <li>■ <b>Repairs:</b> Stone fragments were mended using Akemi Akepox 2030 two part epoxy. Epoxy was allowed to cure to taffy like consistency and excess was trimmed back using a stainless steel scalpel for mortar fills.</li> <li>■ <b>Fills and Replacements:</b> Losses were filled flush using Jahn M-120, lightly tinted with pigments, covered with plastic and misted for a minimum of three days. All original, decorative surfaces kept clean of over-smear.</li> <li>■ <b>Resetting:</b> The granite was raised and leveled on a crushed stone bed.</li> <li>■ <b>Joint:</b> The marble was set in a bed of mortar consisting of 1 part Saint Astier Naturally Hydraulic Lime 3.5 and 2.5 parts white silica sands. The end joints were pointed flush.</li> </ul>

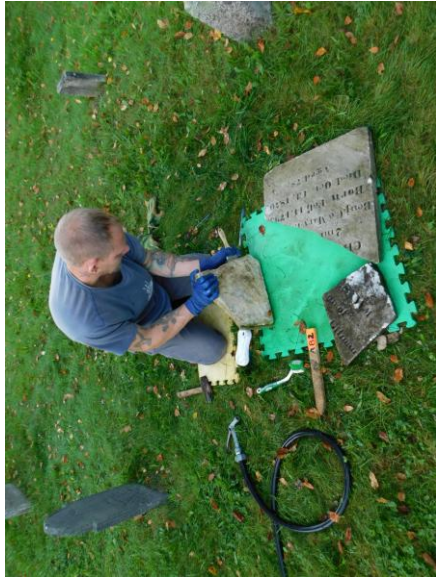
3. EWSC. A82. DT. Cleaning the marble sections with ReVive.
