**WINTER STREET CEMETERY  
CONSERVATION TREATMENT REPORT  
EXETER, NEW HAMPSHIRE**

**Submitted By:**            Conserve ART LLC  
                                  Francis Miller, Conservator  
                                  19 Lansdowne Avenue  
                                  Hamden, CT 06517  
                                  Cell:     203-506-6846  
                                  Email:   conserveartllc@gmail.com

**Date:**                        January 18, 2017

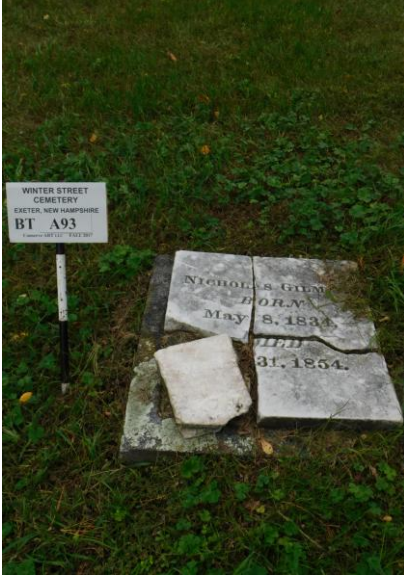
<b>Dimensions:</b> H: $\frac{24''}{30''}$ W: $\frac{18''}{24''}$ D: $\frac{2''}{7''}$				1. EWSC. 109. BT. Overview before treatment.		
<b>MARKER CONDITION</b>						
<p><input checked="" type="checkbox"/> <b>Surface Growth/Soiling:</b> Minor biological growths over the surfaces and in grain boundaries.</p> <p><input type="checkbox"/> <b>Stains:</b> There are soil stains on portions buried below grade.</p> <p><input checked="" type="checkbox"/> <b>Friable Stone:</b> Fine grain marble is lightly sugary to the touch, otherwise stone is sound.</p> <p><input type="checkbox"/> <b>Spalls:</b></p> <p><input type="checkbox"/> <b>Cracks:</b></p> <p><input checked="" type="checkbox"/> <b>Breaks:</b> The marble is broken into at least four sections; three were located on the base.</p> <p><input checked="" type="checkbox"/> <b>Losses:</b> There are losses along the break-line. The bottom, proper left corner is missing.</p> <p><input checked="" type="checkbox"/> <b>Hazardous Alignment:</b> The granite is misaligned.</p> <p><input type="checkbox"/> <b>Other:</b> The stone was buried too deeply to read the text.</p> <p><input type="checkbox"/> <b>Previous Repairs:</b> There is failed epoxy along break-line at grade from previous repair.</p>

- Surface Growth/Soiling:** Minor biological growths over the surfaces and in grain boundaries.
- Stains:** There are soil stains on portions buried below grade.
- Friable Stone:** Fine grain marble is lightly sugary to the touch, otherwise stone is sound.
- Spalls:**
- Cracks:**
- Breaks:** The marble has a single break.
- Losses:** There are losses along the break-line.
- Hazardous Alignment:** The marble was partially buried
- Other:** During removal of the marble it was found that the flush marker has a granite base.
- Previous Repairs:** There is failed epoxy along break-line at grade from previous repair.

- **General Soiling & Biological Growth Removal:** Surfaces washed with ProSoCo ReVive biological and atmospheric stain remover followed by water rinse.

- **Consolidation:** Marble was treated with ProSoCo HCT (Hydroxylating Conversion Treatment) a water borne treatment that provides bonds between weakened calcium carbonate stone grains. The material was applied in three cycles following the manufacturer’s recommended procedures.

- **Crack Injection:**
- **Repairs:** Stone fragments were mended using Akemi Akepox 2030 two part epoxy. Epoxy was allowed to cure to taffy like consistency and excess was trimmed back using a stainless steel scalpel for mortar fills.

- **Fills and Replacements:** Losses were filled flush using Jahn M-120, lightly tinted with pigments, covered with plastic and misted for a minimum of three days. All original, decorative surfaces kept clean of over-smear.

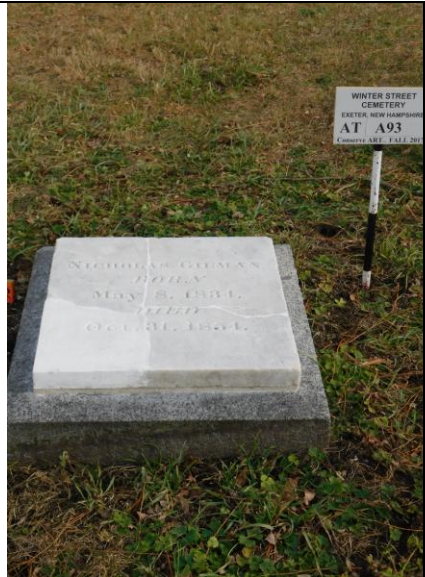
2. EWSC. A93. AT. Overview after treatment of the marble and granite base.

<b>PERSONNEL</b>		Francis Miller, Silas Finch			
<b>PROJECT DATES</b>		<b>Begin:</b> Summer 2017		<b>Complete:</b> Fall 2017	
<p><b>MARKER TREATMENTS</b></p> <ul style="list-style-type: none"> <li>■ <b>General Soiling &amp; Biological Growth Removal:</b> Surfaces washed with ProSoCo ReVive biological and atmospheric stain remover followed by water rinse.</li> <li>■ <b>Consolidation:</b> Marble was treated with ProSoCo HCT (Hydroxylating Conversion Treatment) a water borne treatment that provides bonds between weakened calcium carbonate stone grains. The material was applied in three cycles following the manufacturer's recommended procedures.</li> <li>□ <b>Crack Injection:</b></li> <li>■ <b>Repairs:</b> Stone fragments were mended using Akemi Akepox 2030 two part epoxy. Epoxy was allowed to cure to taffy like consistency and excess was trimmed back using a stainless steel scalpel for mortar fills.</li> <li>■ <b>Fills and Replacements:</b> Losses were filled flush using Jahn M-120, lightly tinted with pigments, covered with plastic and misted for a minimum of three days. All original, decorative surfaces kept clean of over-smear.</li> <li>■ <b>Resetting:</b> The granite was raised and leveled on a crushed stone bed.</li> <li>■ <b>Joint:</b> The marble was set in a bed of mortar consisting of 1 part Saint Astier Naturally Hydraulic Lime 3.5 and 2.5 parts white silica sands. The end joints were pointed flush.</li> </ul>

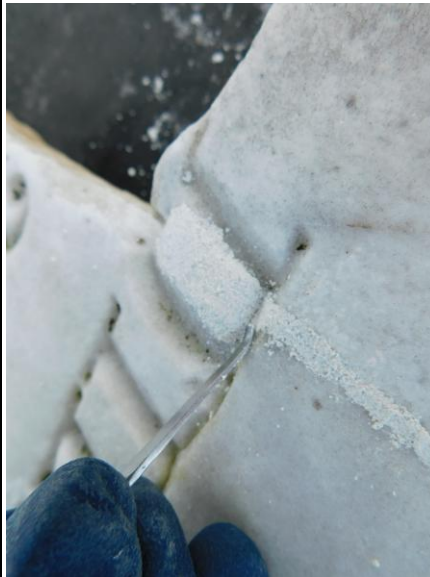
7. EWSC. A93. DT. Detail of filling losses with Jahn mortar.

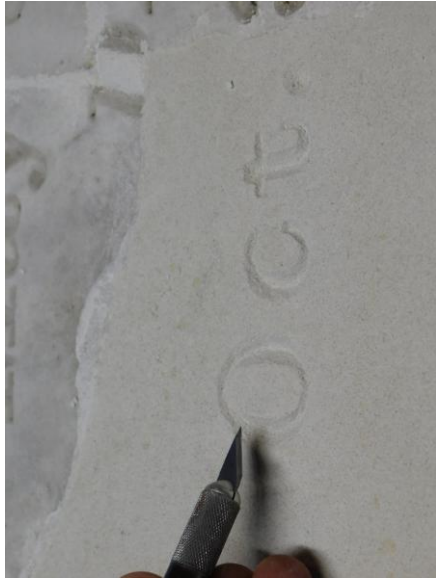
9. EWSC. A93. DT. Carving text in replacement element.

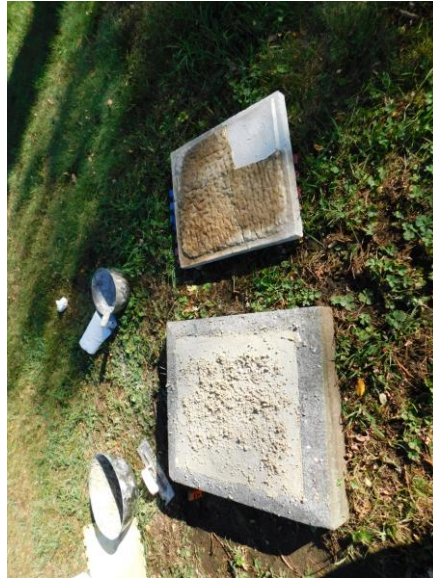
10. EWSC. A93. DT. Mortar bed on granite.

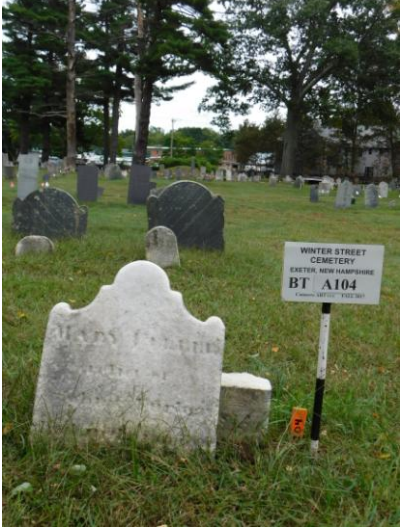
<b>Dimensions:</b> H: 24"    W: 16"    D: 2"			1. EWSC. A104. BT. Overview before treatment.

- **Surface Growth/Soiling:** Minor biological growths over the surfaces and in grain boundaries.
- **Stains:** There are soil stains on portions buried below grade.
- **Friable Stone:** Fine grain marble is lightly sugary to the touch, otherwise stone is sound.
- Spalls:**
- Cracks:**
- **Breaks:** Stone has a break at mid-stone.
- **Losses:** There are losses along the break-line.
- Hazardous Alignment:**
- **Other:** The stone was buried too deeply to read the text.
- Previous Repairs:** There is failed epoxy along break-line at grade from previous repair.

<b>PERSONNEL</b>		Francis Miller, Silas Finch				
<b>PROJECT DATES</b>		<b>Begin:</b> Summer 2017		<b>Complete:</b> Fall 2017		
<p><b>MARKER TREATMENTS</b></p> <p><input checked="" type="checkbox"/> <b>General Soiling &amp; Biological Growth Removal:</b> Surfaces washed with ProSoCo ReVive biological and atmospheric stain remover followed by water rinse.</p> <p><input checked="" type="checkbox"/> <b>Consolidation:</b> Marble was treated with ProSoCo HCT (Hydroxylating Conversion Treatment) a water borne treatment that provides bonds between weakened calcium carbonate stone grains. The material was applied in three cycles following the manufacturer's recommended procedures.</p> <p><input type="checkbox"/> <b>Crack Injection:</b></p> <p><input checked="" type="checkbox"/> <b>Repairs:</b> Stone fragments were mended using Akemi Akepox 2030 two part epoxy. Epoxy was allowed to cure to taffy like consistency and excess was trimmed back using a stainless steel scalpel for mortar fills.</p> <p><input checked="" type="checkbox"/> <b>Fills:</b> Losses were filled flush using Jahn M-120, lightly tinted with pigments, covered with plastic and misted for a minimum of three days. All original, decorative surfaces kept clean of over-smear.</p> <p><input checked="" type="checkbox"/> <b>Resetting:</b> Marker reset in earth to read text.</p>

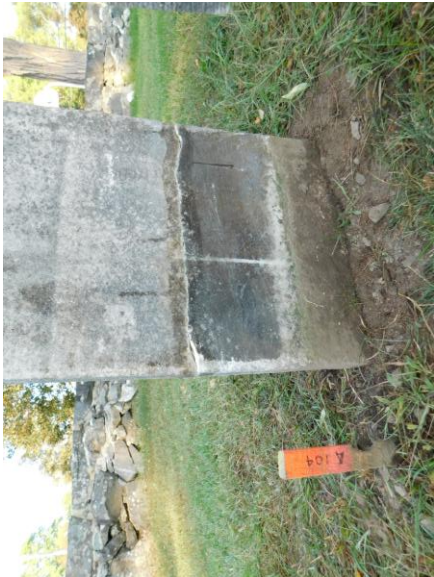
6. EWSC. A104. DT. Stone mended. Note release on marble faces.

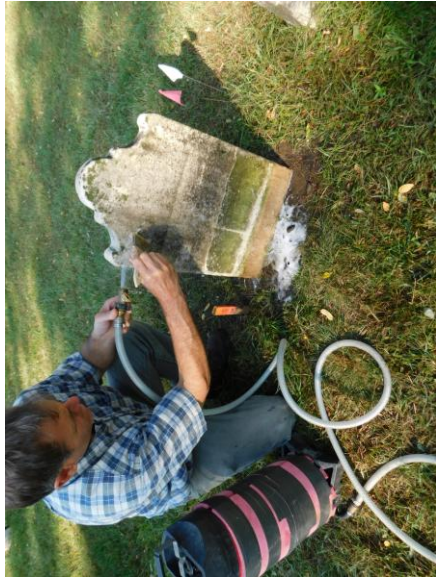
9. EWSC. A104. DT. Cleaning marble with ReVive.

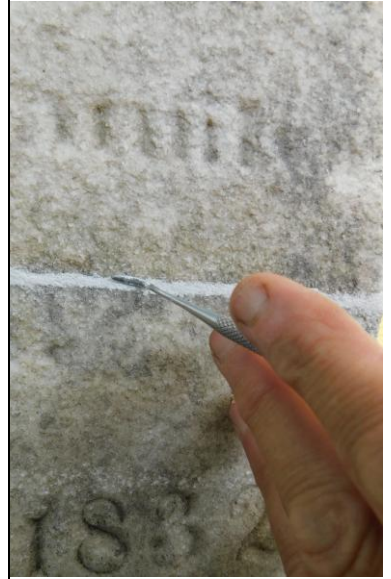
11. EWSC. A104. DT. Break-line during fills.

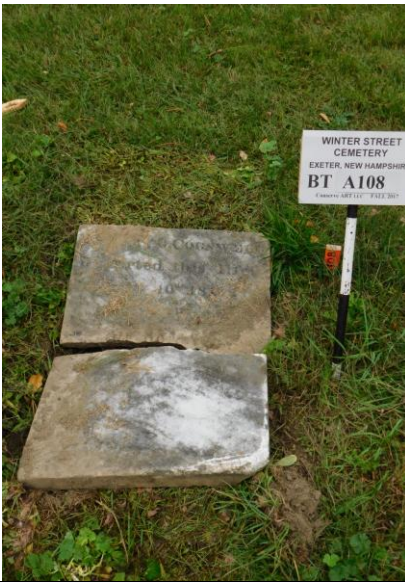
<b>Priority (1-5):</b>		1:high - 5:low	NA		
<b>Dimensions: H:</b> 24" <b>W:</b> 18" <b>D:</b> 2"				1. EWSC. A108. BT. Overview before treatment.	
<b>MARKER CONDITION</b>					
<ul style="list-style-type: none"> <li>■ <b>Surface Growth/Soiling:</b> Minor biological growths over the surfaces and grain in boundaries.</li> <li>■ <b>Stains:</b> There are soil stains on portions buried below grade.</li> <li>■ <b>Friable Stone:</b> Fine grain marble is lightly sugary to the touch, otherwise stone is sound.</li> <li><input type="checkbox"/> <b>Spalls:.</b></li> <li><input type="checkbox"/> <b>Cracks:</b></li> <li>■ <b>Breaks:</b> Stone has a break at mid-stone.</li> <li>■ <b>Losses:</b> There are losses along the break-line.</li> <li>■ <b>Hazardous Alignment:</b></li> <li>■ <b>Other:</b> The stone had three levels of foundations below grade. The lowest level was stone, the mid-level was brick and the upper level was concrete and rubble.</li> <li>■ <b>Previous Repairs:</b> There is failed cement along break-line from previous repair.</li> </ul>

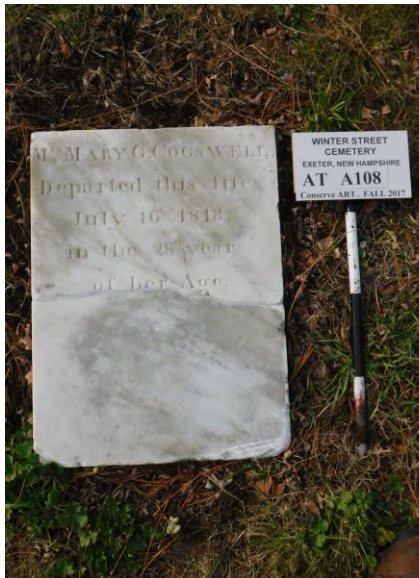
2. EWSC. A108. AT. Overview after treatment.

<b>PERSONNEL</b>		Francis Miller, Silas Finch			
<b>PROJECT DATES</b>		<b>Begin:</b> Summer 2017 <b>Complete:</b> Fall 2017			
<p><b>MARKER TREATMENTS</b></p> <p><b>■ General Soiling &amp; Biological Growth Removal:</b> Surfaces washed with ProSoCo ReVive biological and atmospheric stain remover followed by water rinse.</p> <p><b>■ Consolidation:</b> Marble was treated with ProSoCo HCT (Hydroxylating Conversion Treatment) a water borne treatment that provides bonds between weakened calcium carbonate stone grains. The material was applied in three cycles following the manufacturer's recommended procedures.</p> <p><input type="checkbox"/> <b>Crack Injection:</b></p> <p><b>■ Repairs:</b> Stone fragments were mended using Akemi Akepox 2030 two part epoxy. Epoxy was allowed to cure to taffy like consistency and excess was trimmed back using a stainless steel scalpel for mortar fills.</p> <p><b>■ Fills:</b> Losses were filled flush using Jahn M-120, lightly tinted with pigments, covered with plastic and misted for a minimum of three days. All original, decorative surfaces kept clean of over-smear.</p> <p><b>■ Resetting:</b> The various levels of foundation were reset and the marble brought to grade in a bed of crushed stone. Crushed stone was used to enhance drainage for the horizontal marble slab.</p>

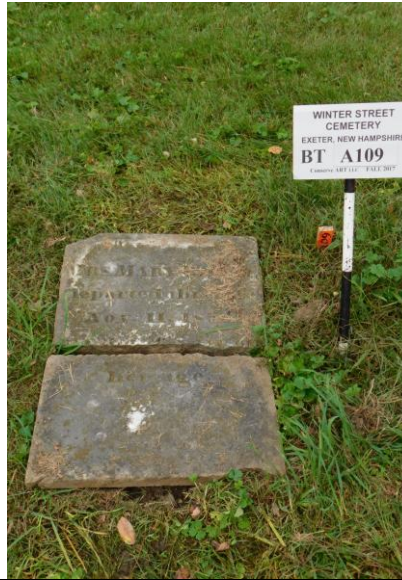
1. EWSC. 109. BT. Overview before treatment.

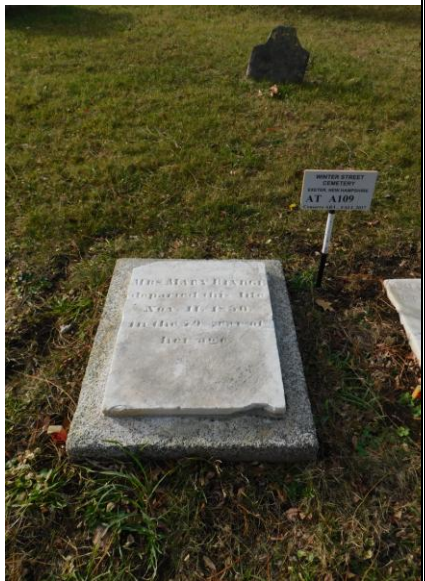
3. EWSC. A109. AT. Overview after treatment.

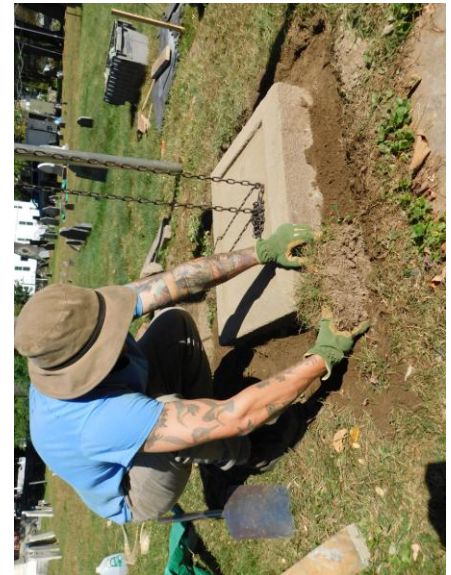
9. EWSC. A109. DT. Replanting sod along granite base.

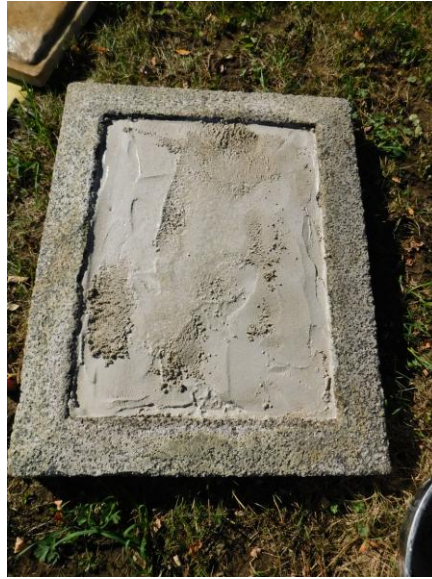
11. EWSC. A109. DT. Overview of granite ready for setting in mortar.

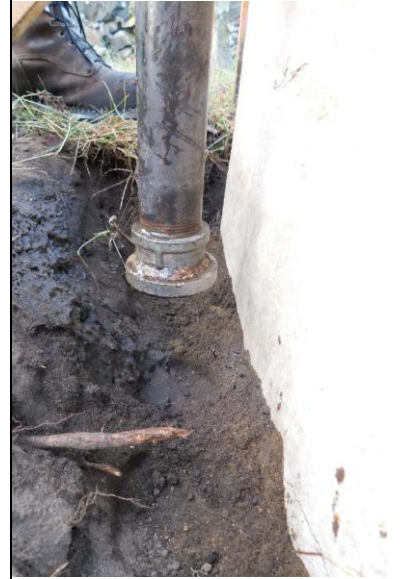
11. EWSC. A126. DT. Tamping earth around marble.

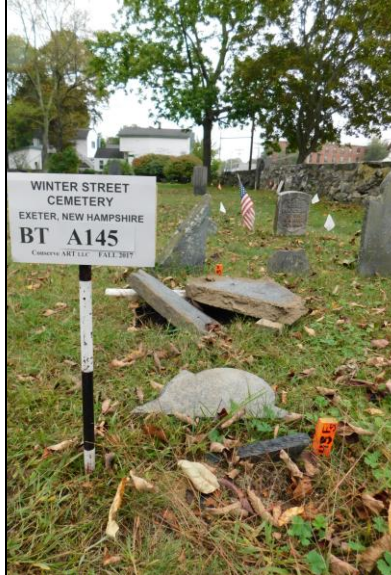
1. EWSC. A145 FS. BT. Front overview before treatment.

- Surface Growth/Soiling:** There are soil stains on portions buried below grade.
- Stains:**
- Friable Stone:**
- Spalls:**
- Cracks:** There are hairline cracks in the slate along stone anomalies.
- Breaks:** Stone has a central break grade.
- Losses:** .
- Hazardous Alignment:**
- Other:**

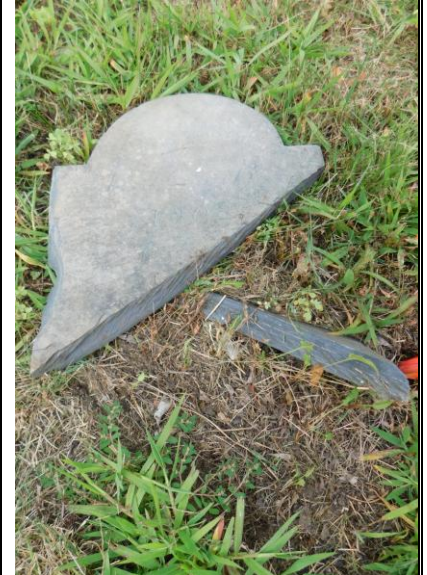
2. EWSC. A145 FS. BT. Top view before treatment.

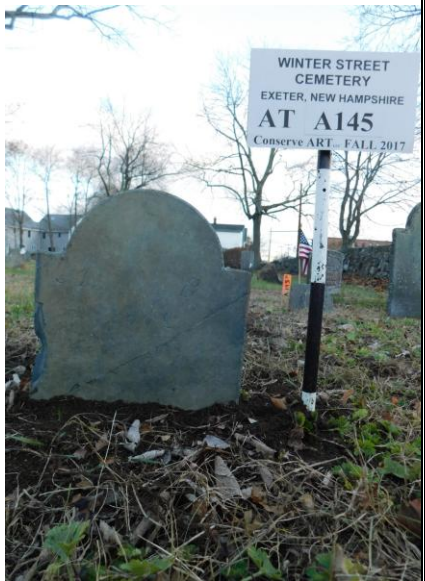
3. EWSC. A145 FS. AT. Front overview after treatment.

- **General Soiling & Biological Growth Removal:** Surfaces washed with ProSoCo ReVive biological and atmospheric stain remover followed by water rinse.
- **Consolidation:**
- **Crack Injection:**
- **Repairs:** Stone fragments were mended using Akemi Akepox 2030 two part epoxy. Epoxy was allowed to cure to taffy like consistency and excess was trimmed back using a stainless steel scalpel. The trim was flush and left minor fill with additional epoxy.
- **Fills/patches:**
- **Resetting:** Reset in the earth in found location behind headstone.

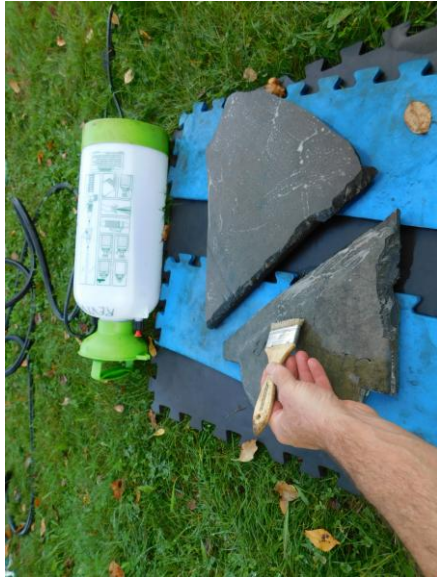
4. EWSC. A145 FS. DT. Cleaning slate with ReVive.

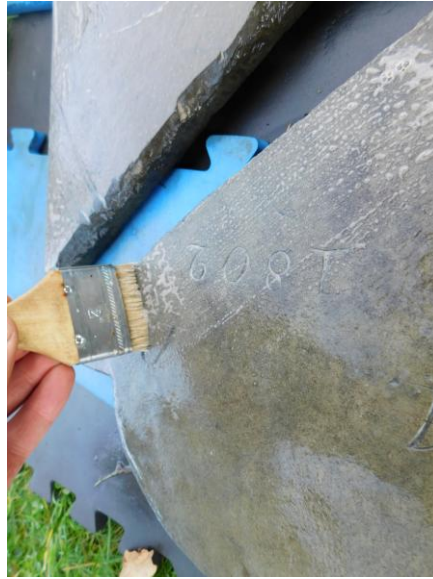
5. EWSC. A145 FS. DT. Cleaning slate with ReVive, detail.

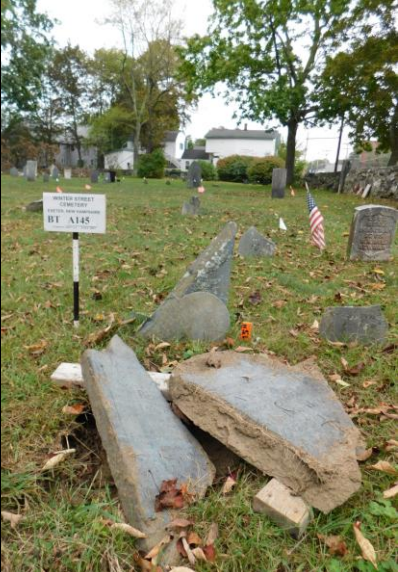
<p><b>Dimensions: H:</b> 30"    <b>W:</b> 20"    <b>D:</b> 2"</p>		<p>I. EWSC. A145 FS. BT. Front overview before treatment.</p>

- **Surface Growth/Soiling:** There are soil stains on portions buried below grade.
- Stains:**
- Friable Stone:**
- Spalls:**
- **Cracks:** There are hairline cracks in the slate along stone anomalies.
- **Breaks:** Stone is broken into five sections. Two of the breaks are still well adhered with epoxy.
- **Losses:** There are losses along the break-lines.
- **Hazardous Alignment:** The marker was misaligned and leaning
- **Other:** The stones joined by a previous epoxy repair are misaligned, not allowing to adhere the currently detached sections in appropriate alignment with carved text and detail. The existing epoxy fragments are being separated with organic solvents before proceeding with additional treatment.

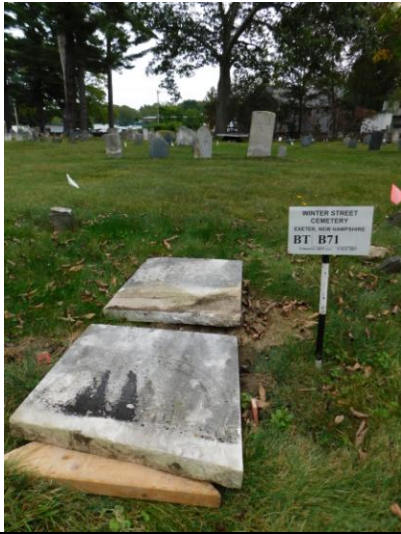
<b>Dimensions:</b> H: 22"    W: 18"    D: 1 1/2"				1. EWSC. B71. BT. Overview before treatment.

- **Surface Growth/Soiling:** Minor biological growths over the surfaces and grain in boundaries.
- **Stains:** There are soil stains on portions buried below grade.
- **Friable Stone:** Fine grain marble is lightly sugary to the touch, otherwise stone is sound.
- Spalls:**
- Cracks:**
- **Breaks:** Stone has a break at mid-stone.
- **Losses:** There are losses along the break-line.
- Hazardous Alignment:**
- **Other:** The stone was buried too deeply to read the text.
- Previous Repairs:** There is failed epoxy along break-line at grade from previous repair.

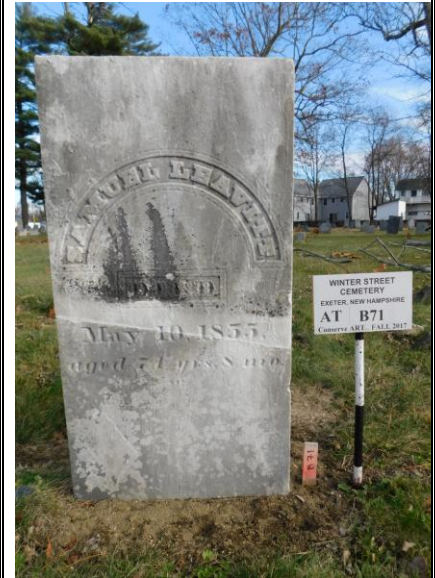
2. EWSC. B71. AT. Overview after treatment.

- Crack Injection:**
- **Repairs:** Failed adhesive removed by hammer and chisel and by Dremel. Stone fragments were mended using Akemi Akepox 2030 two part epoxy. Epoxy was allowed to cure to taffy like consistency and excess was trimmed back using a stainless steel scalpel for mortar fills.

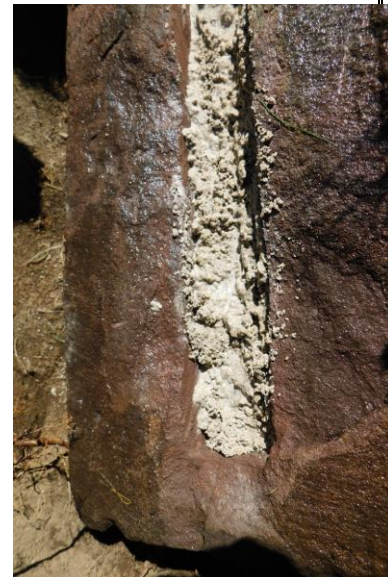
8. EWSC. B71. DT. Mortise with NHL 3.5 for setting marble.

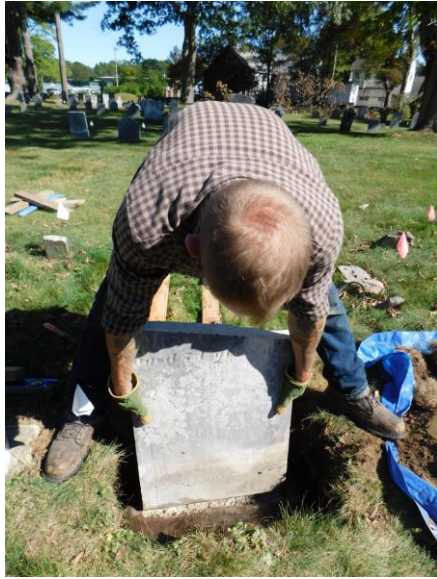
9. EWSC. B71. DT. Setting marble in mortise with NHL 3.5.

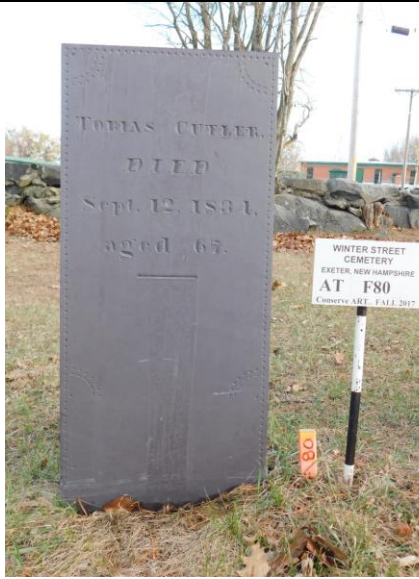
- Surface Growth/Soiling:** There are small organic growths on the purple marble.
- Stains:**
- Friable Stone:**
- Spalls:**
- Cracks:**
- Breaks:**
- Losses:**
- Hazardous Alignment:**
- Other:** The marker had thick tar poured over the top that defaced the front and back of the slate.

3. EWSC. F80. AT. Front overview after treatment.

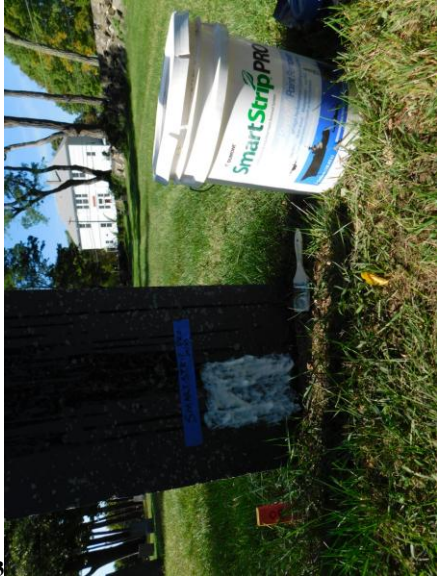
4. EWSC. F80. DT. First stripping test with Smart Strip Pro.

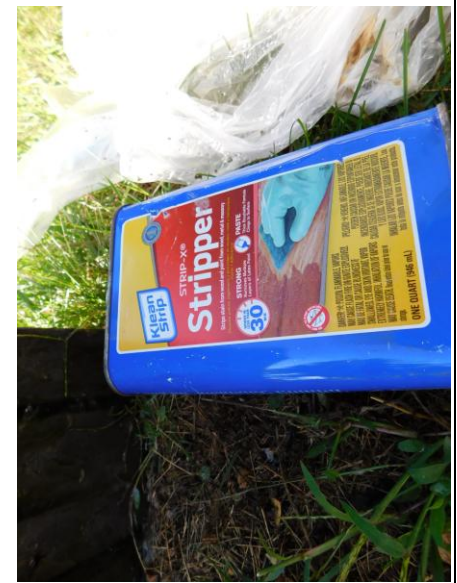
9. EWSC. F80. DT. Second stripping test on back showing container.

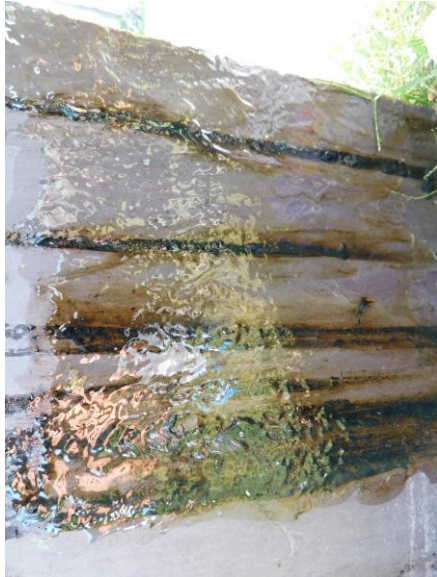
10. EWSC. F80. DT. Second stripping test on back before rinsing, detail.

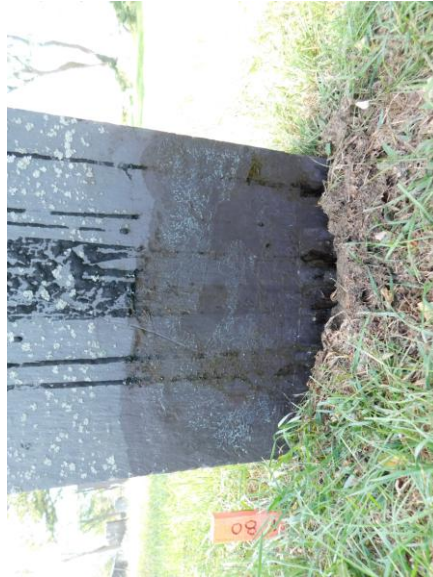
11. EWSC. F80. DT. Second stripping test on back before rinsing.

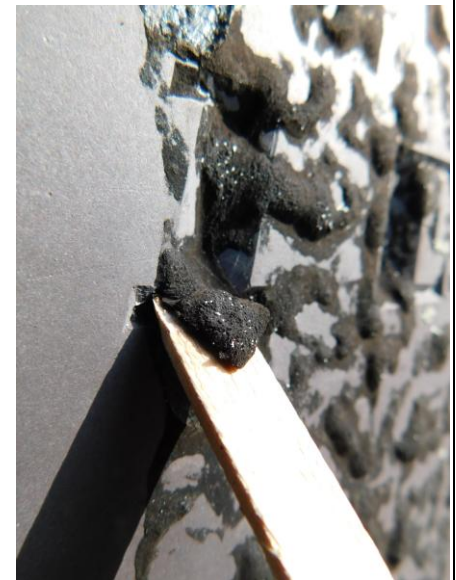
15. EWSC. F80. DT. Detail of scraping tar with wood popsicle stick.

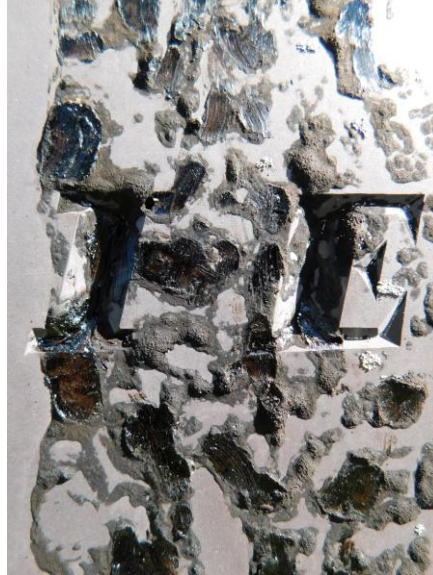
17. EWSC. F80. DT. Front detail after scrapping with wood popsicle sticks.

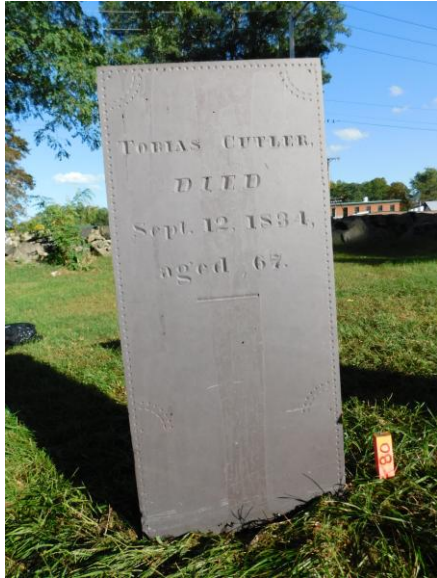
22. EWSC. F80. DT. Overview after three applications.

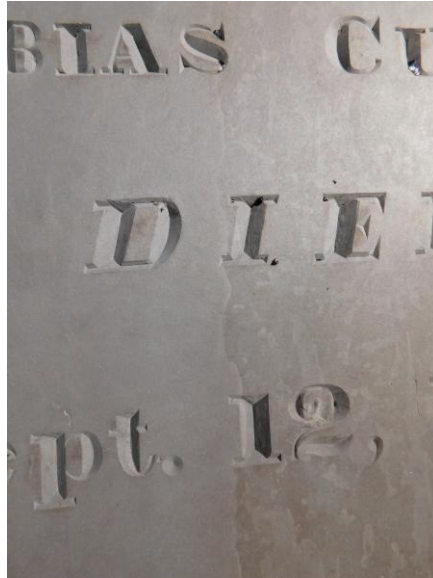
23. EWSC. F80. DT. Small tar accumulations in carving detail.

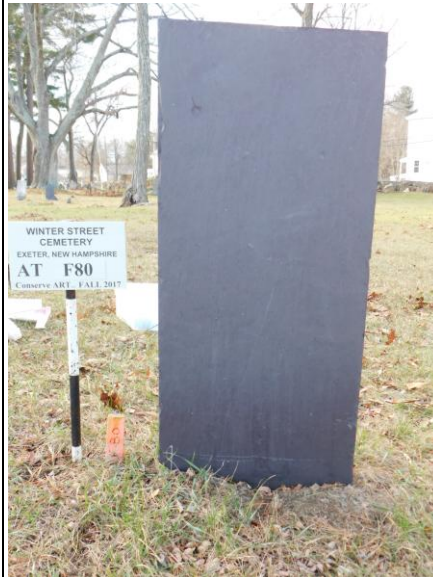
26. EWSC. F80. AT. Back overview after treatment.
