Leathers & Associates

Planet Playgroud - Exeter, NH

General Playground

This assessment is based on a site visit meeting with Michael Favreau. The playground is 17.5 years old. The playground should be expected to last around 20 years with proper maintenance. It's apparent from its condition that this playground is a well-used attraction in the area. There is a strong emotional connection with the community and the playground.

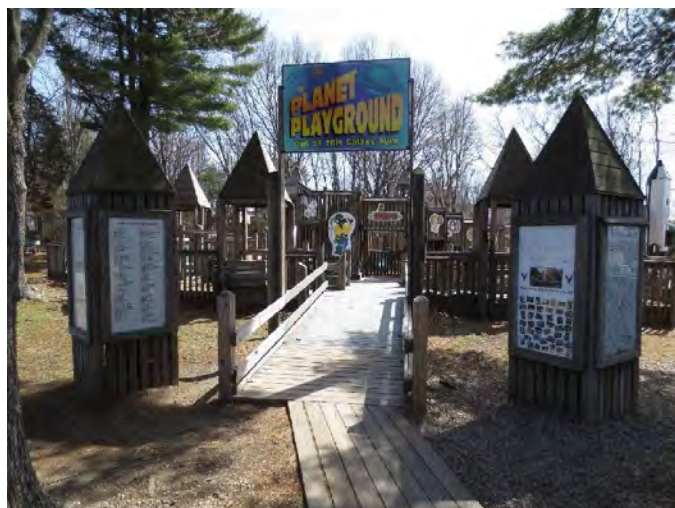
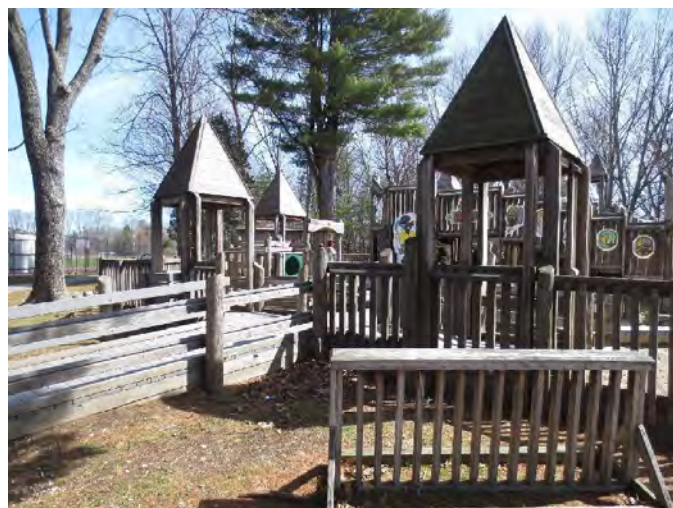
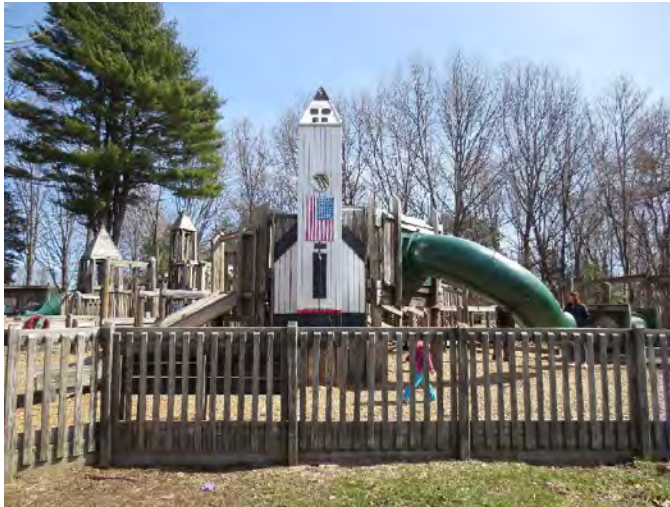
Overview

This is not a full playground audit, but a subjective assessment of your playgrounds condition and our professional recommendations.

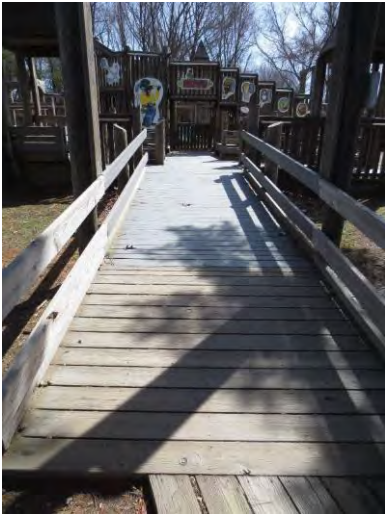
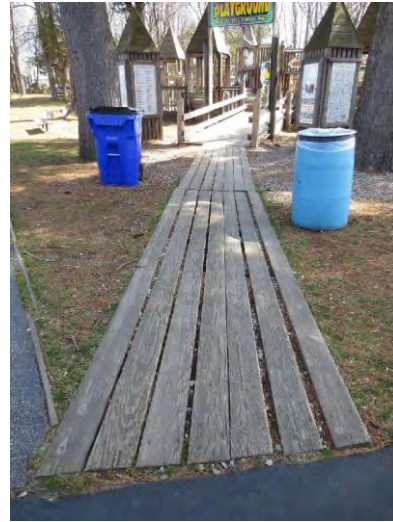
The fence is in poor condition (major splintering, missing pickets and wear).

Replace with new all plastic fence.

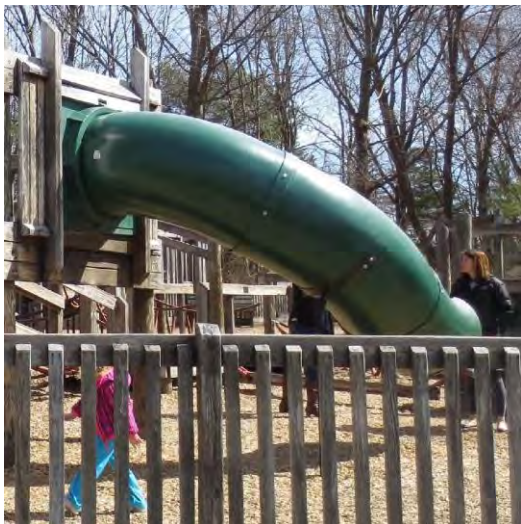
Slide #1 (Type & Condition)

Left Turn Tube Slide

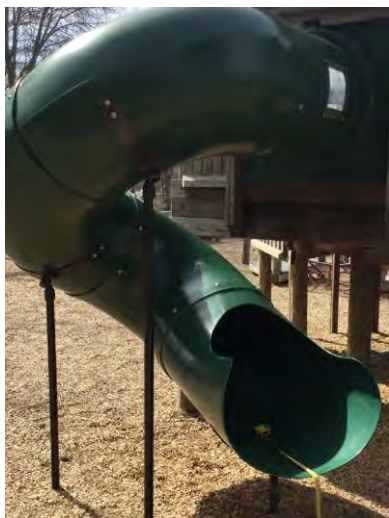
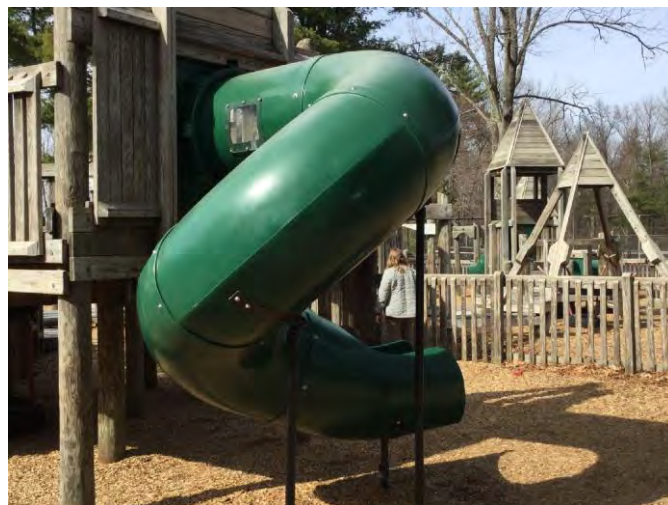
Slide #2 (Type & Condition)

Spiral Tube Slide

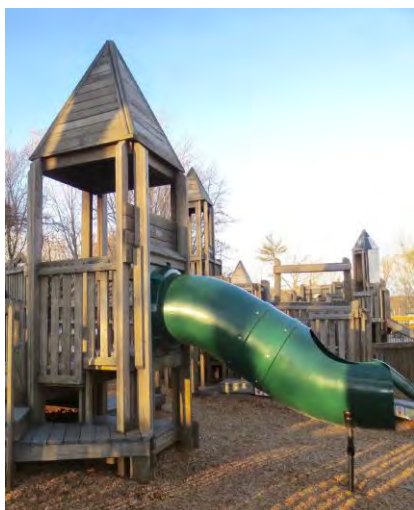
Slide #3 (Type & Condition)

Tot Tube Slide

Slide #3 Is the slide exit height between 7"-15" from minimum safety surfacing.

Non-Compliant

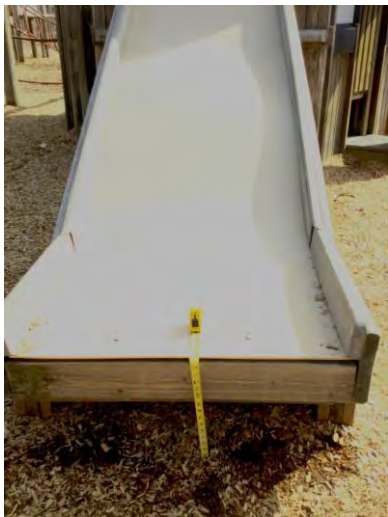
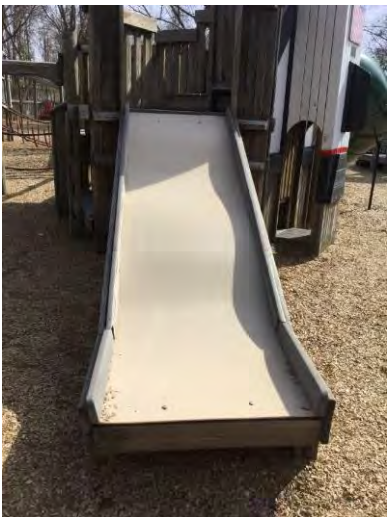
Slide #4 (Type & Condition)

Wave Slide (Site Built)

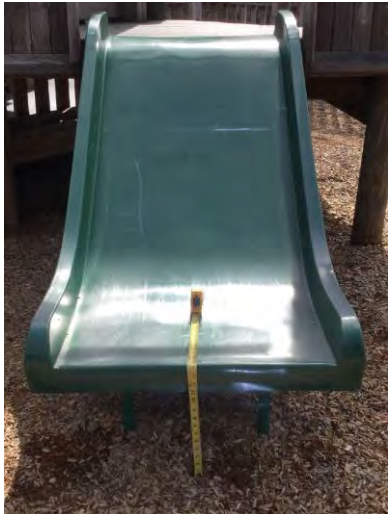
Slide #5 (Type & Condition)

Tot Slide

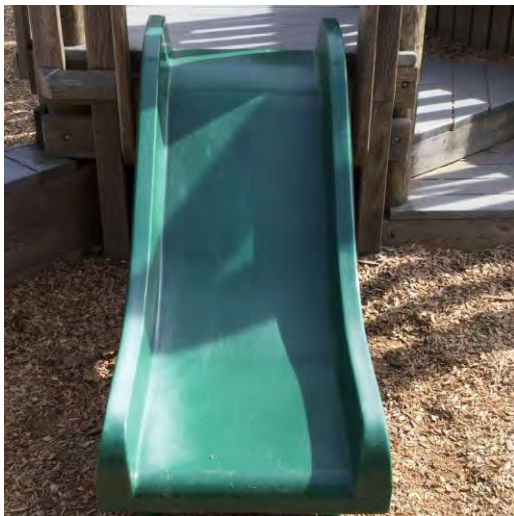
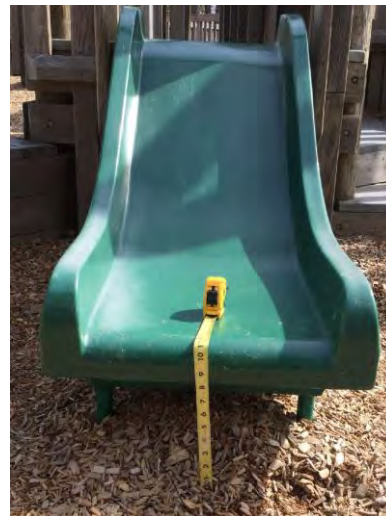
Slide #6 (Type & Condition)

Tot "Mini" Slide

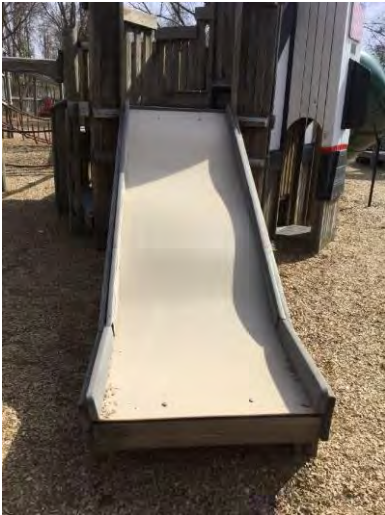
Slide #1 (Type & Condition)

Bumpy Slide (See slide #4 under Manufactured Slides0

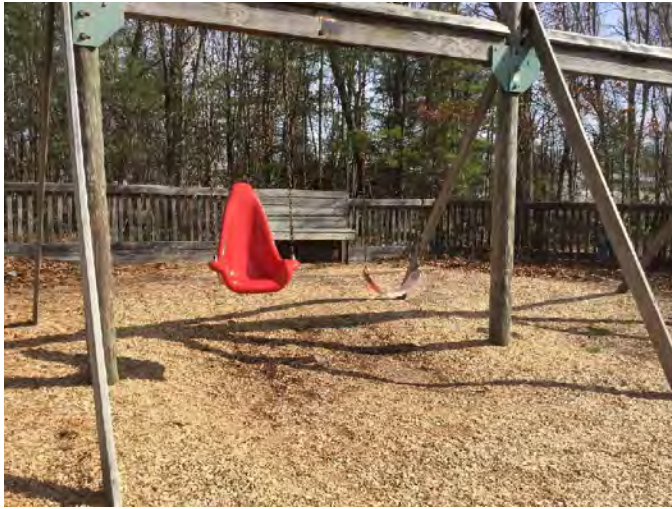
Swing support brackets and swing connected swing beams show sagging and wear due to 18 year of use. We recommend a full replacement.

Swing chains are rusted.

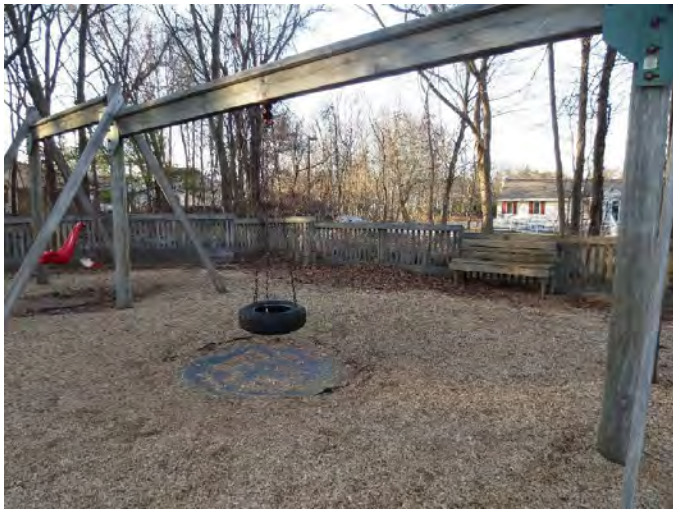
Are all components accounted for	Compliant
<hr/>	
Are support footings stable and buried below the protective surfacing materials	Compliant
<hr/>	
Is the swing support structure in good repair, secure with no noted movement	Non-Compliant
<div>Swing beam brackets and bolts show wear as mentioned above.</div> <div>Has the fault been repaired?No</div>	
<hr/>	
Are swing seats in good condition, no cracks, splits or damage	Compliant
<hr/>	
Are swing fasteners (S-hooks, lock devices, etc.) in good condition and fully closed	Non-Compliant
<div>As mentioned above.</div> <div>Has the fault been repaired?No</div>	
<hr/>	
Are swing support hangers in good condition and fully closed	Non-Compliant
<div>Swing hanger shows signs of wear from use.</div> <div>Has the fault been repaired?No</div>	
<hr/>	
Are swing support chains in good condition with no obvious wear or damage noted	Non-Compliant
<div>Swing chains are rusted.</div> <div>Has the fault been repaired?No</div>

Replace with new manufactured equipment

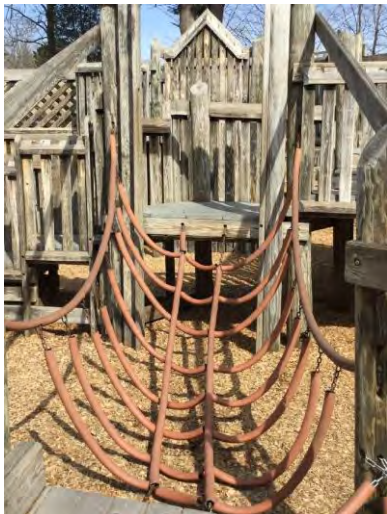
Chain Ladder

Replace with new cable version. There are 2 of these. The smaller one is labeled "chain cargo net" (near the sand digger) was built as a chain ladder rather than a cargo net.

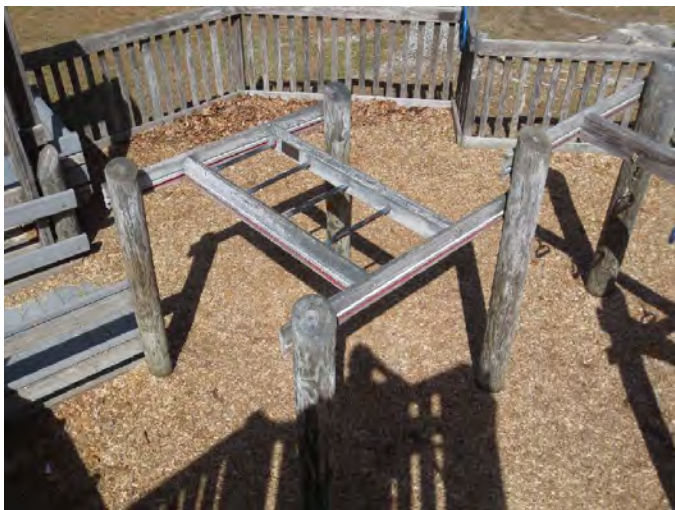
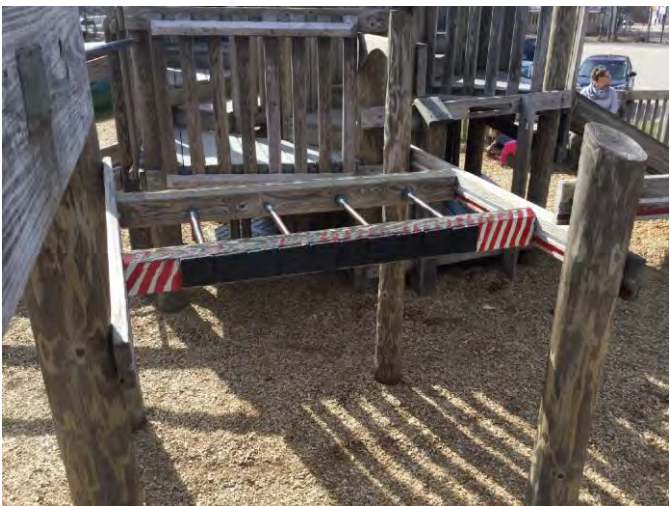
There are 2 low ladders. Replace both with new manufactured equipment.

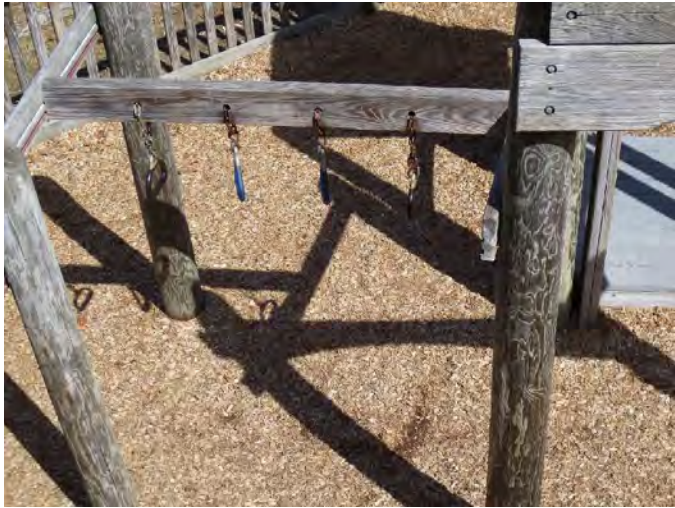
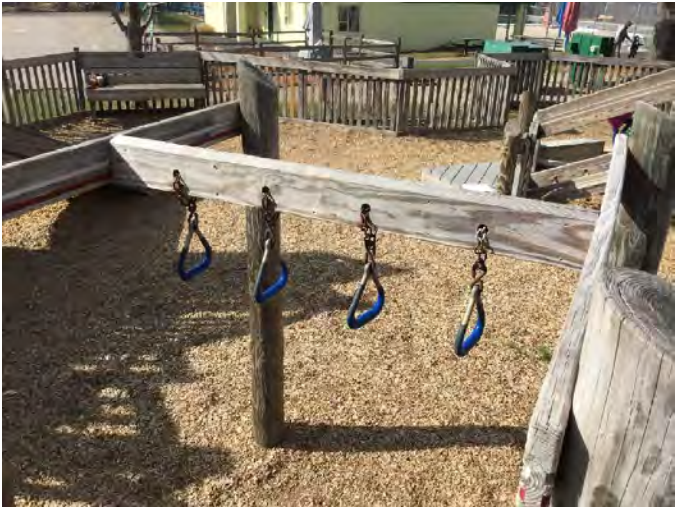
There are 2 sets of low rings. Replace both with new manufactured equipment. Replace with new manufactured equipment

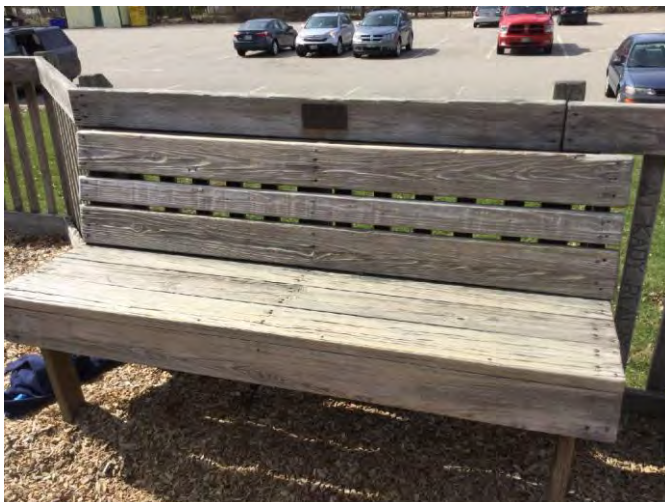
Replace with new. All benches are in very poor condition.
