FACILITY CONDITION ASSESSMENT

Town of Exeter New Hampshire
10 Front Street
Exeter, New Hampshire 03833-2737
Russell Dean

Public Works Campus
13 Newfields Road
Exeter, New Hampshire 03833

July 28, 2023

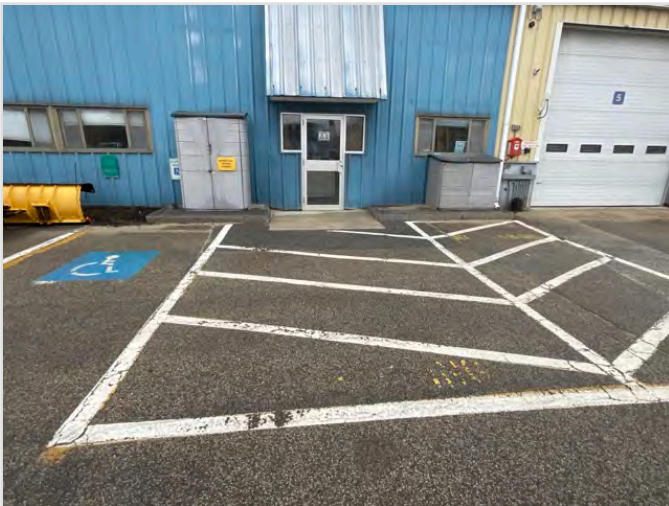
ACCESSIBLE PATH

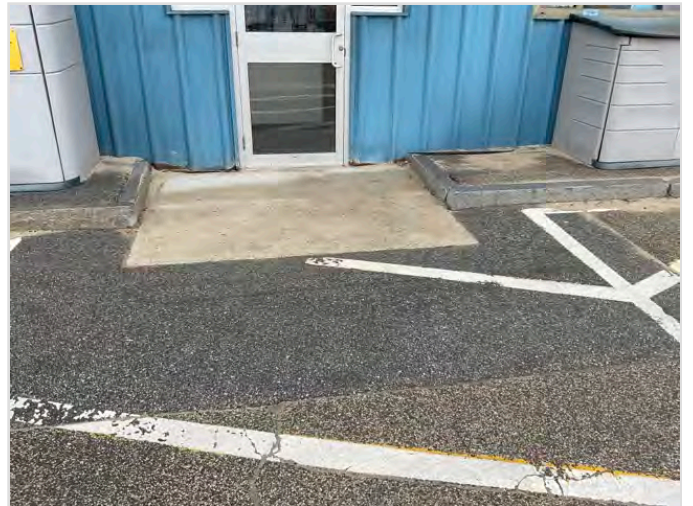
CURB CUT

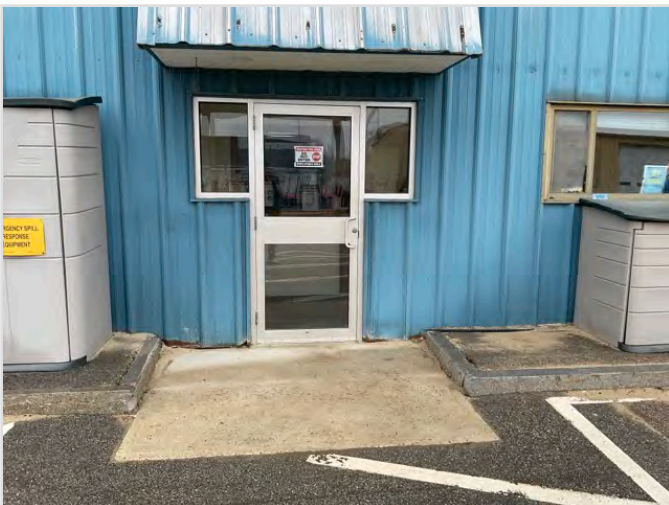
MAIN ENTRANCE

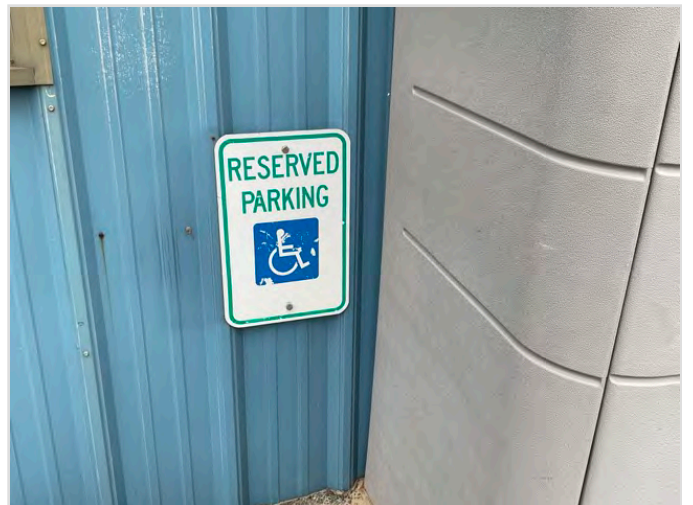
SIGNAGE

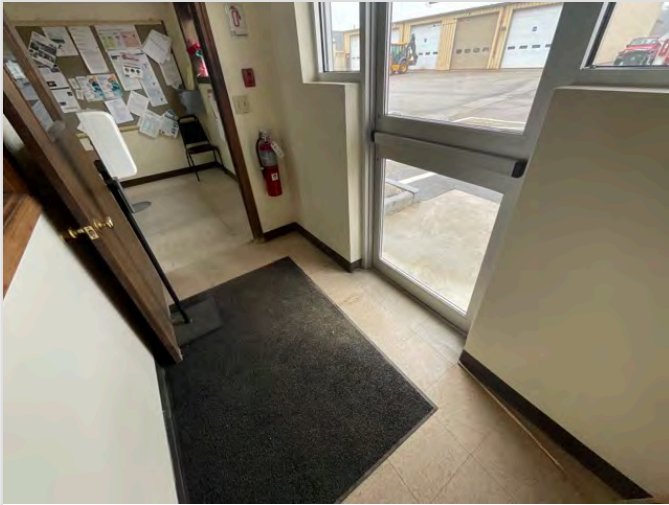
ACCESSIBLE INTERIOR PATH

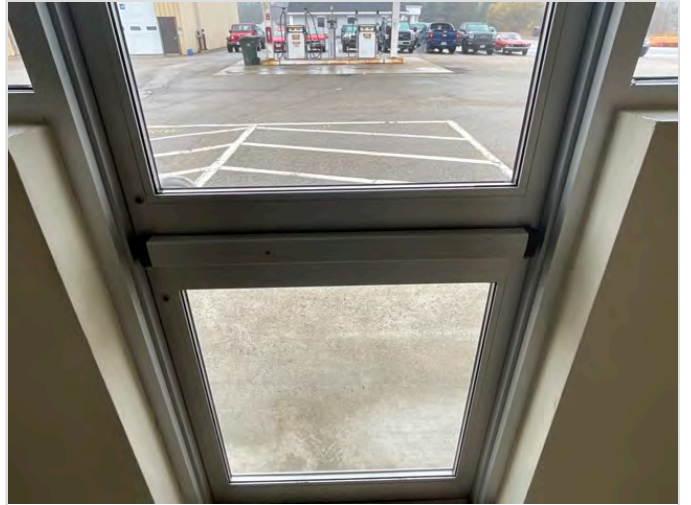
DOOR HARDWARE

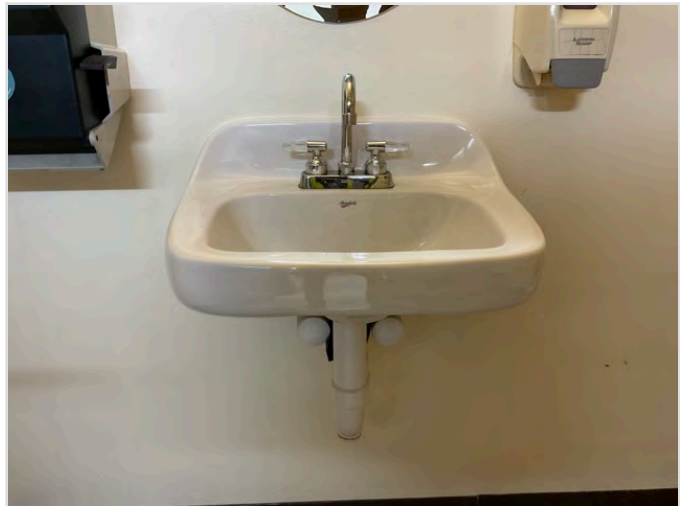
SINK, FAUCET HANDLES AND ACCESSORIES

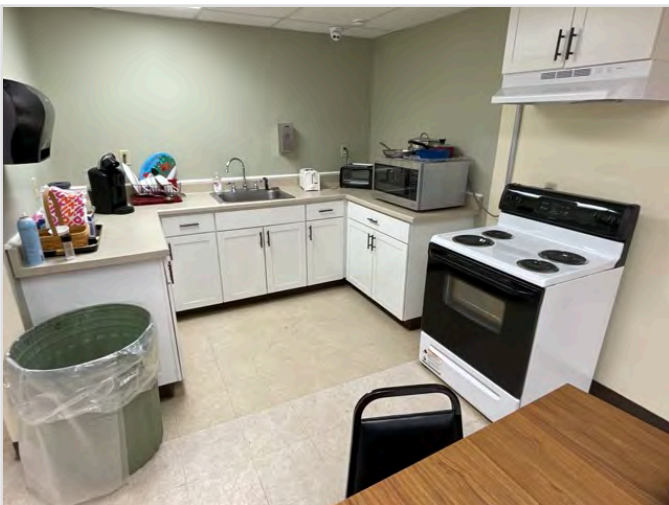
KITCHEN OVERVIEW

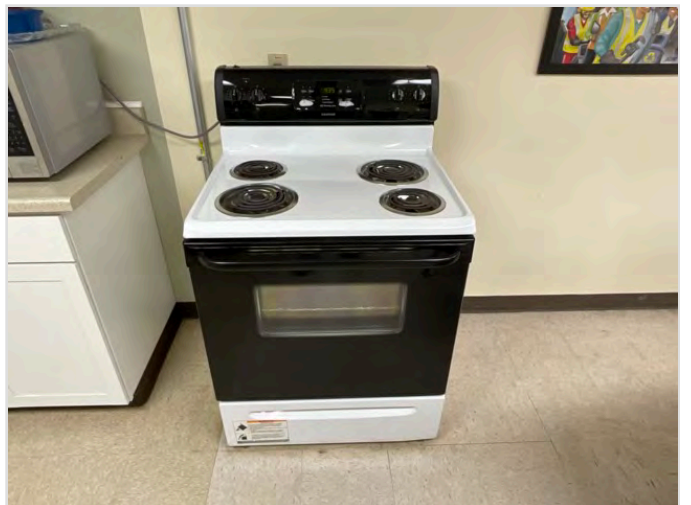
OVEN WITH CONTROLS
